Chapter 10

Damage to Ports and Coastal Facilities

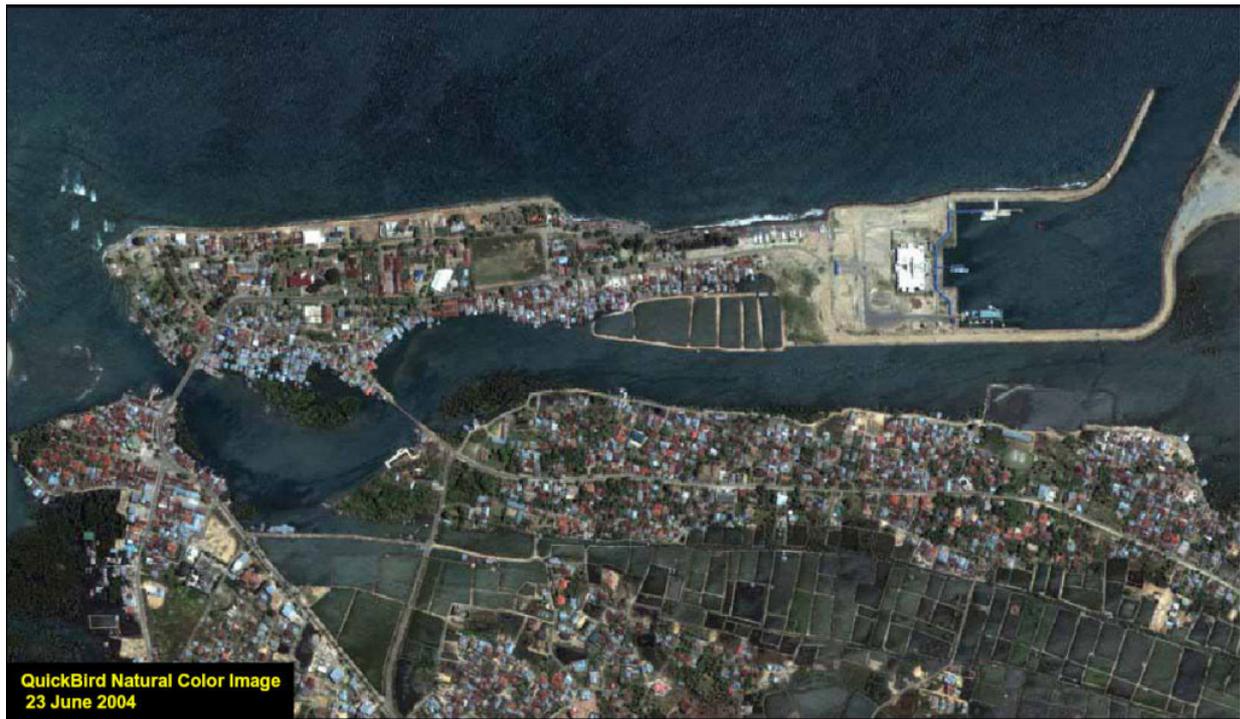
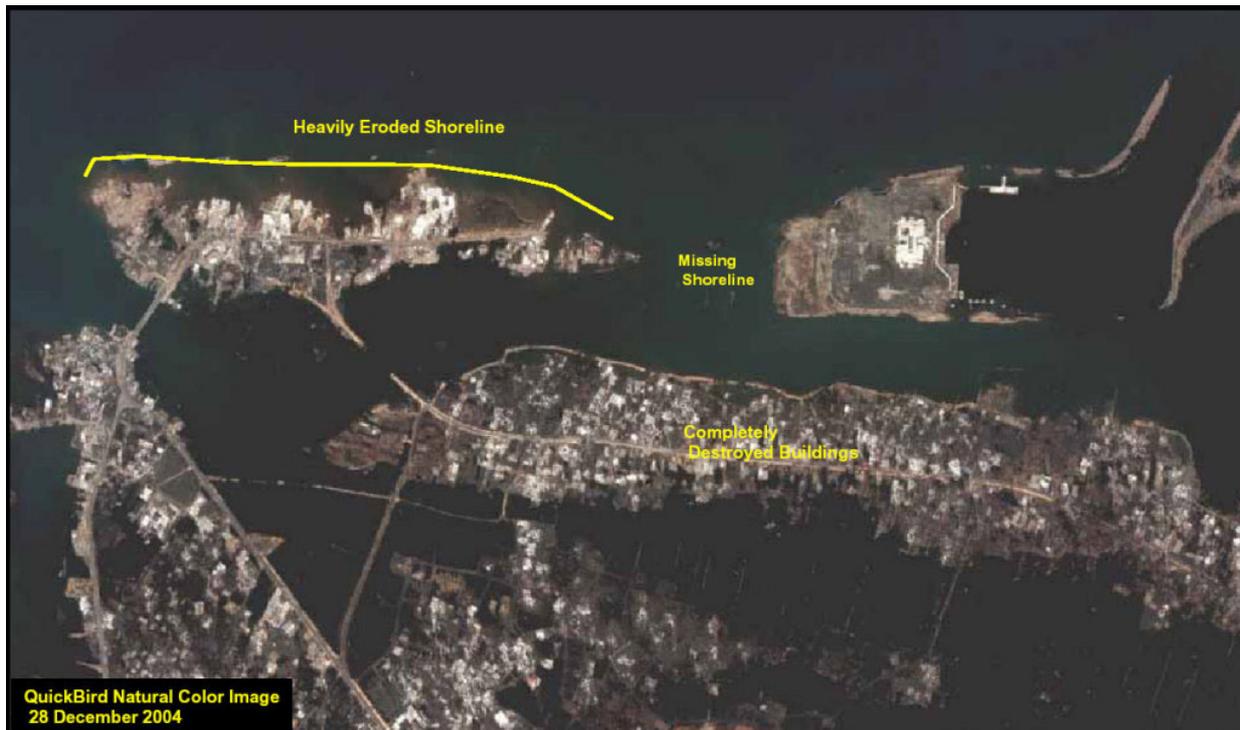
Figure 10.2 show satellite views of Banda Aceh port before and after the earthquake. As noticed from the comparison of two satellite views, a huge area was damaged by the tsunami and was settled, eroded and scoured due to probably ground liquefaction induced by ground shaking as well as due to the tsunami waves. The ground consists of sandy soil in this area. It is also of great interest that some parts of the dykes of the harbor disappeared. Besides the effects of liquefaction, the flow direction of tsunami waves might have some damaging effects on the missing section of the dykes.

Figure 10.2 Satellite views of Ulee Lheue port before and after the earthquake

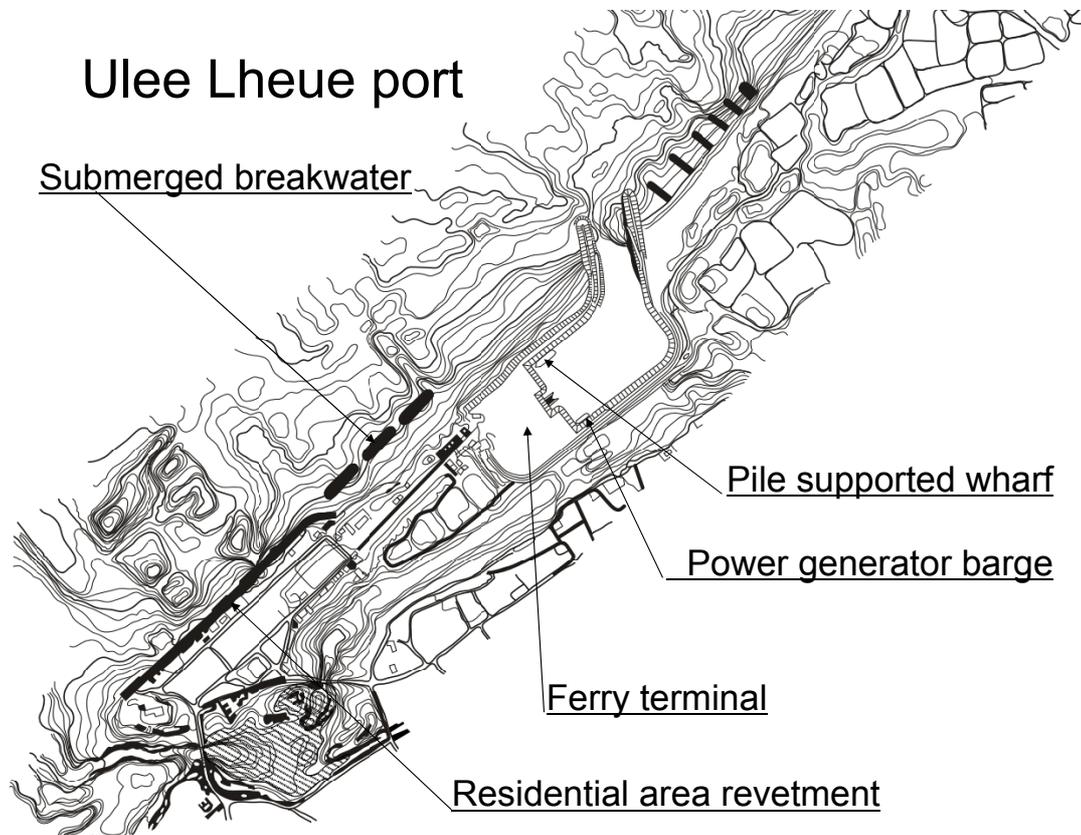
Figure 10.3 Plan View of Ulee Lheue Port

The plan view of Ulee Lheue port is shown in Figure 10.3 and 10.4. The residential area is protected by rubble stone (2000kg-3500kg) revetment with gentle slope as shown in Figure 10.5. The severely damaged missing area between residential area and the ferry terminal is used as small boat/fishery boat access port with submerged breakwater as shown in Figures 10.4 and 10.5.

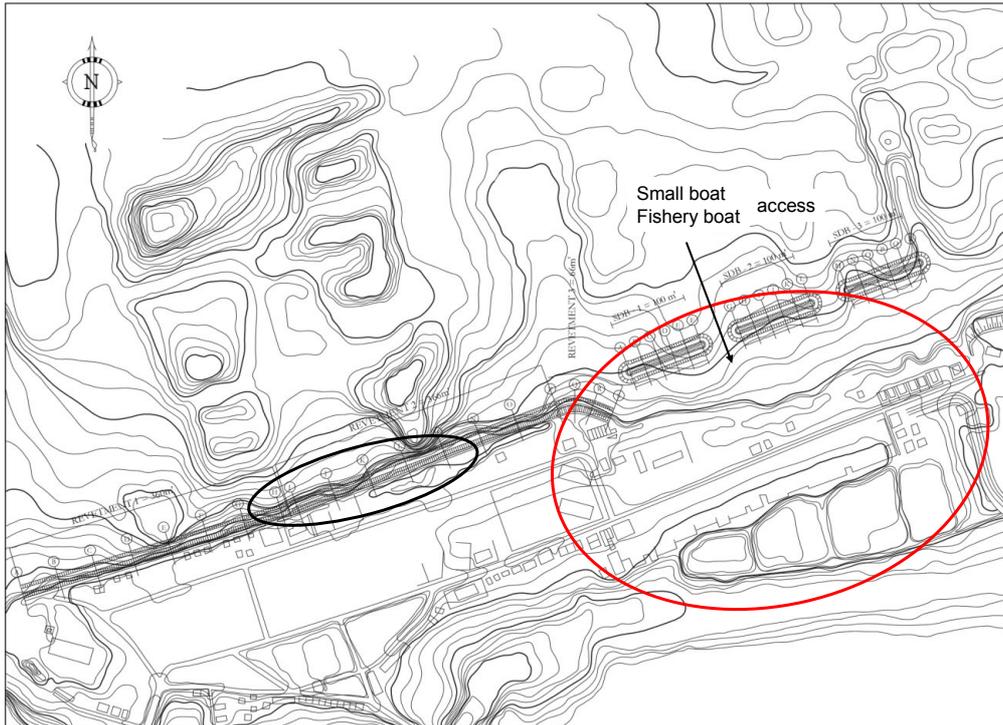
Figure 10.4 Plan view of the revetment and the submerged breakwater
 (Traced drawing of the picture provided by Departemen Permukiman dan Prasarana Wilayah,
 Direktorat Jenderal Sumber Daya Air, Detail Design Panttai Syiah Kuala Kota Banda Ache, 2003)

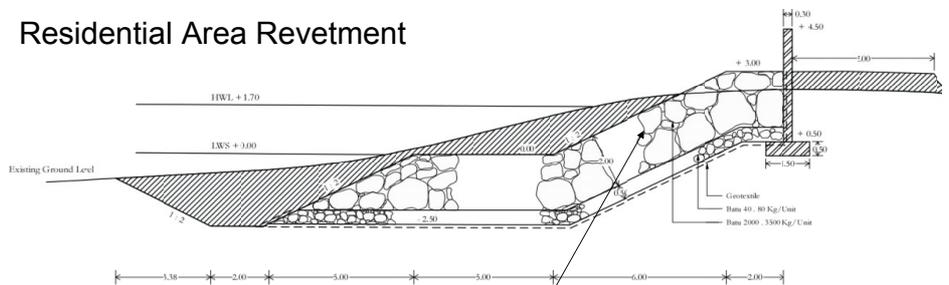
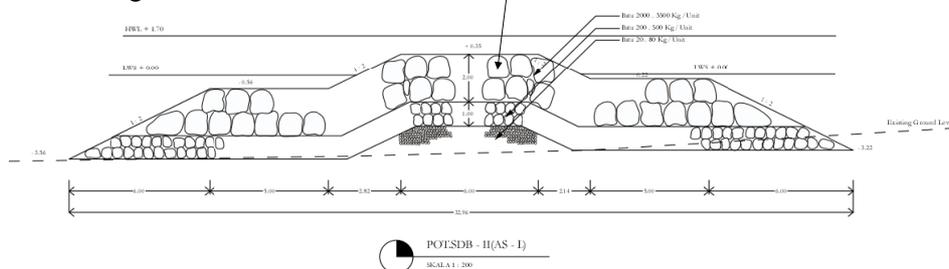
Large stone blocks were thrown by the tsunami waves over the wharf of the port as seen in Figure 10.3 However, as shown in Figure 10.2, just behind the stone rubble revetment a residential area was disappeared. During construction of the revetment, naturally deposited sandy dyke was excavated and stone rubbles were placed and then remolded as shown in Figure 10.5 top. The remolded water pluvial sand layer should had been liquefied during the earthquake motion.

Figure 10.5 Cross section of revetment and submerged breakwater
 (Traced drawing of the picture provided by Departemen Permukiman dan Prasarana Wilayah,
 Direktorat Jenderal Sumber Daya Air, Detail Design Panttai Syiah Kuala Kota Banda Ache, 2003)

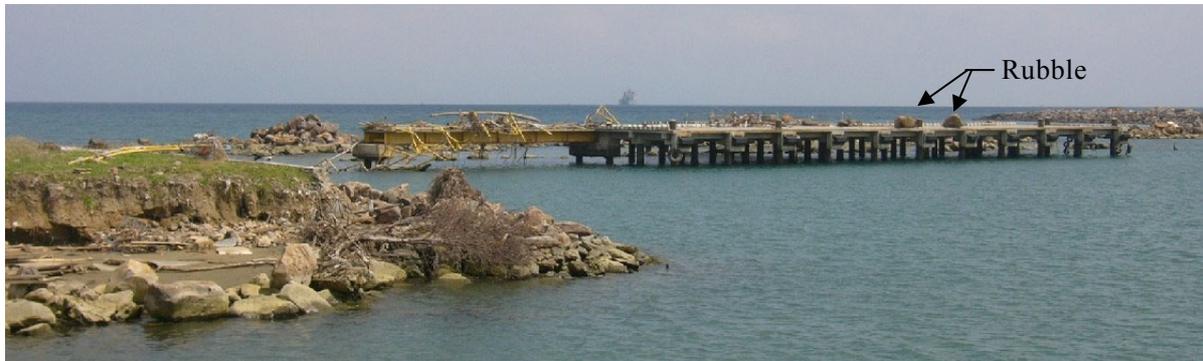
The pile supported wharf for ferry boat (Figure 10.6) has no damage during the earthquake motion and the tsunami. However, two pieces of rubble stones (2,000kgf-3,500kgf) observed on the deck as shown in Photo 10.1 due to the tsunami wave.

Photo 10.1 Pile supported wharf for ferry boat

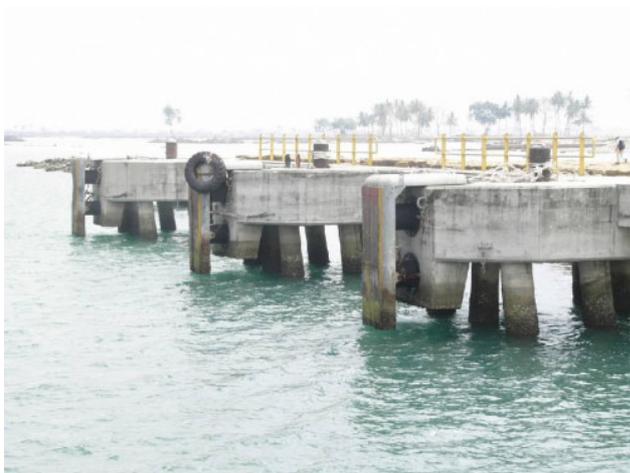
Although the dolphin for a barge with a power generator was not damaged by the tsunami as seen in Photo 10.2, the barge (Photo 10.3) was displaced from the dolphin to a distance of 3km inland.

Photo 10.2 Dolphin for a power generator barge

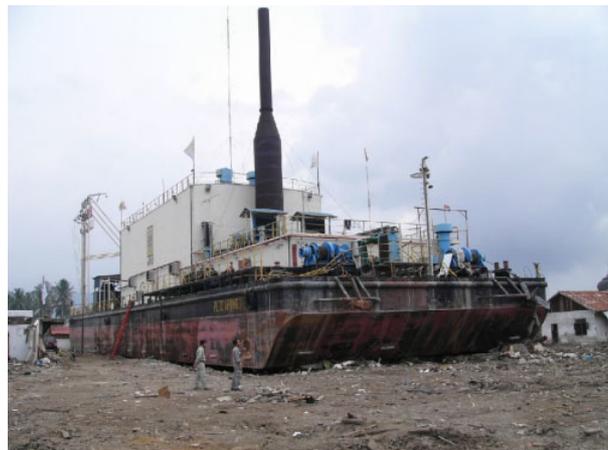
Photo.10.3 Power generator barge

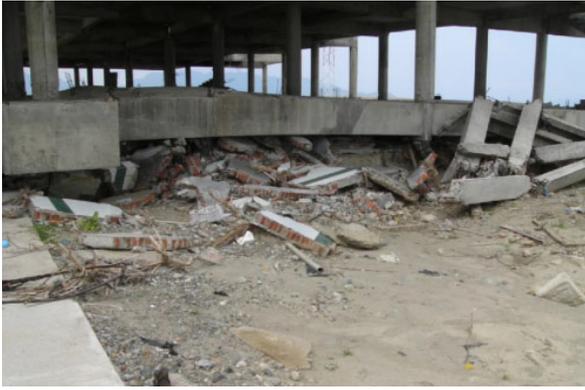
The RC building of the port facility collapsed at the ground floor as seen in Photo 10.4. However, the main cause of collapse was ground shaking rather than the tsunami waves because of the second floor with slightly damaged columns was survived during the tsunami waves (Photo 10.5). The ferry terminal building, which is a RC pile-deck structure without shear walls, collapsed at ground floor and the ground floor columns acted as a base isolation system. The second and top floors survived the earthquake and the tsunami.

Photo 10.4 Ferry terminal (collapsed ground floor)

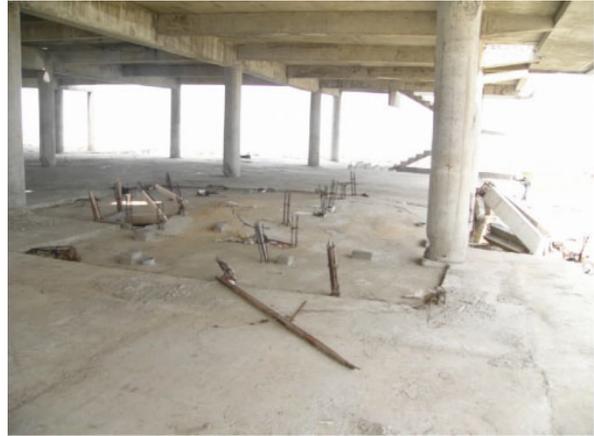
Photo 10.5 Ferry terminal (2nd Floor)

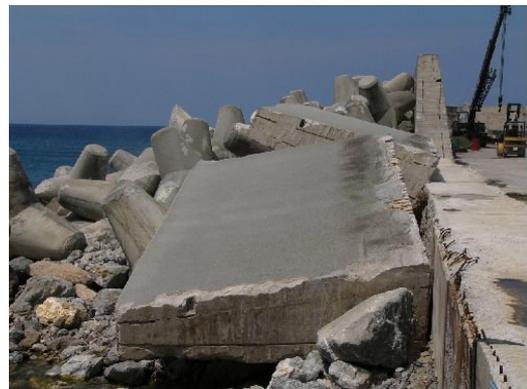
The port facility for the cement factory was also damaged by the tsunami. The 5m high gravity type parapet with a trapezoidal cross section was overturned as shown in Photo 10.6. Totally, three blocks were overturned, two blocks of the parapet were overturned outside direction of the port and other one was overturned opposite direction. To investigate the overturned scenario, detail consideration of the layout of the parapet and tsunami wave action should be needed.

Photo 10.6 Damaged seawall at cement factory

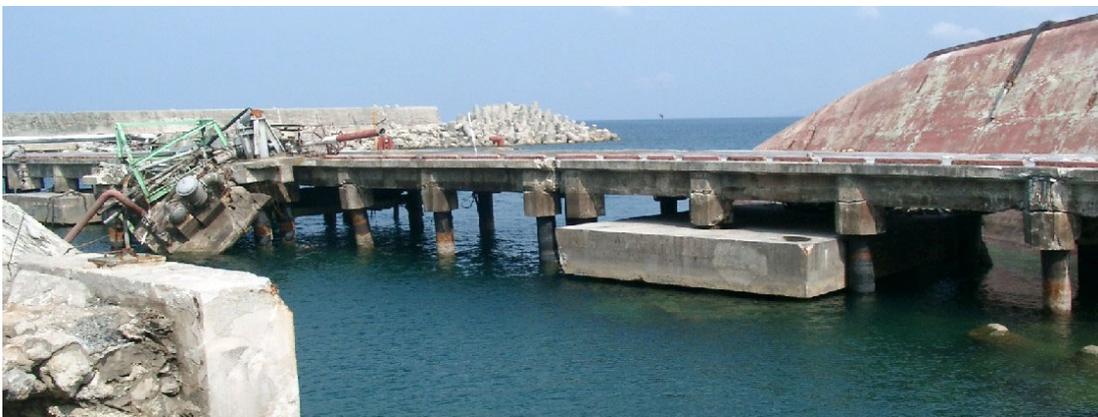
Photo 10.7 shows the damage of pile-supported wharf due to the capsized ship impact force during the tsunami. A pile supported wharf showed good performance during tsunami waves as mentioned in section 10.2, however, it must be considered drifting object's impact force against the structures.

Photo.10.7 Damaged pile-supported wharf at cement factory
