## Chapter 11

### Damage to Transportation Facilities

#### 11.1 Damage to Bridges and Roadways

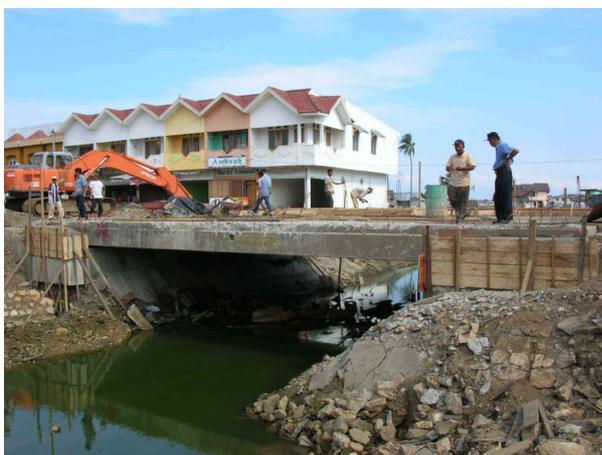
Photos 11.1 and 11.2 show one of the significantly damaged bridges. The simply-supported pre-stressed concrete girder bridge with a span of about 20m was washed out by the tsunami. The girder was just set on the top of abutments and there seemed to be no shear connection at the bearing supports. The tsunami height was just as the same height as the ceiling level of the 1st story of the houses. A temporary bridge was built soon after the earthquake to assure the traffic. At the time of investigation (about two month after the

Photo 11.1 Repair of Washed-out Girder Bridge

the earthquake), the washed-out girder was reused and already placed on its original location as the permanent repair.

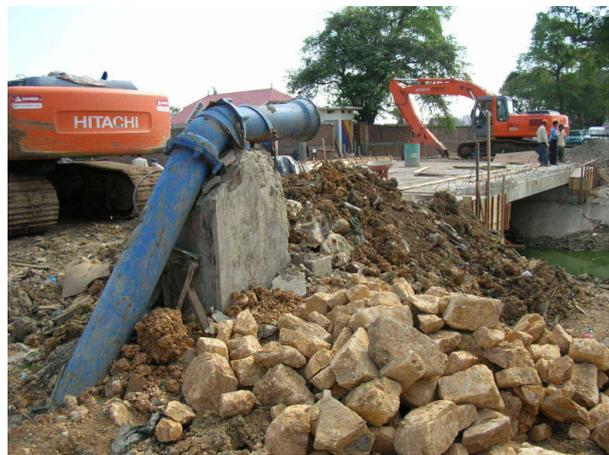
Photo 11.2 Collapse of Water Pipes

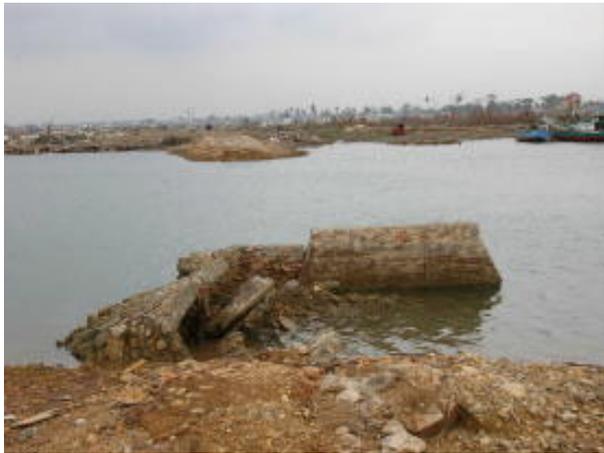
Photos 11.3 and 11.4 show another bridge where the superstructures were completely washed out. It was reported that the bridge had a relatively shallow superstructure made of wooden materials. Substructures were made of masonry materials connected with concrete.

Photo 11.3 Complete Washout of Bridge  
(being reported as wooden bridge)

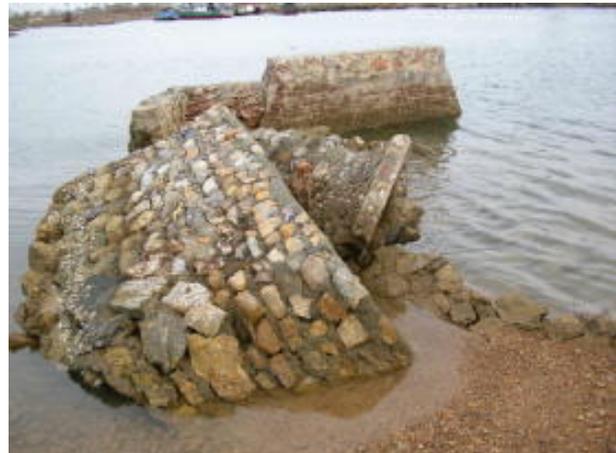
Photo 11.4 Masonry Substructure and  
Washout Effect of Surrounding Soils

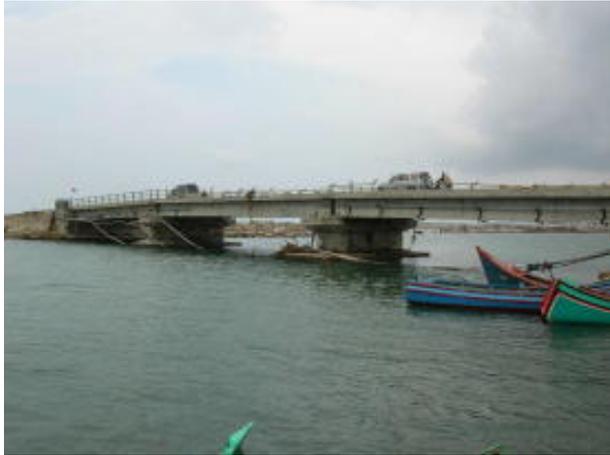
Photos 11.5 to 11.8 show the typical damage to a bridge in which the significant lateral displacement was developed by the effect of Tsunami. The superstructure of the bridge was 3 span simply-supported reinforced concrete girder bridge and was supported by the wall type reinforced concrete piers. The rubber sheet type bearings were used and there was no shear key to connect between girder and substructures. The decks were moved about 50cm laterally and the rotation occurred at the decks since the decks were wedged geometrically between the both abutments. The handrails were partly but heavily damaged and it was estimated that the handrails were broken by the effect of the impact of boats or driftage. The washout effect at the backfill soils of abutments was also found.

Photo 11.5 Damaged Bridge

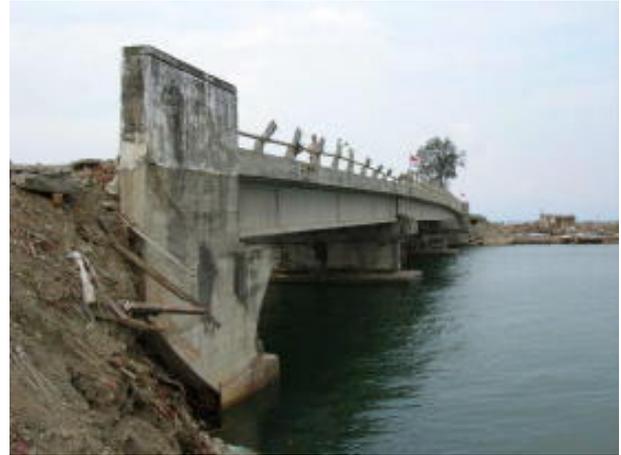
Photo 11.6 Washout Effect of Backfill Soils

- 5) Abutment Backfill Soils: Several damaged abutments with the backfill soils washed out were observed. To fill the soils as a temporary measure to assure the traffic is relatively easy. But if such damage should be prevented for higher abutments in long term, more substantial repair works are necessary after the earthquake and the bank protection measures for abutments are effective.

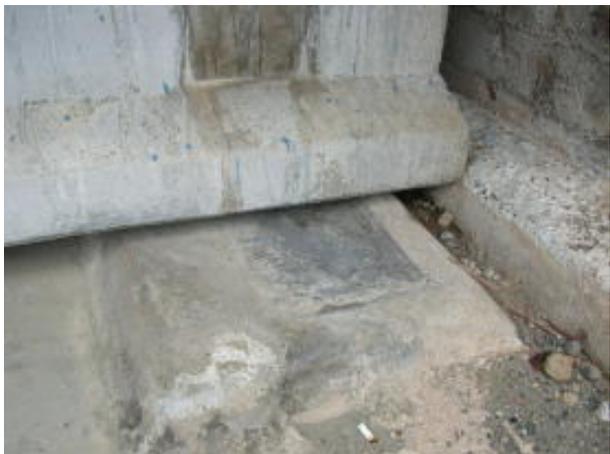
Photo 11.7 Lateral Displacement of Deck

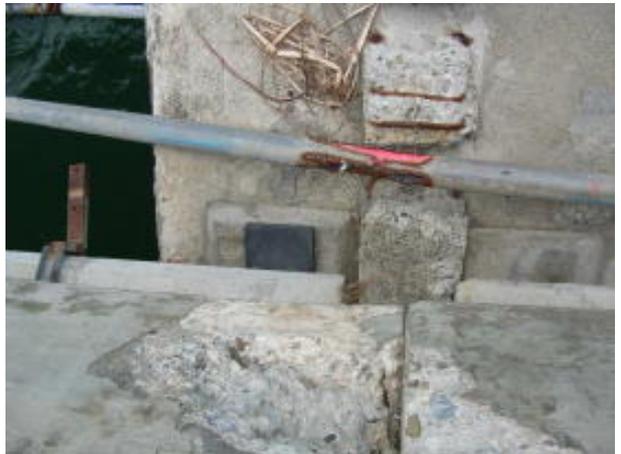
Photo 11.8 Rubber Sheet Type Bearing and Lateral Displacement at Bearing

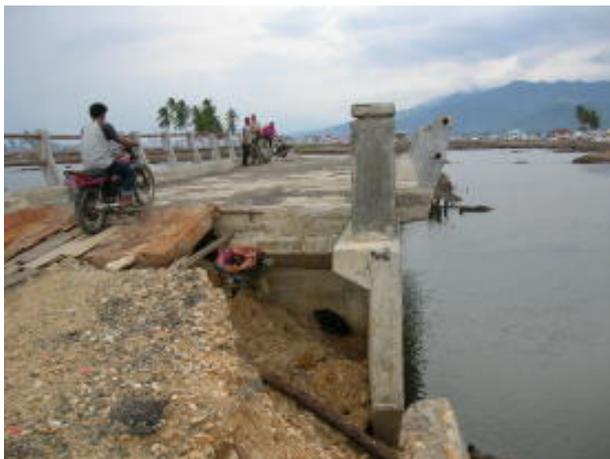
Photos 11.9 and 11.10 show another bridge where the significant displacement was observed. The bridge is a simply-supported reinforced concrete girder with a span of about 20m. The deck was moved in the transverse direction about 1m due to the tsunami effect. The girder was supported by the rubber sheet type bearing and there was no shear connection between girder and substructures.

Photo 11.9 Lateral Displacement of Deck

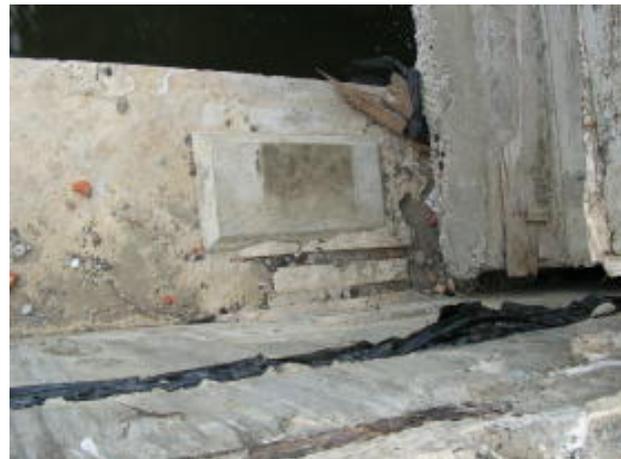
Photo 11.10 Displacement at Bearing

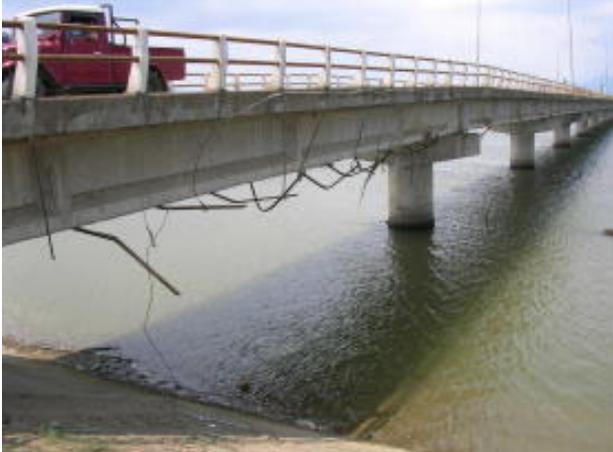
damage by the tsunami. The height of the tsunami was estimated to be about several meters over the bridge deck level. Heavy damages to houses were found around the bridge. The bridge was a long bridge with a 10 span simply-supported concrete girder bridge which was supported by circular reinforced concrete columns. The rubber bearings were used and the concrete block shear keys were provided. Although the attached facilities beside the girders were heavily failed, the main body of the bridge was not damaged. Slight damage to the shear keys such as cracking was observed. Although the detailed investigations such as the tsunami height are necessary, it was estimated from the bridge behavior that the shear keys seemed to work well to resist against the lateral force imposed by the tsunami.

Photo 11.11 Undamaged Bridge by Tsunami

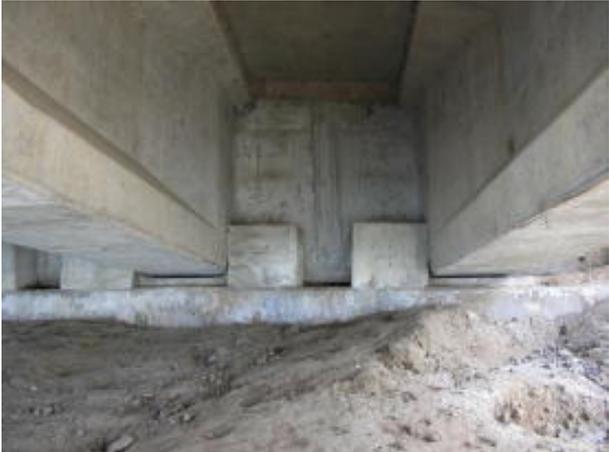
Photo 11.12 Concrete Block Shear Keys

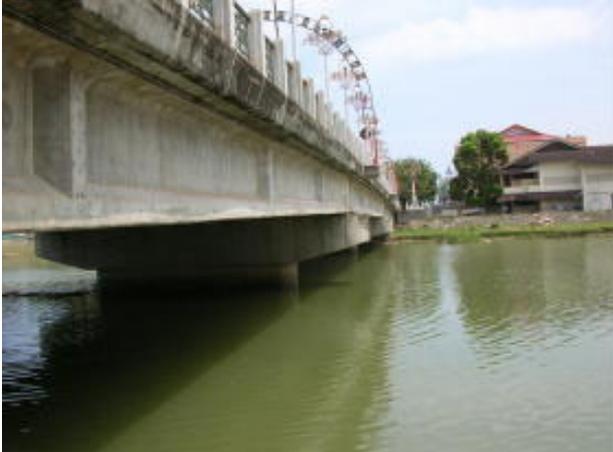
Photos 11.13 and 11.14 show another bridge to show the slight damage to shear keys. The bridge was a 3 span simply-supported concrete girder bridge and supported by the rubber bearing and concrete block shear keys. The bridge was not affected by the tsunami. The shear keys were slightly damaged including the concrete cracking. The damage was considered to be caused by the strong ground motions.

Photo 11.13 Bridge affected by Shaking

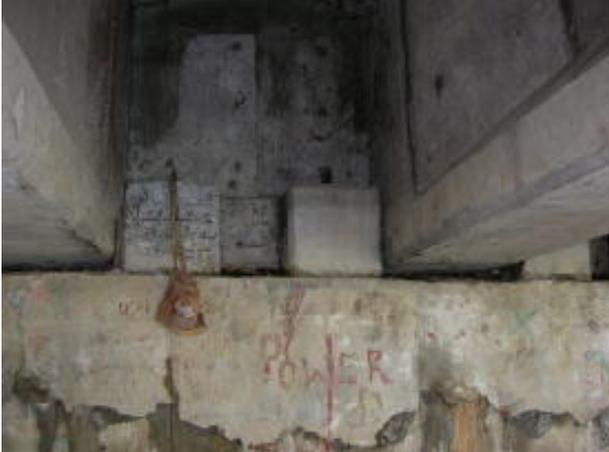
Photo 11.14 Slight Damage to Shear Keys

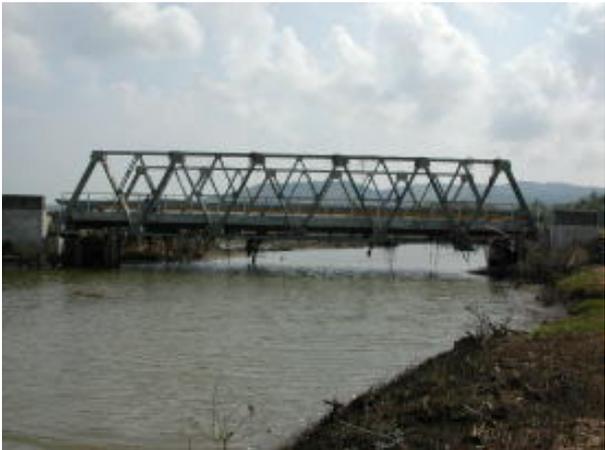
As will be discussed later, many truss bridges with relatively longer spans were washed out along the west coast route from Banda Aceh to Meulaboh. Although The detailed investigation could not be made for all of the collapsed bridges, some collapsed bridges did not have the connection and shear keys between decks and substructures. Photo 11.15 and 11.16 show the behavior of the truss bridge with stiff connections between deck and substructures. Since the bridge is located at the east of Banda Aceh, the Tsunami height might not be so significant. But the Tsunami height was clearly exceeded over the upper member level of the truss. There was no damage at the bridge. It seems that the stiff connections between deck and substructures can be one reason for “no damage”.

Photo 11.15 Steel Truss Bridge without Damage

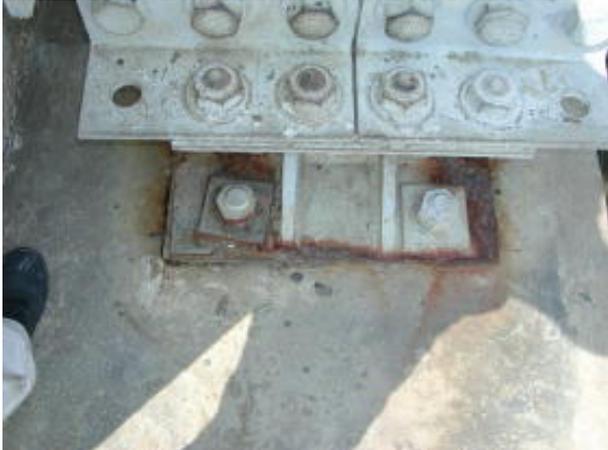
Photo 11.16 Steel Bearing Supports

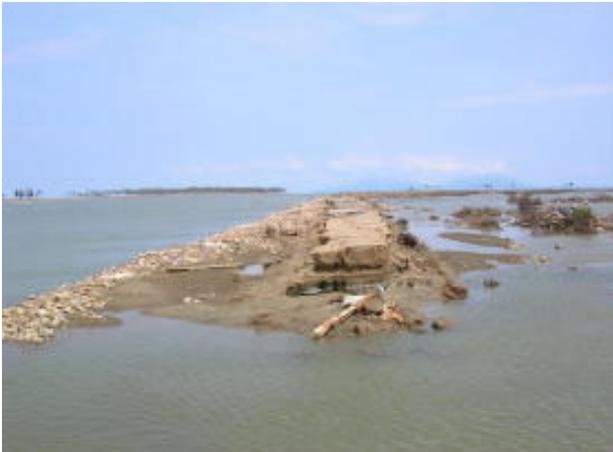
Photo 11.17 and 11.18 show the damage to soil embankment structures. Complete washout of river dikes and damage to pavement on the river dikes was found. Since the height of the tsunami was estimated to be widely over the height of the river dikes, the washout effect of soils were observed at several sections.

Photo 11.17 Washout of River Dike

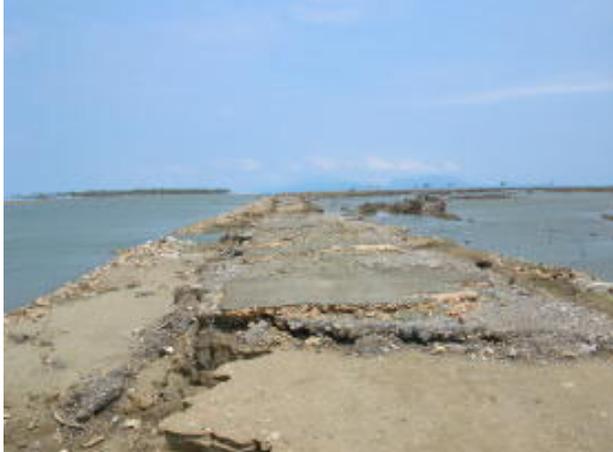
Photo 11.18 Washout of Pavement and Soils

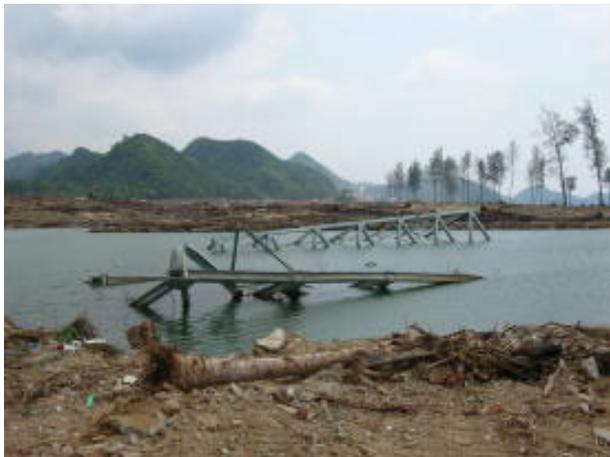
The city of Lho'nga is located at the west of Banda Aceh along the west coast. The area was significantly affected by the Tsunami and the Tsunami run-up height is estimated to be over 30m at maximum. Photos 11.19 to 11.21 show the complete washout of a 2-span steel truss bridge, which was supported by the wall type reinforced concrete columns. The decks were supported by the bearings and bolts were used to connect deck and substructures. There was no shear connection between deck and substructures except the bolts. Since the truss girders were washed out to the upstream side and the bolts connecting deck and substructure were bended toward the upstream side, it is estimated that the decks were washed out by the tsunami waves in the direction of upstream side. This route is an important route to connect Banda Aceh with the Meulaboh in south, the temporary bridges were built for emergency measures. It should be noted here that it is estimated the truss type bridge is employed for a relatively longer span bridge in the area.

Photo 11.19 Washing out of Steel Truss

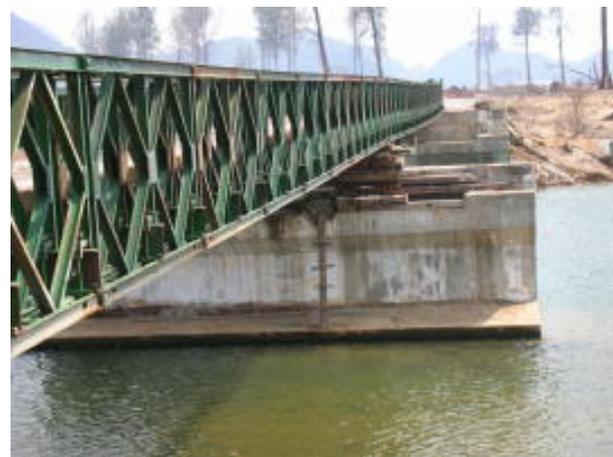
Photo 11.20 Temporary Bridge

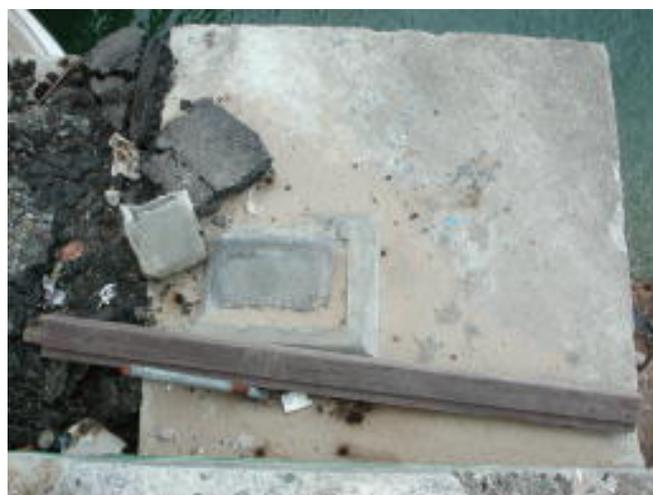
Photo 11.21 Bearing Support and Bolt to connecting Deck and Substructures

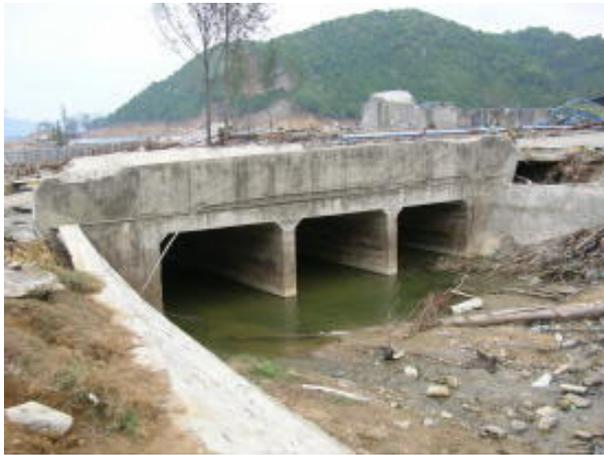
Photo 11.22 and 11.23 show the behavior of the reinforced concrete box culvert bridge. The bridge is located in the cement factory, which was significantly damaged by the tsunami. Some damage was found at the sidewall but there was almost no damage on the main body of the bridge.

Photo 11.22 Concrete Box Culvert Bridge

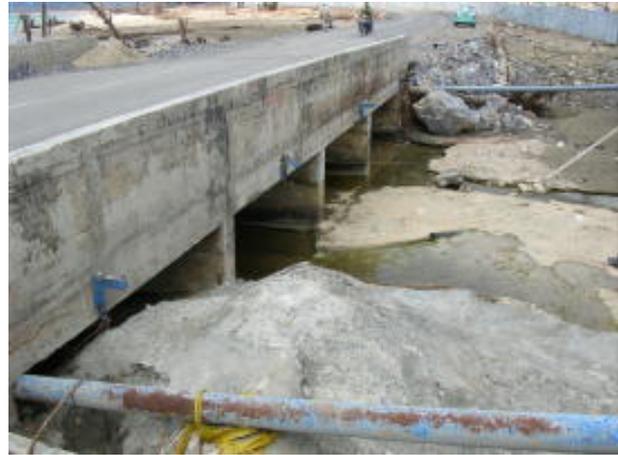
Photo 11.23 Concrete Box Culvert Bridge

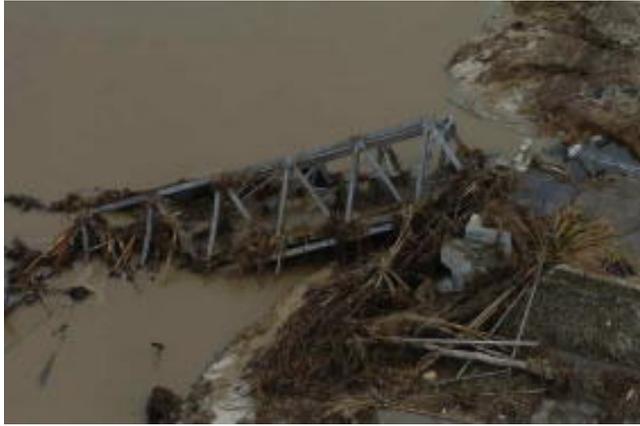
Photos 11.24 to 11.28 show the washout of the bridges in the route. All photos shown here were taken by UN on the behalf of Aceh Provincial Government. There are several steel truss bridges and the deck was completely washed out toward the upstream side. Since the most piers and abutments remained at the original location, it is estimated that the superstructures were washed out by the tsunami. Although detailed investigations are needed, it is estimated that the stiff connection or shear key enough to withstand the washout force was not provided at the bearings in view of the bridge designs in Banda Aceh.

Photo 11.24 Washout of Truss Bridge (1)  
(courtesy of Aceh Provincial Government)

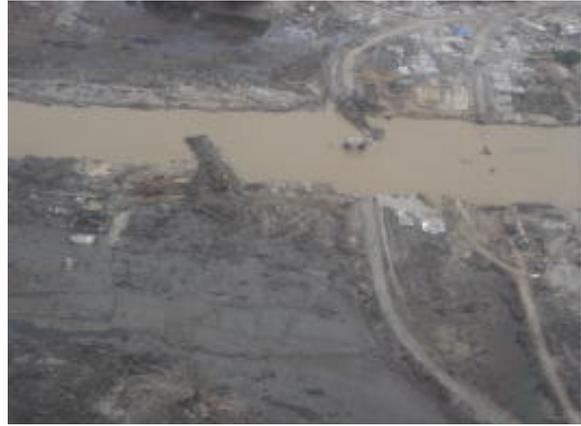
Photo 11.25 Washout of Truss Bridge (2)  
(courtesy of Aceh Provincial Government)

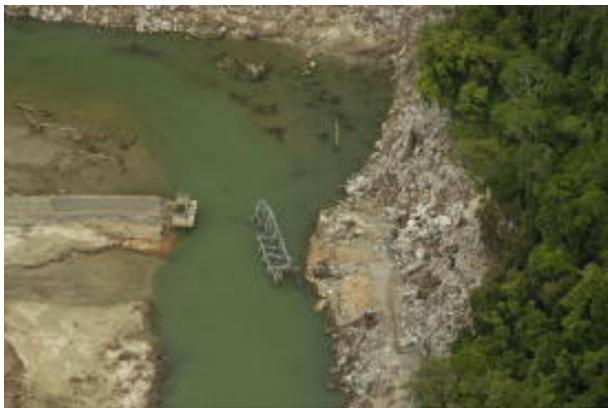
Photo 11.26 Washout of Truss Bridge (3)  
(courtesy of Aceh Provincial Government)

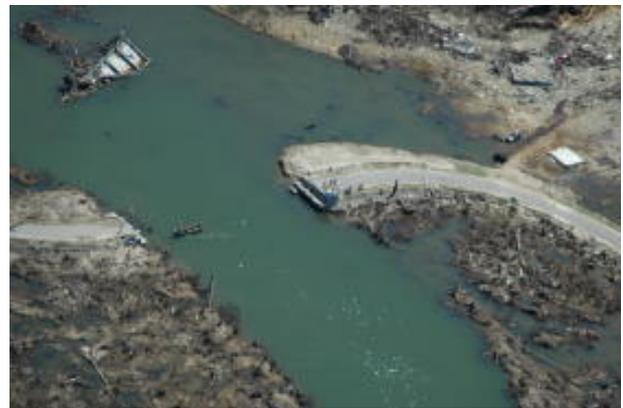
Photo 11.27 Washout of Truss Bridge (4)  
(courtesy of Aceh Provincial Government)

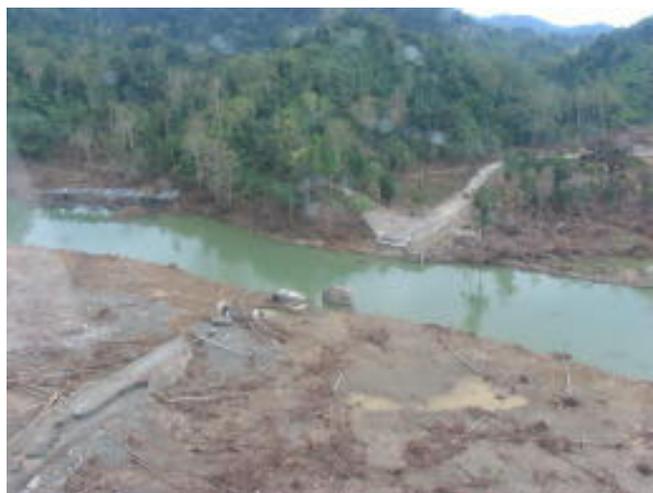
Figure 11.28 Washout of Truss Bridge (5) (courtesy of Aceh Provincial Government)

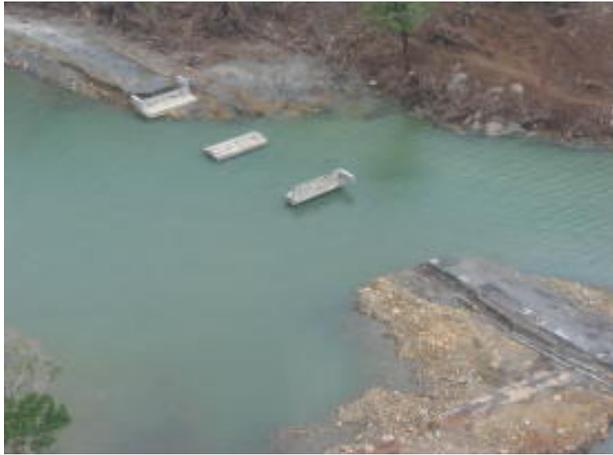
Photos 11.29 to 11.33 show the washout of the roadways, which were completely eroded by the tsunami effect. The land itself was also estimated to have sunk one half to one meter in elevation along the coast but the erosion of the coastline was much more significant.

Photo 11.29 Washout of Bridge and Soil  
(courtesy of Aceh Provincial Government)

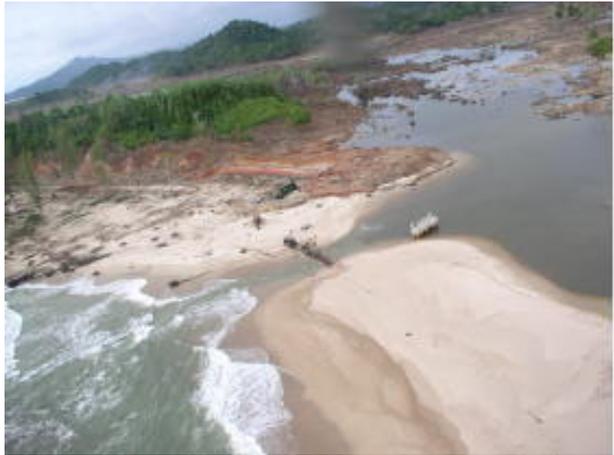
Photo 11.30 Erosion of Road and Coastline  
(courtesy of Aceh Provincial Government)

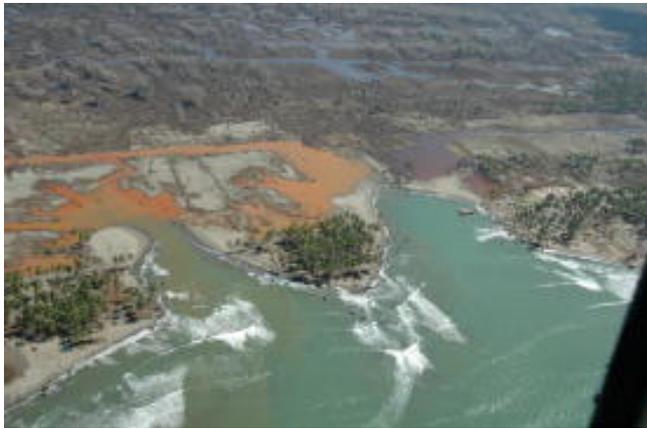
Photo 11.29 Erosion of Road and Coastline  
(courtesy of Aceh Provincial Government)

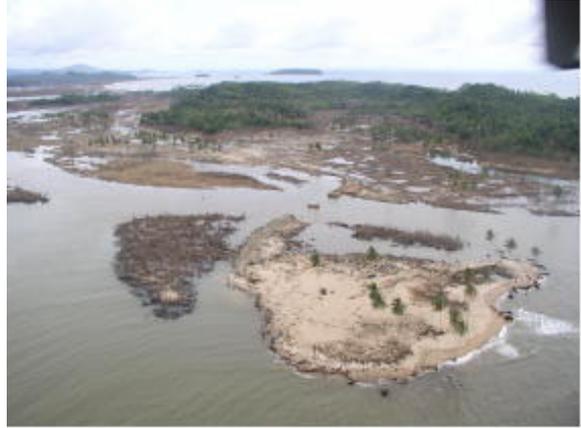
Photo 11.30 Erosion of Road and Coastline  
(courtesy of Aceh Provincial Government)

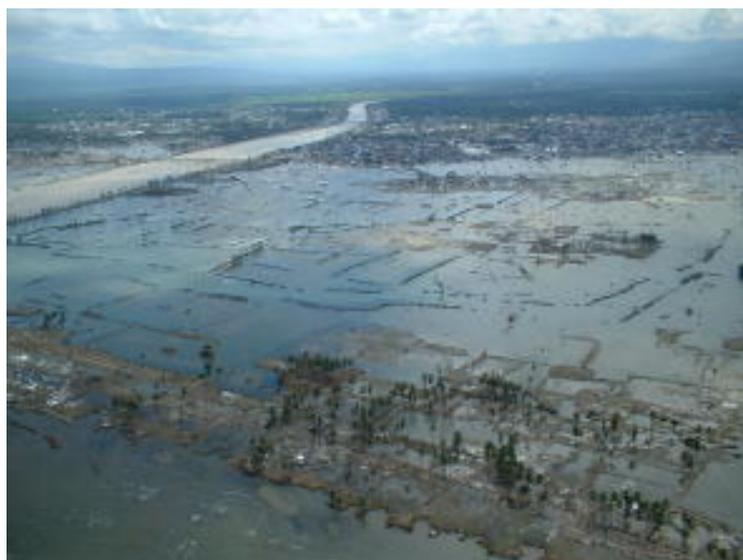
Photo 11.31 Erosion of Road and Coastline (courtesy of Aceh Provincial Government)

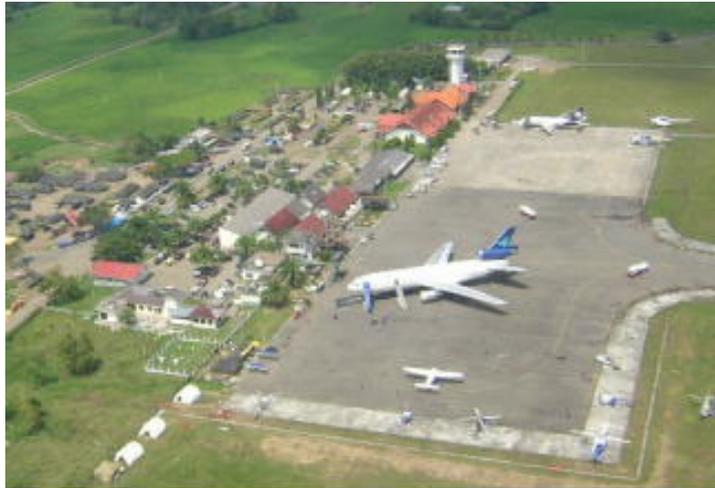
The only airport in the affected region by the earthquake is the Iskandar Muda Airport to which commercial flights are in operation. This airport was not damaged either by ground shaking or by tsunami waves as shown in Photo 11.32. At the Meulaboh Airport, the dislodgement at the airstrip was developed as shown in Photo 11.33 and the section of 1,100m within 1,300m was used for the flight.

Photo 11.32 No Damage to Iskandar Muda Airport

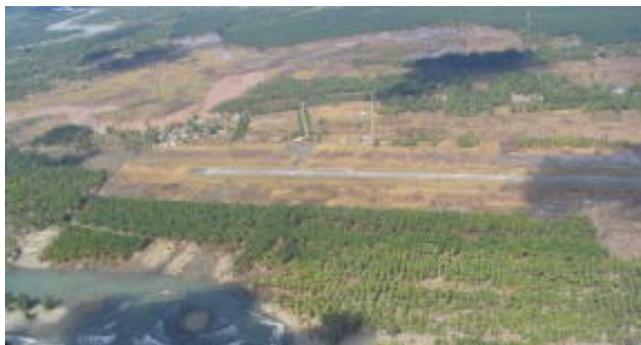
Photo 11.33 Damage of Airstrip at Meulaboh Airport

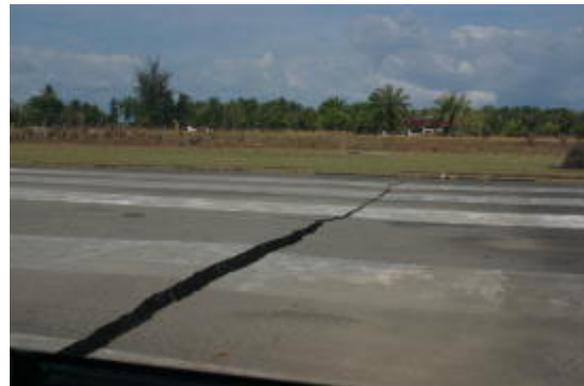
Photo 11.34 Damage of Airstrip  
(courtesy of Dr. Osumi)
