- ## ネパール最重要道路のハザードマップとリスク管理
- 1.はじめに
 - 2.調査対象
 - 3.道路斜面危険箇所の特徴
 - 4.道路ハザードマップ
 - 5.道路リスク管理の考え方とハザードマップの重要性
 - 6.今後のネパールでの道路防災のあり方
 - 7.まとめ

Landslide Damages in Changunarayan Hill of Nepal and the Conservation of World Heritage Site

Kankyo Chishitsu Co. Ltd Hideki Inagaki
Ehime Univ. Netra P. Bhandary
Ehime Univ. Ryuichi Yatabe

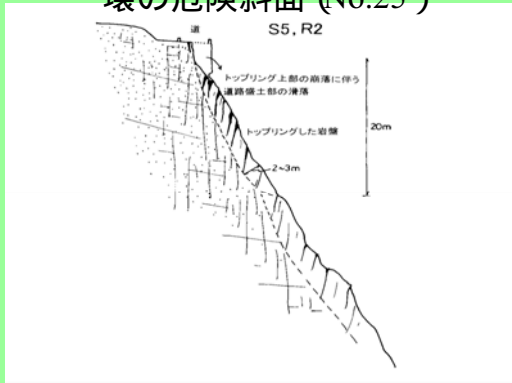
図-3 トッピングによる受け盤岩石崩壊の危険斜面 (No.25)

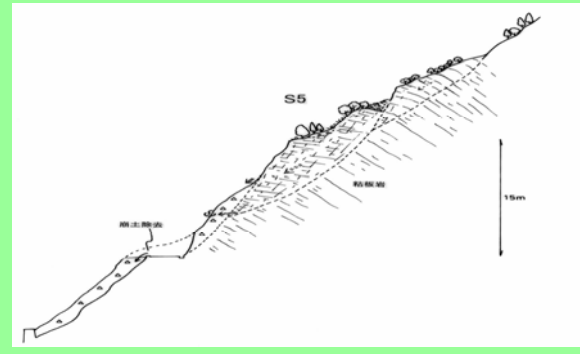
図-4 受け盤岩石崩壊の危険斜面 (No.1)

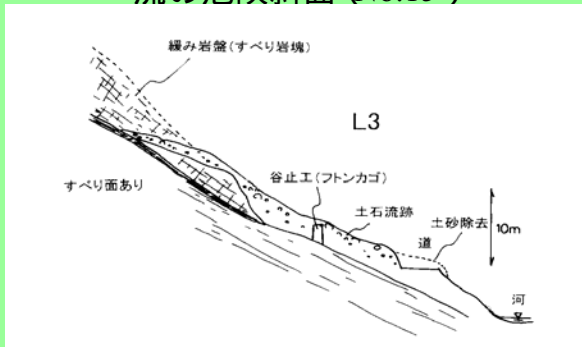
図-5 岩盤地すべりと沢沿いの土石流の危険斜面 (No.15)

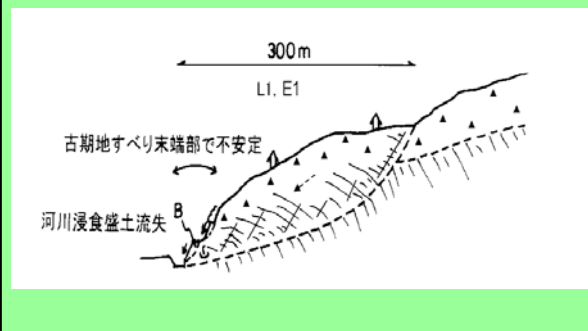
図-6 土砂地すべりと末端部の河岸浸食 (No.4)

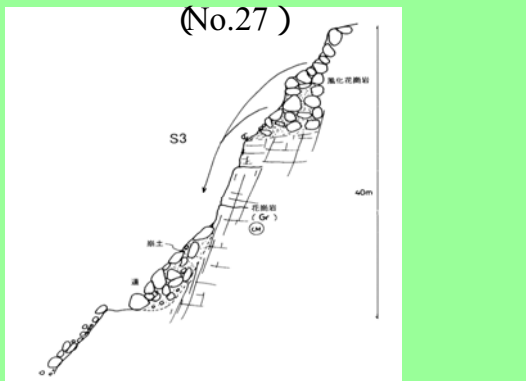
図-7 風化岩崩壊の危険斜面 (No.27)

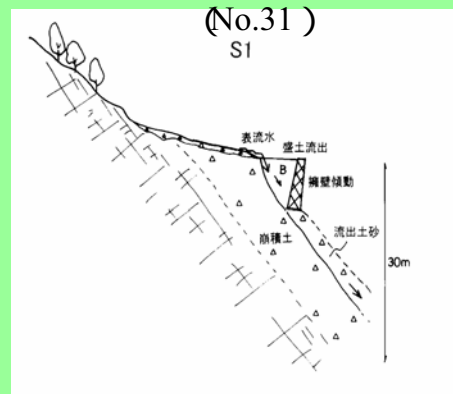
図-8 盛土崩壊の危険斜面 (No.31)

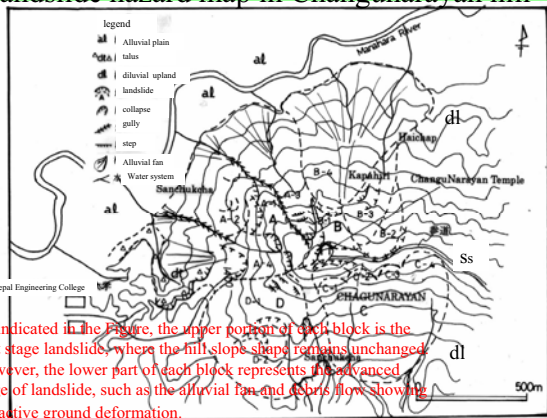
Landslide hazard map in Changunarayan hill

- Bhattarai et al (2004) explain that the landslide damage to the temple has been caused by river sand mining and agricultural activities along the Manohara River.
- According to the authors' investigation, there are 4 large-scale landslides (A, B, C, and D) around Changunarayan temple.
- Blocks A, B, and C are divided into 4 sub-blocks, and Block D is divided into 2 sub-blocks.
- The landslide hazard map of Changunarayan Hill is shown in the next Figure.

As indicated in the Figure, the upper portion of each block is the first stage landslide, where the hill slope shape remains unchanged. However, the lower part of each block represents the advanced stage of landslide, such as the alluvial fan and debris flow showing the active ground deformation.

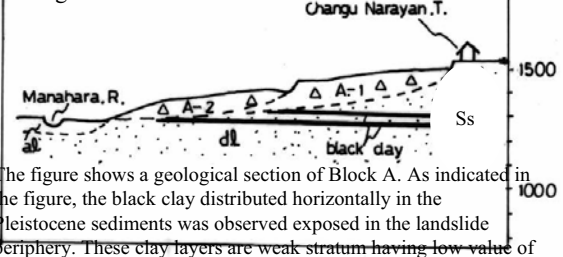
Geological section of A landslide block

The figure shows a geological section of Block A. As indicated in the figure, the black clay distributed horizontally in the Pleistocene sediments was observed exposed in the landslide periphery. These clay layers are weak stratum having low value of shear strength underneath the landslide mass. So, it is considered that the landslide takes place through the black clay layer. Furthermore, the river sand mining along Manohara River flowing through the foot of Changunarayan hill may be one reason for the reduced landslide stability.

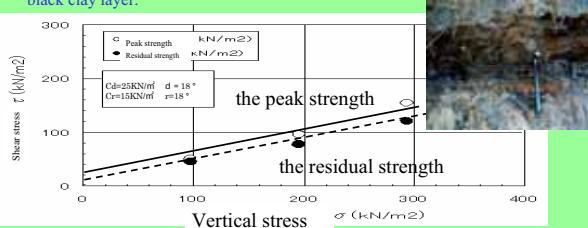
- The black clay sample identified as the landslide slip layer in the Changunarayan Hill has high water content, and consists of sericite, biotite and other clay minerals.
- According to the figure, the peak strength of this clay in terms of angle of internal friction and cohesion is $\phi = 18^\circ$, $c = 25\text{kN/m}^2$, as measured in ring shear apparatus. Similarly, the residual strength in terms of angle of internal friction and cohesion is $\phi = 18^\circ$, $c = 15\text{kN/m}^2$ (a decrease of 10kN/m^2). The residual strength of black clay layer decreases by 10kN/m^2 from the peak strength ; therefore, it is considered that the landslides have been caused by the black clay layer.

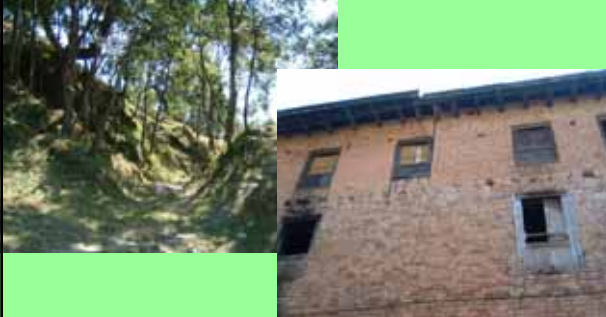
- There are only traces of landslide damage to the temple and its surrounding structures at present with the increase of landslide movement. However progressing to upper portion of the hill near the temple during the events of heavy rainfall and big earthquakes, the damage could be extensive resulting in complete destruction of temple structures in the periphery.

Left side photo shows the main scarp of a landslide, where many cracks and tilting of the ground can be observed as the indications of the landslide. Right side photo shows damage to temple structures can be noticed

- In order to conserve this world heritage site, the geotechnical survey in detail including slope stability analysis is urgently required.
- The timely preventive measures will help protect the world heritage monuments from being damaged or destroyed during natural disasters, and it is always important to conserve these cultural monuments so as to harmonize the cultural and environmental balance.

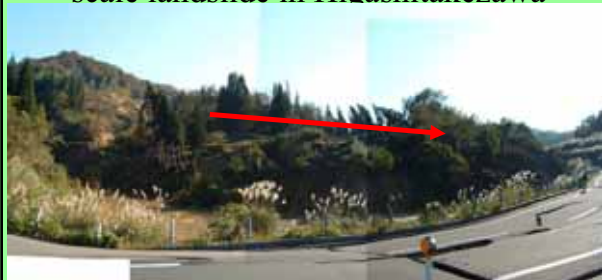
Damming up of Imo River due to large-scale landslide in Higashitakezawa

There is a slipping down cliff on the left side of the photograph and completely slid block rotating upward in the right.

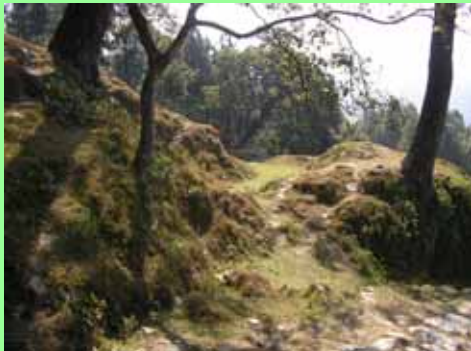
チャングナラヤンは地すべりタイプ

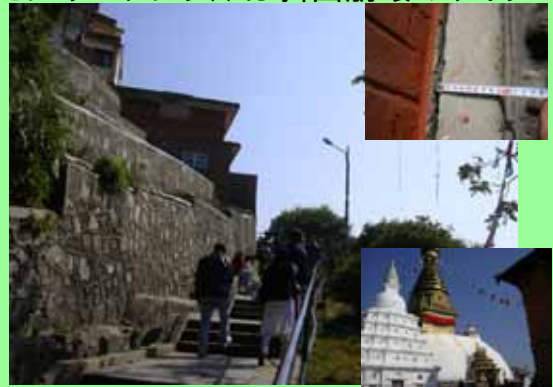
モンキーテンブルは斜面崩壊のタイプ
