# **Preliminary Report: Mid-Niigata Prefecture Earthquake**

## **Preliminary report on damage caused by the Mid-Niigata Prefecture Earthquake on October 23, 2004**

KONAGAI Kazuo

Team Leader, Emergency Damage Investigation Team, Japan Society of Civil Engineers

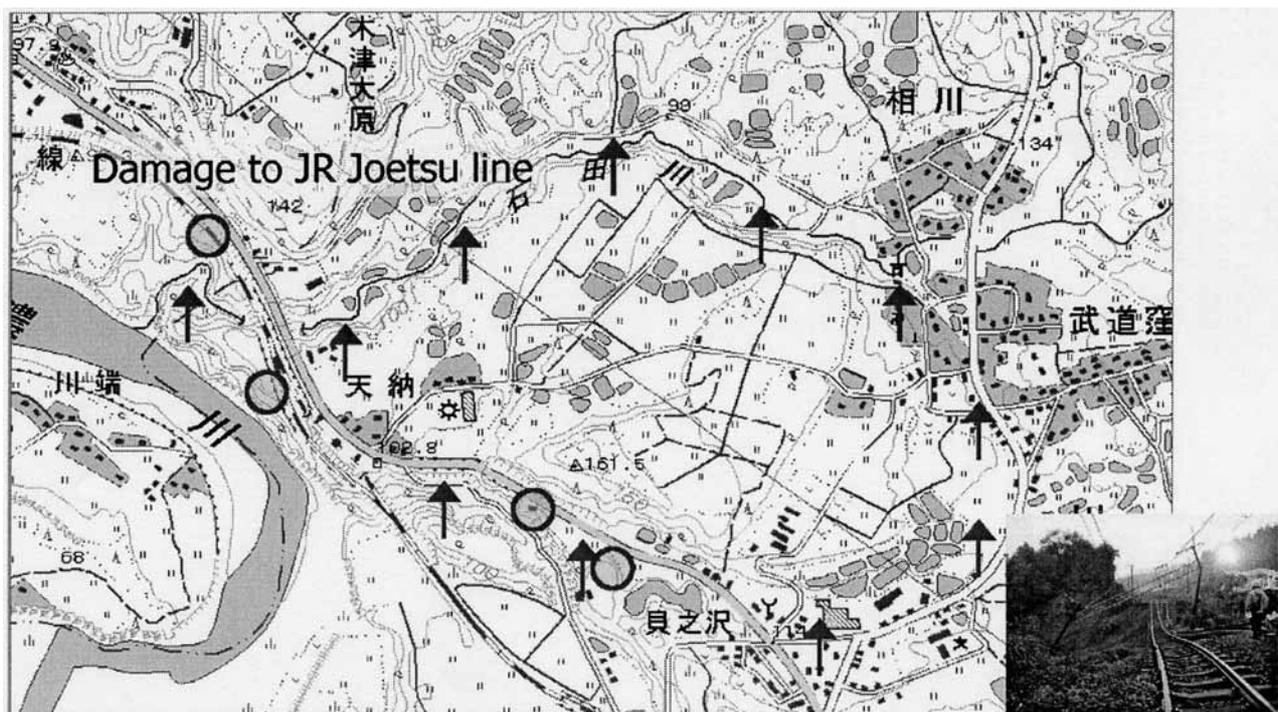
In the densely-inhabited disaster-stricken districts along the Sinano and Uono Rivers, meandering watercourses gradually carved away the differentially denudated land and left the river plain as a series of horseshoe-shaped areas of flat land (incised meanders). With repeated upheaval, portions of the horseshoe-shaped areas lining the rivers formed terraced cliffs. Earthquake damage was concentrated on railways and roads that follow the rivers. (Fig. 6, Photo 1)

Fig. 6 Meanders left by old watercourses (indicated by arrow) and failed cliff (indicated by circle)  
 At point (A), the ground underneath National Route 17 and the parallel Joetsu railway line slid together with the concrete retaining wall (Photo 1)  
 (Data added to topographical map at a scale of 1:25,000 compiled by the Geographical Survey Institute)

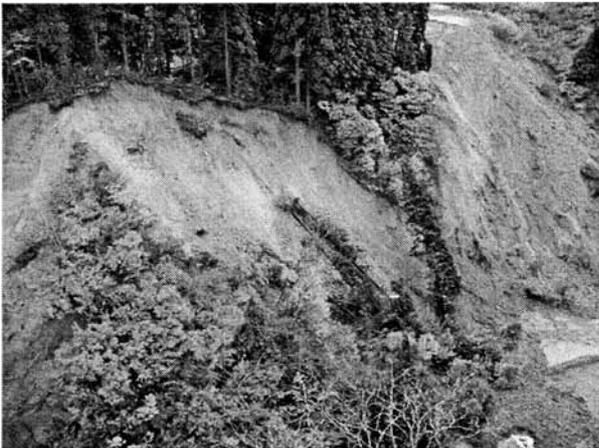
Slides consisting of thin, weathered surface layers took place on slopes of soft rock containing Neogene mudstone about 30 m in height and inclined at 30 degrees or more. (Photo 2: Yamakoshi village) Massive slope failures also took place at deep slip planes. Failures of weathered rock strata were identified. (Photo 3: Shiroiwa (white rock) at Myoken; Photo 4: large failure on Prefectural Road 196 on the right bank of the Shinano River downstream from Uonuma Bridge) A cliff was formed on the right bank of the Shinano River by erosion. Failures of talus layers were also identified. (Photo 5: failed residential land in Nigorizawa) But Yamakoshi village is where basic damage was most concentrated. Failures of sloping land reportedly took place at more than 800 points in the village, which has an abundance of terraced rice paddies and uncountable small ponds specific to landslide hazard areas. Some landslides involving rice paddies and ponds, in addition to those on natural slopes, were observed. (Photo 6) Surface and spring water outflows were observed at the sites of slope failures. The heavy typhoon rains just before the earthquake and small ponds located high up are considered possible causes of the outflows.

Photo 2 Failure of surface layer on slope comprising Neogene mudstone in eastern Yamakoshi village  
(Photo by Kouji Kokusyo)

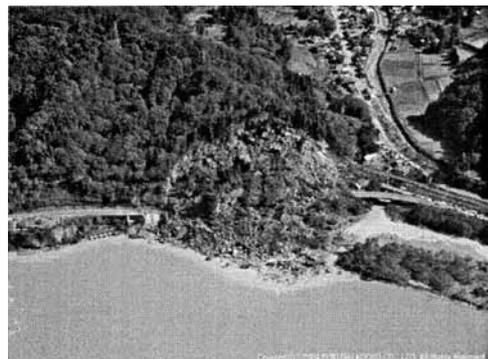
Photo 3 Massive failure of the so-called Shiroiwa (white rock) at Myoken, Ojiya city  
(Web site of Kokusai Kogyo Co., Ltd.)

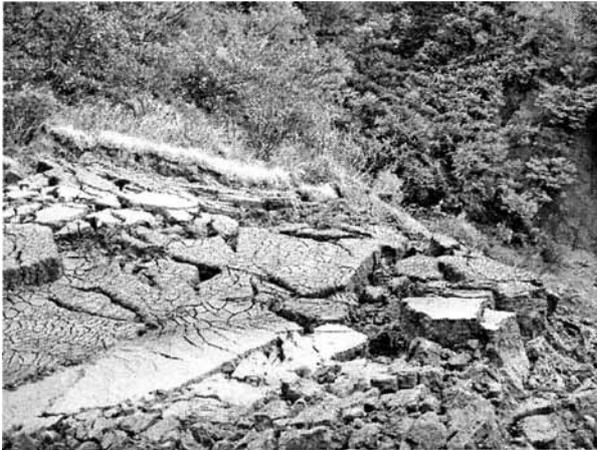
Photo 6 Landslide involving a reservoir at Higashi Takesawa, Yamakoshi village  
(Photo by Kouji Kokusyo)

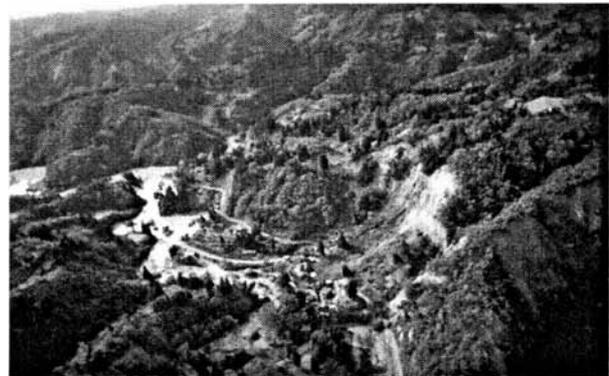
Large natural dams were created by landslides along the Imo River at five locations. In the northernmost Terano district, a relatively gentle slope (that appears to be the site of an old landslide) on the east side of the river slid out. In addition, a steep slope on the west side failed and blocked the river course. In the Nanpei and Naraki districts, steep slopes failed and blocked the river. The natural dam in the Higashi Takezawa area is the largest in the Yamakoshi area; it was created through extensive failure of a relatively gentle slope on the east side of the river (about 200 m in width and about 300 m in length). The area submerged by this dam stretched about 1 km along the river as of October 30. (Photo 7)

Photo 7 Natural dam created in the Imo River  
(Photo by Susumu Yasuda)

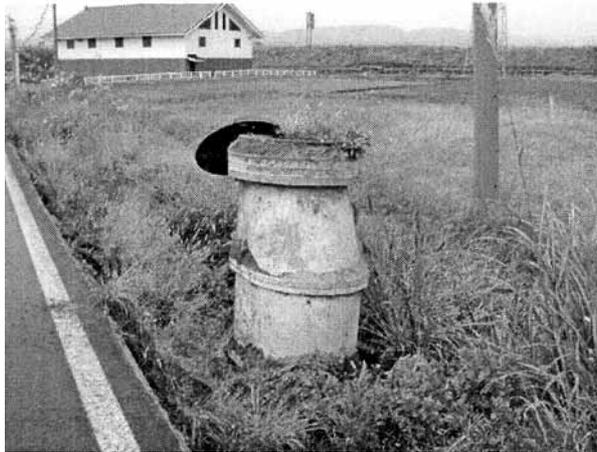
Although it is thought possible that buried water, sewer and gas pipes have been damaged in many locations, the type of damage identified during the primary investigation was uplifted manholes in the sewage system. (Photo 8) Such damage was extensive in Wakaba, western Ojiya city, where the surface layer consists of peat. In Nagaoka city, similarly, uplifted manholes were observed in Watarisawa in the southeastern part of the city, along the old National Route 17 in the center of Kawaguchi town, and in Tokuda, Horionuchi town.

Photo 8 Uplifted manhole (in Furuya district, Ojiya city)  
(Photo by Susumu Yasuda)

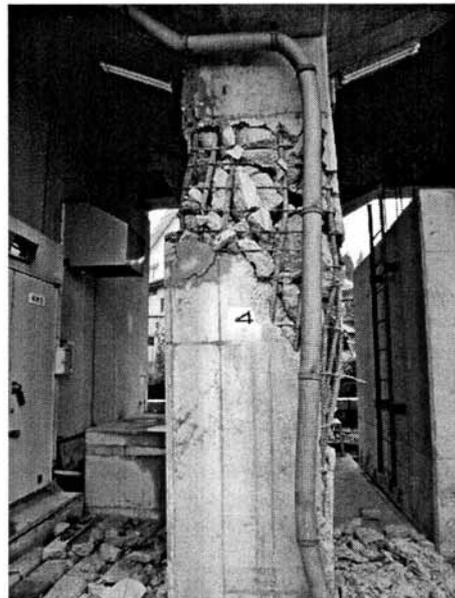
Some concrete fell away from a shinkansen (bullet train) viaduct just short of Takiya Tunnel between Nagaoka Station and Niigata (near where a shinkansen train “Toki No. 325” was derailed). (Photo 9) Four RC columns of the Wanazu viaduct on the shinkansen line failed between the Uonuma and Horinouchi Tunnels, as shown in Photo 10. Viaducts in this area had yet to be retrofitted with earthquake-resistant reinforcement. The failure mode seems to be shear failure. In addition, an RC pier of the Uonumagawa Bridge suffered damage at a rebar cut-off point. (Photo 11) Finally, an RC pier of the Ojiya Ohashi Bridge over National Route 17 suffered damage at a rebar cut-off point.

Photo 10 No. 1 Wanazu viaduct (shear failure of RC column)  
(Photo by Hiroshi Mutsuyoshi)

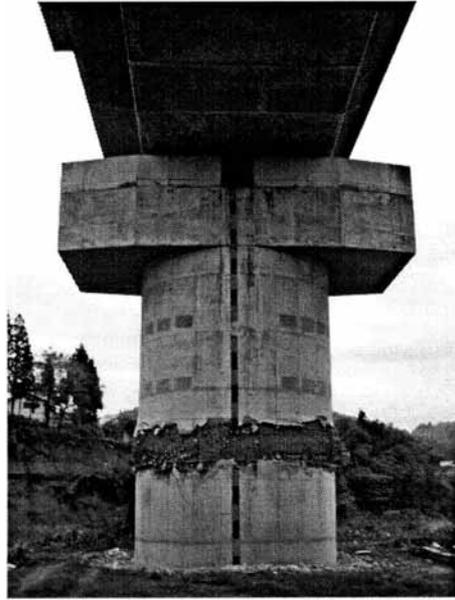
Photo 11 Uonumagawa Bridge (damage to RC bridge pier at the rebar cut-off point)  
(Photo by Hiroshi Mutsuyoshi)
