# Preliminary Report on Damage from Mid-Niigata Prefecture Earthquake in October 2004

INAGAKI Hideki

KAMAI Toshitaka

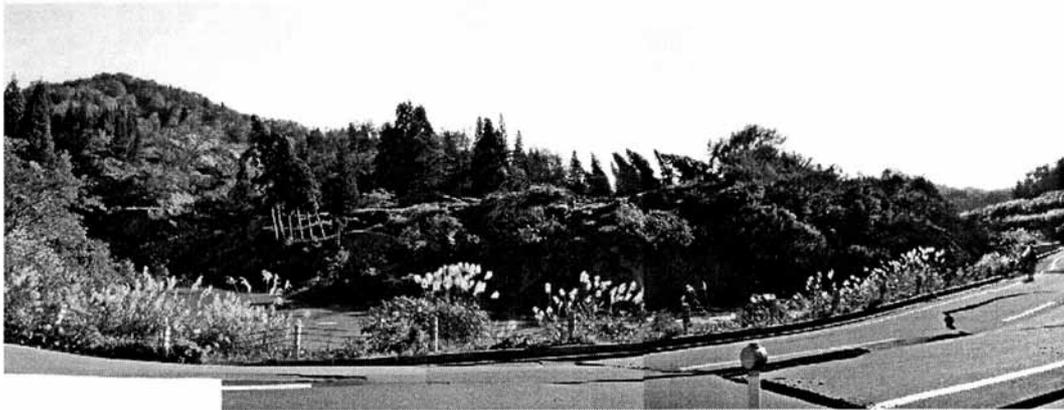
Photo 1 River blocked by enormous landslide that formed a lake near Higashi Takezawa in Yamakoshi village

Photo 1 shows the extensive landslide that blocked the river, forming a lake, near Higashi Takezawa in Yamakoshi village. The landslide site is on the left. The landslide completely blocked the road on the right of the photo and the Imo River in the center. Figure 1 is an explanatory cross-sectional view of the landslide. Photo 2 shows the mudflow that surged into Higashi-Takezawa Elementary School on the other side of the river. Riverbed gravel and even fish were bulldozed out ahead of the mudflow and scattered around. Photo 3 shows the lake that formed in the Imo River when it was blocked by the landslide.

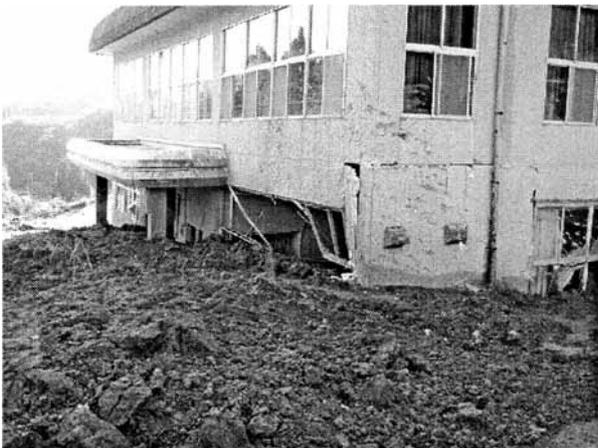
Photo 2 Higashi-Takezawa Elementary School damaged by mudflow

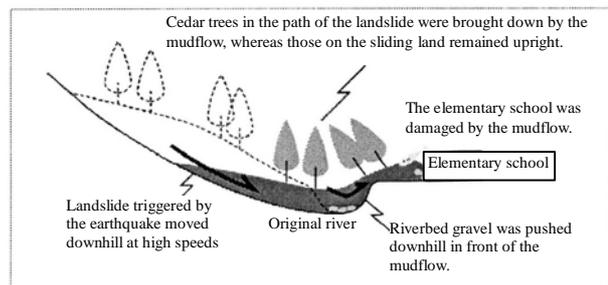
Fig. 1 Imo River blocked by massive landslide at Higashi Takezawa to form a lake

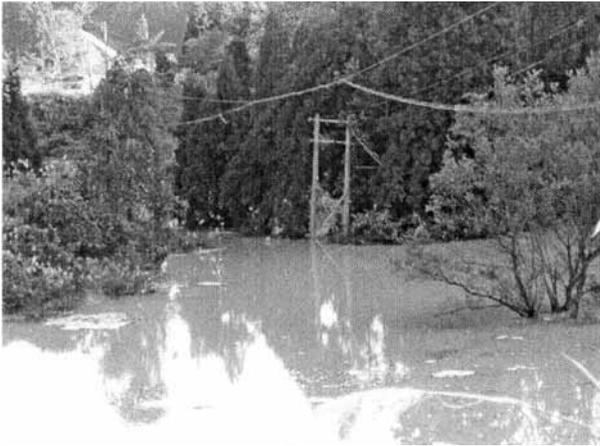
Photo 3 Lake formed by the Imo River after the landslide in Yamakoshi village

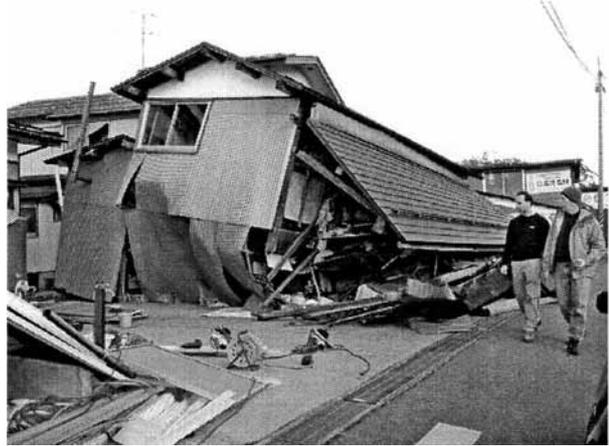
Photo 4 shows a collapsed house on filled ground near Uemura in Ojiya city. When groundwater levels are high, earthquake damage tends to be concentrated in areas developed on the filled ground.<sup>1)</sup> Damage to snow-resistant houses on ground of good quality was minor. Photo 5 shows a section of failed roadbed on filled ground; groundwater continued to flow from the damaged area. Failure occurred in many places where slopes had been filled to form rice paddies, and again spring water continued to flow out from the failure points. Photo 6 shows traces of sand boils in a rice paddy in the city of Ojiya. Many sand boils were identified in rice paddies on low land in the city. In addition, uplifted manholes were also found along roads.

Photo 4 Collapsed house on land developed on filled ground near Uemura in Ojiya city

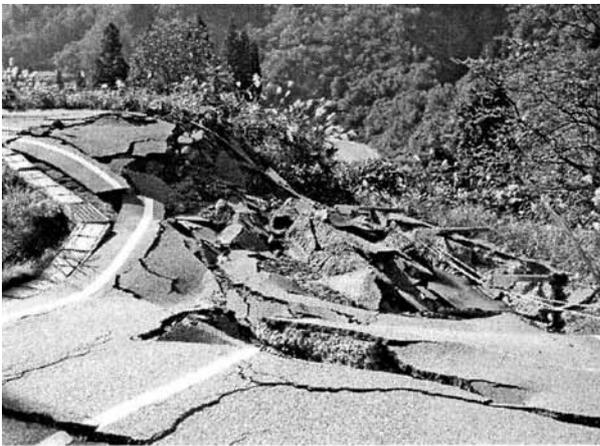
Photo 5 Collapsed road on filled ground; groundwater continued to flow from the damage

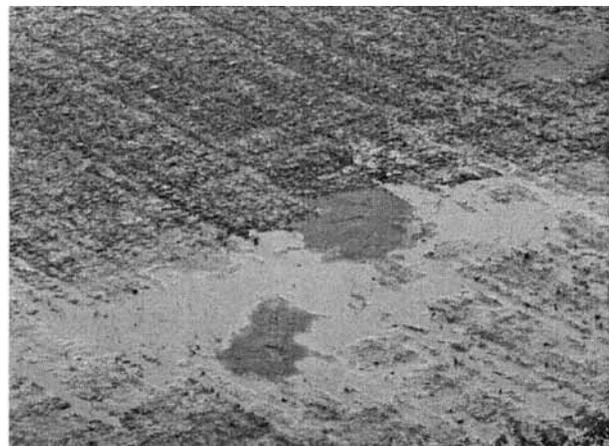
Photo 6 Traces of sand boils in a rice paddy in Ojiya city

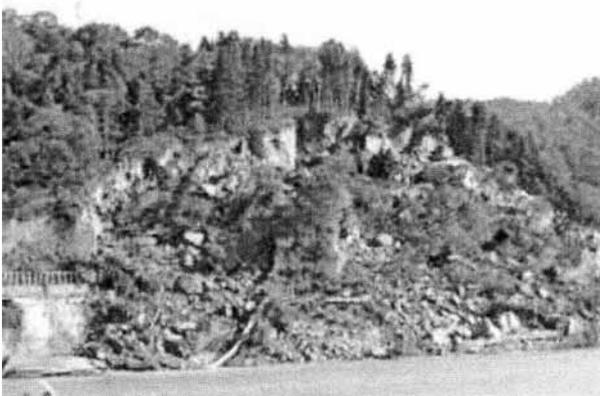
Photo 7 shows a failed cut embankment along a road in Shiroya, Ojiya city. The embankment had been cut from land in the shape of an inverted 'V'. The blocks of failed stone consisted of sandy mudstone. When the photo was taken, efforts were under way to rescue a girl trapped among the blocks. Unfortunately, the rescue team gave up the search and left the site the same afternoon. The characteristics of slope failure originating at the top of high ridges closely resembles damage seen at Mt. Usu and during the volcanic earthquakes on Kozu Island in 2000.<sup>2),3)</sup> Photo 8 shows the failed surface layer on a steep cliff-like slope in Yamakoshi village. Only the vegetation-covered surface layer slid down the slope. The failure surface exhibited a few cracks but no plant roots were identified, so this can be identified as a failure along the lateral root layer of the vegetation.<sup>4)</sup>

Photo 7 Failed slope cut from 'V'-shaped land in Shiroiwa, Ojiya city. Efforts were under way to rescue a girl trapped inside the blocks.

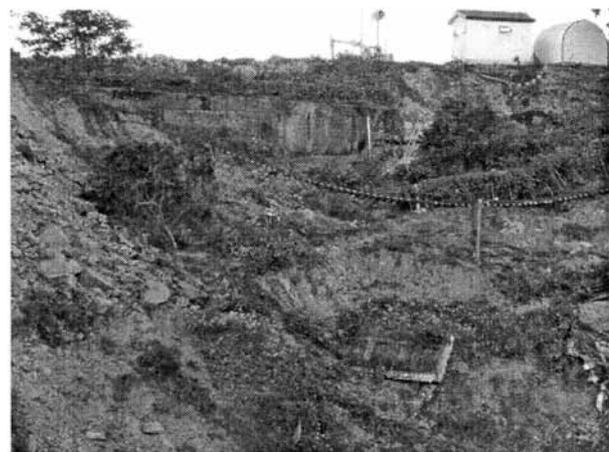
Photo 9 shows cases where failure of filled ground affected important infrastructure: the Japan Railways Shinetsu line and National Route 17. The filled ground that failed was a sloping area along the Shinano River. It will take time to restore the failed slope.

Photo 9 Track hanging free on the Shinetsu line after failure of filled ground and blockage of National Route 17

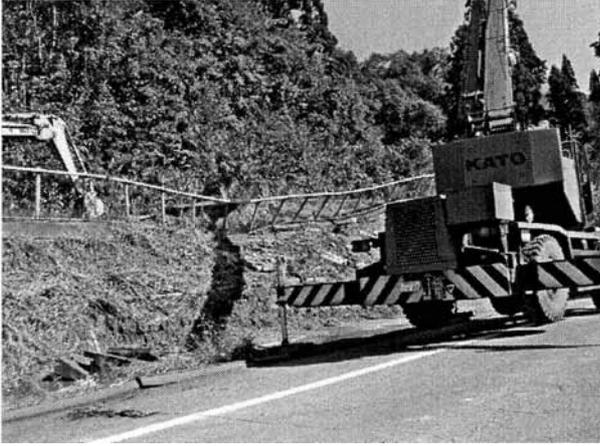
Photo 10 Recovery work under way at damage site on the Kanetsu Expressway

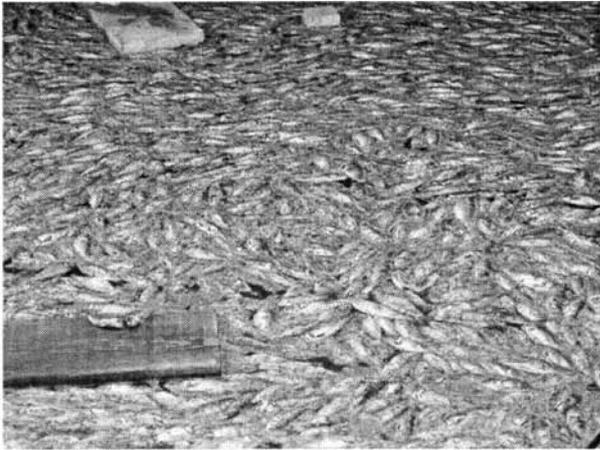
Photo 12 Damage to Nishiki carp production; large numbers of carp died leading to a foul stench.

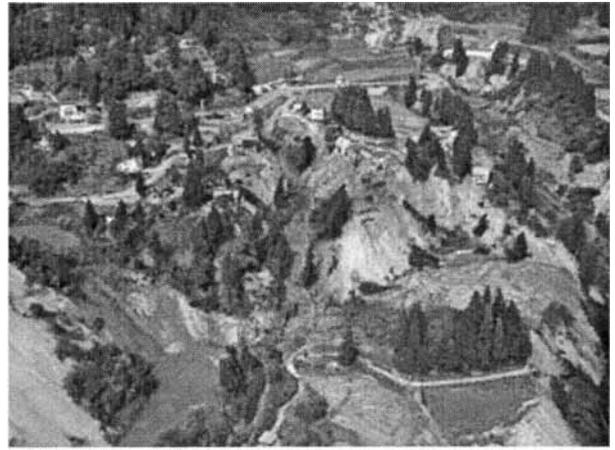
Photo 13 Damage to houses after slope failed near Nanpei in Yamakoshi village  
(Photo by Nakanihon Air Service Co., Ltd.)

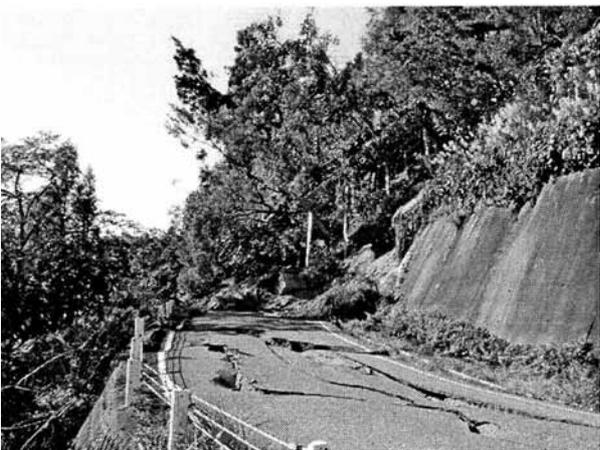
Photo 14 Road to Yamakoshi village blocked by failed slope

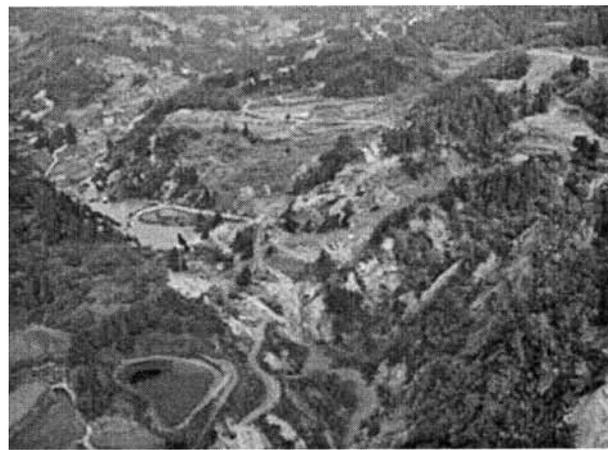
Photo 15 Failure of a dam formed after a landslide in the river gives rise to the danger of a secondary disaster  
(Photo by Nakanihon Air Service Co., Ltd.)
