# Preliminary Report on December 26, 2003 Iran Bam Earthquake

Prepared by JSCE Iran Bam Earthquake Disaster Investigation Team

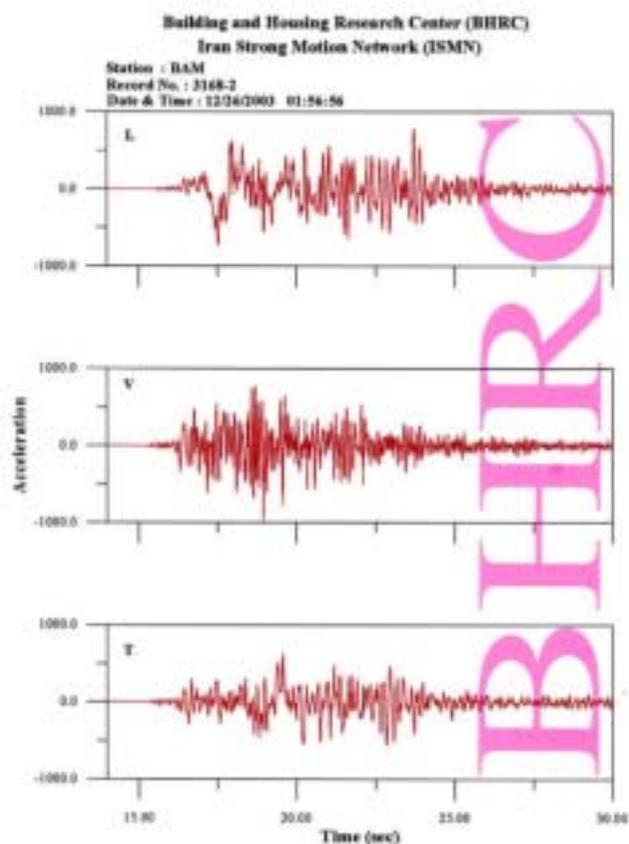
Figure-2: Strong-motion seismograms recorded in the city of Bam<sup>2)</sup>

Table-2 shows the maximum acceleration at various sites. In Bam, a vertical motion of over 1G is observed, and the horizontal motion has marked a very high value of 800gal as well. Figure-2 is the strong motion waveforms that BHRC disclosed. It may be considered that the horizontal component (L) expresses the characteristic of the site near the fault. As the strong-motion seismograph was placed under a desk, on the first floor of a two-storied concrete reinforced brick structure, there was no impact from falling objects. However, as the adjacent locker fell, there is a possibility that the record reflects the impact of this fall, or of the shaking of the structure itself, which was partly damaged.

(From the top: horizontal, vertical, horizontal-transverse components. The maximum rates are shown in Table-2)

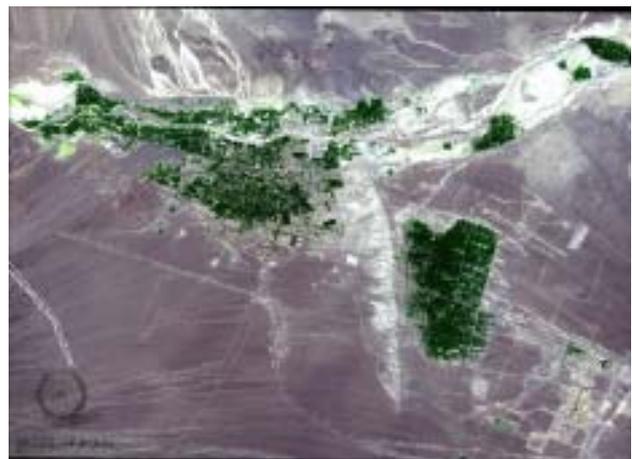
Photo-1: Aerial photo of Bam and Baravat

the city of Bam. At the site, an almost continuous stretch of scarp that has been formed by the past fault movements extends in the north-south direction. This scarp has a relative height of 20m with its higher point on the west side. Photo-1 is an aerial photo showing the cities of Bam (western green area) and of Baravat (eastern green area). The white area stretching from north to south, in between the two cities is the flexural scarp. The Bam fault is a right lateral reverse fault but it is considered that the fault did not reach the ground surface and was limited to the development of the flexural scarp. Photo-2 shows a fissure that appeared on the road traversing the flexural scarp. It is not considered a slip surface of the epicentral fault but an open fissure caused by the development of the flexural scarp.

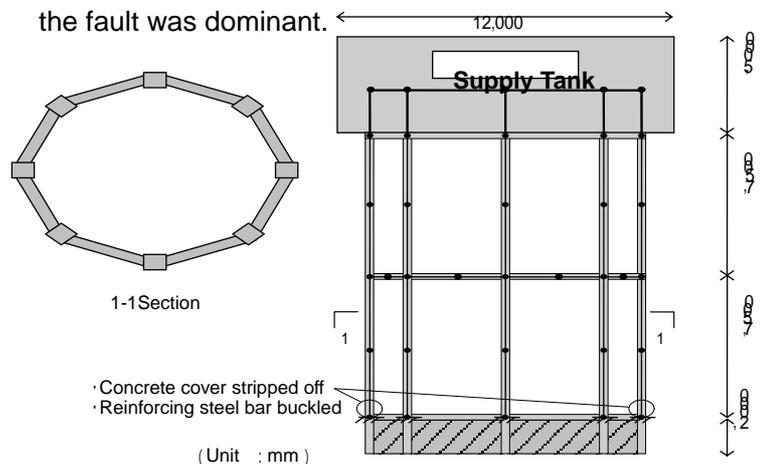
Figure-3: Structure of the Water Tower

Damages were observed in a reinforced concrete water tower located at the center of the stricken area, where the concrete that was covering the lower end of its pillar was stripped off and the reinforcing steel bar (in the direction of the axis) was exposed and buckled (Figure-3). The pillars were placed octagonally, in a rigid-frame structure with mid-layer beams. In order to grasp the dynamic bearing capacity of the water tower, we have undertaken a static increasing horizontal seismic coefficient analysis using a frame model. Figure-4 indicates the relationship between horizontal seismic coefficient and horizontal displacement at the center of gravity of the water supply tank. The result of the analysis shows that after the point where the lower end of the pillar yielded, the slope of the curve became gradual. Therefore, it may be considered that the yield horizontal seismic coefficient of the entire water tower was approx. 0.37, and the horizontal acceleration equivalent to over 370gal of earthquake motion was in action. Moreover, the damages such as the stripped concrete cover of the western pillar due to tension, and the buckled reinforcing steel bar of the eastern pillar due to the compression suggest that the westward action perpendicular to the fault was dominant.

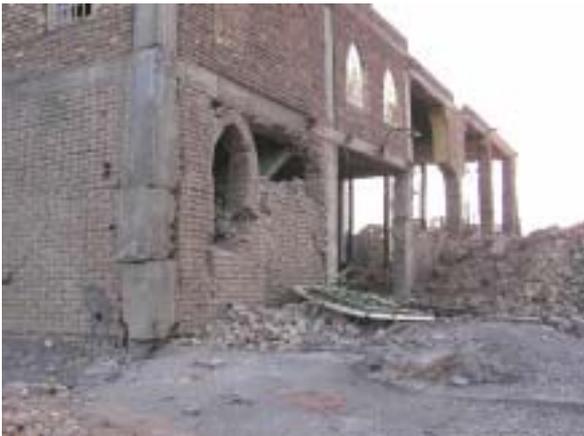
As in other structures, reinforced concrete mosques have suffered smaller damages than brick or adobe structure ones. However, brick walls have collapsed even in reinforced concrete mosques. Photo-3 shows a mosque where the collapse of the wall has claimed 7 lives. Yet, compared to brick houses, these structures suffered smaller, B-degree damages. This may be due to the effect of the difference in the quality of building materials used. Whereas ordinary houses are built with bricks by the residents themselves, due to their large scale, mosques are built with high quality mortar by professional construction workers.

Photo-3: A damaged mosque

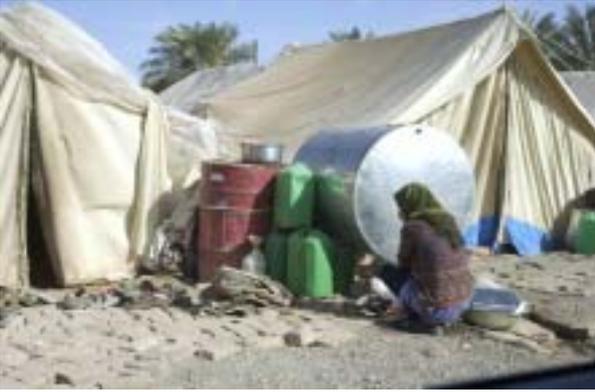
The water supply systems in both Bam and in Baravat suffered no damage in tanks and other facilities, except in the underground pipes. The underground pipes made of Asbestos-cement, P.V.C. and polyethylene were damaged at their T or straight joints as well as at their body. There have been a great number of collapsed houses and due to that, excavation work has been impossible in many areas. In many of these areas, temporary ground pipe systems have been introduced. For residents living in tents, water tanks like the one shown in Photo-4 were supplied.

Photo-4: Water tank supplied to the residents

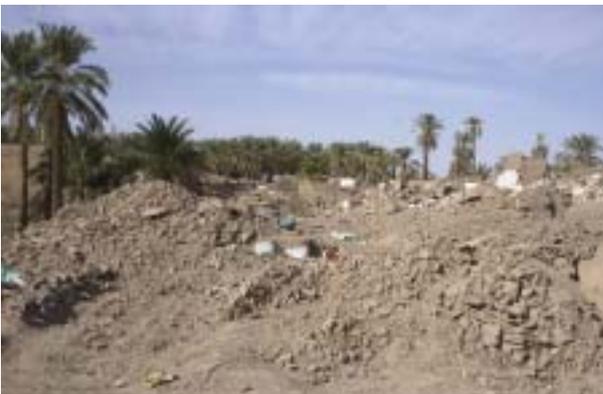
There are many adobe structure houses in central Bam, and most of them have collapsed. In the same area, there are many non-reinforced brick houses, which have collapsed as well. The rate of collapse is said to amount to 80-90%. As shown in Photo-5, there are many areas that are covered with heaps of rubbles, and the next important task there would be to remove these rubbles and to plan the reconstruction. During the on-site investigation, we have undertaken in-person hearings on questionnaire seismic intensity and microtremor observation among

Photo-5: Collapsed adobe structure houses
