Preliminary Report on December 26, 2003 Iran Bam Earthquake

Prepared by JSCE Iran Bam Earthquake Disaster Investigation Team

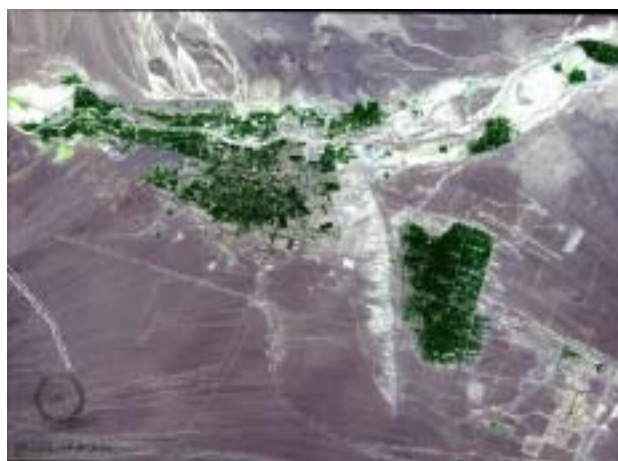
Photo-1: Aerial photo of Bam and Baravat

the city of Bam. At the site, an almost continuous stretch of scarp that has been formed by the past fault movements extends in the north-south direction. This scarp has a relative height of 20m with its higher point on the west side. Photo-1 is an aerial photo showing the cities of Bam (western green area) and of Baravat (eastern green area). The white area stretching from north to south, in between the two cities is the flexural scarp. The Bam fault is a right lateral reverse fault but it is considered that the fault did not reach the ground surface and was limited to the development of the flexural scarp. Photo-2 shows a fissure that appeared on the road traversing the flexural scarp. It is not considered a slip surface of the epicentral fault but an open fissure caused by the development of the flexural scarp.

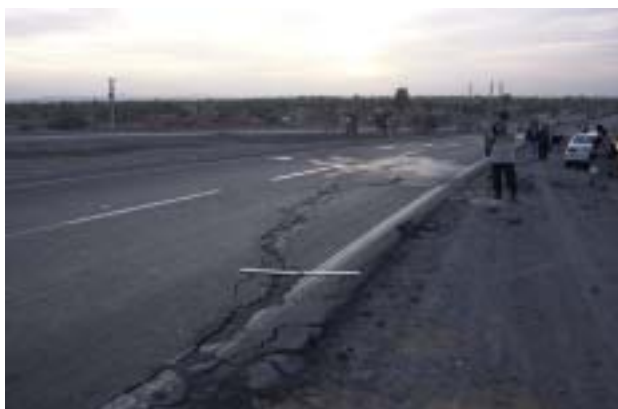
Photo-2: Crack on the road traversing the flexural scarp

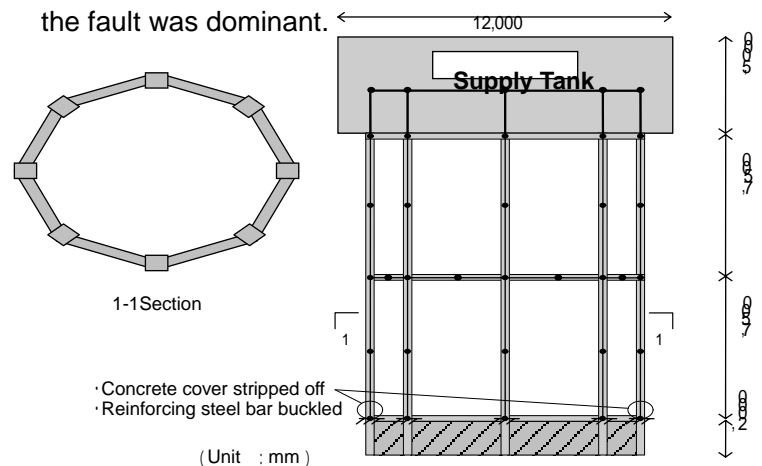
Figure-3: Structure of the Water Tower

Damages were observed in a reinforced concrete water tower located at the center of the stricken area, where the concrete that was covering the lower end of its pillar was stripped off and the reinforcing steel bar (in the direction of the axis) was exposed and buckled (Figure-3). The pillars were placed octagonally, in a rigid-frame structure with mid-layer beams. In order to grasp the dynamic bearing capacity of the water tower, we have undertaken a static increasing horizontal seismic coefficient analysis using a frame model. Figure-4 indicates the relationship between horizontal seismic coefficient and horizontal displacement at the center of gravity of the water supply tank. The result of the analysis shows that after the point where the lower end of the pillar yielded, the slope of the curve became gradual. Therefore, it may be considered that the yield horizontal seismic coefficient of the entire water tower was approx. 0.37, and the horizontal acceleration equivalent to over 370gal of earthquake motion was in action. Moreover, the damages such as the stripped concrete cover of the western pillar due to tension, and the buckled reinforcing steel bar of the eastern pillar due to the compression suggest that the westward action perpendicular to the fault was dominant.

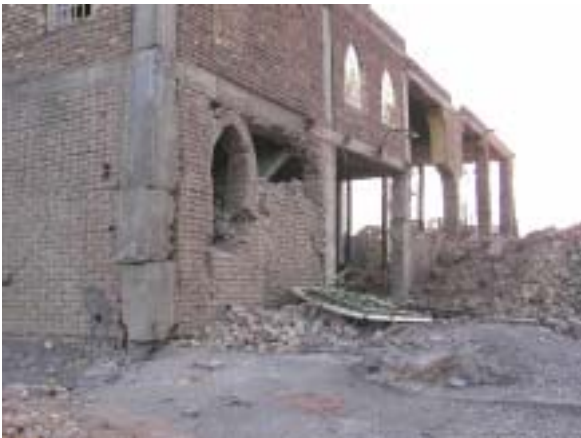
As in other structures, reinforced concrete mosques have suffered smaller damages than brick or adobe structure ones. However, brick walls have collapsed even in reinforced concrete mosques. Photo-3 shows a mosque where the collapse of the wall has claimed 7 lives. Yet, compared to brick houses, these structures suffered smaller, B-degree damages. This may be due to the effect of the difference in the quality of building materials used. Whereas ordinary houses are built with bricks by the residents themselves, due to their large scale, mosques are built with high quality mortar by professional construction workers.

Photo-3: A damaged mosque

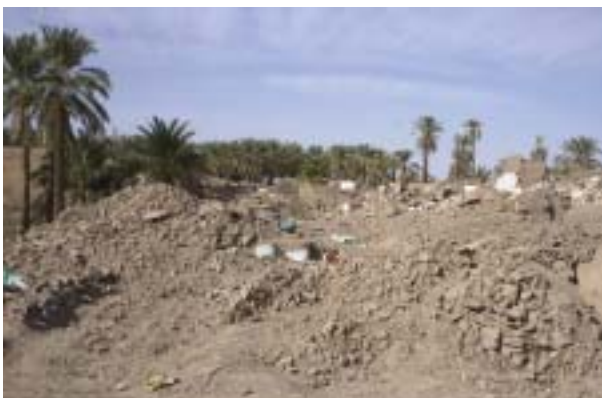
There are many adobe structure houses in central Bam, and most of them have collapsed. In the same area, there are many non-reinforced brick houses, which have collapsed as well. The rate of collapse is said to amount to 80-90%. As shown in Photo-5, there are many areas that are covered with heaps of rubbles, and the next important task there would be to remove these rubbles and to plan the reconstruction. During the on-site investigation, we have undertaken in-person hearings on questionnaire seismic intensity and microtremor observation among

Photo-5: Collapsed adobe structure houses
