Japan Society of Civil Engineers
Yotsuya 1, Shinjuku-ku, Tokyo 160-0004
<http://www.jsce.or.jp/>

Provisional Report on the January 13, 2001 Earthquake Occurred Off The Coast of El Salvador (updated 15, February, 2001)

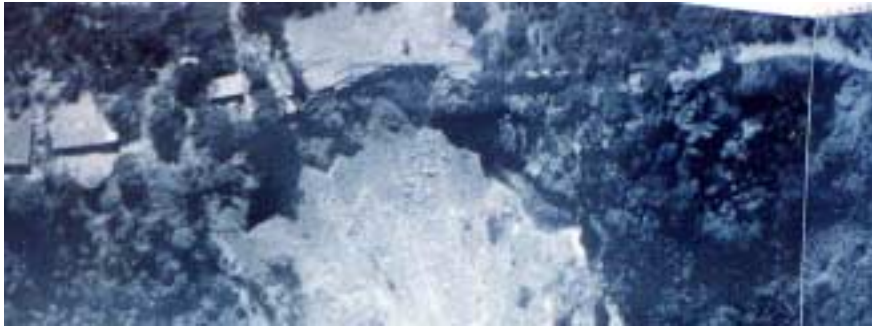
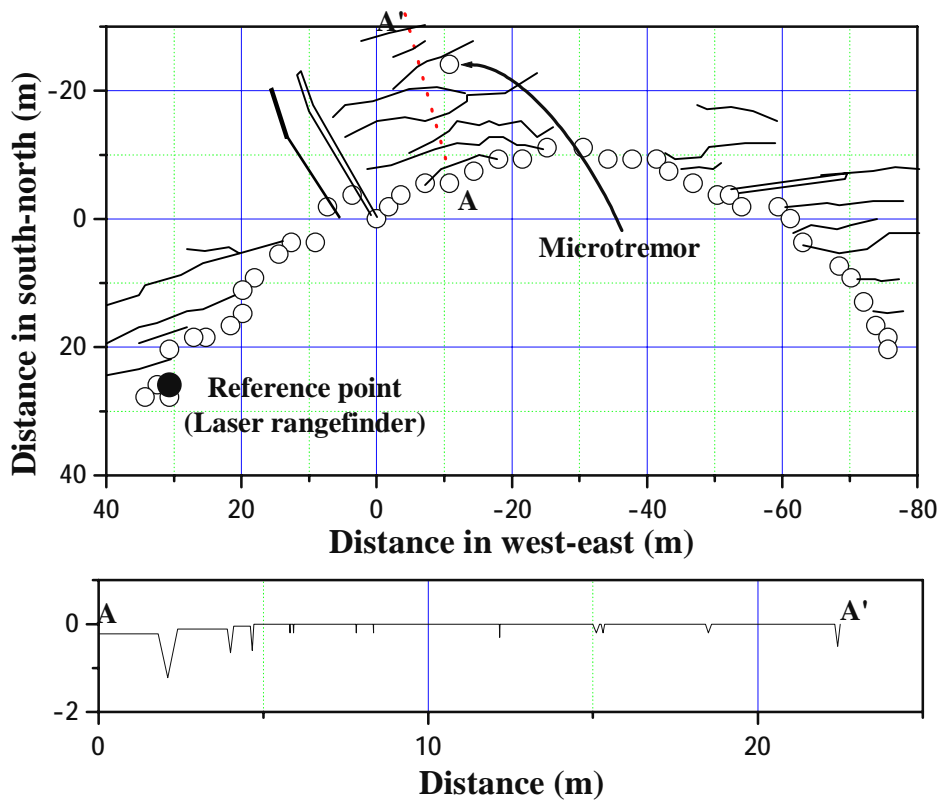
Fig. 1.2. Perimeter of scar, Las Colinas Landslide

Total 43 points were marked along the perimeter of the scar using a GPS receiver (**Fig. 1.2**). Behind the scar, there were extensive cracks running in almost west-east. Crack openings (12 visible cracks; **Table 1.1** and **Fig. 1.2** (below)) were measured along Line A-A'. Total 1.25 m's opening was reached over the 22 m's distance of Line A-A'. Namely, about 5% average strain was induced within the soil behind the scar. Extensive cracks were found along the ridge crest even in areas that did not slide (**Fig. 1.3**); the cracks are certainly the threat of further slides.

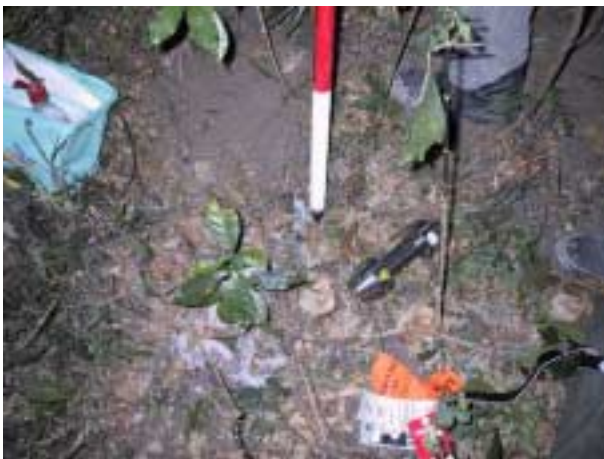
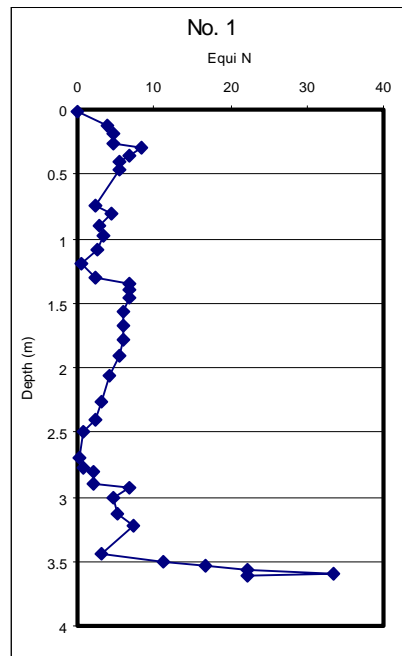
Fig. 1.4 Sounding using cone-penetrometer

Sounding of soil stiffness was done by using a single cone-penetrometer at the western crest of the hollow (**Fig. 1.4** and *Star mark* in **Fig. 1.1(a)**). Thin soft wet layers were found at about 1.2m and 2.5m deep. These two weak layers seem to be pumices and/or fragmental volcanic products, white-yellow-colored light porous volcanic rocks sandwiched in the uppermost part (EL. +1030 - +1076) of the ridge. This part of the ridge is a thick sediment of tephra, with some wet layers of pumice or tuff underlain thin gray less-permeable films. The tephra sediment is overlaid with a stiff tuff forming the top terrace of the slope.

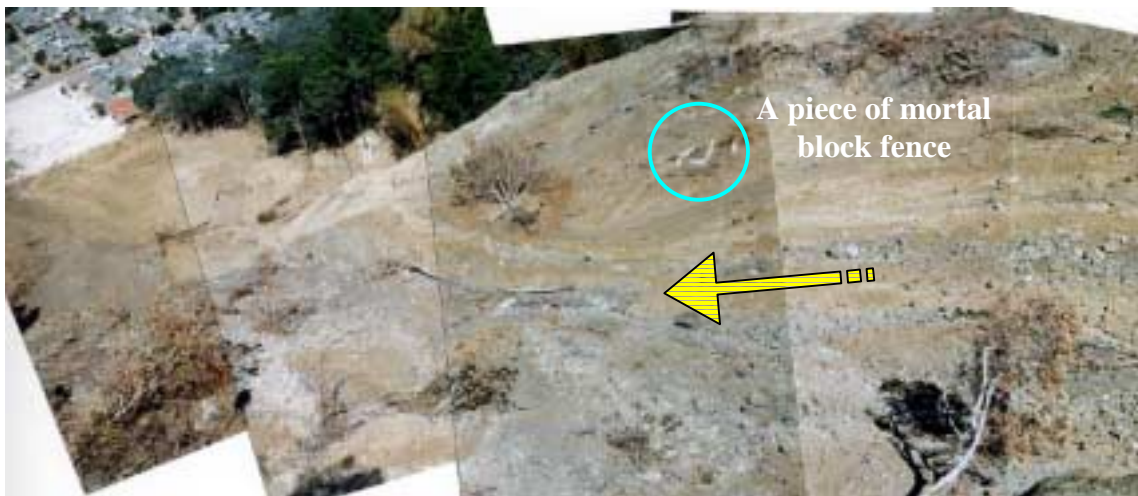
Fig. 1.5 Lower part of the hollow: A piece of mortar block fence (within the circle) is caught on the small amount of the soil mass stopped at the lower edge of the hollow.

Broken pieces of a mortal-block fence were caught on the soil mass remaining on the outer edge of the hollow, and there are some downward streaks remaining on the bottom of the hollow (arrow in **Fig. 1.5**). These may be evidencing that most soil mass, which originally fitted into the hollow, seems to have been pushed forward, and flown down the lower steep slope.

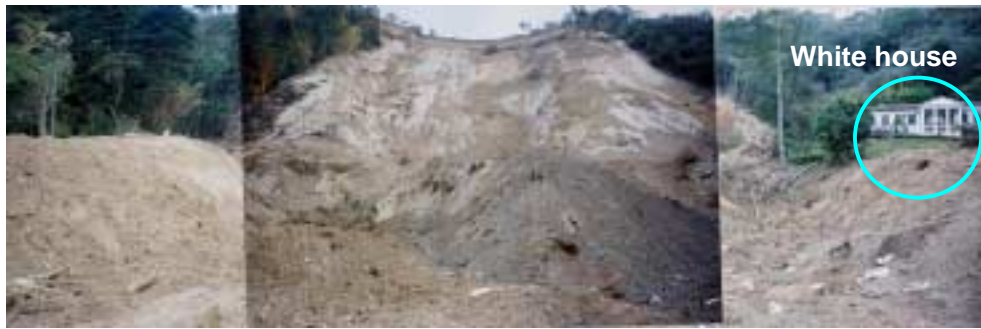
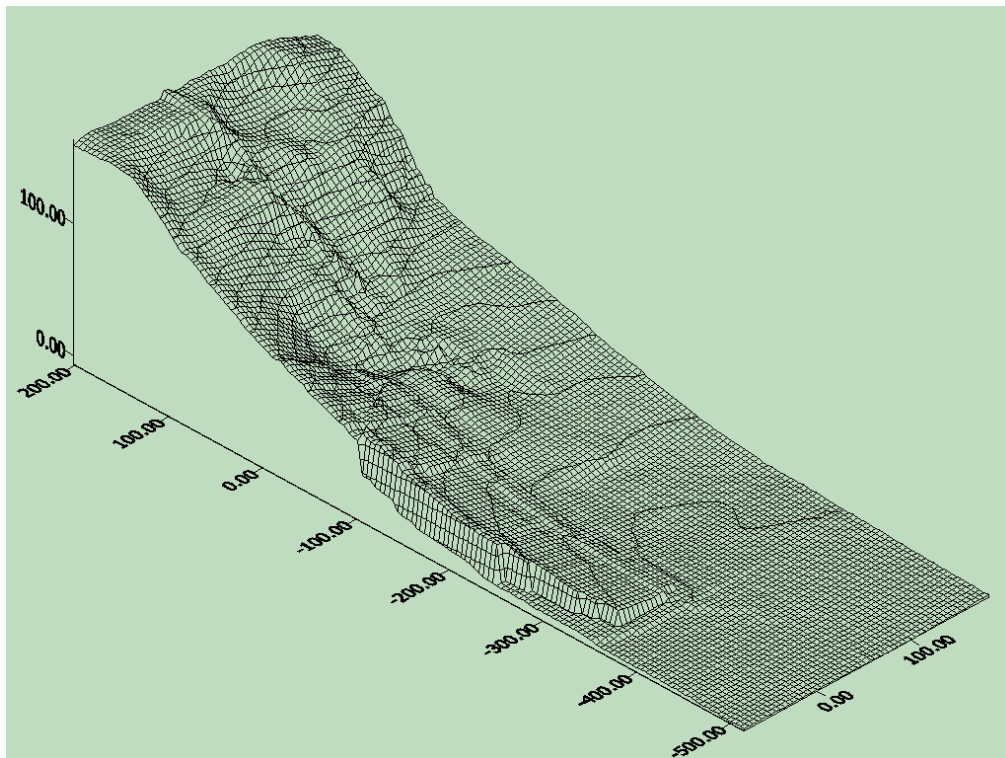
Fig. 1.6. 3D Configuration of the slope
(Contour lines: every 10 m elevation increment)

The 3D configuration of the entire slope was surveyed from three reference points (**Fig. 1.6**). Two ravines coming down from both sides of the slope curve forward and meet at the middle of the slope width. The steepest slope was covered thin with a film of mud including porous fragments of pumice; the film is noticeably stiff after totally dried up. The film covered trees, bamboos and other plants mowed down on the slope (**Fig. 1.7**). This fact suggests that the bottom surface of the slid soil mass was wet, and may have been liquefied (Sassa, 2000), possibly related to some weak tephra layers spreading over less permeable paleosols (http://landslides.usgs.gov/html_files/central.a.shtml).

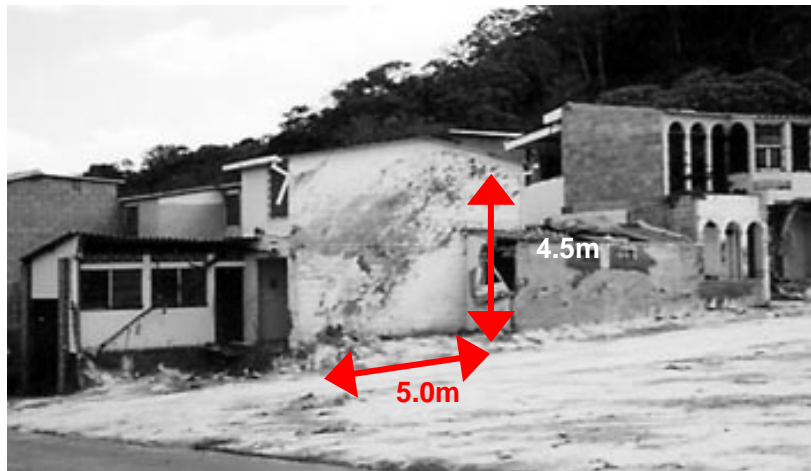
Fig. 1.9. House wall spotting with splashes

There were many splashes of mud remaining on house walls, trees and etc. In general, the splashes seem to be higher at around the toe of the slope than those in the middle or close to the distal end of the soil deposition zone. The highest splash of about 10 m was found on a trunk near the toe. There was water stopped on a pavement. Fig. 1.9 shows the wall of a dwelling on the eastside perimeter of the slid soil mass, the wall spotting in parabola with mud splashes. The parabola with its peak of about 4.5m high drops downward, and reaches the ground after about a 5m horizontal run. This fact suggests that the time t needed for the splashes to reach the ground from their peak height Δh ($= 4.5$ m) was about 1s ($\Delta h = g \cdot t^2 / 2$), and during this time, the splashes ran about the 5m horizontal distance (5 m/s). The main stream of the soil mass flow might have faster than this speed even after running through dwellings standing close together.

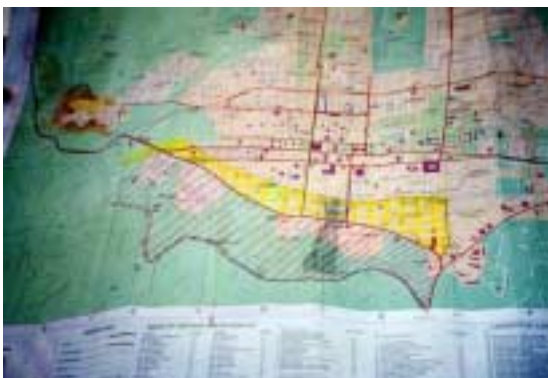
Fig. 1.10. Zones of potential risk

Extensive cracks running along the ridge crest are the serious threat of further slides. The city of Santa Tecla is controlling the potential hazard zones, the red zone with the highest risk and the yellow zone of slightly less danger (**Fig. 1.10**). A week after the earthquake, the number of residents evacuated from the zones exposed to the menace of possible landslides reached 14,000, and as of Feb. 3, about 4,000 refugees were still being forced to live in tents (**Fig. 1.11**).

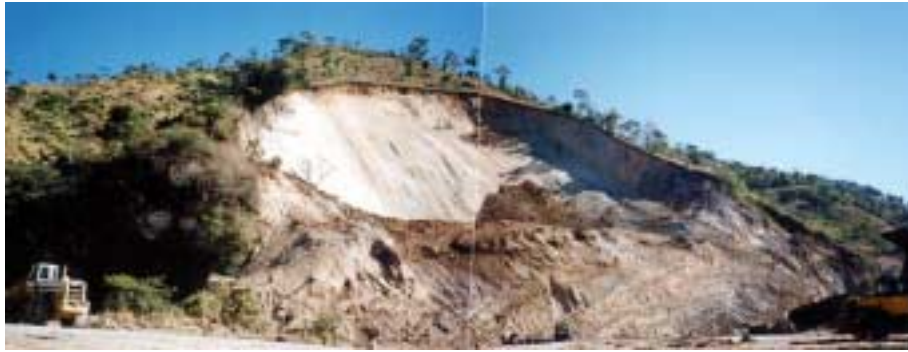
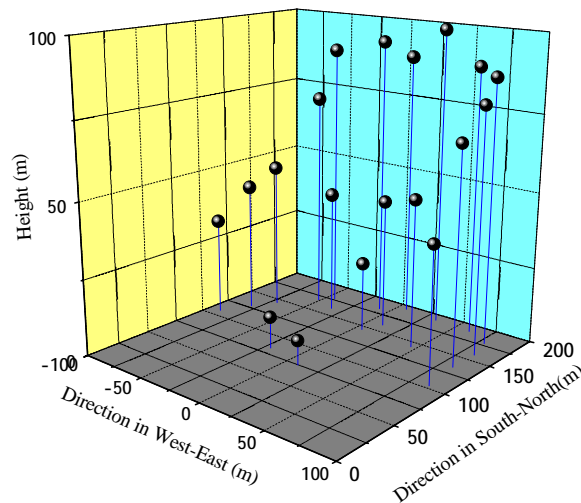
Fig. 1.2 Configuration of San Vicente Landslide

At the 53rd km of the Panamerican Highway, in San Vicente, a slid soil mass has blocked the road (**Fig. 1.12, above**). Three dimensional shape of the slip surface (hollow) was measured (**Fig. 1.12 below**), and the possible volume of the slid soil mass was roughly estimated to be about 300,000 m³. A steeply dipping joint surface seem to have served as a slide plane. Some cracks were found further above the upper end of the scar.

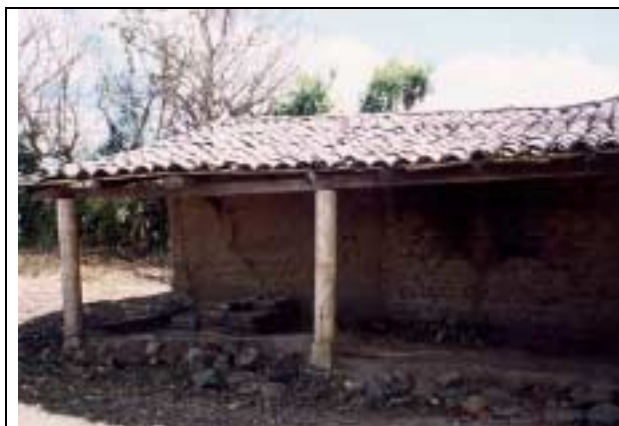
Fig. 1.3. Bahareque house near San Vicente landslide: This bahareque house, standing on the terrace high above the headscarp of the slide, performed quite well, though it suffered some diagonal shear cracking.

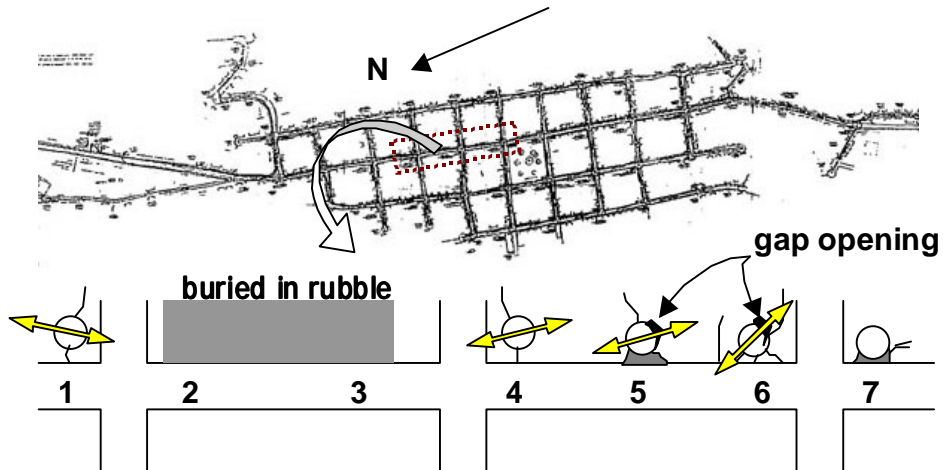
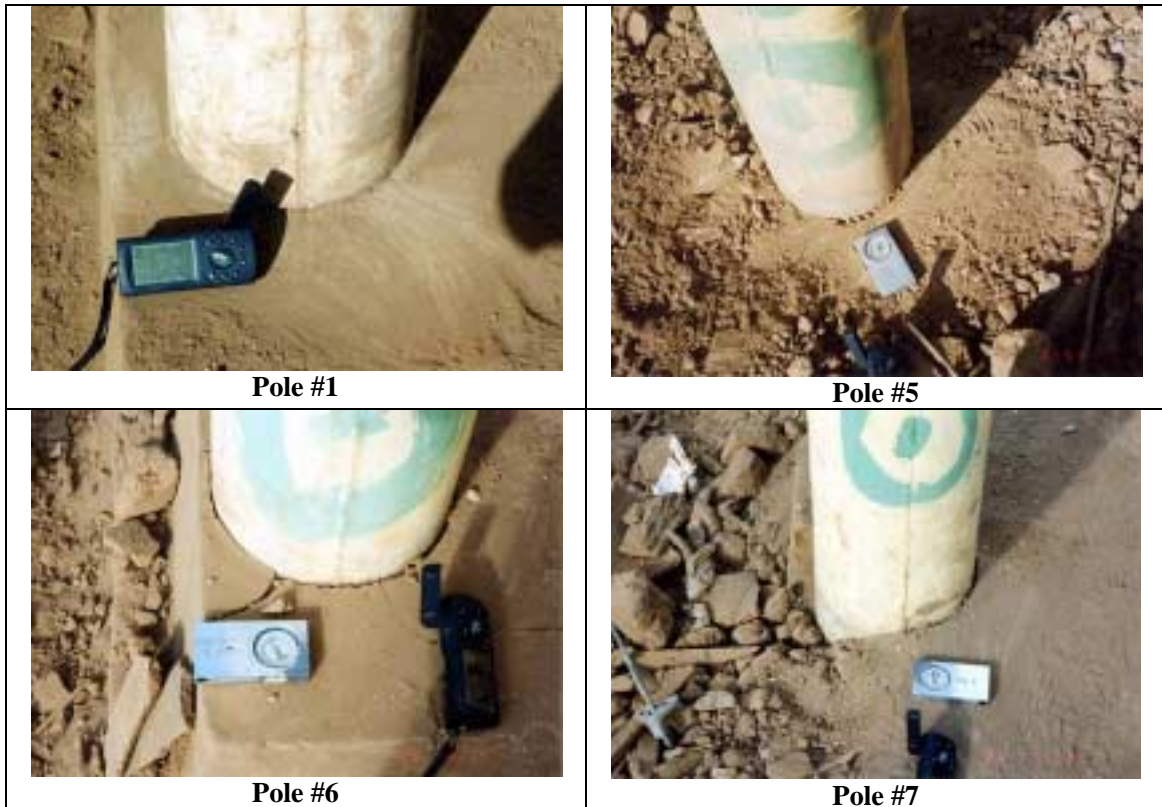
Fig. 2.1. Cracks appearing around utility poles

Utility poles (5m tall) are embedded upright in concrete-paved sidewalk. Cracks developing outwardly on the pavement from these poles were mapped. Some poles (No. 6 and 7) are very close to the step-shaped edge of the sidewalk. The thin cover concrete thus might have affected the crack pattern. Though the number of the examined utility poles is not sufficient for thorough statistical manipulations, some poles seem to have been forcibly shaken in about N-S direction.

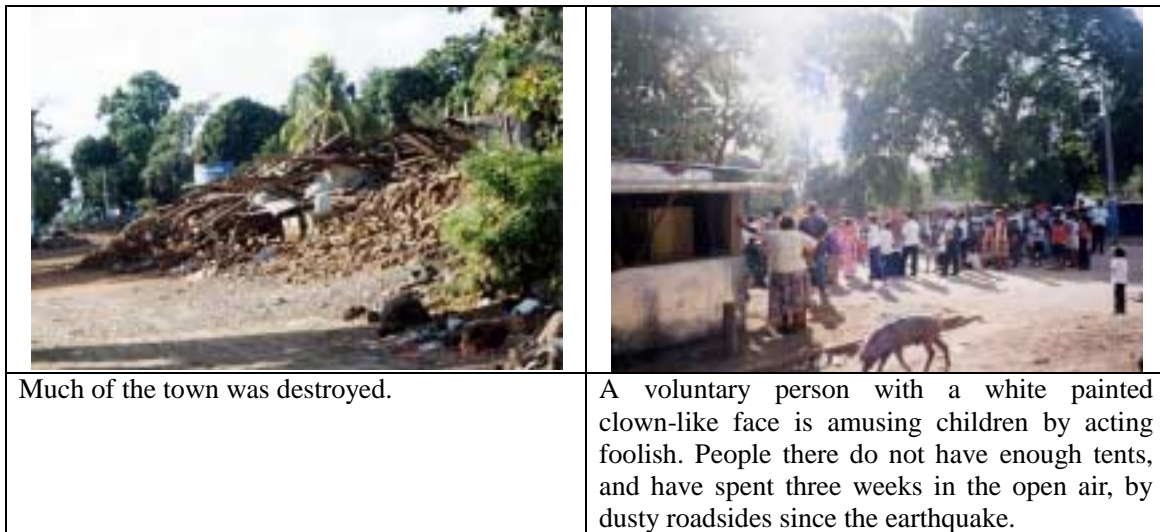
Fig. 2.2. San Agustin (Feb. 4, 2001)

About 90% adobe and un-reinforced masonry houses were flattened in this town (Fig. 2.2, next page).

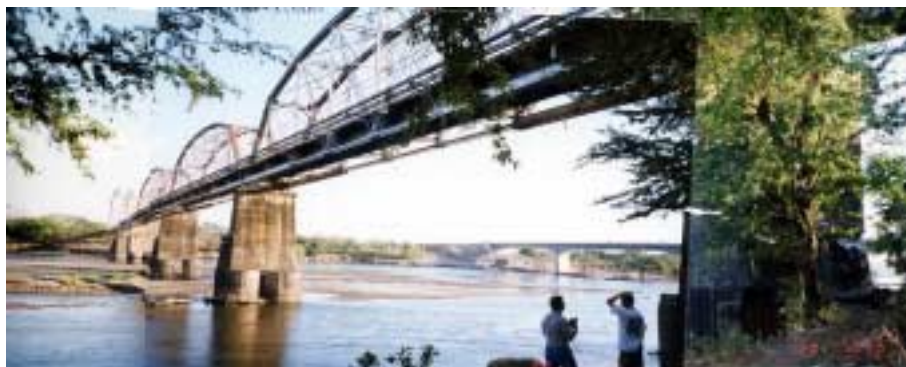
Fig. 3.1. Old railway bridge crossing Rio Lempa

Immediately above the San Marcos Bridge of Carretera Litoral Highway, there is an old railway bridge (1936-) crossing the Rio Lempa (**Fig. 3.1**). The upper deck of the bridge, after the railway was discontinued, was totally asphalt-paved, and served as a route for vehicles. Liquefaction-inflicted lateral spread of soil and associated cracks were found only on the right side of the river (**Fig. 3.2**); the right riverside might have been an old river trace. Fine sands (0.3-0.5 mm) cover thin the ground surface.

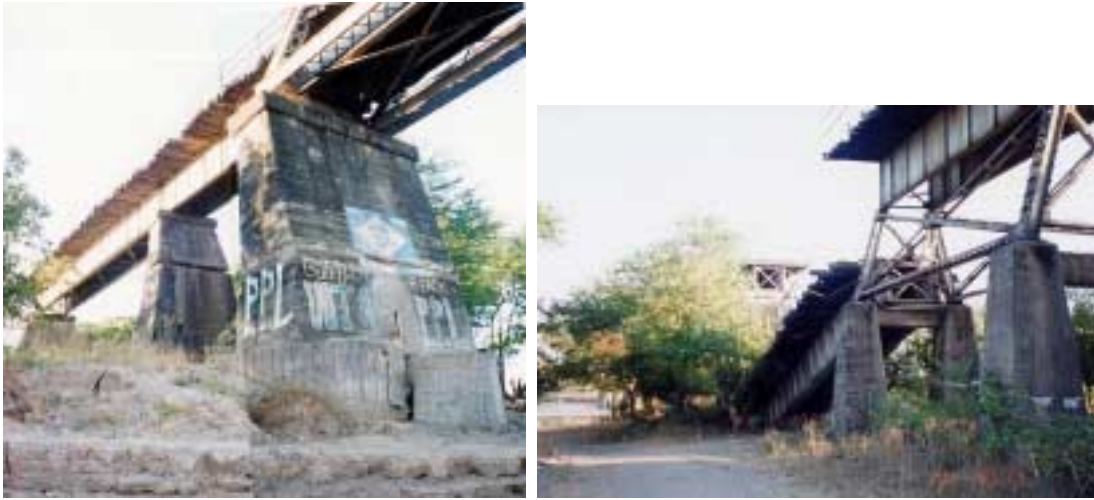
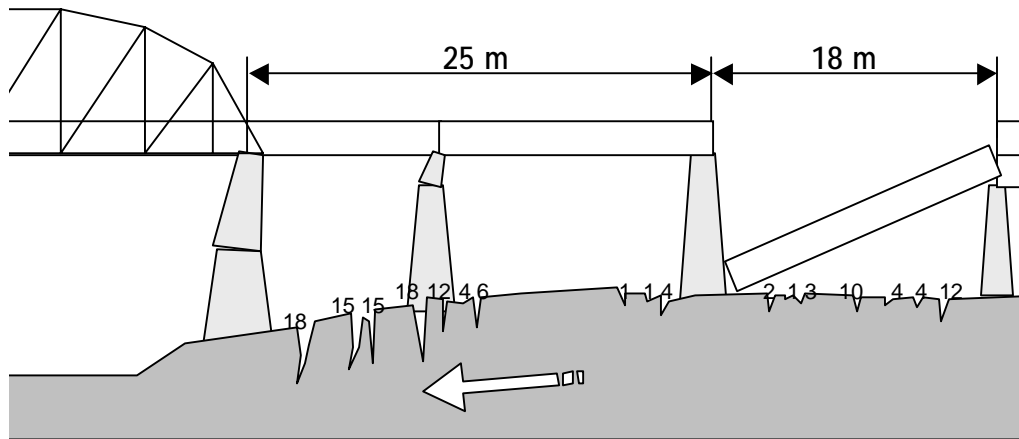
Fig. 3.2. Crack openings (cm)

Visible crack openings were measured (**Fig. 3.2**). Total 1.27 m's opening was reached over the 45 m's distance. Piers (caisson foundations?) supporting truss guiders seem to be stable and stiff. The truss girders propped up the right approach girders, while the lateral flow of soil have carried the lower parts of piers towards the river. → Construction joints opened wide.
