A QUICK REPORT
ON
MIE-KEN KAMEYAMA EARTHQUAKE ON APRIL 15, 2007

Ömer AYDAN
Chairman
Earthquake Disaster Investigation Sub-Committee

April, 2007

Japan Society of Civil Engineers

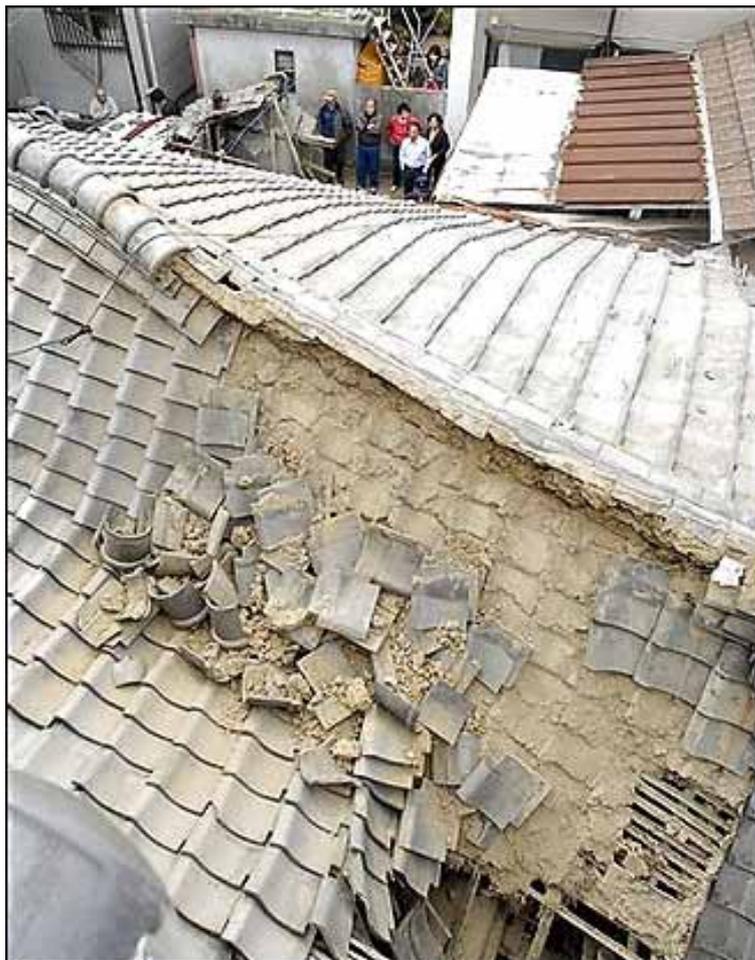
Mainly old wooden houses were damaged. The mode of damage was quite similar to those observed in previous earthquakes.. The damage mechanism fundamentally involved hinging of wooden columns at the base and also at the connections between 1st floor and 2nd floor as a result of large horizontal earthquake forces (Figure 6.1). Many wooden houses suffered from cracking in the walls. The number of damages was highest in Kameyama city (109 households) while it was only 1 household in Geino town, which is the nearest settlement to the epicenter. 7 households were suffered some damage in Suzuka City, which is situated over relatively soft ground.

Figure 6.1: An example of heavily damaged wooden houses (from Kyodo News/AP)

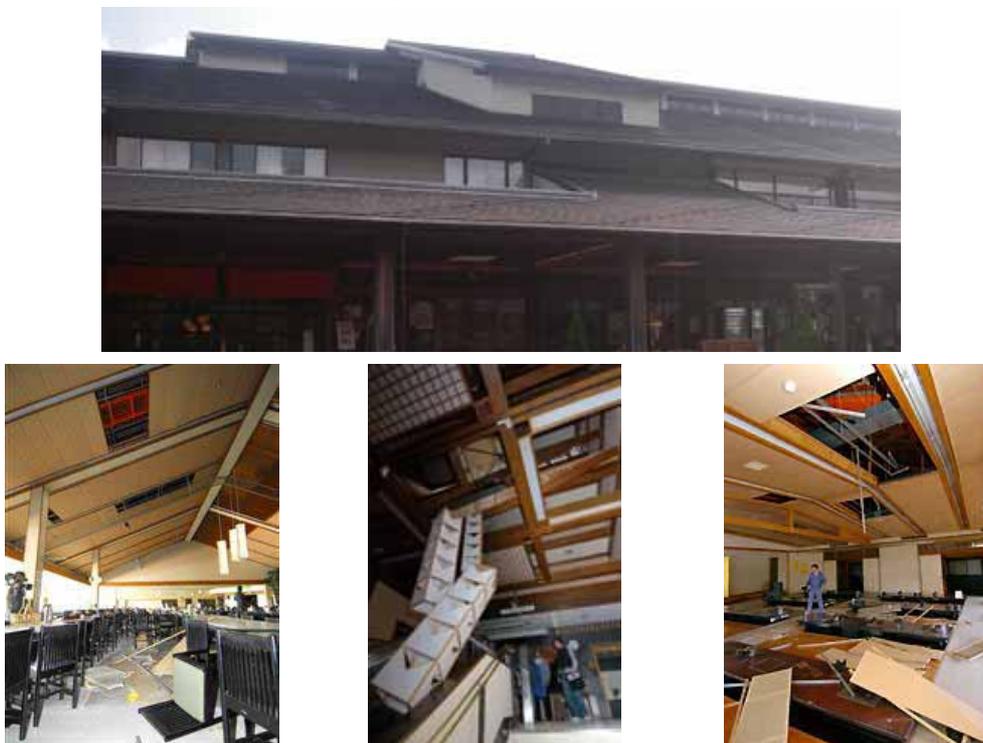
Large halls for various social events at hotels, conference centers, indoor sport centers and restaurants generally have suspended ceiling panels. The fall of ceiling panels injured two people at the second floor of a drive-in restaurant nearby Seki I.C (Figure 6.2). The similar incidents also occurred in indoor sports halls and swimming pools in Suzuka City. Since the earthquake occurred on Sunday and the schools were closed, there was luckily no incident resulting in injury.

Figure 6.2: Views of collapsed ceiling panels (some pictures from various newspapers)

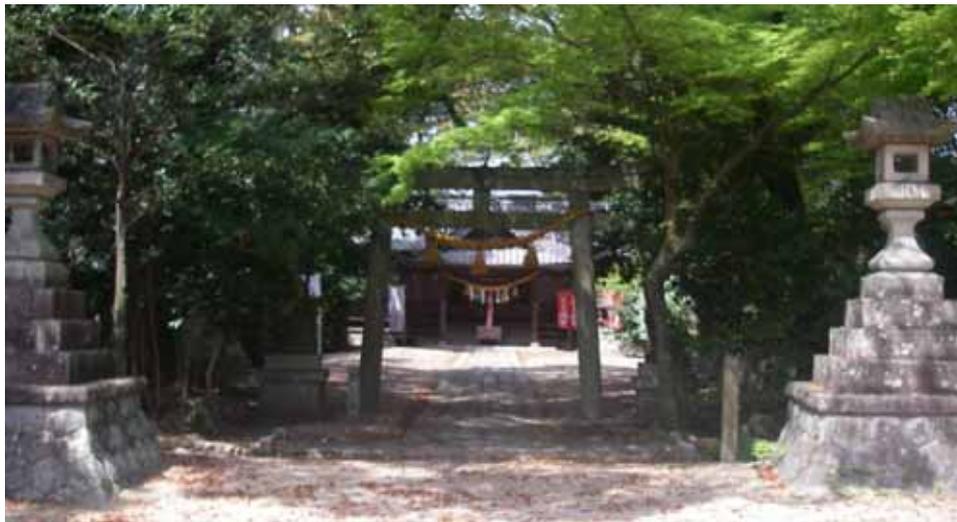
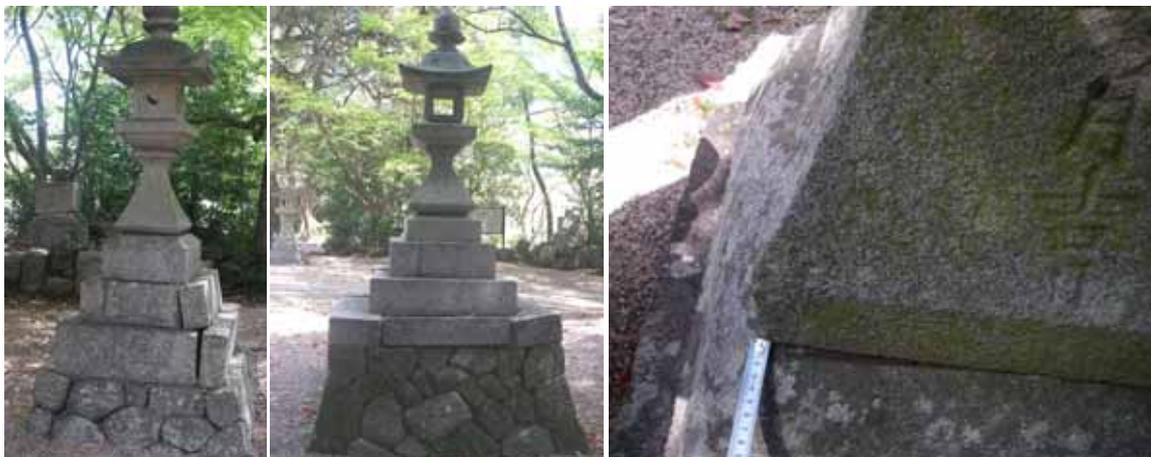
There was no damage to temples and their fort-gates (torii) made of granitic columns and beams in this earthquake. However, the masonry lantern monuments were dilapidated at their base or dislocated (Figure 6.3). The height of these lanterns was 210cm with a square base with a side length of 85cm. For example, the main compound of Kameyama Temple was intact although slight traces of dislocations were observed. The temple is about 18 km away from the hypocenter.

Figure 6.3: Dilapidated or dislocated masonry lantern at Kameyama Temple

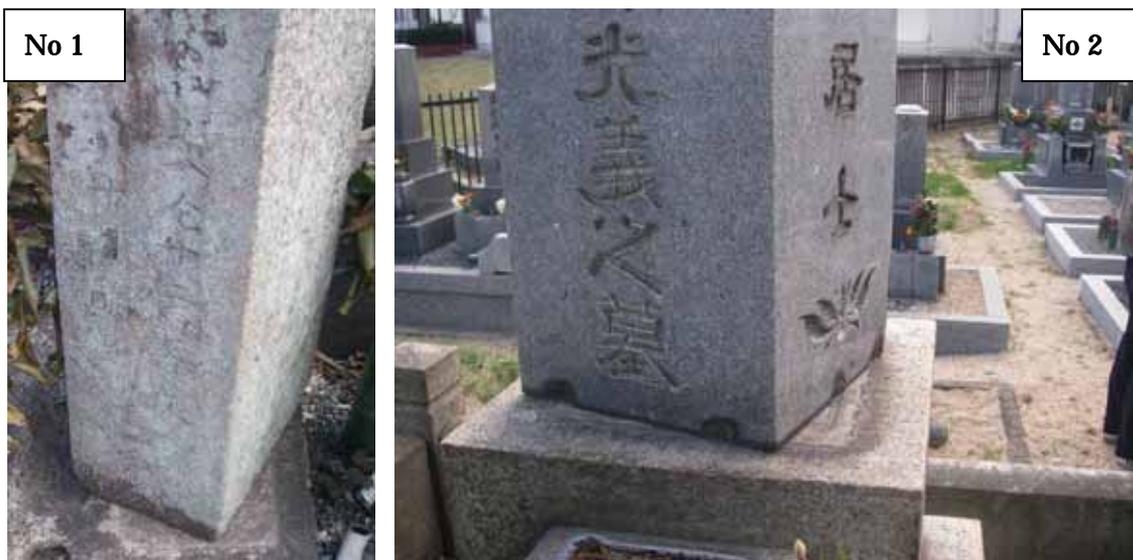
instrumentation is scarce or non-existent. Figure 6.4 shows some pictures of cemetery stone dislocated and rotated in Kameyama City. The distance from the hypocenter to this cemetery was about 19 km. The dimensions of the stones are given in Table 6.1. All stones were rotated in a clock-wise sense. The rotation angle ranges between 20 and 25°. Most of stones were made of diorite or granite and a few of them was made of tuff. Furthermore, their base is saw-cut without any polishing.

Figure 6.4: Dislocated and rotated cemetery stones

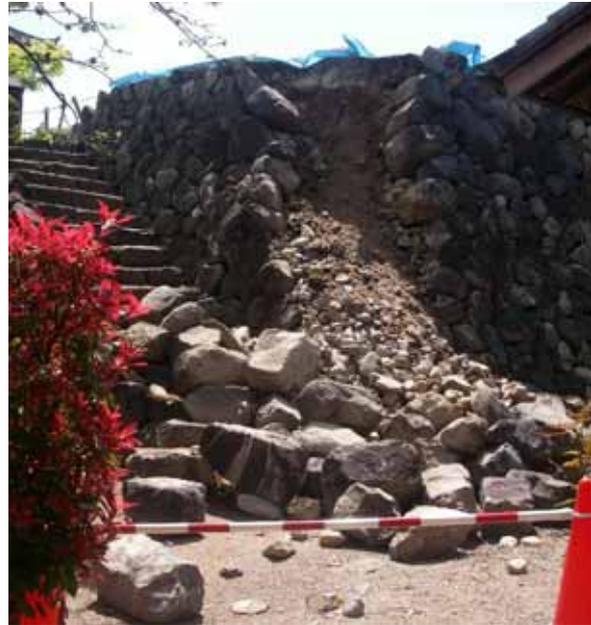
Kameyama castle was built in 1590 on a 10m high hill. The inclination of south, east and west walls is about 50° while the inclination of north wall is much steeper and it is about 70-75°. The earthquake caused the collapse of NW corner of the 5m high northern wall, where a masonry stone stair is located. The collapsed section was 2m wide and this section was actually damaged by a typhoon in 1972 and it was repaired. The stone used at corners was 30 cm wide, 30cm high and 55cm long and rock itself is either andesite or diorite. Figure 6.5 shows plan and cross-section illustrations of the castle while Figure 6.6 shows some views of the intact and collapsed sections of the castle.

(c) Collapsed NE Corner

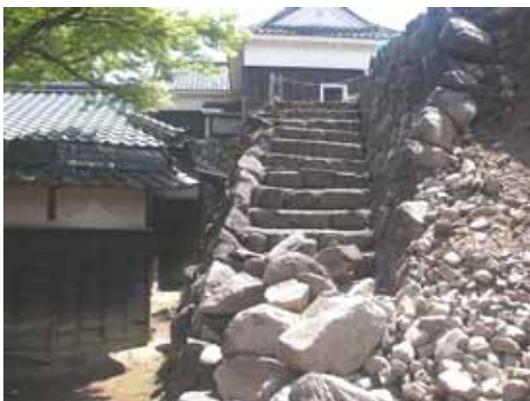
(d) Eastward view of NE corner

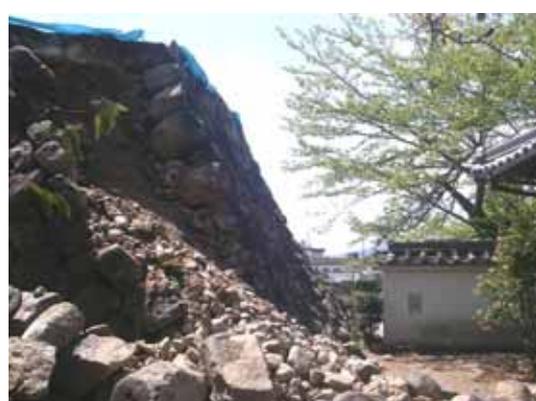
(e) Southward view of NE corner

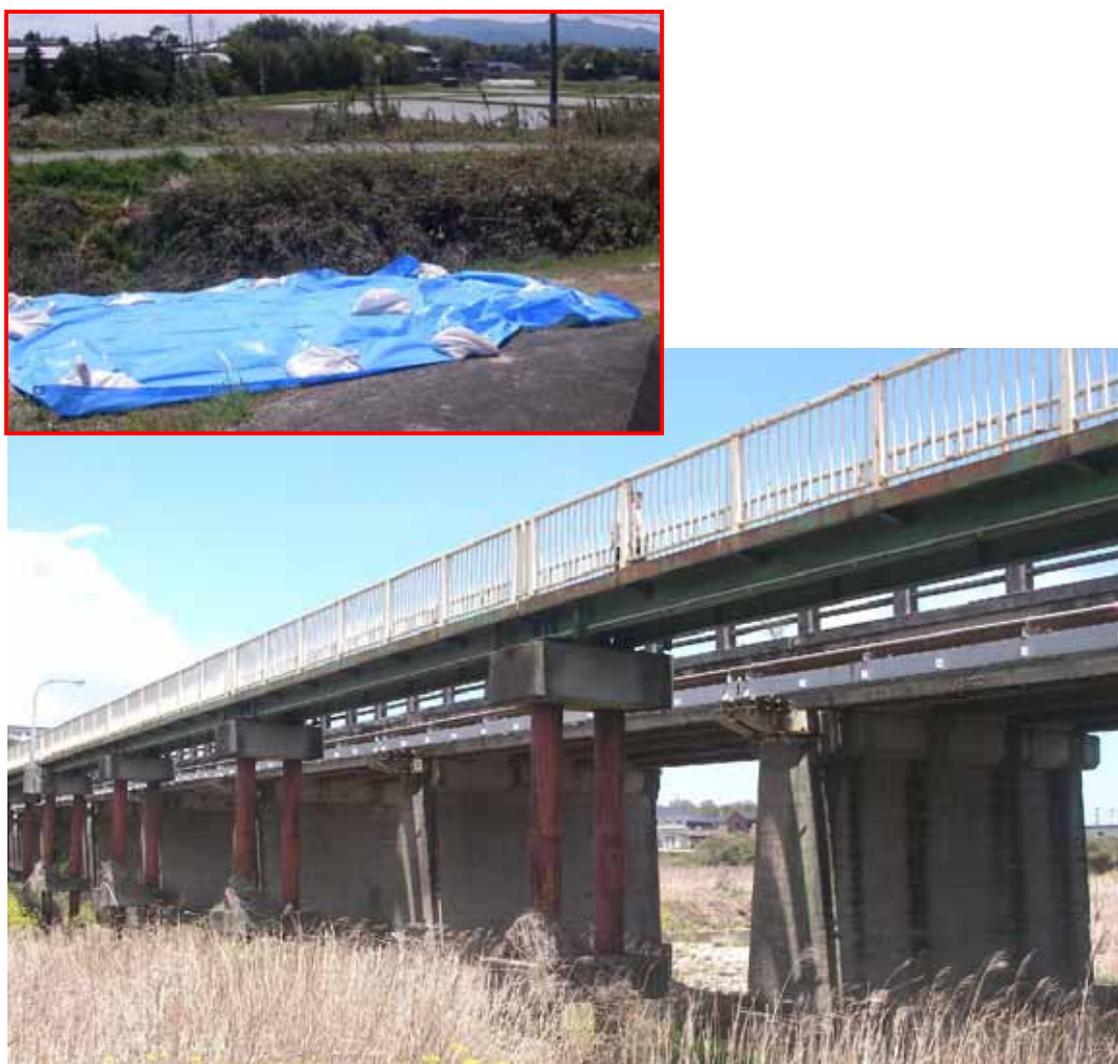
Bridges spanning over Suzuka River in Kameyama City are also inspected. Kashima Bridge is a relatively old cast-in place bridge without any retrofitting did not exhibit any damage (Figure 6.9). However, the southern approach embankment was damaged by the settlement and cracking. The inspection of Kameyama Bridge yielded that there was no damage.

Figure 6.9: Views of Kashima bridge and its damaged southern approach embankment over Suzuka River in Kameyama City

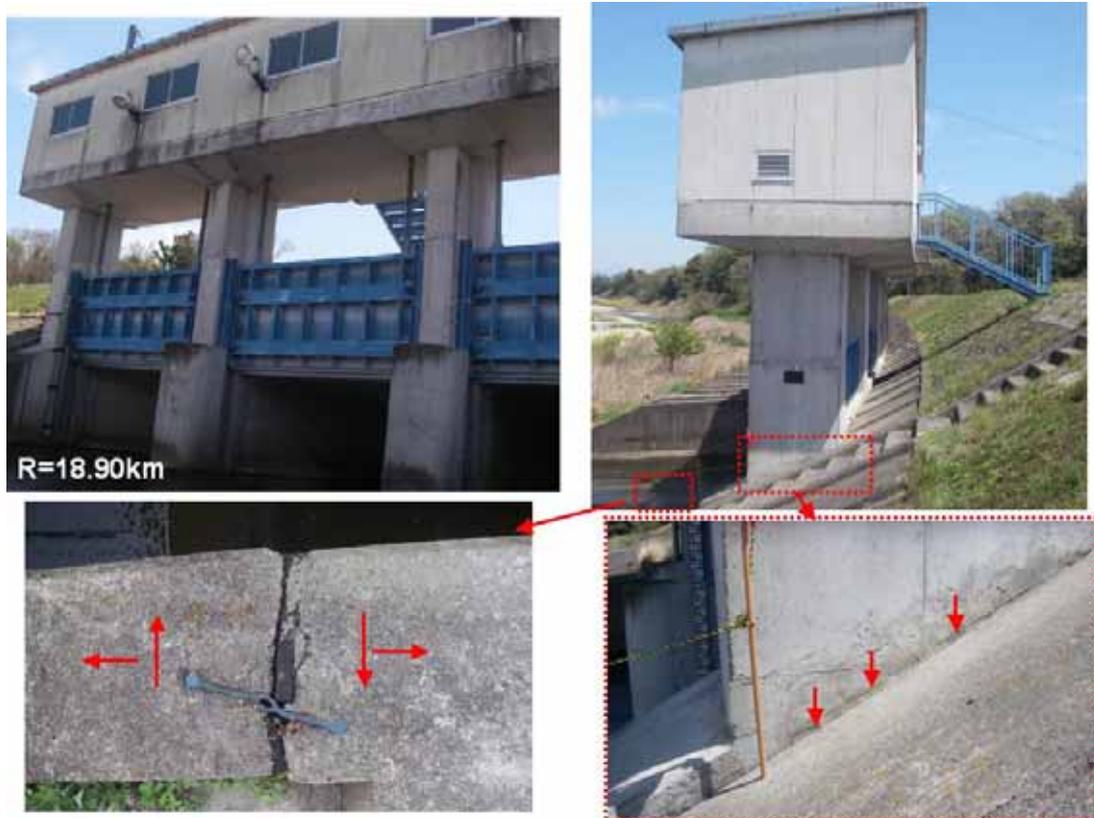
There was a flood control gate along Suzuka River in Kameyama City. The structure is a top-heavy structure. The close inspection indicated that the embankment next the gate was settled more than 50mm. Furthermore, a concrete panel wall attached to the gate structure was slightly displaced and relative joint opening did occurred (Figure 6.10). Except these slight damages, the flood control gate was structurally intact.

Figure 6.10: Views of slightly damaged flood control gate

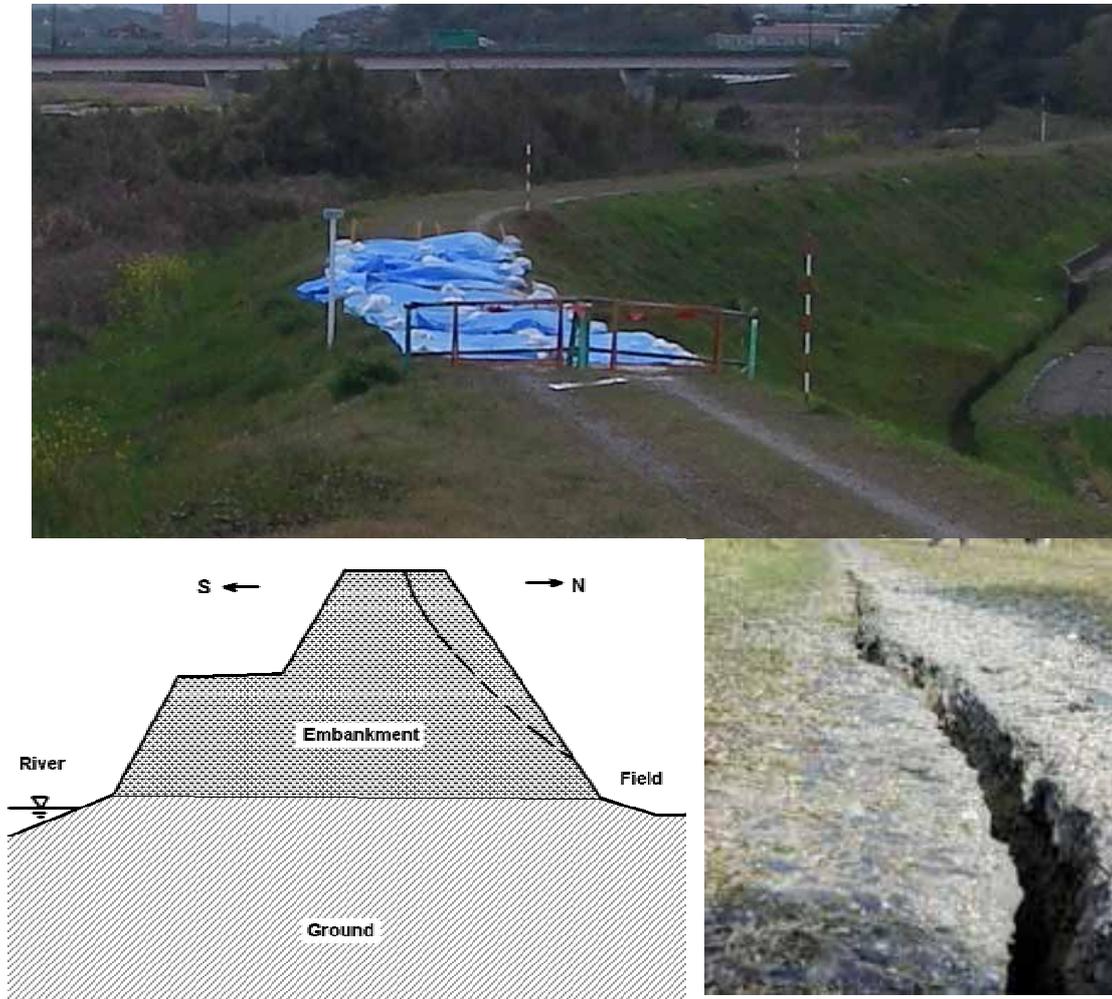
The earthquake induced some geotechnical damage such as embankment failures and surficial slope failures. The embankment damage was observed along Suzuka River at 10 locations. The damaged embankments were generally more than 4m. The embankment inclination is generally 45° . When one side of the embankment is

non-stepped while the other side is stepped, the cracking and settlement occurred on the non-stepped side (Figures 6.11 and 6.12). There was also some cracking of pavement on embankments with a relatively small height due to full saturation conditions next to rice paddies. No liquefaction incident induced by this earthquake was observed or reported.

Figure 6.11: Damaged embankment along Suzuka River in Kameyama City

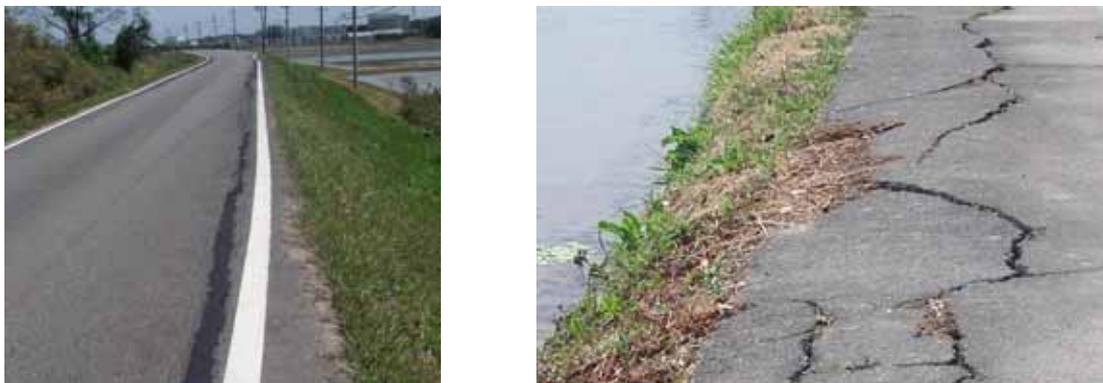
Figure 6.12: Damaged embankment along Suzuka River and rice paddies

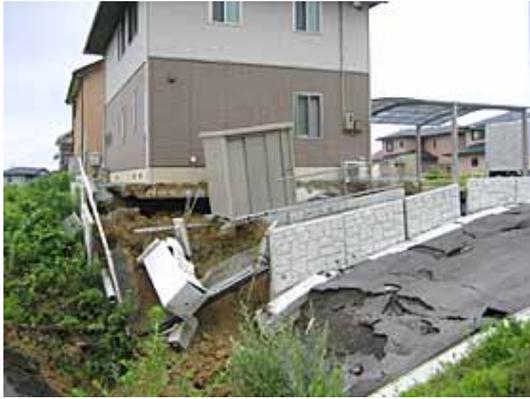
(a) Cave-in in August 2006

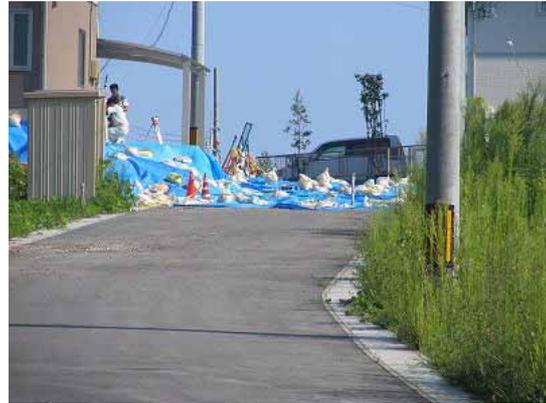
(b) After restoration before earthquake

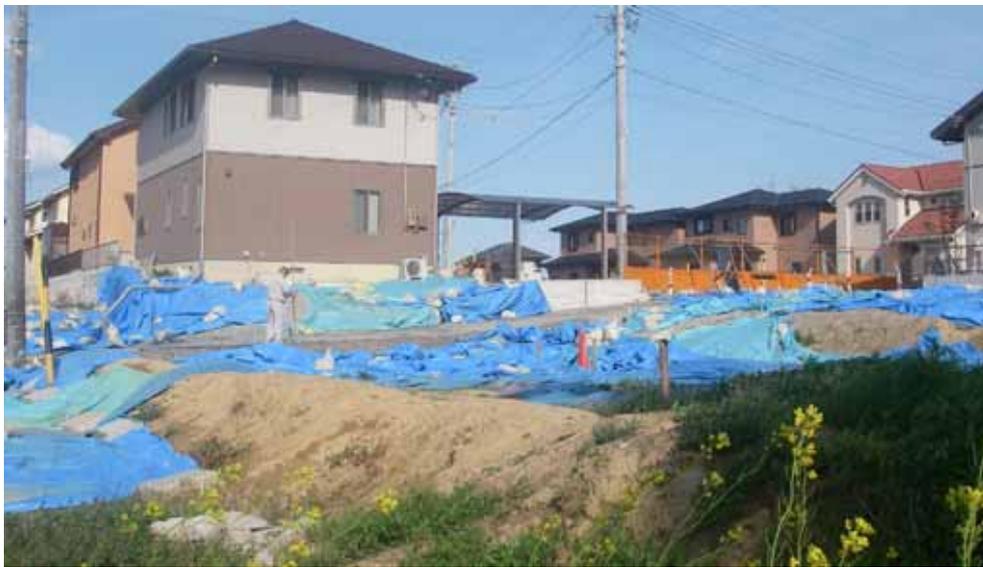
The 2003 Miyagi-Hokubu earthquake caused collapse or subsidence of ground above abandoned lignite mines (Aydan and Kawamoto, 2004). It is known that lignite was exploited in Mie prefecture. Furthermore, abrasion sand (migaki suna) was quarried from open pits and underground quarries in the Handa district of Tsu City. Since ground motions were quite high both in Kameyama and Tsu Cities and Geino town, it is expected that the earthquake may have some effects on the abandoned underground mines and quarries in view of past experiences (Aydan et al. 2006). A large scale cave-in occurred in Handa district of Tsu City in August 2006 due to the exploitation of abrasion sand from underground quarries after heavy rains (Figure 6.14). The authors first inspected this cave-in site. The visual inspection of the site did not show any further damage in this site. The ground settlement is monitored by Tsu city civil engineering section and their measurements did not show any effect of the earthquake at this locality.

(c) View of the restored site after the earthquake
