12 LIQUEFACTION, GROUND SUBSIDENCE AND SLOPE FAILURES

12.1 Liquefaction and Its Effects

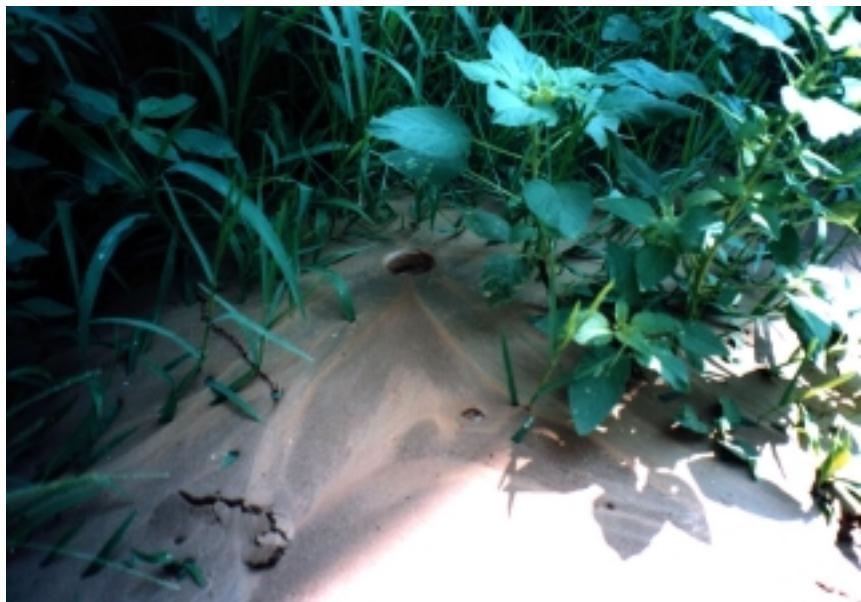
Liquefaction was widely distributed and caused damage to structures and lifelines in the region between Adapazarı and Yalova. Liquefaction was observed for a length of 120 km almost along the earthquake fault break within a band of about 10 km (Figure 12.1). The most devastating effect of liquefaction was observed in Adapazarı which was about 6 km away from the fault break on the northern block. According to people interviewed, the liquefied sand and water came out of ground gradually. Figure 12.2 and 12.3 show some typical examples of liquefaction in Adapazarı.

Figure 12.2 Sand volcano observed on Aug. 18, 1999 in Erenler (Adapazarı)

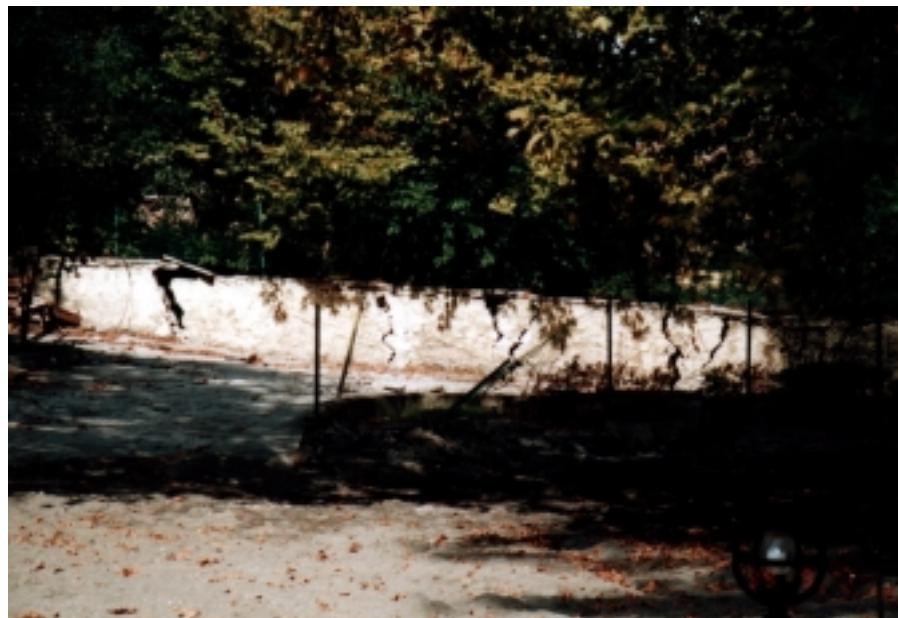
Figure 12.3 Wide-spread sand ejection and lateral spreading along souther shore of Sapanca Lake near Sapanca town (note the settlement and separation of the wall in the background)

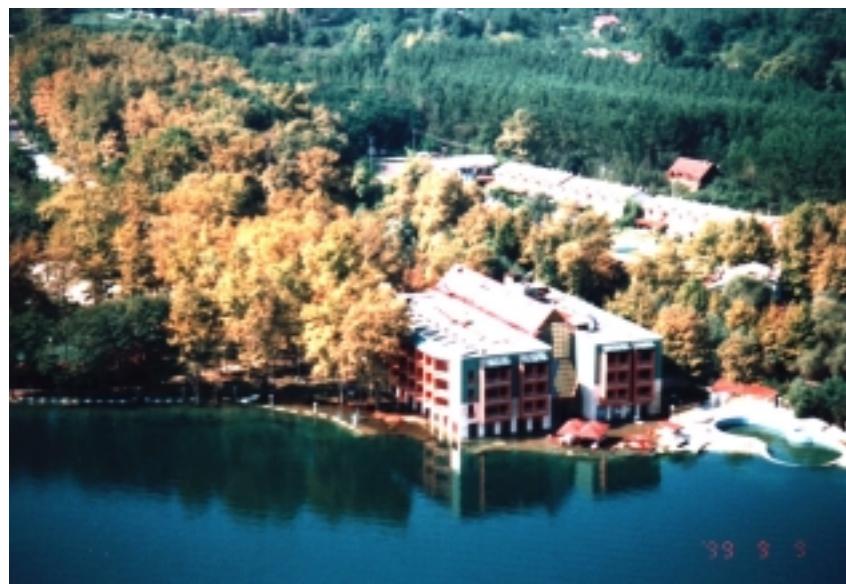
Along the coastline of the Sapanca Lake liquefaction-induced lateral ground displacement was observed and a hotel building moved towards the lake and sunk as shown in Figure 12.4.

Figure 12.4 Lateral spreading and settlement of a hotel along the shore of Sapanca Lake
(details of liquefaction site is shown in Figure 12.3)

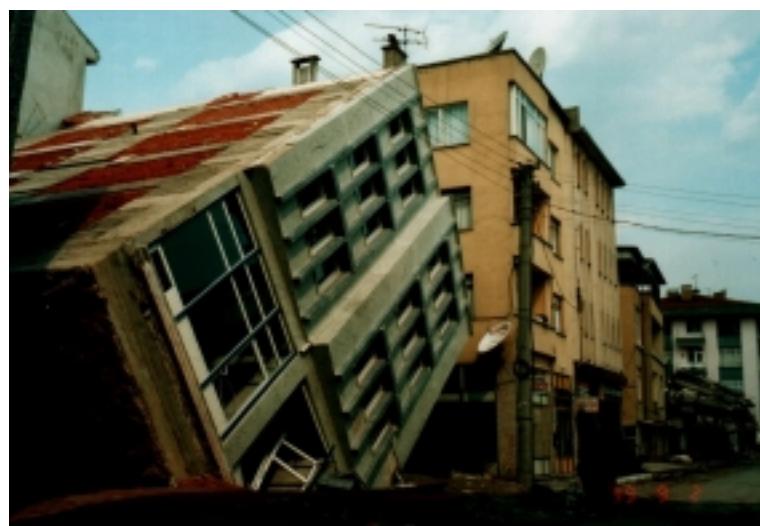
The most severest damage to structures due to liquefaction was observed in Adapazar City. Many buildings were settled, tilted or totally collapsed. The settlement of buildings up to 110 cm were observed. The building shown in Figure 12.5 showed one of typical examples of severe tilting resulting from the loss of bearing capacity of the foundation ground. This type of failure is quite similar to that observed in the 1964 Niigata earthquake and the 1983 Nihonkai-Chubu earthquake.

Figure 12.5 Tilted and collapsed buildings (Adapazar)

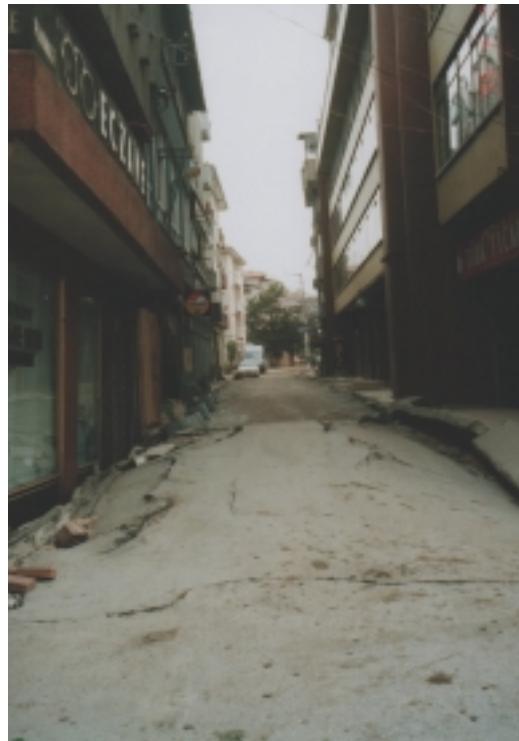
The heaving of ground occurred as a result of settlement of buildings and the uplift of seewage pipes as shown in Figure 12.6. Electric poles were either sunk or inclined as a result of the liquefaction of the ground.

Figure 12.6 Heaving of a roadway as a result of settlement of adjacent buildings and the uplift of seewage pipe

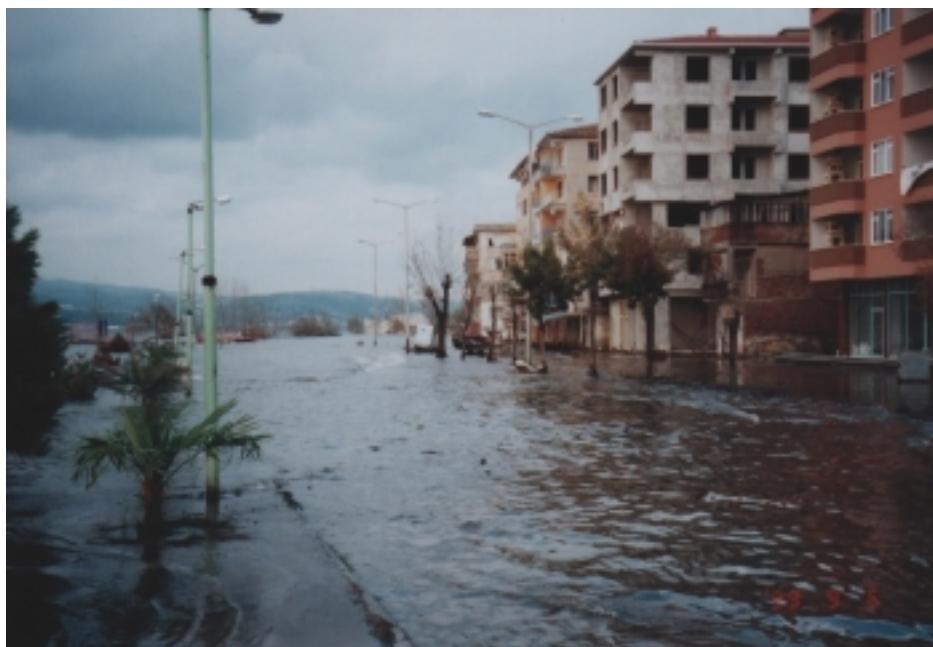
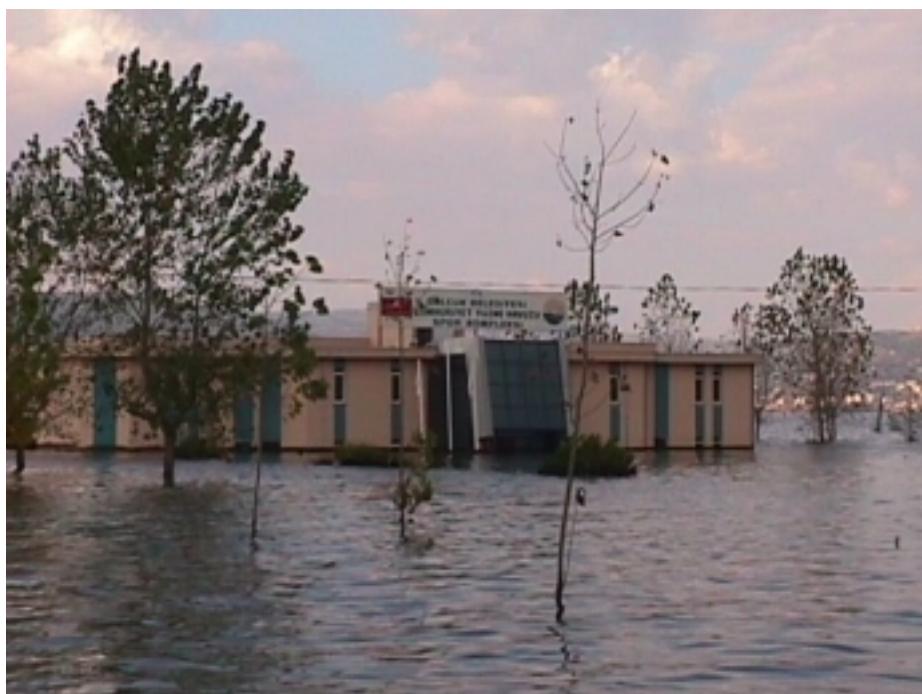
A huge scale ground subsidence occurred at Kavaklı district of Gölcük town (Figure 12.12). This ground subsidence took as a result of normal faulting associated with the main lateral strike slip event. The normal fault could be traced from Kavaklı shore up to Hisareyn village along the main highway where the fault terminated. The vertical throw of the fault was more than 2m at several locations. The land on the overhanging block of the fault subsided into the sea so that a large part of Kavaklı district became submerged. In this location, very fine soil

was ejected as a result of ground liquefaction. Nevertheless, the ground liquefaction is not thought to be the main cause of the subsidence.

Figure 12.12 Submerged Kavaklı District of Gölcük town

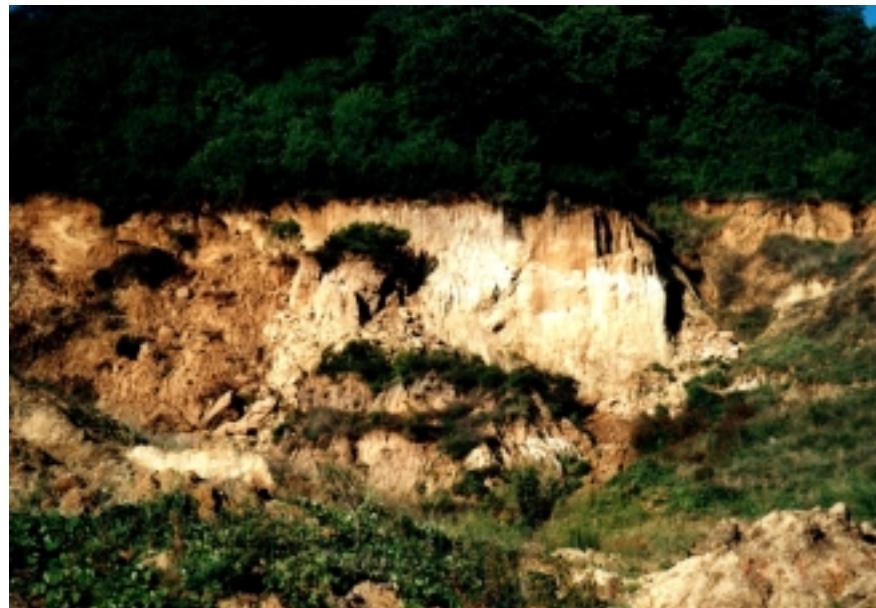
There were some soil slope failures on the banks of roadways and along Sakarya rivers (Figures 12.13). Most of soil slope failures are seemingly circular sliding. The failures were mainly observed on the slopes facing west and east. This observation was quite consistent with the maximum acceleration observed in the strong motion records.

Figure 12.13 Soil slope failure at Yalova

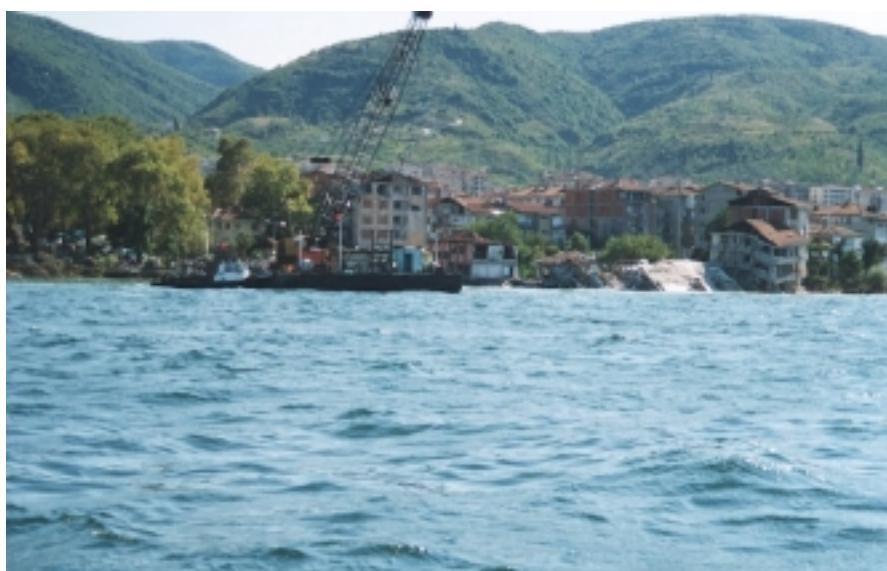
Figure 12.4 Location of sub-marine land slide at Deirmendere

The most publicised sub-marine slide took place at De irmedere where a 5-story hotel slides into the sea together with two adjacent buildings (Figure 12.14). The site investigation showed that there were tension cracks extending into the land for an 80 m distance from the post-failure seashore. The spacing of these tension cracks was quite consistent. The bathymetry of the seabed indicates that the slope angle was quite steep at the sliding location.

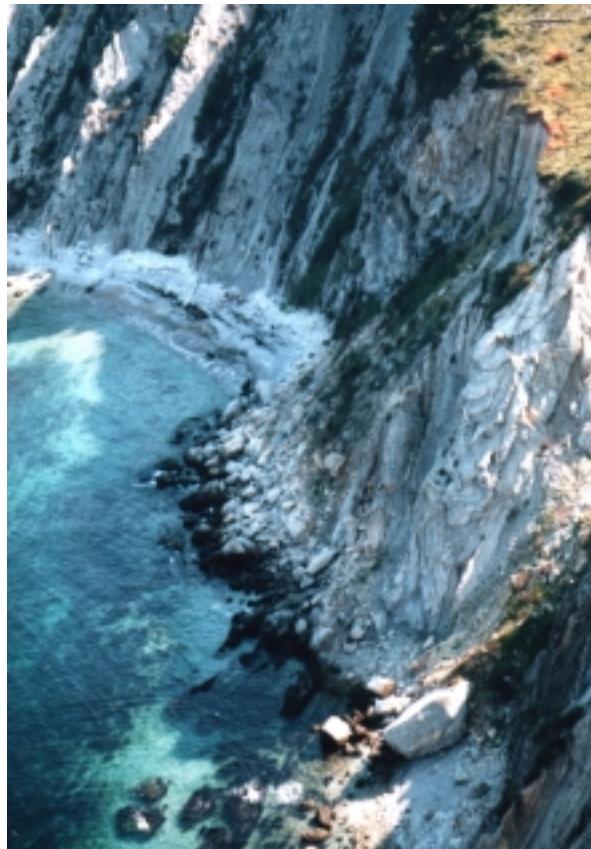
Figure 12.15 Rock falls along the shore of Black Sea near İile

Rock slope failures were mainly observed along Tran-Europe Motorway (TEM) on the northern shore of Marmara Sea, D-100 highway passing along the northern shore of Sapanca Lake, Karamürsel, Black Sea cost near İile and the valley between Akyazı and Düzce (Figures 12.15 and 12.16). The slides and rock fall along the TEM were of limited scale as the slope angle was quite small. The large scale rock slides occurred along D-100 highway near Kocaeli-Sakarya provincial boundary where secondary normal faulting events took place. Although the discontinuities of rock masses at those locations were quite favorable for the stability of rock slopes, the vertical and horizontal accelerations must have been quite large to

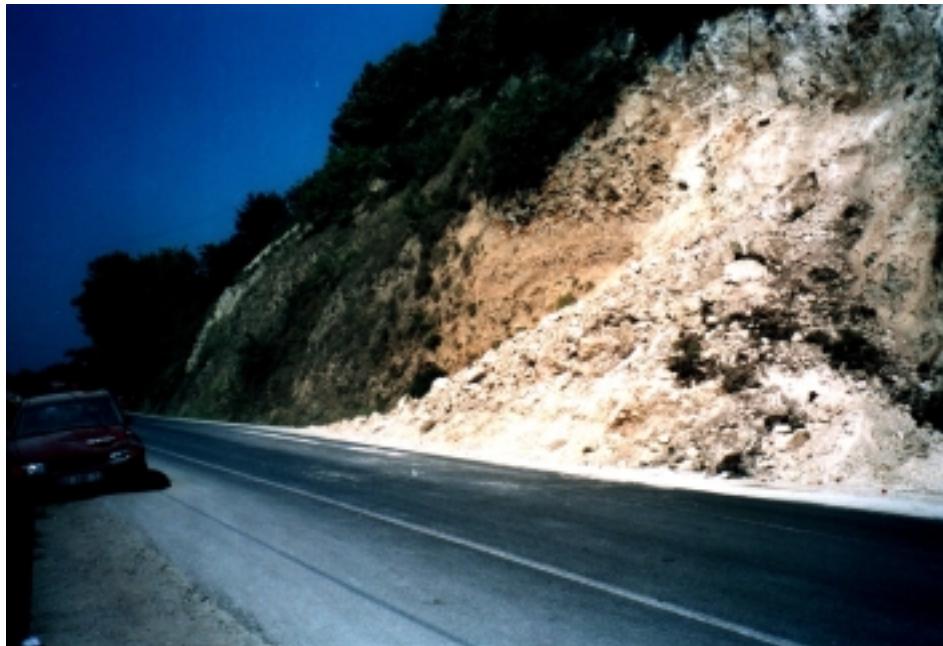
cause the failure of the rock slopes. Rock falls were observed between Gölkaya and Akyaz along the D-100 highway and the highway between Karamürsel and Yalova. The rock slopes are quite steep near the Karamürsel Army base along the highway.

Figure 12.16 Rock slope failure at Kocaeli-Sakarya provincial boundary along D-100 highway (note that the car on the left-hand side of the highway was hit by the fallen debris)
