## **5 DAMAGE TO TRANSPORTATION FACILITIES**

### **5.1 DAMAGE OF ROAD FACILITIES**

### **5.1.2 Arifiye Overpass**

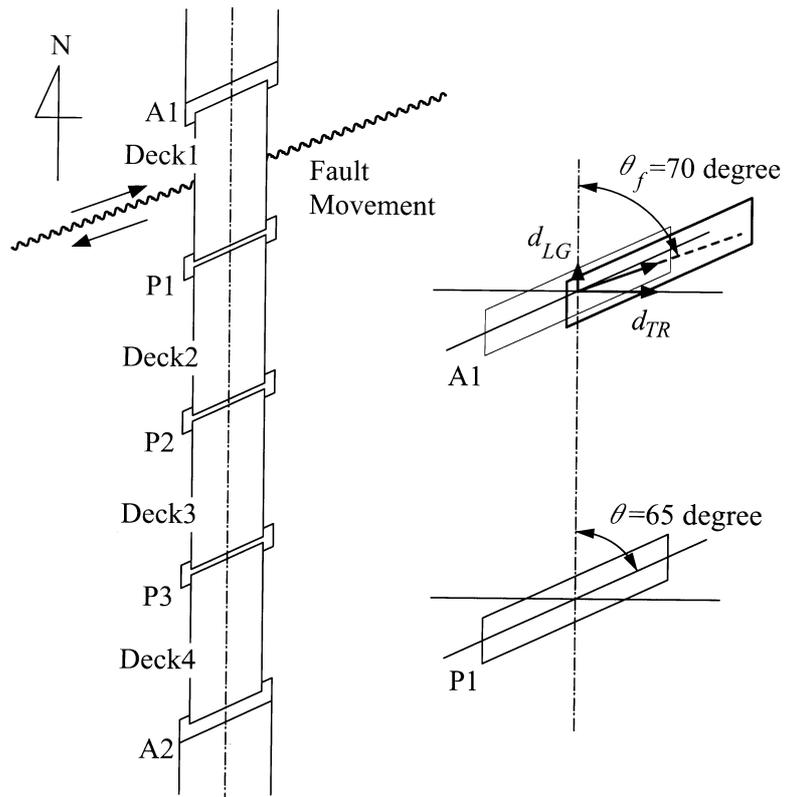
Fig. 5.3 Arifiye Overpass

As shown in Fig. 5.3, the fault rupture passed through between A1 and P1 with an angle of about 70-degree. The right-lateral strike-slip fault forced A1 to move in east and north directions with

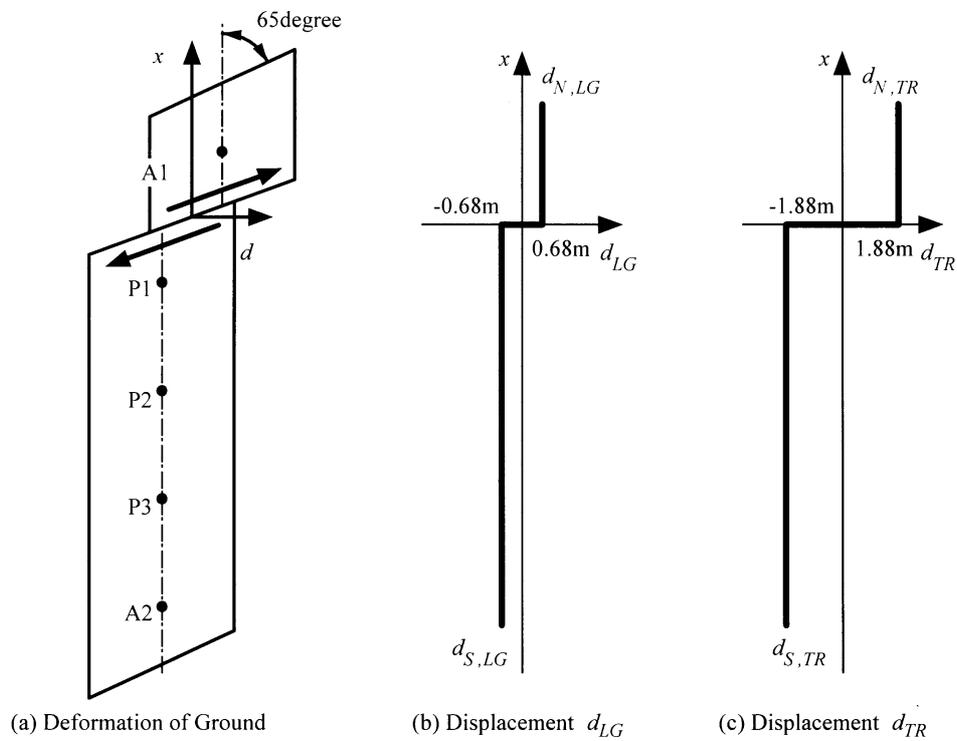
Fig. 5.6 Effect of Fault Movement

Assuming  $D_0 \cong 4$  m and  $\theta=70$  degree, the ground displacements in Eqs. (2) and (3) may be obtained as shown in Fig. 5.6 (b) and (c). The relative displacement between A1 and P1 in longitudinal direction  $D_{LG}$  may be obtained as

$$D_{LG} = d_{N,LG} - d_{S,LG} = D_0 \cos\theta = 1.37\text{m} \quad (4)$$

This was much larger than the seat length of about 0.6 m at A1 and 0.45 m at P1. It seems that D1 dropped due to such a large relative displacement induced by the fault rupture between A1 and P1. On the other hand, the foundations of P2, P3 and A2 were forced to move in south direction. It appears that such a southward movement of foundations resulted in dislodging D2, D3 and D4 from their support at the north ends.

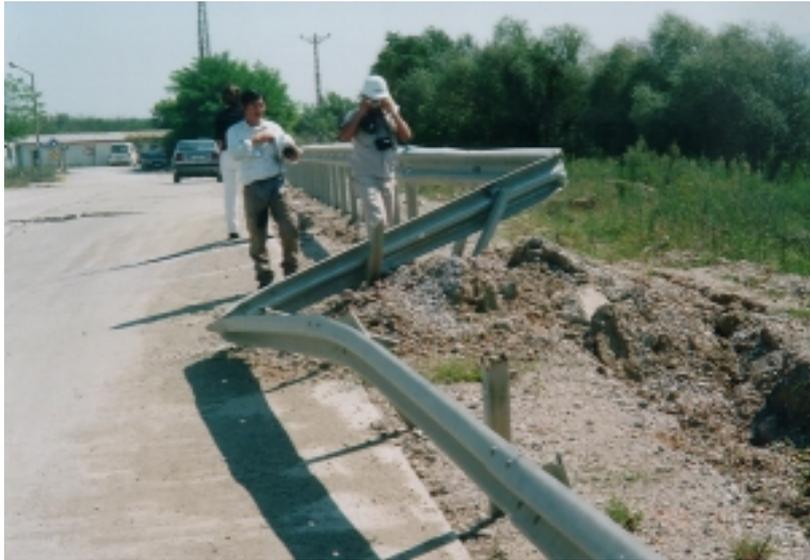
In the east of Arifiye area, the fault rupture was first observed at the Toyota S.A. Factory. At an approaching road to the entrance of Factory (Point A, refer to Fig. 5.2), the fault rupture crossed the road with a shallow angle, and damaged the concrete pavement as shown in Photo 5.1. From the movement of equally spaced steel guardrail poles along the road, the road offset was estimated 1.2 m and 2.65 m in transverse and axial directions, respectively.

Photo 5.1 Damage of an Approaching Road to Toyota S.A. Factory (Point A, refer to Fig. 2)

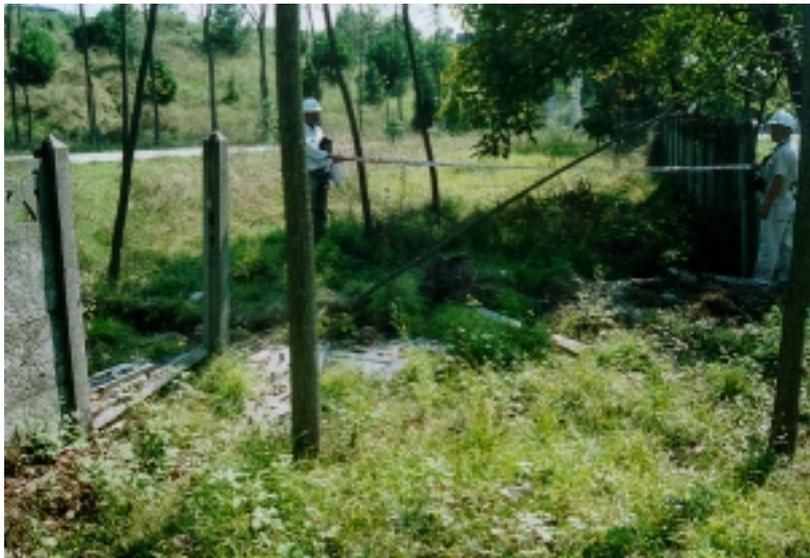
The fault rupture continued west to reach Point B where it collapsed the Sakarya Bridge. Detail of the bridge damage will be described in 5.1.4. The fault rupture then crossed the Motorway at Point C (near south abutment of the Overpass No. 1), and passed through the Overpass No. 2 near its north abutment. It then developed a 4.3-m offset of a concrete fence of an automobile factory (Arbas Arac Kadlama Fabrikasi) at northeast corner (Point D), as shown in Photo 5.2.

Photo 5.2 Offset of a Concrete Fence at of 4.3 m North-East Corner of an Automobile Factory (Arbas Arac Kadlama Fabzikasi) (Point D, refer to Fig. 2)

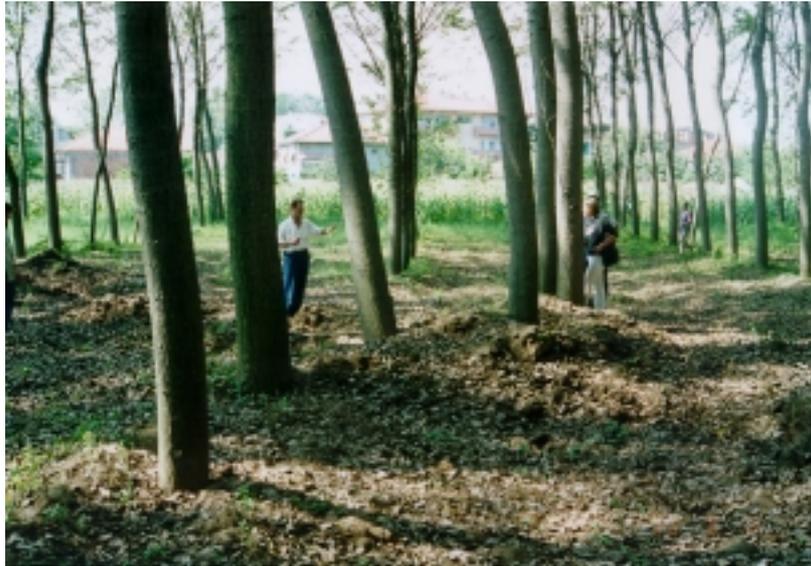
After crossing a cone field again, the fault rupture reached a poplar grove at Point G. The largest fault offset measured from displaced poplar trees originally planted in lines was 4.3-m as shown in Photo 5.3.

Photo 5.3 Offset of Poplar Tress of 3.5-4.3m (Point G, refer to Fig. 2)

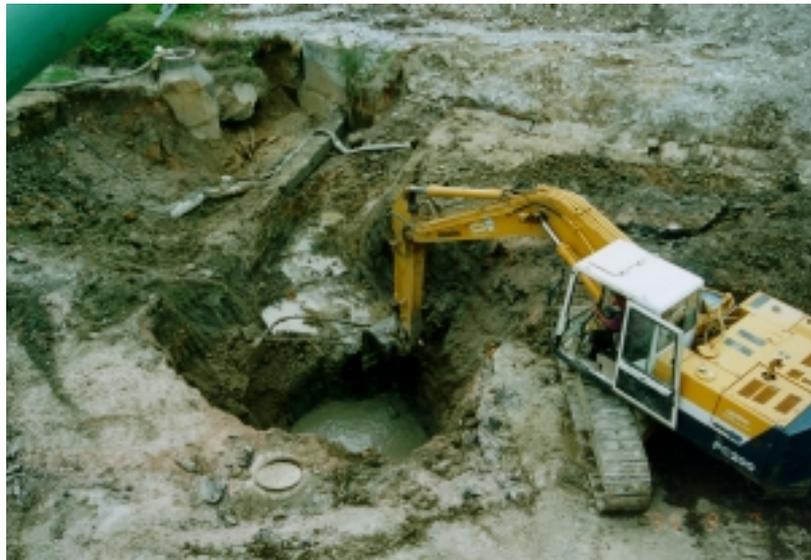
Photo 5.4 Offset of a Sewer Pipe of about 4 m (Point H, refer to Fig. 2)

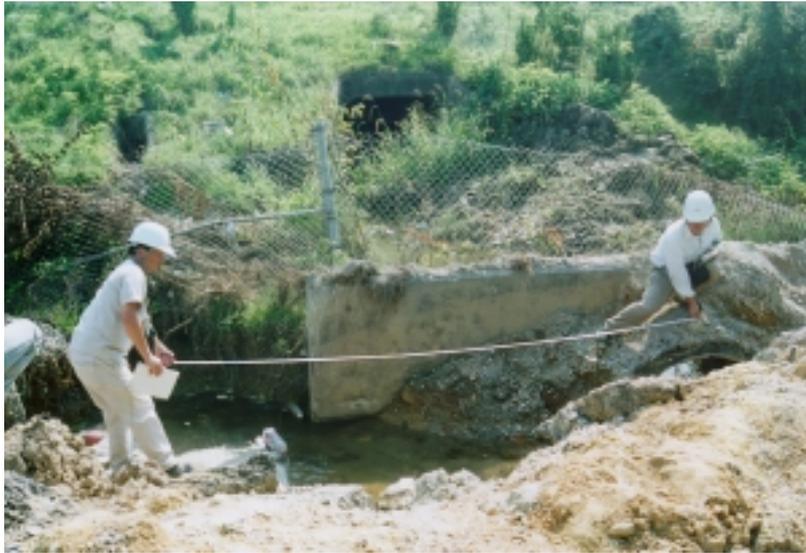
Photo 5.5 Offset of a Drainage Pipe of about 3.6 m (Point I, refer to Fig. 2)

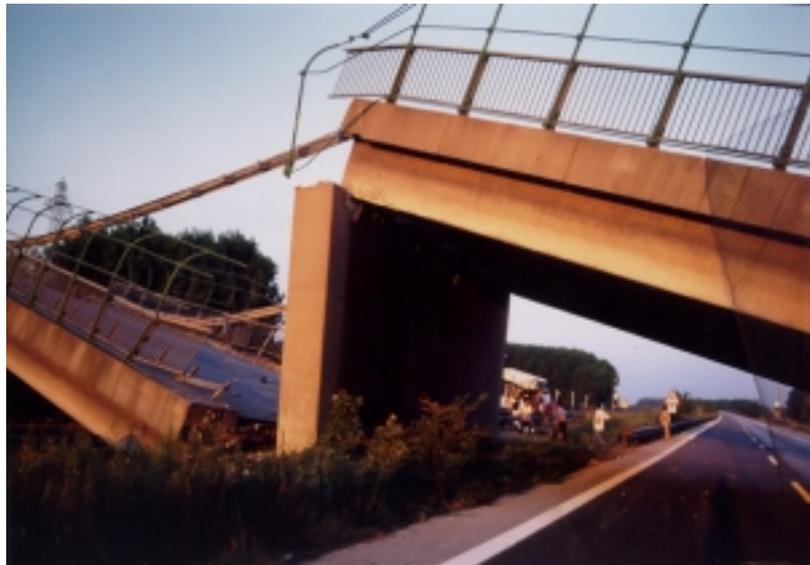
The Arifiye Overpass was of 4 span simply supported prestressed concrete bridge as shown in Fig. 5.3. It was supported by two end-abutments and 3 wall-type reinforced concrete piers. It was skewed bridge with a skew angle of 65-degree. Two center spans overpassed the Motorway and a side span each on both sides overpassed a local road. The substructures and the decks are denoted herein as A1, P1, P2, P3 and A2, and D1, D2, D3 and D4, respectively, from north to south. The D2, D3 and D4 dislodged from their supports at south ends and fell down with the north side still

being supported by the piers as shown in photo 5.6. It was not clear from which side the D 1 dislodged from the support first, but it rested on ground almost horizontally.

Photo 5.6 Collapse of Arifiye Overpass (Courtesy of H. Hoashi)

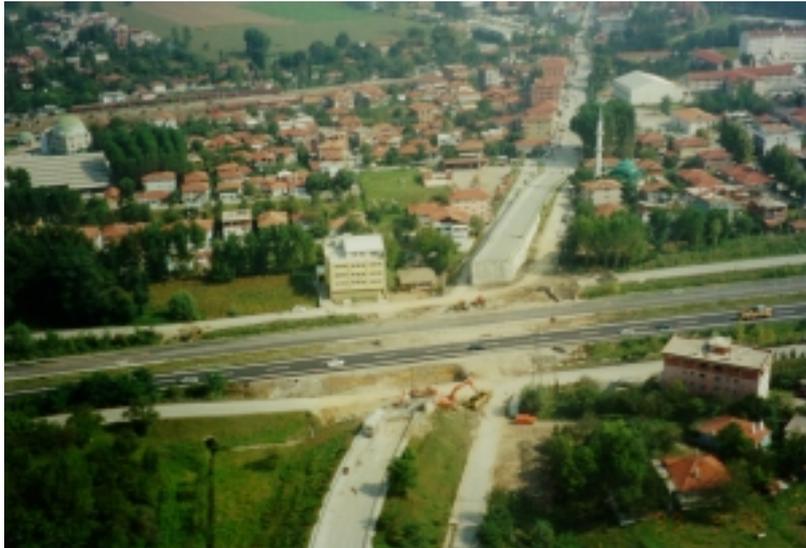
The superstructure was already demolished and A1, A2 and a part of the footings of P1 and P2 were left as shown in Photo 5.7, when we visited the site. Photos 5.8 and 5.9 show A1 and A2, respectively. Six reinforced concrete stoppers were provided at both abutments to limit relative displacement of the decks in transverse direction. At A2, they suffered damage at the east face with the west face not being damaged at all, as shown in Photo 5.10. The elastomeric bearings were displaced in the west direction. It was obvious from such evidence that the stoppers on A2 were subjected to a large lateral force from east to west associated with a clockwise rotation of D4. It is well known that a skewed bridge rotates when a deck collides with an abutment<sup>1)-3)</sup>. However no evidence showing collisions of D4 with the parapet wall of A2 was seen. It appeared therefore that D4 rotated subjected to the fault movement at the foundations. On the other hand, the stoppers on A1 were not damaged. The seat length at the abutments and piers was about 0.6-m and 0.45-m, respectively.

Photo 5.7 Arifiye Overpass Being Demolished

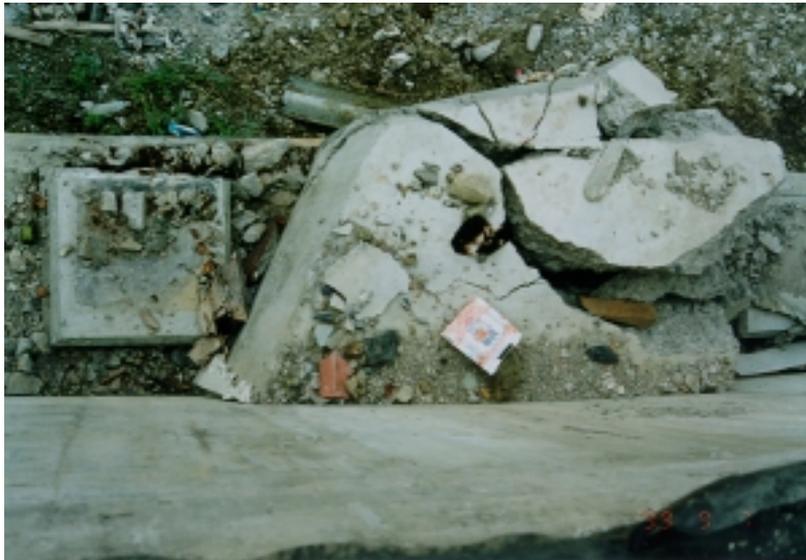
Photo 5.10 Damage of Reinforced Concrete Stoppers on A2 (Only west side was damaged), Arifiye Overpass

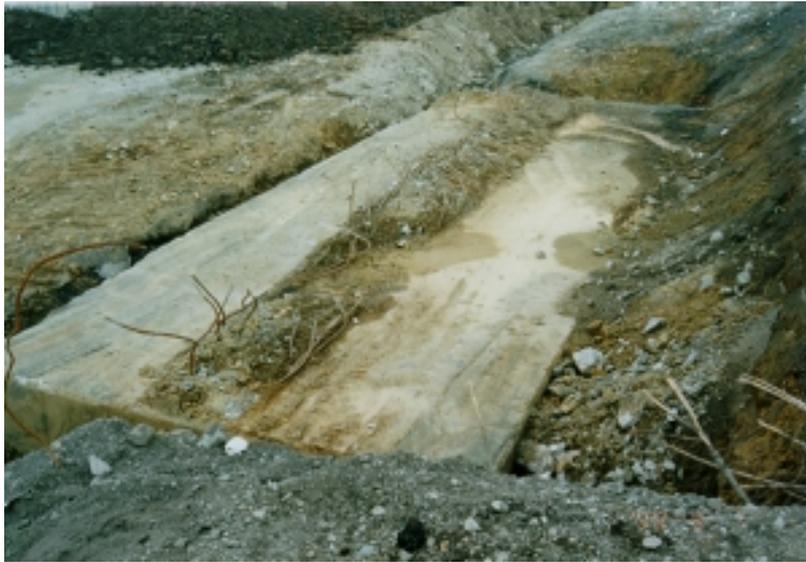
The reinforced concrete footing that supported P1 was 5.3-m long and 14-m wide in longitudinal and transverse directions, respectively, and it did not suffer damage as shown in Photo 5.11. The footing of P3 was supported by 8 1-m diameter cast-in-place reinforced concrete piles as shown in Photo 5.12. The piles were reinforced by 12 20-mm plain bars. The averaged concrete strength investigated with the Shumit hammer was 56 MPa and 47 MPa at the front wall of A2 and the upper surface of P1 footing, respectively.

Photo 5.11 Footing of P1, Arifiye Overpass

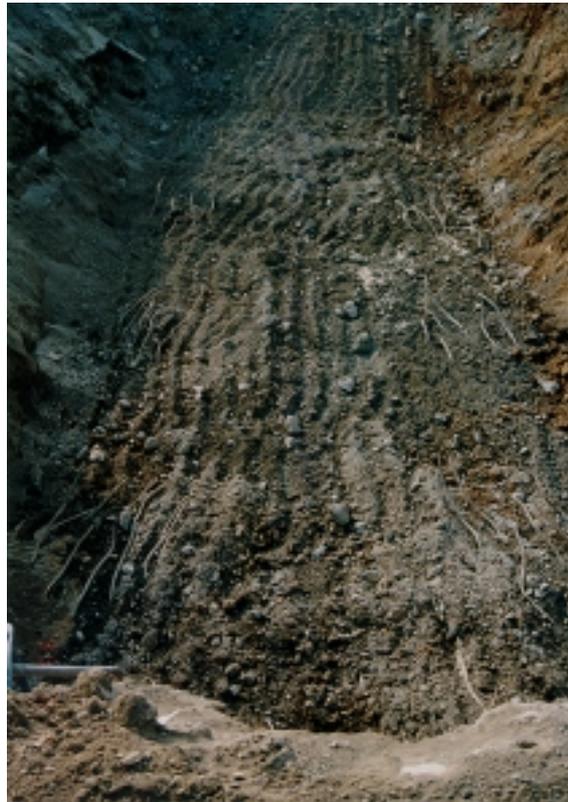
Photo 5.12 Piles That Supported P3 Footing, Arifiye Overpass

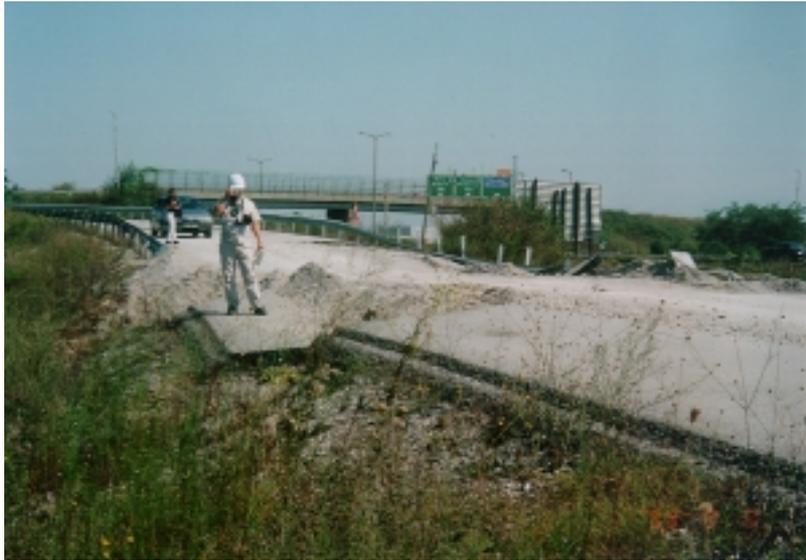
No. 1 Overpass was located about 1 km east of the Arifiye Overpass close to Toyota S.A. Factory and Toyota S.A. Hospital. It was a two-span simply supported overpass as shown in Photo 5.13. The fault rupture crossed the Motorway at about 100-m west of the Overpass and passed through the south abutment of the Overpass. Residual displacement of about 50 mm was developed in the elastomeric bearings in transverse (west) direction. Since the Overpass was located north of the fault line, the foundations were forced to move in east direction, which resulted in the deformation of elastomeric bearings in west direction. Except the bearings, the damage was less significant; only covering concrete protecting the surface of embankment in front of the south abutment (A2) spalled off due to settlement of the abutment. It was confirmed that a short-span bridge supported by short and rigid wall-type piers and abutments performs well in an earthquake.

Photo 5.13 No. 1 Overpass

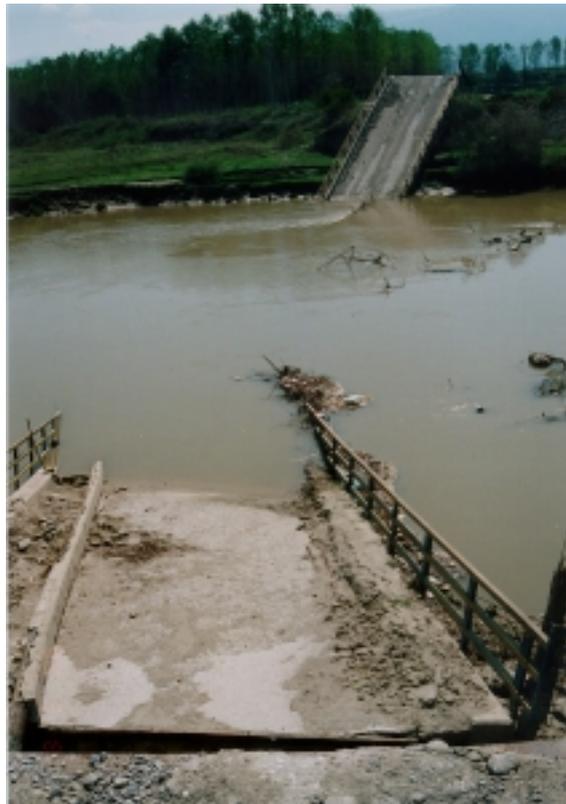
A bridge spanning the Sakarya River near the Toyota S.A. Hospital (No. 5 Bridge) collapsed as shown in Photo 5.14. The bridge was of either 4 or 3 spans simply supported decks. The deck(s) at center was/were completely collapsed and both side-decks dropped at the riverside with the embankment-side being up. At the north abutment (A1), the side-deck dislodged from the abutment and fell down about 3 m downstream from the original position. The fault rupture directly hit A1 resulting in the collapse of the total bridge. The seat length was 600 mm, but this was not adequate to prevent the collapse.

Photo 5.14 Collapse of Sakarya Bridge

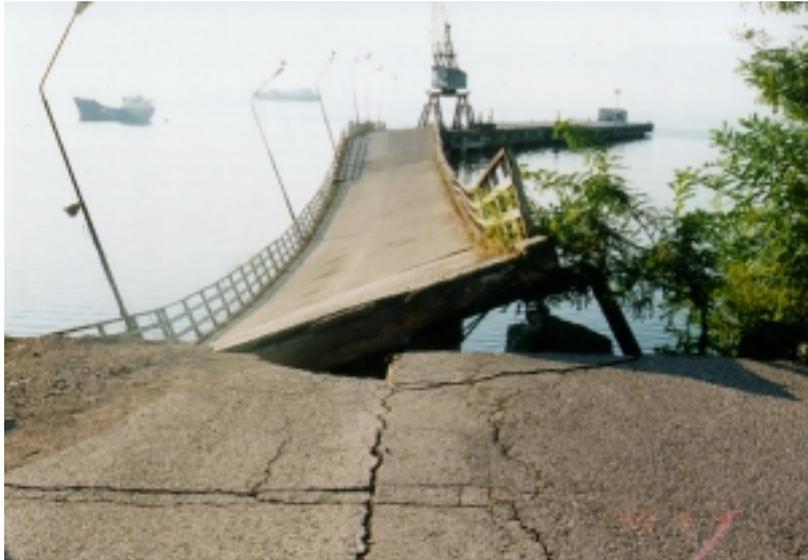
This was not a road bridge but an approaching bridge to quay in SEKA Paper Factory. The concrete slab decks settled about 2 m over 30 spans as shown in Photo 5.15. They were supported by 800-mm diameter circular reinforced concrete columns with the bottom underneath the sea surface being the circular steel piles. The reinforced concrete columns were reinforced by 30 mm round bars, and were confined by 10 mm diameter round bars placed 150 mm interval. About 11 reinforced concrete columns failed in shear as shown in Photo 5.16. No evidence of fault movement was observed around the bridge.

Photo 5.15 Damage of an Approaching Bridge in a Paper Factory

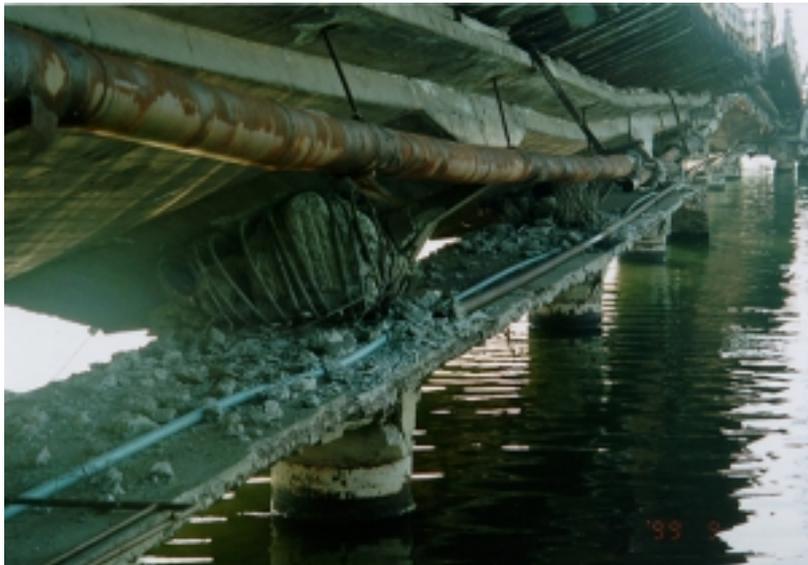
Photo 5.16 Shear Failure of Reinforced Concrete Columns

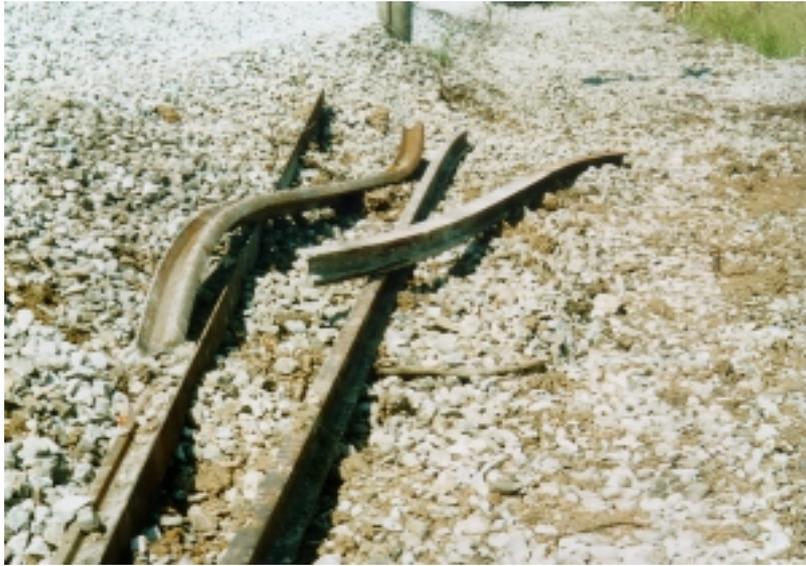
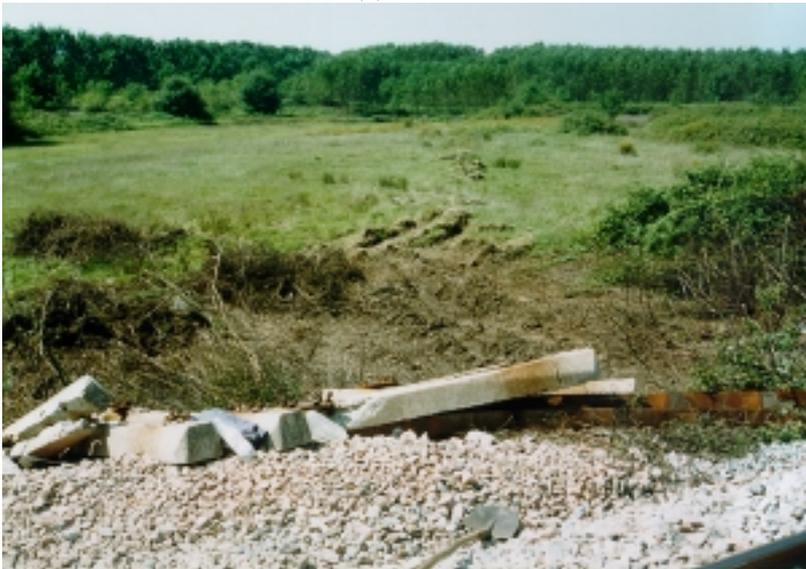
rails was still left for an interval of about 300-m. It was found that the fault was almost EW direction, and crossed the rails (N30E) with an angle of 60 degree. Photo 5.17 shows the damaged rails and reinforced concrete sleepers (supporters) removed after the earthquake. The right-lateral fault rupture measured at nearby popular grove was 2.5 m (refer to Photo 5.18).

Photo 5.17 Damage of Rails and Sleepers, near Tepetarla Station

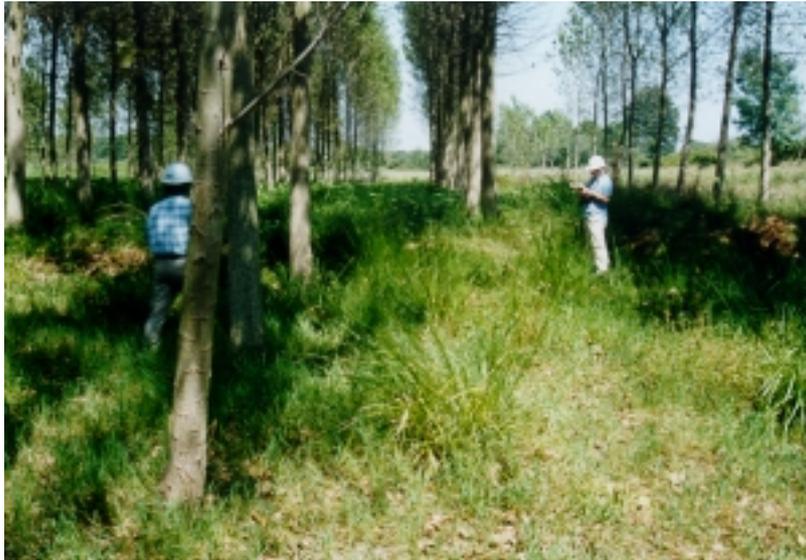
Photo 5.18 Offset of Poplar Trees of 2.5-m, near Tepetarla Station

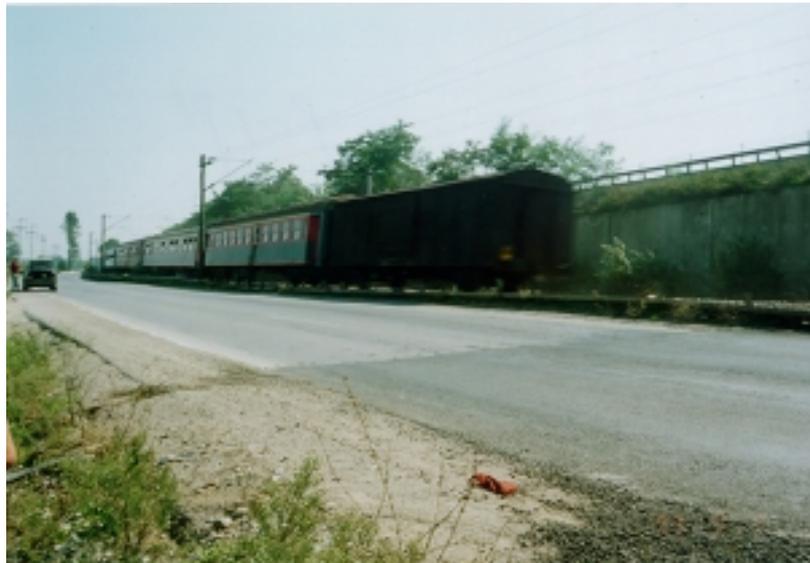
At south of Sapanca Lake, railways suffered damage due the fault rupture. The railways and a local road were in almost NS direction under an 8-10 m high terrace. On the terrace, the Motorway was running parallel to the railways. The fault was almost in EW direction, and crossed the railways as well as the local road and the Motorway. A reinforced concrete coastal fence offset 230 mm and reinforced concrete wall along the cliff of the terrace suffered damage as shown in Photo 5.19. Thirty-eight reinforced concrete sleepers located north of the fault line rotated in north direction, showing that the rails were pulled in north direction. The removed rails were laterally bent and the sleepers were damaged to expose the reinforcing bars as shown in Photo 5.20.

Photo 5.19 Damage of Railways at South of Sapanca Lake

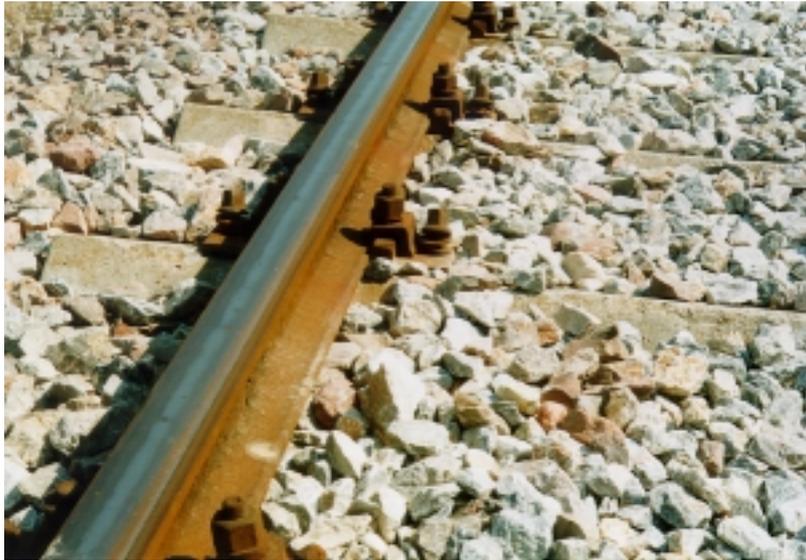
Photo 5.20 Damaged Rails and Sleepers, South of Sapanca Lake

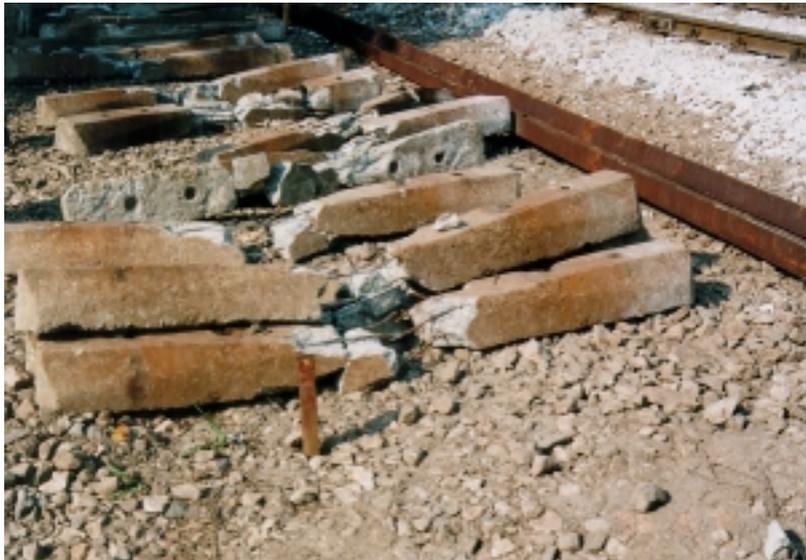
At about 500-m northeast of the Arifiye Overpass, the same fault, which damaged the Arifiye Overpass, crossed railways and caused damage. The railways were almost in NS direction, where the fault rupture crossed the railways in almost EW direction. The repair was being conducted so that 1.8-m offset developed by the fault rupture was adjusted by changing the alignment for a distance of about 100m. Photo 5.21 shows the removed rails and sleepers. It should be reminded that the fault rupture measured from the offset of poplar trees located at about 300 m west of the site was 3.6-4.5 m (refer to Photo 5.3).

Photo 5.21 Damaged Rails and Sleepers, near Arifiye Overpass
