## 7 DAMAGE TO INDUSTRIAL FACILITIES

### 7.1 TÜPRA Refinery

## 7.2 TOYOTA-SA Car Plant

## 7.3 Damage to Other Industrial Facilities

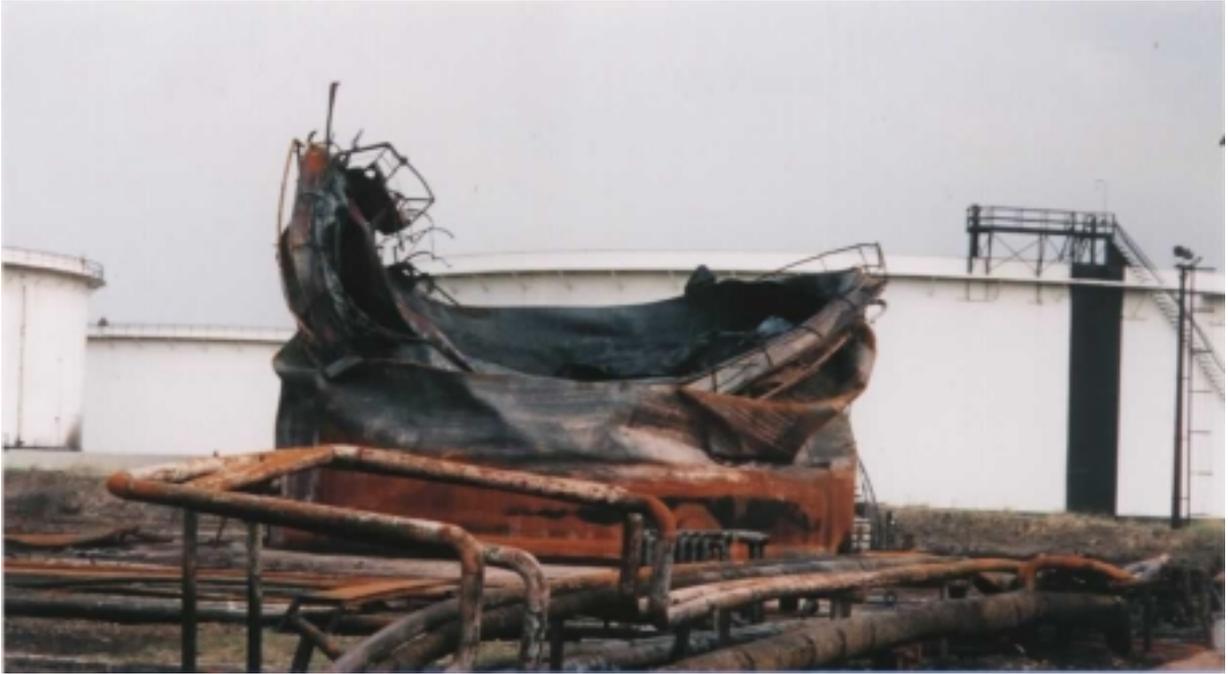
6 cylindrical tanks having floating roofs burned due to the earthquake. Out of 6 tanks, 4 middle size tanks has a diameter of 20-25 m and 2 small size tanks has a diameter of 10 m. Naphtha in the middle size tanks were completely burned. Tanks were damaged as a result of thermal deformation. The estimated naphtha is about 36,000 ton. Figures 7.3 and 7.4 show the deformed state of burned tanks.

The fire in a Naphtha tank farm was considered to be initiated by sparks created by bouncing of the floating roof in one of the tanks during the earthquake. The sparks ignited the Naphtha. There are 46 tanks with floating roofs and they were damaged independent of the size of tanks. They are now being repaired.

Figure 7.3 Burned cylindrical tank

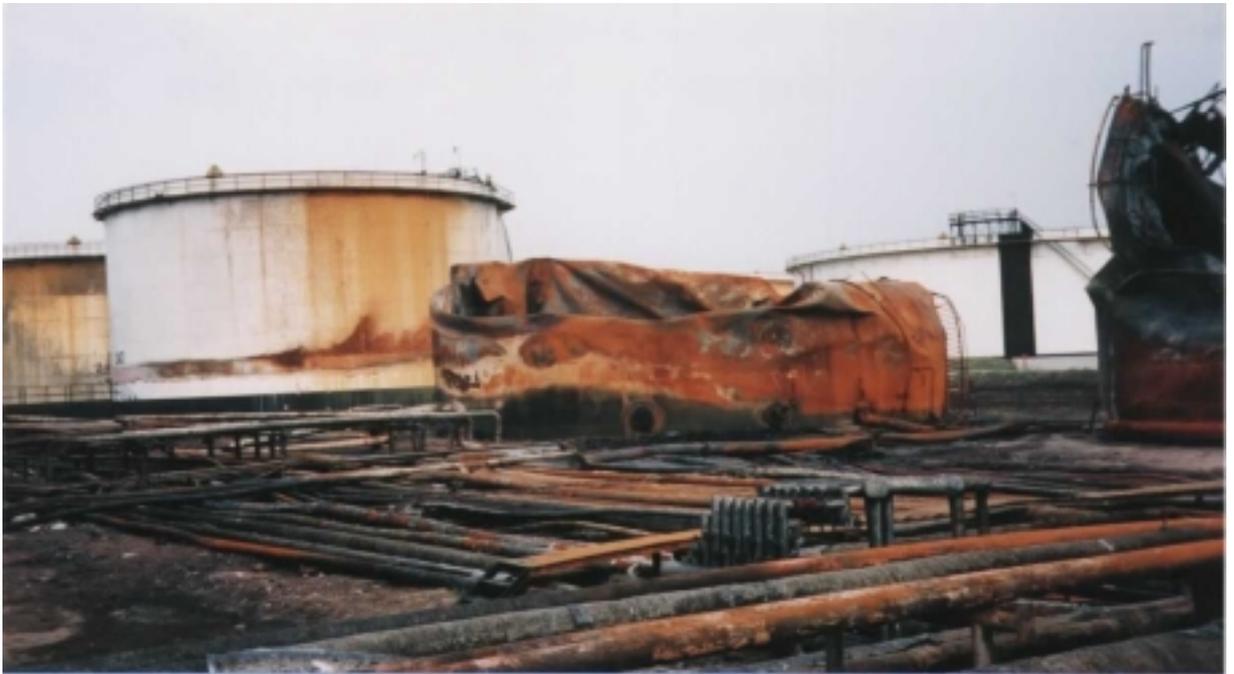
Figure 7.4 Burned cylindrical tank

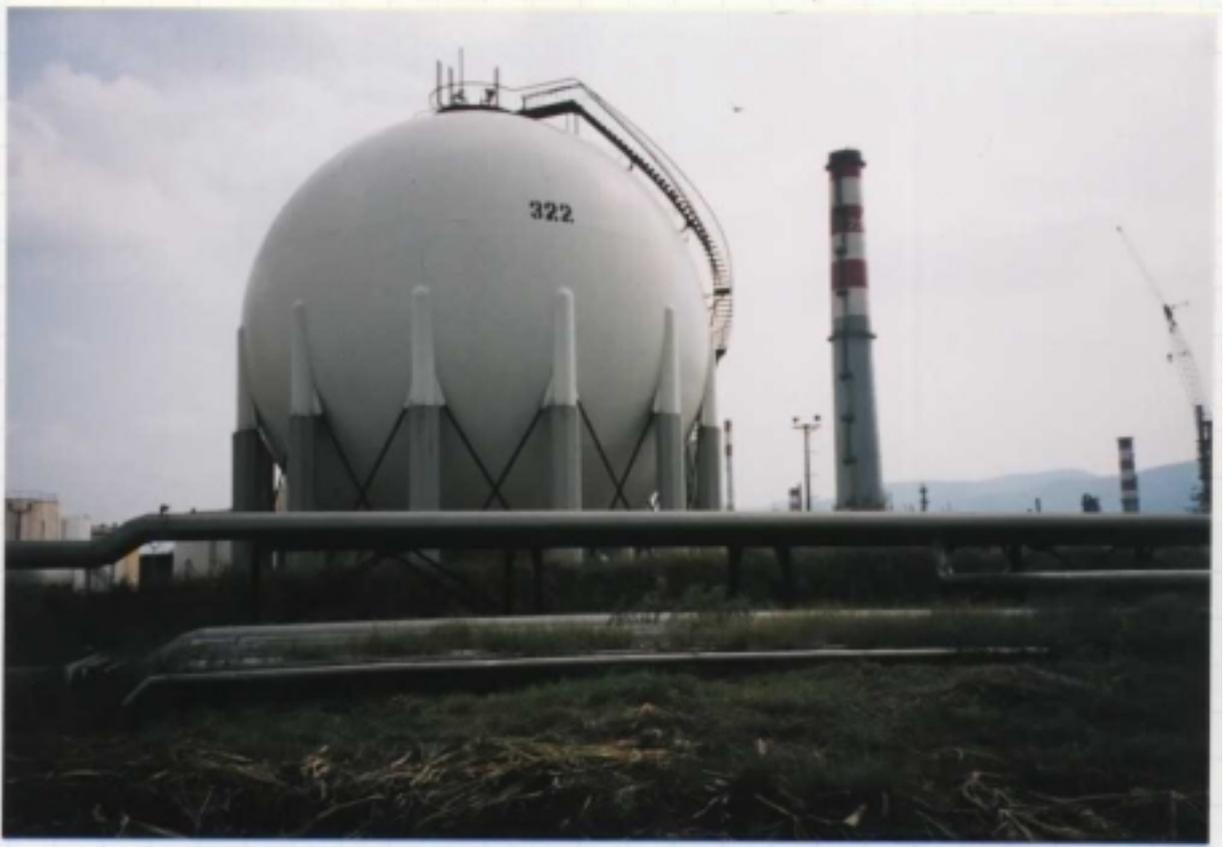
Most of tanks were built in 1961 according to the earthquake design code of California for a Level 4 earthquake shaking. In addition to cylindrical tanks, there are some spherical tanks in the plant. None of these was damaged. As seen in Figure 7.5, the piers and bracing of these spherical tanks shows no visible damage. Therefore, they should have had enough resistance against the ground shaking during the earthquake. The sealing of the tanks with the floating roof built in 1961 was mainly metallic.

Figure 7.5 Undamaged spherical tank

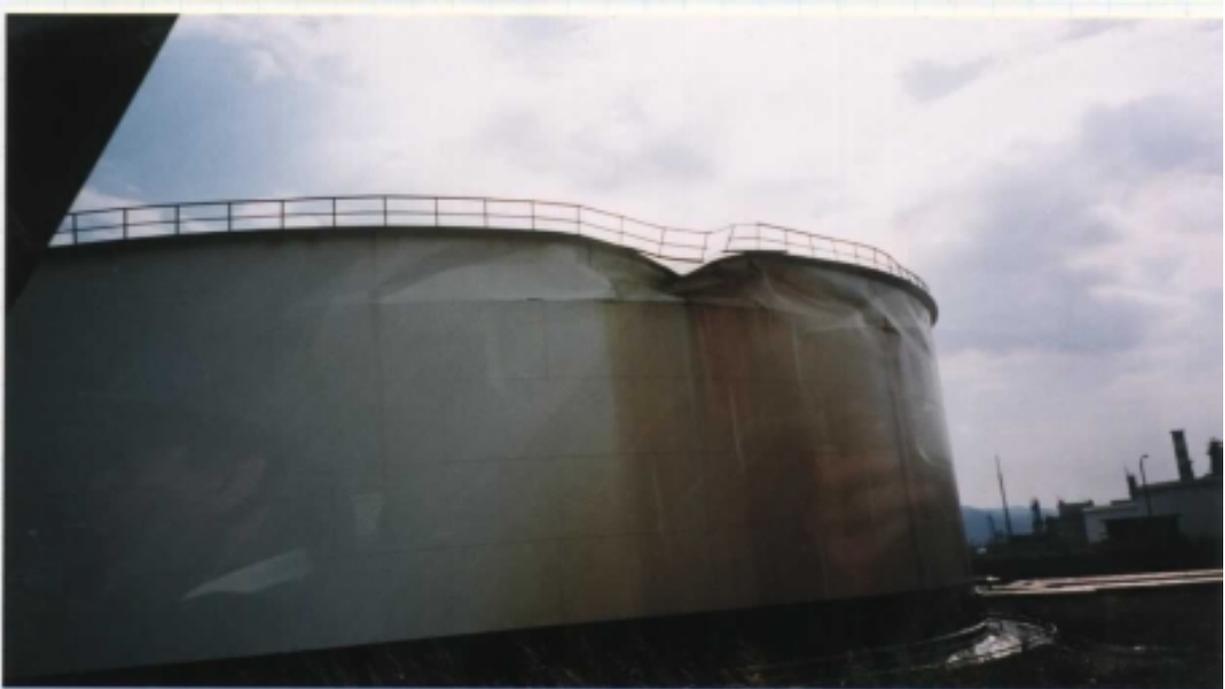
As seen in Figure 7.6, the upper part of a tank with a fixed roof near a burned tank was deformed as a result of pressure caused by heating rather than sloshing.

Figure 7.6 Deformation of a cylindrical tank with a fixed roof

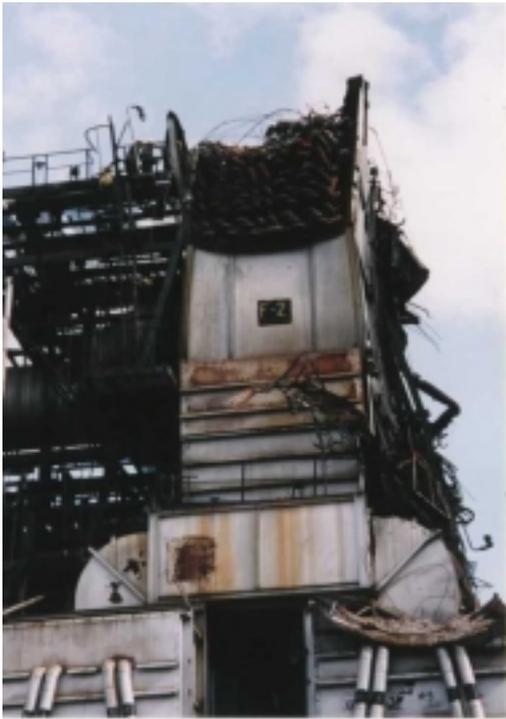
The collapse of one of crude oil stacks with a height of 105m caused the crude oil unit fire. The temperature of the collapsed part was more than 500 °C. Figure 7.7 and 7.8 shows the burned crude oil unit and collapsed heater stack.

Figure 7.7 Damaged crude oil furnace

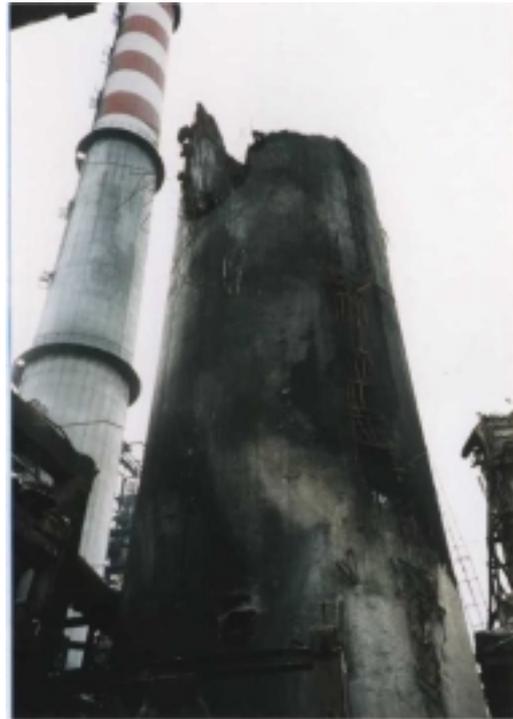
The height of heater stack ranges from 90m to 115m and there are 5 heater stack in the plant. The collapsed heater stack was 105m high. The heater stacks were built in 1981.

The reason of collapse of the heater stack may be associated with material degradation as a result of corrosion due to alkali gases. It is difficult to consider that the main cause of the collapse of the stack is ground shaking only. Both fires started soon after the earthquake. The fire of the crude oil unit extinguished at the night of August 17. While extinguishing the fire at the crude oil unit, the fire in the tank farm become very strong and unmanageable. The fire at the tank farm was completely extinguished on August 20, 1999 (4 days after the earthquake).

Figure 7.8 Collapsed stack

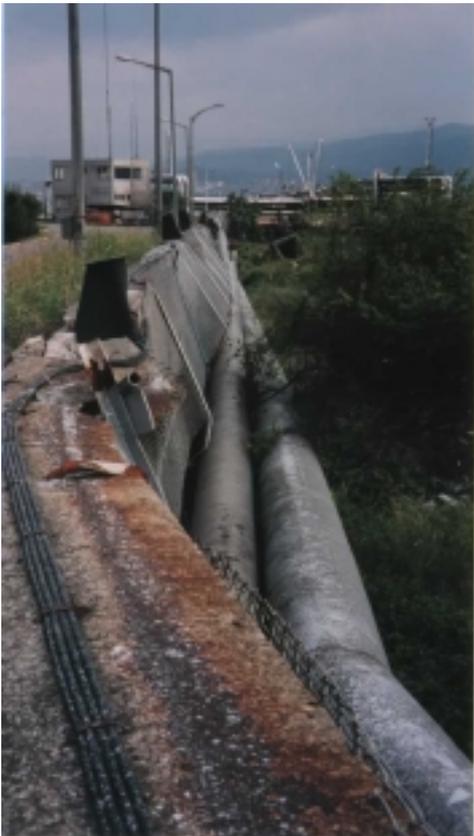
The pipes having a diameter of 700mm installed over a concrete embankment were fallen towards the sea-side as seen in Figure 7.10 for a length of 150m. Nevertheless, the pipes were almost non-damaged.

Figure 7.10 The fallen pipes from embankment wall

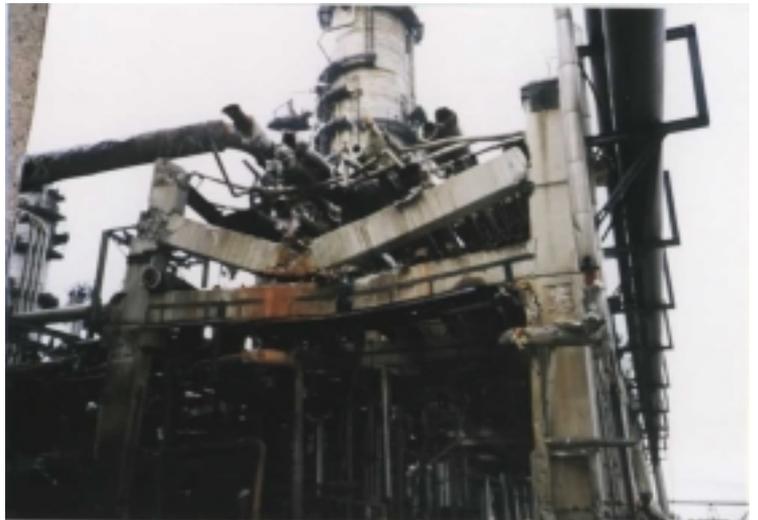
A part of the collapsed heater stack hit the pipe-rack and caused extensive damage as seen in Figure 7.9.

Figure 7.9 Damaged pipe-rack hit by the collapsed stack

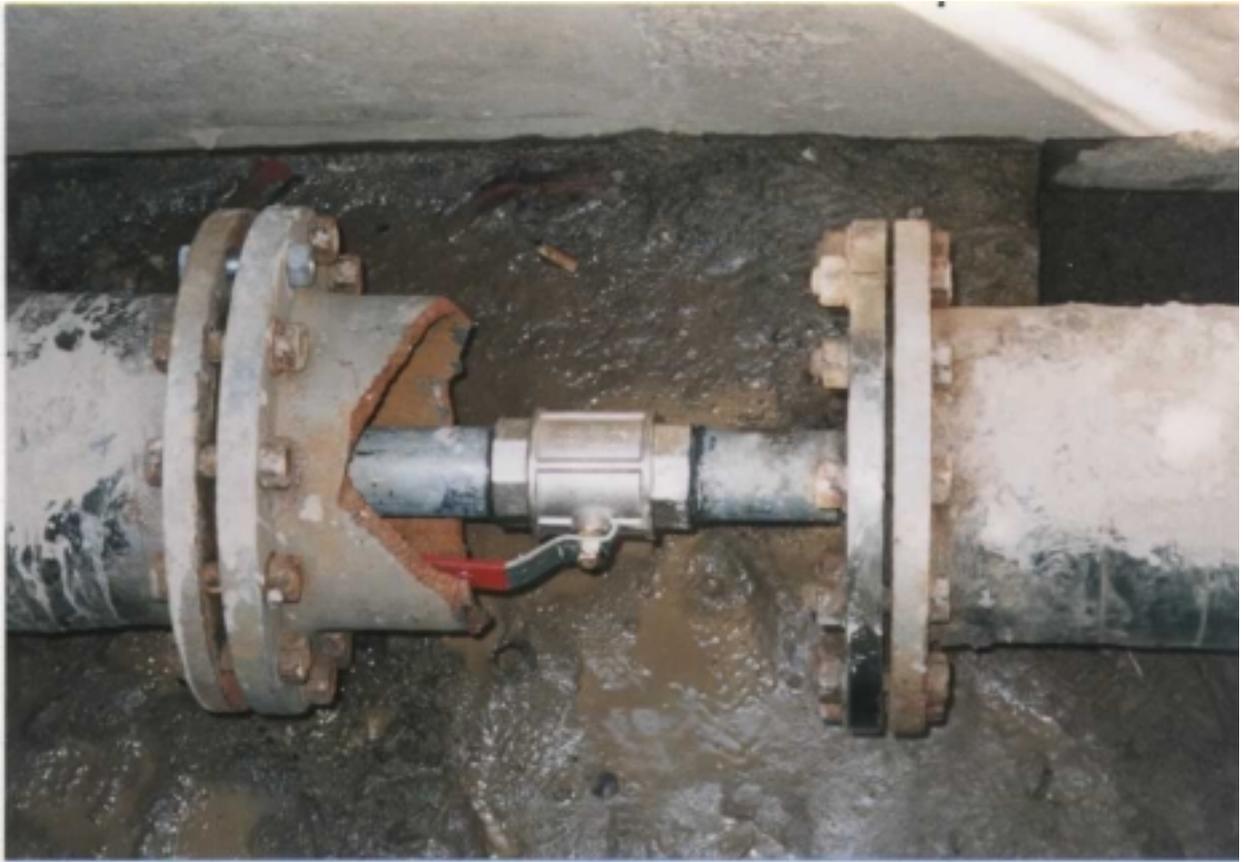
Pipes for water, electricity and fire extinguishing were broken or damaged as a result of ground breaks. Water pipes had a diameter of 400mm and made of concrete. Fire extinguishing pipes are steel and had a diameter of 200mm. The pipes were ruptured at connections or whalves. Figure 7.14 and Figure 7.15 show a mended pipe connection and damaged whalves, respectively.

Figure 7.14 Repaired embedded pipes (damaged at joint)

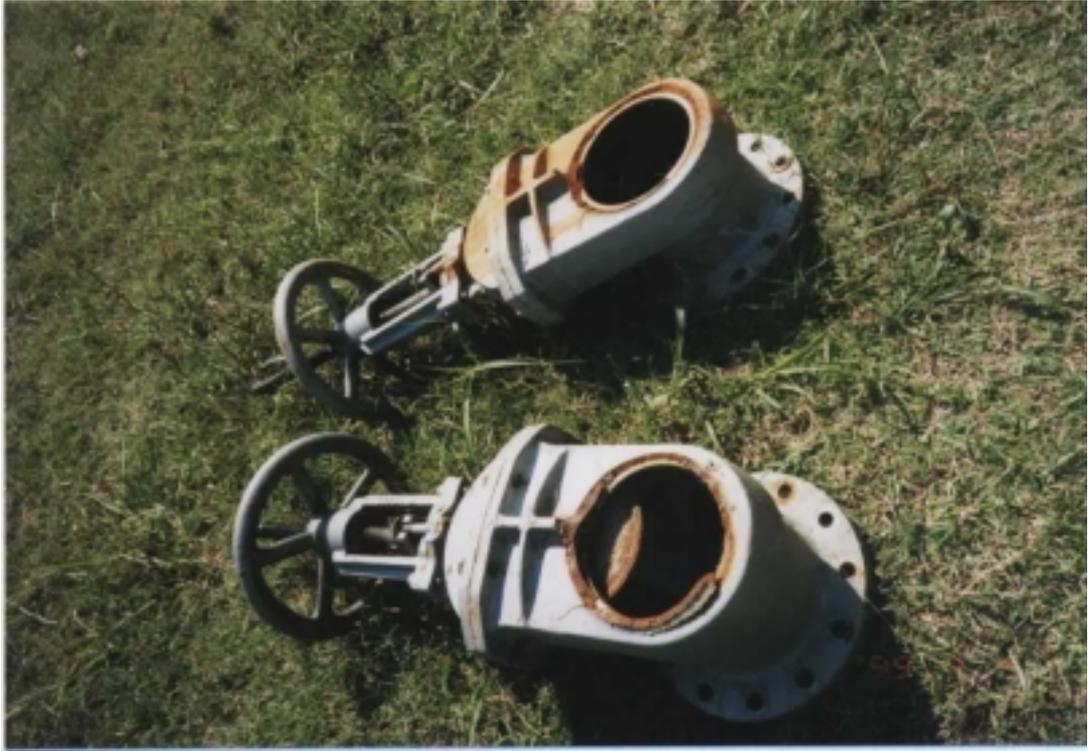
Figure 7.15 Broken valves

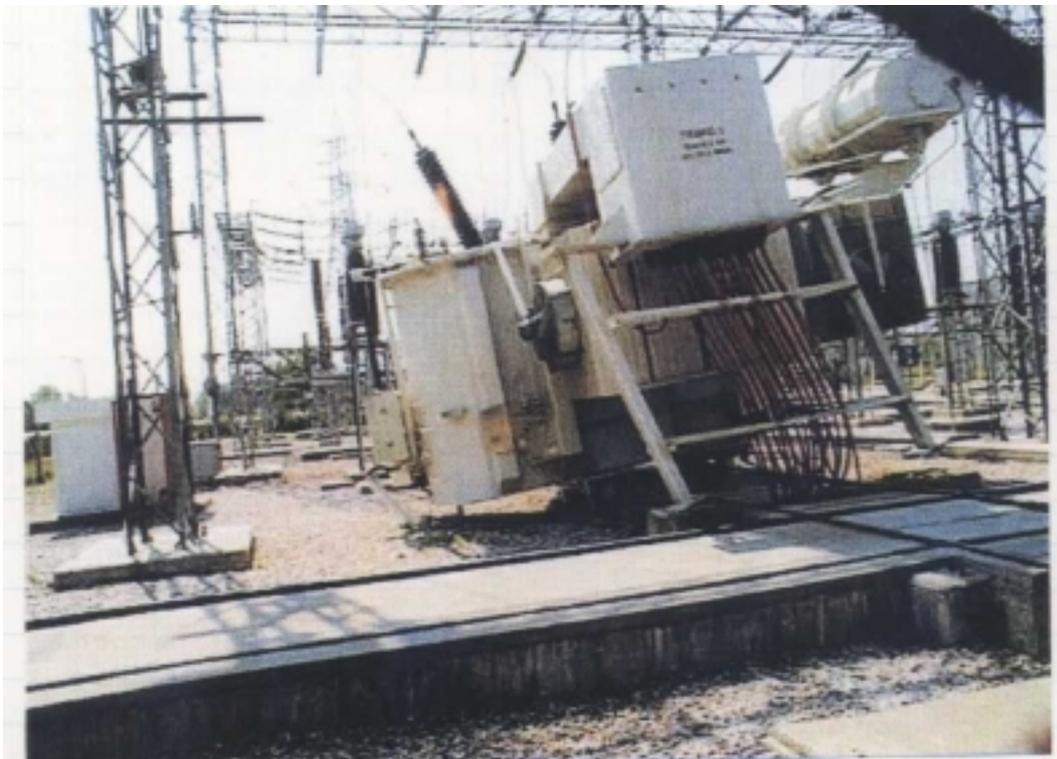
Out of 2 transformer, one transformers was fallen as a result of the failure of its supports as seen in Figure 7.16. Both transformers are put on on rails. Anchors were used to restrain the movements of transformers during ground shaking. These anchors were pulled out of their concrete foundations and the transformers were displaced.

Figure 7.16 Fallen transformer (courtesy of TOYOTA-SA)

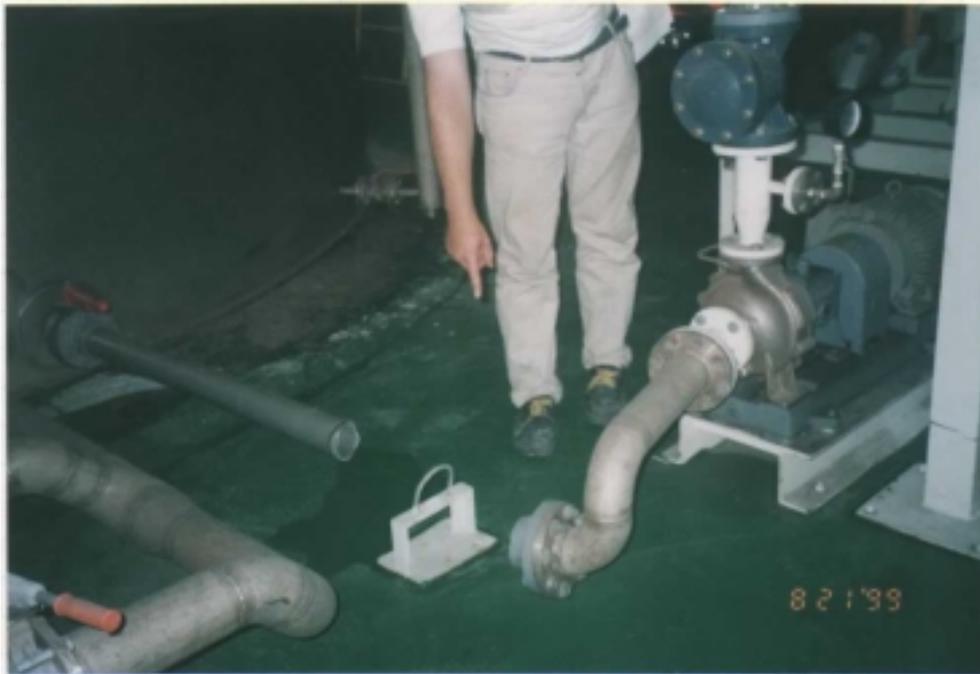
3 cylindrical tanks put horizontally were undamaged. On the other hand the cooling water tank put vertically slided 1 m and pipe connections were broken.

Figure 7.17 Sliding of Cooling water tank and rupture of pipes (courtesy of TOYOTA-SA)

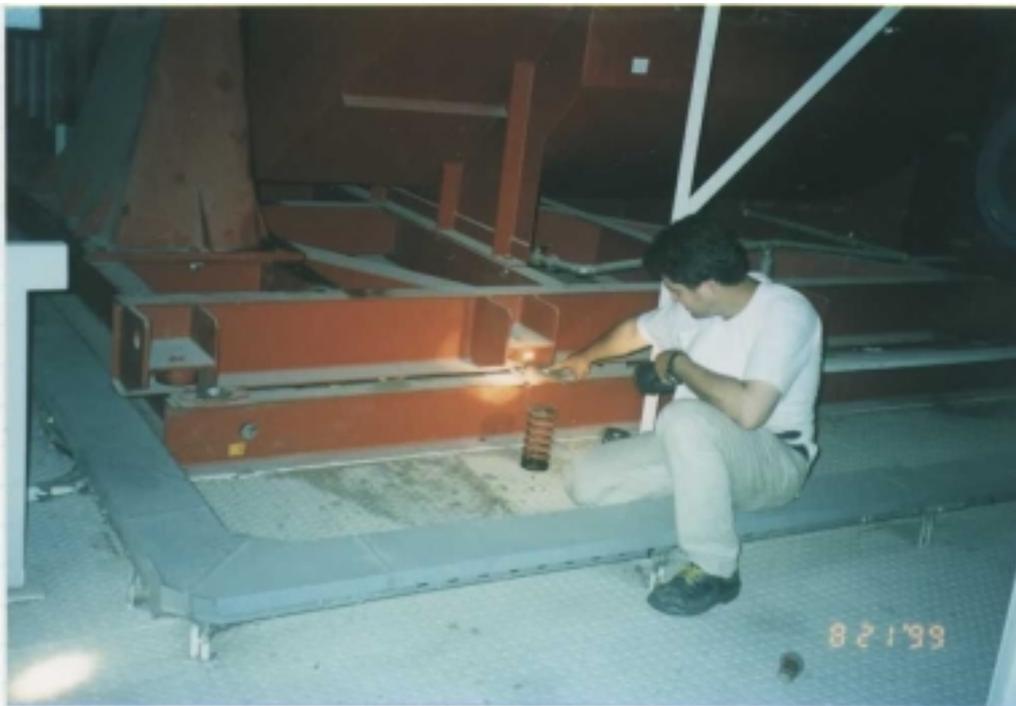
The ventilator (8 ton) in a 9m high building was fallen as a result of breakage of the pin of vibration-proof coilsprings as seen in Figure 7.18.

Figure 7.18 The fall of a large fan (courtesy of TOYOTA-SA)

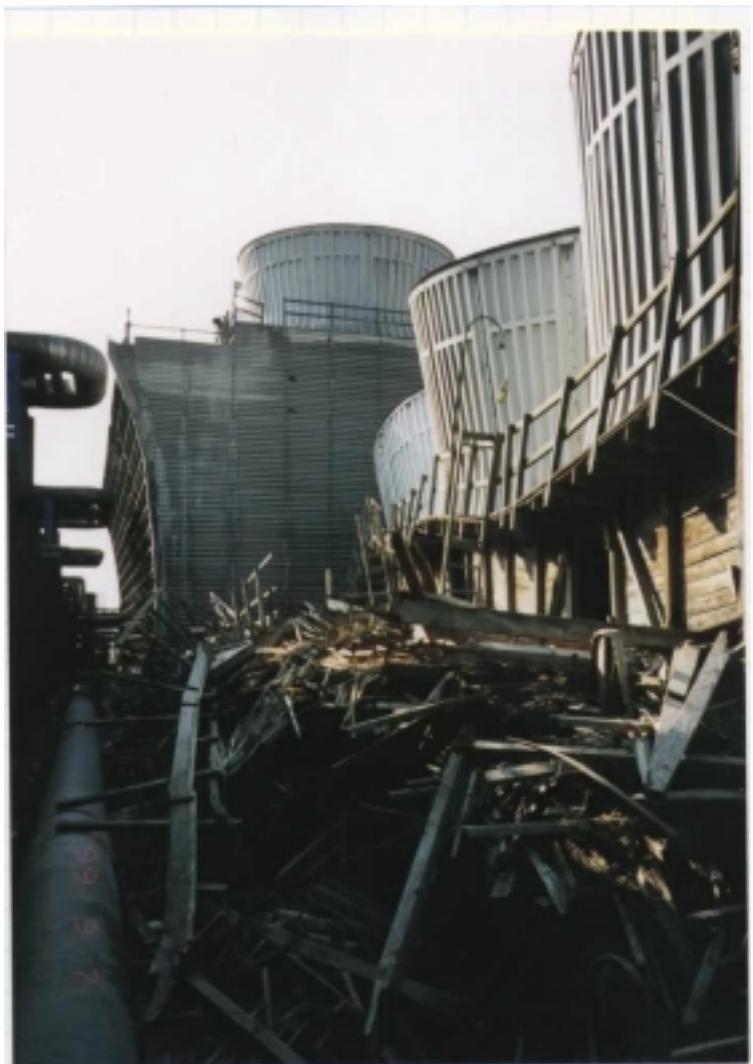
Figure 7.19 shows the damaged state of the wooden cooling tower. Figure 7.20 shows the damaged columns of the reinforced concrete cooling tower. Pipes suspended to the jetty were fallen for several centimeters. However, they were already repaired at the time of the visit.

Figure 7.19 Collapsed wooden cooling towers (concrete  
Towers are un-damaged

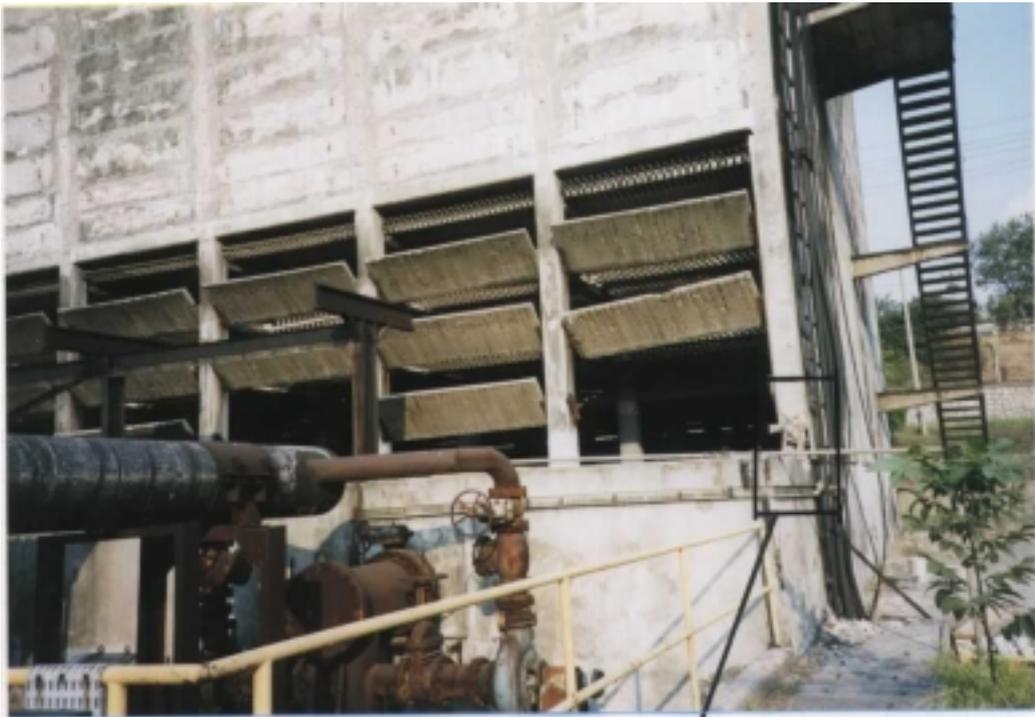
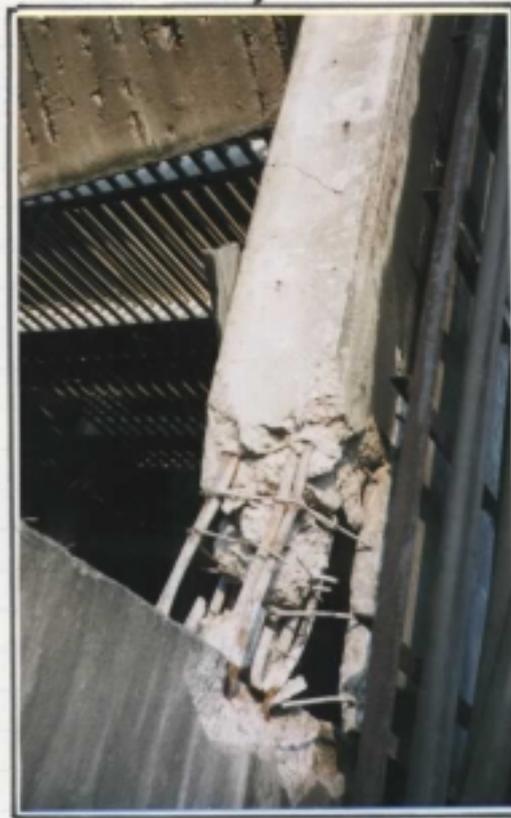
Figure 7.20 Damaged support columns of reinforced concrete towers

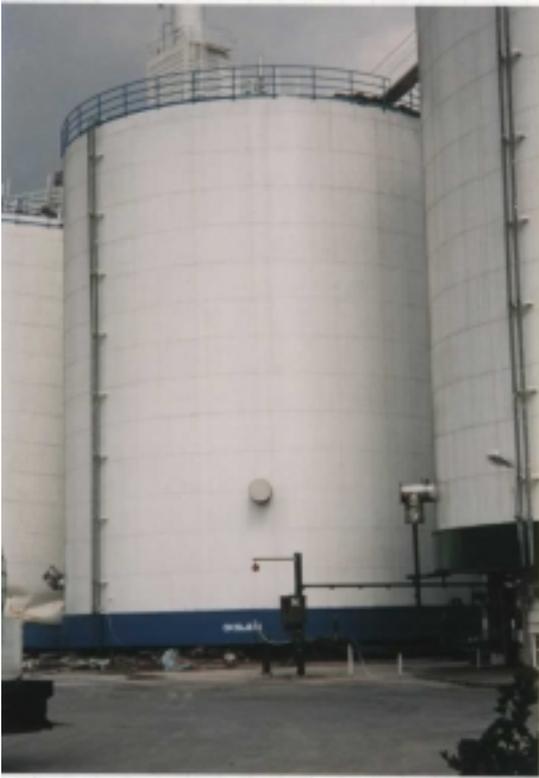
In Köseköy near zmit, a liquified gas plant called HABA liquified gas company is located. In this plant, there are tanks for liquified oxigen and argon. The tanks are cylindrical and supported by concrete columns. Out of three tanks, the columns of the two tanks were broken. The volume of tanks is 1500 m<sup>3</sup>. The undamaged tank was almost empty at the time of the earthquake. Figure 7.21 and 7.22 show the damaged state of the tanks.

Figure 7.21 Damaged supporting columns of vertical cylindrical tank

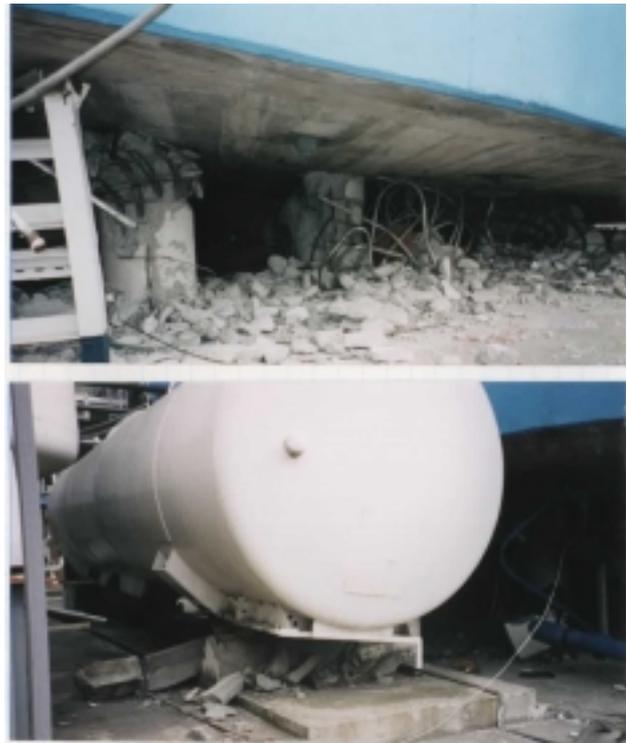
Figure 7.22 A close-up view of broken support columns of the vertical cylindrical tank and an adjacent horizontal cylindrical tank
