8 DAMAGE TO LIFELINES

8.1 Electricity

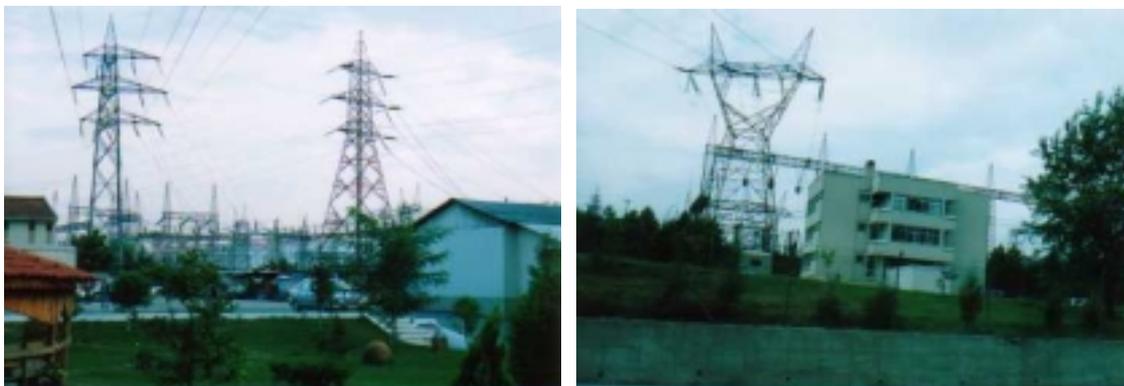
Figure 8.1 Sakarya substation and its administration building

All four transformers slipped about 50cm out of place when their foundation bolts broke off. The weight of each transformer is 200 tons. Five of six major circuit breakers suffered damage leading to oil leakage from the bushings because the bushings slipped out of their positions. Those damaged circuit breakers were made in Sweden while non-damaged one was made in Japan. There was breakage of the support insulators of 15 disconnection switches. Immediately after the earthquake, they began to restore the equipment by two shifts of 100 workers. They successfully restored the function of substation by 2 PM on the same day. Some part of the central city of Sakarya, however, could not receive the electricity because of the damage to houses and distribution poles.

At the time of the visit of the JSCE members, the damaged circuit breakers had been replaced with new ones, and the transformers had been repaired. As for the seismic design code for these equipments, we were told that there was no Turkish original one. It seems that the seismic design is performed according to the codes of the exporting countries.

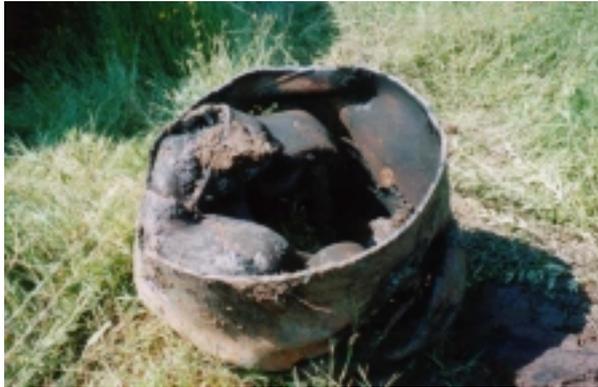
The ground displacement induced by faulting remarkably occurred in the damaged areas. The buried pipelines crossing the fault, suffered damage severely. Figure 8.2 shows the buckling of water supply steel pipe with 28 inches of diameter at Acısu Village. This pipeline crossed the main fault line slantwise. The horizontal displacement of 2.5m was observed in a row of poplar trees close to this site. Figure 8.3 shows the break of pipelines crossing a secondary normal fault with a vertical displacement of more than 2m at Kavaklı in Gölcük City. Figure 8.4 shows the breakage of sewage pipe at Arifiye. This pipeline crossed perpendicularly the

Figure 8.2 Buckling of water supply steel pipe

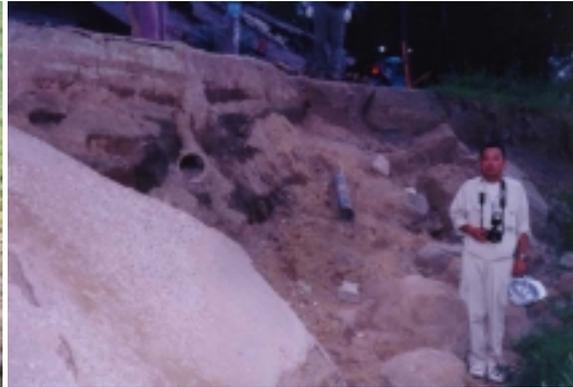
Figure 8.3 Break of buried pipeline crossing a normal fault with a vertical displacement

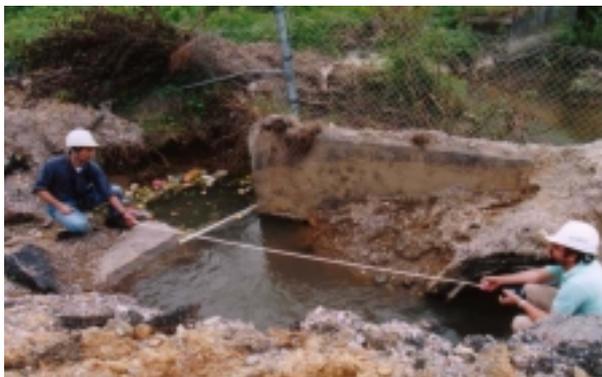
main fault and separation of pipe was about 3m. As mentioned above, many pipelines suffered damages due to the permanent ground displacement induced by faulting.

Figure 8.4 Breakage of sewage pipe crossing a main fault

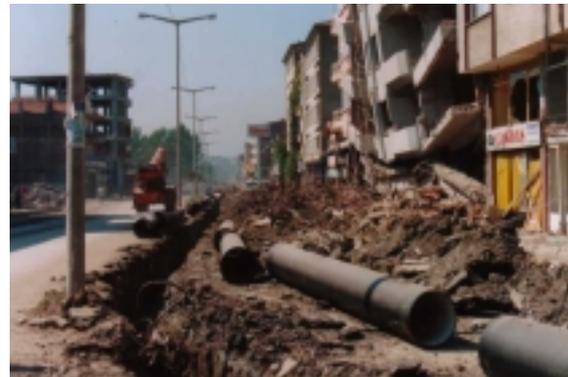
Figure 8.5 New pipeline laid in the downtown in Adapazari

The emergency water delivery was conducted by using tank trucks in Gölcük, Adapazari and Izmit where the destructive damages to buildings were occurred. Although the repair works were not almost started in these cities yet as of September 10, 1999, new pipelines were laid in the downtown of Adapazari City as shown in Figure 8.5. Since this area is one of the hardest damaged area of buildings in the city, the pipelines also seems to suffer heavy damages. The pipelines buried here, therefore, abandoned and new pipeline was constructed.
