## 9 DAMAGE TO BUILDINGS

### 9.1 Natural Period of Structures in Turkey

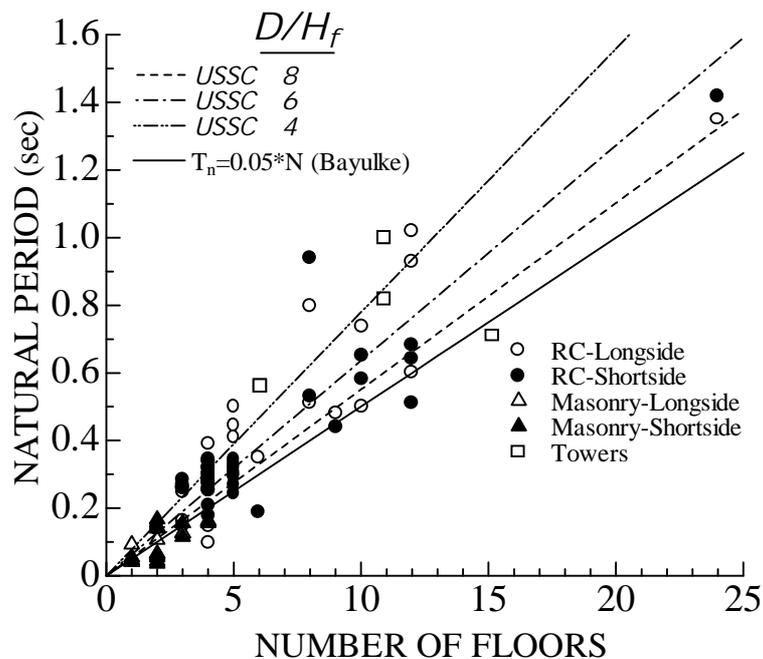
The natural periods of structures first were measured by Aykut and his work was later followed by Bayülke (1978). Their data together with new additional ones are plotted as a function of number of stories in Figure 9.1. This experimental data were fit to a linear function by considering the number of stories up to 8. The following relations approximately hold between the natural period  $T$  of the building and the number  $N$  of stories:

Figure 9.1 Natural periods of structures in Turkey

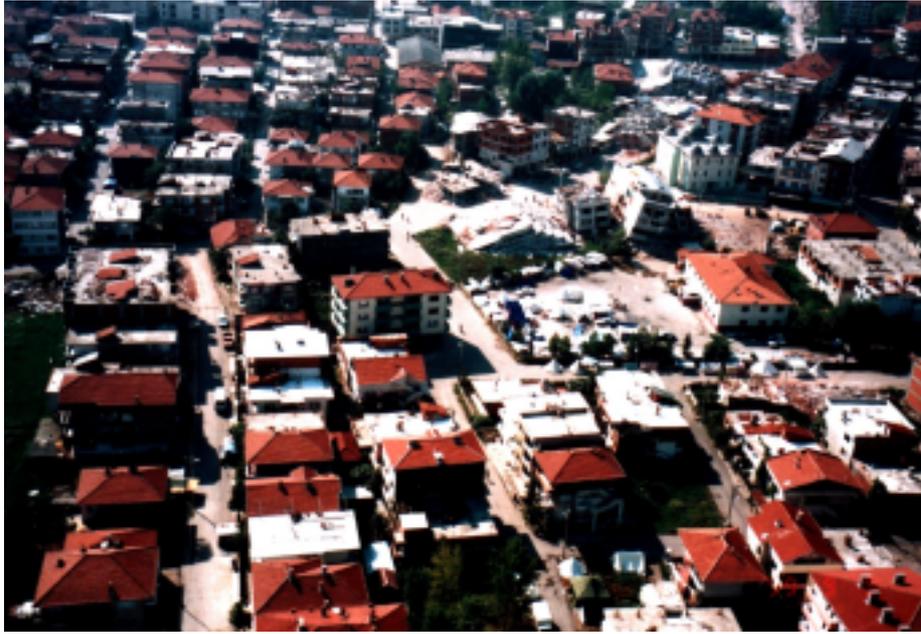
The totally collapsed or heavily damaged apartment buildings had 5-8 stories as shown in Figure 9.2. The natural periods of these buildings mostly coincide with the dominant periods of the horizontal earthquake motion. These structures were designed as moment-resistant frame structures with in-fill walls made of hollow bricks. The diameter of reinforcing bars and stir-ups were mostly 8-16 mm and 4 mm respectively. Bars were generally of smooth type. However the use of deformed bars were observed in buildings under construction or new buildings.

Figure 9.2 An aerial view of collapsed reinforced concrete buildings in Adapazar

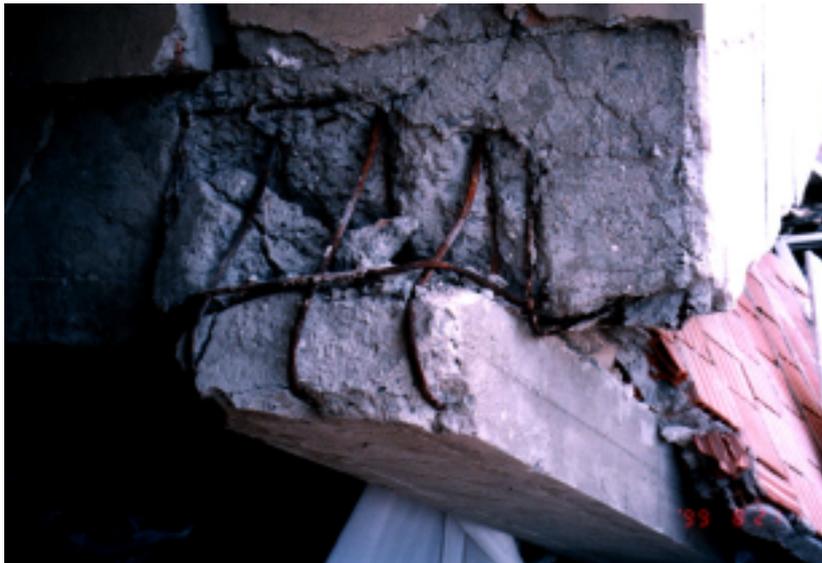
**Construction mistakes:** One of the most striking construction mistakes or negligence was the confinement of concrete at the beam-column connections (Figure 9.3) in spite of the Turkish design code for seismic regions. As stir-ups were very few at such locations without concrete adherence, the failure of concrete was very brittle and it could not absorb the work done by the earthquake forces. Furthermore, the diameter of steel bars were less than that required in the design code.

Figure 9.3 Improper column-beam connections (Note that reinforcing bars have smaller diameter and are not hooked with each other and lack of stir-ups and also lack of adherence of concrete. The building is shown in Figure 9.14

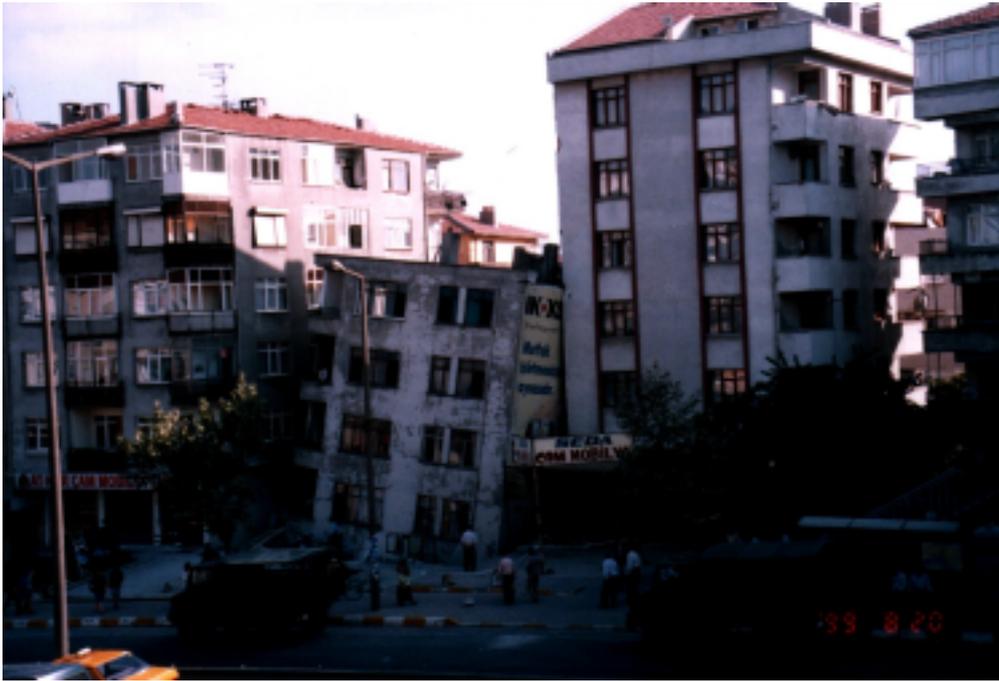
Figure 9.4 Collapsed 5 story RC building in Avcılar (Istanbul)

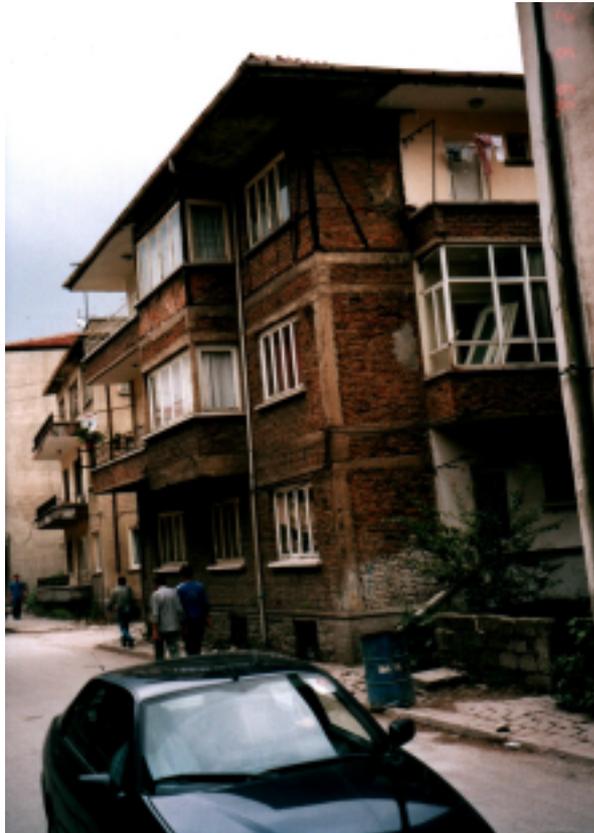
**Soft (Weak) floor:** Many buildings had shops at their ground floor. Since there are generally no shear-walls to take up the load during earthquakes, the total load is transferred on the columns. The super structure acts a top-heavy structure on the columns and in-fill walls, which are in poor contact with columns and beams, has no effect against the earthquake loading and they fail subsequently as seen in Figure 9.4. It was interesting to note that structures having solid bricks or angular rock blocks as in-fill walls and columns constructed after the construction walls performed much better and damage was none or very limited. (Figure 9.5)

Figure 9.5 Non-damaged reinforced concrete building with solid bricks in T c lar district of Adapazar where liquefaction was widespread

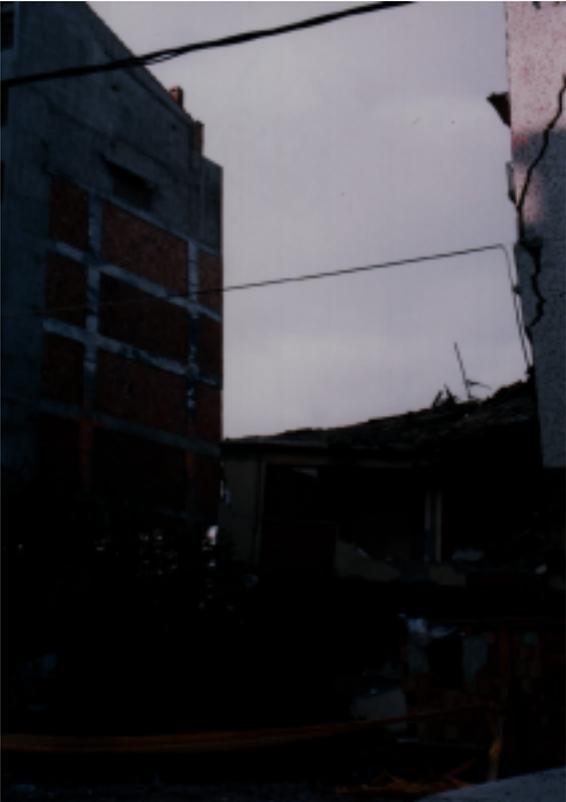
**Collision of Adjacent Structures:** Buildings at the corners of streets were collapsed as a result of collision with the adjacent building (Figure 9.6)

Figure 9.6 Collapse of 6 story RC building due to collision with a adjacent 8 story RC building in Avc lar ( stanbul)

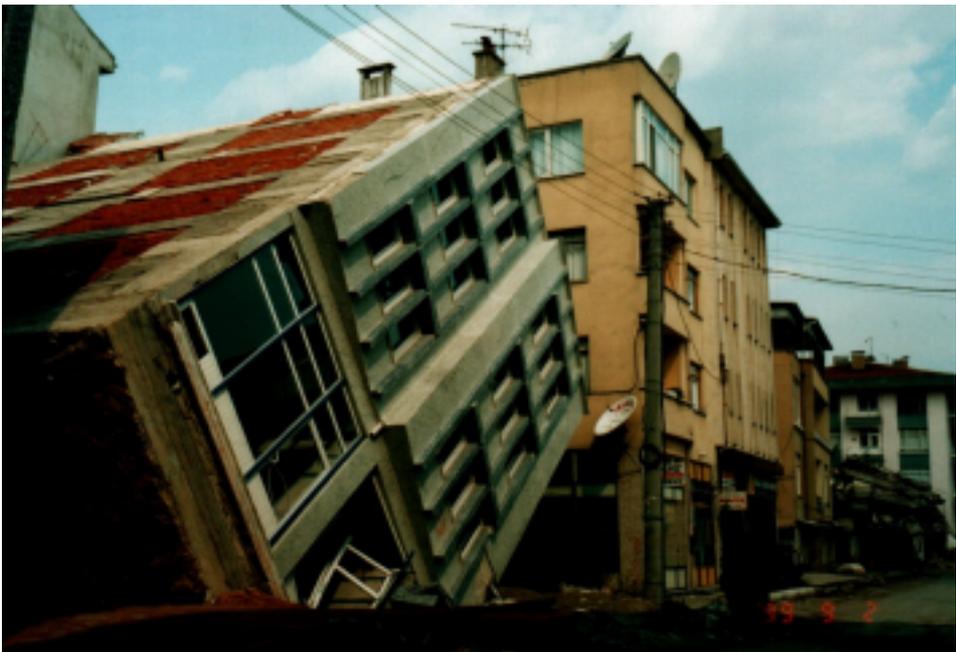
**Liquefaction of ground:** The liquefaction of ground resulted in the reduction of bearing capacity of ground which resulted in either rigid-body like toppling or collapse of structures in a pan-cake mode as seen in Figure 9.7.

Figure 9.7 Toppled and collapsed buildings in T c lar district of Adapazar

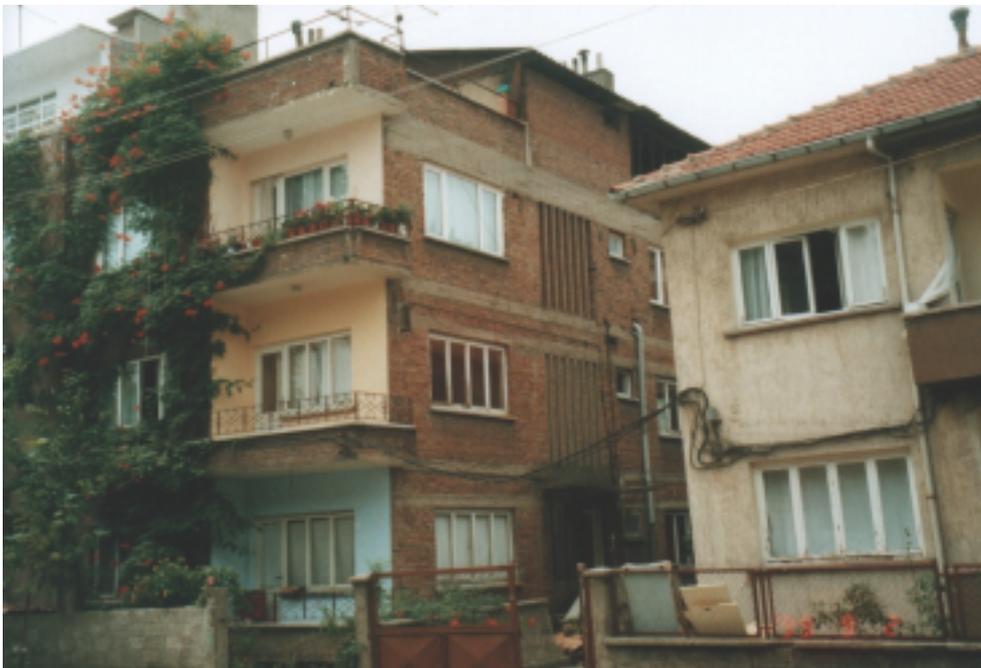
The most severe damage was observed in houses made of delikli Tuğla (hollow bricks). Although the use of this type of brick as a load bearing element was forbidden after the experience in 1992 Erzincan earthquake, its use is presently widespread in Turkey. It should be noted that this material is very brittle. Once it starts to fail, it fails very quickly as stress-concentrations develop everywhere. The houses made with solid bricks and reinforced with concrete slabs for the continuity of structures and having stories less than four performed very well during the earthquake even in a liquefied district (Figure 9.8).

Figure 9.8 Non-damaged buildings made with solid bricks in Tıncalılar district of Adapazarı where liquefaction was widespread

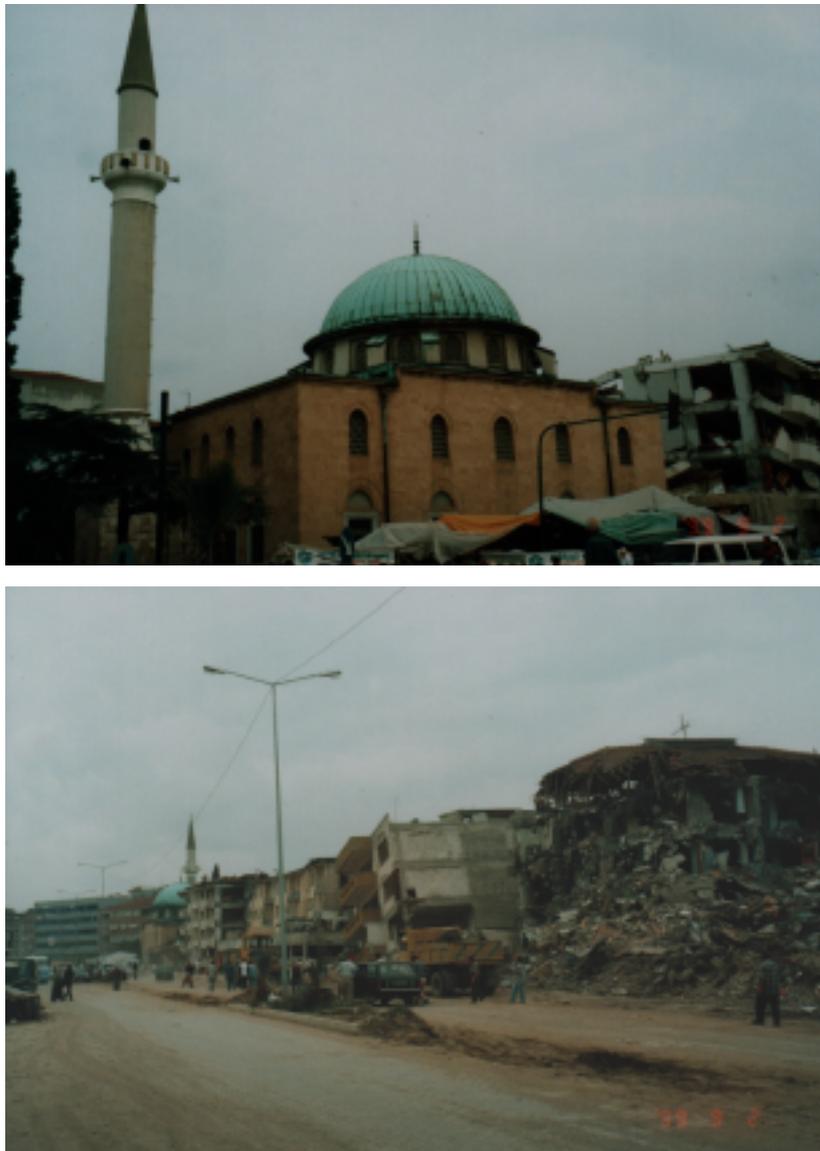
This type of structure is quite rare in the earthquake-affected area. During the site investigation, three such buildings were identified. One of them was Sapanca railway station and the other ones were Yeni Cami (mosque, built in 1946) in Adapazar and a mosque in Gölcük. None of these buildings were damaged. Particularly Yeni Cami was founded on alluvial deposits and was experienced also 1967 Mudurnu Suyu earthquake. Many modern reinforced concrete buildings next to this mosque were totally collapsed (Figure 9.9).

Figure 9.9 Views of Yeni Cami and its close vicinity in Adapazar

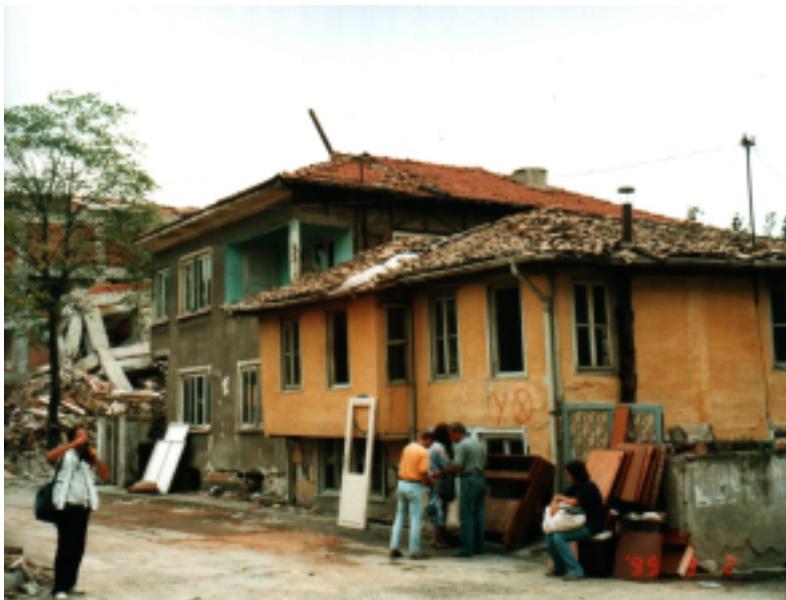
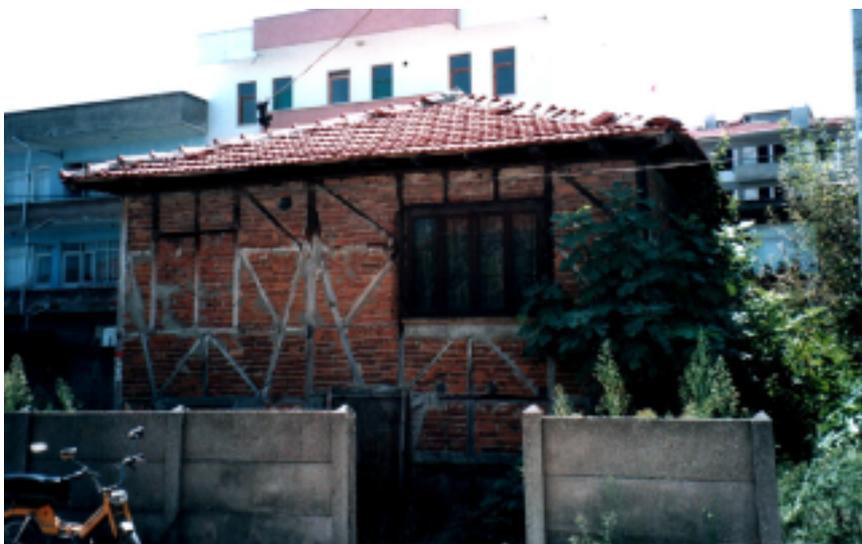
This type of buildings is generally common when wood is locally available. The filling material of this type houses is adobe or solid brick and they are quite similar to truss structures. None of these structures was totally collapsed even some of them were quite old. The damage of these houses was taken place in the form of falling plasters or in-fill walls (Figure 9.10).

Figure 9.10 Views of Ba dadi houses in Adapazar city
