A QUICK REPORT
ON
NOTO PENINSULA EARTHQUAKE ON MARCH 25, 2007

April, 2007

Japan Society of Civil Engineers

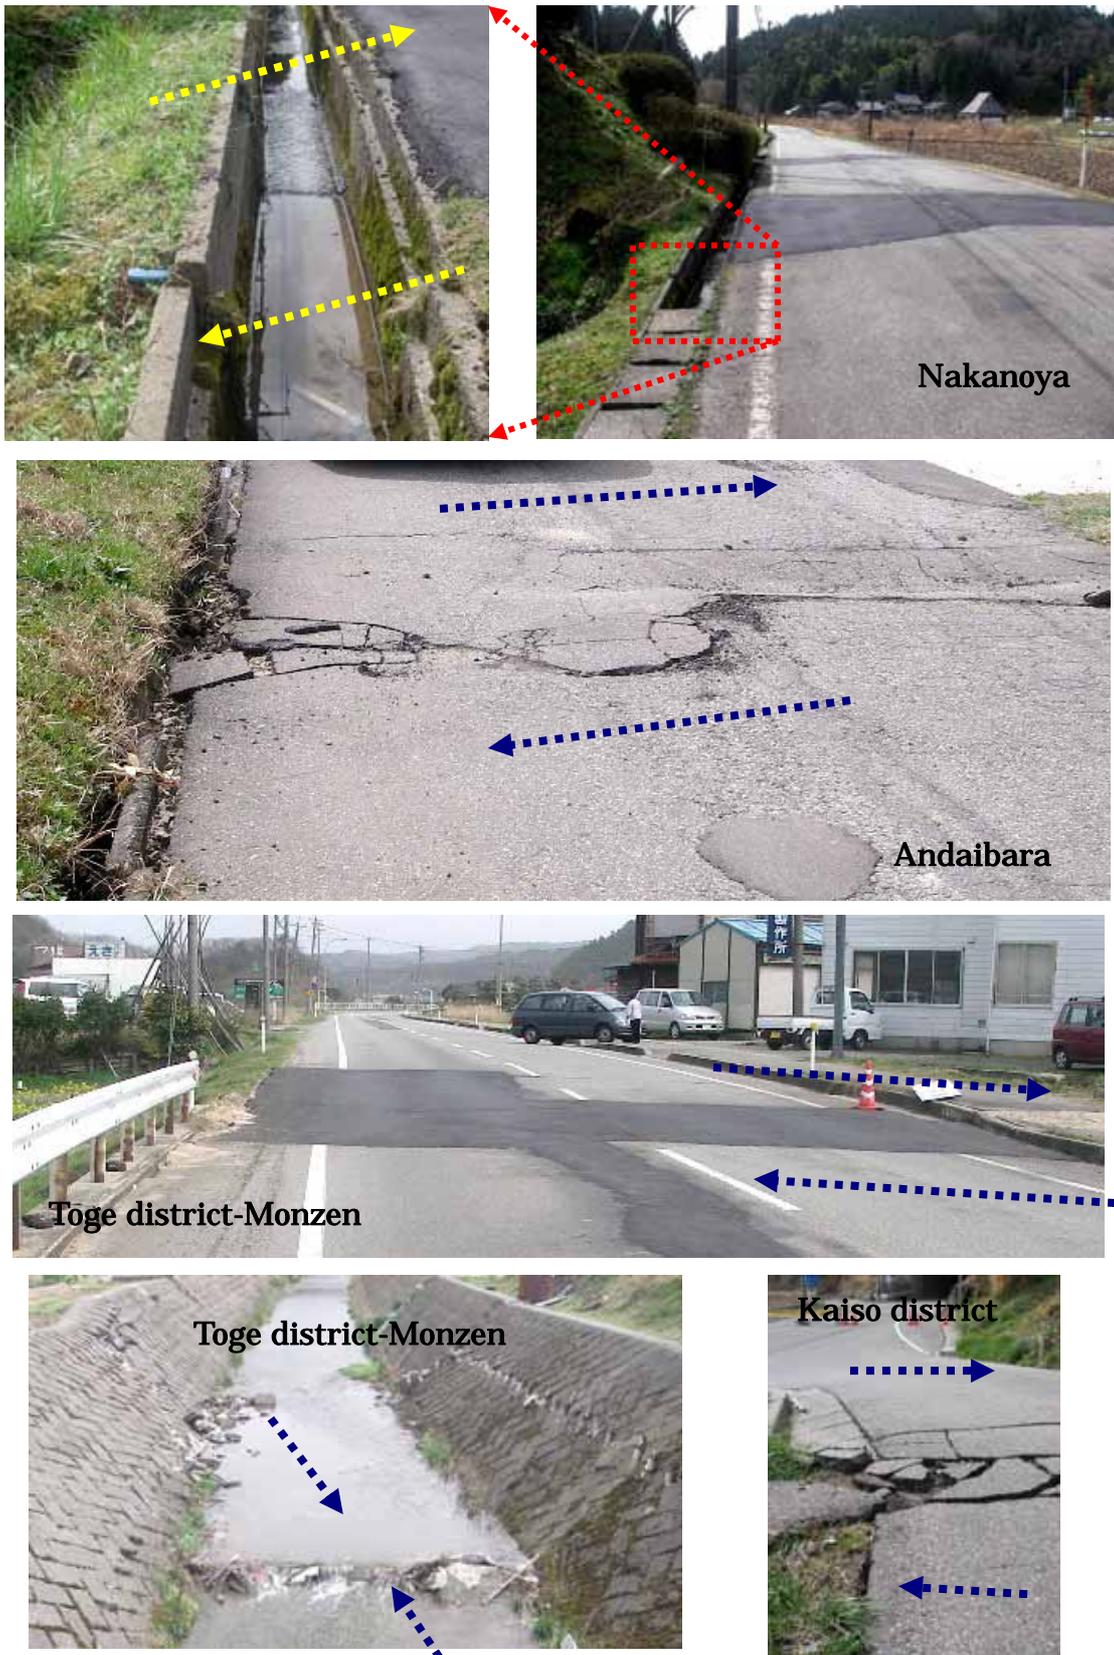
earthquake and model tests on thrust faulting, the deformation front may be diluted by extensive rock slope failures. The authors plotted the locations of rock slope failures, liquefaction locations and observed surface ruptures in Figure 5.3 and views of surface ruptures observed by the authors (Figure 5.4).

Figure 5.4: Close up views of locations of observed surface ruptures

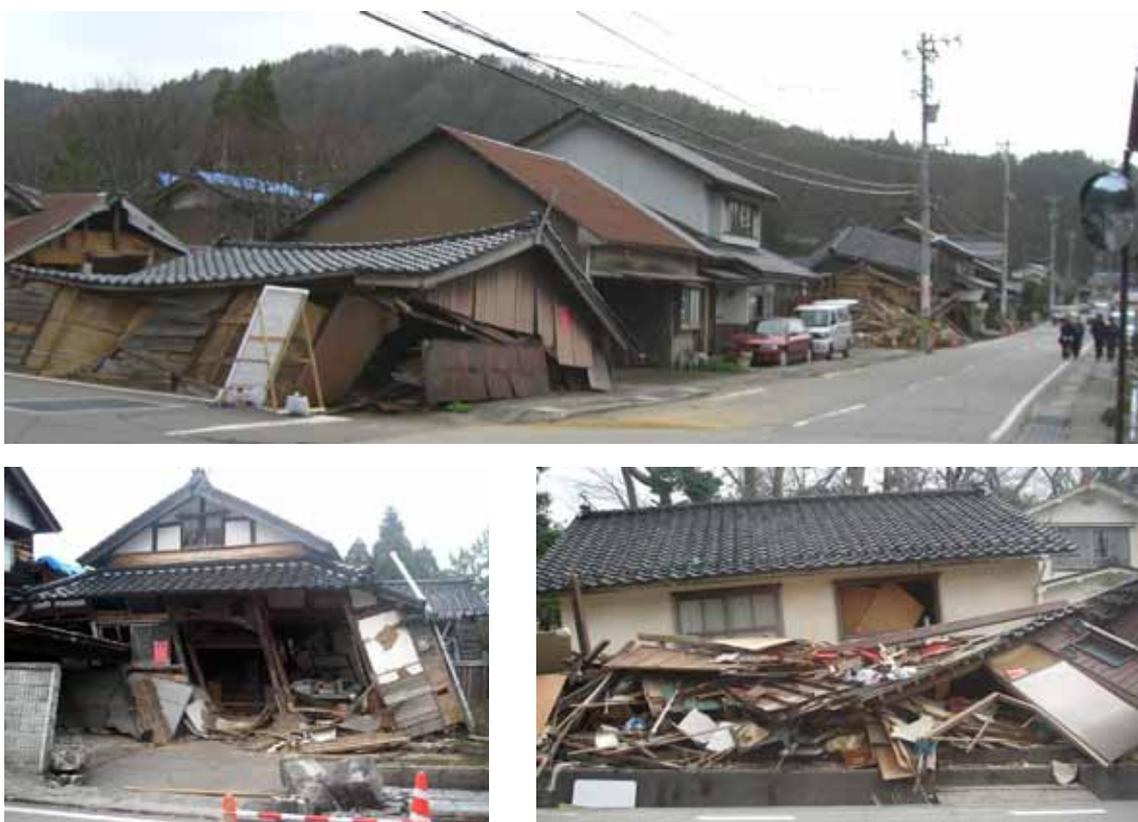
Mainly old wooden houses either collapsed or were heavily damaged. The failure was quite similar to those observed in 1995 Kobe earthquake. The failure mechanism fundamentally involved hinging of wooden columns at the base and also at the connections between 1st floor and 2nd floor as a result of large horizontal earthquake forces (Figure 7.1). The traces of such mechanism can be seen widespread in the epicentral area. In addition some relatively new wooden houses either collapsed or were damaged. The main cause was the weak floor situation observed at the first floor used as garage, workshop or storage. Some houses either collapsed or were damaged due to slope or embankment failure, on which they were built (Figure 7.2). This type of failure observed in mainly hilly regions and also nearby creeks and rivers. The heavy damage at Toge district of Monzen town was partly surface ruptures associated with faulting and lateral spreading of loose sand ground. The authors found boiled sand volcanoes at several locations in this district (see chapter 8).

Figure 7.1: Some typical examples of collapsed or heavily damaged wooden houses

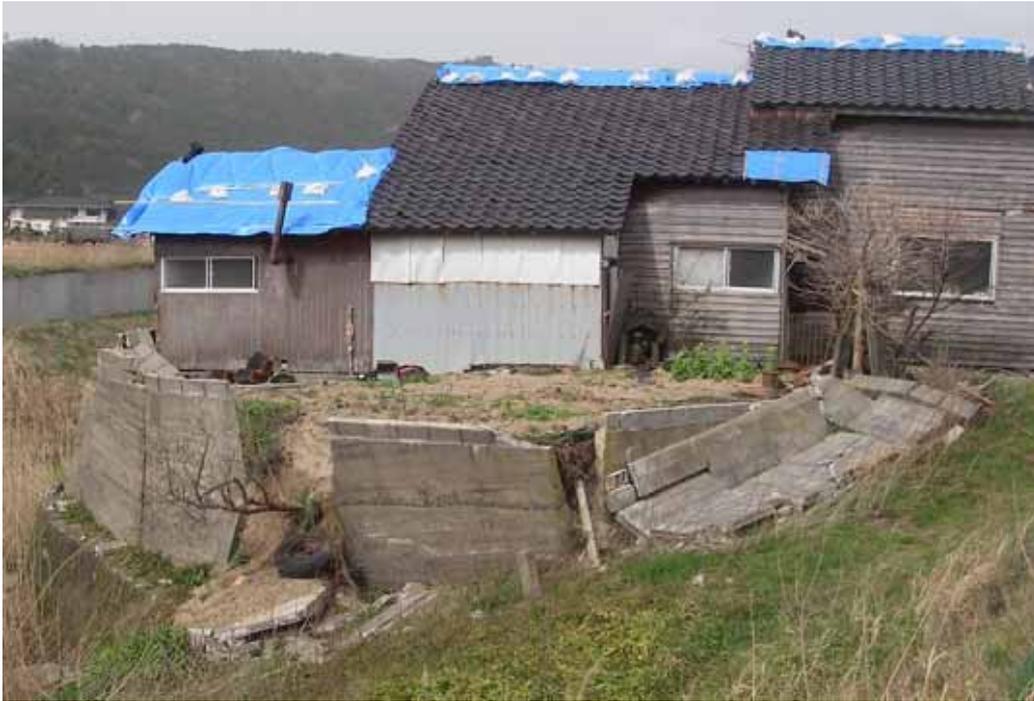
Figure 7.2: An example of damaged house built on an embankment in Monzen town

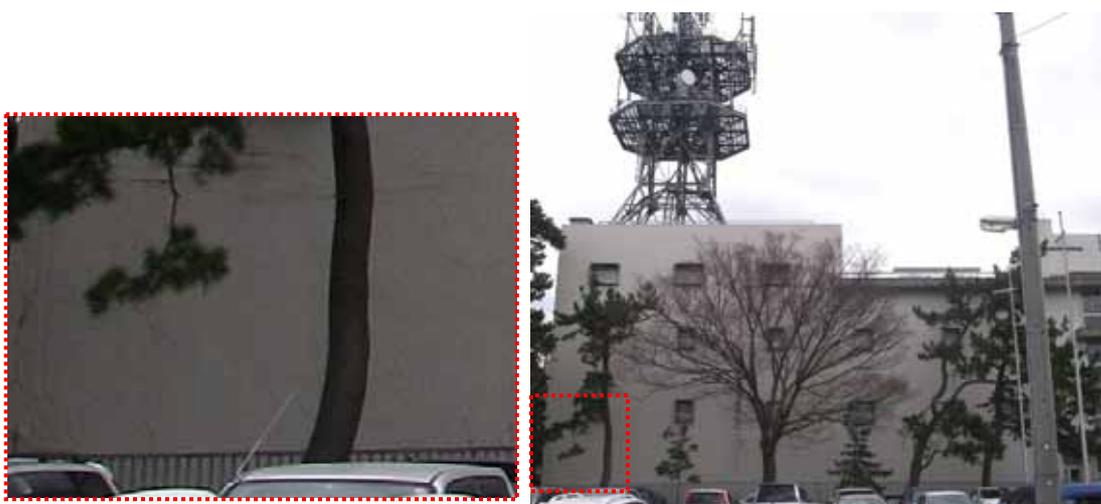
RC buildings in the epicentral region are few and they are used as schools, public offices and a few as residential buildings. The number of stories is mostly 3 to 5. Furthermore, the infill walls of the RC buildings are reinforced concrete shear-walls. Some of public reinforced buildings were retrofitted with steel frame bracing. Almost all reinforced concrete buildings performed well during the earthquake. The observations and investigations in many cities and towns indicated that RC buildings were generally none or slightly damaged in spite of high ground accelerations. The shear-walls of the RC building of NTT in Wajima city experienced some cracking as seen in Figure 7.3. However, it should be noted that the damaged section of the building supports a high transmission tower on its roof.

Figure 7.3: NTT building and close-up view of cracked shear walls

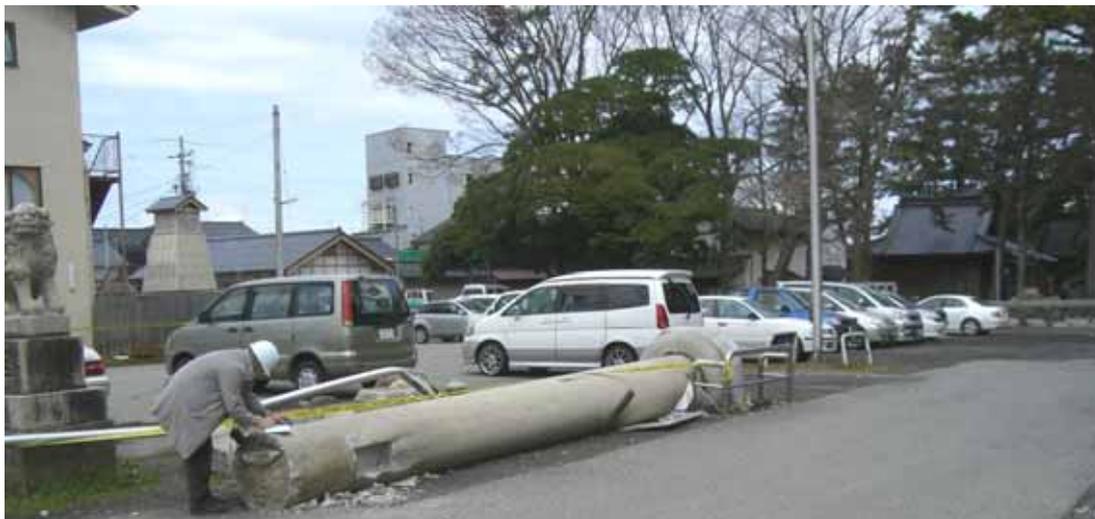
Damage to temples was generally observed at fort-gate (torii) made of granitic columns and beams. One spectacular example was observed at Soji Temple next to the NTT building. The granitic column were uprooted from their base and toppled as seen in Figure 7.3(a). The main compounds were generally non-damaged (Figure 7.3(b)) due to superior earthquake-resistant-ability.

(a) Topped fort-gate of Soji temple

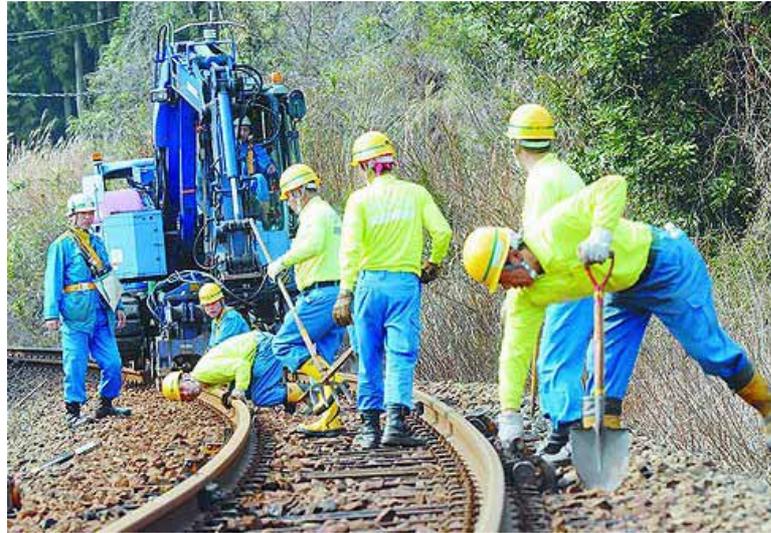
The railway network of Noto Peninsula is not dense as compared with other parts of Japan. Japan Railways extends up to Nanao city and the Noto railway line operated by the third sector runs between Nanao and Anamizu. The line between Anamizu and Suzu is not in operation any longer. The effect of the earthquake was quite negligible on JR lines. Nevertheless, trains were stopped until the safety of the railways checked. JR lines were back to operation on March 26, 2007. The railway line between Anamizu and Nanao were damaged at 25 locations due to deformation of rails. Some repairs of rails on the line between Anamizu and Nanao were carried out soon after the earthquake and the railway line was in operation on March 30, 2007 after 5 days. Buses were used as a temporary measure to deal with train stoppage.

Figure 7.5: A repair work on Anamizu-Nanao railway line (from Yomiuri Newspaper)

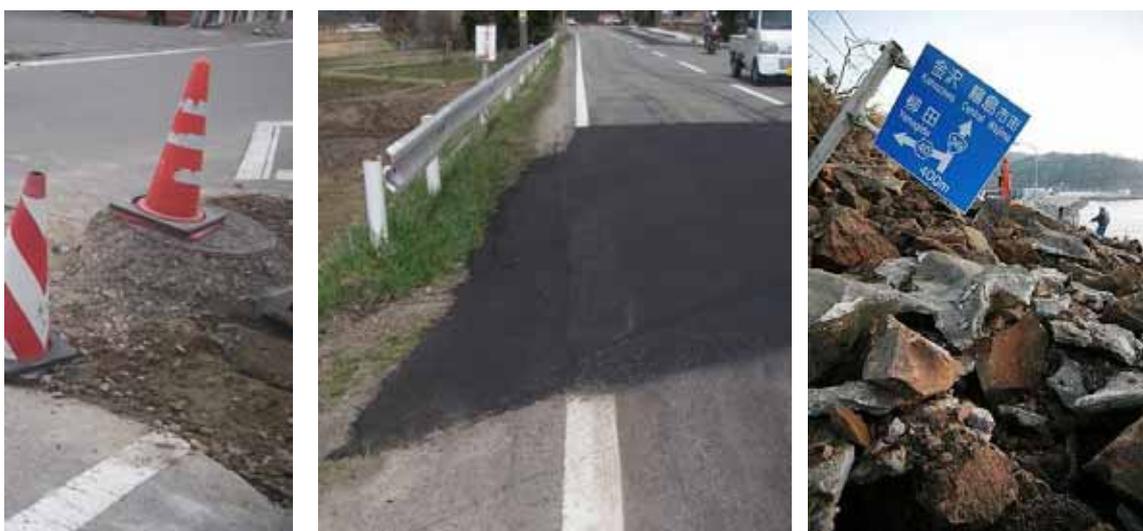
Surface ruptures and settlement of ground damaged roads in Monzen town (Figure 5.4). Furthermore, they were either obstructed or damaged by slope failures and rock falls. The settlement of embankments of roadways at bridges were generally more than 100-200mm. The settlement was caused by either ground shaking or ground liquefaction at some places. In addition, the settlement of improperly compacted infill material of sewage lines was extensively observed and the settlement was particularly amplified at manholes.

Figure 7.6: Some examples of damage to roadways

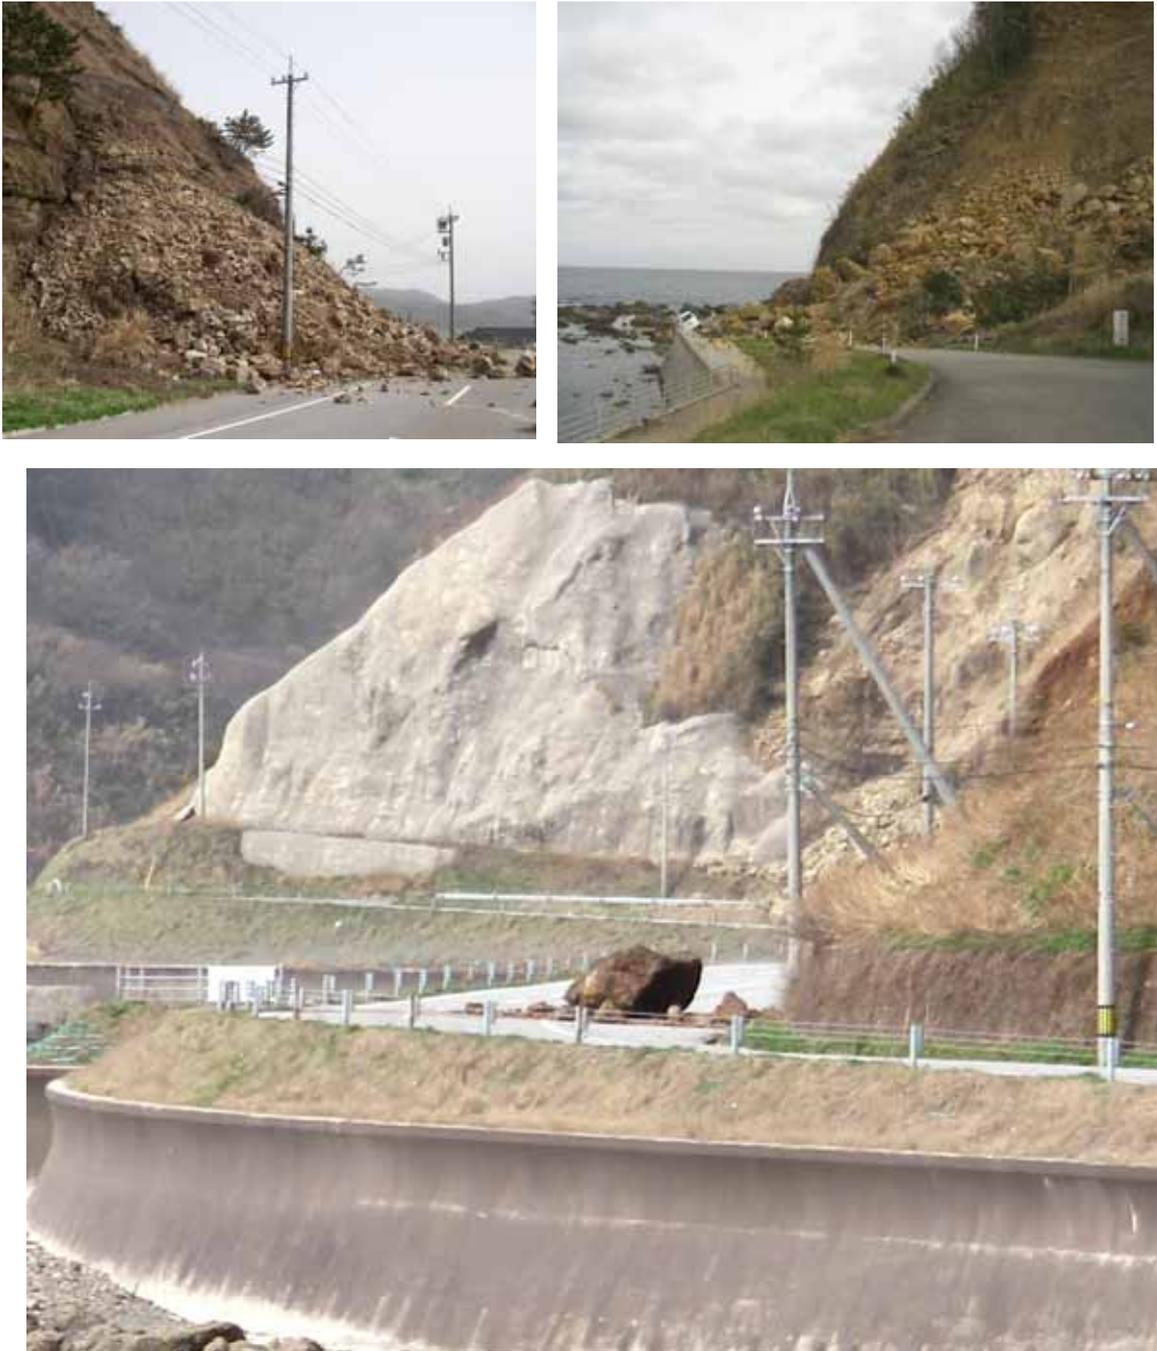
Highways R1, R249, R38 pass through the epicentral region. These highways built on existing ground or embankments were damaged in various parts due to either the failure and/or settlement of embankments and slope failure (Figure 7.7). The 249 Highway was obstructed by slope failures at Maura. R38 along the northern shore of Noto Peninsula were obstructed by slope failures and rockfalls near Ozawa village, Saruyama mountain and Kaiso.

Figure 7.7: Rock slope failures and rock falls obstructing highways

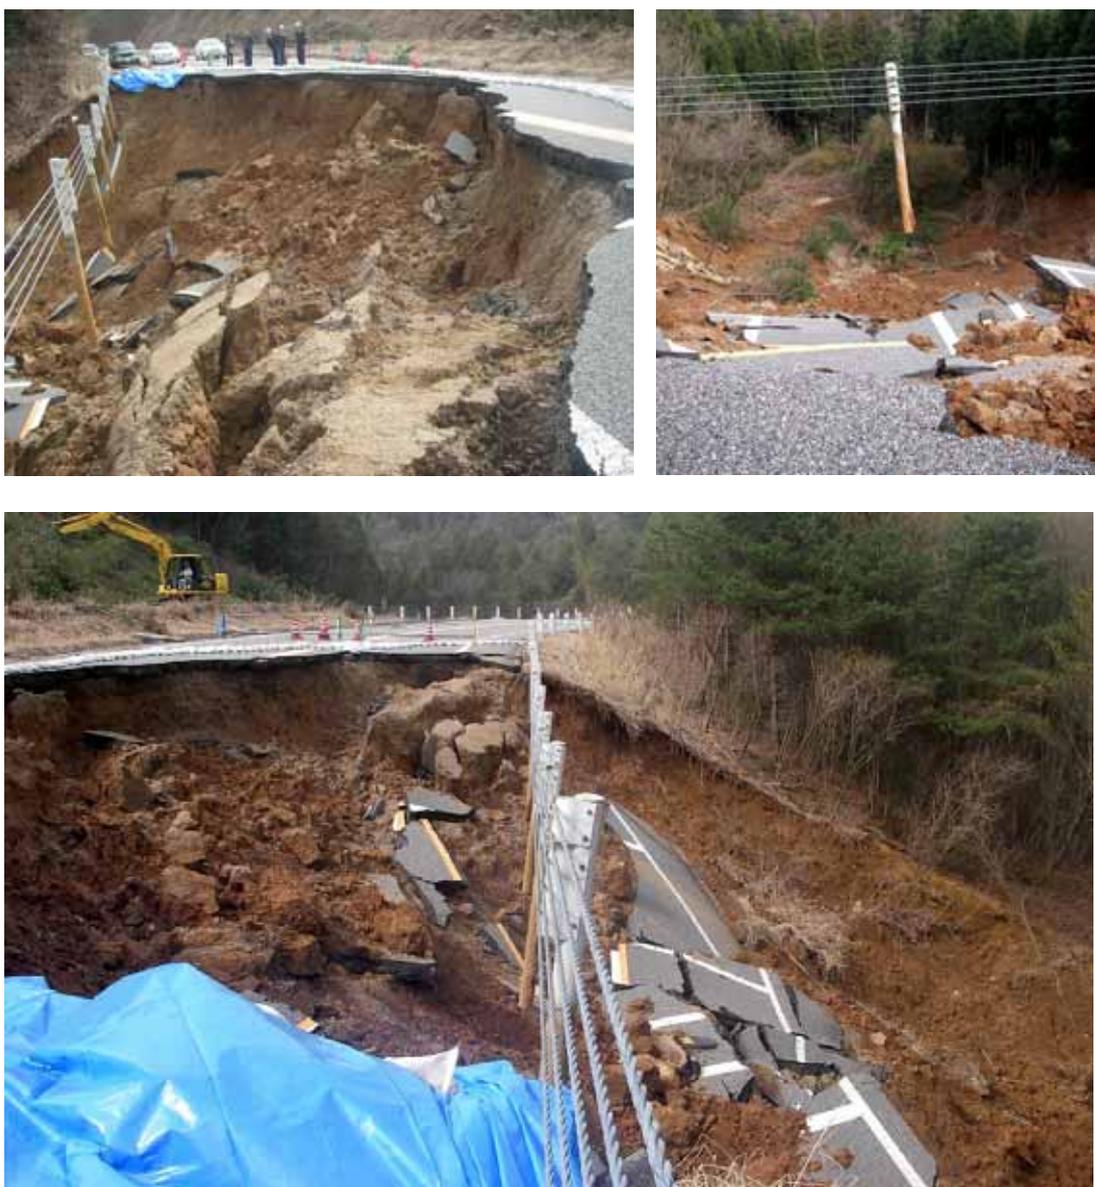
Noto Tollway is closed between Yanagida IC (Hakui) and Tokuta-otsu IC due to extensive embankment failures. The almost entire embankments along this segment of the toll way failed due to ground shaking. The sliding direction of the embankments was eastward. It is considered that the ground shaking together with high ground water pressure could be main causes of the failure of embankments. The authors observed some pools of ground water within the failed part of the embankments nearby at their toes (Figure 7.8).

Figure 7.8: Failure of embankments of Noto Tollway

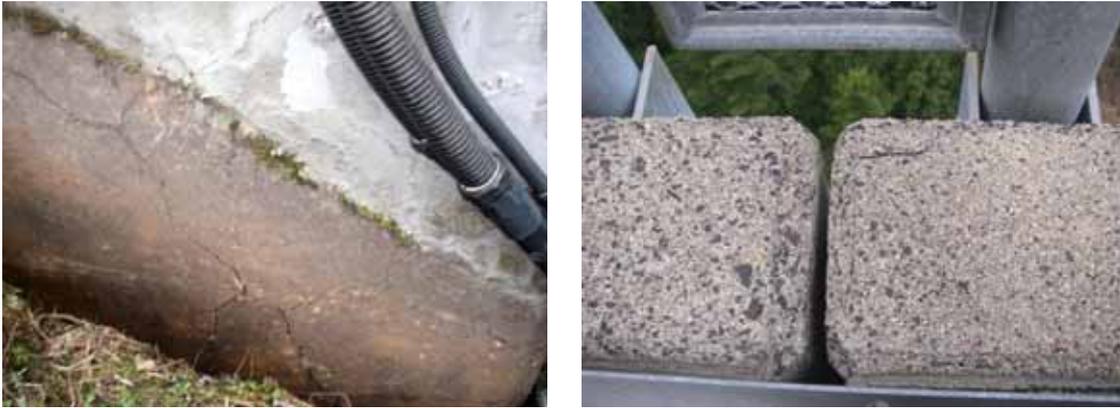
Noto bridge (viaduct) consists of 4 piers and prestressed curved girders are connected to each other at the mid. It is 400m long and 9.5m wide and it was completed in 1983 (Figure 7.10). The southern embankment of the viaduct was separated from the pier by more than 150mm and it had several open fractures. Furthermore, there were ruptured fragments on the western side of the girders at the middle of the viaduct (Figure 7.11). Although the separation was about 10mm, it seems that the girders might have collided with each other during the earthquake shaking. The observations from the ground indicated that the eastern side of the connection part is much wider than that on the western side.

(a) Fractures and embankment separation (b) fragmentation at the connection joint

Figure 7.11: Some examples of damage at Noto Viaduct

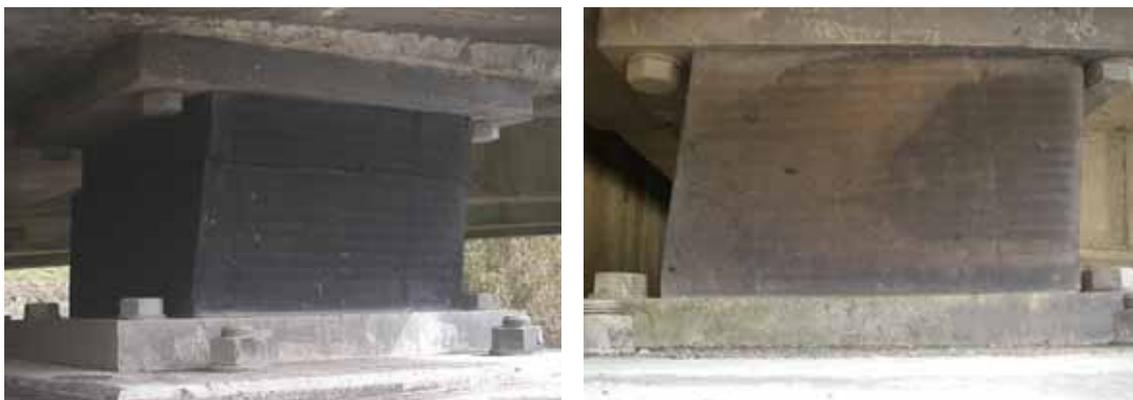
Toge viaduct is just south of Toge district of Monzen town. The viaduct consists of 5 piers with a height ranging between 10-13m and separated from each other by a distance of 33m and it has a continuous prestressed girder (Figure 7.12). The girder sits on rubber bearings and It was completed in 1999. The close inspection of this viaduct indicated that the girder was displaced by about 10mm southwardly with a slight rotation. Although none of piers were damaged by ground shaking, one of the rubber bearings at the northern abutment was ruptured as seen in Figure 7.13. The rubber bearings were subjected shearing at both abutments.

(a) Ruptured rubber bearing (north side)

Figure 7.13: Views of ruptured and strained rubber bearings

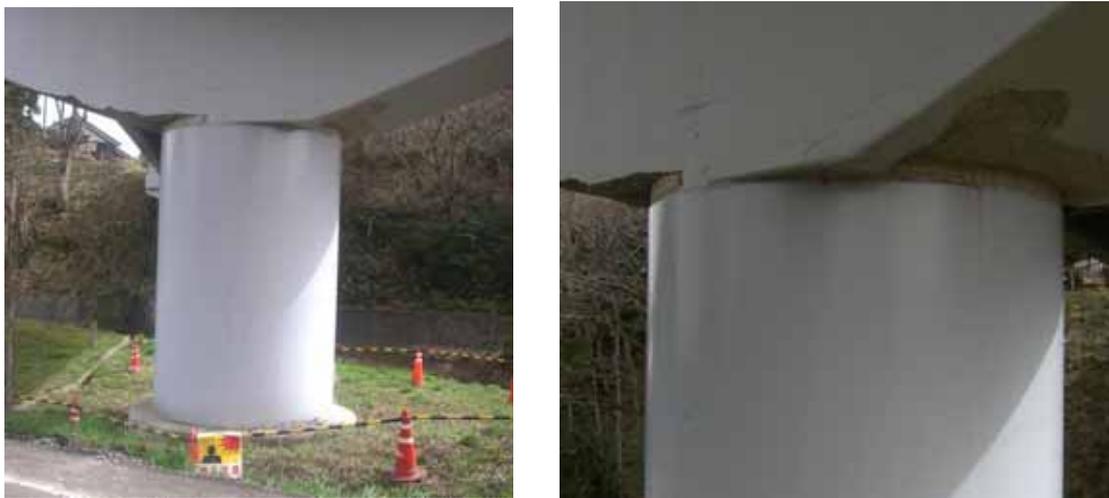
Ichinosaka is a four-span simple-beam type viaduct (Figure 7.14). The piers are of T-type and they were retrofitted with steel plates. Although there was no visible damage to bearings of the girders, the upper part of the piers underwent some cracking and spalling initiating from the junction between the steel-plates and upper concrete slab (Figure 7.15).

Figure 7.15: Piers with spalling

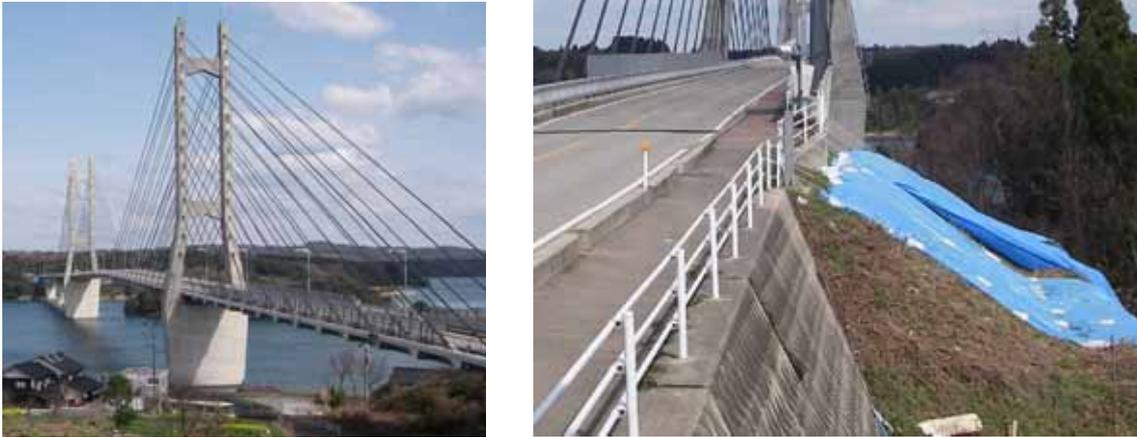
center span is 230m long with a clearance of 19m for ship passage. Although there was no visible damage to the superstructure, the embankments at both sides of the bridge were damaged by ground shaking (Figure 7.17). Furthermore, there were some relative settlements between bridge deck and road at embankments. .

Figure 7.17: Views of the bridge and its embankment

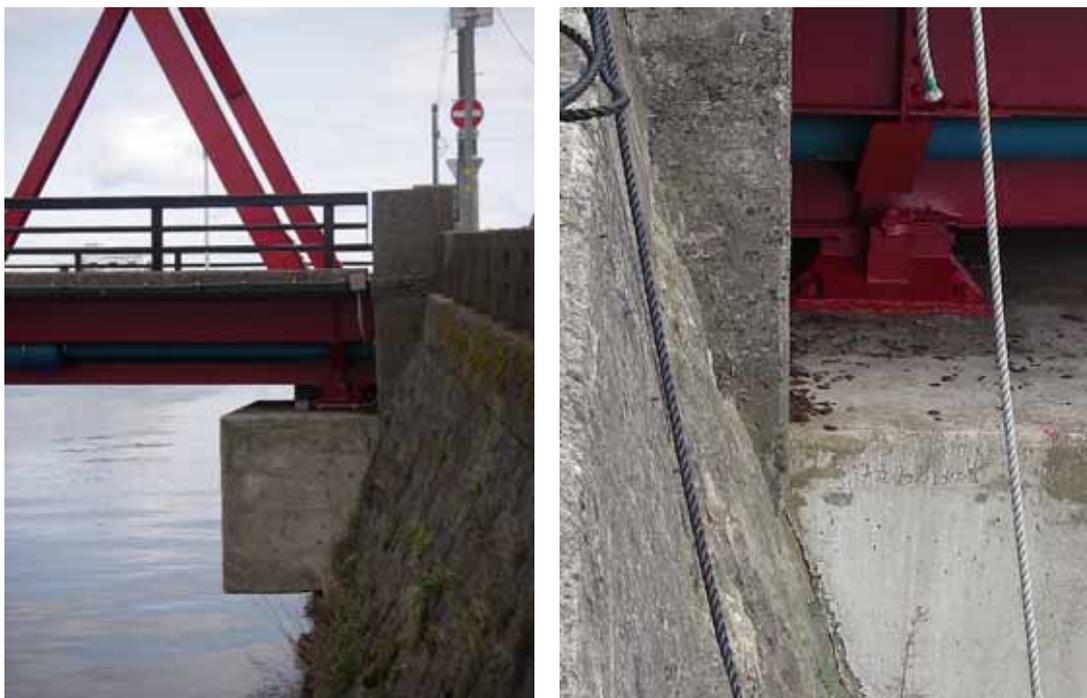
The construction of Iroha Bridge on Kawaharata river was completed in 1962 and it is a single span 50m long simply supported truss bridge (Figure 7.18). The abutment piers of the bridge were recently retrofitted. Cracking occurred at the southern side of the both piers and bearings were deformed at the west abutment due to sliding and rotation (Figure 7.19).

(a) East pier (south side)

Figure 7.19: Damage at piers and bearings of Iroha Bridge in Wajima City

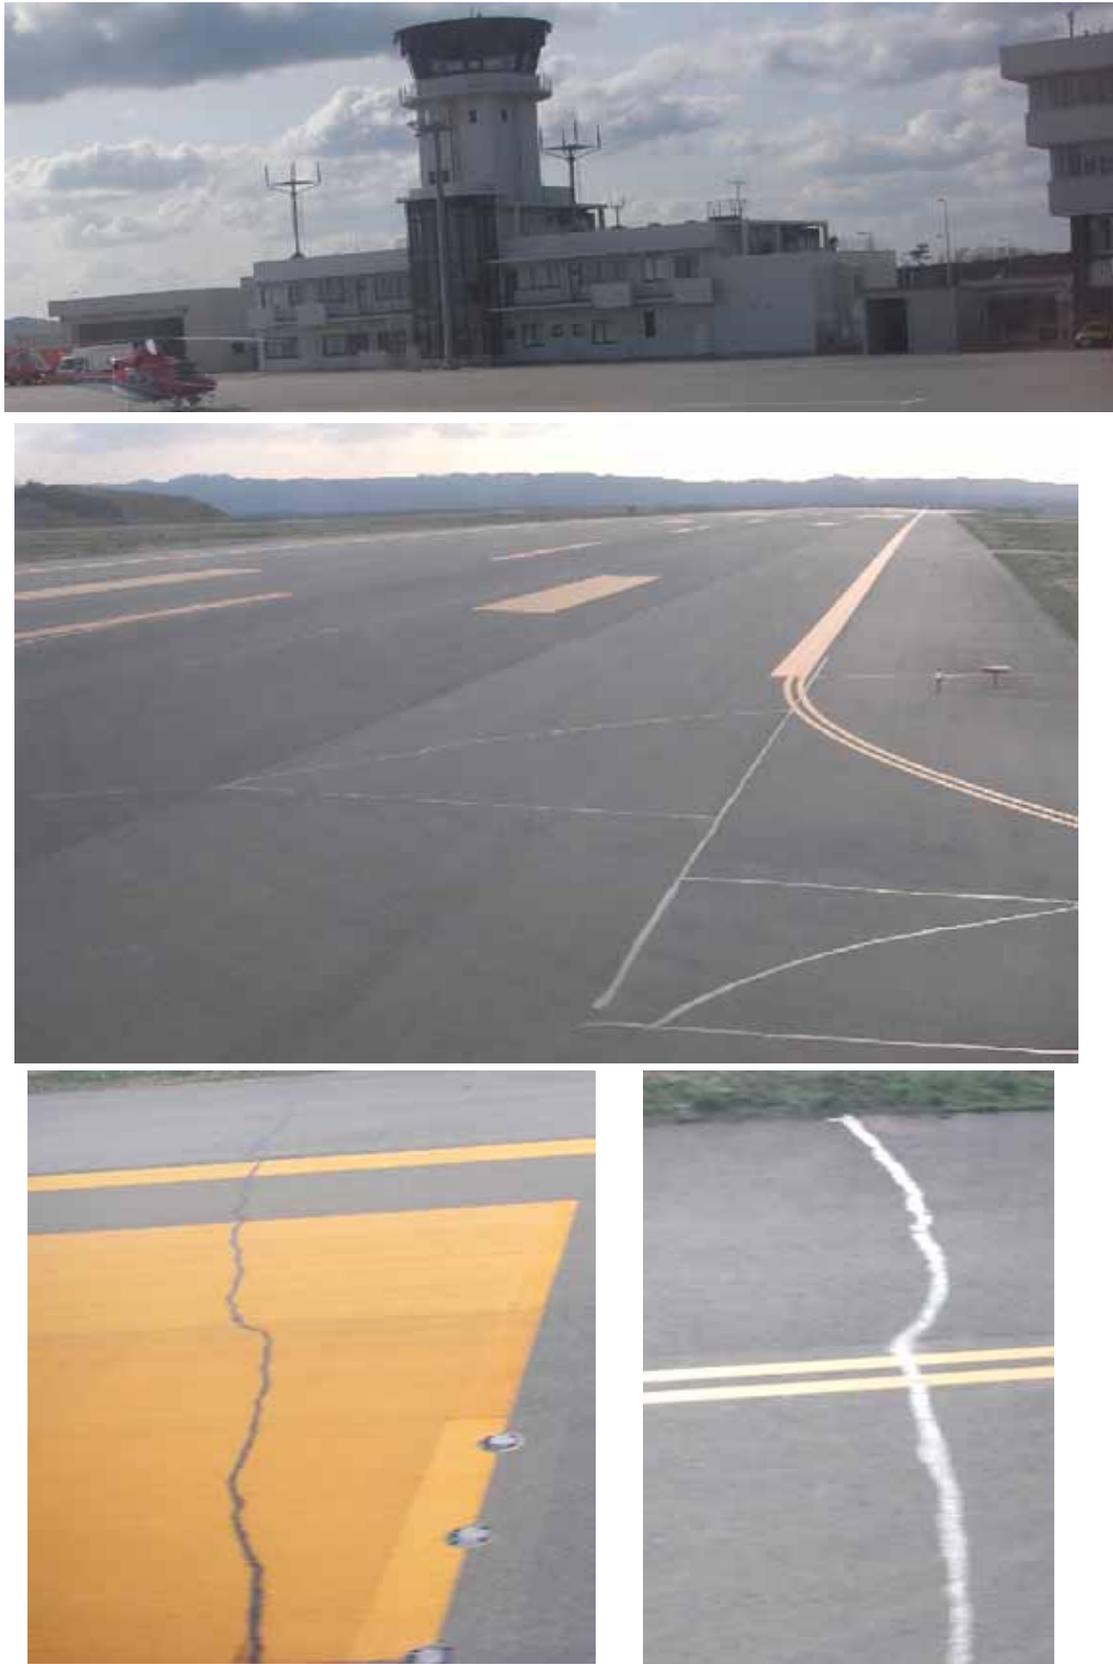
The construction of the new Noto airport was completed in 2003 and its runway is 2000m long. The airport was built on a hilly terrain and its construction involved slope cuts and filling of valleys. The construction of Noto Airport was carried out at a quick pace. The large-scale embankment involving a total volume of 16,000,000 m³ soil and a maximum embankment height of 55m was completed within 3 years (Nagahara et al. 2004). One of the typical cross section of Noto Airport is shown in Figure 7.20 and a grain size distribution of the embankment materials is shown in Figure 7.21. In order to stabilize the soft cohesive soil with high natural water content ($w_n=30-80\%$) that was used as the fill material, the embankment was constructed with the use of horizontal geotextile drains to accelerate the consolidation of the compacted wet soil. the drains embedded at 5-m intervals vertically and 2-m intervals horizontally. The earthquake induced some cracks at 22 locations on the runway while the terminal building and control tower were intact except the toppling and sliding of interior items (Figure 7.22). The cracks were quickly repaired and the airport resumed operations on March 26, which was closed on March 25 after the quake.

Figure 7.22: Views of non-damaged control tower and cracked runway at Noto Airport

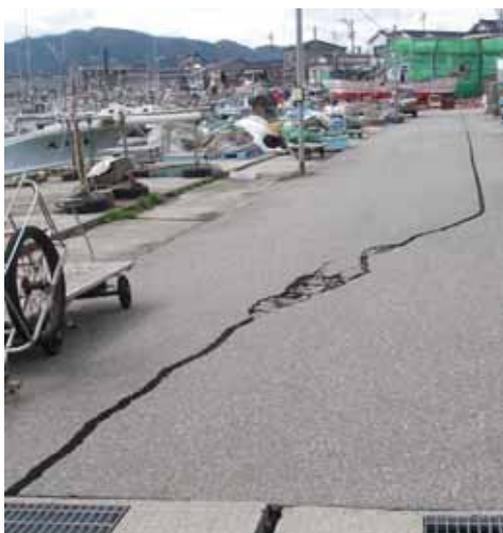
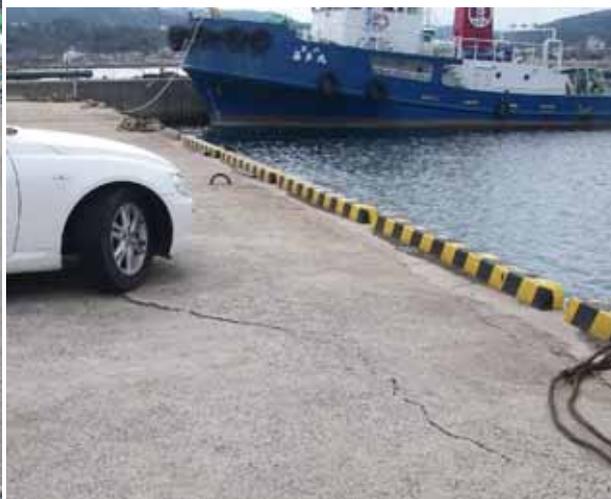
The major port facility is located in Nanao City. The second biggest port is in Wajima city. The jetties, piers and quays were partially damaged in the ports of Nanao, Wajima and Kaiseo due to ground shaking as well as ground liquefaction. The most extensive damage occurred in Nanao port and the main cause was ground liquefaction. Since the authors visited Nanao port around 19:30 evening, it was difficult to check the overall damage. However, extensive liquefaction and cracking of concrete slabs of quays were observed at many locations (Figure 7.23). Wajima, Shika and Kaiseo ports also suffered from the same problem with less severity (Figure 7.24).

Figure 7.24: Views of some damage to Wajima port

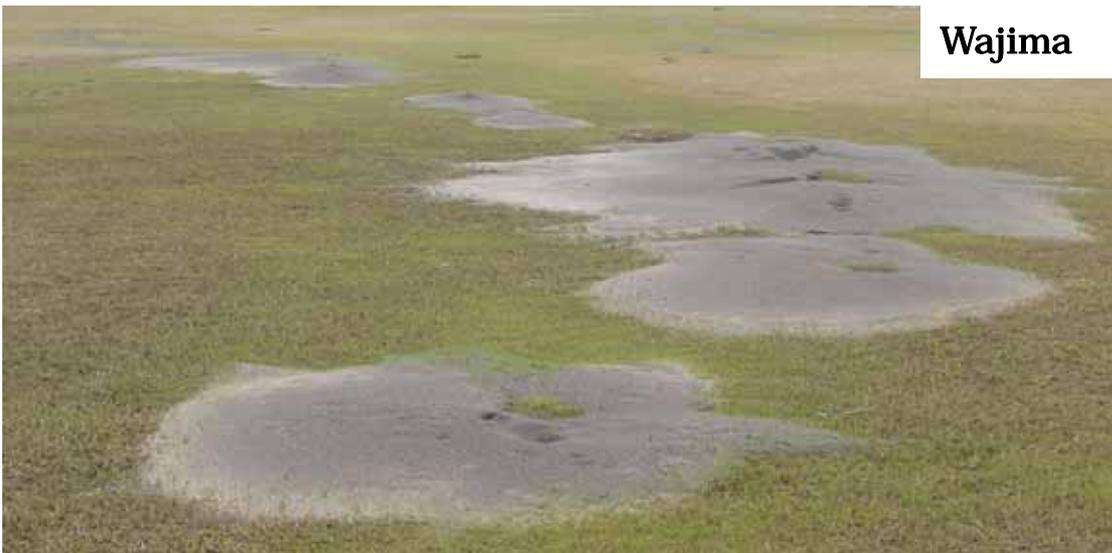
Liquefaction was observed at other locations such as Anamizu, Tatsuruhama and Shika towns, Nanao city of Ishikawa prefecture and Himi town of Toyoma Prefecture. Compared to the effects of ground liquefaction observed during Chuetsu-Niigata earthquake, this earthquake did not cause much damage to structures due to ground liquefaction. The physical and geotechnical properties of one of the soil samples collected are given in Table 8.1 and grain-size distributions are shown in Figure 8.1. Figure 8.2 shows the relation between the hypo-central distance and earthquake magnitude for liquefied sites together with liquefaction state limits. Figure 8.3 shows several views of soil liquefaction in the earthquake-affected area.

Figure 8.3 Some examples of liquefaction and its effects

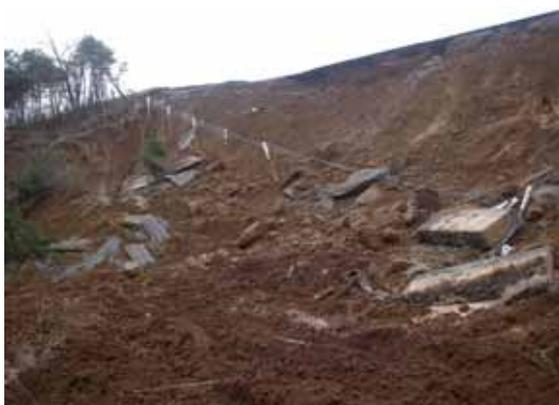
(a) Failed embankment of Noto Tollway

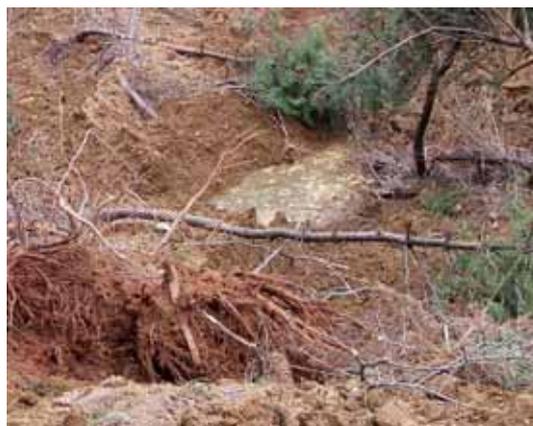
(b) waterpool at the toe of the failed embankment

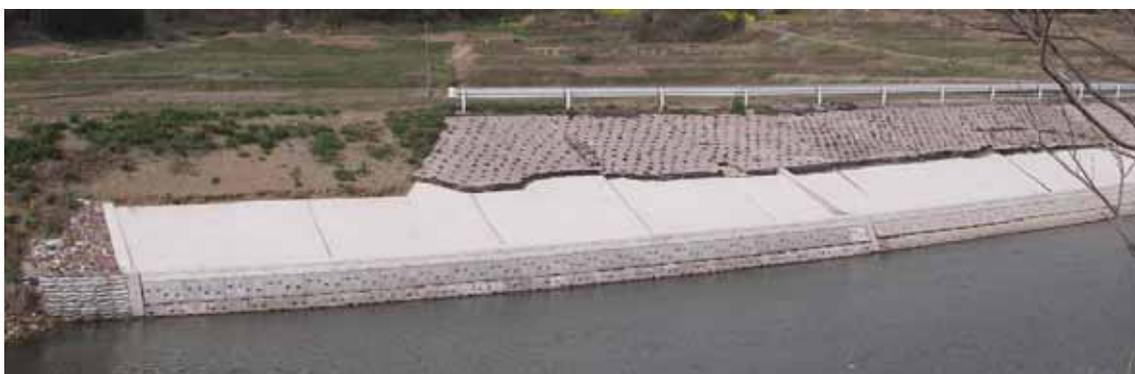
(a) Embankment failure in Toge district of Monzen town

Figure 8.4: Some examples of embankment failure

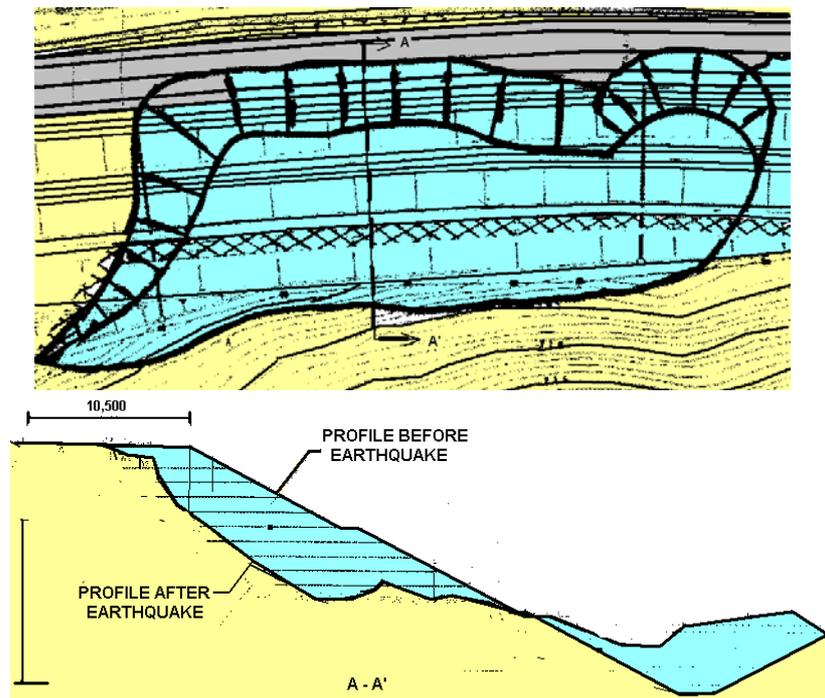
(a) Plan and cross section view of an embankment slide (N37.1584,E136.8565)

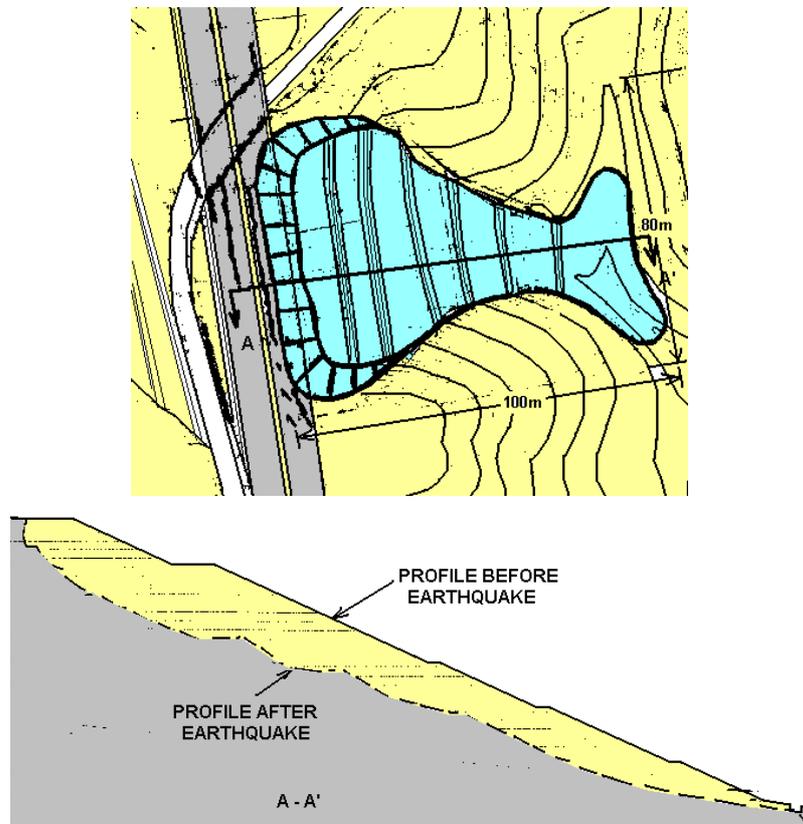
(b) Plane and cross section view of an embankment slide (N37.1745,E136.8577)

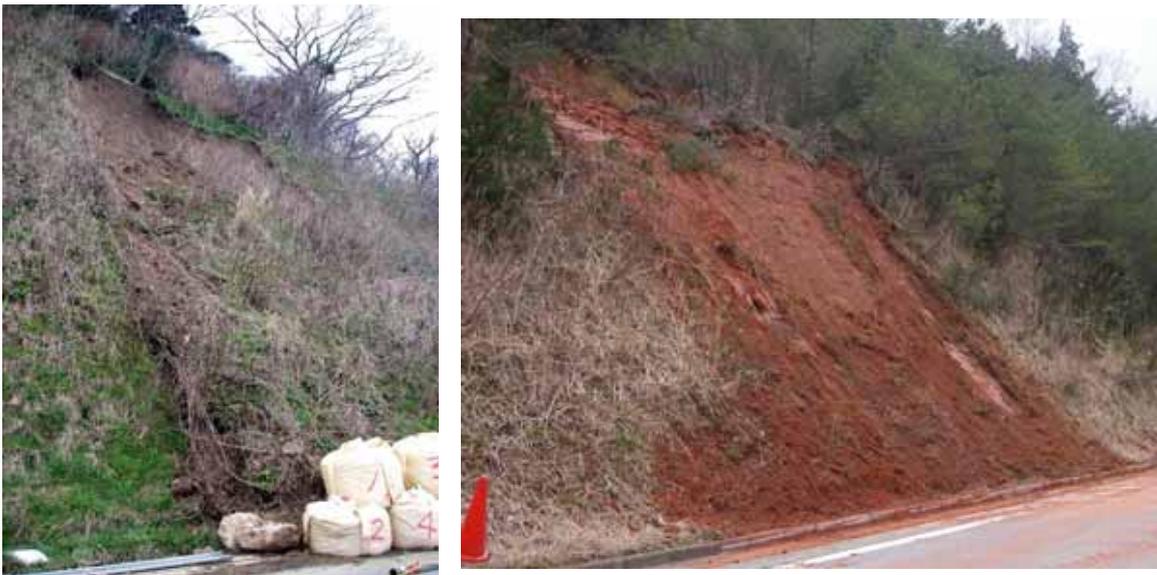
Figure 8.6: Surficial slope failures

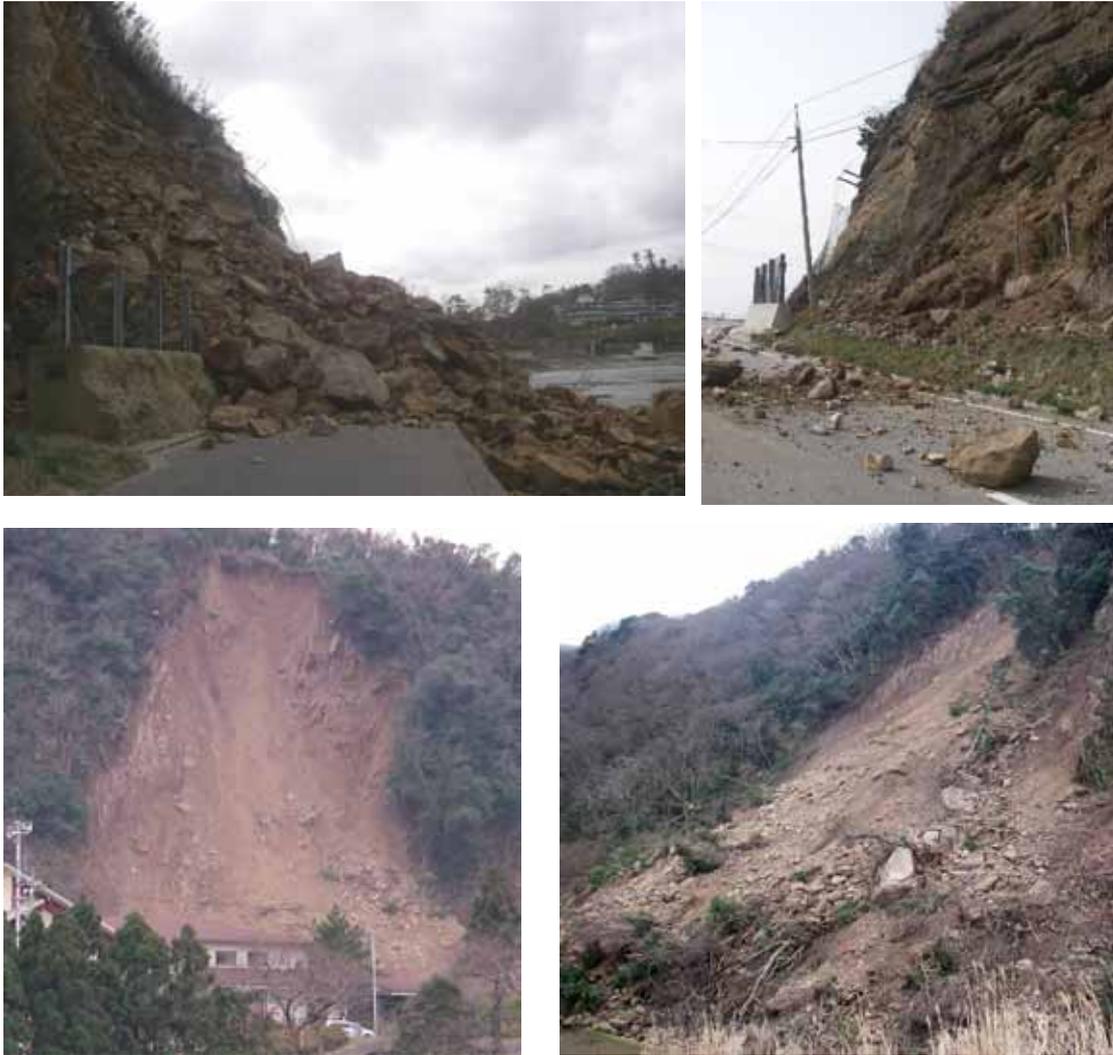
Figure 8.7: Combined sliding and toppling failure of rock slopes

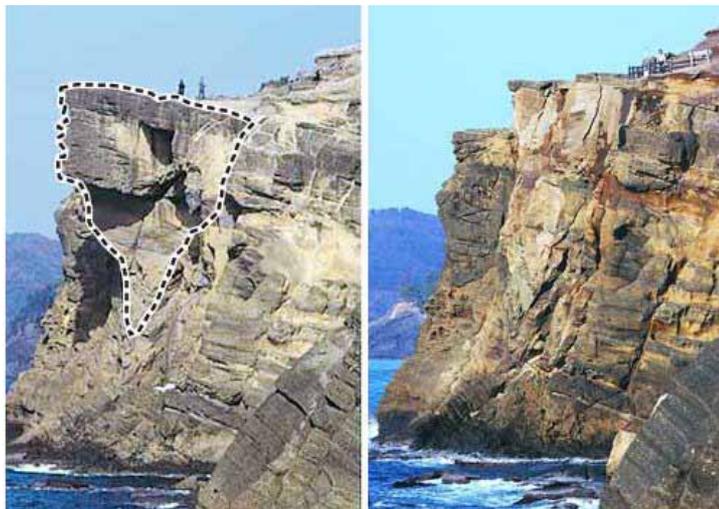
Figure 8.8: Toppling failure (from Yomiuri newspaper)

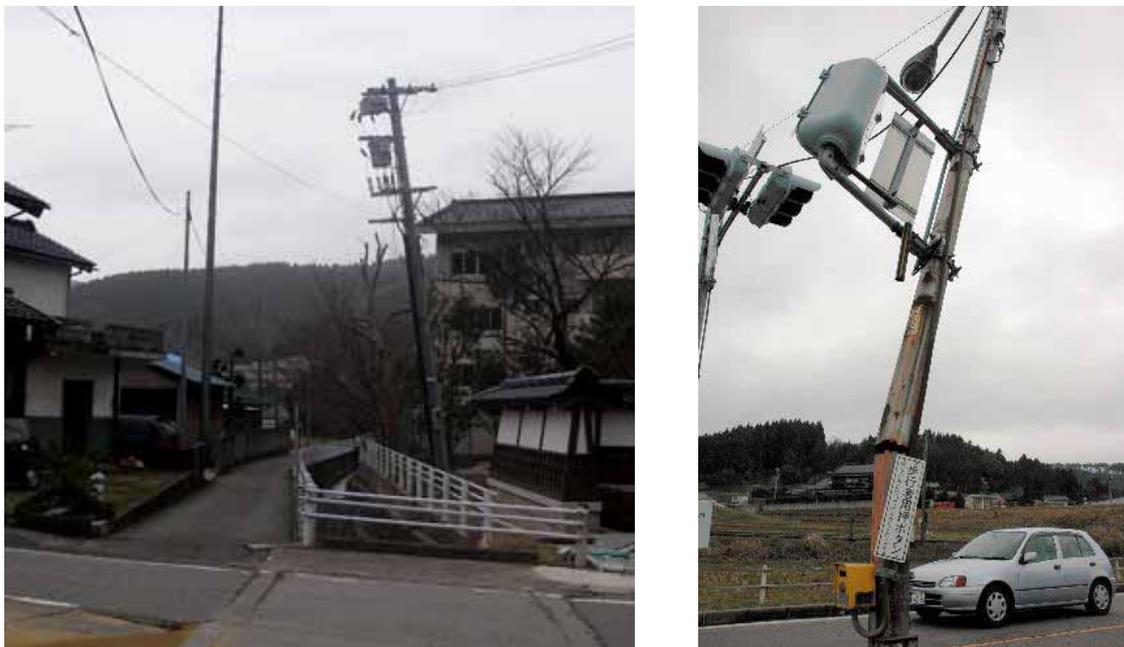
The electricity distribution system in the region is done through poles and high-voltage transmission lines. Although concrete poles were inclined as a result of partial bearing failure of the surrounding ground, none of transmission towers were damaged or toppled during this earthquake (Figure 9.2). The poles having transformers mounted on were particularly suffered more and also the poles were inclined in heavily liquefied areas. Nevertheless, the repair works on electricity distribution system could be accomplished in a short period of time. The main transmission lines are elevated and supported through 40-50m high steel pylons. In spite of wide spread slope failures,

Figure 9.2: Inclined or damaged poles in Monzen town
