A QUICK REPORT
ON
NOTO PENINSULA EARTHQUAKE ON MARCH 25, 2007

April, 2007

Japan Society of Civil Engineers

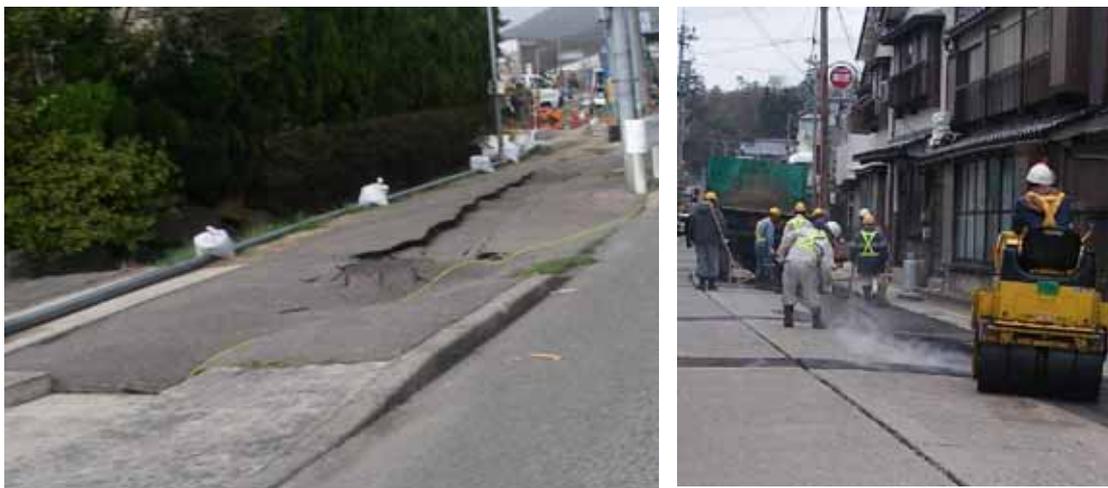
(a) Motoichi-Monzen

The sewage systems were damaged by the liquefaction and/or settlement of back- fill soil (Figure 9.3). The uplift of manholes could be observed in Monzen town. The uplift

Figure 9.3: Settlement of backfill material of sewage systems and their repair

of manholes was as much as 600mm.. The local authorities now have been checking the sewage system and replacing the sections underwent uplifting or rupturing. Since the permanent ground deformations occurred due to lateral spreading of ground as a result of liquefaction, the joints of the sewage system suffer some leakage and need repairs.
