Geological conditions and soil deformations in the July 17, 2007, Chuetsu Off-shore Earthquake* (Ver. 1.1)

Kazuo KONAGAI¹, Jorgen JOHANSSON², Takaaki IKEDA³ and Shigeki TAKATSU⁴

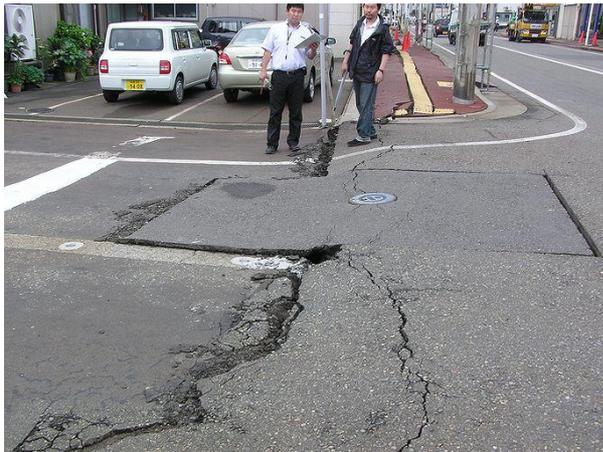
Fig. 2 is a map of cracks that appeared on pavements in the area enclosed with broken line in Fig. 1. Red and blue lines show respectively cracks opened (**Photo 1**) and compressed (including those colliding over the others, buckled up; see **Photo. 2**). Most clusters of opened cracks are seemingly found along ridges of the sand dunes while many compressed marks were found along toes of the dunes and some were found along an S-shaped sagged zone among the sand dunes.

Photo. 1: Crack opened along ridge of sand dune

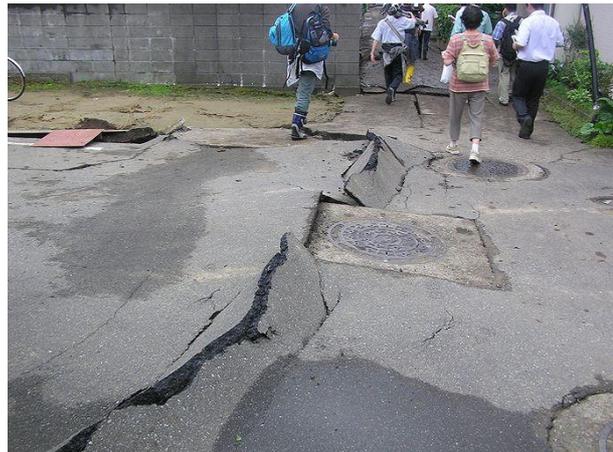
Photo 2: Pavement buckled up

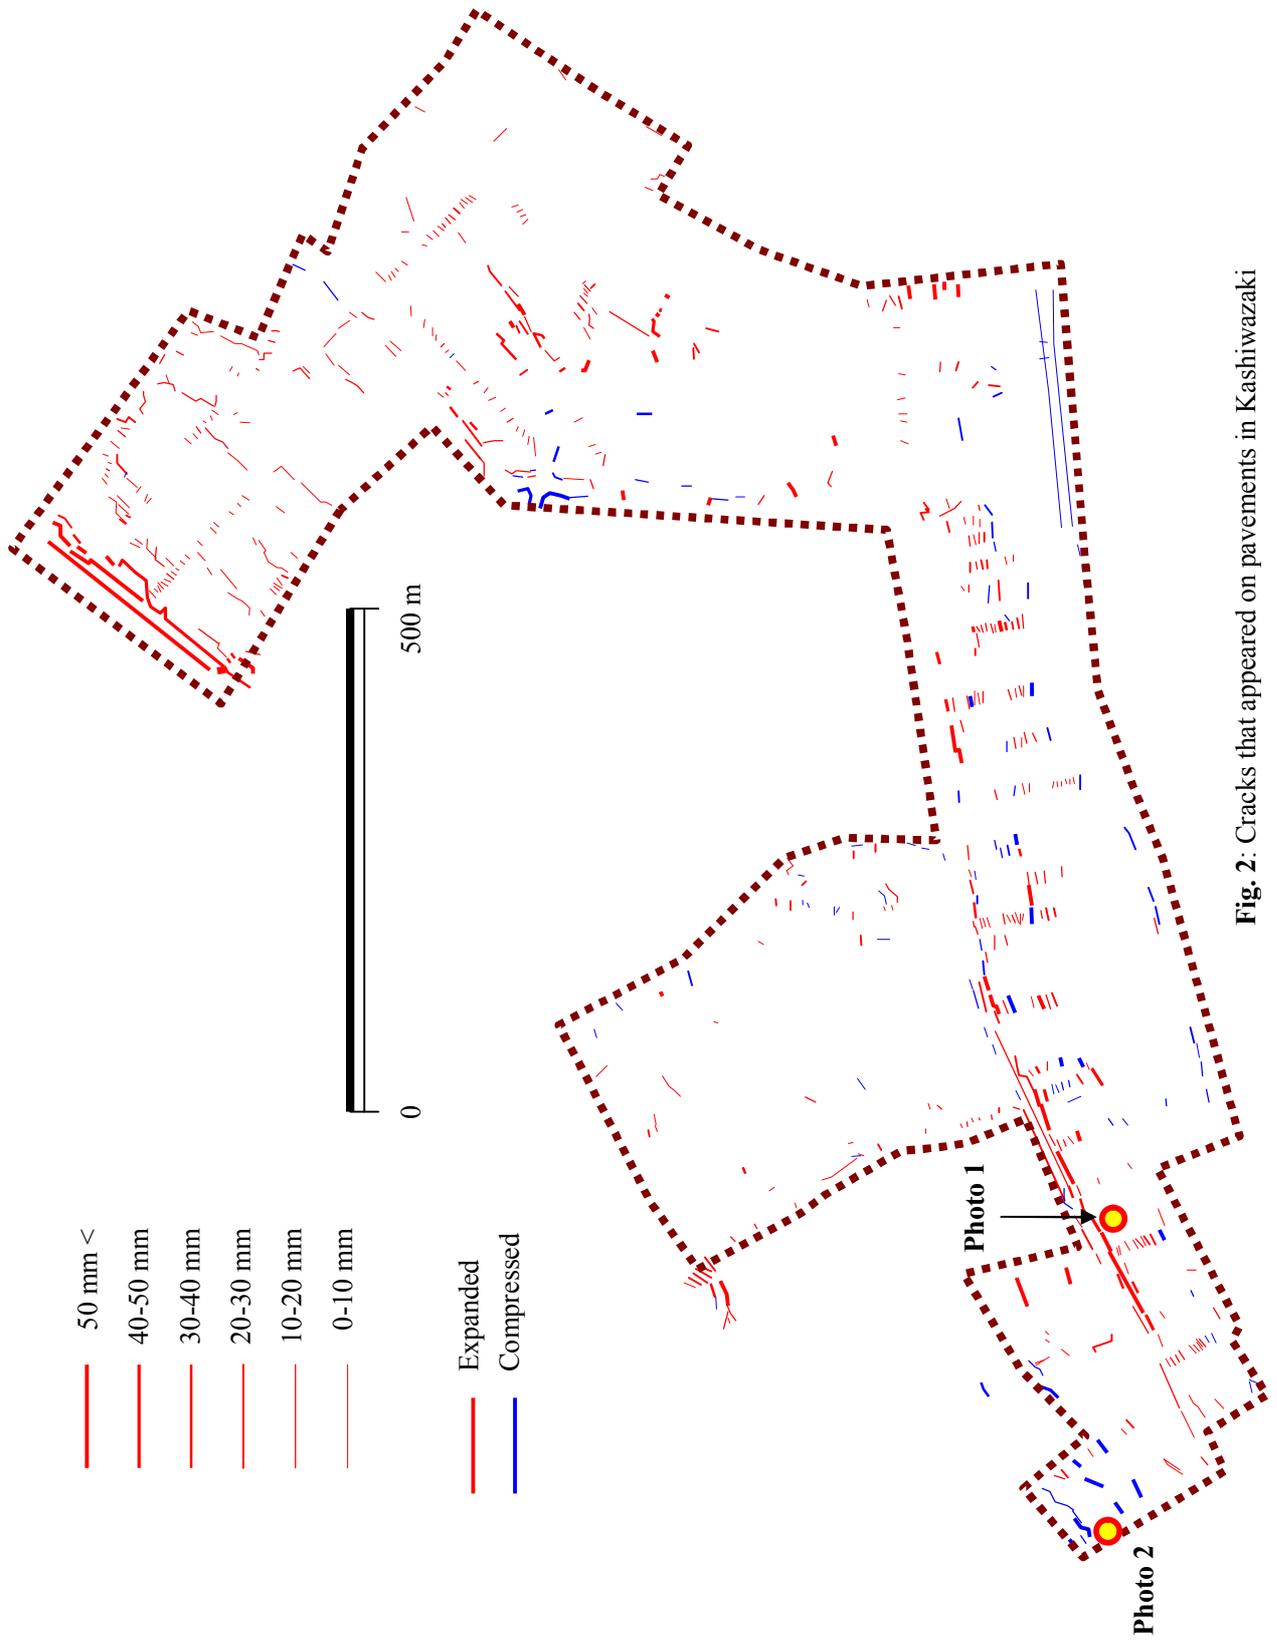
Fig. 2: Cracks that appeared on pavements in Kashiwazaki

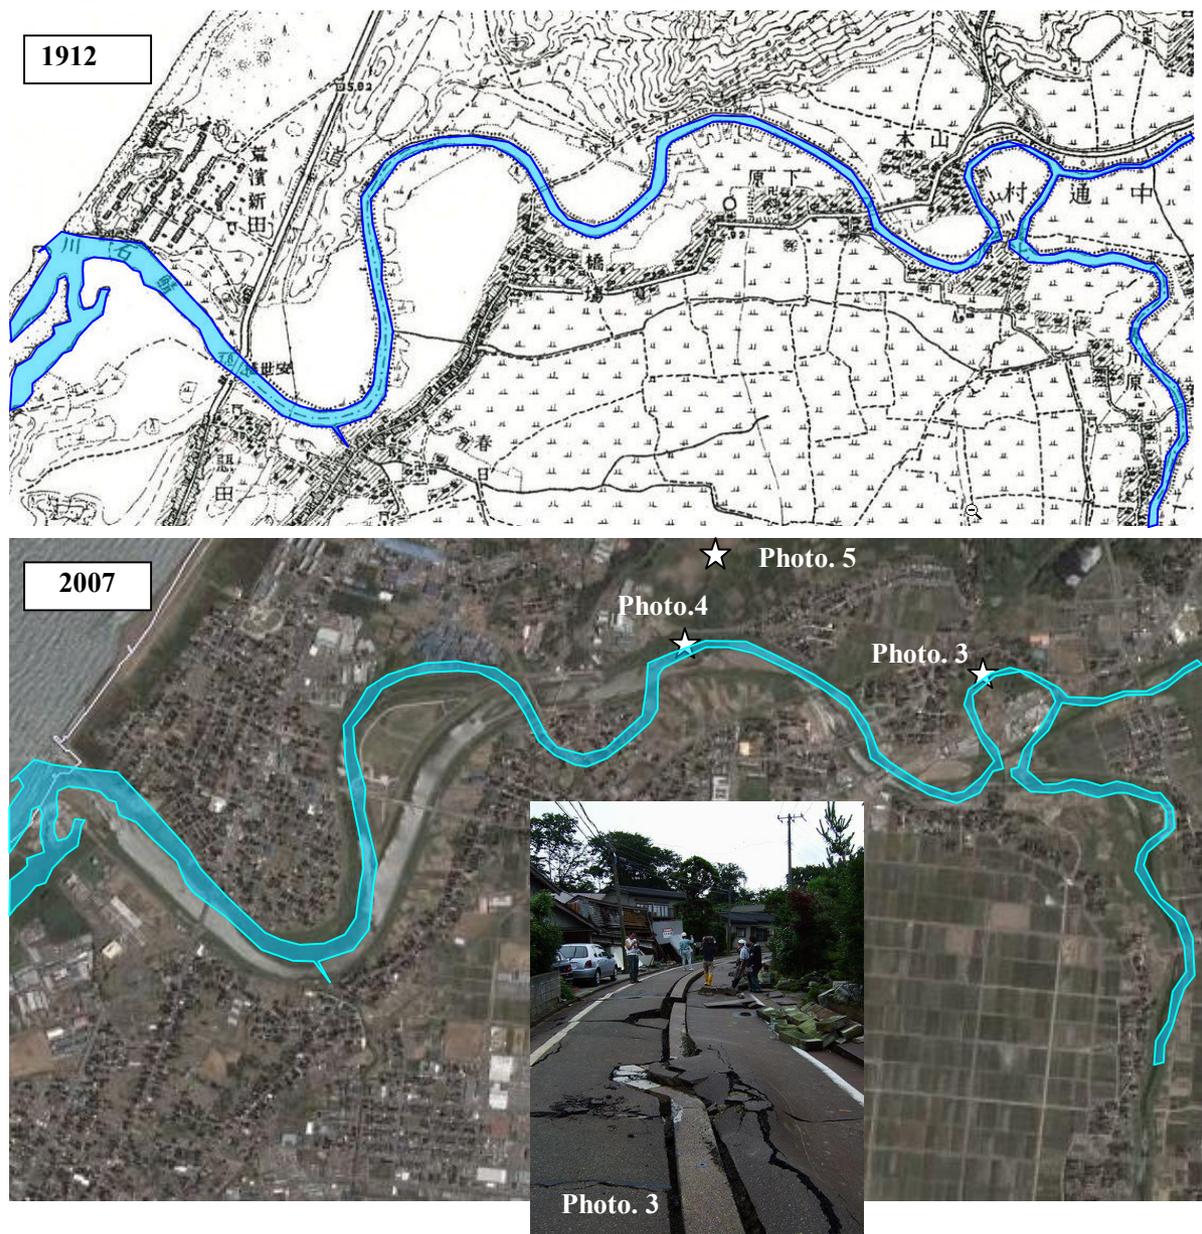
Fig. 3: Lower course of Sabaishi river, north of Kashiwazaki

Fig. 3 shows lower course of Sabaishi river in 1912 (above) and 2007 (below) respectively. Due to river improvement works, the present course has become shorter than that in 1912. Soil deformations are clearer along old river traces such as an old horse-shoe lake near Nakadori (**Photo. 3**). River erosion must have been clearly large on the outside of a river bend at the waste incineration plant of the city (**Photo. 4**). Immediately north of the plant, there is a sand dune of about 70m high above the sea level (**Photo 5**).

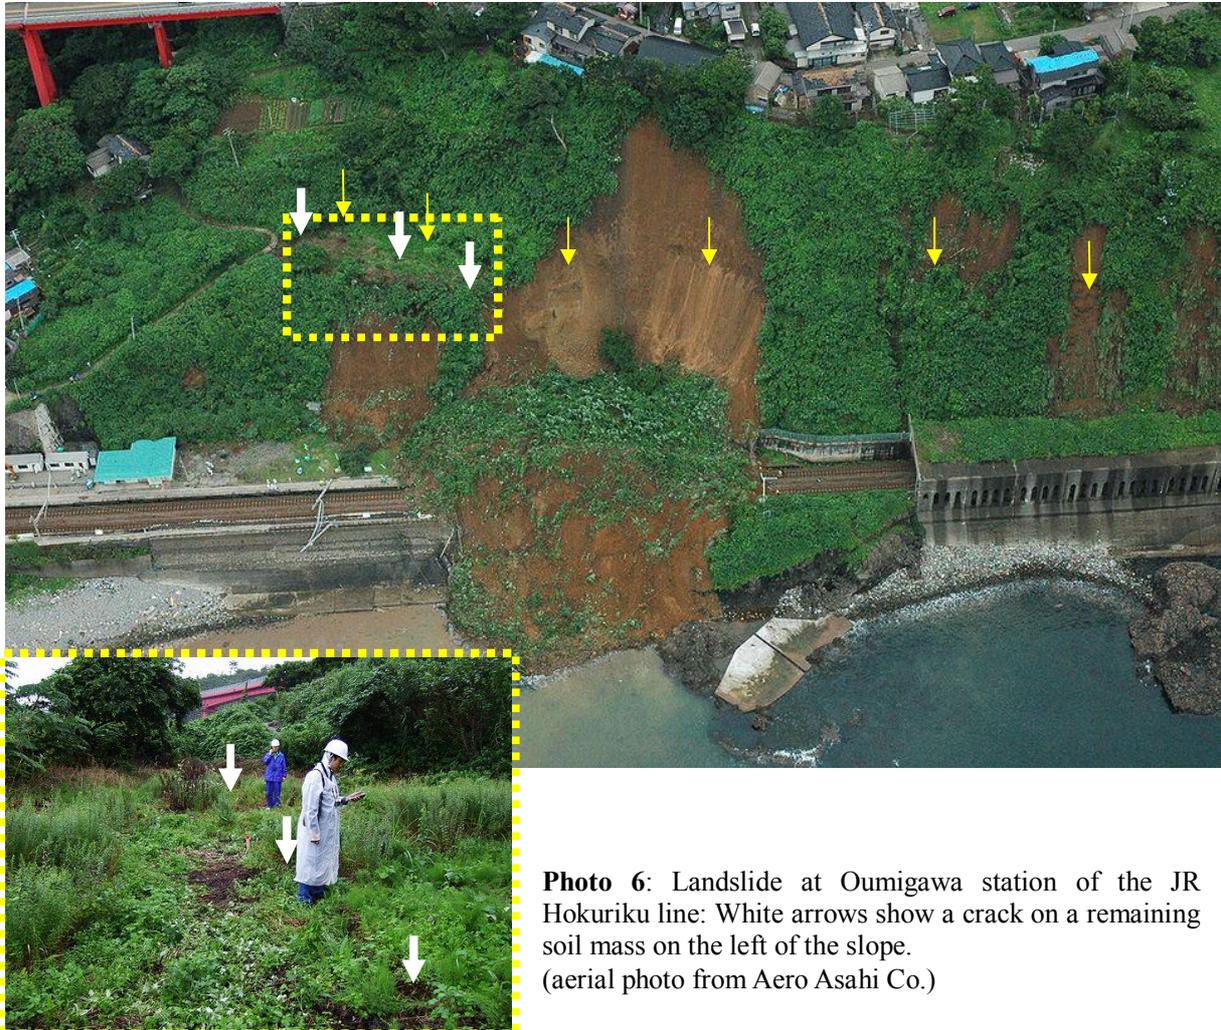
A slope failure mass occurred at Oumigawa station of the JR Hokuriku railway, and covered its western approach (Photo 6). Water is seeping out along a layer boundary slightly dipping west across the entire terrace (see yellow arrows in Photo. 6 and Photo 7).

Photo 6: Landslide at Oumigawa station of the JR Hokuriku line: White arrows show a crack on a remaining soil mass on the left of the slope. (aerial photo from Aero Asahi Co.)

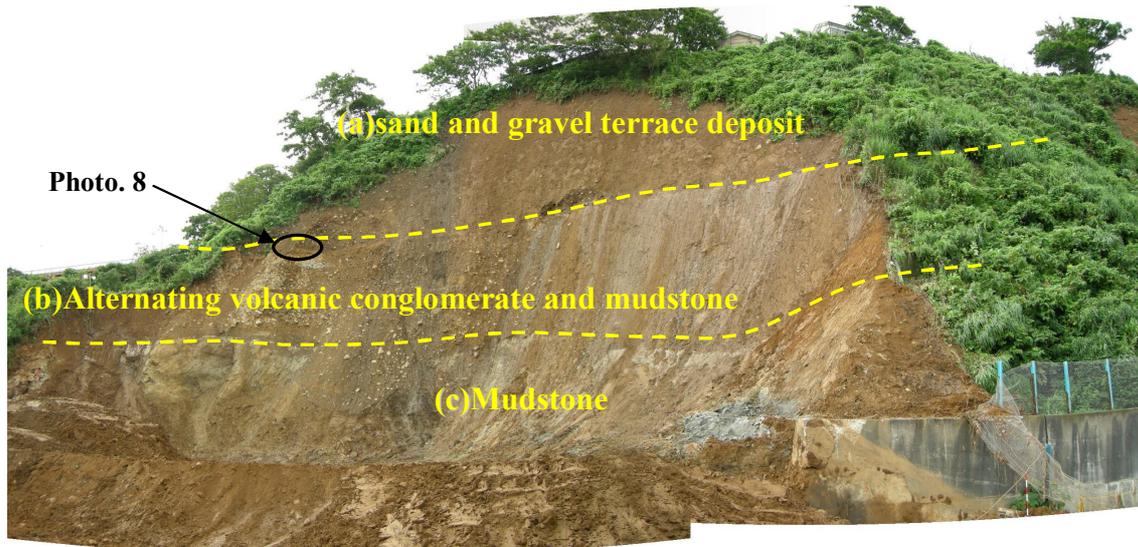
At the time of our group's third visit to Oumigawa station on July 30, some recovery works have started and the soil mass covering the railway has been partially removed. The geological stratification was inferred from a close-up of the failure surface that appeared south behind the station (**Photo 7**).

Photo 7: Failure surface with geological stratification.

There are three major geological formations exposed on the failure surface: (a) sand and gravel terrace deposit, (b) inter-bedding formation of volcanic conglomerates and mudstones, and (c) mudstone, from the top.

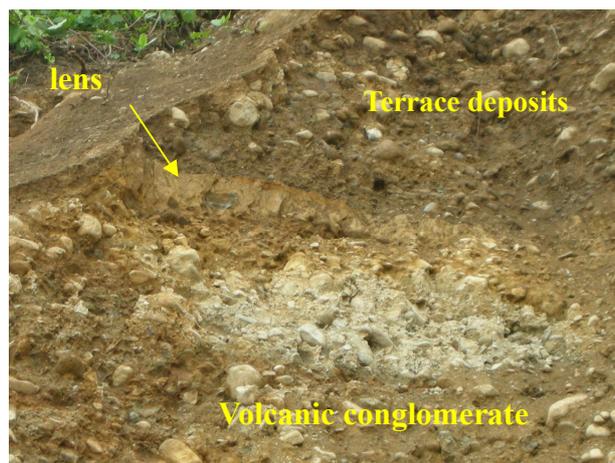
This inter-bedding formation consists mainly of volcanic conglomerate. Thin lenses of mudstone are found bedding in at some locations along the boundary between two formations (a) and (b) (**Photo 8**). These lenses are weathered, and are more compact than the overlying terrace deposit.

Photo 8: Thin lens of mudstone.

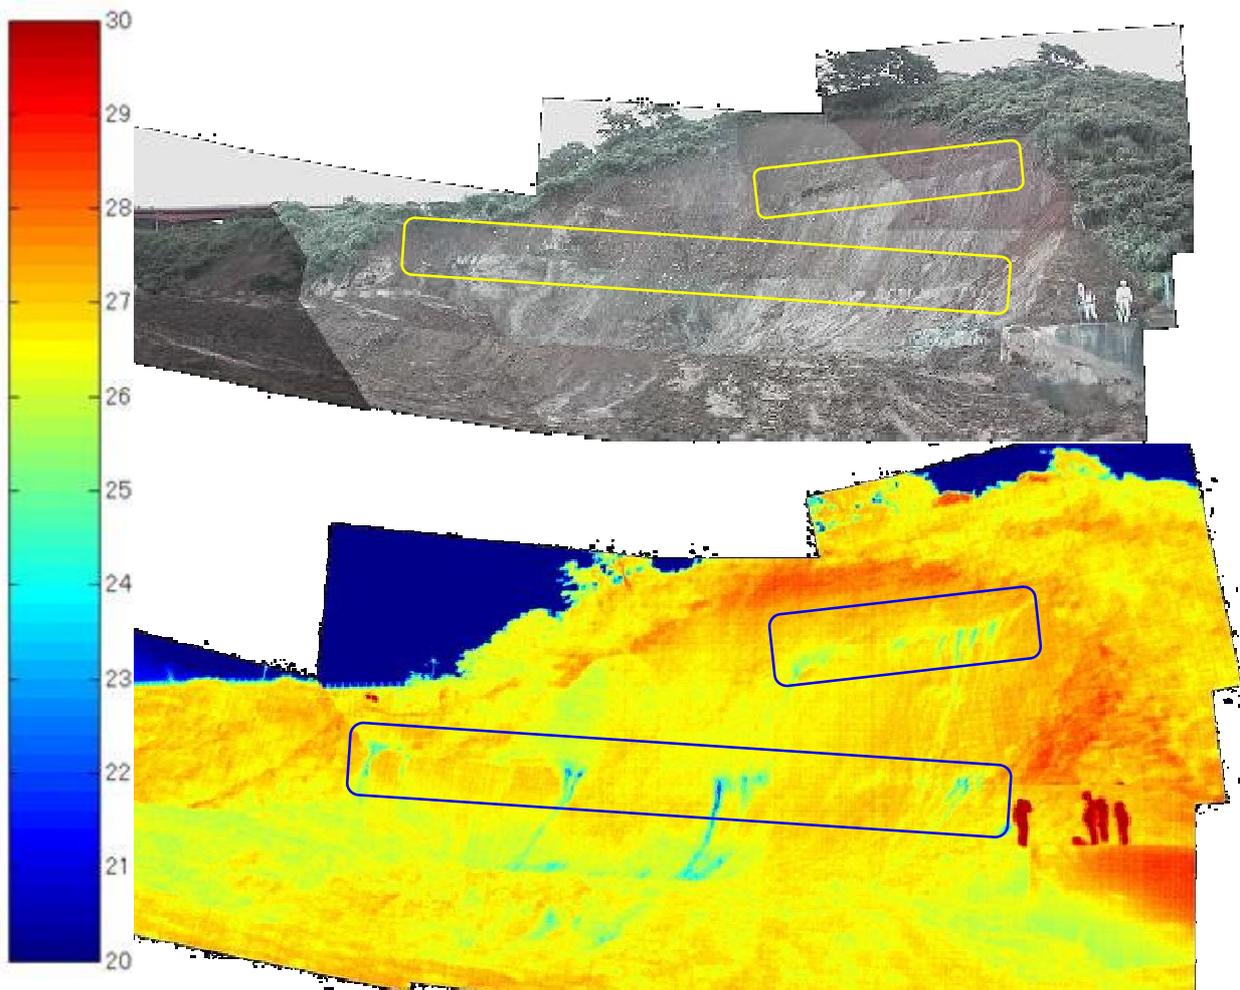
This terrace deposits dates back to the geological time of about 0.11Ma (Kobayashi et al, 1995). Streaks from layer boundaries show that ground water is seeping out from the boundaries among the exposed geological formations (see **Photo. 9**). Yoneyama formation ((b) and (c) in **Photo 7**), immediately below the (a) terrace deposits, is inferred as a base rock of Pliocene period. It has a strike in nearly E-W direction and dips about 8 degrees to north (Kobayashi et al, 1995).

With an infrared camera (NEC SanEi TH702MV), we took images of the whole failure surface. Blue to green streaks of underground water (20-25 degrees on Celsius scale) are found seeping out at some locations along two major boundaries among the geological formations. This information together with the geological information can be useful for the recovery works. E.g. drainage installations can be concentrated in areas where waters are seeping out.

Photo 9: (a) normal and (b) Infrared image of slope surface. Color scale shows “degrees” on Celsius temperature scale.
