2011 Tohoku Chiho-Taiheiyo-Oki Earthquake

- Damage of electric power facilities in
Tohoku Electric Power Co., Inc. -

Yoshiharu Shumuta

Central Research Institute of Electric Power Industry
Civil Engineering Lab.

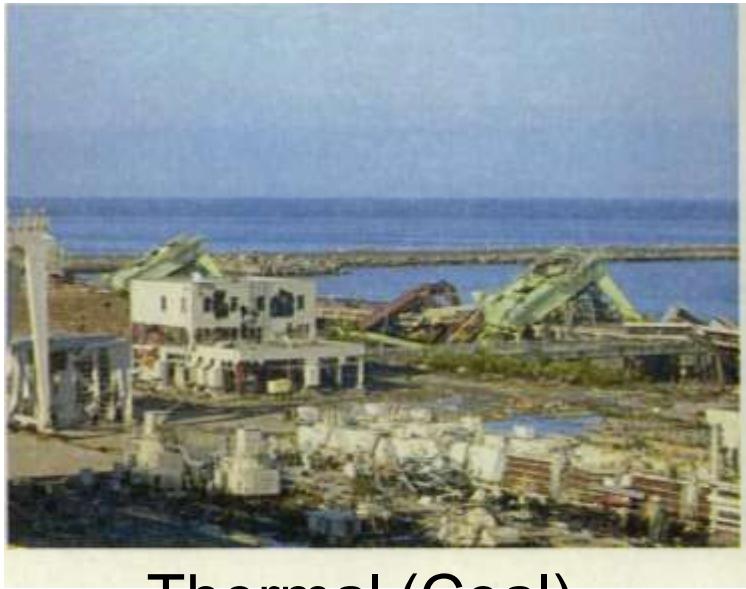
Tsunami Damage

Tsunami
