Waterworks damage

Yasuko Kuwata
Dept. of Civil Eng., Kobe University

Damage to water supply facility Miyagi pref.

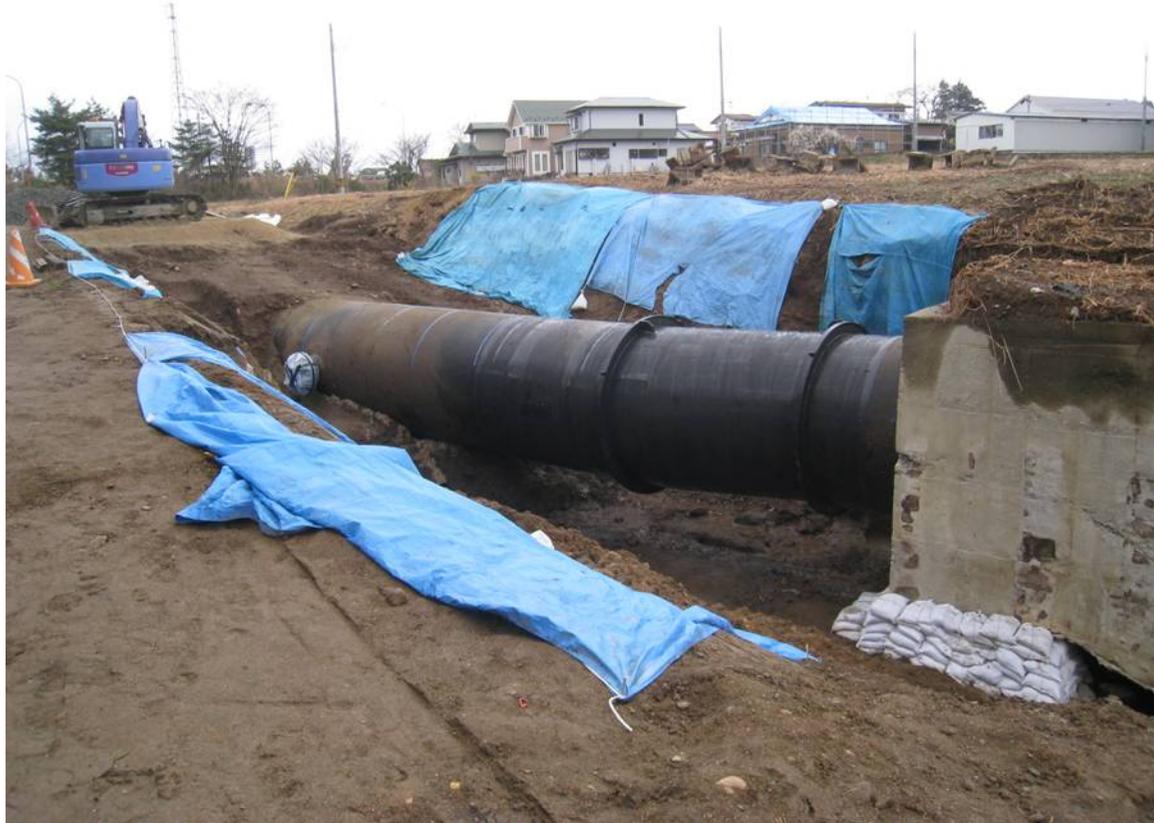
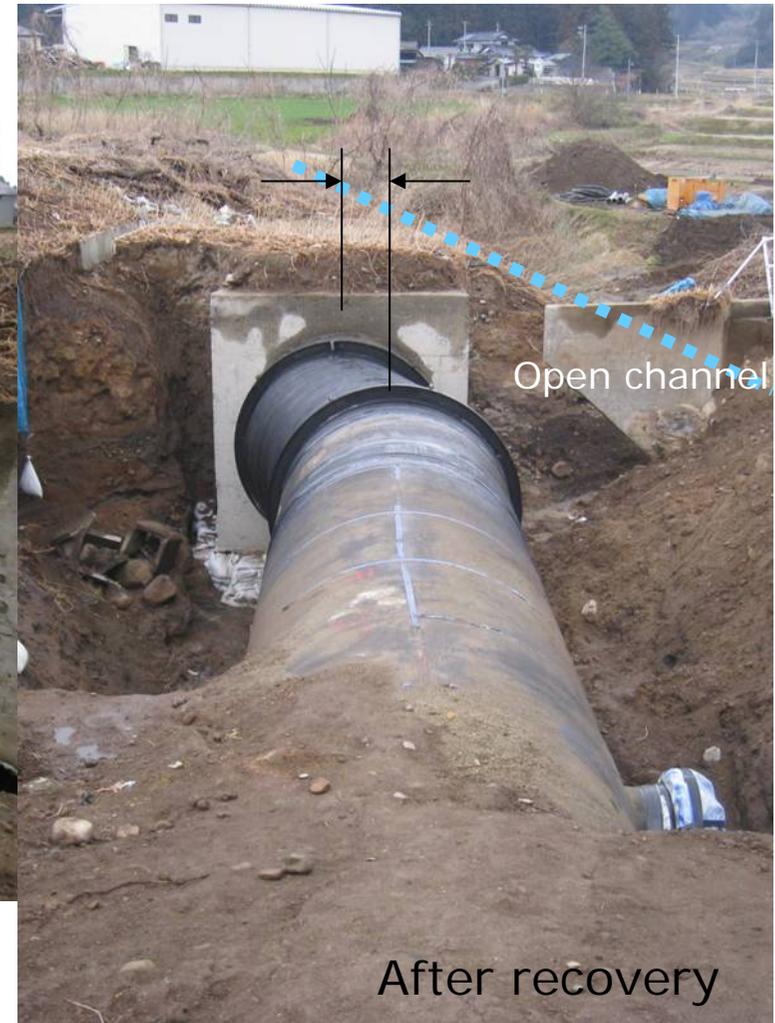
Large diameter pipe damage/ Shiraishi

River under-passing
transmission pipeline SP ϕ 2400

Lateral sliding 70 cm

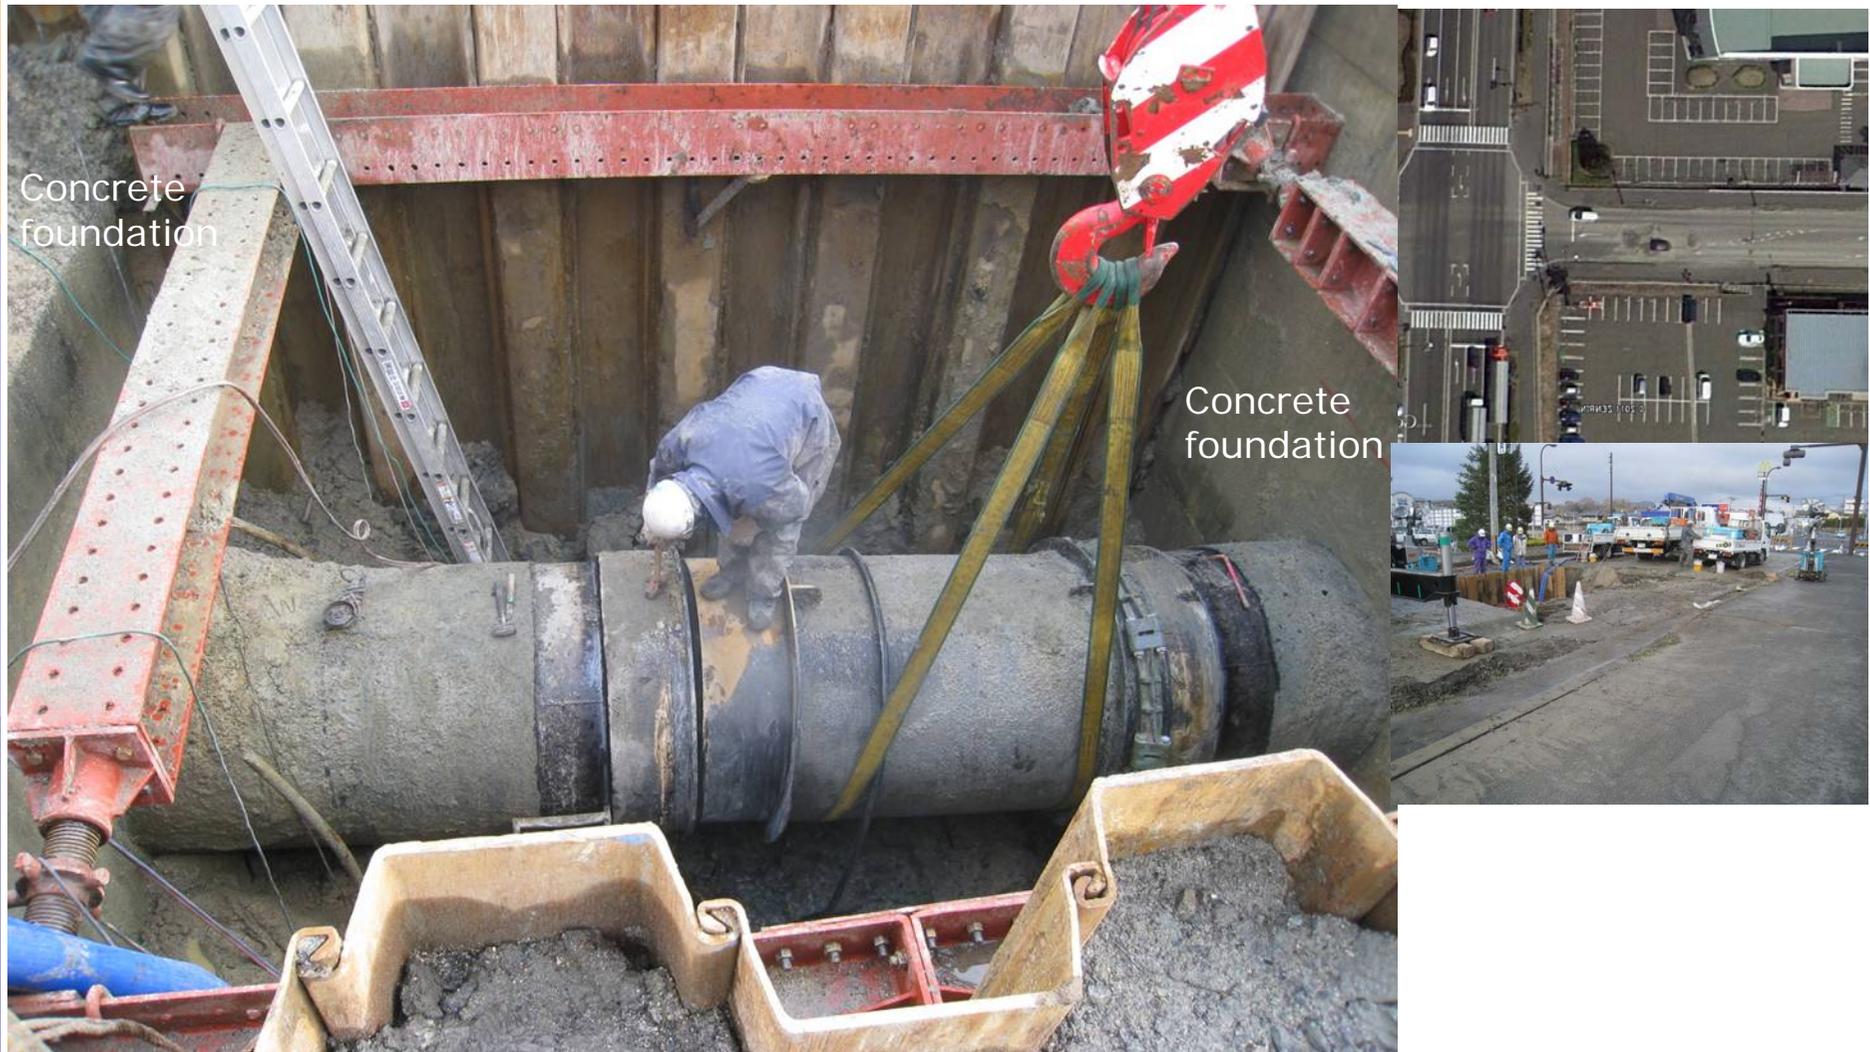
Large diameter pipe damage/ Shiraishi

Joint at SP ϕ 1200, damaged by April 7, aftershock

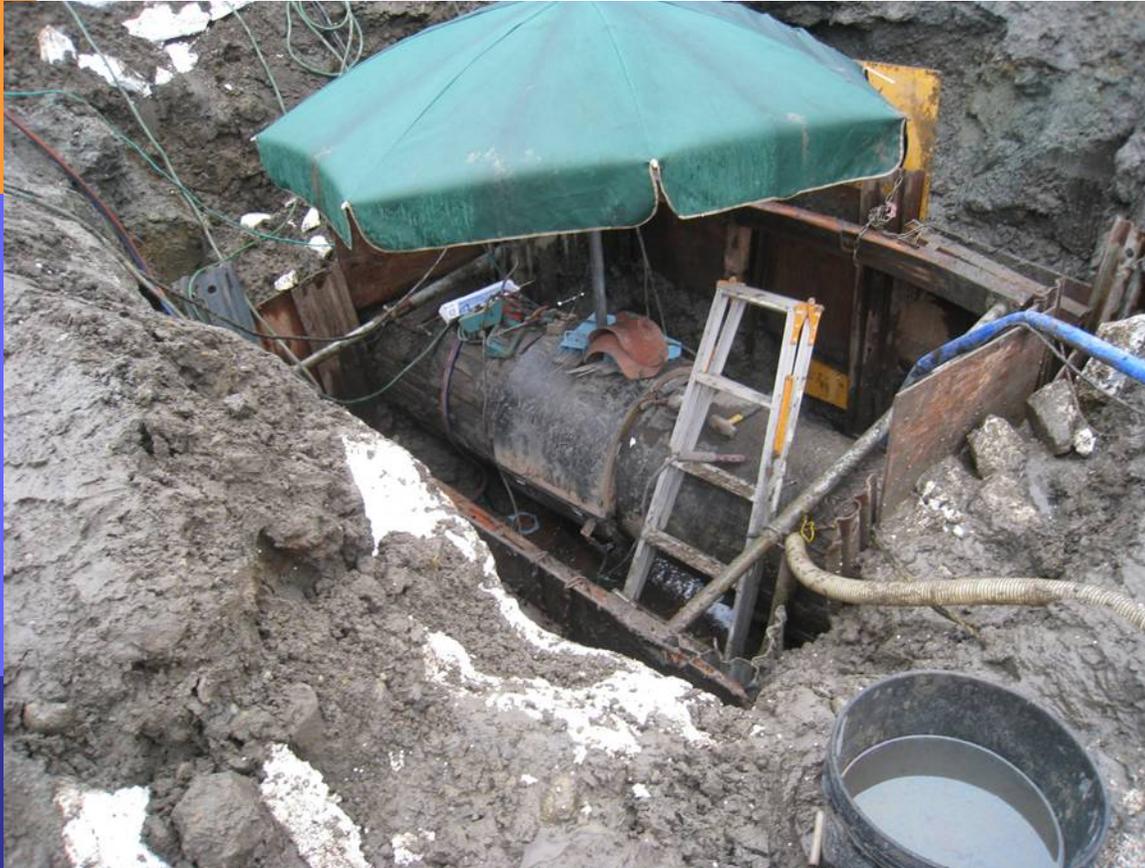
Large diameter pipe damage/ Sendai

Water leak at welded part of steel pipe,
Sendai: SP ϕ 700 damaged by April 7,
aftershock

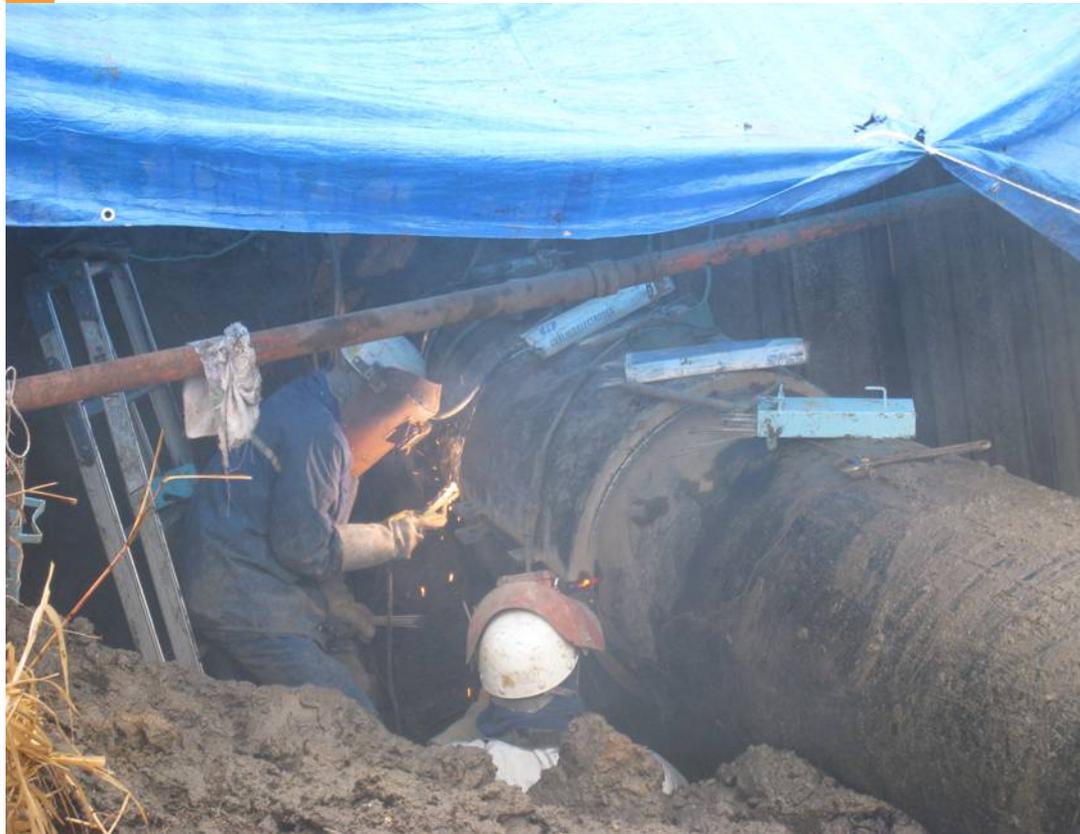
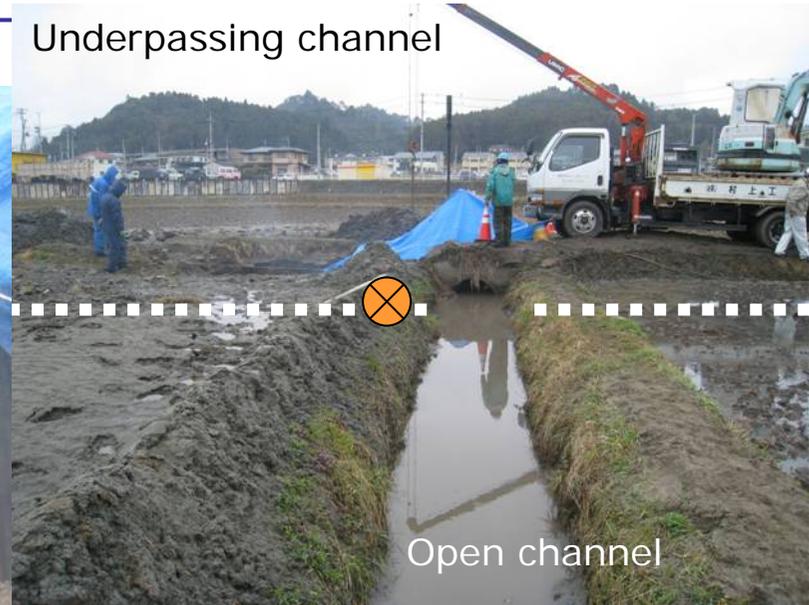
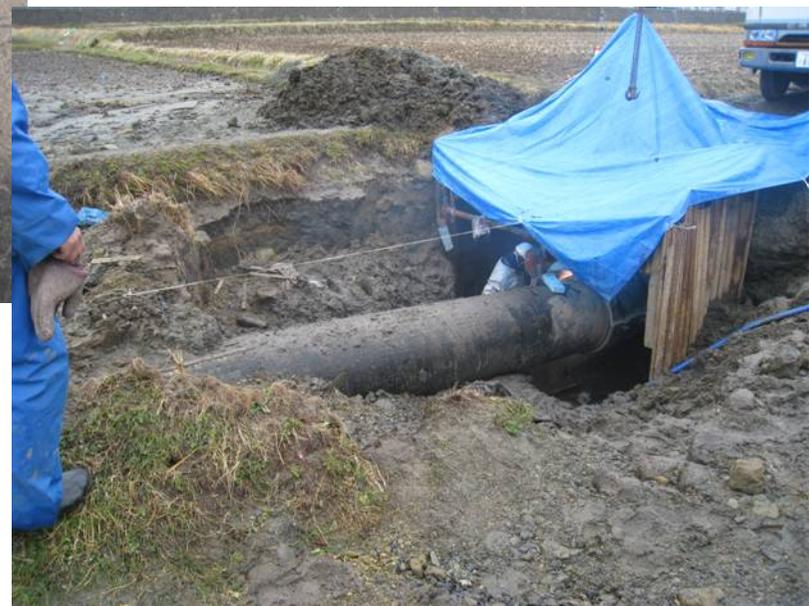
Large diameter pipe damage/ Sendai

Water leak at welded part of steel pipe, Sendai: SP ϕ 700 damaged by April 7, aftershock

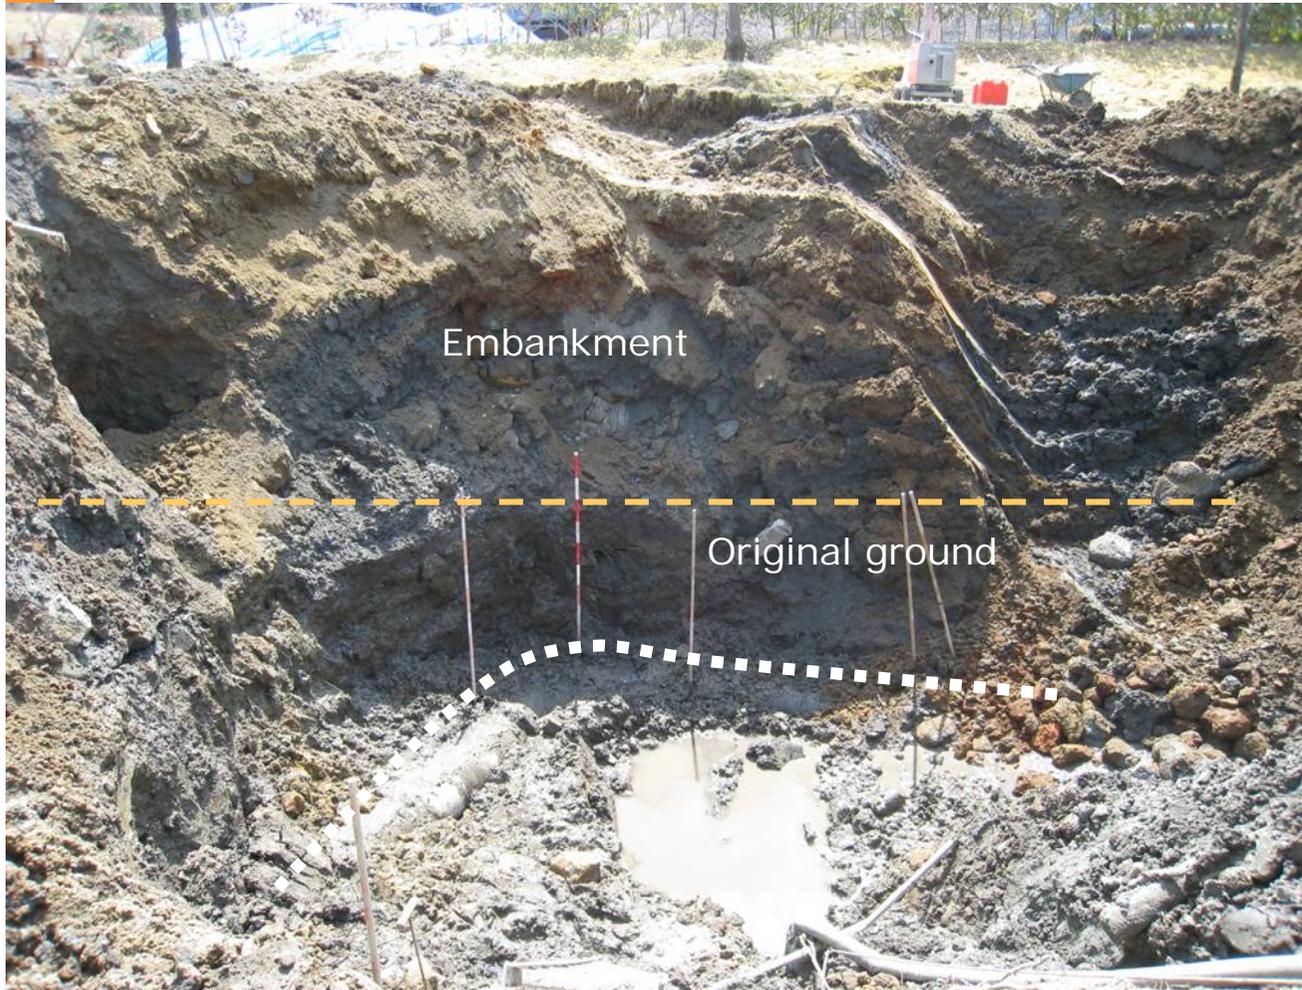
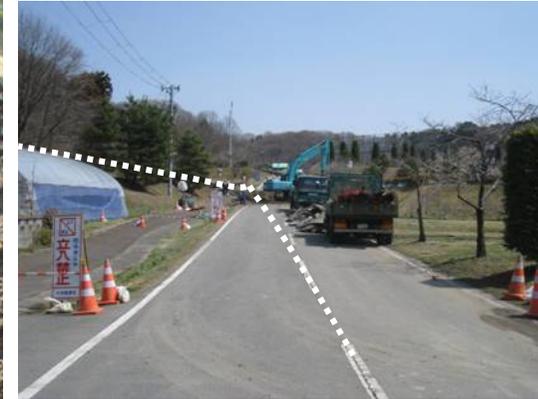
Large diameter pipe damage/ Osaki

Water leak from joints at bending part DIP ϕ 500, damaged by April 7 aftershock

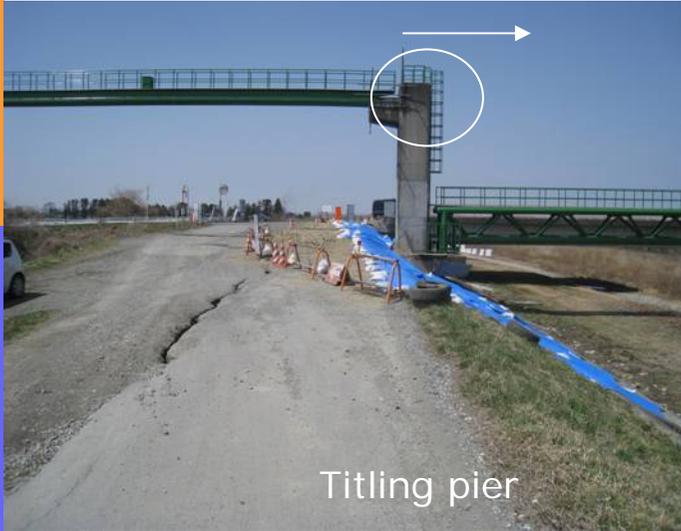
Pipe bridge damage/ Misato

Tilting pier

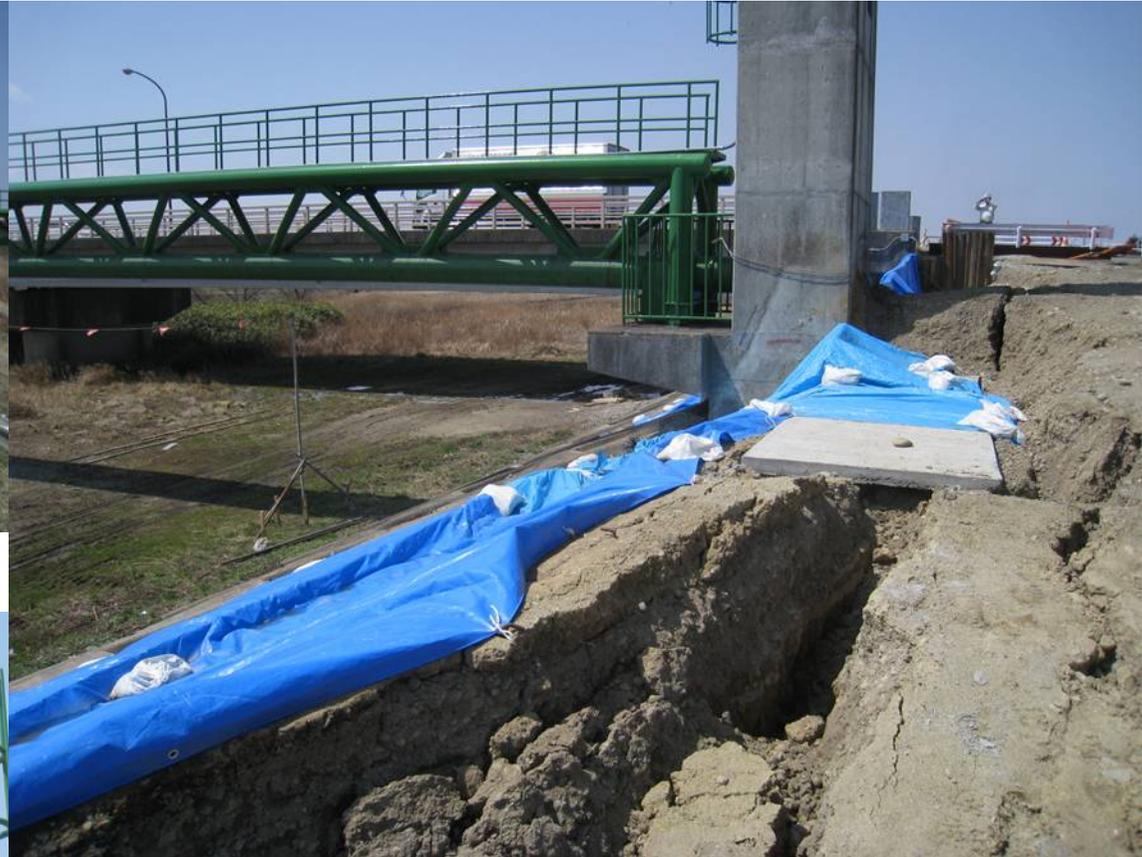
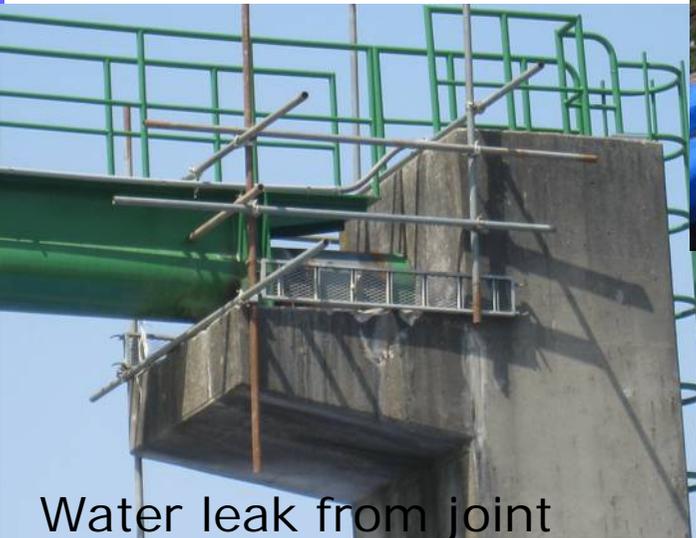
Water leak from joint

Slide of embankment at water pipe bridge ($\phi 500$) and water leak from flexible joint, after April 4 aftershock

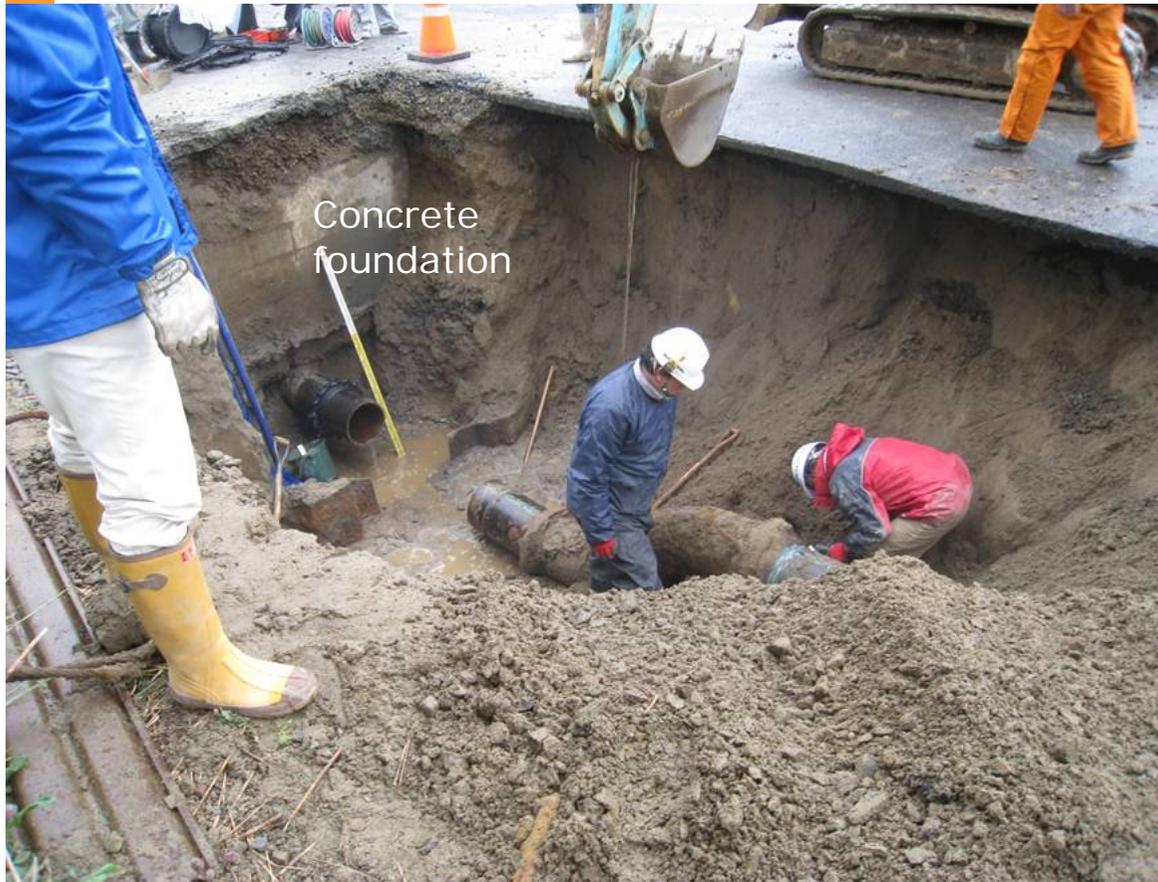
Pipe damage, Natori

DIP ϕ 300, damaged by April 7 aftershock

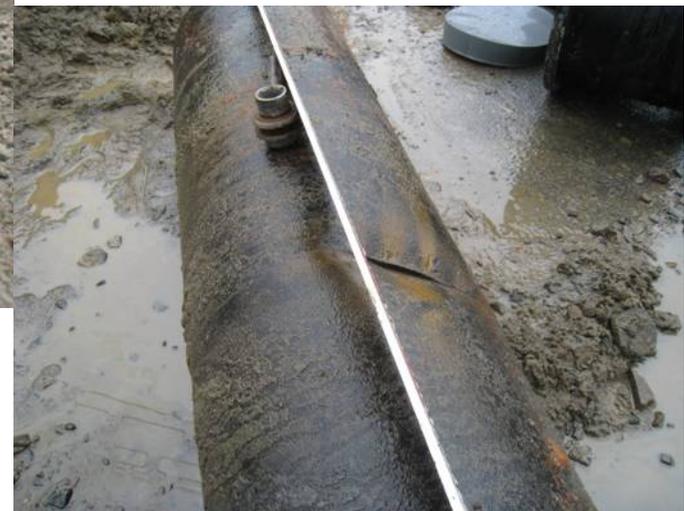
Crack on pipe body

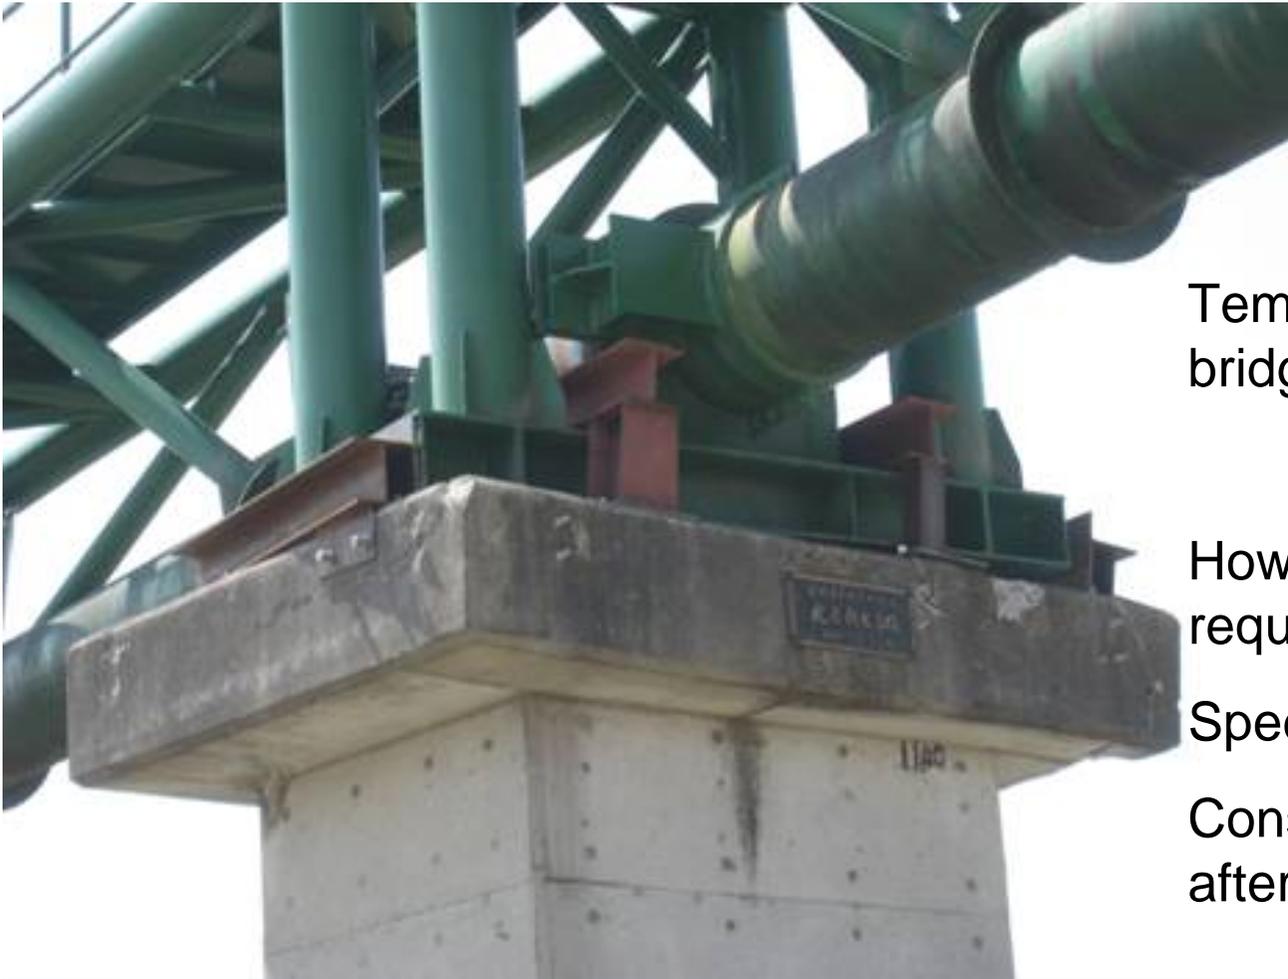
Temporal repair of water pipe bridge.

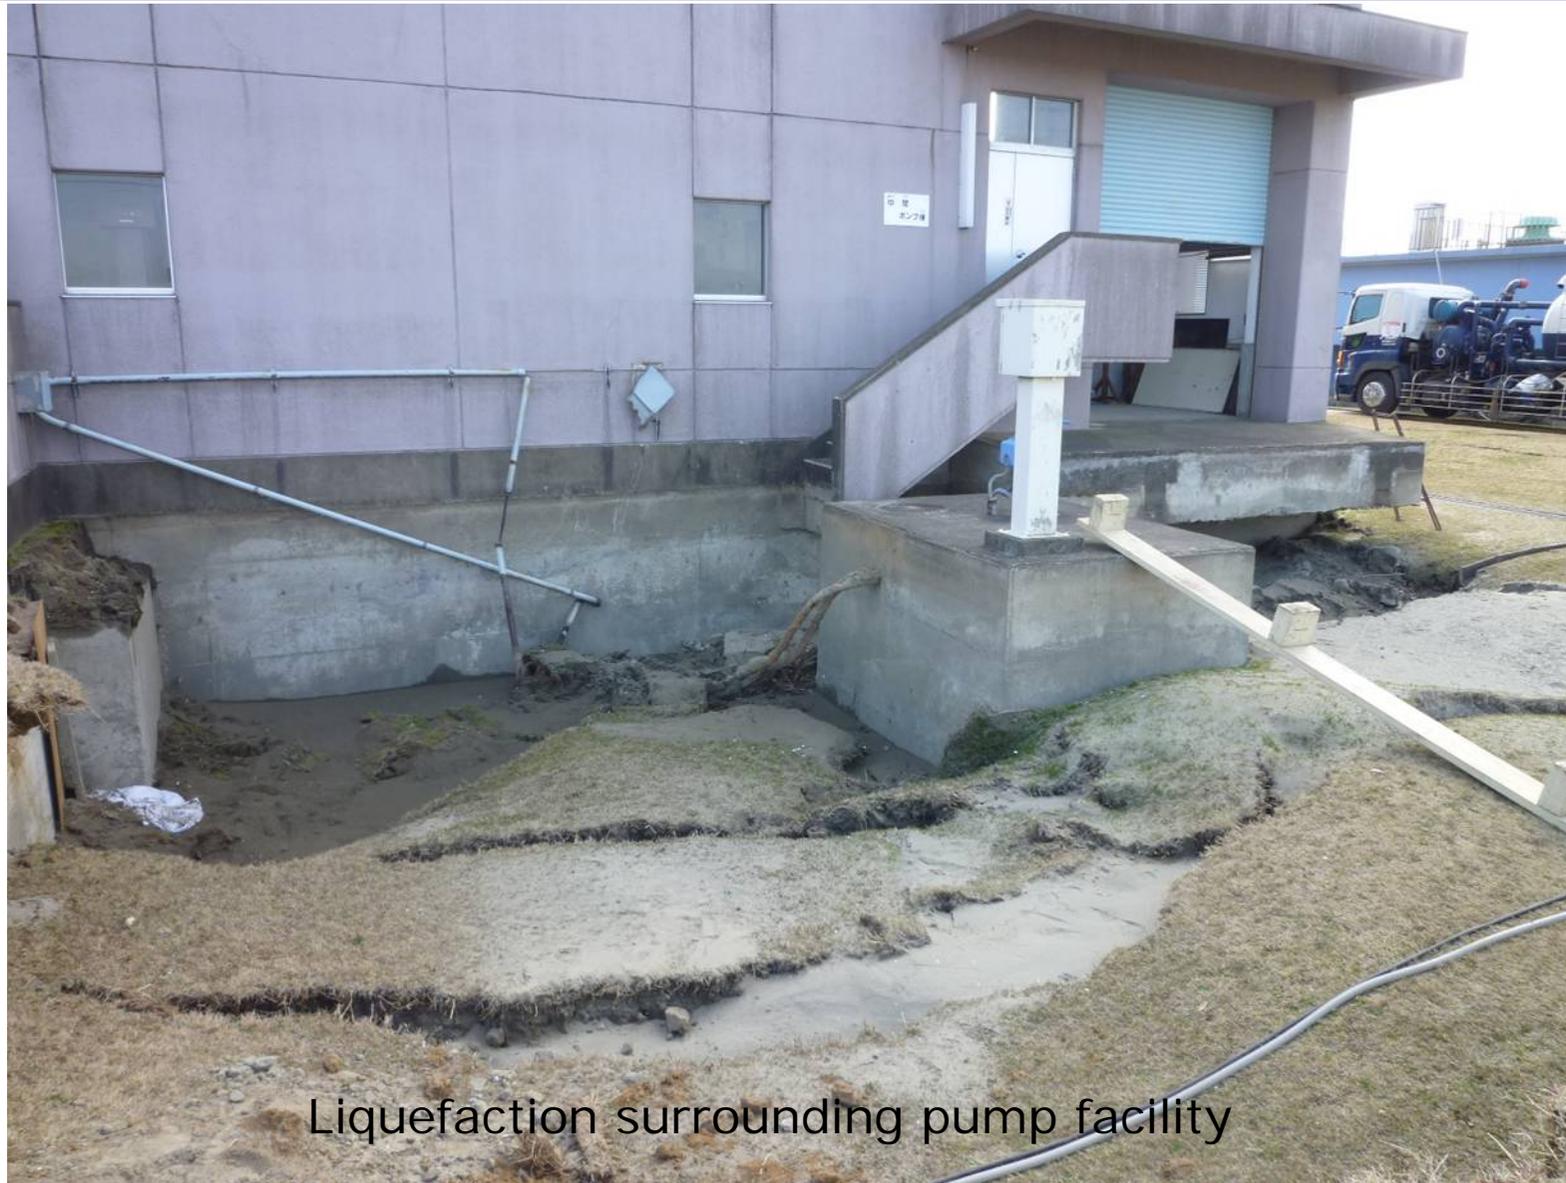
Damage at Wanigawa purification plant

Liquefaction surrounding pump facility

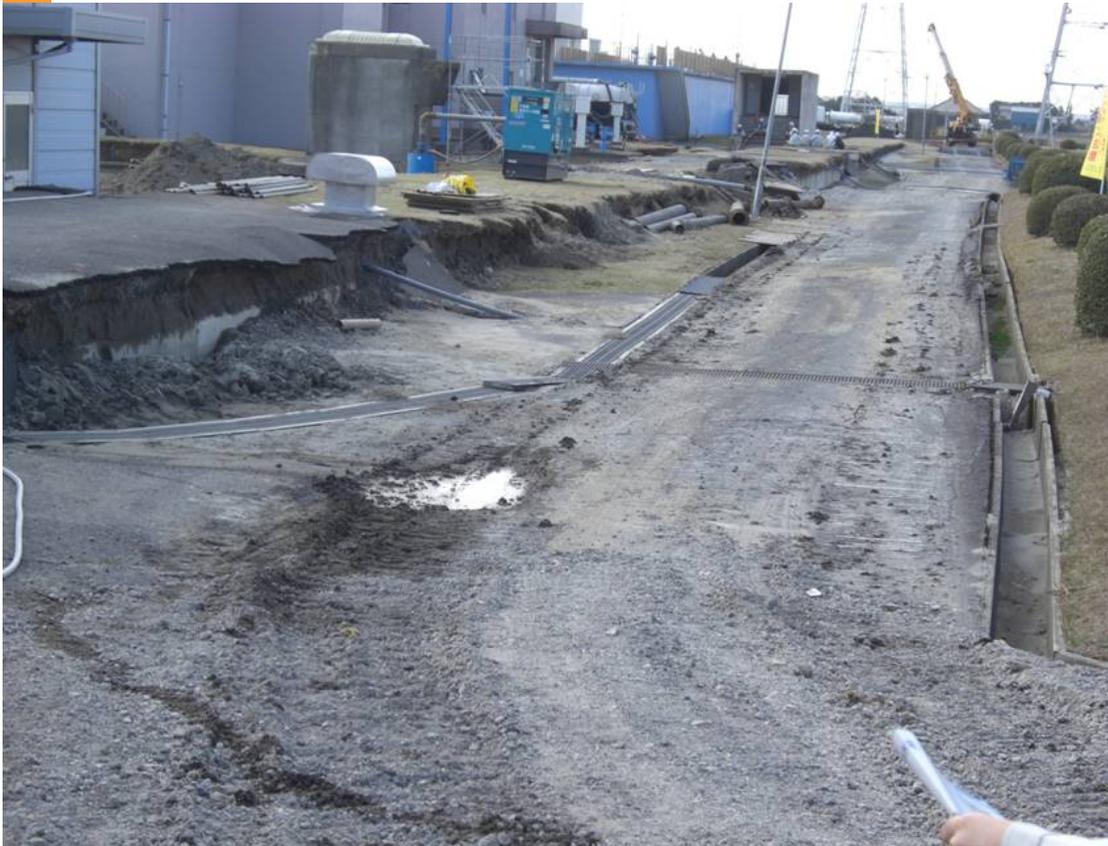
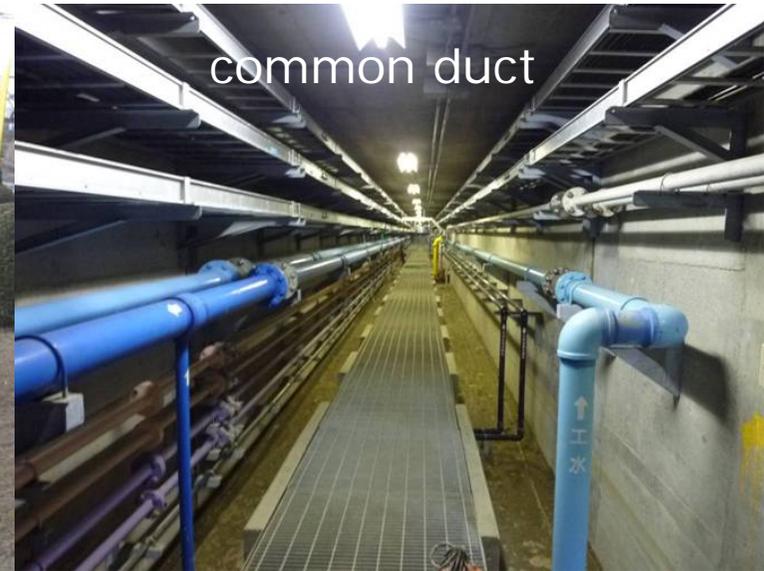
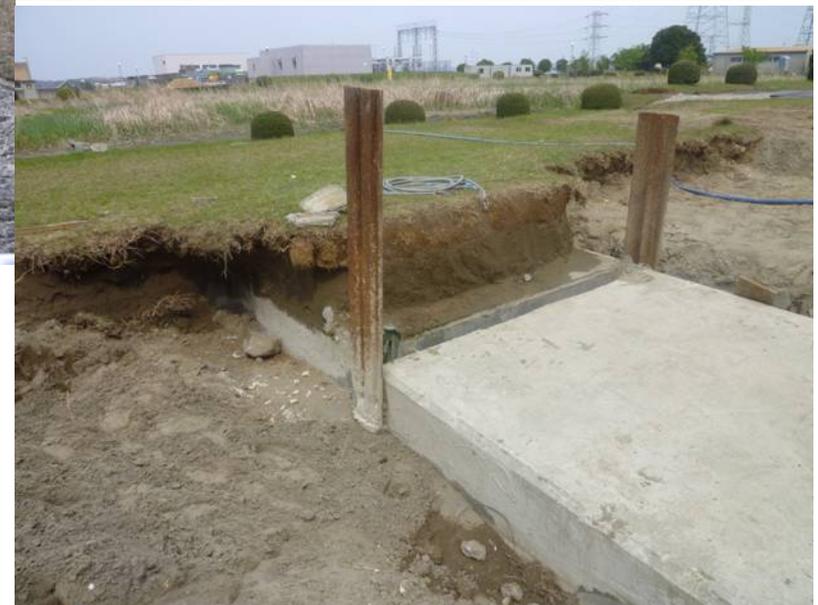
Damage at Wanigawa purification plant

Liquefaction damage

Common duct 50 cm lift up

Surround ground 50 cm subsidence

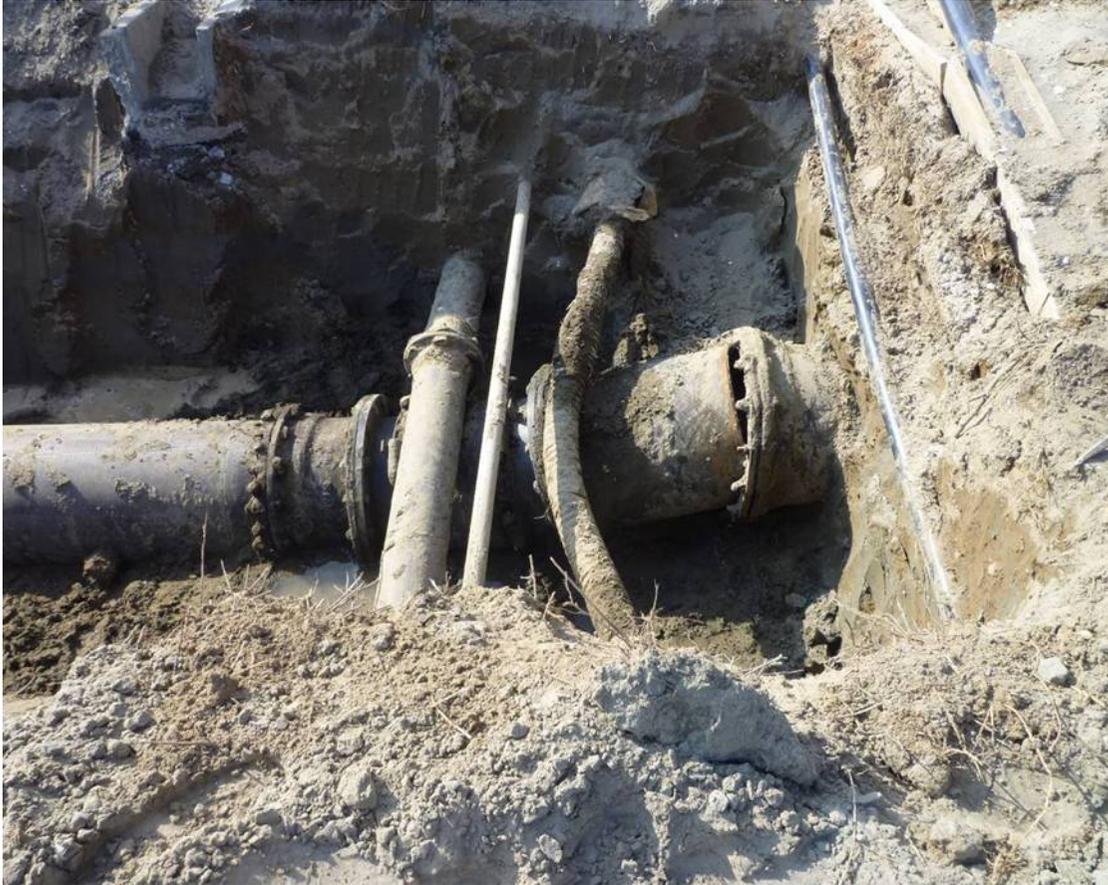
Damage to flexible joint, DIP ϕ 600, by subsidence due to liquefaction at the connection to the facility

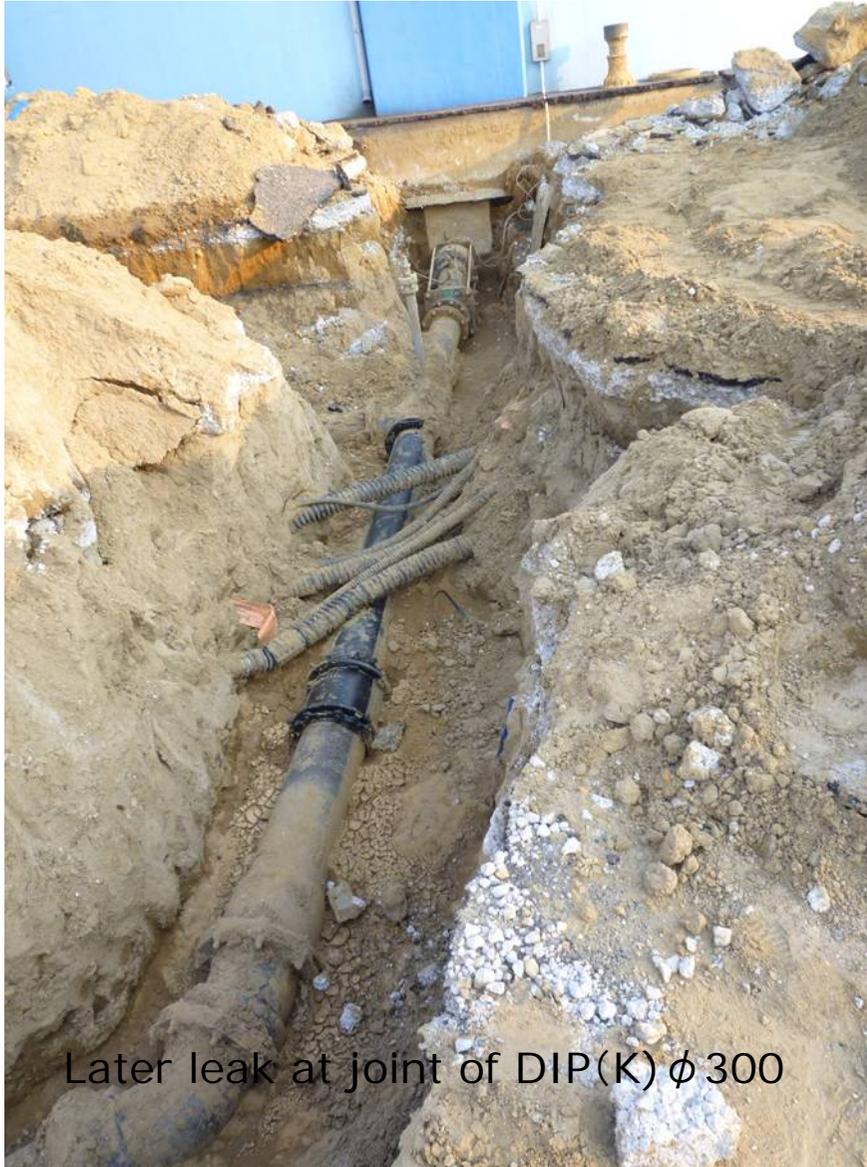
Later leak at joint of DIP(K) ϕ 300

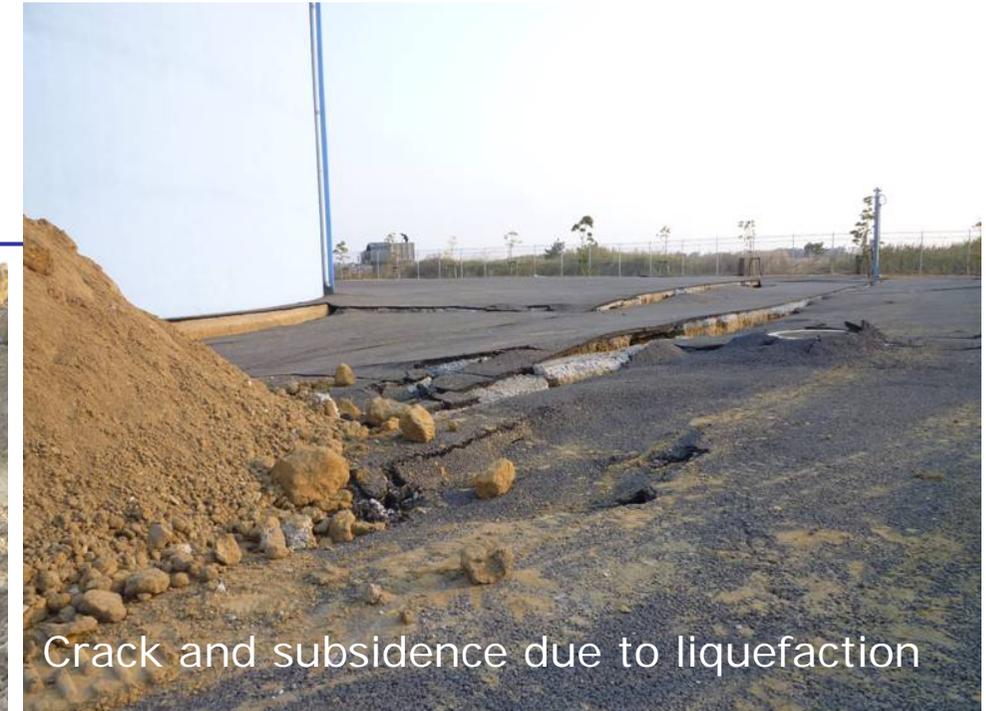
Crack and subsidence due to liquefaction

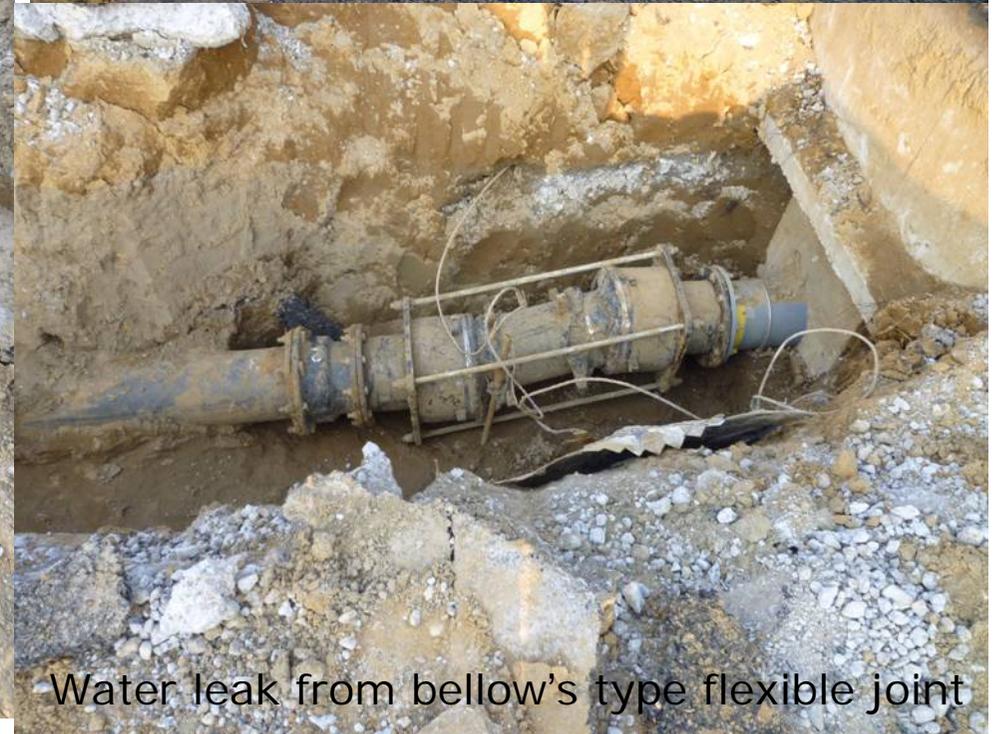
Water leak from bellow's type flexible joint

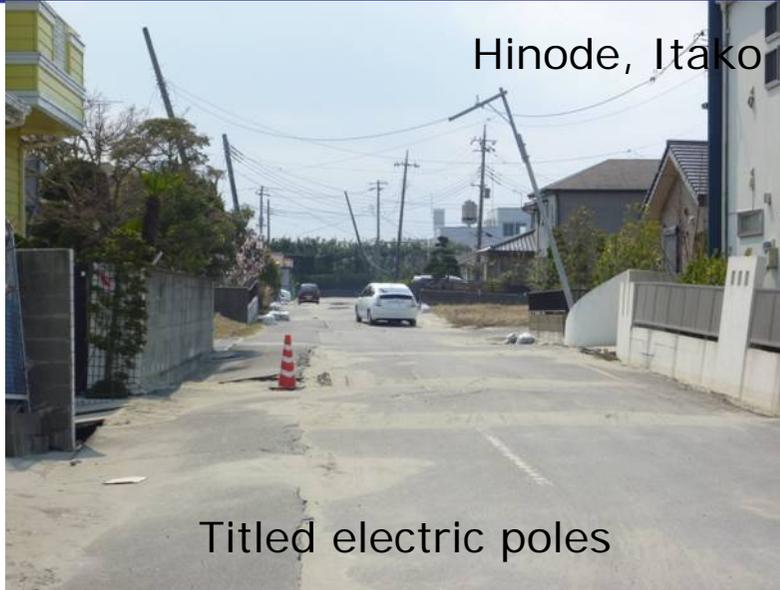
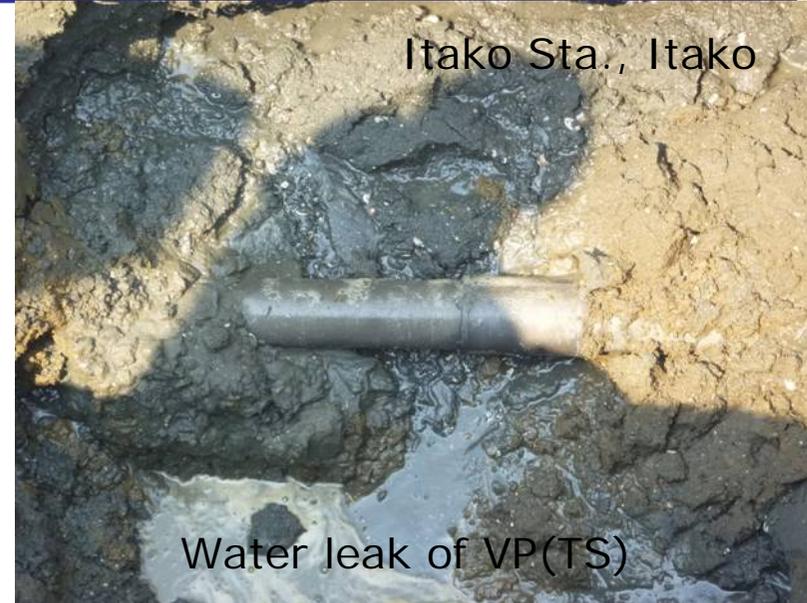
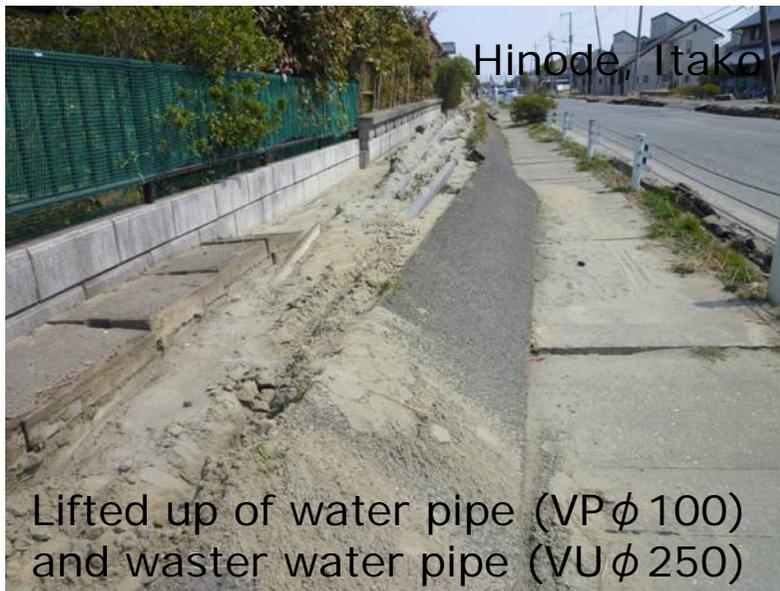
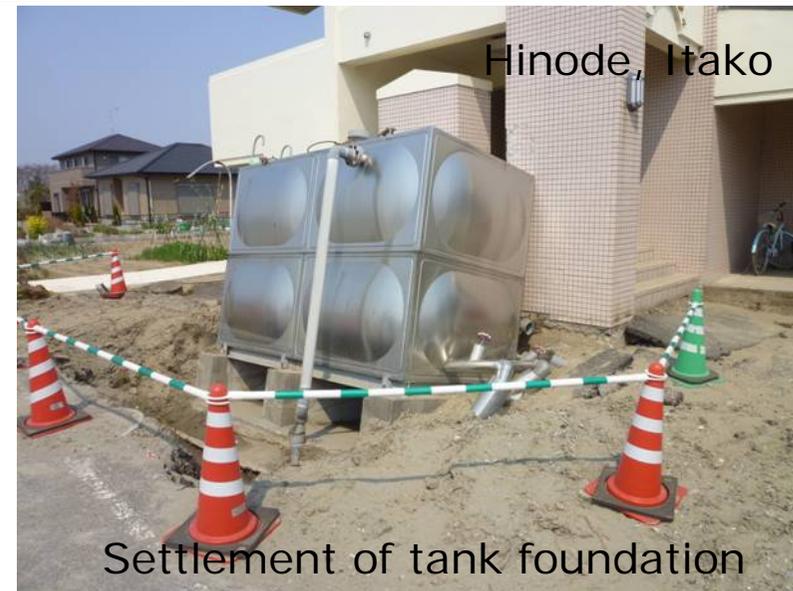
Pipeline damage due to wide-area liquefaction/ Itako, Ibaraki
