Waterworks damage

Yasuko Kuwata
Dept. of Civil Eng., Kobe University

Damage to water supply facility Miyagi pref.

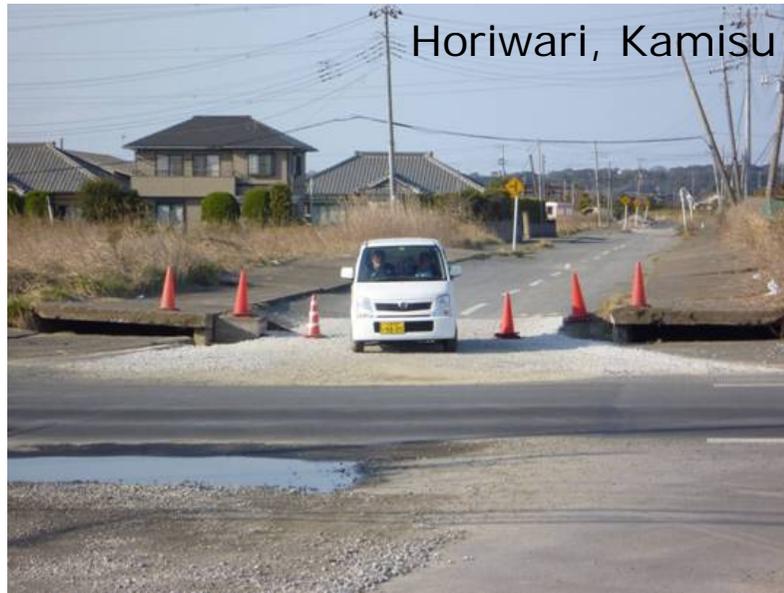
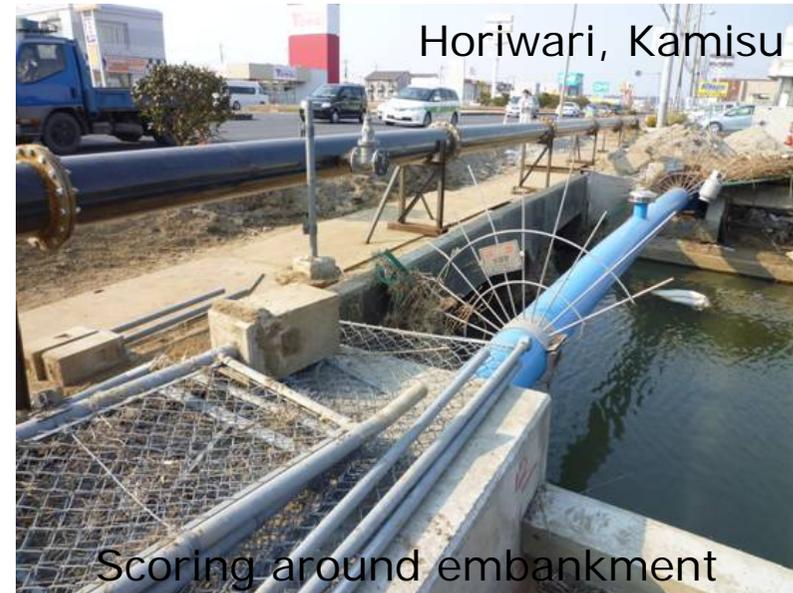
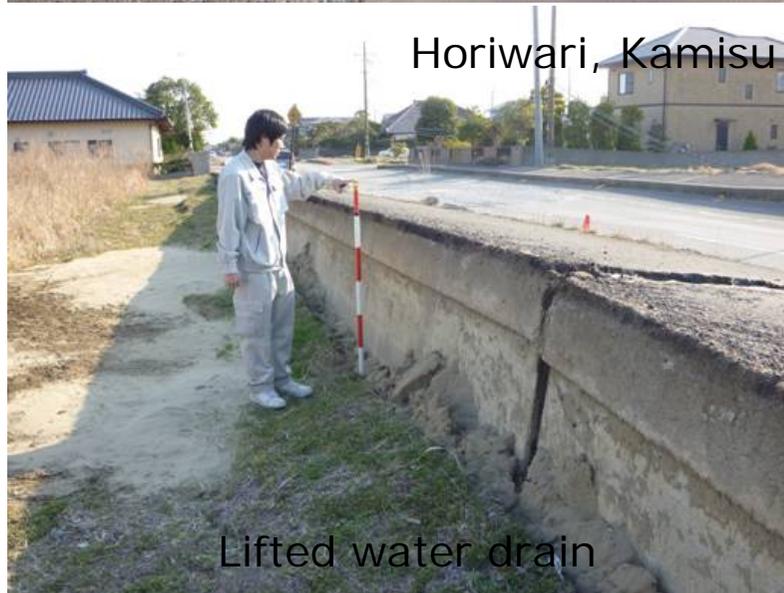
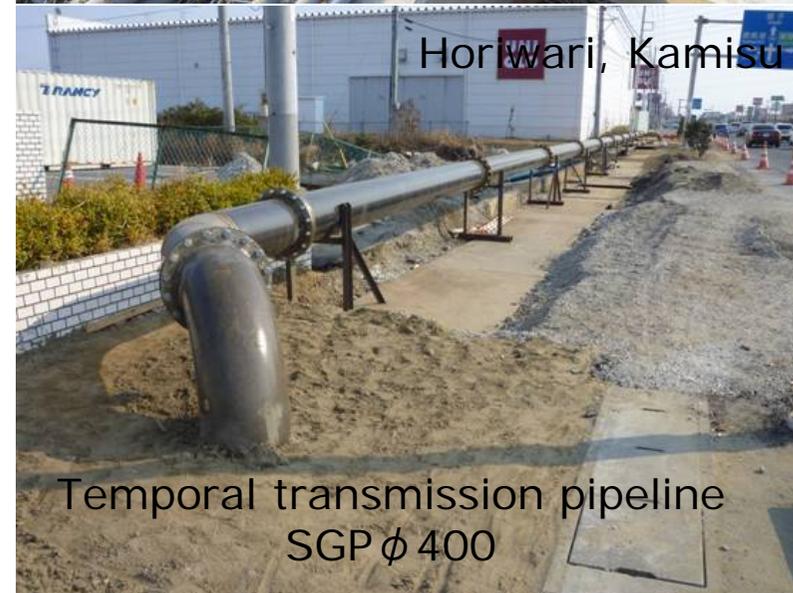
Pipeline damage due to wide-area liquefaction/ Kamisu, Ibaraki

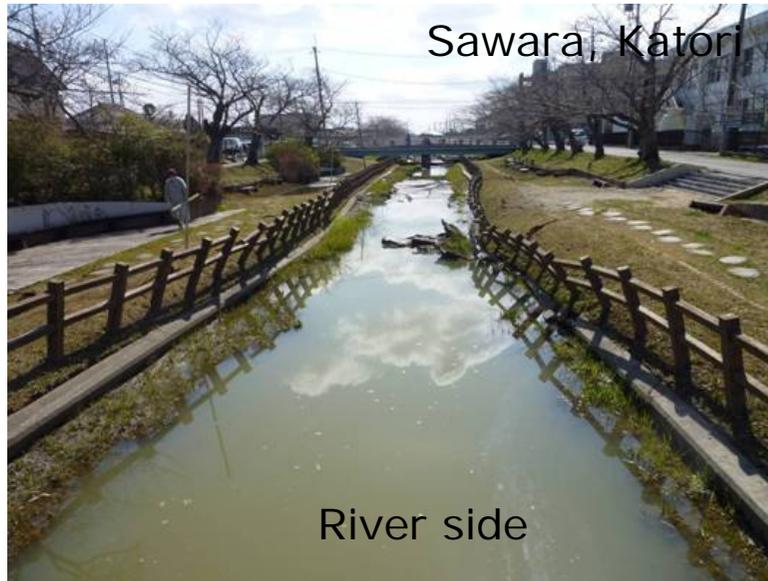
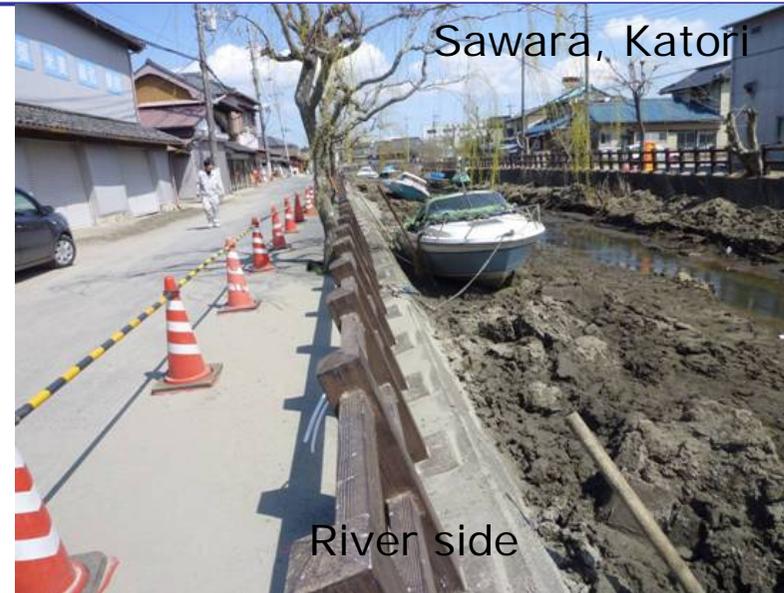
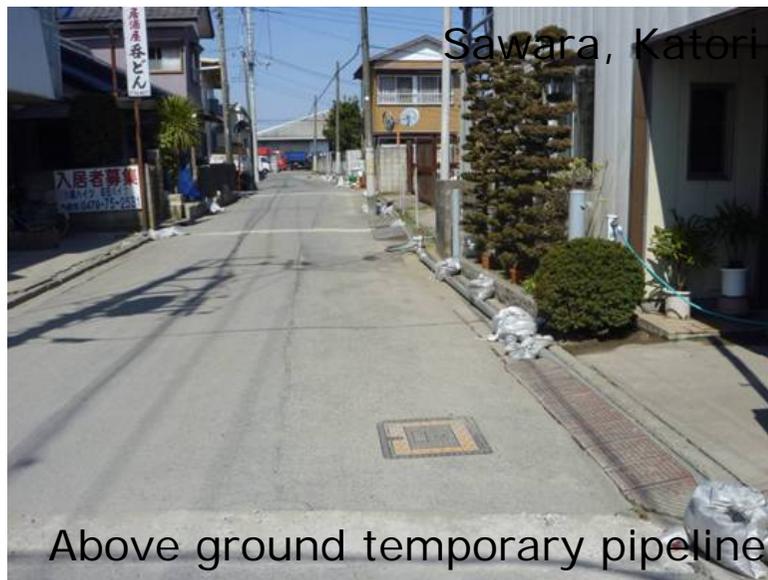
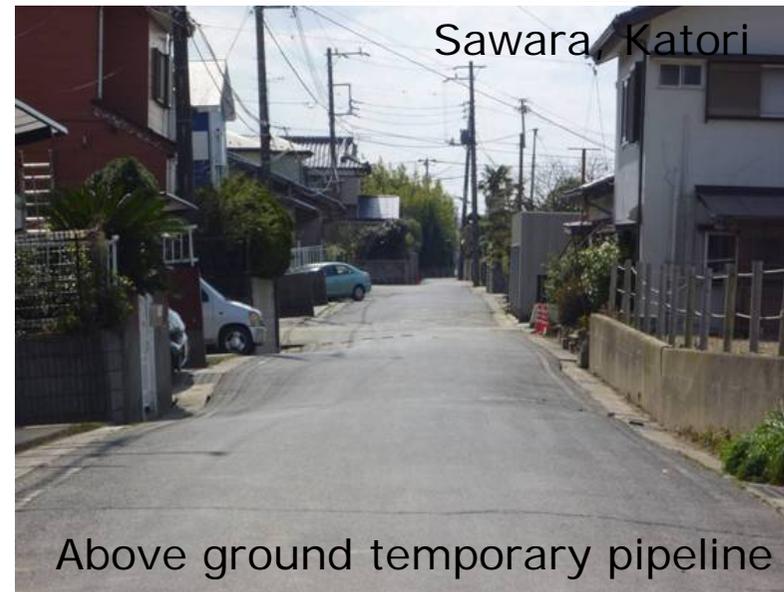
Pipeline damage due to wide-area liquefaction/ Katori, Chiba

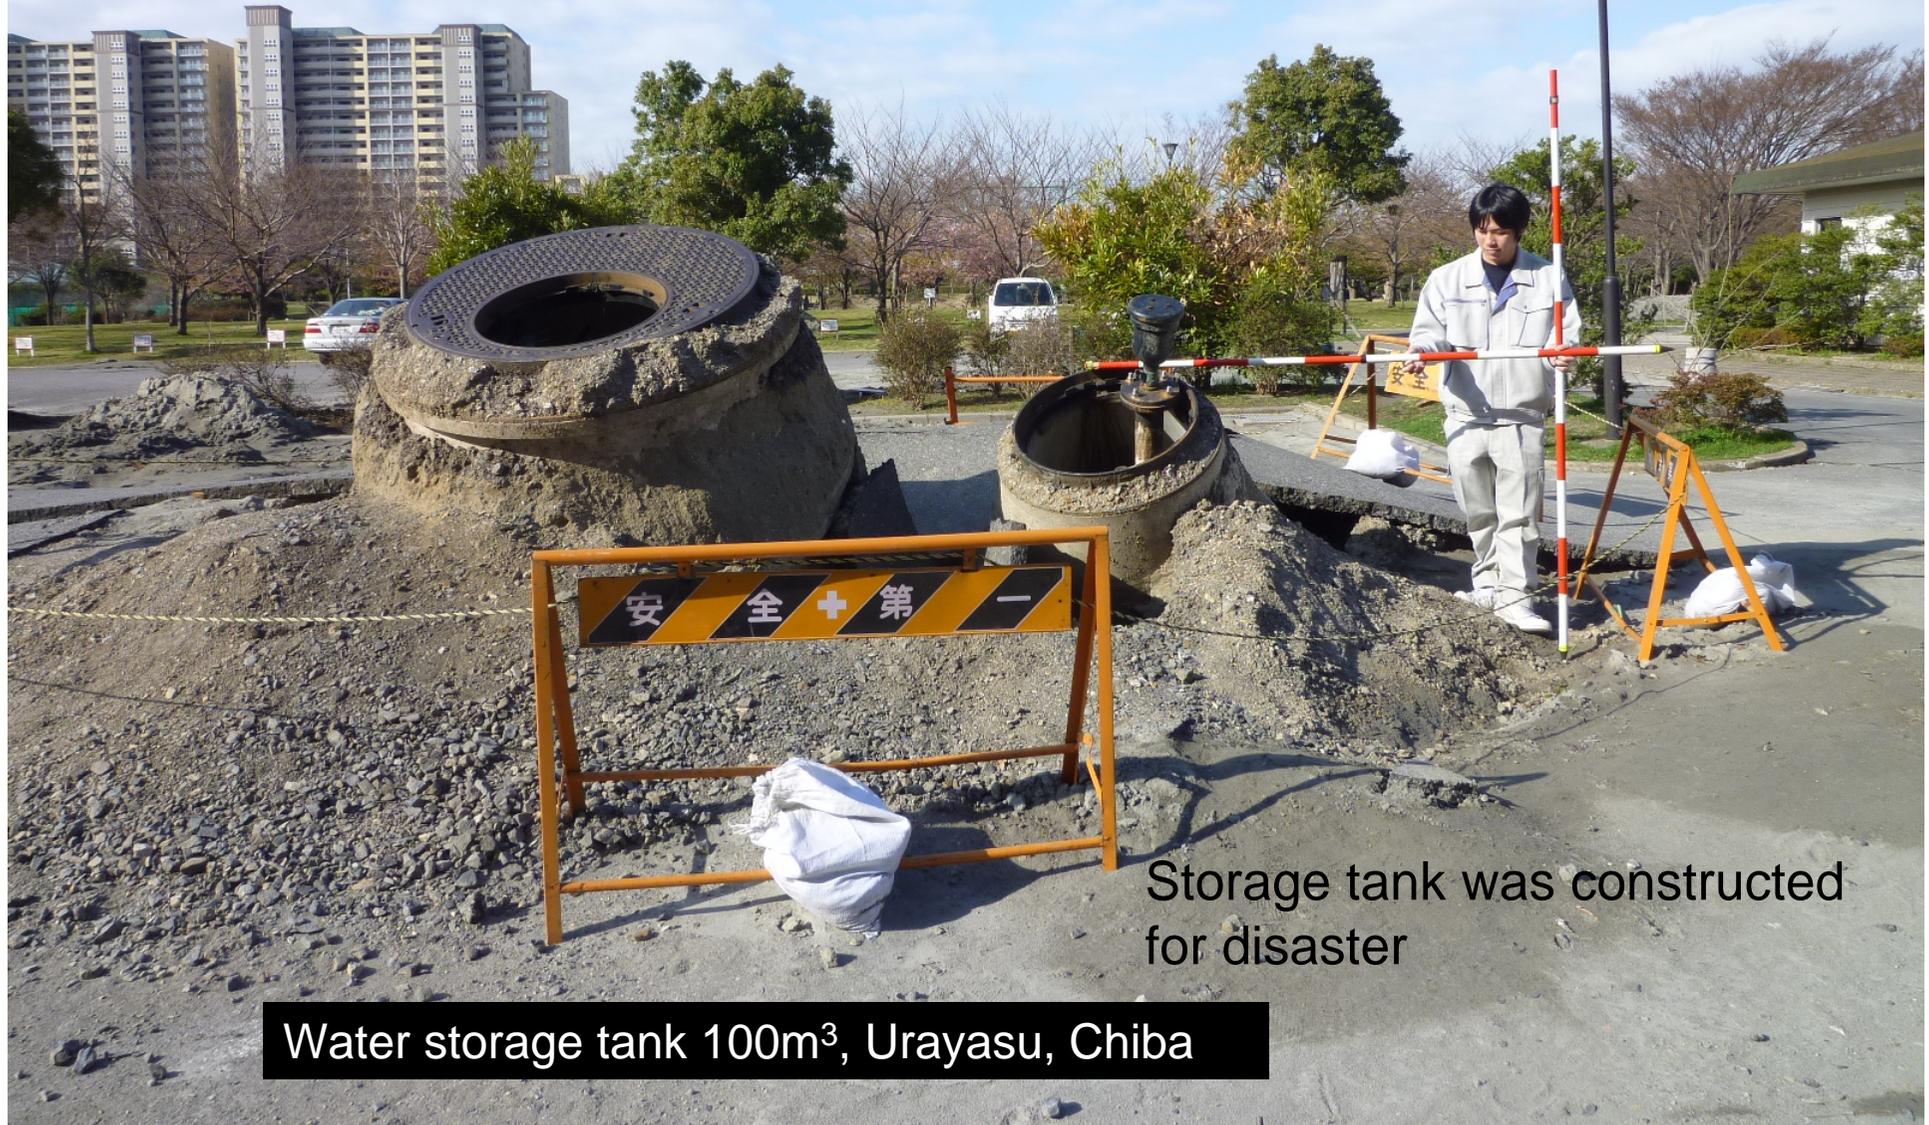
Water storage tank 100m³, Urayasu, Chiba

Lift up of water storage tank by liquefaction

Storage tank was constructed for disaster

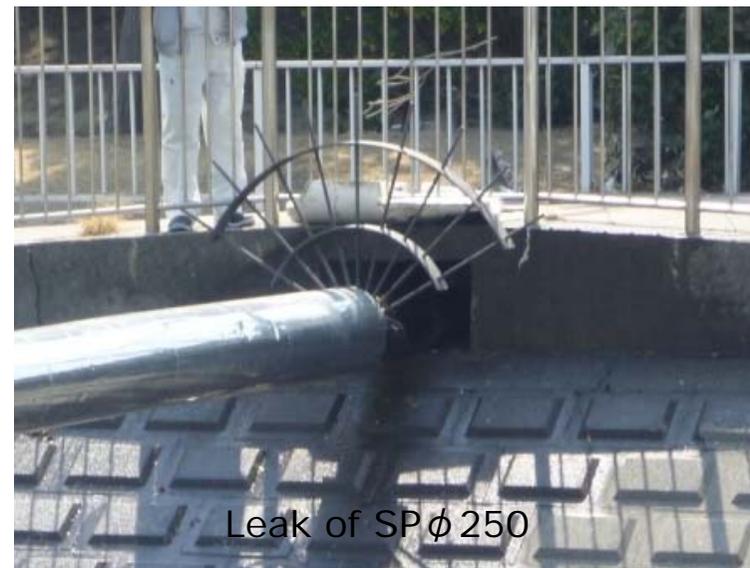
Hitachi

Leak of SP φ 250

Pipe at sliding bearing of pipe beam bridge hit at walls

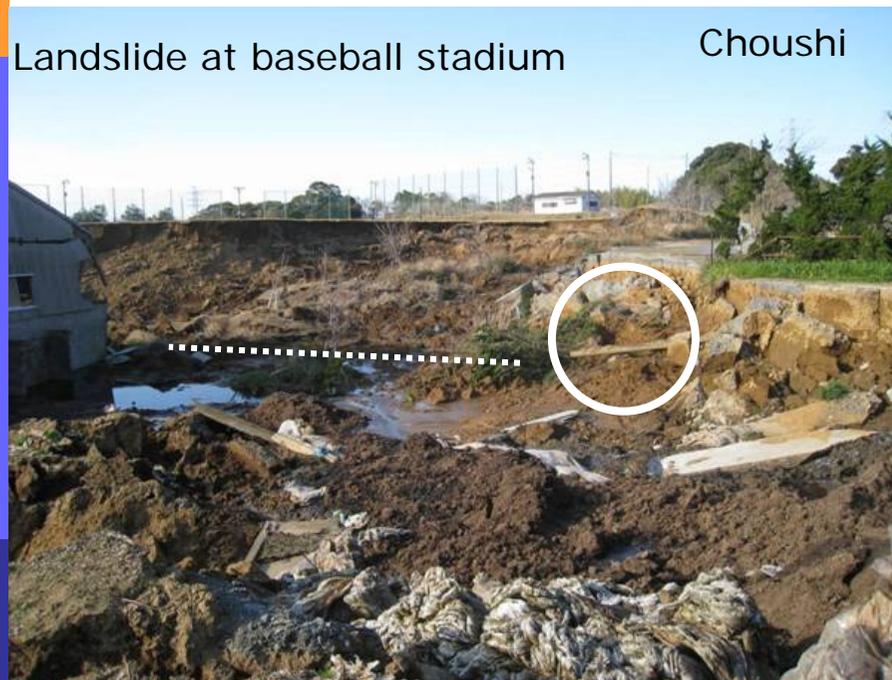
Pipeline damage, DIP ϕ 150, due to landslide

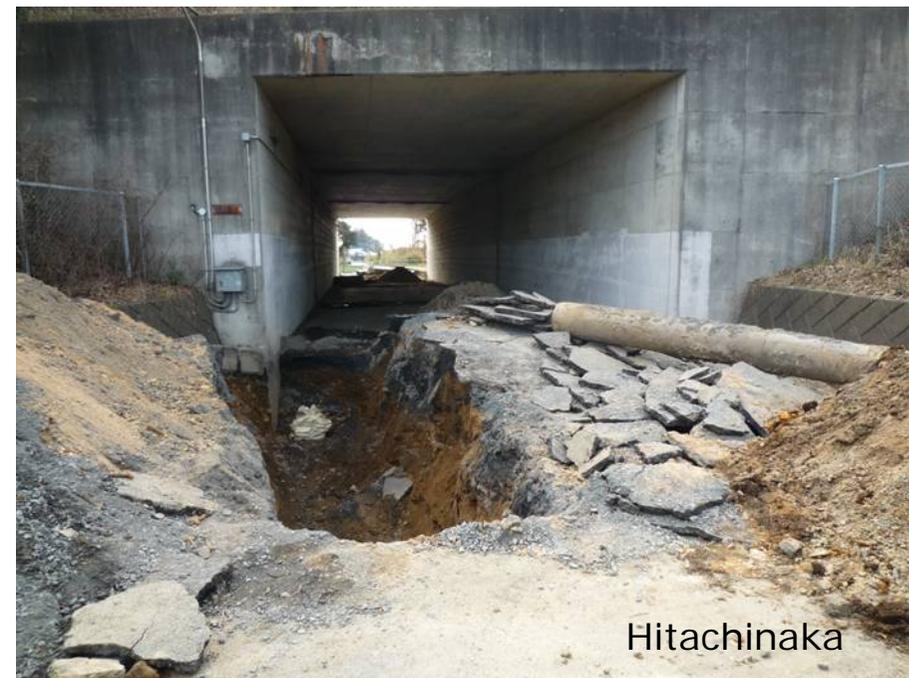
Pipeline damage, DIP(A) ϕ 350, due to raised ground surrounding underpass of highway embankment
