## 2003年アルジェリア北部の地震 報告2 : ALGER – BOUMERDES, ALGERIA EARTHQUAKE OF MAY 21, 2003

Kheir-Eddine Ramdane, JSPS Research Fellow  
Building Research Institute, 1 Tachihara, Tsukuba, Ibaraki 305-0802  
[eddine\\_r@yahoo.fr](mailto:eddine_r@yahoo.fr) or [eddine\\_r@kenken.go.jp](mailto:eddine_r@kenken.go.jp)

### PART I : INTRODUCTION, EARTHQUAKE CHARACTERISTICS AND DAMAGE

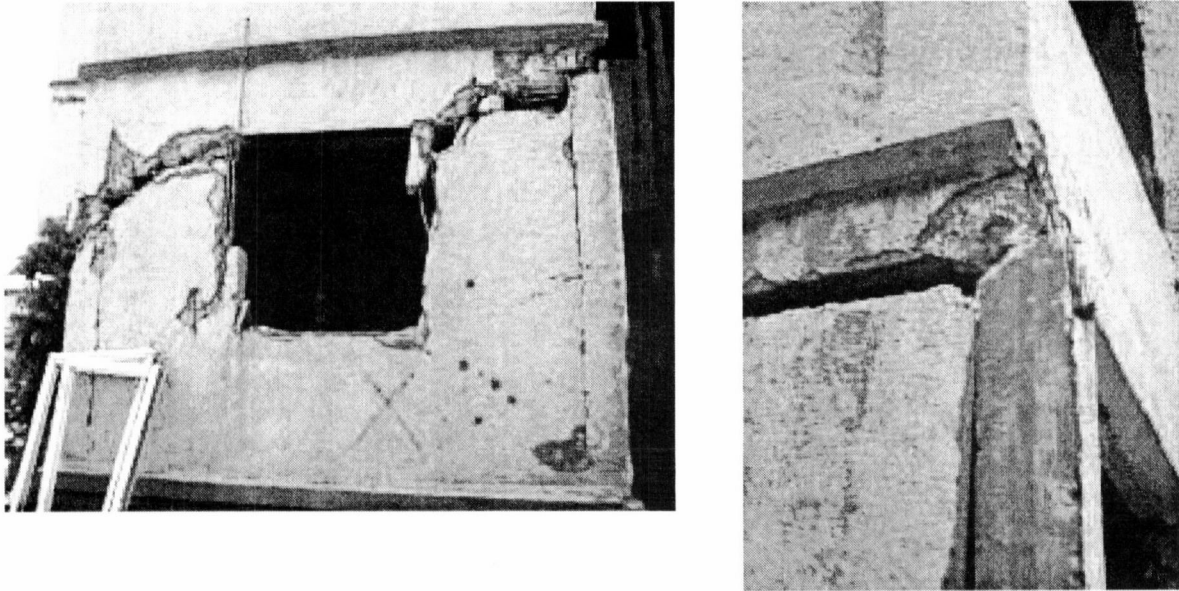
- Shear failure of column and beam-column joint failure (102 apartment, Corso), figure 8

Figure 8: Shear failure of column and beam-column joint failure

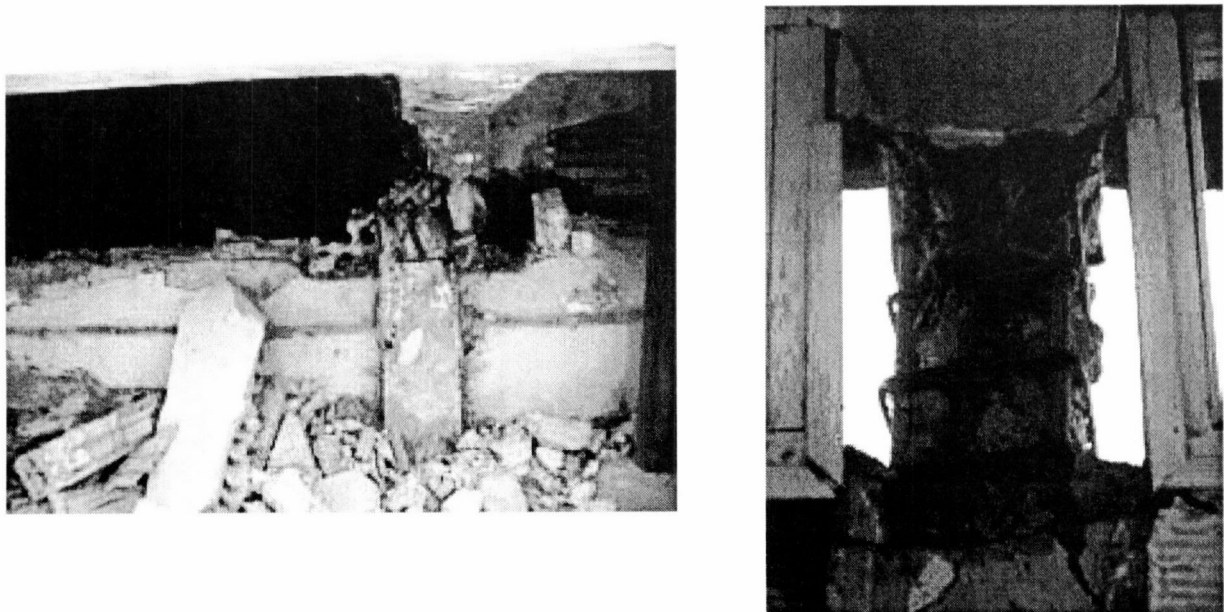
- Use of a crawl space and short column failure, figure 9

Figure 9 : Use of a crawl space and short column failure

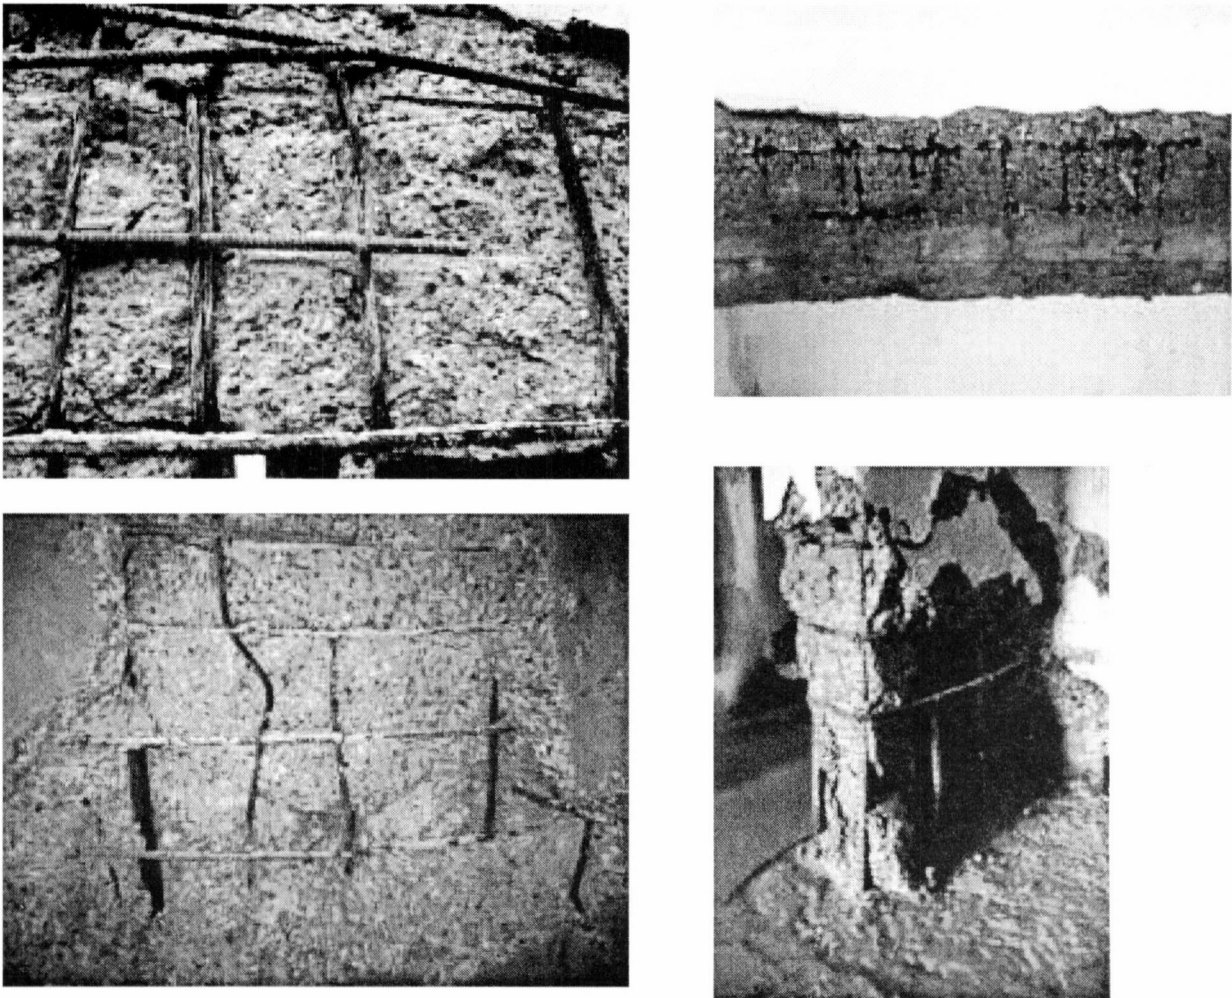
- Poor reinforcement and poor inspection, figure 10

Figure 10: Poor reinforcement and poor inspection

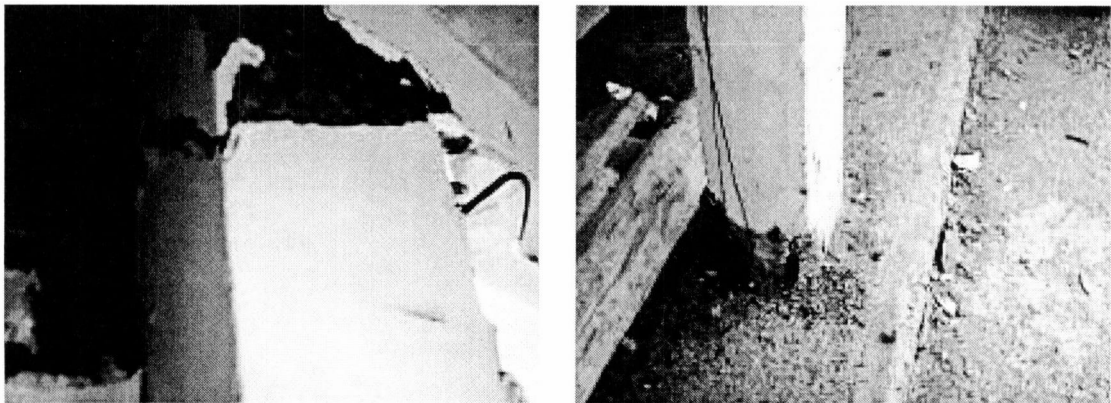
One line of structural columns underwent bursting of concrete at the plastic hinges (at the base and top), without rupture of the reinforcement. The bursting is accompanied by a light buckling of longitudinal reinforcement.

Damaged hinge at the top

From this study, it is imperative to proceed with the retrofitting of the building by jacking the columns of the ground floor. It is to be noted that:

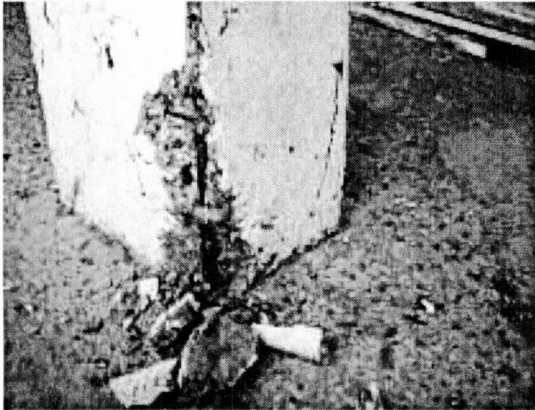
Damaged hinge at the base

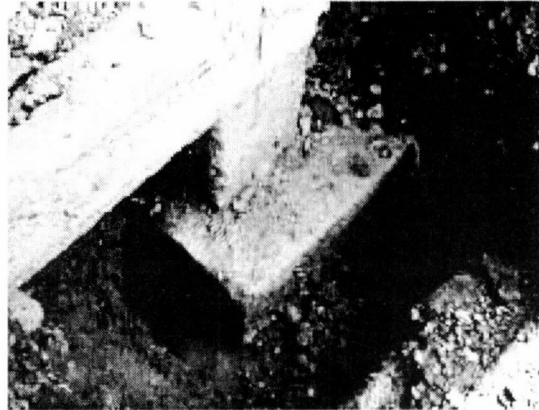
Damaged hinge at the base

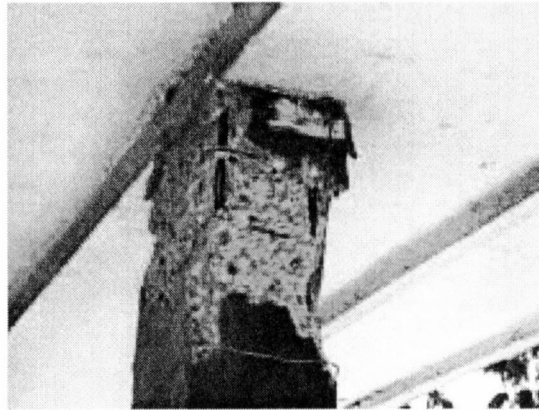
pulling off of the cover concrete

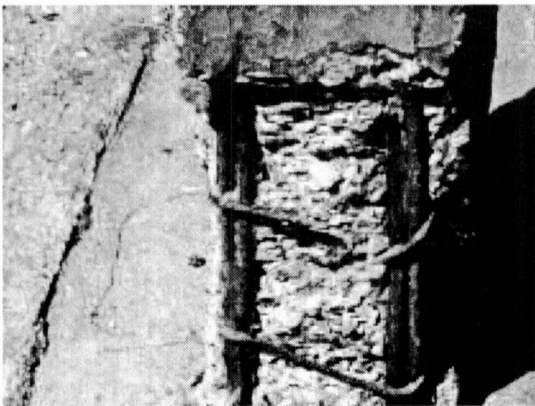
weak reinforcement in both directions

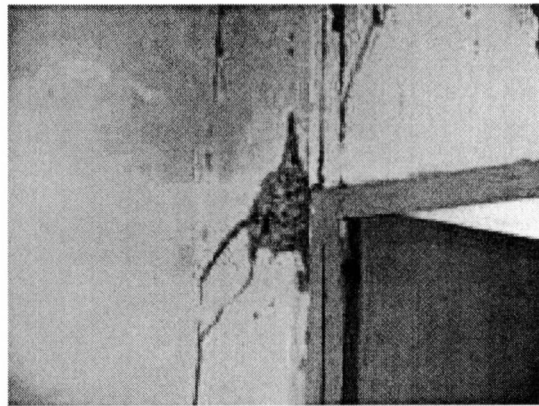
transversal reinforcement failing in shear due to initial corrosion

Column severely damaged due stiff still frame of the door.
