10. LIQUEFACTION AND GROUND FAILURES

10.1. Liquefaction and Its Effects

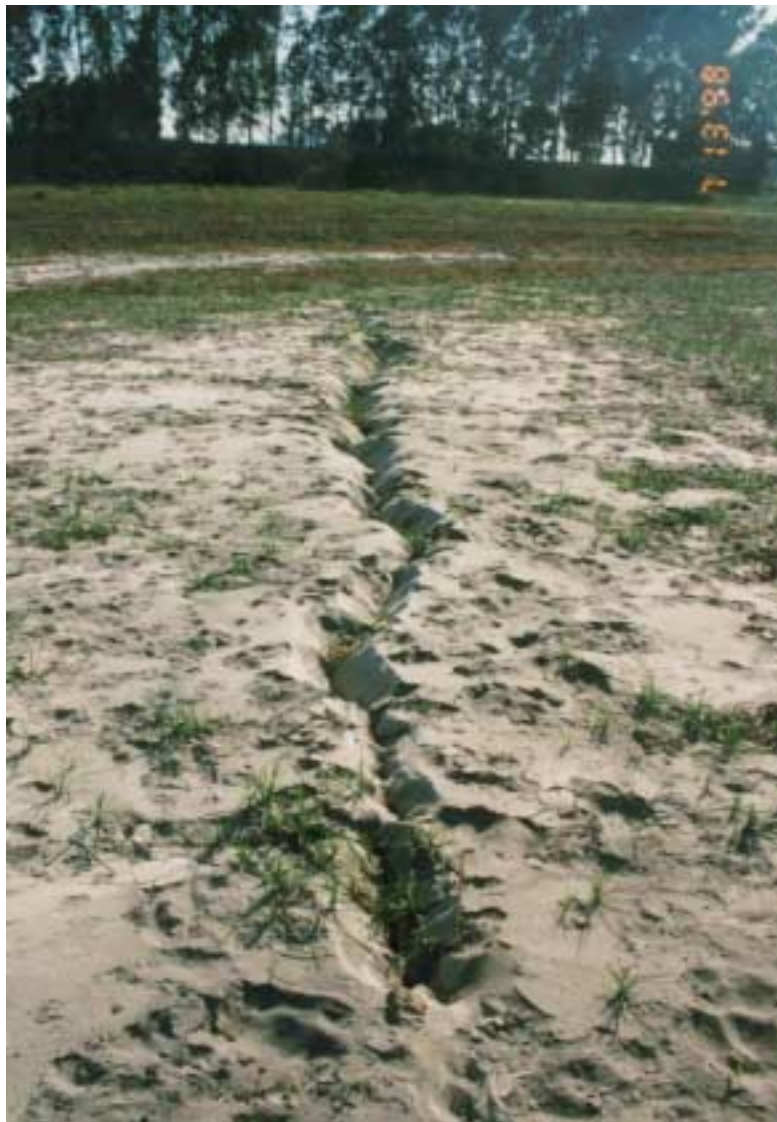
Figure 10.1 Liquefaction near Asmali bridge

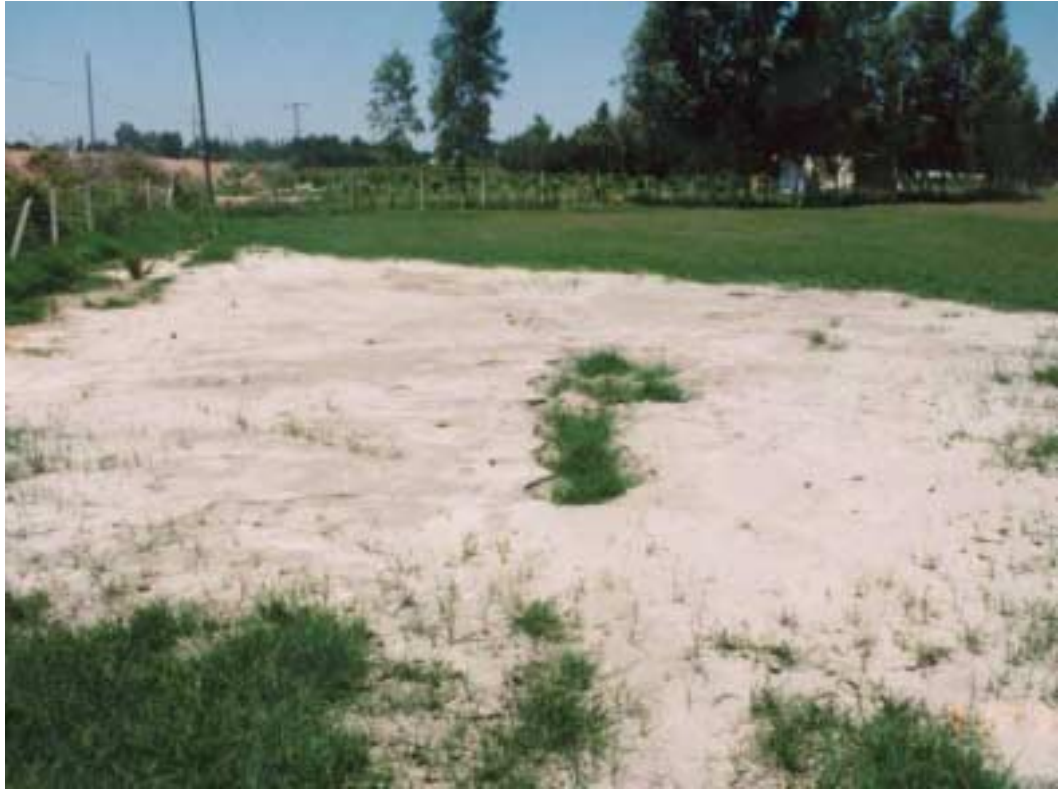
Figure 10.2 Liquefaction in a school yard in Abdioğlu village

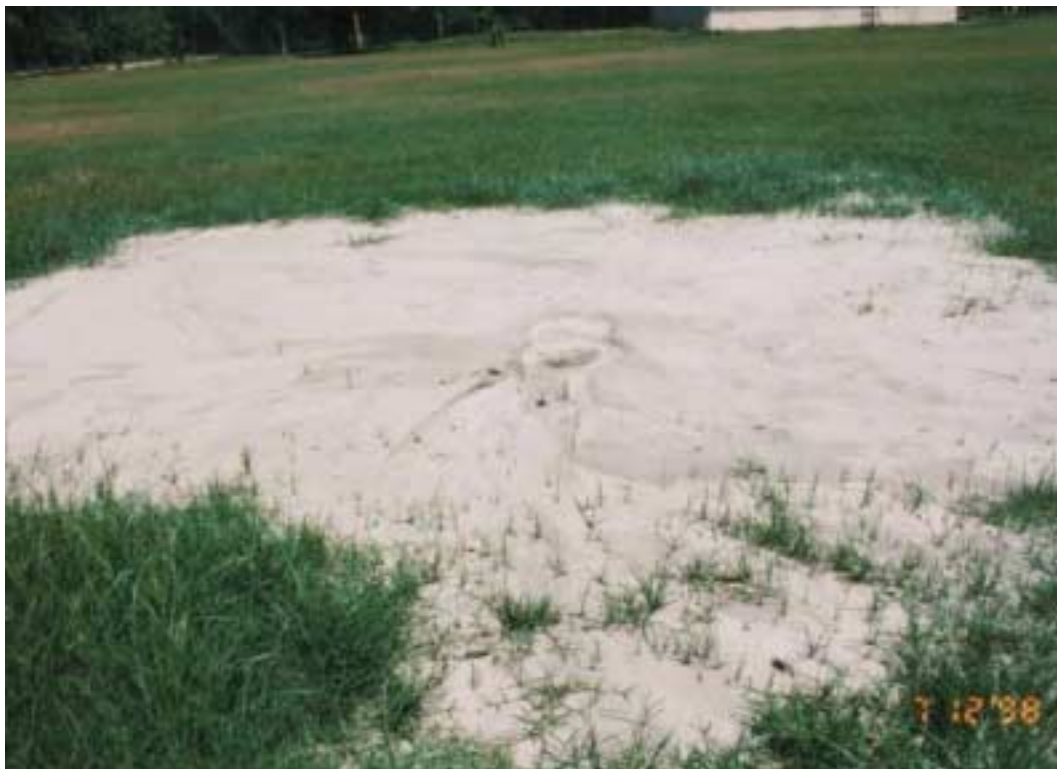
Figure 10.3 Liquefaction in a school yard in Abdioğlu village

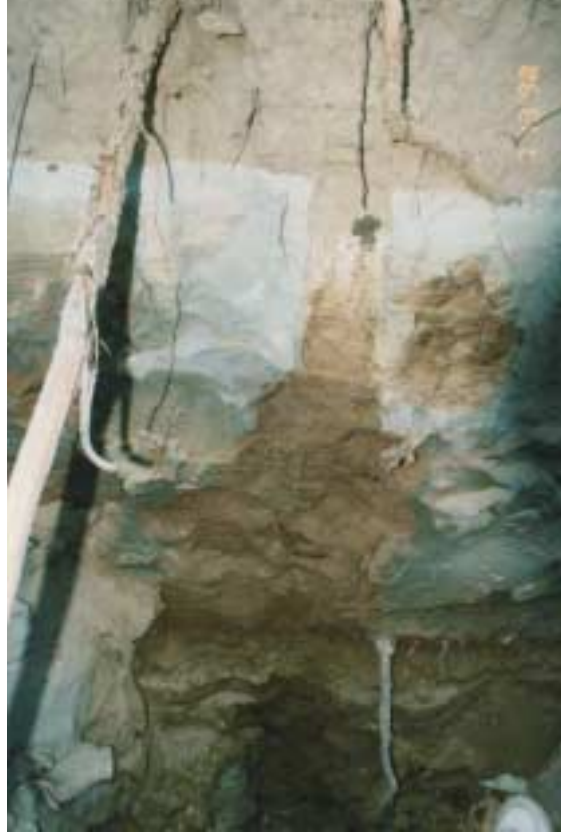
Figure 10.4 Trace of liquefied soil on a fracture crevasse of soil slope failure along Ceyhan River near Mercimek village

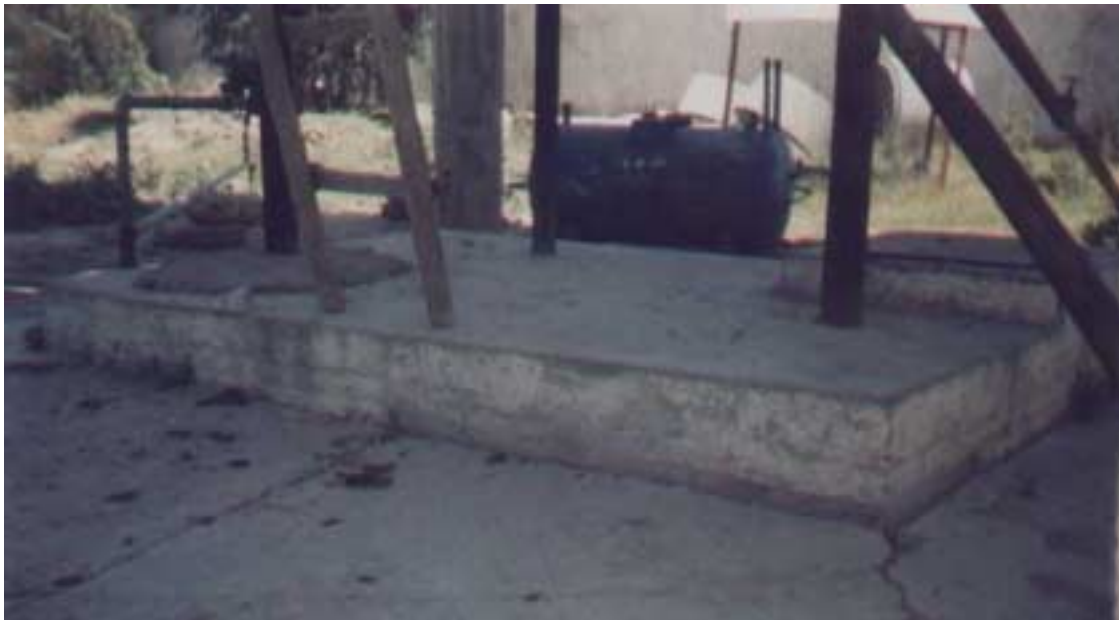
differential settlement of about 5 cm beneath the water-storage tower at the same location (Figure 10.7). Furthermore, uplifting of a concrete water tank was observed beneath the same tower. Similarly, a crack developed through a concrete water pipe near a home at the entrance of Abdioğlu (see Figure 7.48), and goal pillars in the garden of Kazime Özler Primary School between Misis and Abdioğlu, tilted about 8° (Figure 10.8).

Figure 10.7: Differential settlement of 5 cm beneath the water-storage tower at Abdioğlu

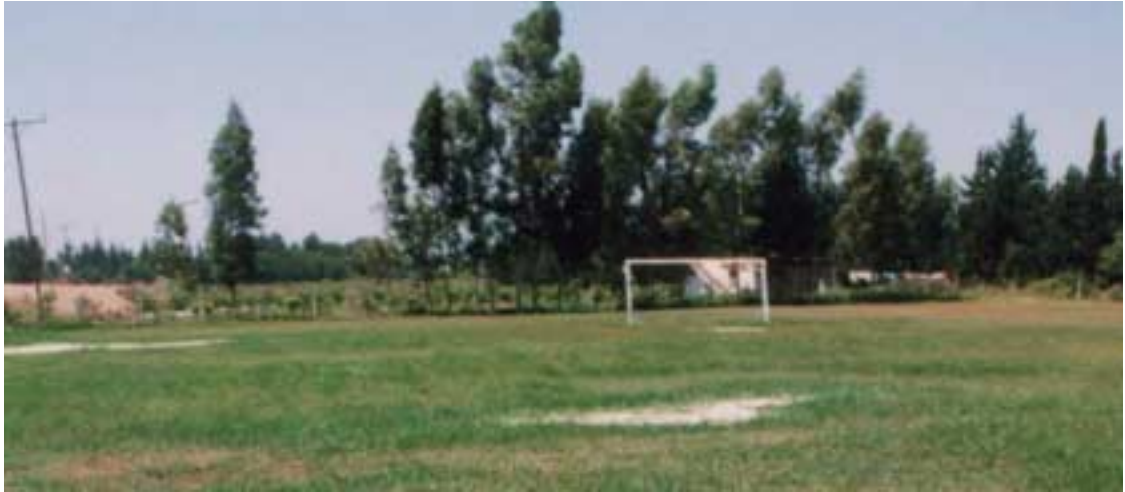
Figure 10.8: Tilted pole and goal pillars in Abdioğlu
