## **7. DAMAGE TO STRUCTURES**

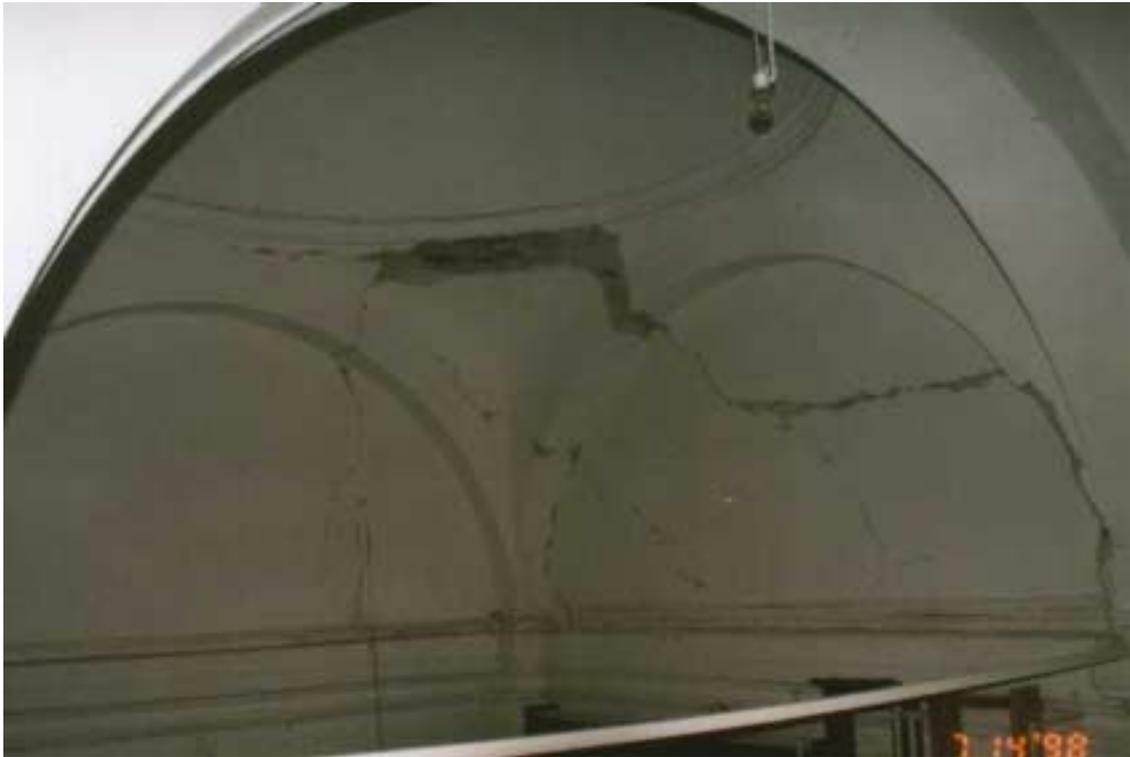
Most of the mosques were intact or suffered very slight damage. Damage was generally concentrated at corners (Figure 7.8). Minarets in the region, which are generally 20 to 25 m high (Figure 7.9) are almost non-reinforced except having a steel pipe going through the centre of the structure. The minarets were masonry type with some anchors put tangentially between blocks of rocks. However, there were no anchors between layers of rock blocks. The direction of the collapses was generally towards the epicenter. Photographs of fallen minarets are shown in Figures 7.10, 7.11 and 7.12. The farthest of fallen minarets from the epicenter was 30 km away.

Figure 7.8 Slightly damaged mosque at corner in Ceyhan

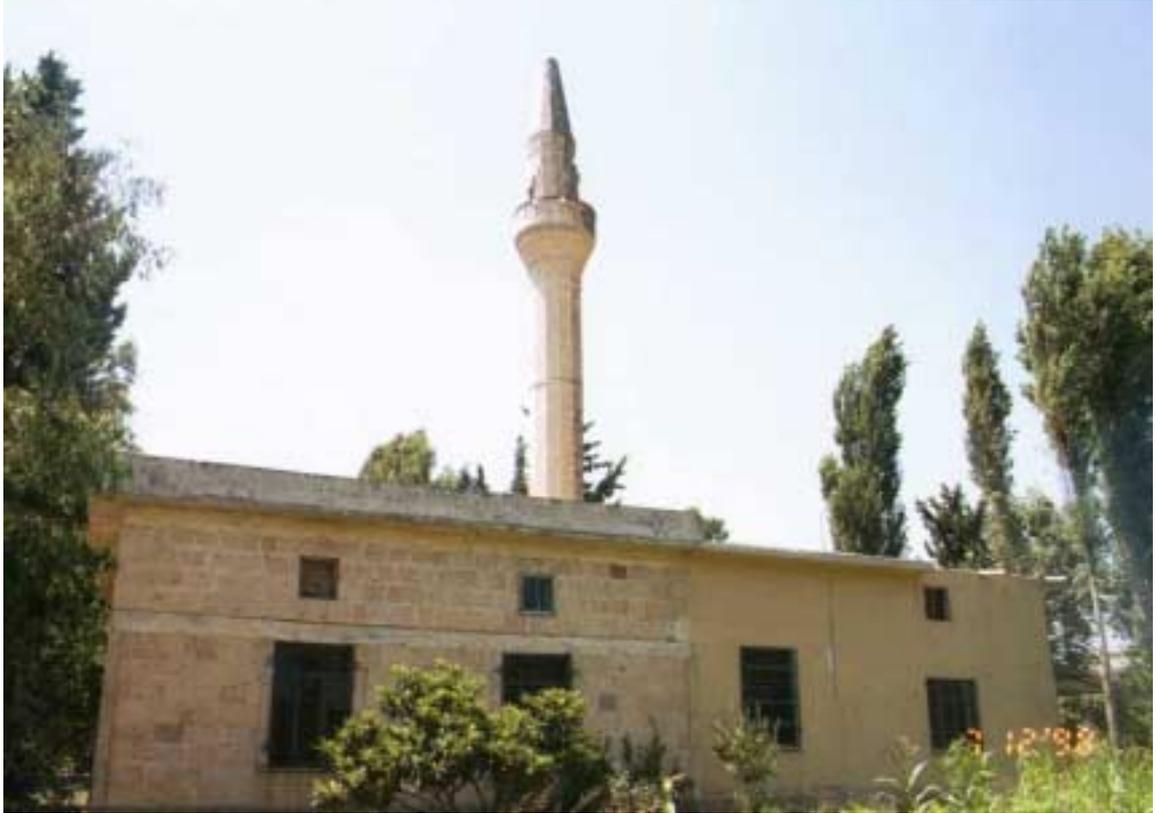
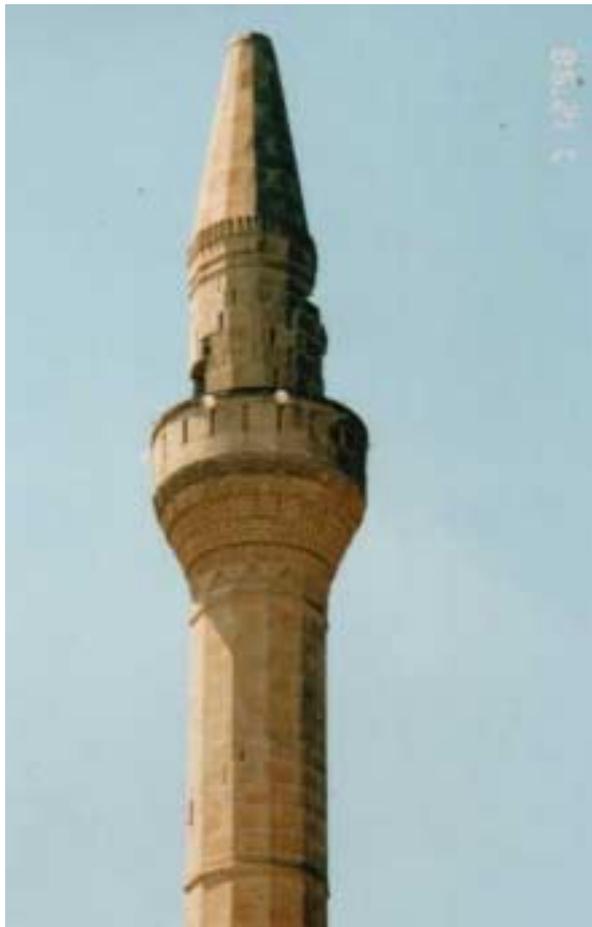
Figure 7.9 Mosque with damaged minaret at Yakapınar village

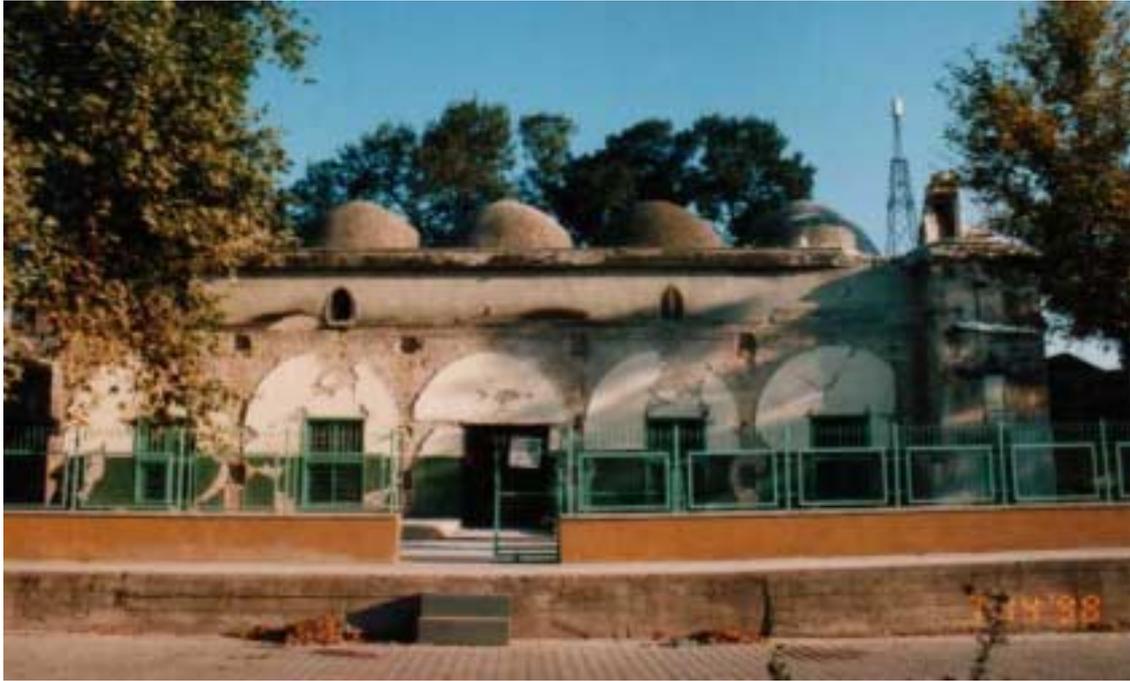
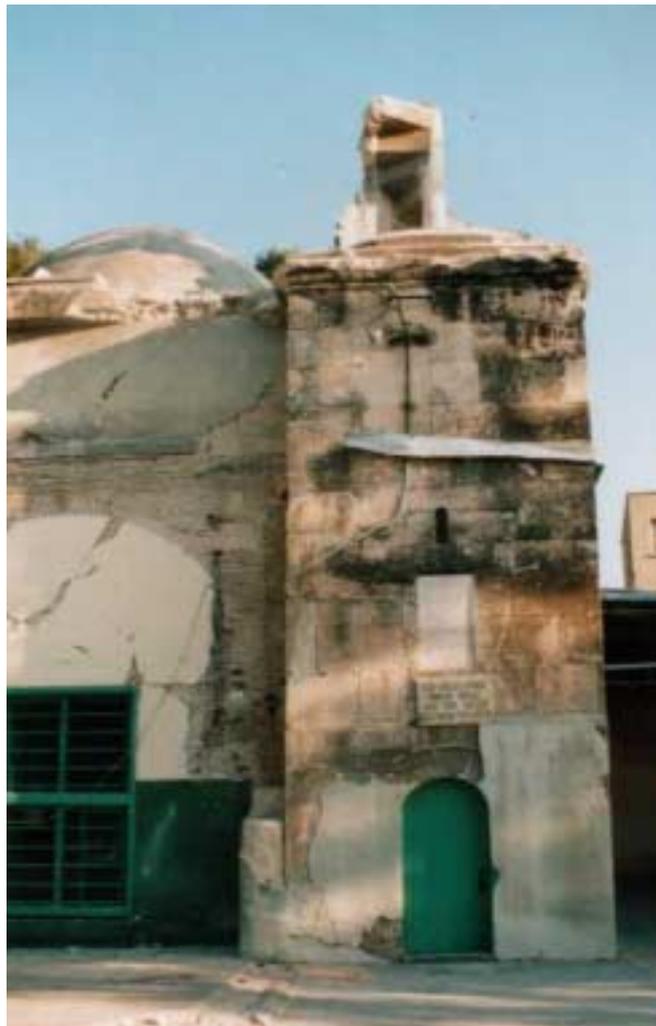
Figure 7.10 Toppled minaret of the mosque in Ceyhan, shown in Figure 7.8

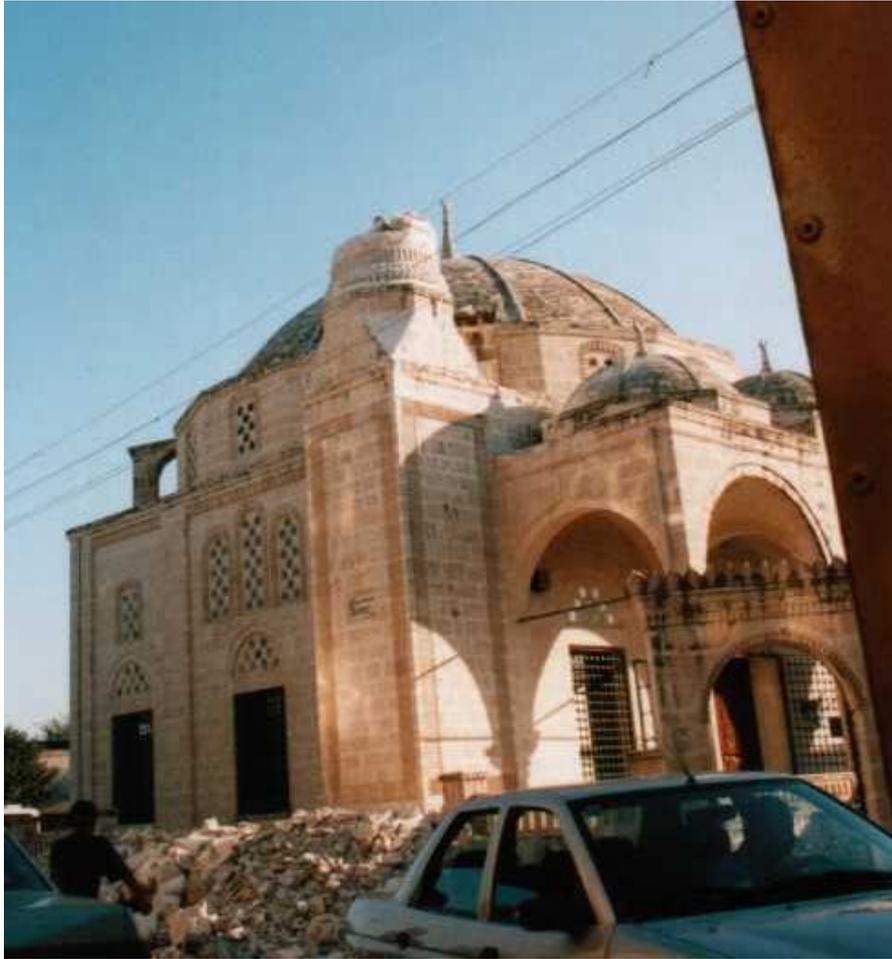
Figure 7.11 Toppled minaret of a mosque in Ceyhan

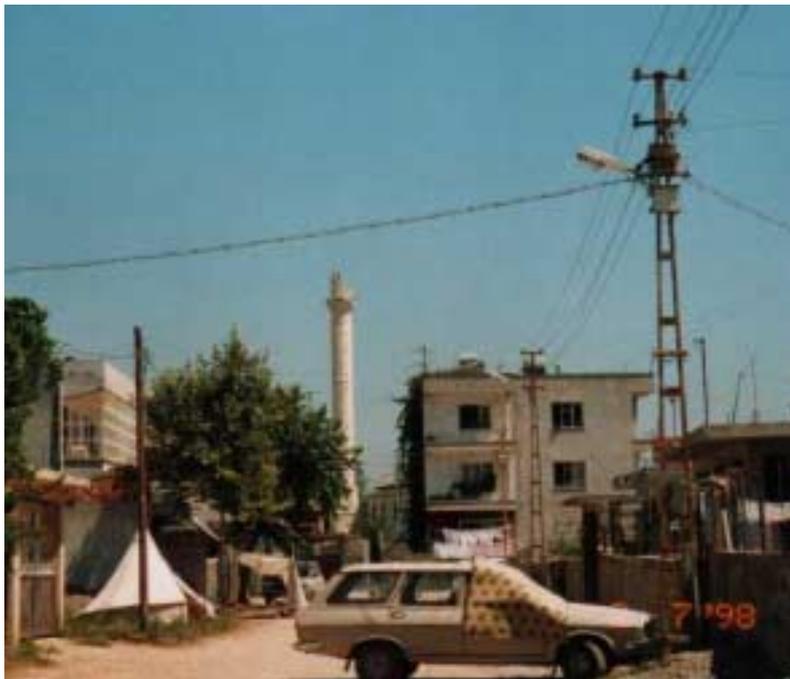
Figure 7.12 Toppled minaret of a mosque in Ceyhan

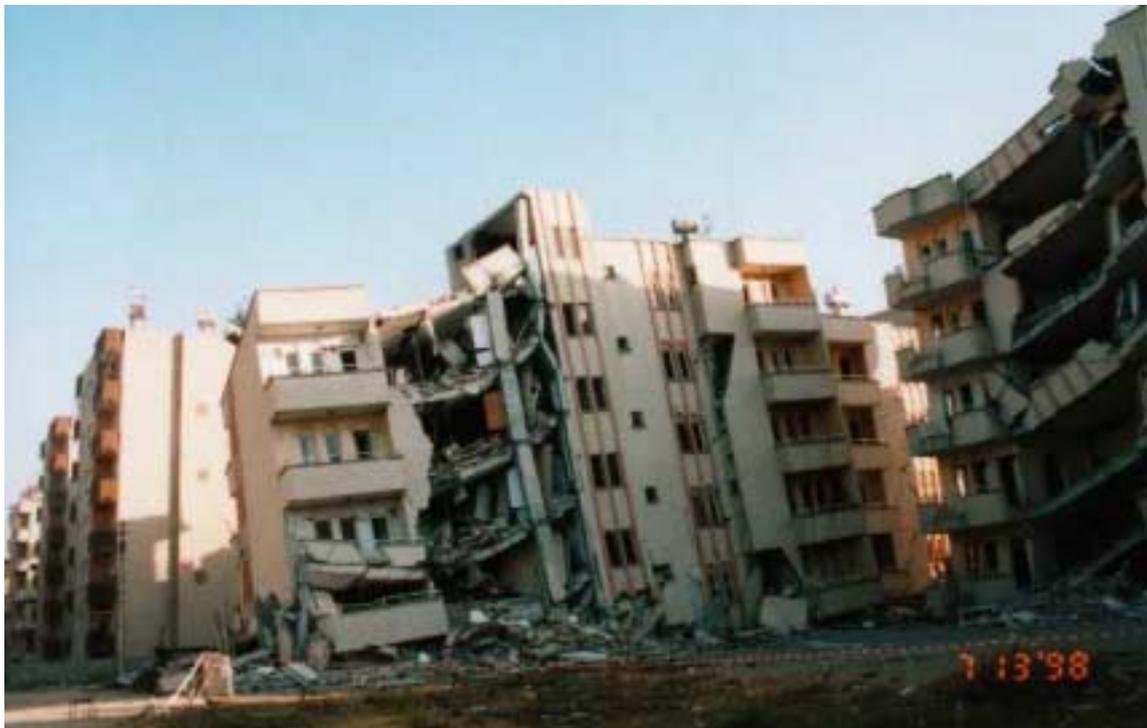
The ground floor of collapsed buildings was used as either shops or garages. As a result, this type of usage constitutes a weak-floor situation. Furthermore, many buildings had balconies of cantilever type.

Figure 7.13 Collapsed 6 stories RC building in Ceyhan with a garage at ground floor

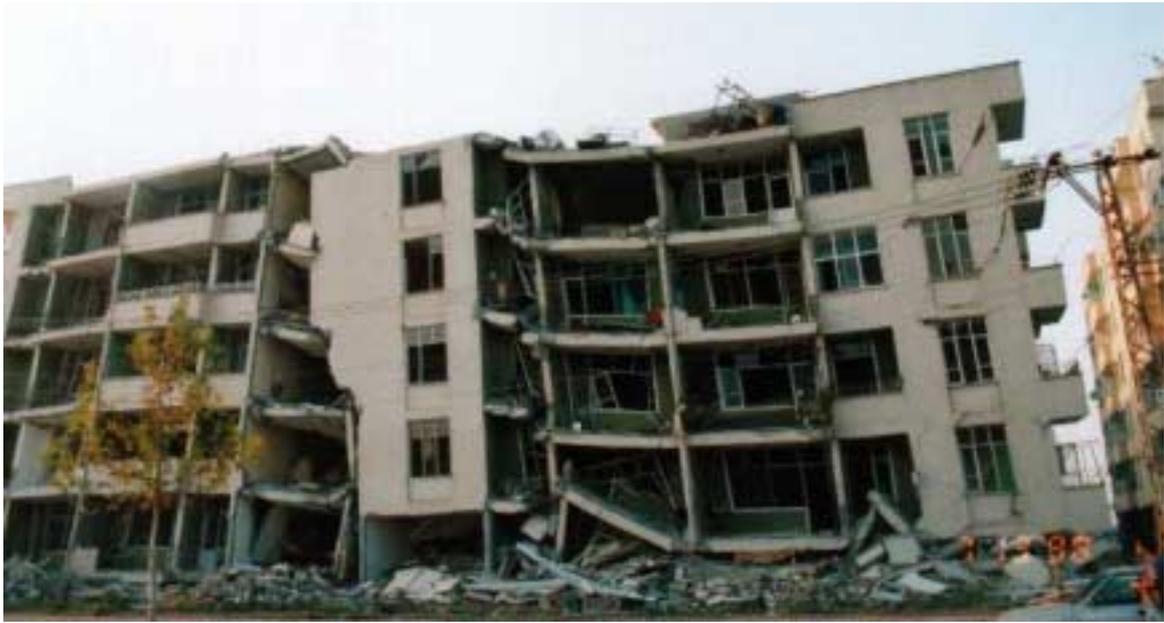
Figure 7.14 Collapsed 5 stories RC building in Ceyhan with shops at ground floor

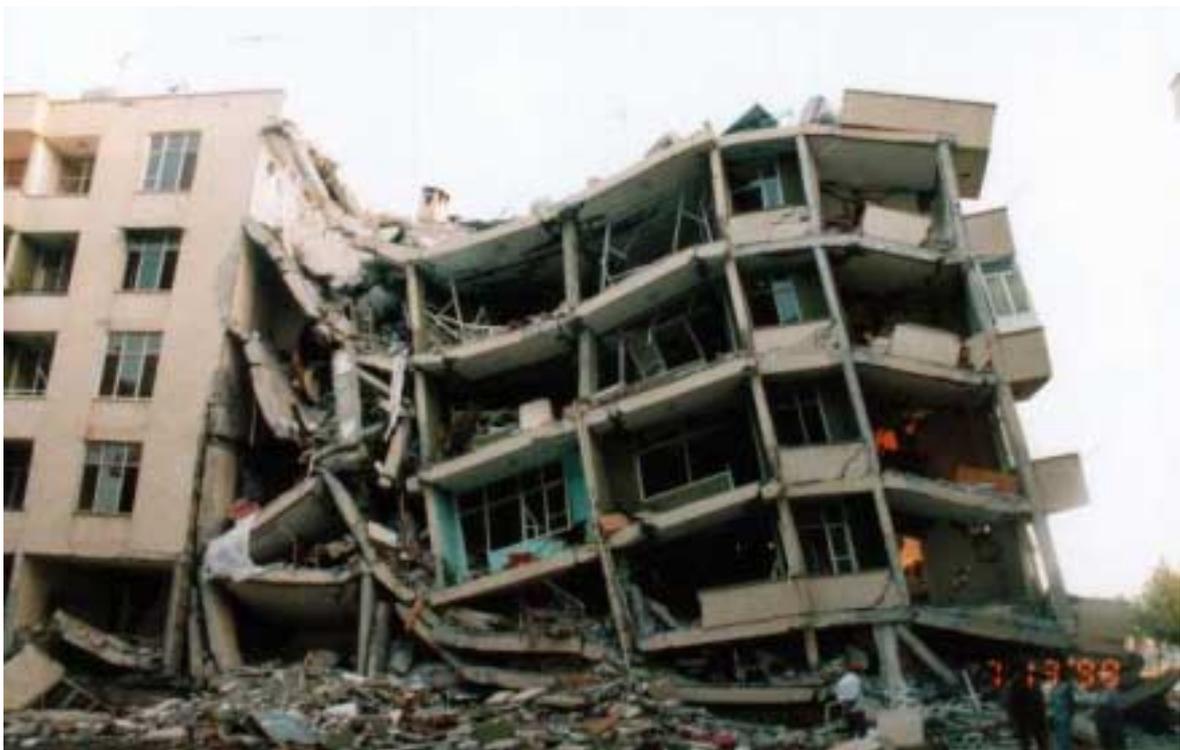
**Collision of Structures:** Many buildings were collapsed as a result of collision with the adjacent building (Figure 7.15). The buildings at the corners mainly collapsed.

Figure 7.15 The collapse of collided 5 and 6 stories RC buildings in Ceyhan with shops at ground floor

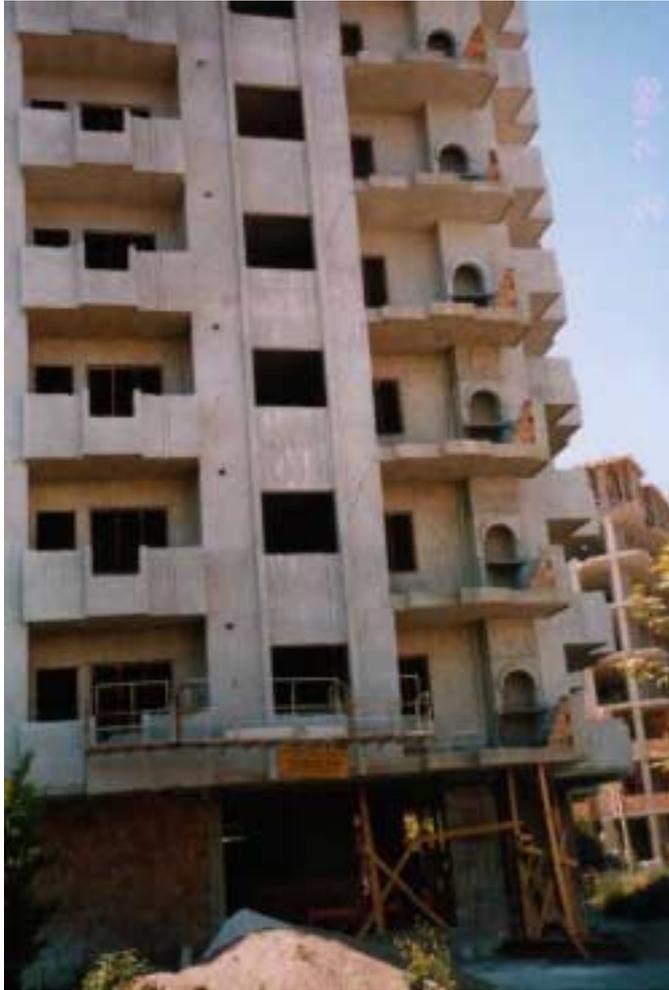
Figure 7.16 Heavily damaged 8 stories building with balconies

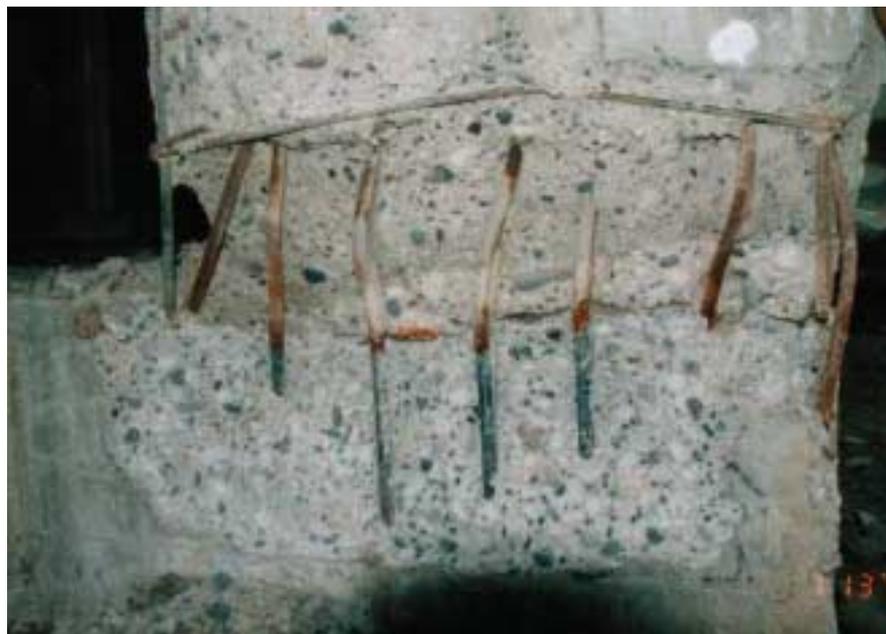
**Poor workmanship:** There are two kinds of poor workmanship. One of them is that the connections of columns and beams were very weak as the connections of steel bars were not properly done and detritus materials at such locations were not cleaned (Figure 7.17 and Figure 7.18).

Figure 7.17 Unproper column-beam connections. Note that reinforcing bars are not hooked with each other

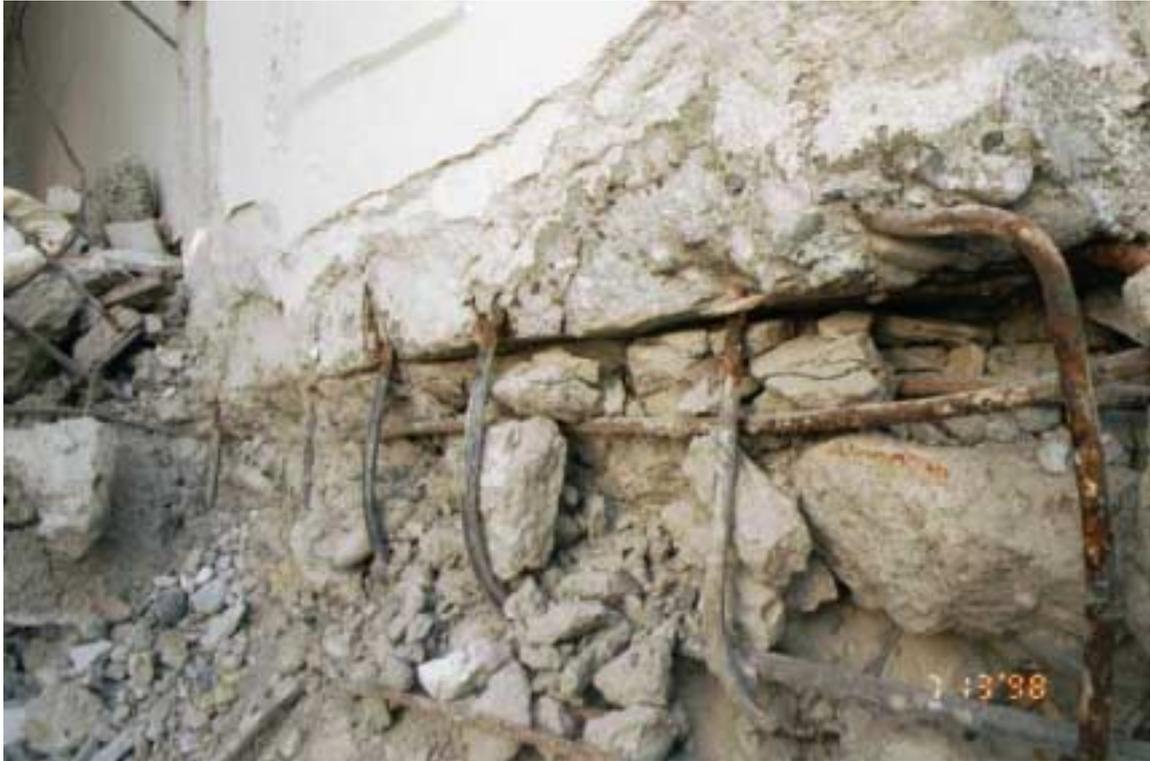
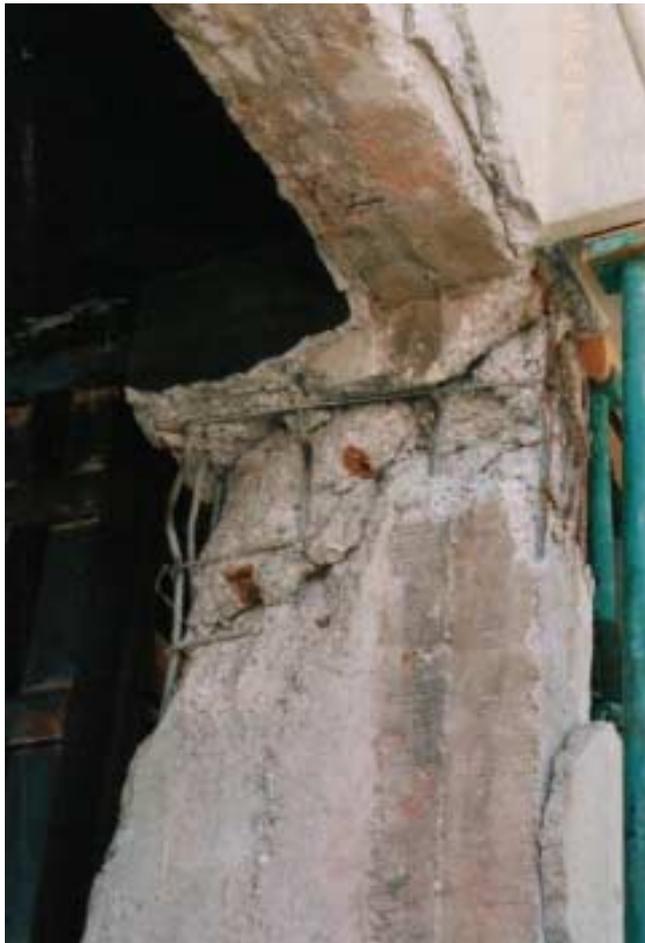
**Granulometry:** The second one is that the granulometry of the sand and gravels of concrete was very poor and the range was wide. In addition, big gravels blocked the concrete during casting at locations where steel connections were dense and this resulted in very porous and weak connections. During the site investigation, such connections were observed by the authors. During shaking, it seems that concrete at the connections first failed and this subsequently caused the buckling of steel bars at such locations.

Figure 7.18 Poor granulometry and detritus material at column-beam connections in a collapsed 5 stories building

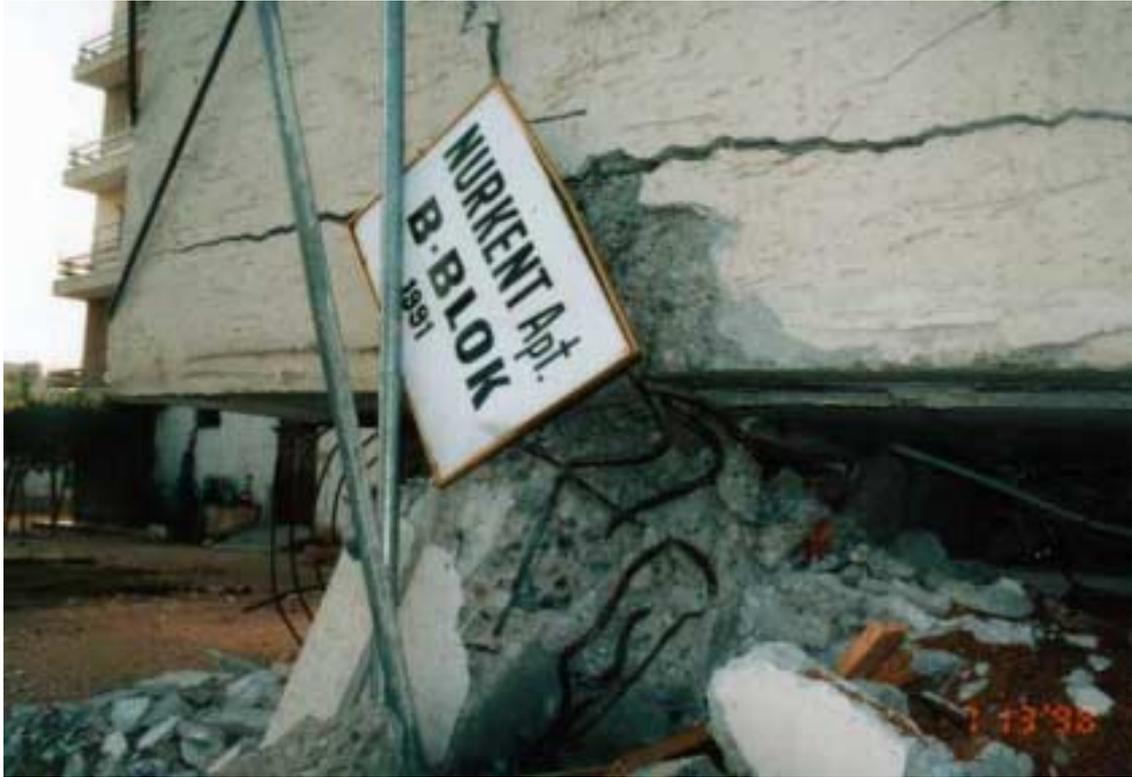
**Design mistakes:** One of the most striking design mistake was the confinement of concrete at the beam-column connections (Figure 7.19) in-spite of the Turkish design code for seismic regions. As stir-ups were very few at such locations, the failure of concrete was very brittle and it could not absorb the work done by the earthquake forces.

Figure 7.19 Unproper column-beam connections. Note that reinforcing bars with small diameter and large spacing of stir-ups

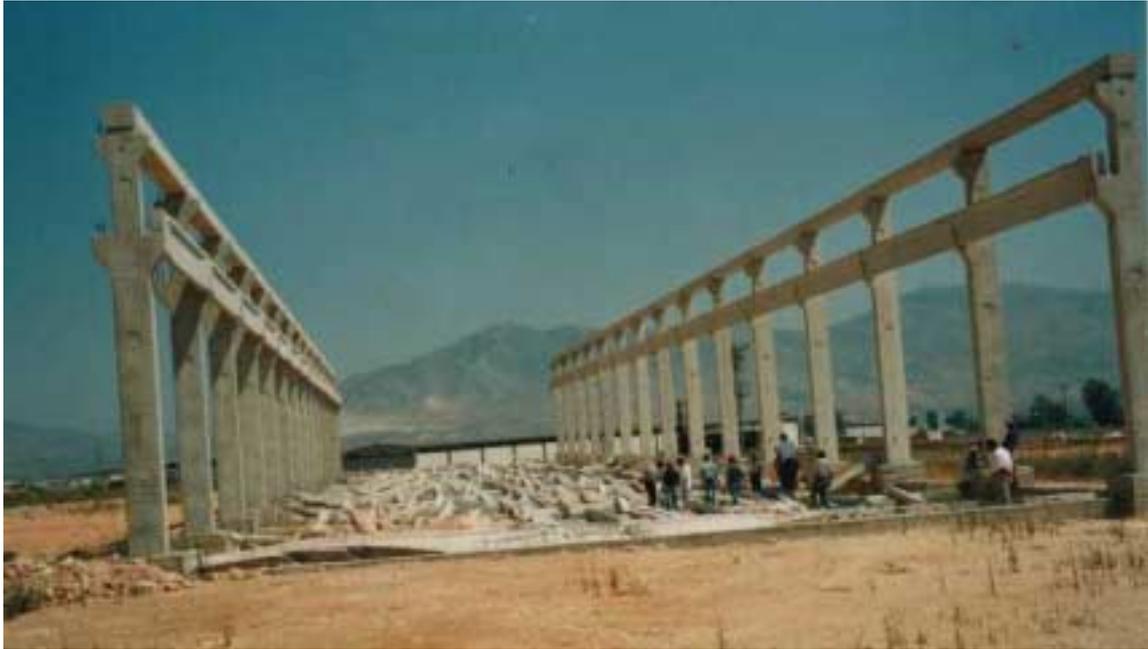
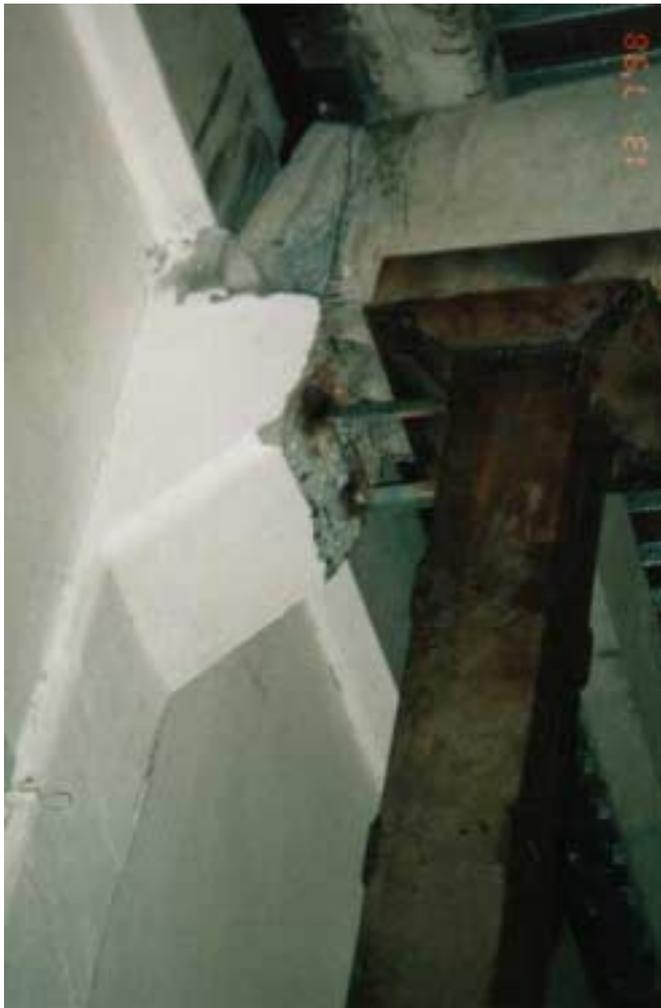
Adana province has been heavily industrialized and there are many big factories. Most of these factories are pre-fabrique structures. Even the ground consisted of travertines or calich was quite firm, some of roof beams of such structure toppled. Figure 7.20 shows such a structure, which was under construction. Roof beams were broken at connections with columns during shaking as a result of either splitting of beam concrete or corbels of concrete columns.

Figure 7.20 A pre-fabrique structure with fallen roof beams and a close-up view of beam-column connection at ground floor

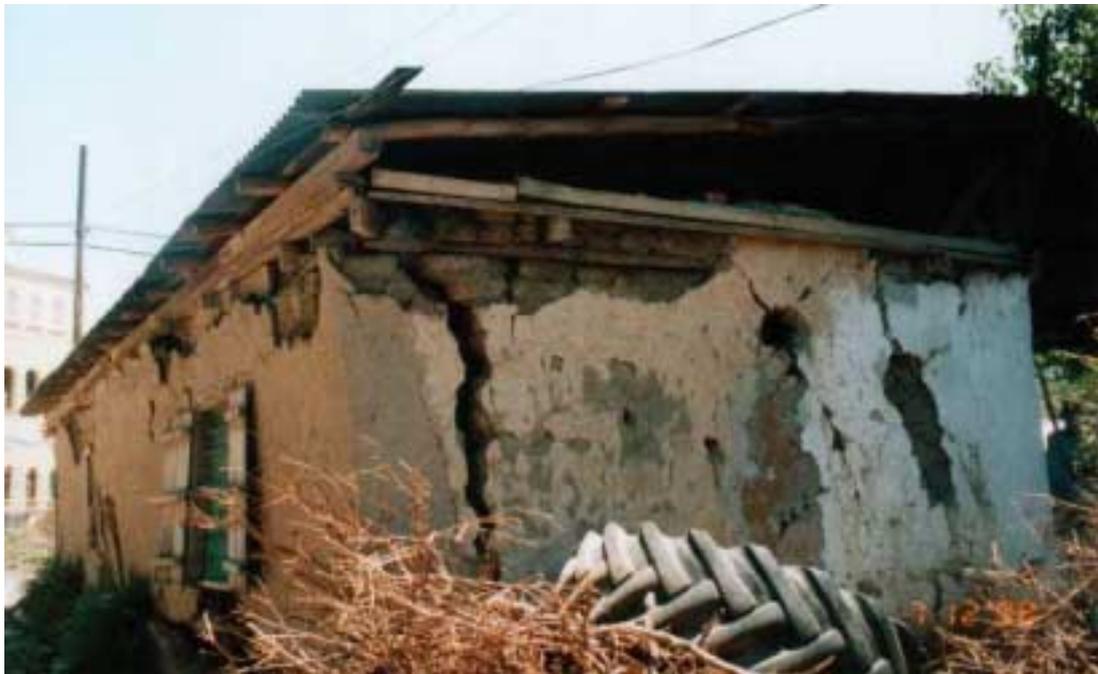
Translational and out of plane failures took place as seen in Figure 7.21. In some houses which are reinforced by concrete and having light roofs, no cracking and no damage were observed even they were founded on alluvial deposits. However, these structures are very few in this region.

Figure 7.21 Out of plane failure of a kerpiç (adobe) house

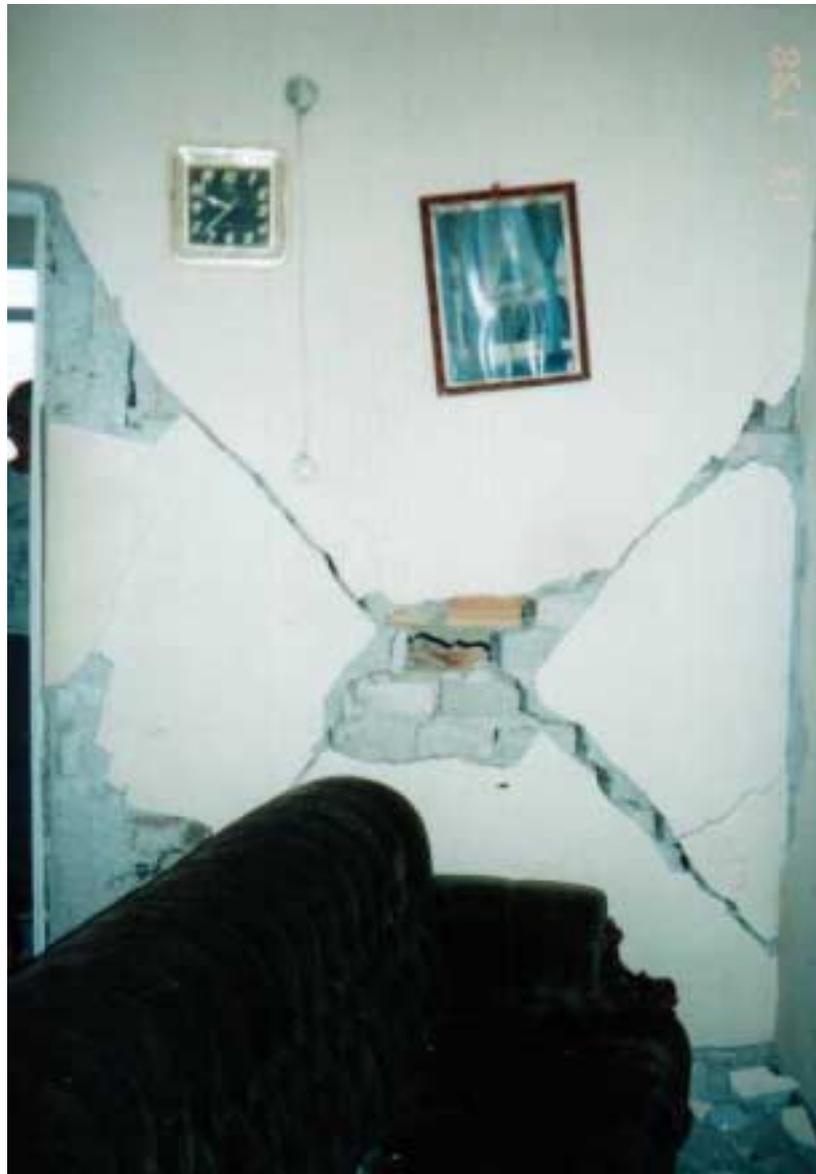
The most severe damage was observed in houses made of delikli Tuğla (hollow bricks). Although the use of this type of brick as a load bearing element was forbidden after the experience in 1992 Erzincan earthquake, its use is wide-spread. It should be noted that this material is very brittle. Once it starts to fail it will fail very quickly as stress-concentrations develop everywhere (Figure 7.22). The houses made with solid bricks and reinforced with concrete slabs for the continuity of structures and having stories less than two performed very well during the earthquake (Figure 7.23 and Figure 7.24).

Figure 7.22 Shear failure of a wall built with delikli Tuğla (hollow bricks)

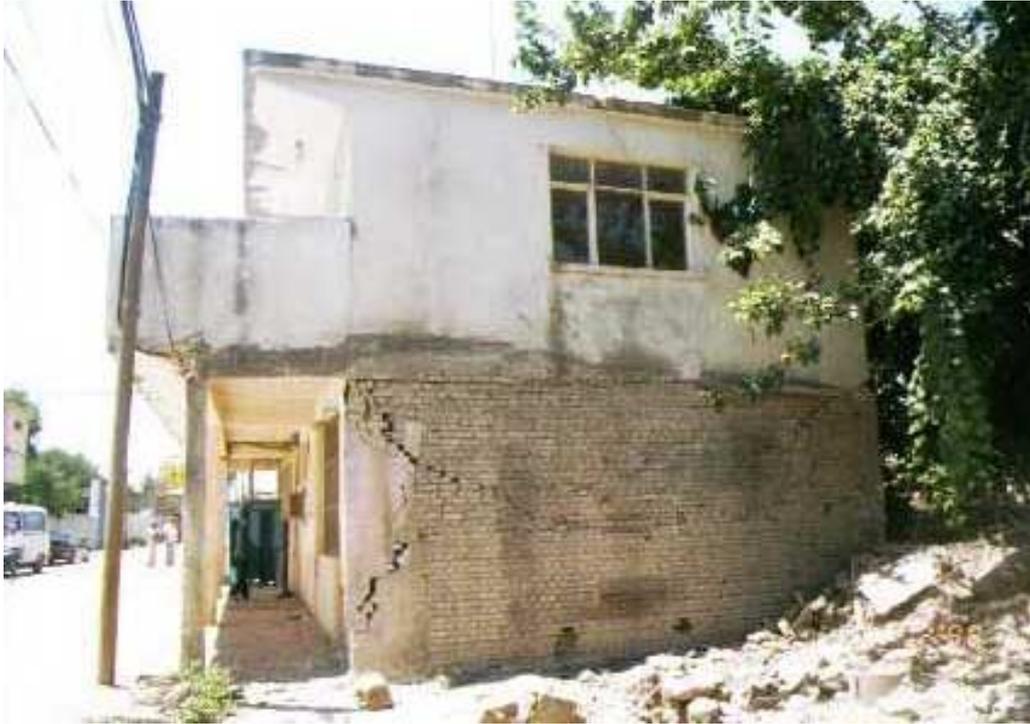
Figure 7.23 Shear failure of a wall built with Horasan tuğla (solid bricks) with continuous concrete slabs in Abdioglu village

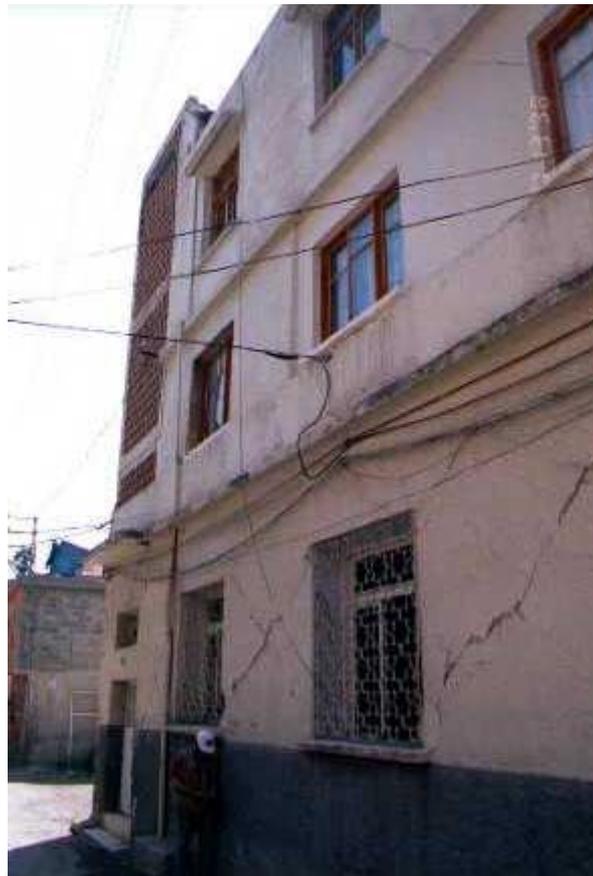
Figure 7.24 Shear failure of a wall built with Horasan tuğla (solid bricks) with continuous concrete slabs in Adana city

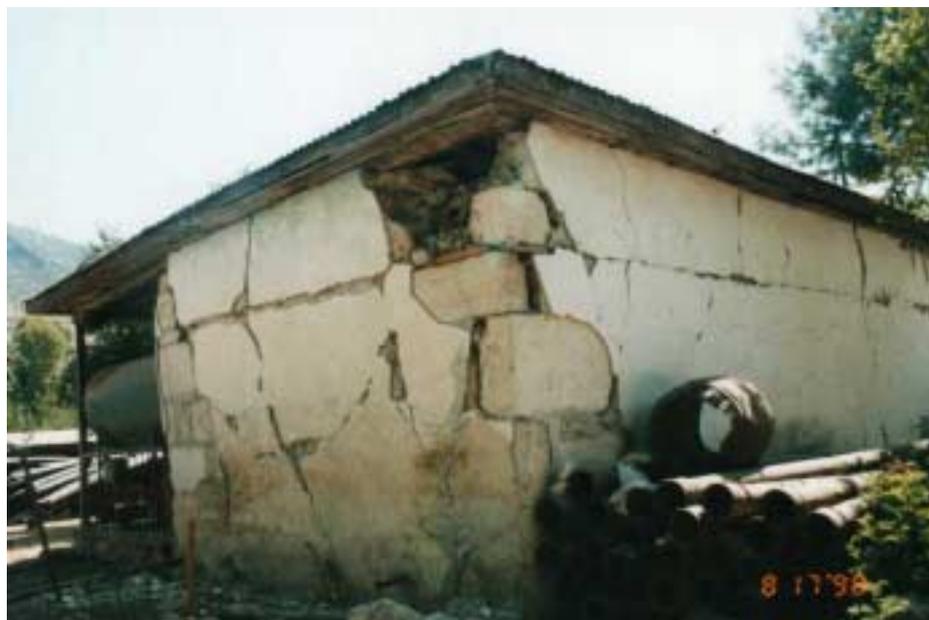
(a) Damaged taş masonry house

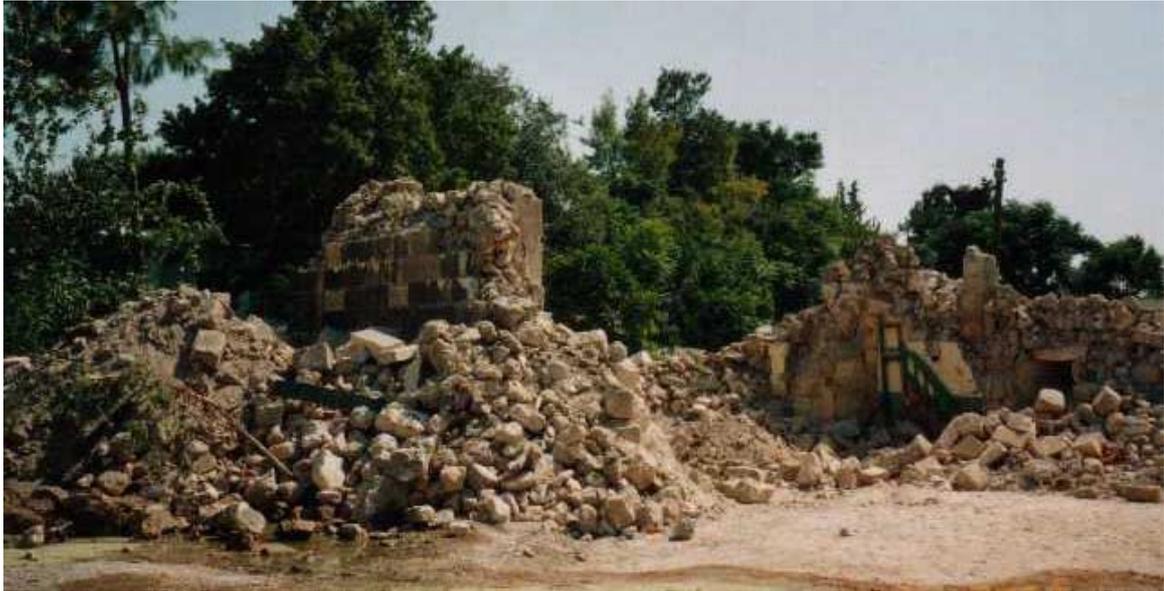
Figure 7.26 Collapsed mosque at Geçitli village (previously was a church)

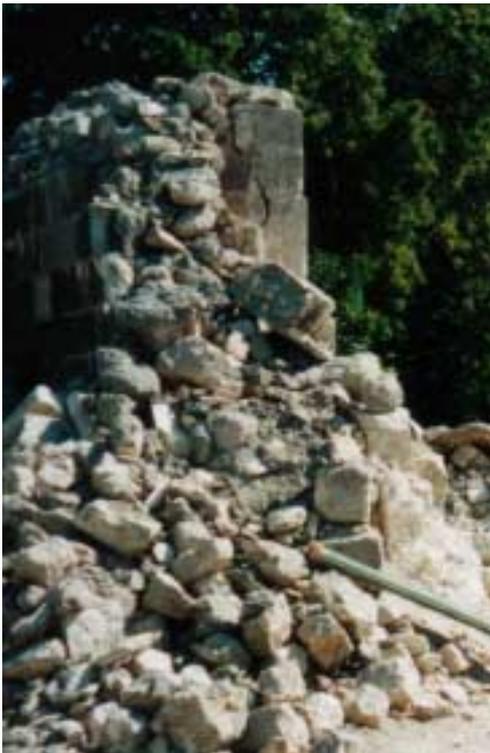
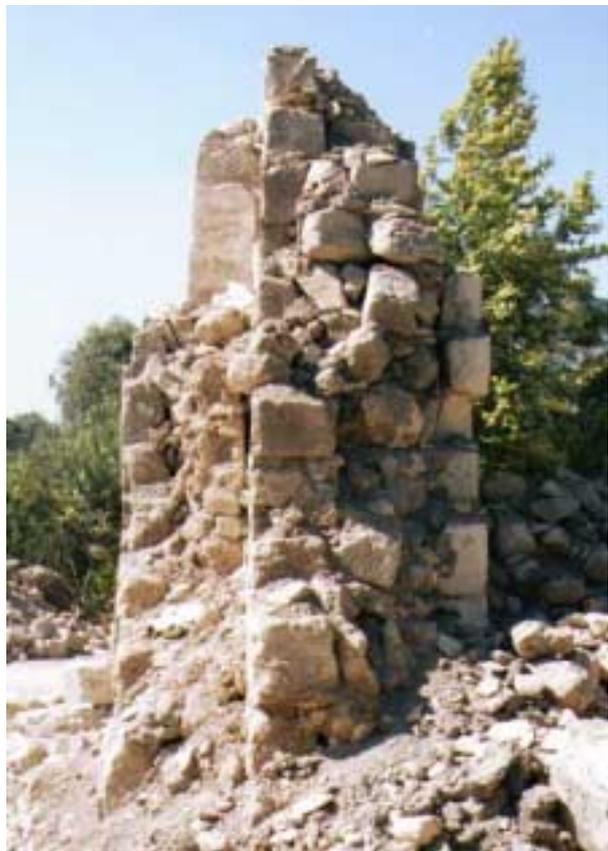
Figure 7.27 Close-up views of the wall of the collapsed mosque at Geçitli village

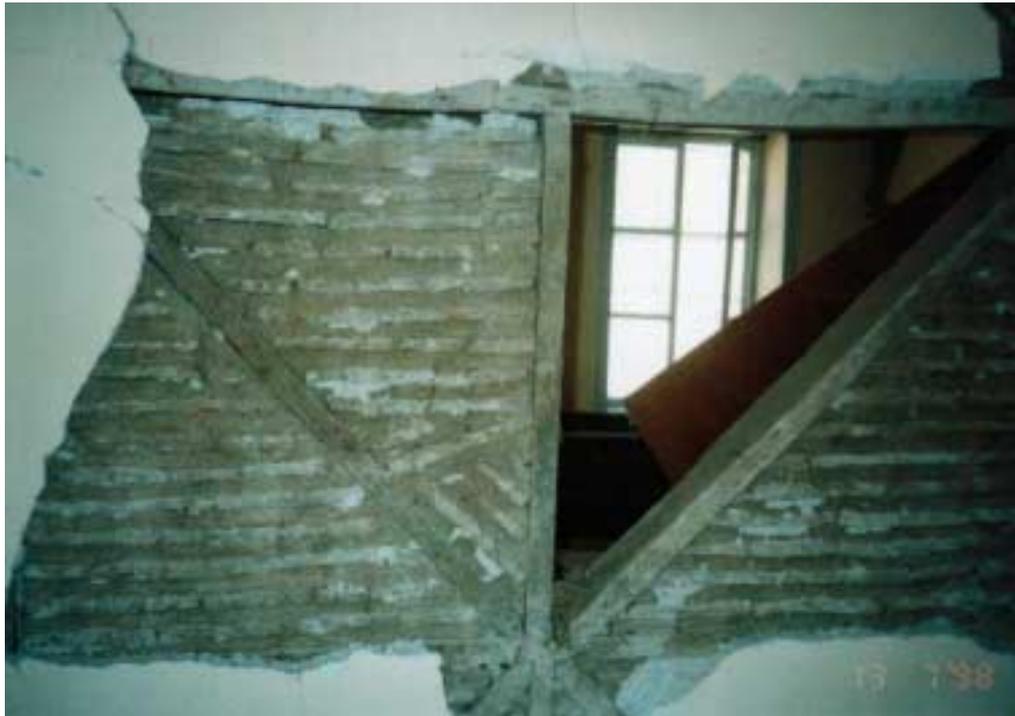
This type of buildings are generally common when wood is locally available and cheap. The filling material of these type houses is adobe and they are mostly old. Even though these structures were very old, they performed much better than so-called modern RC structures. The damage of these houses was taken place in the form of falling plasters or in-fill walls (Figure 7.28).

Figure 7.28 A close-up view of Himiř house having its plaster and a part of in-fill wall fallen in Adana city

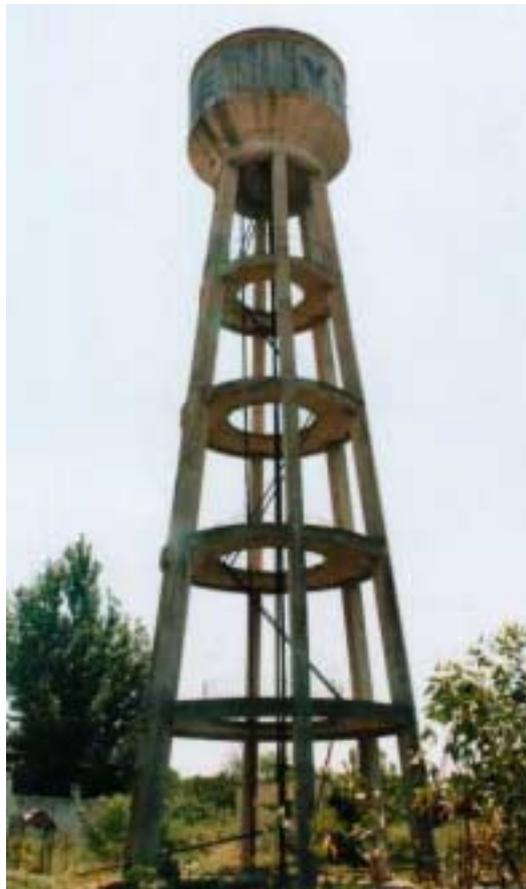
Water towers are RC structures and their height generally ranges between 25-30 meters. The towers have 6 columns and they are symmetric structures. Figure 7.29 shows a water tower in Adana city next to Seyhan dam. No damage was observed at this water tower. The water tower in Abdiođlu village was only slightly damaged (Figure 7.30). A close examination of the columns showed spalling of cover concrete of columns and the settlement of ground by 5 cm around them due to limited liquefaction.

Figure 7.30 Slightly damaged water tower in Abdioğlu village

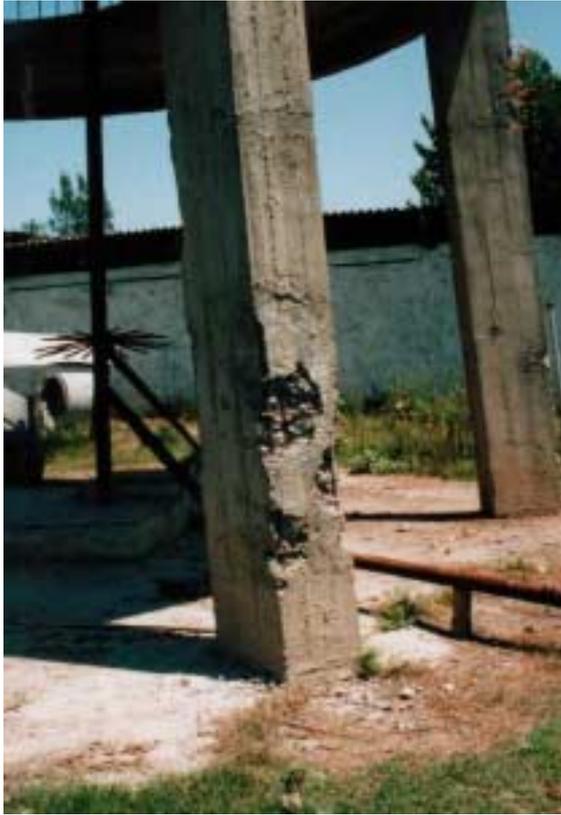
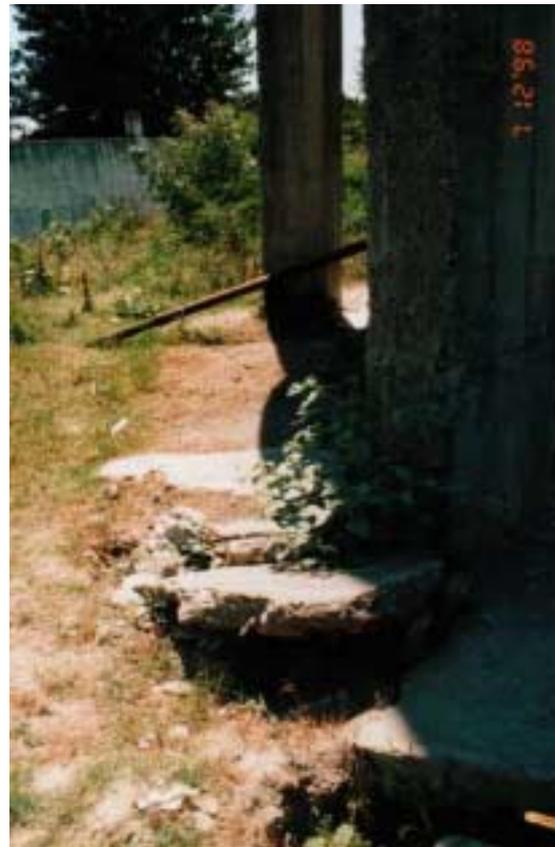
Figure 7.31 A close-up view of damaged column and settled ground around columns

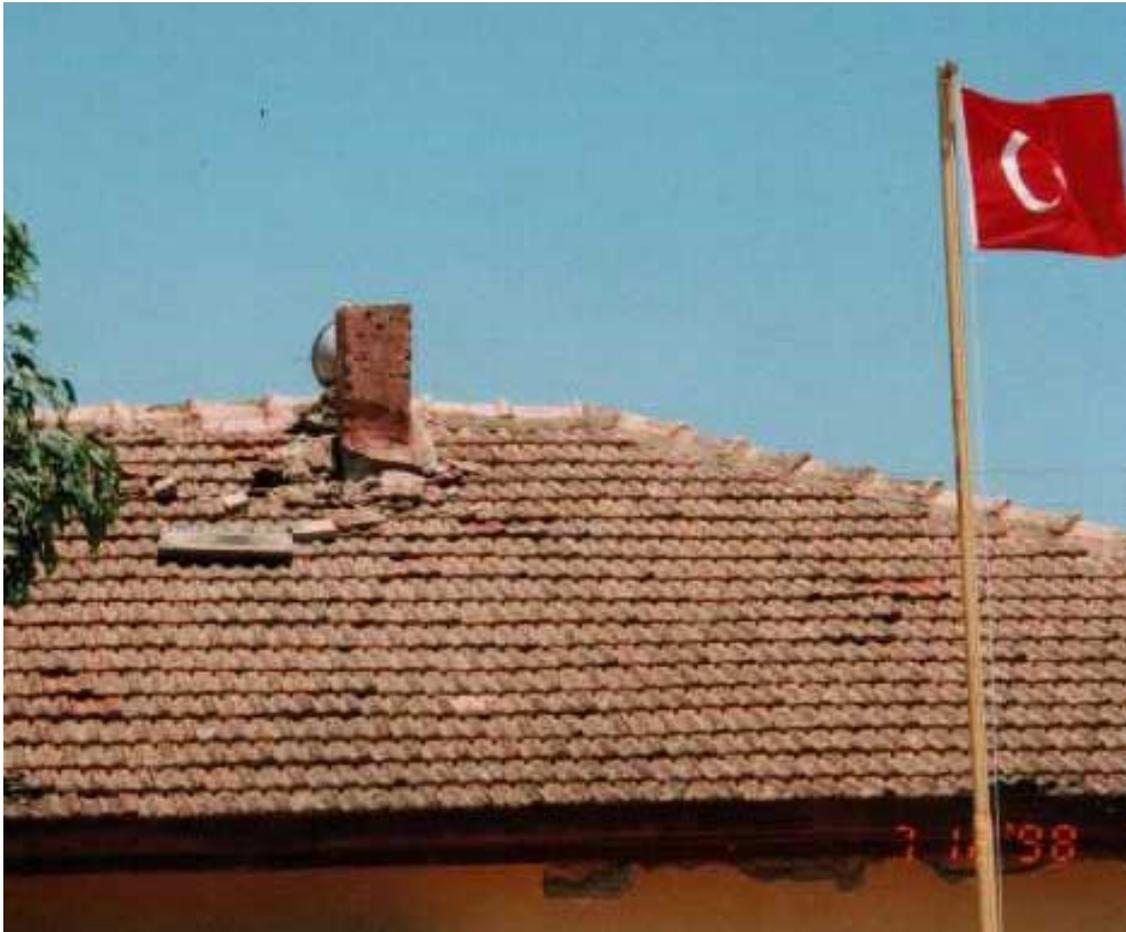
Figure 7.33 Damaged chimney of a 1 story building in Abdioğlu village
