## **7. DAMAGE TO STRUCTURES**

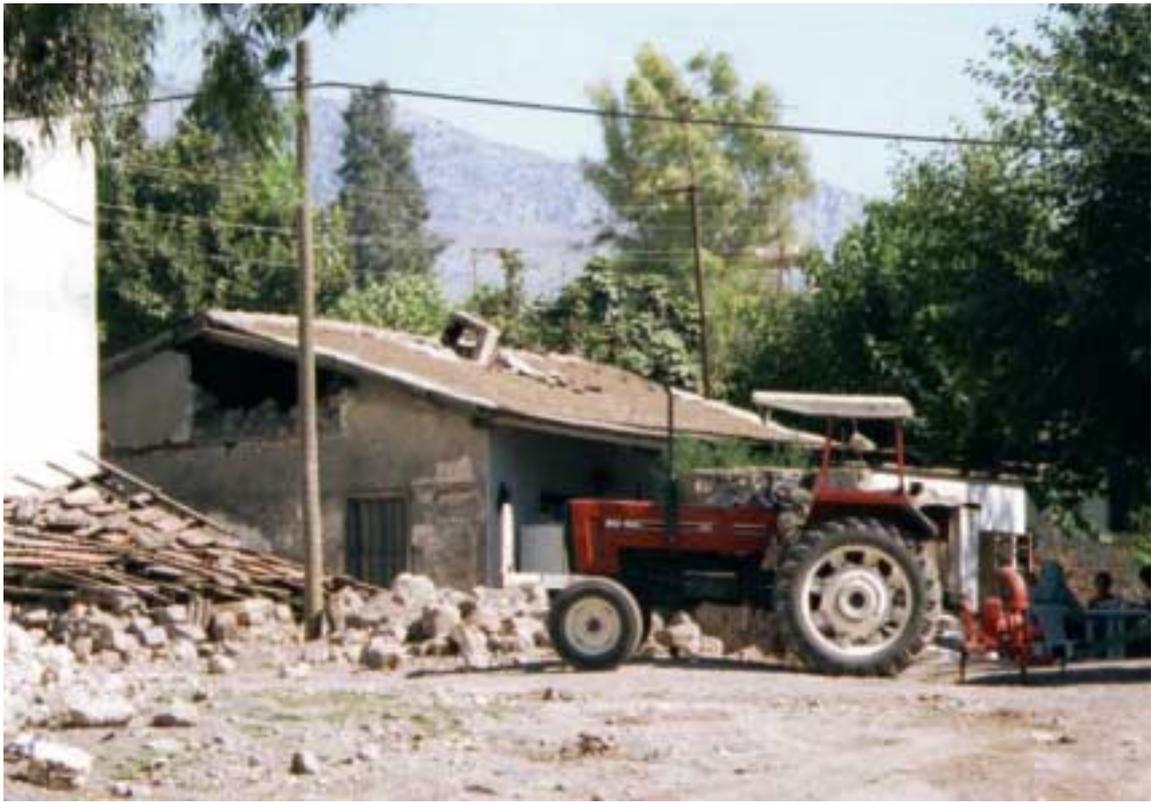
Figure 7.34 A toppled chimney in Geçitli village

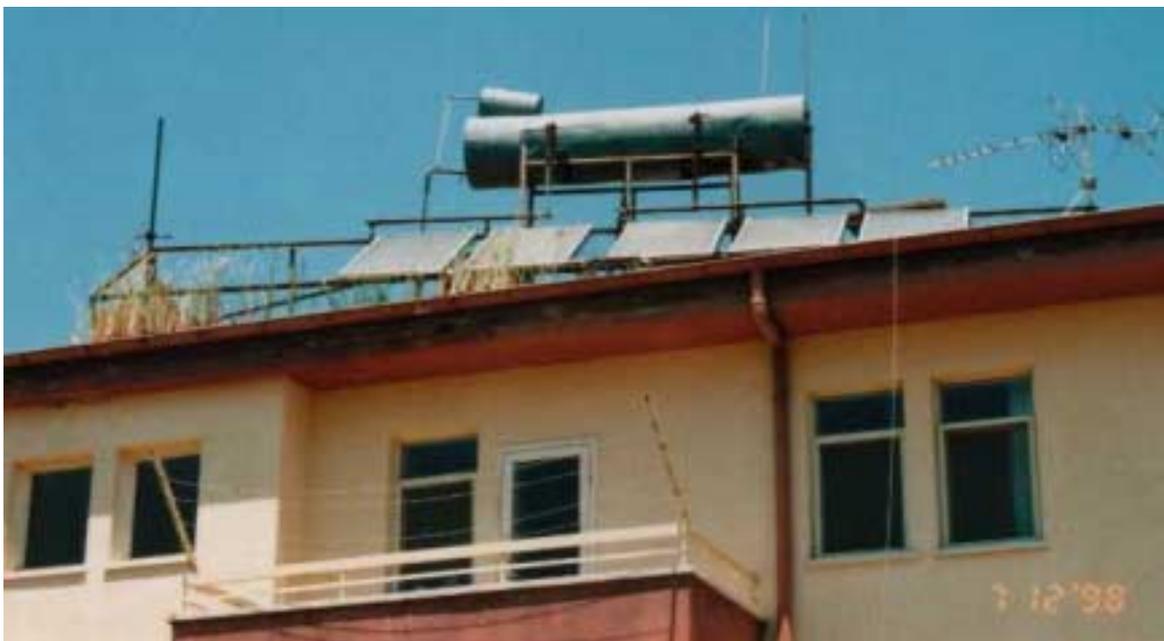
Figure 7.35 A slightly damaged and displaced solar energy panels

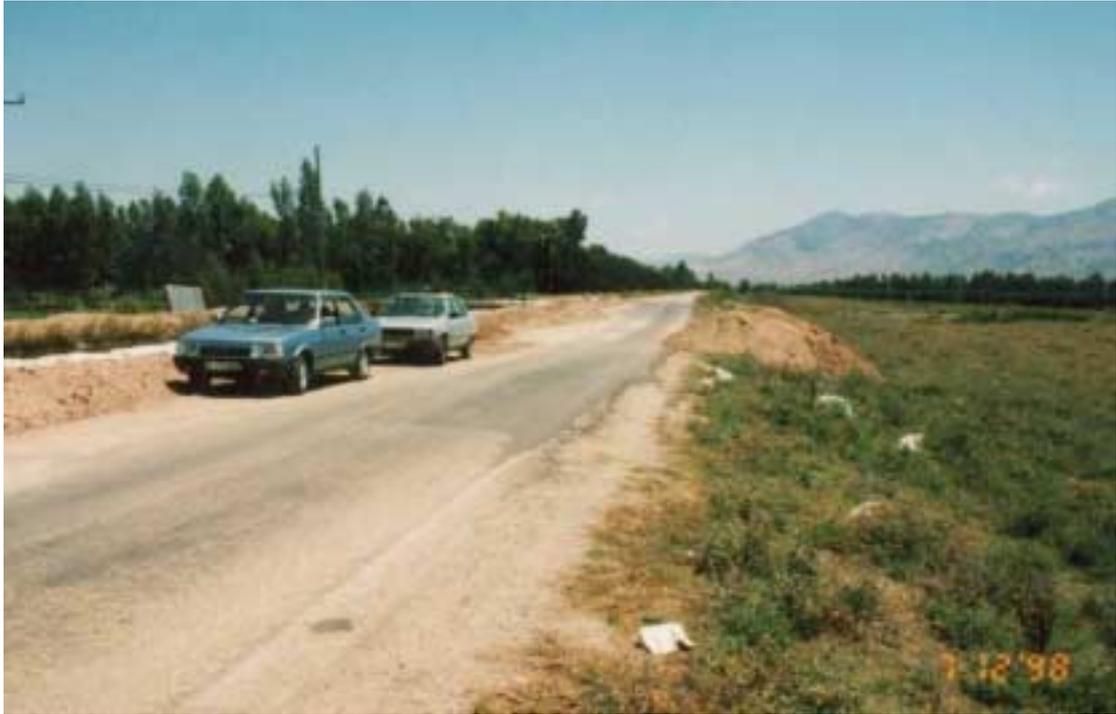
Figure 7.39 Settlement of roadway embankment near Abdioğlu village

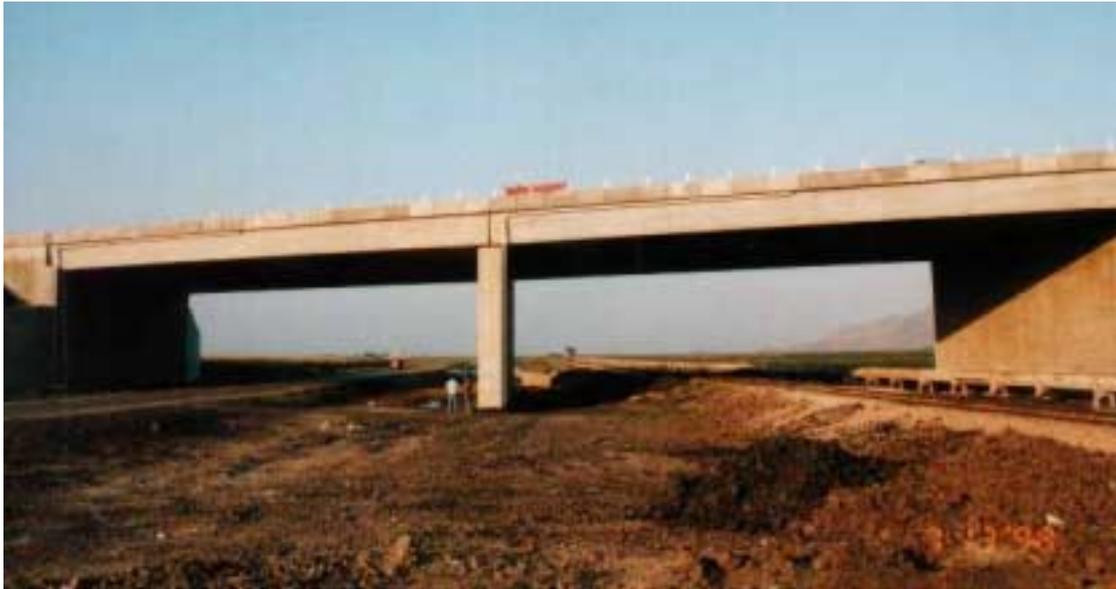
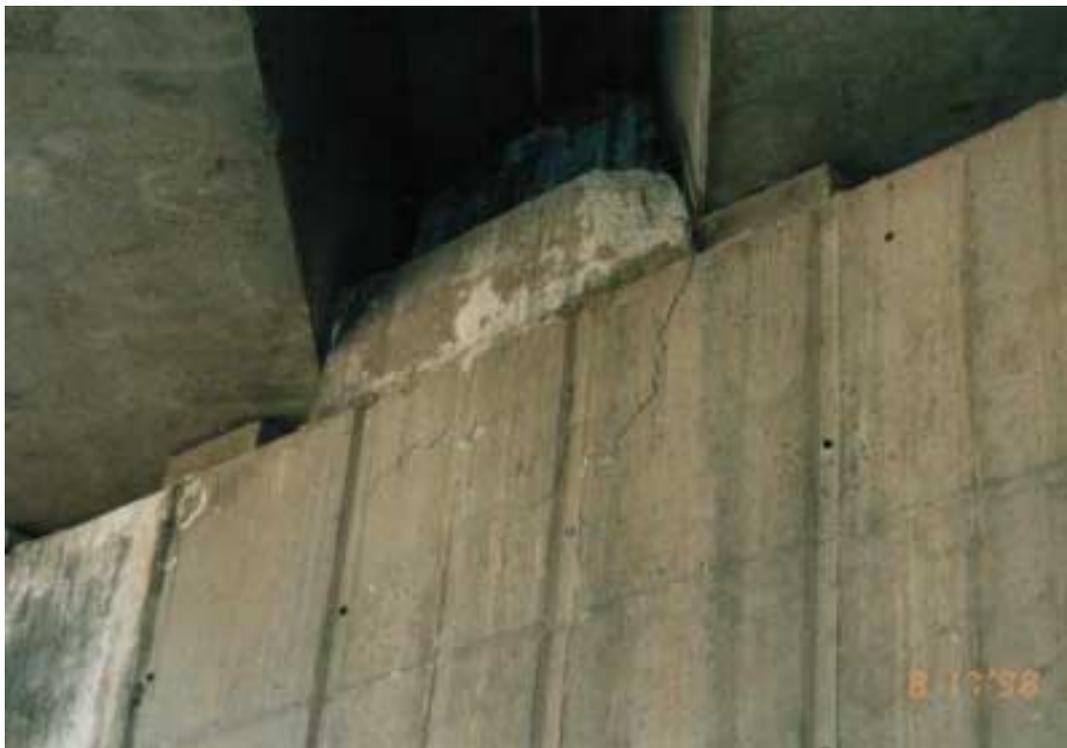
During the investigation, five damaged bridges were observed. Two damaged bridges were overpass bridges on the E-5 expressway and highway. The damage were slight so that there was no effect on their function. The damage was due to shaking of girders perpendicular to the axis of the bridge and concrete blocks at abutments between girders were fractured due to bending (Figure 7.40). The third damaged bridge was observed at Sirkeli village. The girders of this bridge was fractured at supports due to bending. However, the damage does not hinder the passage of vehicles (Figure 7.41(a)).

Figure 7.40 Slightly damaged overpass bridge on E-5 expressway in Ceyhan

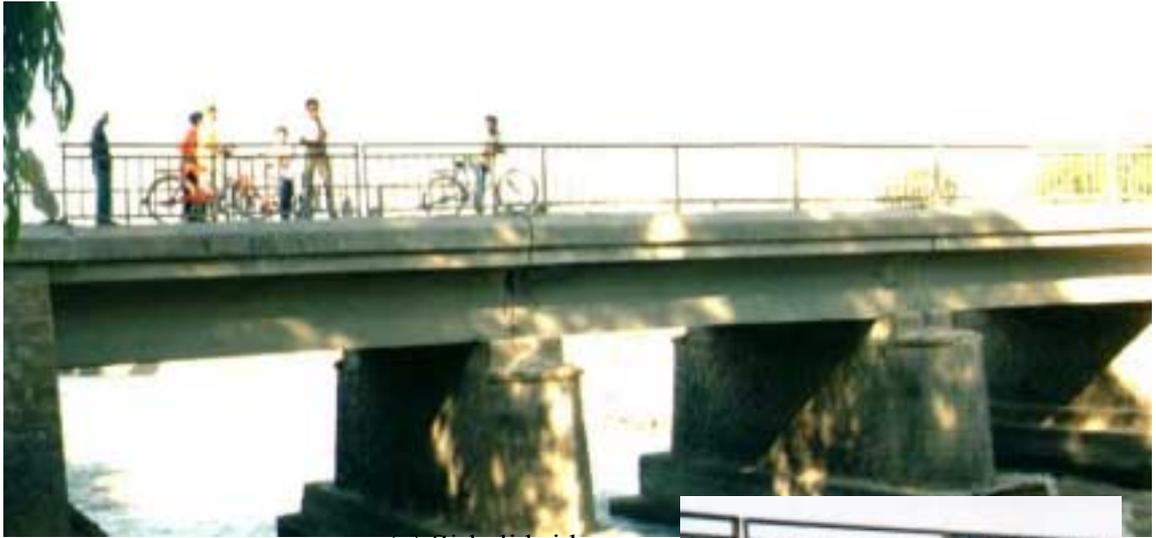
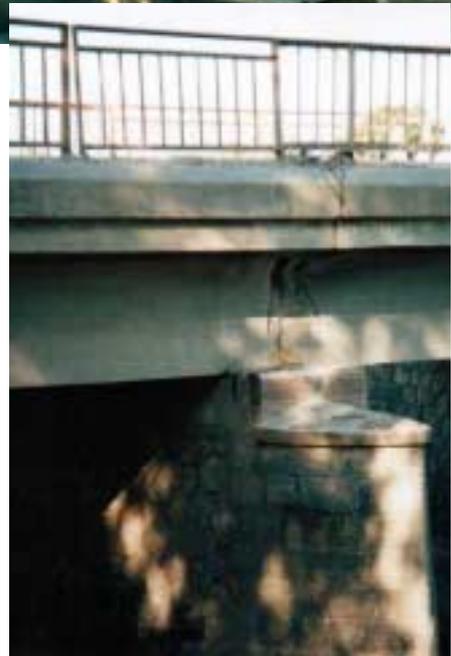
b) Close-up view of the damaged bearing

Figure 7.41 Damaged bridges: (a,b) Sirkeli village (b) Lokman Hekim Bridge

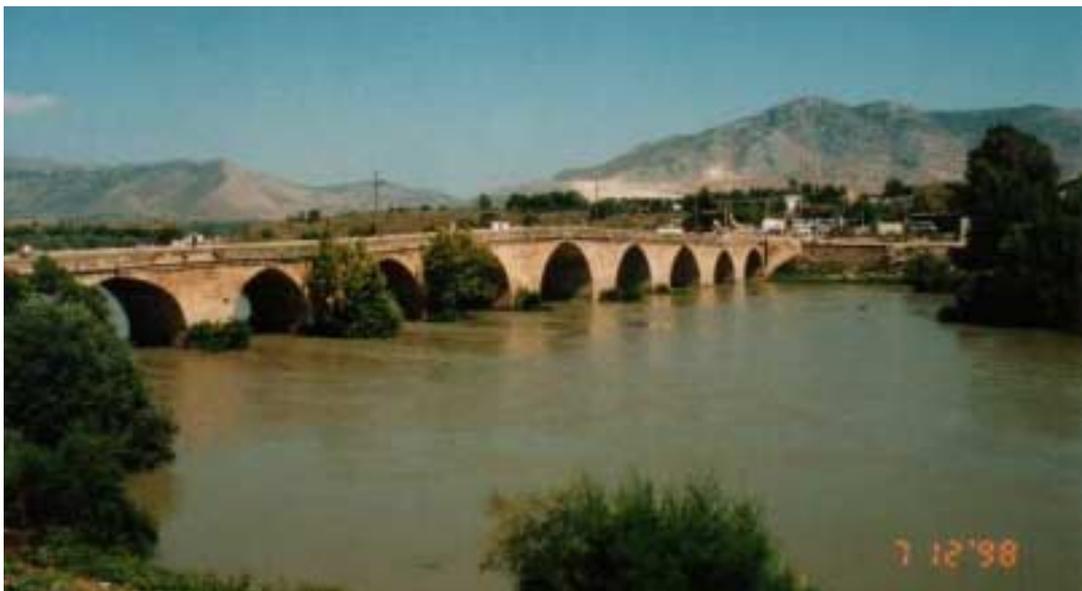
The most severe damage was observed at a stone masonry bridge, called Lokman Hekim Bridge after a Holyman who appears in Qur'an (Figure 7.41(b)) and built in AD 6 century. This is an 10-arched masonry bridge and it is 132.7 m long and 6.50 m wide. The stone blocks are sandstone. There is a permanent relative displacement of the bridge between its abutments. As a result, fracturing and separation of blocks were observed (Figures 6.13, 7.42 and 7.43).

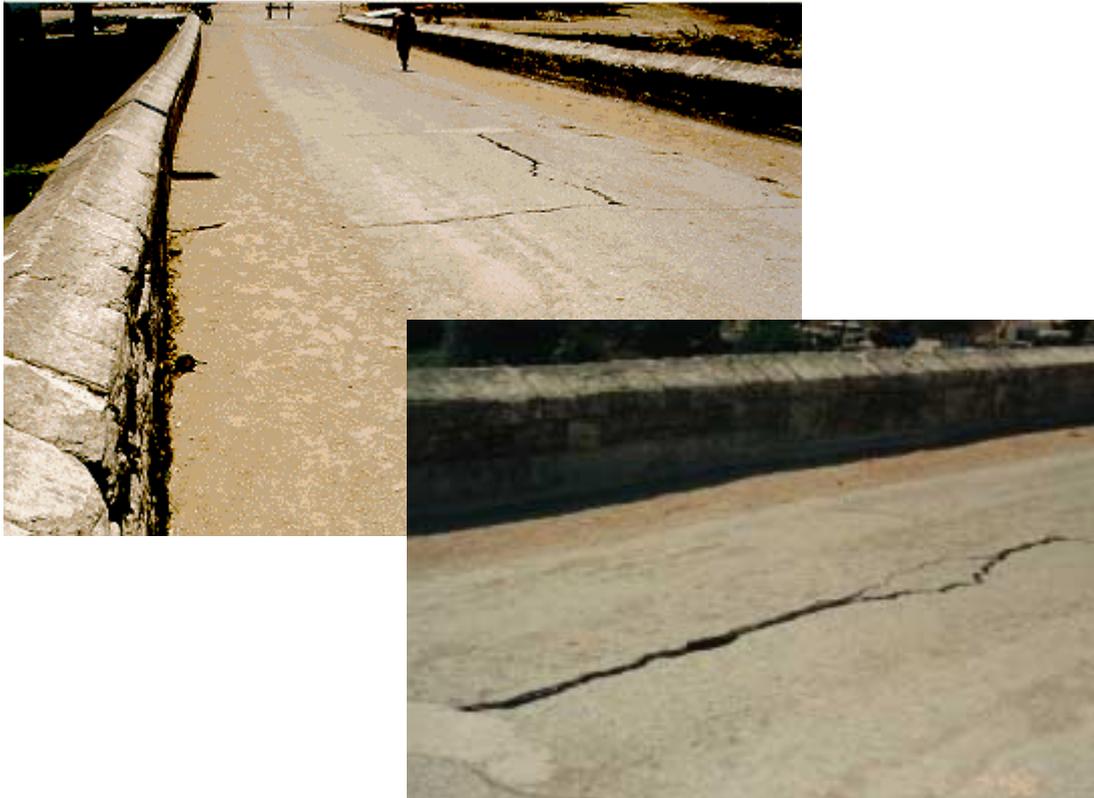
Figure 7.42 Fracturing and separation of Lokman Hekim Bridge entrance

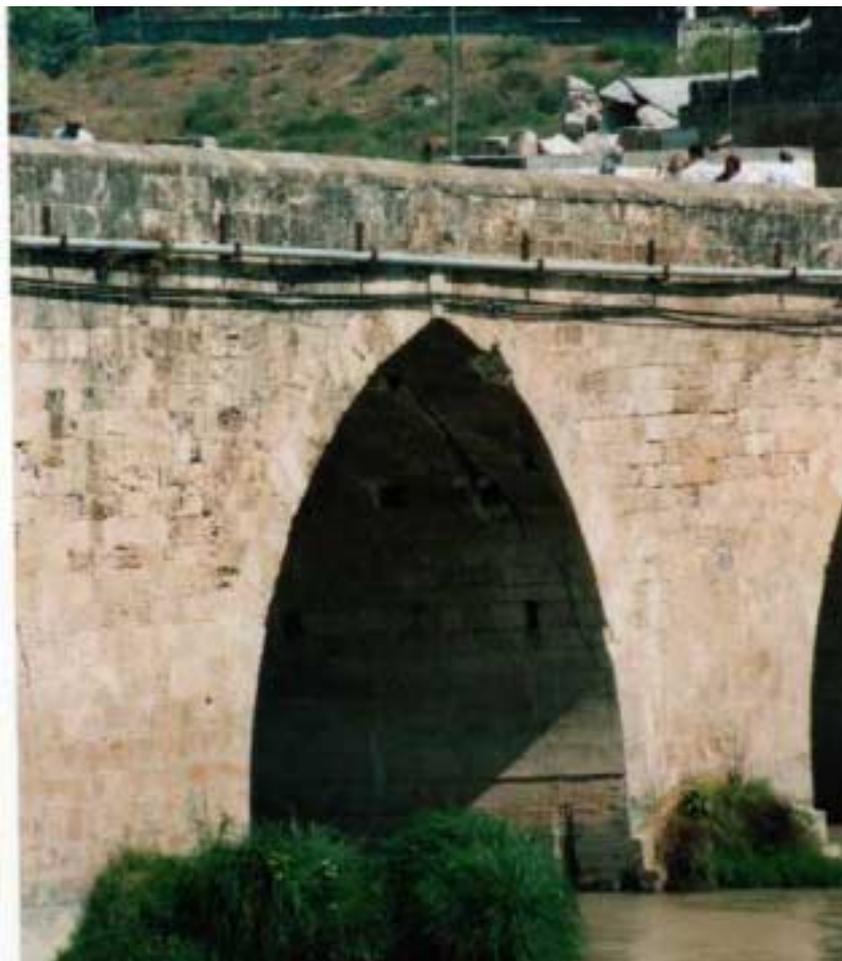
Figure 7.43 Block separation and sliding at one of arches of Lokman Hekim Bridge

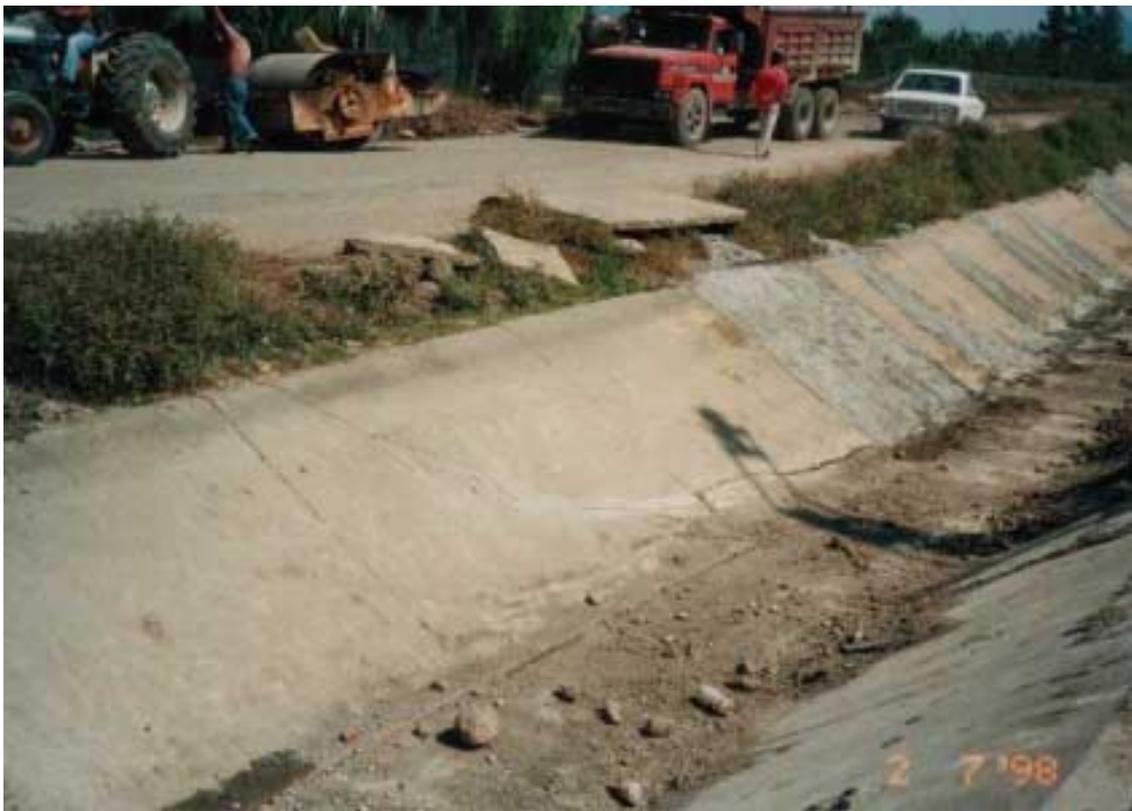
During the investigation at several locations, no severe damage to the network was observed. At several locations, where lateral spreading of ground was observed, some concrete panels were slid down or ruptured (Figures 7.46 and 7.47). At a location near Abdioğlu village, there was a relative displacement at a junction between the canal and V-type conduit as a result of lateral spreading of ground (Figure 7.48).

Figure 7.46 Re-construction of fractured canal panels near Abdioğlu village

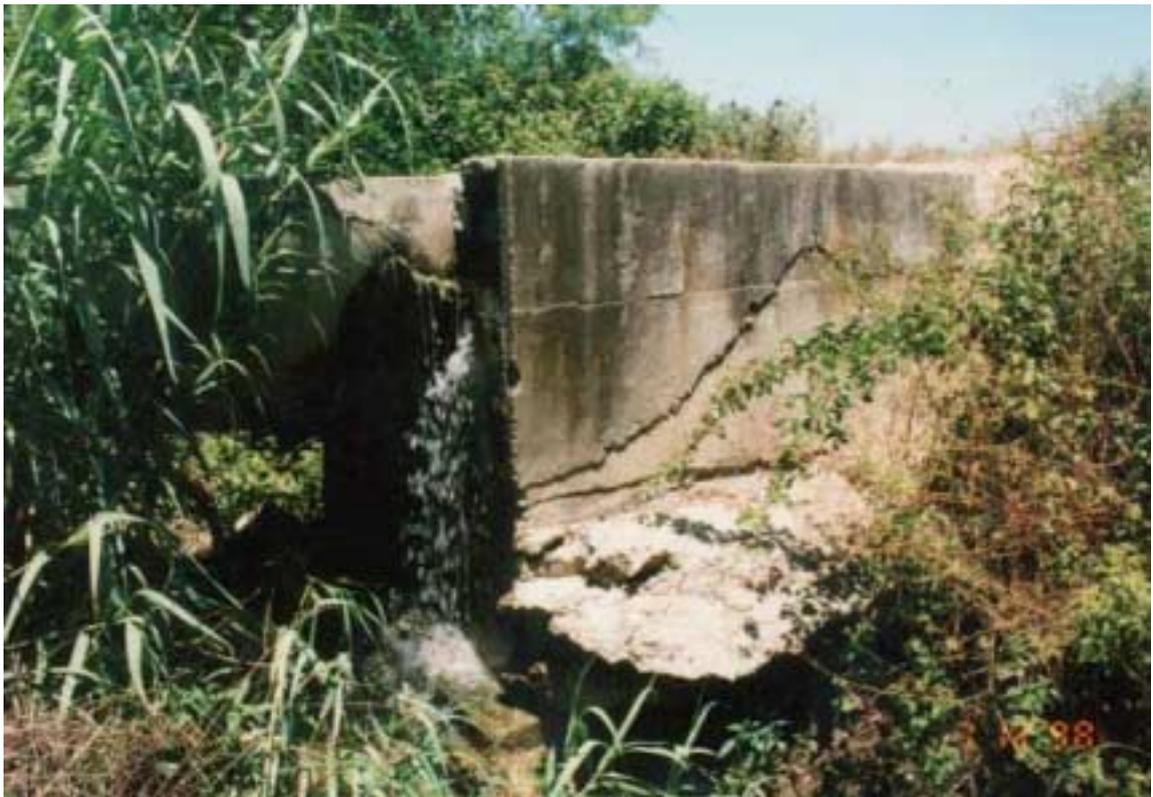
Figure 7.48 Relative displacement at a canal junction with a V-type conduit

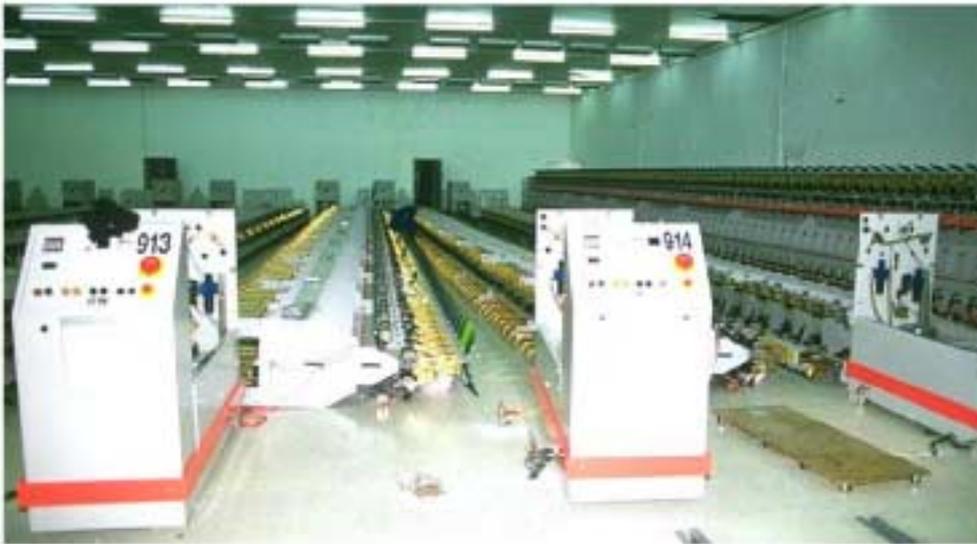
During the investigation, some of factories in the organized industry area of Adana province were visited. In factories visited, some of machinery either toppled or slid. When the machinery is not anchored on the floor, machinery with high aspect ratios were toppled. If the aspect ratio is small, then machinery was displaced permanently (Figures 7.49 and 7.50)

Figure 7.49 Toppled machinery at a textile factory

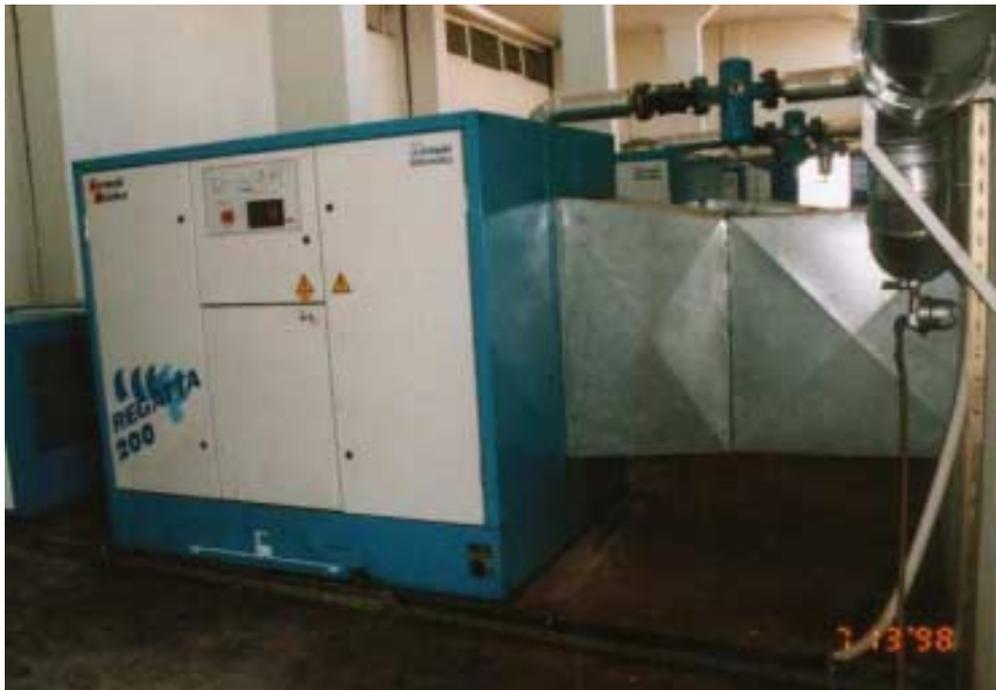
Figure 7.50 Displaced compressor unit at a textile factory
