8. LIFELINES

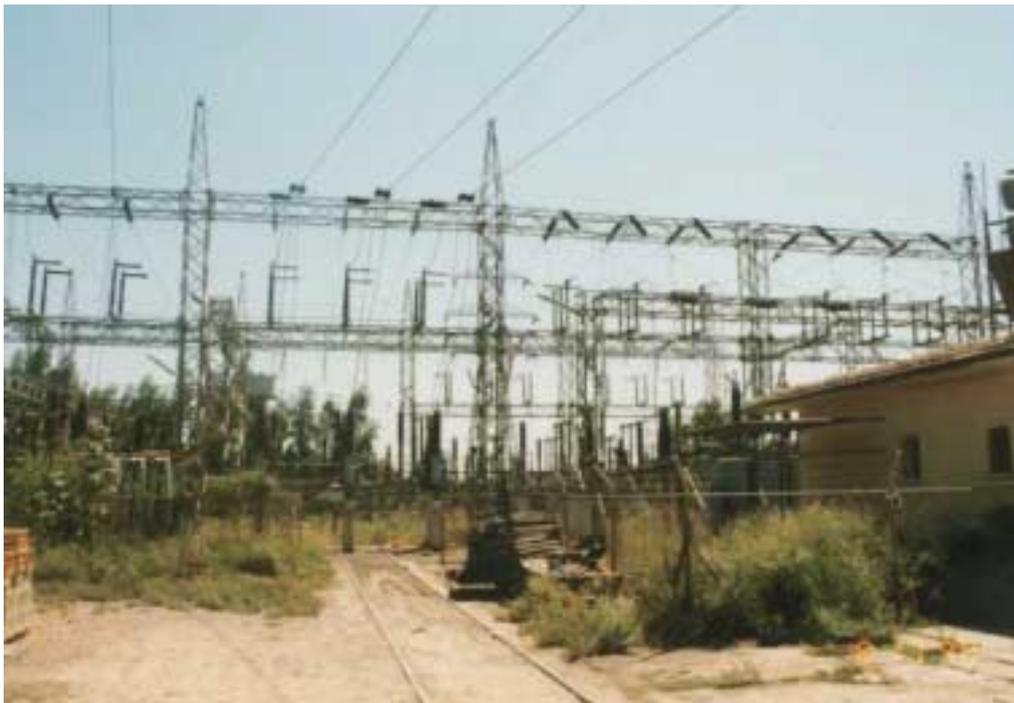
There was no damage to main transmission lines and transformers in the region. However some power lines in Misis town were cut-off. The electricity system was shut down to prevent short circuits. After initial check-up of the system, the electricity was first supplied to strategic places such as the airport, hospitals, security department, governor and mayor offices. Except the collapsed building, the electricity was back in Ceyhan and Adana 3 and 24 hours following the earthquake, respectively.

Figure 8.1 Non-damaged Ceyhan sub-station

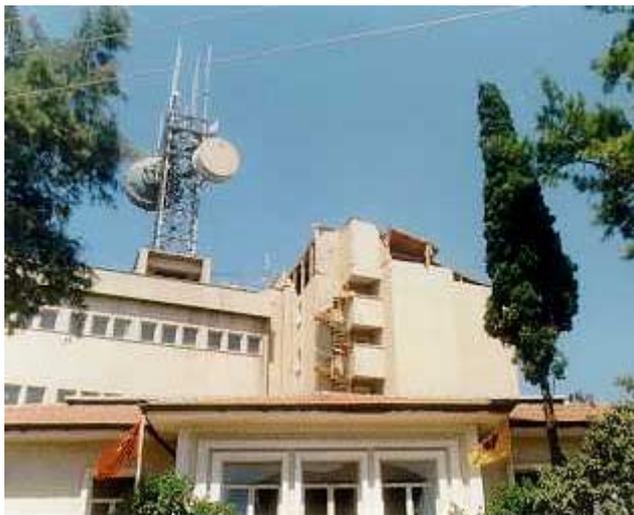
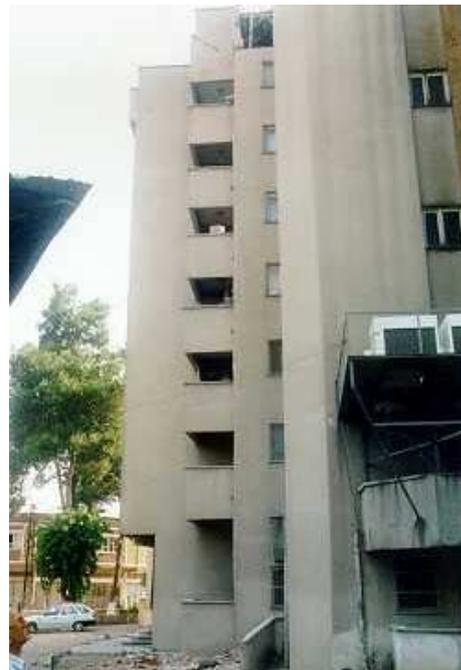
The telephone in Turkey is run by TELEKOM. During the earthquake, the main building of PTT (State Post and Telegraph Directorate) and TELEKOM was slightly damaged (Figure 8.2). However, there was no damage to the telephone system. First aid telephone lines were set up by TELEKOM free of charge soon after the earthquake.

Figure 8.1 Damaged Telekom building in Ceyhan
