9. SLOPE AND EMBANKMENT FAILURES

9.1 Soil Slope Failures

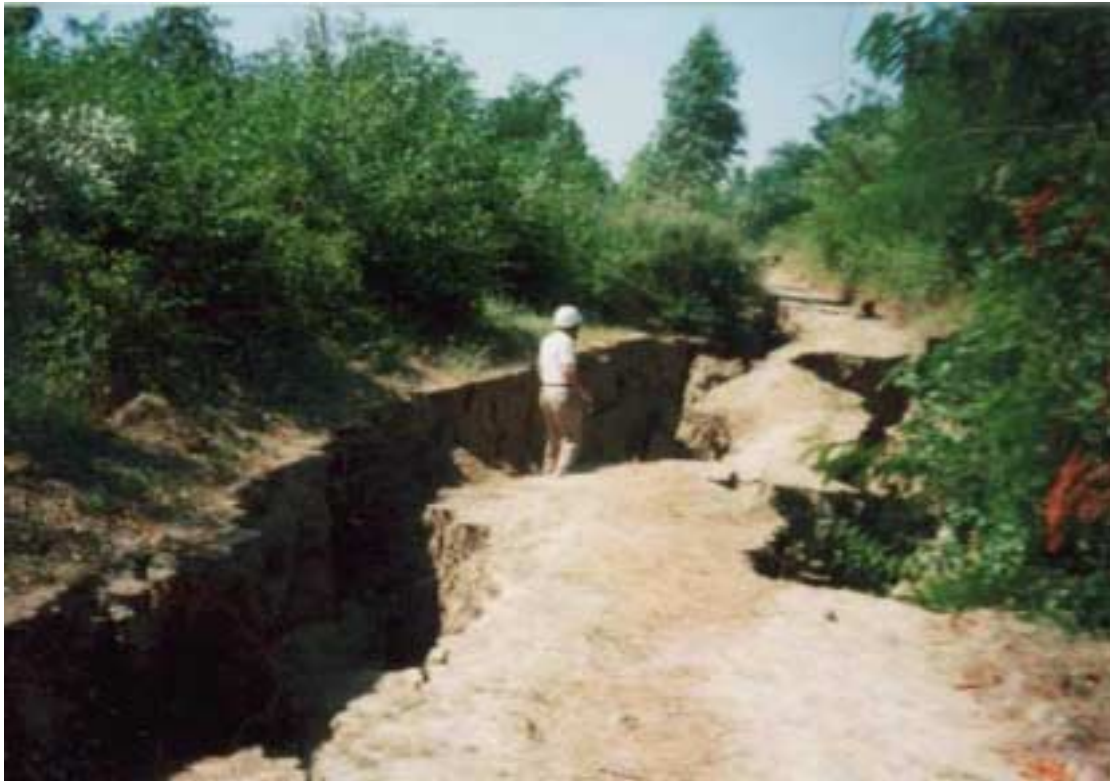
There were some soil slope failures on the banks of roadways and along Ceyhan river (Figures 9.1, 9.2 and 9.3). These are observed Mercimekköy, Yüreğir Pumping Station operated by DSİ and in the vicinity of Abdioğlu, and Mercimekköy at the northeast and southwest parts of the area affected by the earthquake, respectively.

Most of soil slope failures are seemingly circular sliding. The slope failures were mainly observed on the west embankment of Ceyhan river. Their movement was in the direction of north-east, such as N27E (DSİ pump station at Abdioğlu) and N80E (Mercimekköy). The slopes on the eastern embankment of Ceyhan river was very limited in scale. However, a close examination of these soil slope failures implied that they were likely to be a consequence of lateral spreading of ground due to liquefaction. For example, a small pond behind the failed mass was still there even two weeks after the earthquake (see Figure 9.3).

Liquefaction of very shallow subsurface sediments was the cause of such failures at these locations, the liquefied layer decoupled the overlying stiff sediments from the underlying deposits which allowed the upper non-liquefied sediment layers to transiently shift back and forth in the form of ground failure called lateral spreading as illustrated in Figure 9.4. These upper layers broke into large blocks that oscillated independently of surrounding and underlying soils. It is interesting to note that these slope failures were concentrated on western banks of the river.

Figure 9.1: Failure at the southern bank of Ceyhan river near Mercimek village

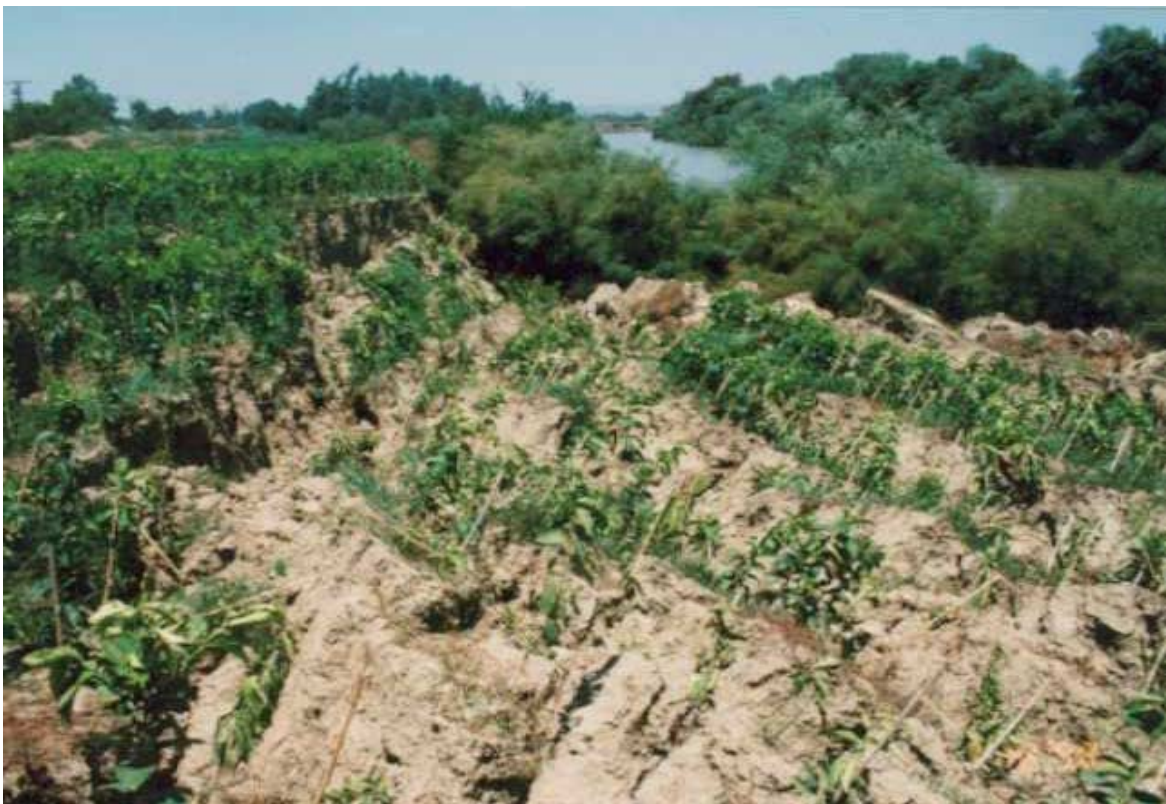
Figure 9.2: Soil slope failure along Ceyhan River near Abdioglu village

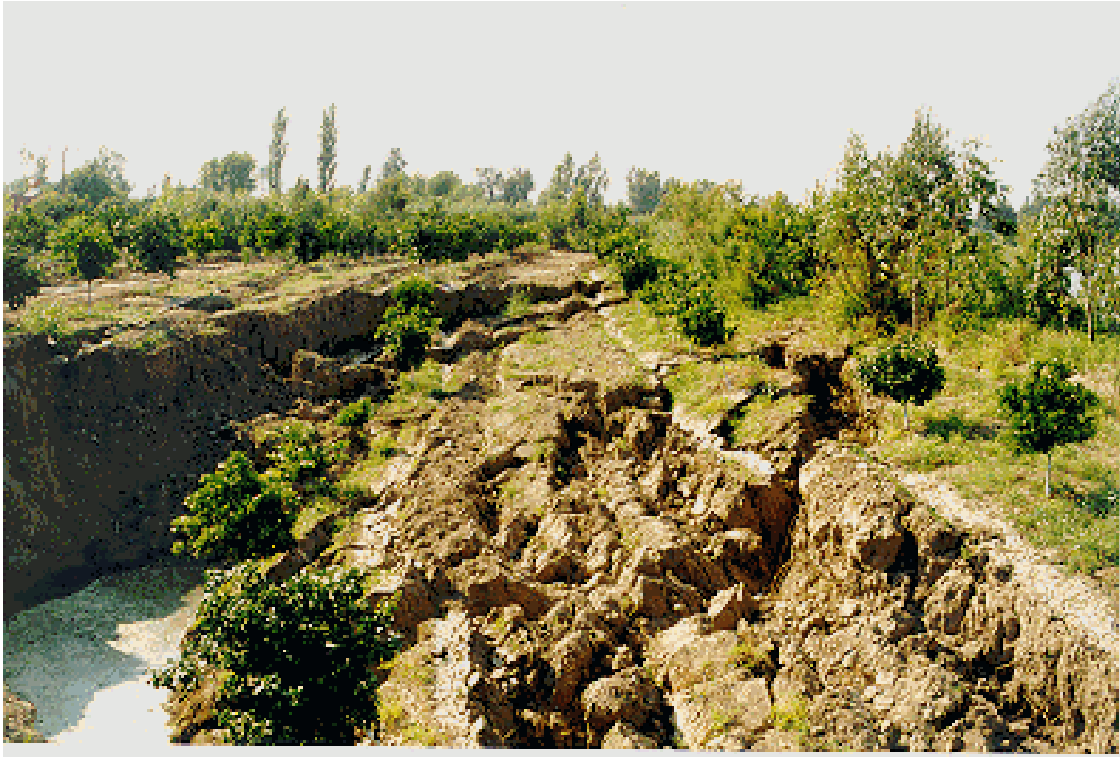
Figure 9.3: Soil slope failure along Ceyhan River near Abdioglu village

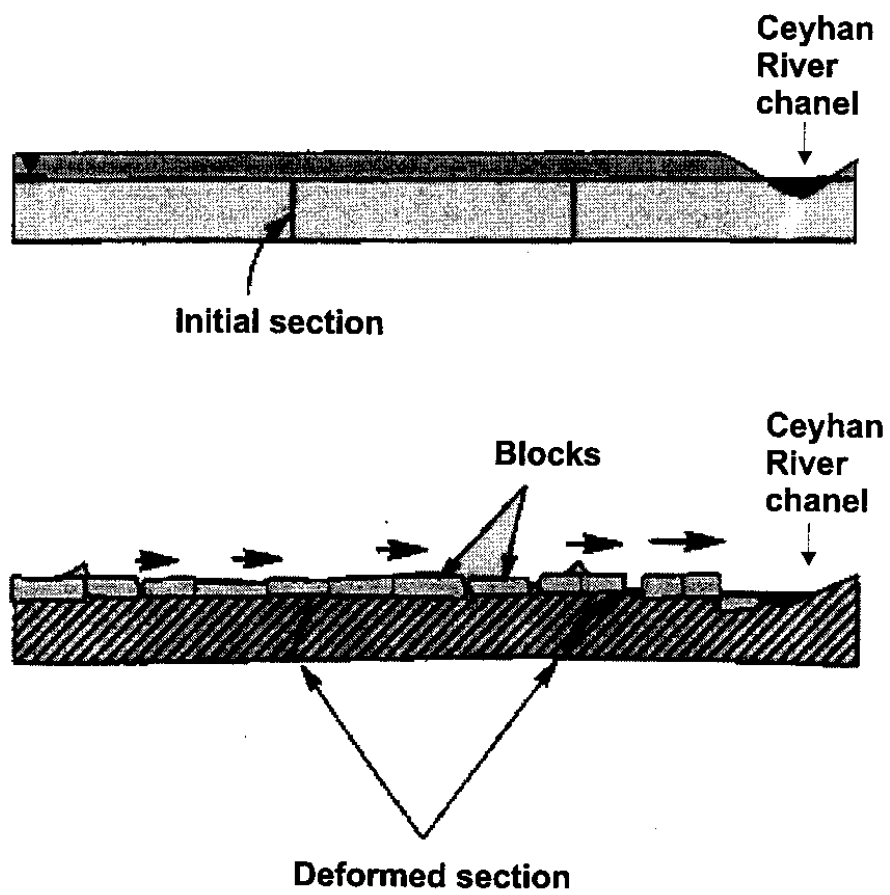
Figure 9.4 lateral spreading adjacent to river channel

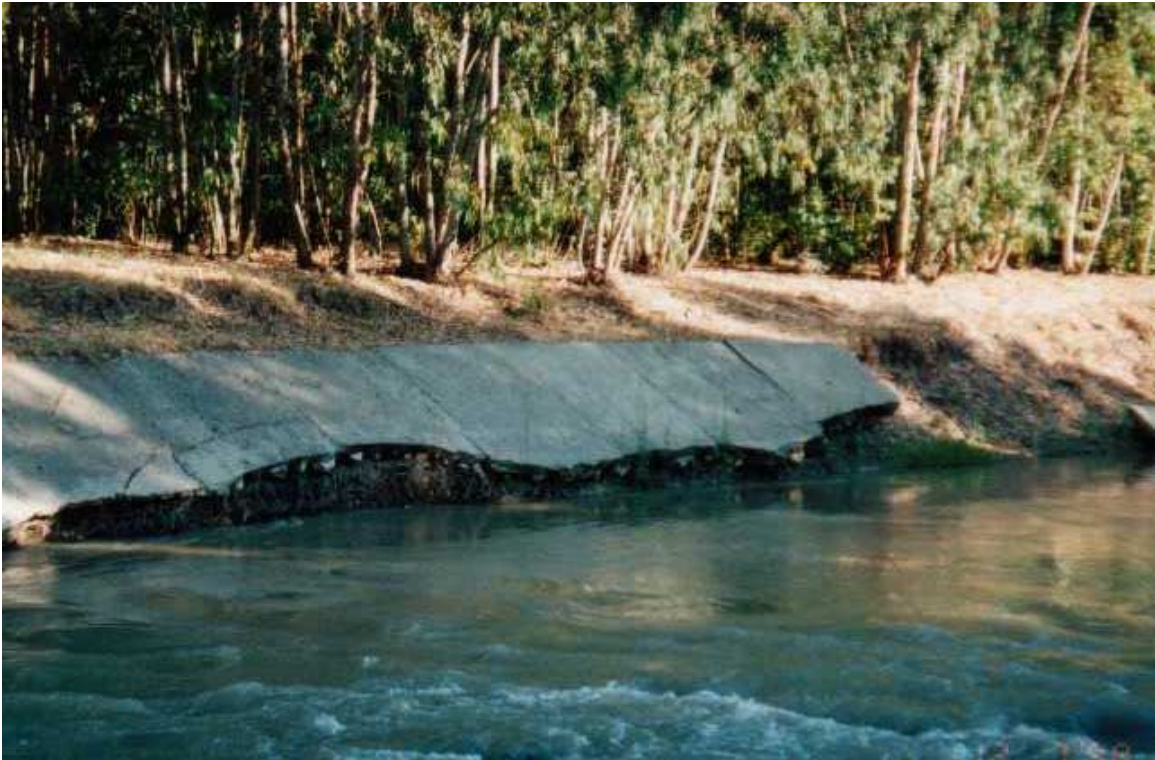
The other slope failures were observed on a side of lined canal between Misis and Abdioğlu and at southern lined bank of a stream near Sirkeli very close Ceyhan (Figure 9.5). Failure directions at both locations were N20E which are similar to those of the lateral spreads mentioned above.

Figure 9.5: Failure at the southern bank of a stream near Sirkeli village (SE of Ceyhan town)

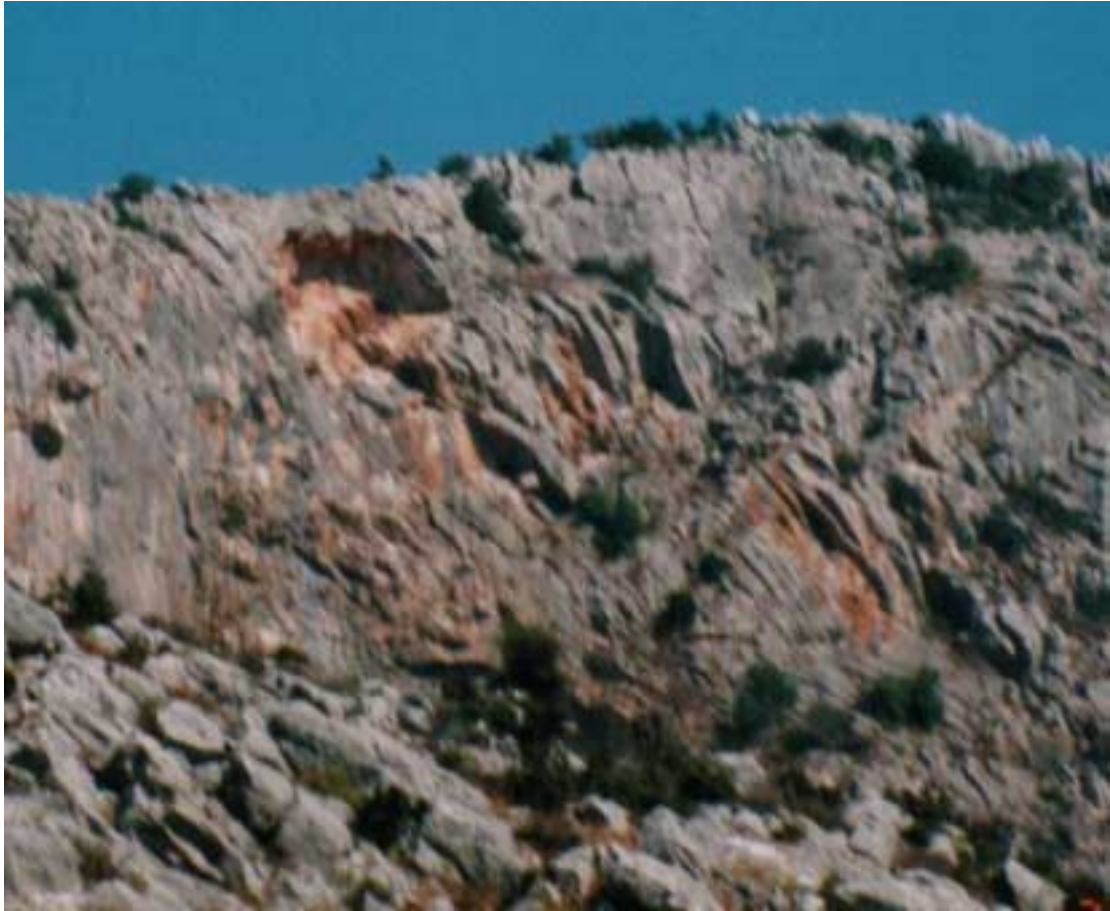
Rock slopes and rock falls were observed mainly on the eastern side of the basin where mountainous terrain exist. Most of rock slope failures and rock falls were observed at Cebelinur Mountain behind Nacarlı village (Figures 9.6 and 9.7). The rock mass is limestone and the layers are nearly vertical. Most of rock falls were of small scale and associated with existing joints in the rock mass. At one location a limestone block was thrown away by shaking (Figure 9.8).

Figure 9.6: Rock slope failure at Cebelinur Mountain near Nacarlı village

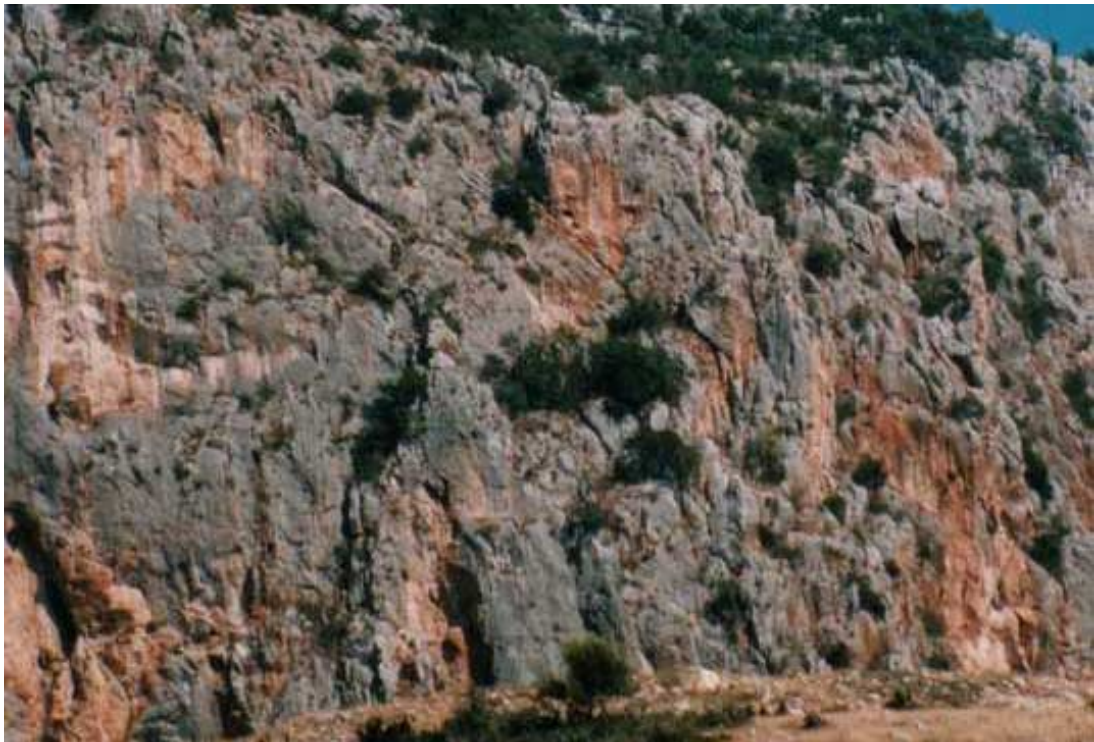
Figure 9.7: Rock slope failure at Cebelinur Mountain near Nacarlı village

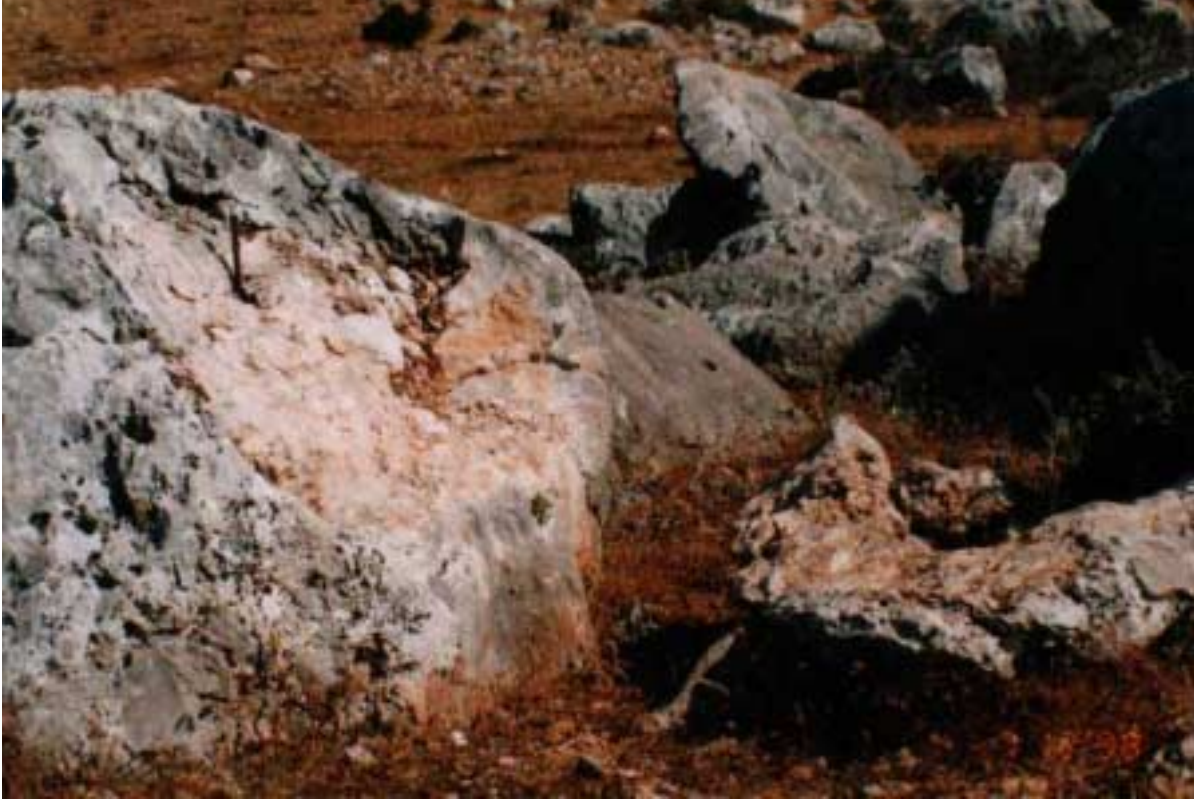
Figure 9.8: Rock block thrown by the shaking of the earthquake

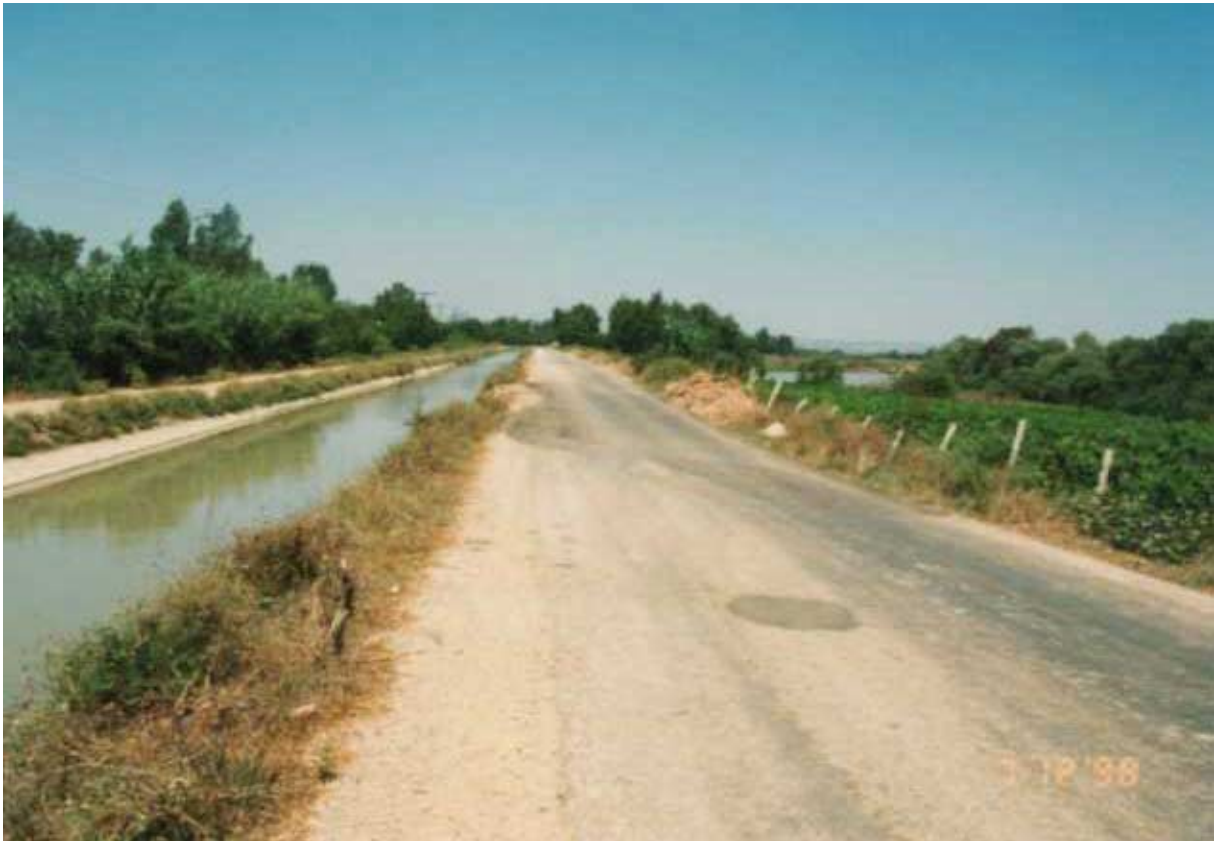
At several places, embankment failures along roadways and canals were observed. The embankment failures are similar to soil failures having a curved failure surface and scarps of failures were observable (Figure 9.9).

Figure 9.9: Embankment failure near Abdioglu village
