3. GEOTECHNICAL HAZARDS

3.1 LIQUEFACTION

3.2 EXPANSIVE SOILS

3.4 DAMAGE TO PAN AMERICAN HIGHWAY

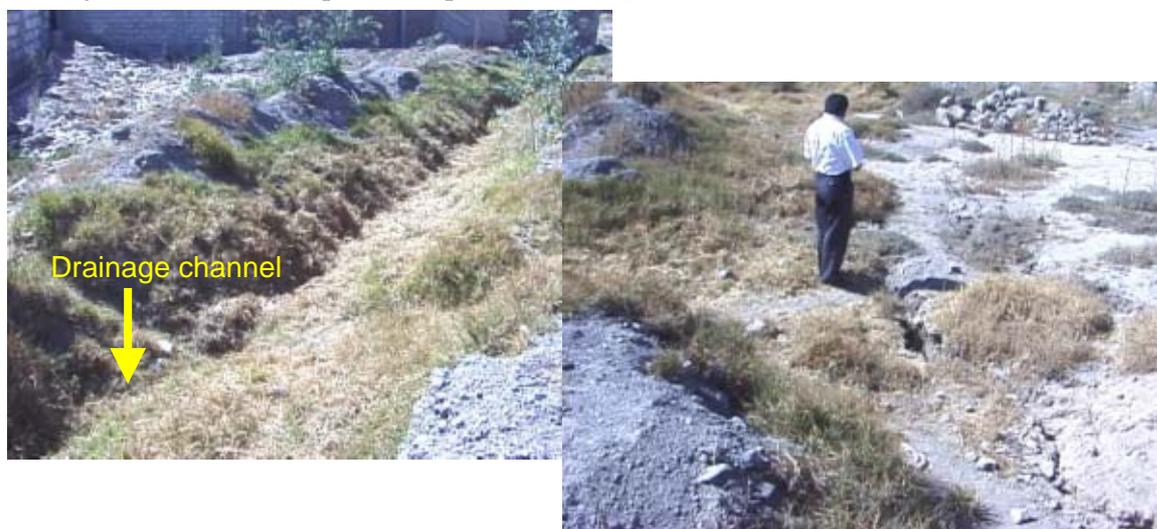
Liquefaction occurred in a lowland of Arequipa (at Lara, Socabaya district; latitude of $S16^{\circ}27.271'$, longitude of $W71^{\circ}32.148'$, and elevation of 2288 m). It induced lateral spreading of ground as typically shown in **Figure 3.1**. The plan of the affected area is shown in **Figure 3.2**. The lateral spreading caused collapse of brick walls (**Figure 3.3a**) and clogging of drainage channels that had an original opening width of about 50 cm (**Figure 3.3b**). Several cracks were also formed in almost level ground at a horizontal distance of about 25 m from the closed drainage channel (**Figure 3.3c**). It should be noted that there was no damage to concrete pipes with a diameter of about 50 cm used for the drainage channel to under-pass an unpaved road (**Figure 3.2**).

(a) Lateral spreading toward drainage channel

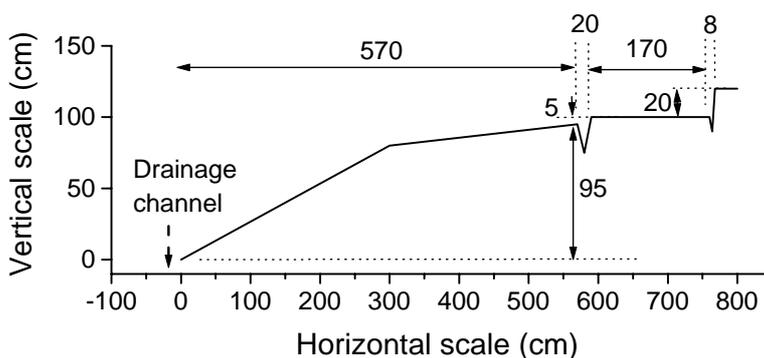
(b) Cross-section of lateral spreading at line A-A' in Figure 3.2

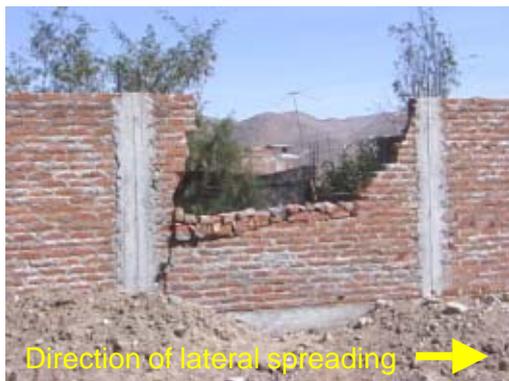
(a) Collapsed brick wall

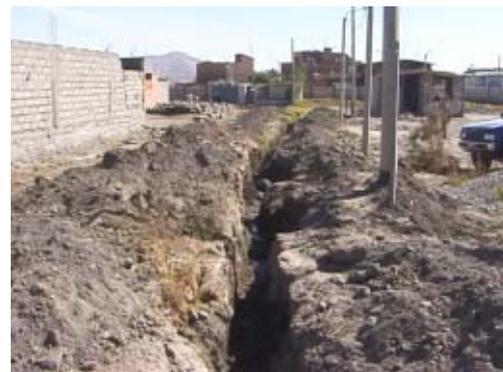
(b) Re-excavated drainage channel that was clogged with spread soil

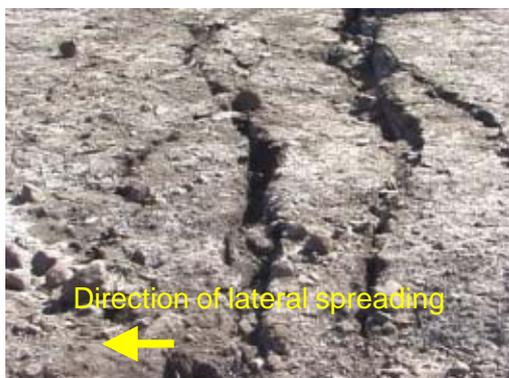
(c) Cracking in ground surface located at horizontal distance of about 25 m from drainage channel

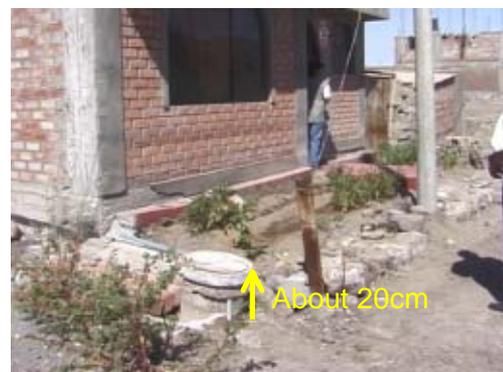
In the affected area, one house suffered uplift of sewage catch basin by about 20 cm (Figure 3.3d) and heaving of house floor due to sand boils (Figure 3.3e). The boiled sand was black under wet state and white under dry state, possibly containing some volcanic or organic components, which also contained coarser particles having a maximum diameter of about 5 mm. It is reported that the heaving took place during the earthquake shaking. It was accompanied by additional ejection of water that lasted for about 1 day, which may have been affected by the re-excitation work of the closed drainage channel.

(b) Uplift of sewage catch basin

It should be noted that a sewage manhole with a diameter of about 60 cm located near the undamaged concrete pipe (**Figure 3.2**) did not suffer any damage or uplift. In contrast to this, the uplifted sewage catch basin (**Figure 3.3d**) had a diameter of about 40 cm and an original depth of about 50 cm below the ground surface, suggesting that its bottom was located above the ground water table even before the earthquake. In addition, it is reported that extensive sand boiling took place around the uplifted catch basin. This uplift damage was, therefore, estimated to have been caused by the upward forces exerted by the boiling sands, not by the loss of stability against uplift due to generation of excess pore water pressures in the liquefied soils.

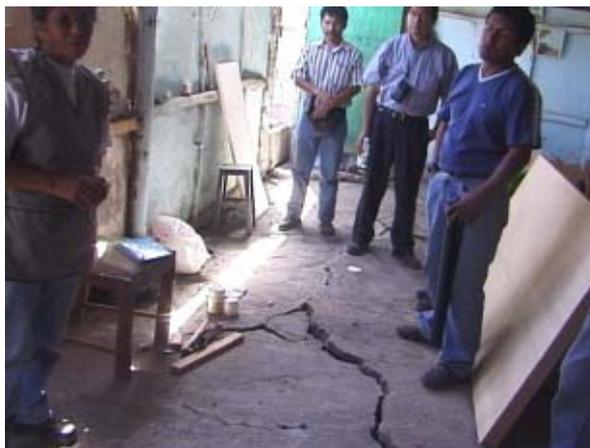
(e) Heave of house floor due to sand boil

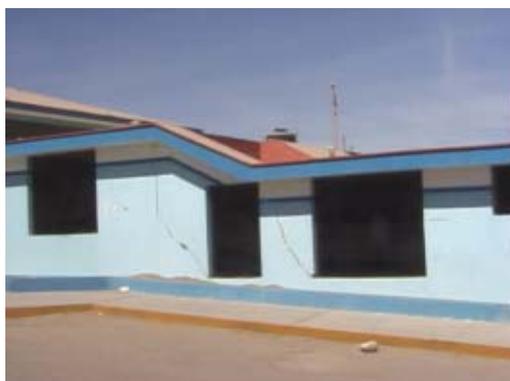
At San Antonio in Moquegua, one health center constructed on expansive soil layers suffered extensive cracks in the walls and floors (**Figure 3.4**). They had been formed before the earthquake, which were not worsened by the earthquake. Similar damage to adjacent houses was also observed. It is reported that the expansive soil layers were activated by water leaking from sewage pipes installed in the affected area.

(a) Cracking in side wall

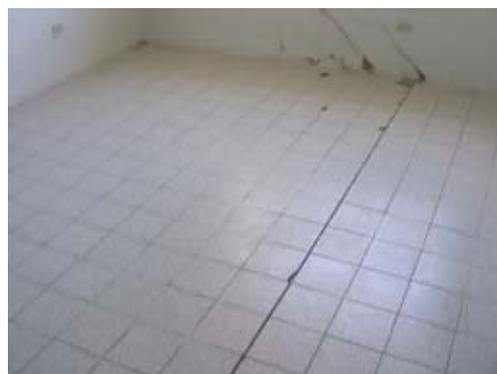
(b) Cracking in floor

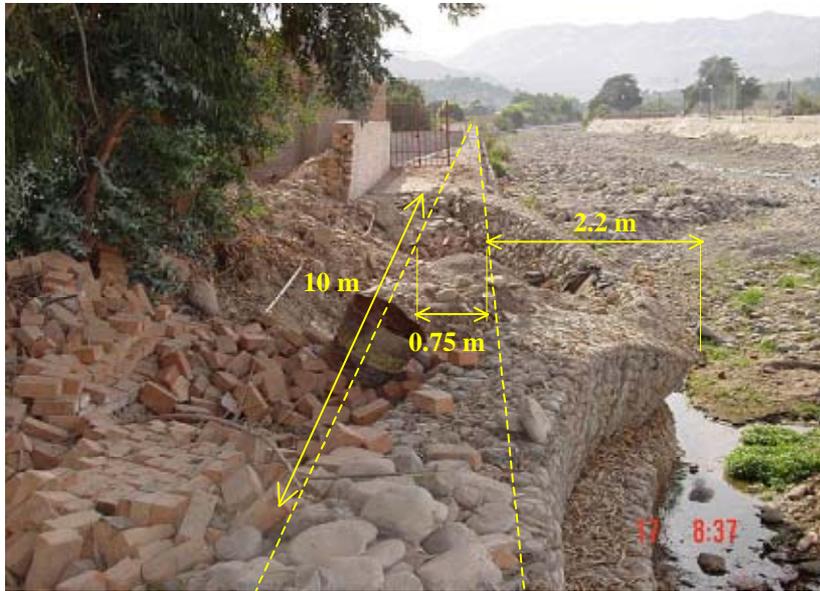
Figure 3.9 below shows a gabion wall that did not rupture even after undergoing a shear strain over 40 % (2.2/5) in the vertical plane. This is good example of the ductility of Mechanically Stabilized Earth structures. (Photo taken at the masonry factory in Moquegua, below the hotel El Mirador).

Figure 3.9 Flexible gabion wall.

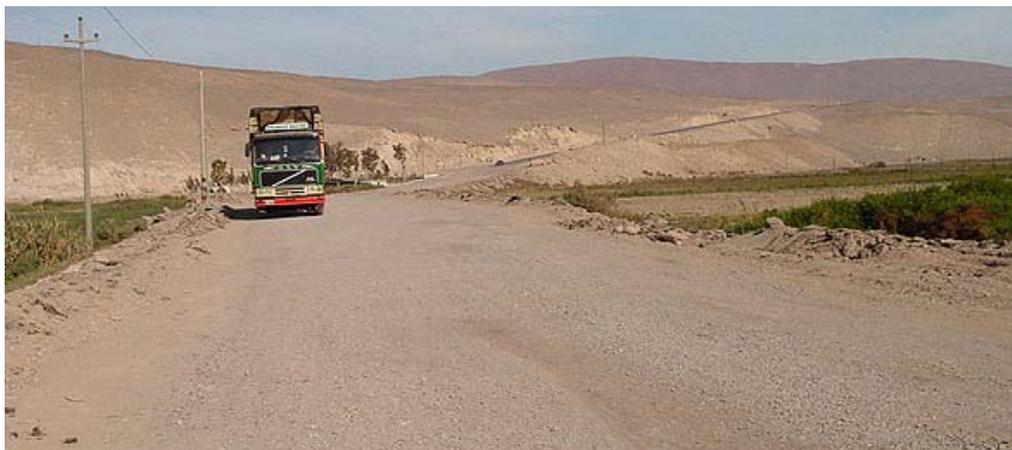
At the 1213 km of the Pan American Highway the ground shaking damaged the pavement so much that it had to be removed to allow the traffic to pass (**Figure 3.10**) and heavy traffic was redirected to another route. The white rail side guard along the road buckled severely due to the large soil deformations as seen on the right side of **Figure 3.11**. The large ground deformations may have been a combination of a basin effect and soft soil layers. The damaged part of the road is situated in an alluvial valley and similar road damage was observed in other alluvial valleys along the Pan American highway between Tacna and Moquegua.

Figure 3.10: Pan American Highway Pavement removed after damaged due the earthquake (looking in Southbound direction).

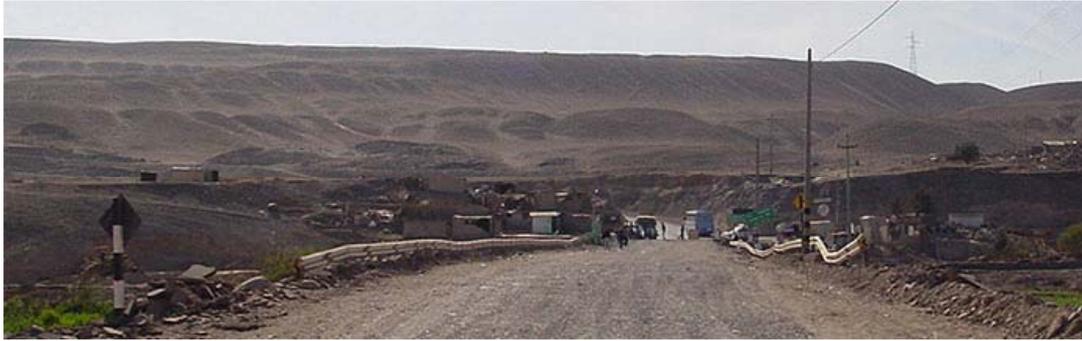
Figure 3.11: Buckled side guard (looking in Northbound direction).

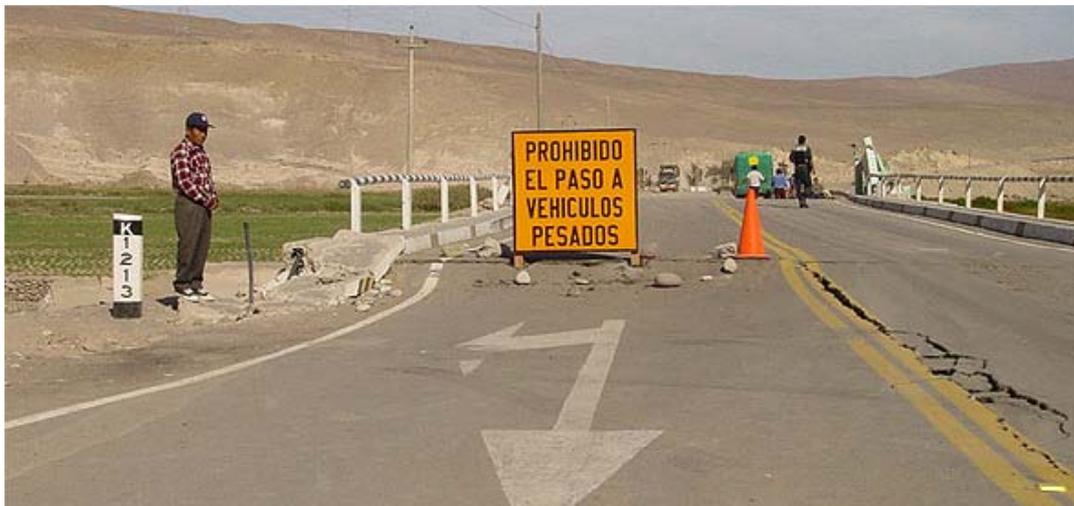
Figure 3.12: Settlement of bridge approach and cracking of road. Only one lane is open for traffic (looking in southbound direction).

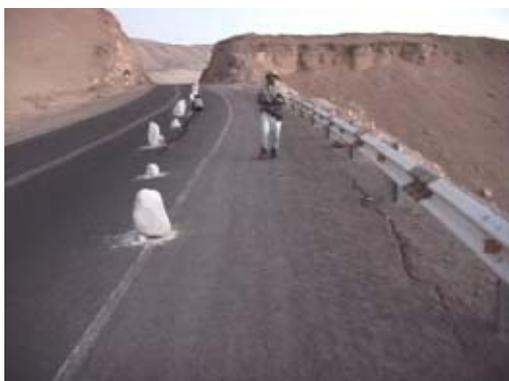
Some road embankments along the Pan American Highway between Moquegua and Tacna, and between Arequipa and Moquegua were damaged. The embankment shown in **Figure 3.13** had a height of about 30 m, which suffered residual settlement of about 5 cm over a length of 72 m with cracking in the pavement having a maximum width of about 30 cm.

(a) Settlement of embankment crest

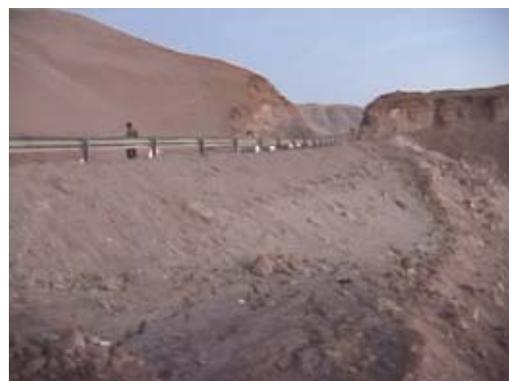
(b) Side view of embankment
