BOUMERDES EARTHQUAKE

May 21, 2003

Japanese Reconnaissance Team

OCTOBER 2004

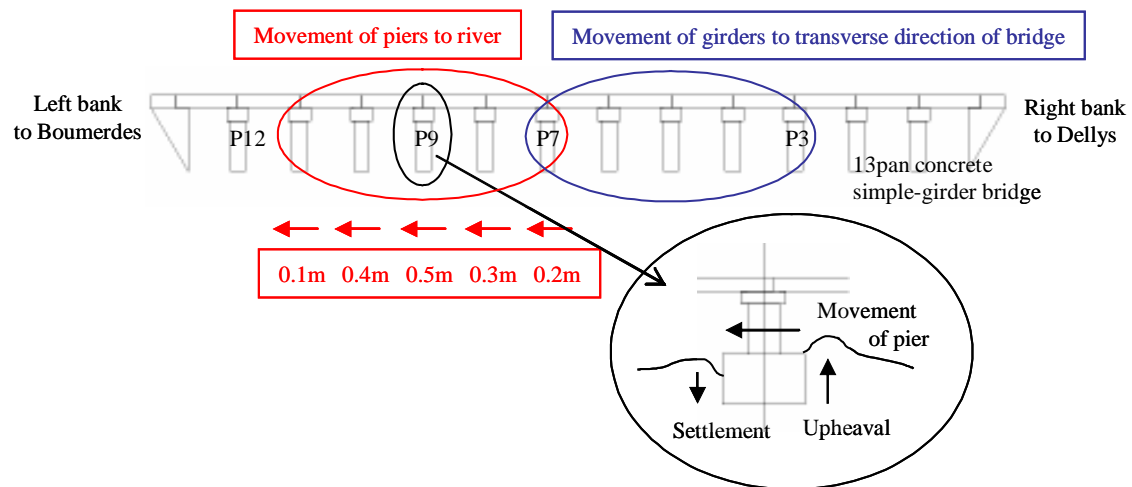
Figure 3.4: Overview of the bridge crossing over the Isser River and the corresponding damage.

Figure 3.4 illustrates the overview of the damage to the bridge and the surrounding ground. Girders between piers P3 and P7 moved in the transverse direction of the bridge. The maximum displacement was about 20 cm as shown in Figure 3.5. The finger-typed expansion joints were also broken by shearing and/or pounding of the girders as shown in Figure 3.6. It is considered that the movement of the girders was reduced by an effect of restrainers installed at the top of the piers and the bottom of the girders. As a result, many restrainers made of concrete blocks were damaged by colliding between each other as shown in Figure 3.7.

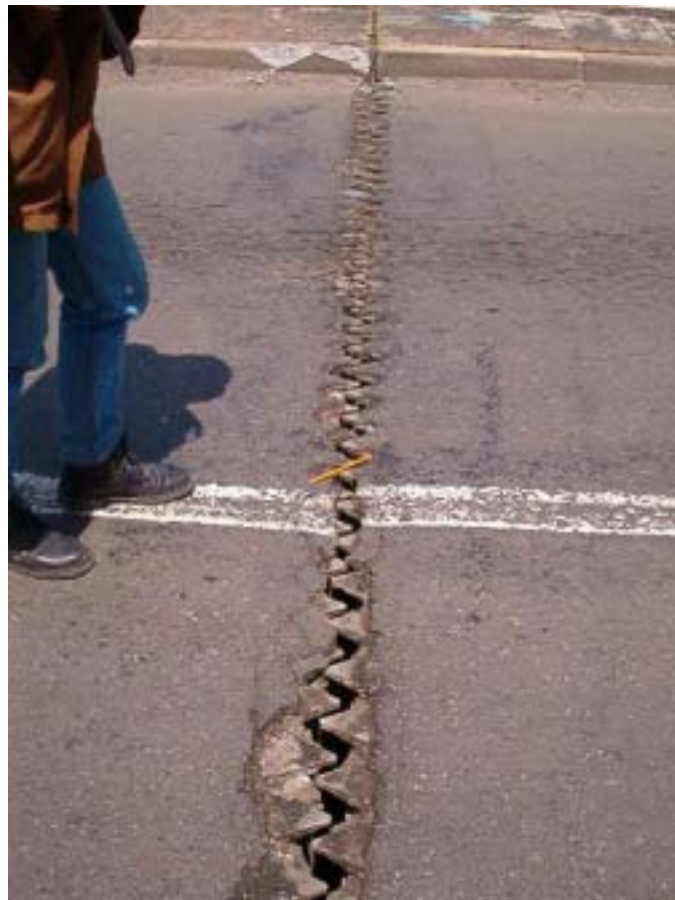
Figure 3.6: Damage to the finger-typed joints between the girders (Photo Provided by CGS)

The gap between the girders' joint and the center of the bridge seat in the axial direction of the bridge at the pier P9 as shown in Figure 3.6. The relative displacement was about 50 cm. The displacements at the other piers were drawn as the movement of the pier as shown in Figure 3.4.

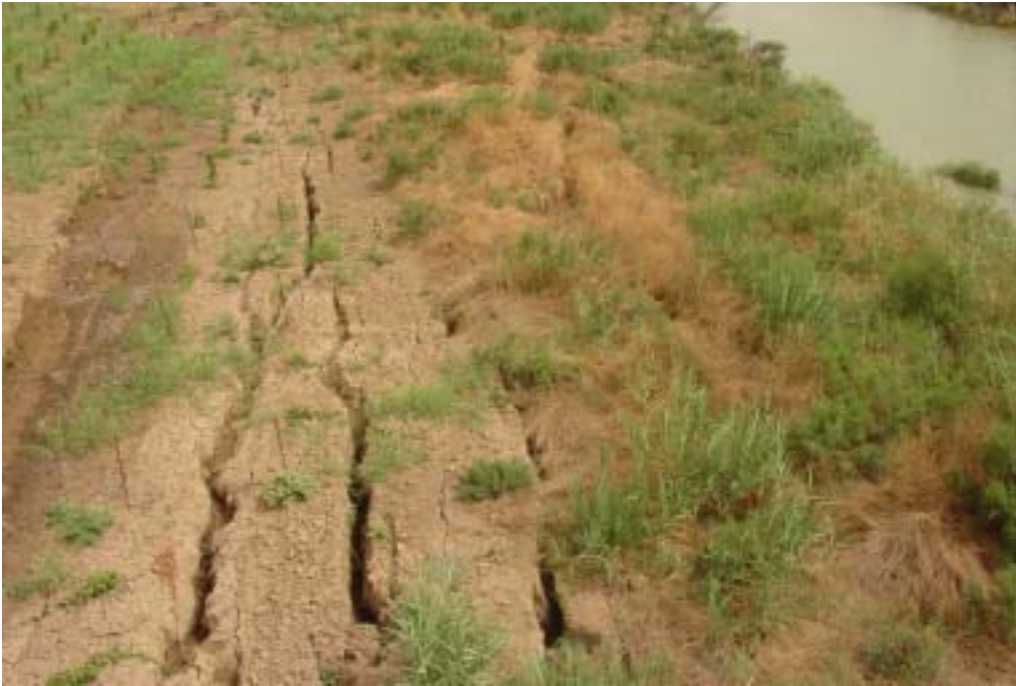
Figure 3.9: Fissures and lateral spreading of the ground.

behind the fissures. It seems that the movement of the ground induced the settlement. The lateral displacement of the ground at the right side of the bank was about 4.2 m, which was measured as the amount of crack width parallel to the river.

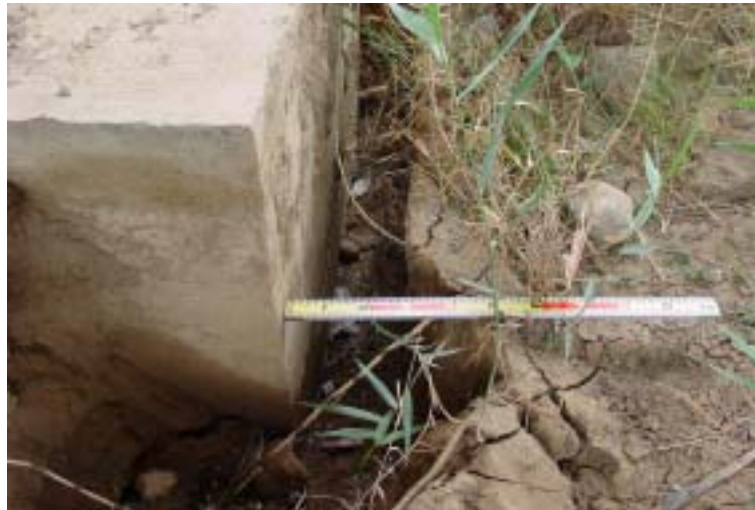
Figure 3.11: Relative displacements between the footing of the pier and the ground.

Figure 3.11 shows the gap between the ground and the footing. Since the movement of the ground toward the river was larger than that of the footing, the settlement of the ground and the gap occurred on the side faced to the river of the footing and the upheaval of about 10 cm occurred at the opposite side, as shown in Figure 3.4.

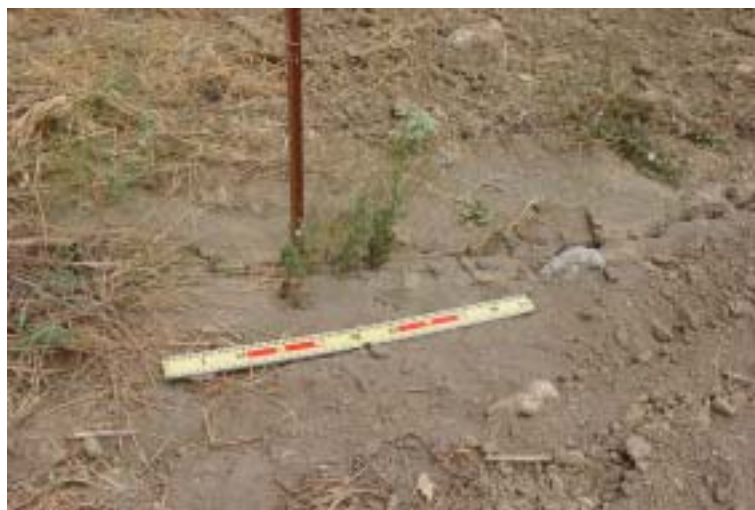
Figure 3.12: Boiled sand around the fissure.

Figure 3.12 shows the ejected sand around the fissure near the pier P9. Since the earthquake occurred two months ago, the sand volcanoes and the ejected sand induced by the soil liquefaction were not clearly visible. It seems that the liquefied sand could not spout out easily, because the surface soil was a non-saturated silt or clay,.

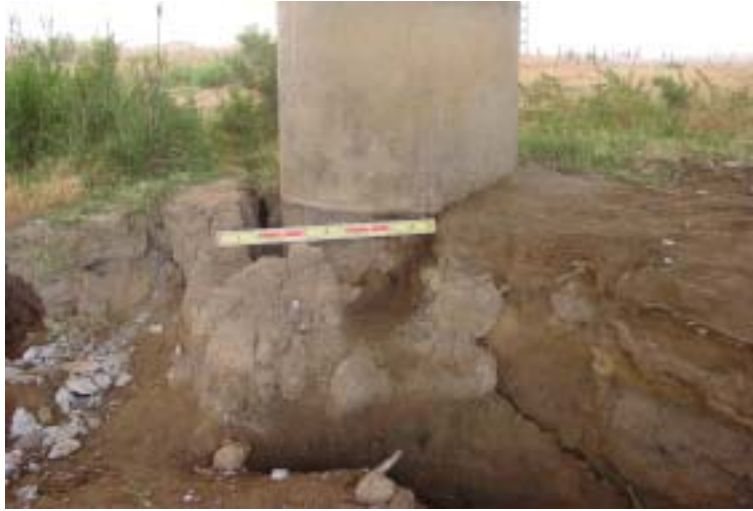
Figure 3.13: Ground failure at pier P12.

Figure 3.13 shows the ground failure around pier P12. The surface ground around the pier collapsed and moved toward the river. However, the gap between the girders' joint and the center of the bridge which seat in the axial direction of the bridge as shown in Figure 3.8 did not occur at pier P12.

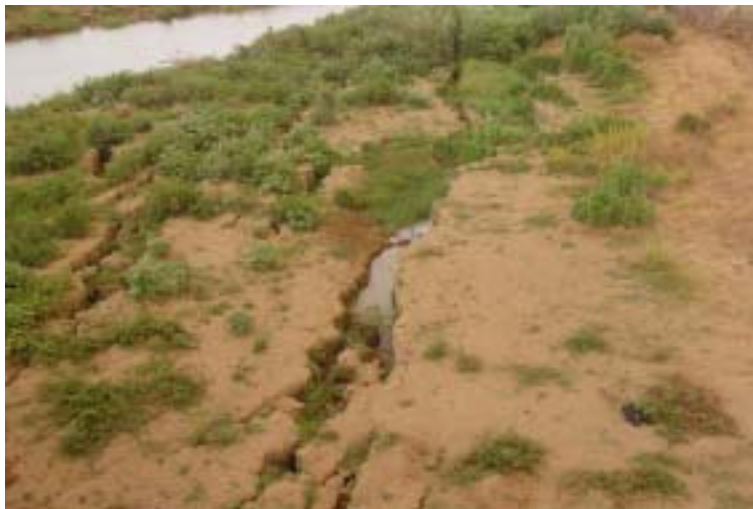
Figure 3.14: Fissures and lateral spreading of ground on the right bank.

Figure 3.14 shows the fissures at the left bank. The lateral displacement of the ground on the left bank was 1.4 m. It was smaller than that of the right bank as shown in Figure 3.4. The displacement of the lateral spreading and the force caused triggered to the pier seem to be small since the area of liquefiable soil layer was limited to the left bank.

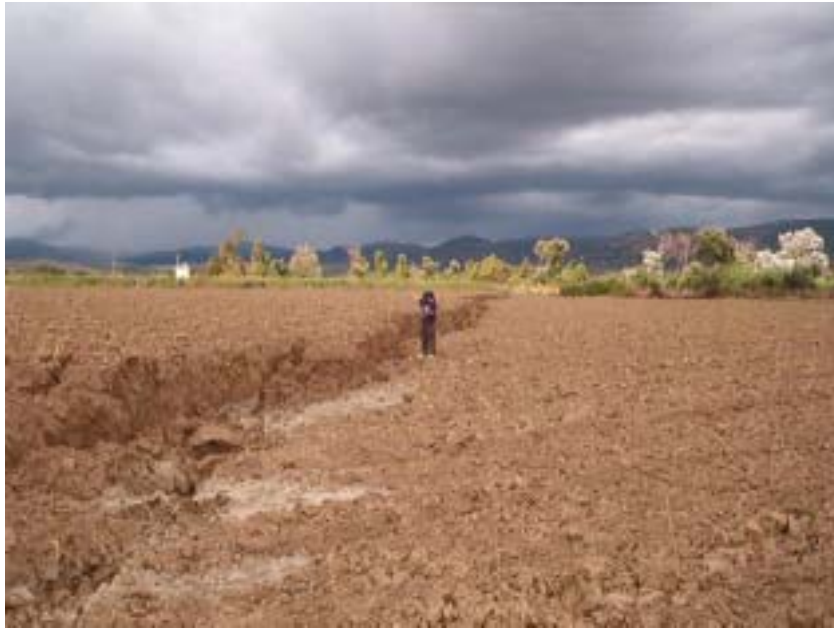
Figure 3.15: Large ground fissure at Point 2 (Photo Provided by CGS).

A large ground fissure whose length was over 100 m appeared in Legatta town is shown in Figure 3.15. It is located at is Point 2 in the southern part of Point 1 as shown in Figure 3.1. The maximum depth of the fissure was about 1.4 m, the width of the opening was about 0.5 m and relative vertical displacement was about 0.6 m. Although there were no sand volcano and ejected sand in this area when we carried out our investigation, it can be seen that there are ejected sands near the fissure as shown in Figure 3.15. The photo was taken just after the earthquake by the CGS. Since there was a stream parallel to the fissure, it is considered that liquefaction-induced lateral spreading of the ground toward the stream caused the fissure.

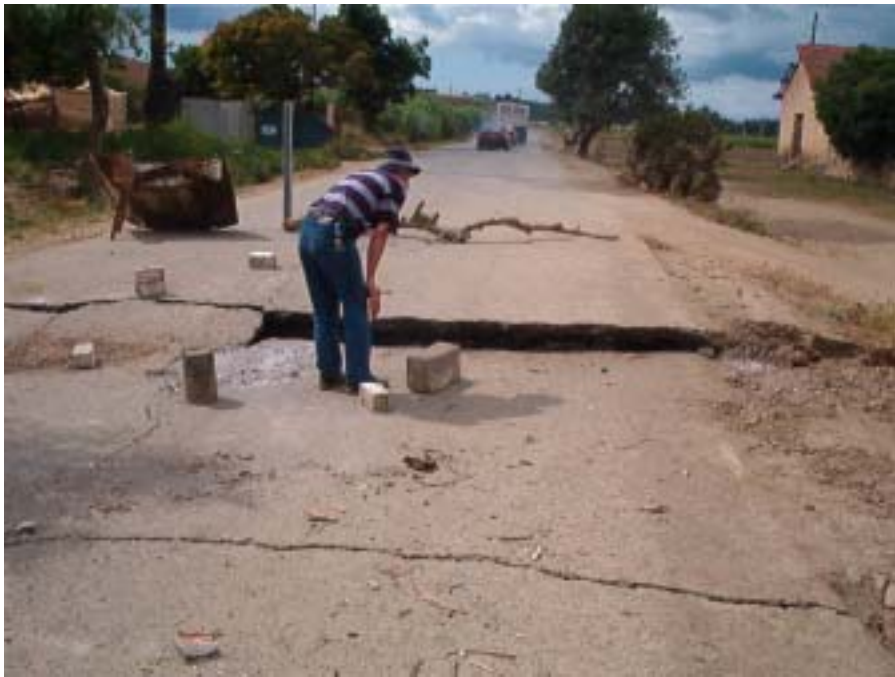
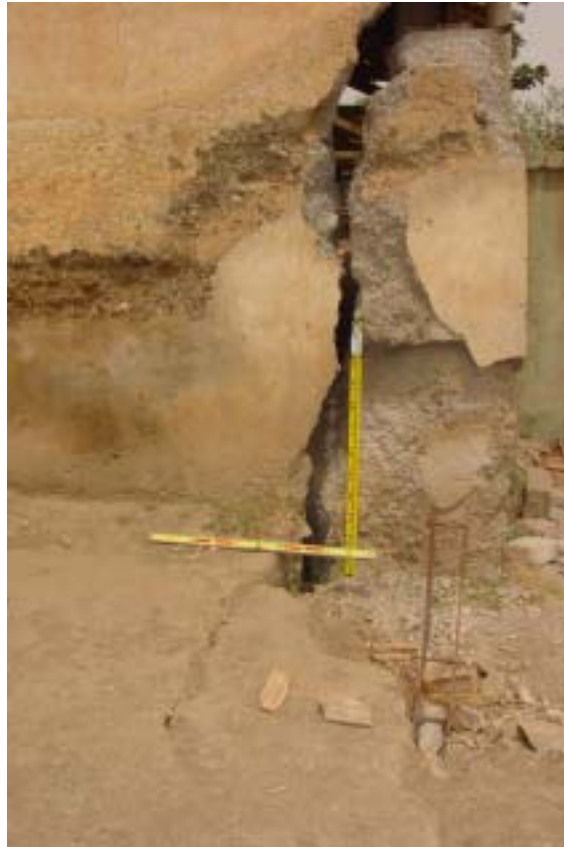
Figure 3.16: Deformation of the road on the extension of the fissure (Photo Provided by CGS).

Figure 3.17: Damage of house on the extension of the fissure.

Figures 3.16 and 3.17 show the damage to pavement and house on the extension of the fissure. A private house on the extension of the fissure suffered severe damage induced by liquefaction. An inhabitant who lived at the house said that a large amount of liquefied sand ejected from the ground into the room. Figure 3.18 shows the mark of the liquefied sand and water spouted out at about 80 cm in height.

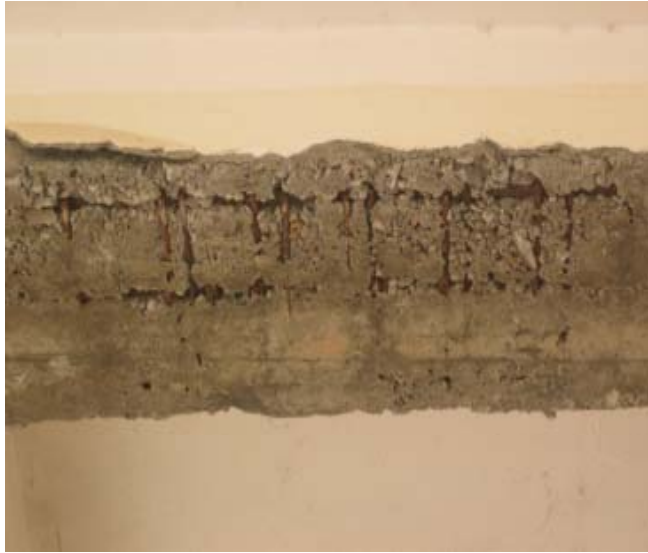
Figure 4.34: Bad quality of concrete inside the apartments

Furthermore, bad quality of concrete such as segregation and/or the lack of enough bars are clearly shown in the Figures below.

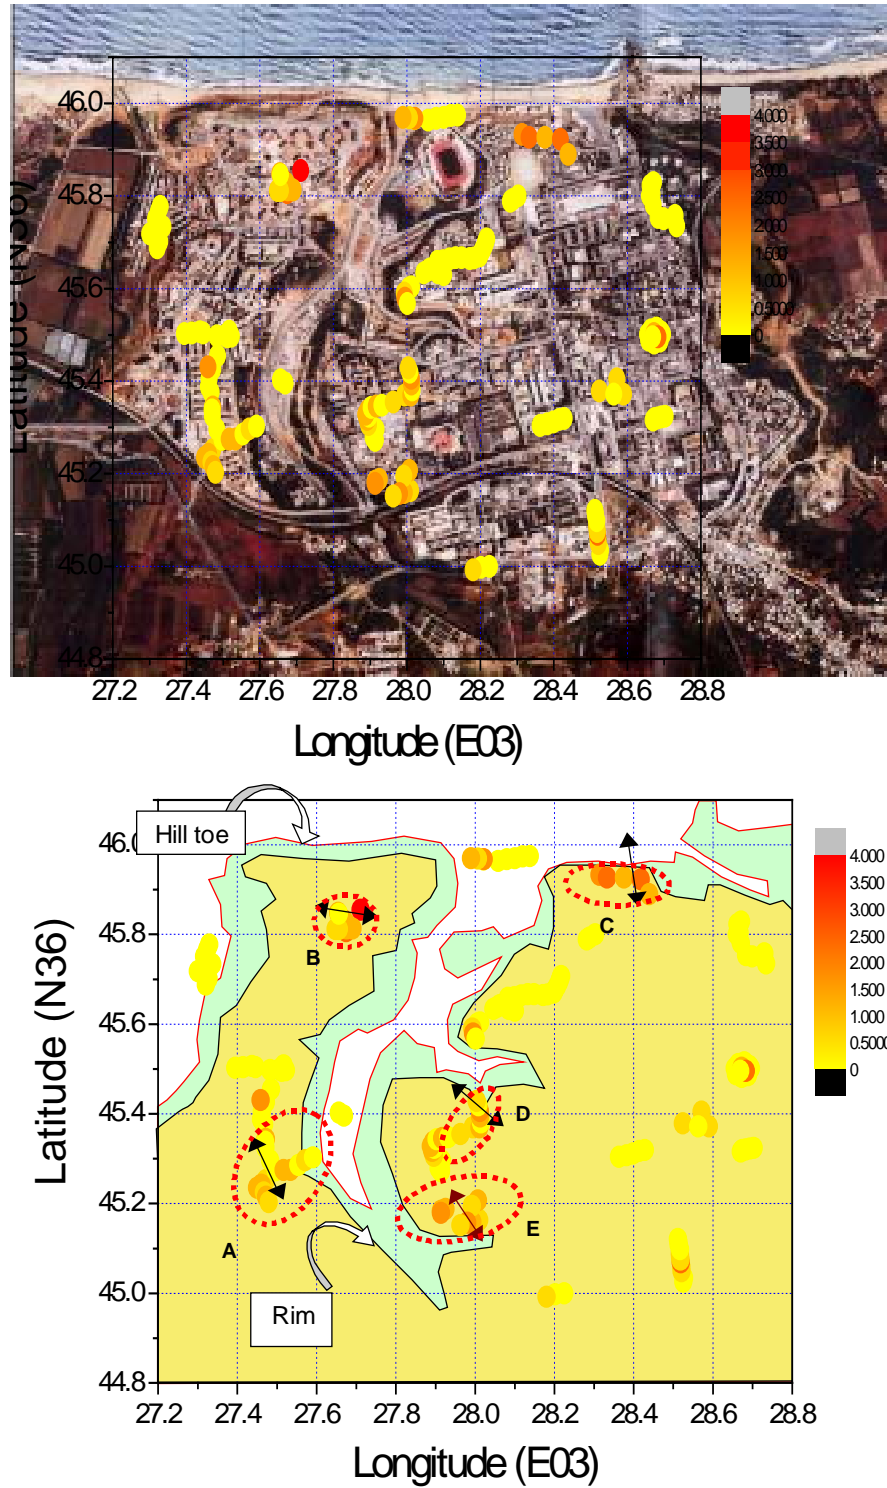
Figure 5.2: Cracks of supporting mortar parts of lampposts in Boumerdes city

Figure 5.2 shows the distribution of crack openings. Areas of widely opened cracks seem to be distributed along the rims where the hill slopes dropped suddenly alongside the valleys. Among those areas, A, D and E areas had many RC middle high rise buildings (apartments) seriously damaged. Additionally, the dominant direction of the seismic motions presumed from the cracks was northwest to southeast. This localization of damage may be explained by high site amplification near the rims and/or soft-soil condition as will be explained in the following sections.
