THE M8.7 NIAS EARTHQUAKE OF MARCH 28, 2005
IN
NIAS ISLAND, INDONESIA

Ömer Aydan
Tokai University, Shizuka, Japan

April 30, 2005

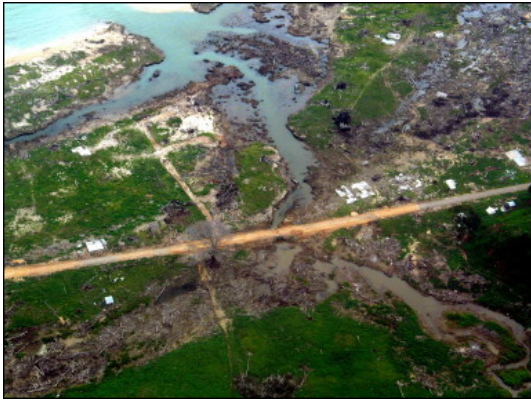
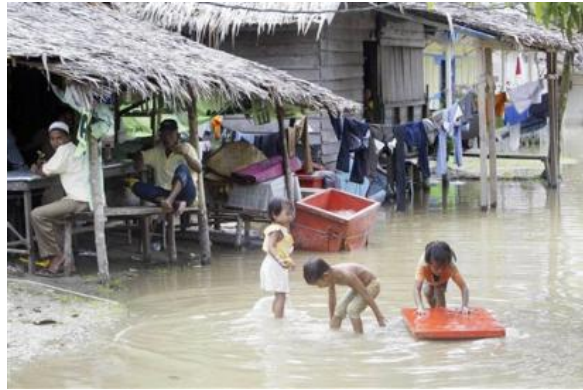
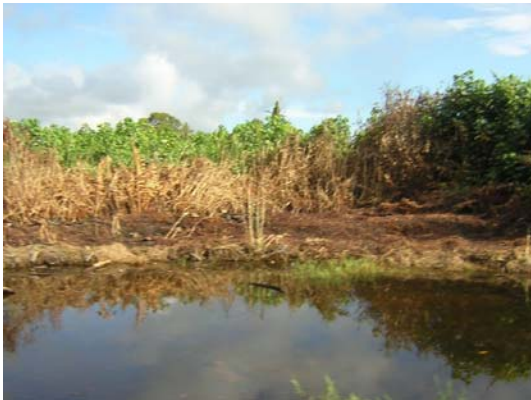
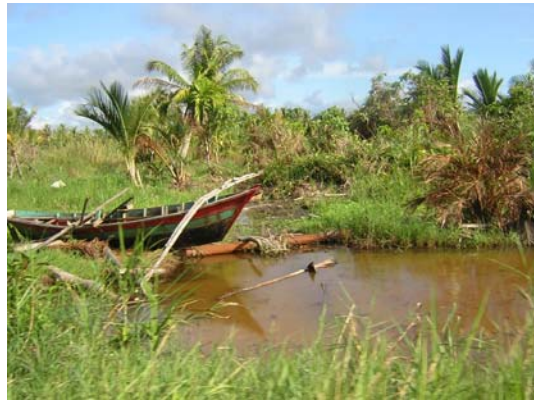
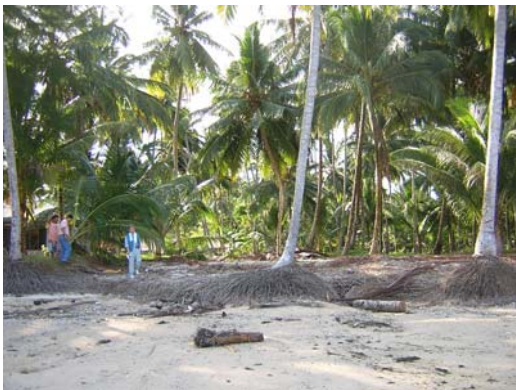
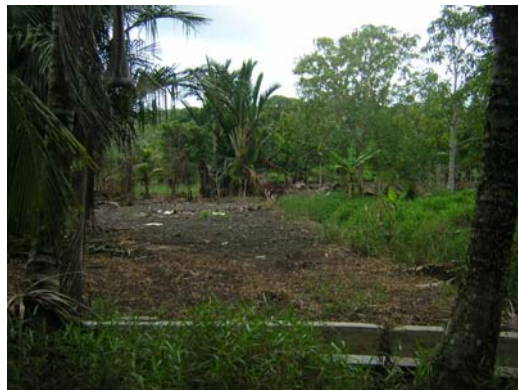
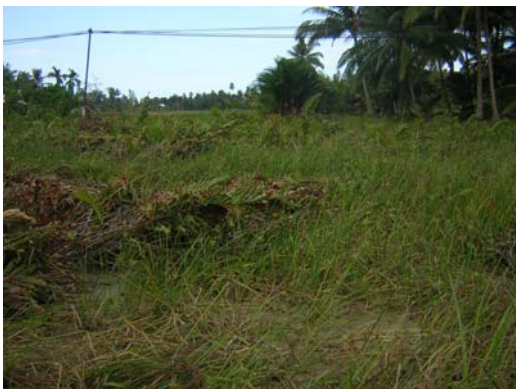
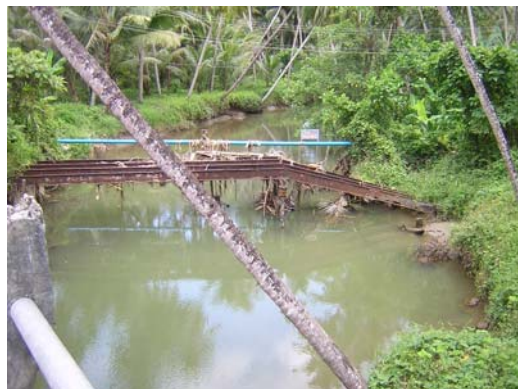
The effects of tsunami was observed at Telukdalam and Thuemberua districts (Figure 6.6). The tsunami height could be about 4-5m in Thuemberua district while this value is less than 2m in Telukdalam district. The effects of tsunami was said to be observed in western coast of the island rather than the east coast.

Figure 6.6 Traces of tsunami in Nias and Sumatra Islands

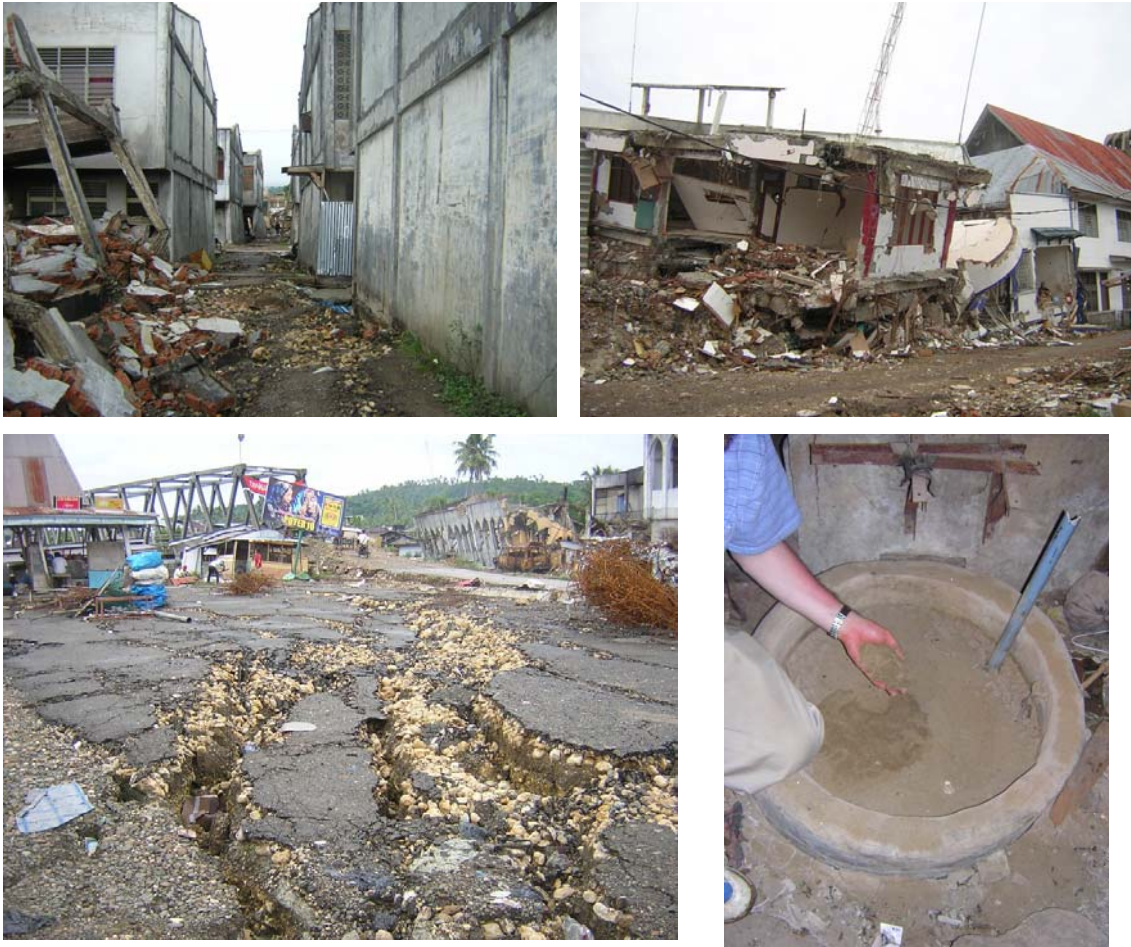
The reclaimed area in the coastal region of Gunung Sitoli was strongly affected by the quake. Along the shore of Gunung Sitoli, settlement and lateral spreading of ground occurred. As a result, many buildings in a zone for a distance of about 800m from the shore were partially settled and dilapidated (Figures 9.2). At Fofold along the northern shore of Nias Island, even single story buildings were heavily damaged. The base concrete of these single buildings were fractured into a square-shaped blocks (Figure 9.3). The ground was wavy and sand volcanoes could be observed around the area. Although the trace of sand boiling could not be seen on ground at Telukdalam, many RC buildings along the shore were collapsed or damaged. Similar events also observed along river banks.

Figure 9.2 Effects of liquefaction and lateral spreading on RC buildings

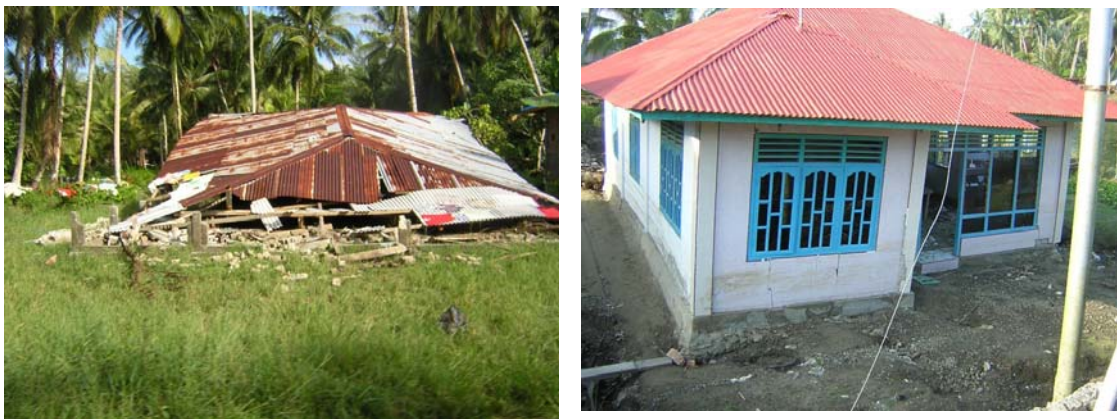
Figure 9.3 Collapsed of heavily damaged single RC story buildings

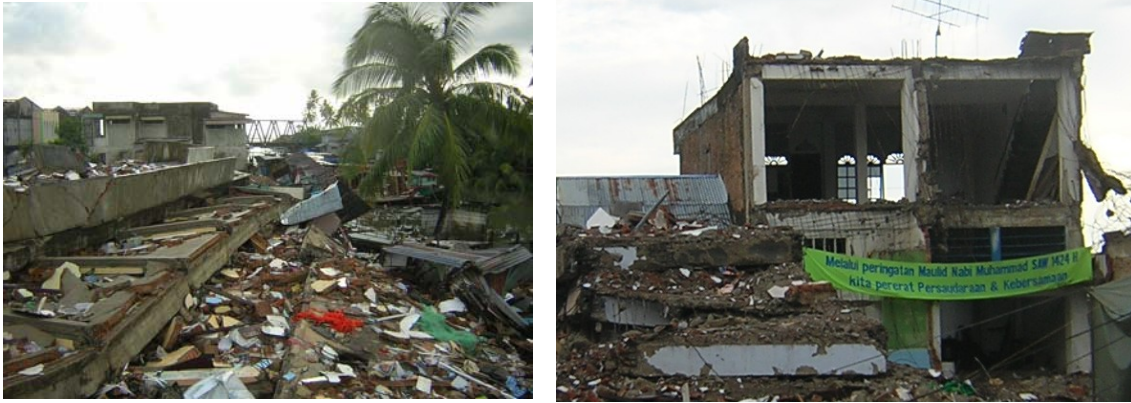
Fragile structural walls and lack of lateral stiffness were another reasons for the collapse or heavy damage although some grooves on the column were constructed in order to increase the integrity of the frame with walls. Although the walls were made of solid red burned clay bricks, they were quite slender (300/10-300/15). These walls were easily come down in the out-of-plane failure mode (Figure 9.4).

Figure 9.4 Out-of-plane failure of infill walls

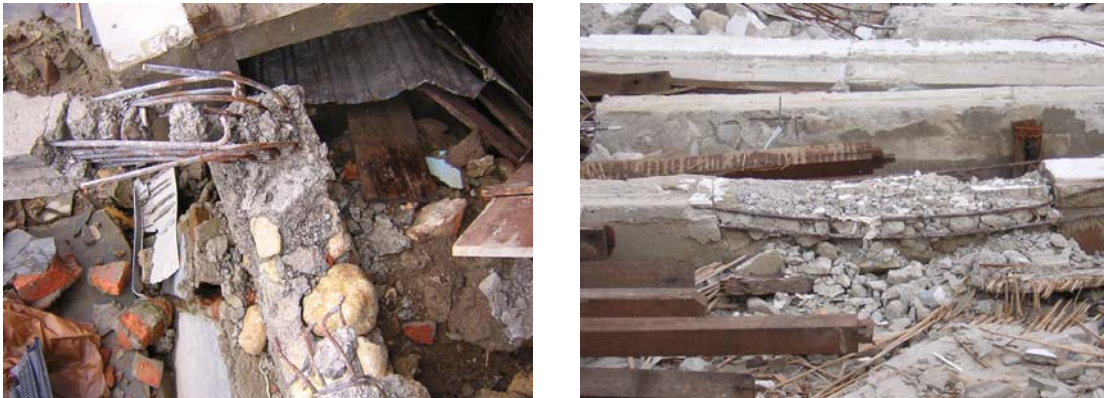
The poor construction quality and structural design problems should be cited as one of the causes of heavy damage to buildings. Figure 8.5 shows that the spacing of stirrups is too large and their too thin for (a) shear resistance and (b) confinement of concrete. Spacing is generally 200mm or larger for a column even at the column ends and their diameter is 8mm. Furthermore the hoops of stirrups are bent 90-degree instead of required 135-degree bent by the modern seismic design codes. As a result the stirrups become loose following the spalling of concrete cover. The spacing of stirrups at member ends for instance in for a shear wall is more than, 200mm, which is too large for preventing diagonal shear crack formation). Although seismic codes require cross-ties to confine the concrete, they were non-existent in almost all collapsed RC buildings..

Figure 9.5 Thin stirrups with too large spacing and large boulders in a column

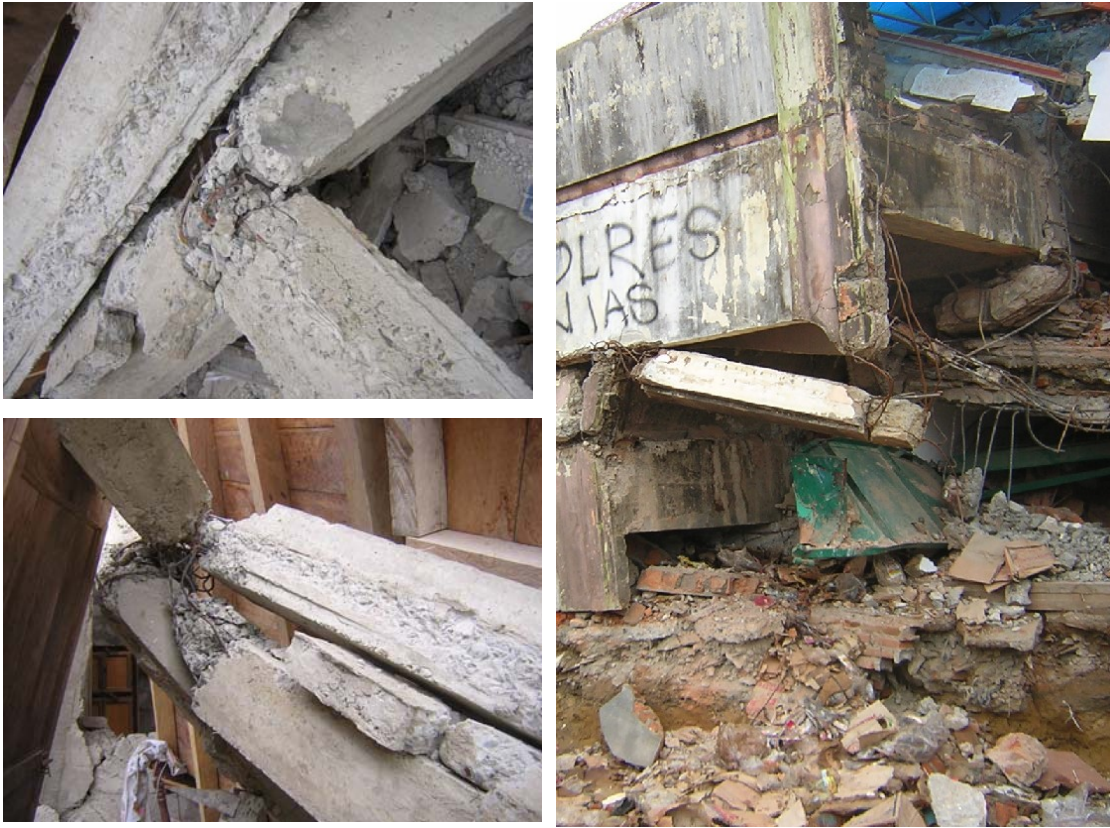
Beam-column joints were not designed to transfer shear force and no lateral reinforcement was placed in these joints. As seen in Figure 9.6, the formation of inclined shear cracks near the joint clearly show one of the causes of the heavy damage to RC buildings and illustrate the plastic hinge occurrence at the joint. The ductility provided by the members and the connections was apparently not sufficient to resist such high level reversed cyclic earthquake loadings and imposed large deformations..

Figure 9.6 Typical poorly constructed column-beam joints

- The column beam connections are not properly done and the modern seismic design codes must be strictly implemented with the consideration of country conditions

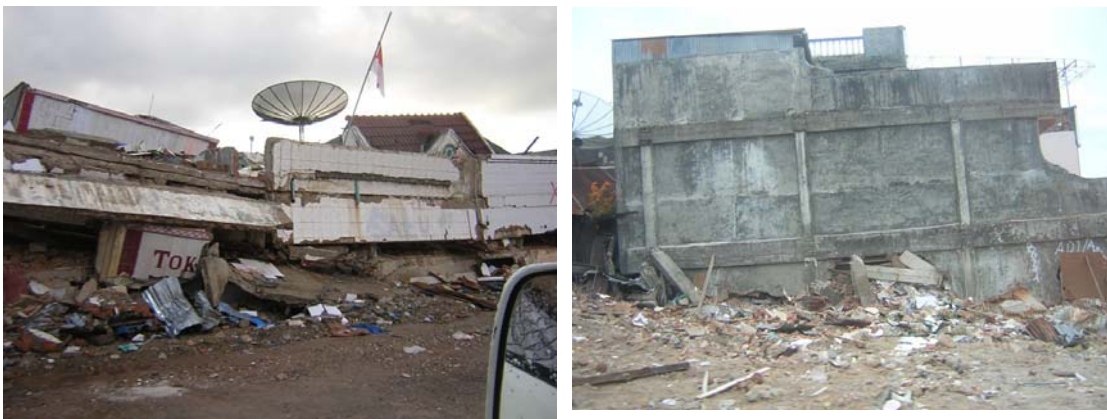
Many buildings had shops at their ground floor. Since there are generally no shear-walls to take up the load during earthquakes, the total load is transferred onto the columns. The super structure acts a top-heavy structure on the columns and in-fill walls, which are in poor contact with columns and beams, has no effect against the earthquake loading and they fail subsequently as seen in Figure 9.7.

Figure9.7 Failure of buildings due to soft floor effect

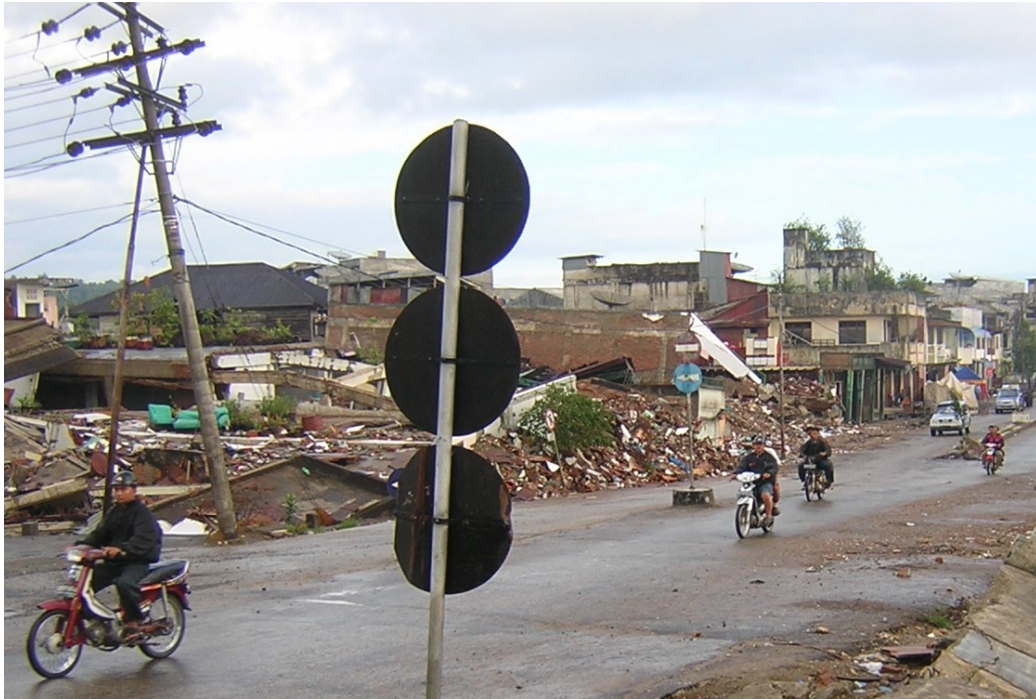
Buildings at the corners of streets collapsed as a result of pounding by the adjacent buildings (Figure 9.8). This is probably one of the important problems in most of town and villages in Nias Island.

Figure 9.8 Collapsed buildings at a corner of street in Gunung Sitoli

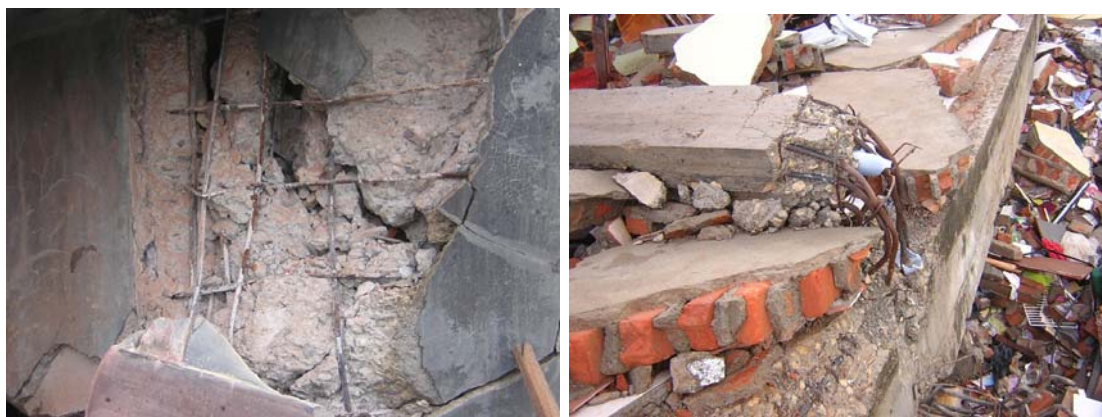
The use of non-clean coral sea sand caused the poor adhesion of concrete and the corrosion of steel bars which subsequently reduced the resistance of columns and beams against lateral loads (Figure 9.9). This is a quite serious problem for buildings constructed in town and villages along the shores of Nias Island.

Figure 9.9 Corrosion of steel bars and non-cleaned sand and gravel

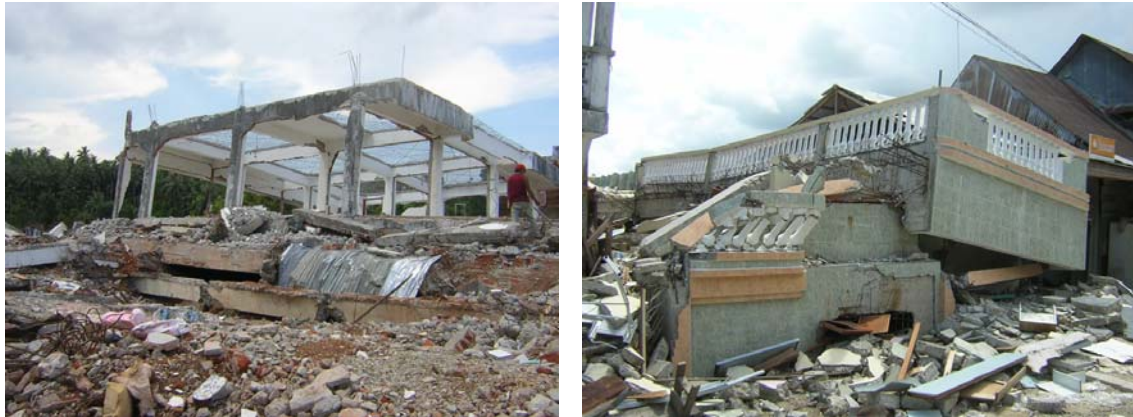
The collapses and heavy damage of RC buildings in Telukdalam town, which is about 150km from the epicenter, may be associated with soft ground condition in addition to the problems mentioned above (Figure 9.10). It seems that the ground shaking may be amplified in soft ground as it is the common case for shaking in coastal areas due to earthquakes in inter-plate subduction zones.

Figure 9.10 Heavy damage or collapse of RC buildings in Telukdalam

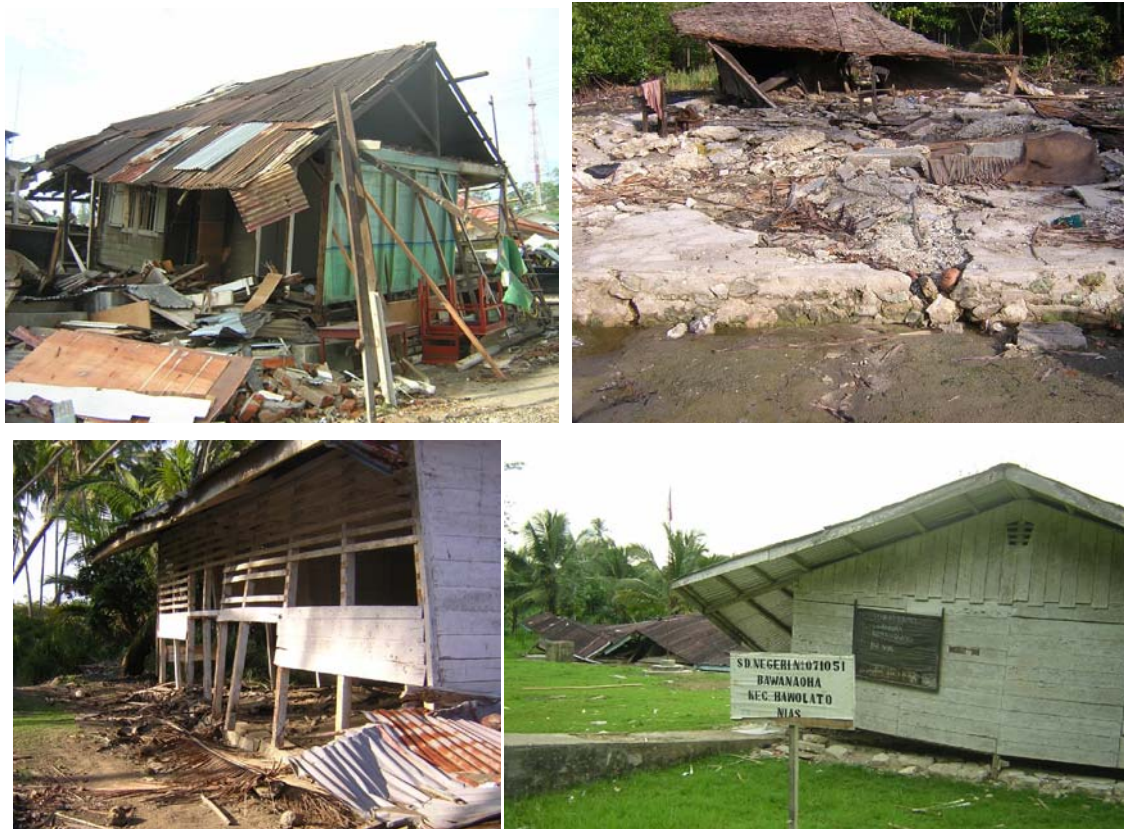
Wooden houses may be divided into modern and traditional types. Many wooden houses are elevated from ground. Although wooden houses generally performed well during earthquake, the damage or collapse of the wooden houses were mainly caused by the dilation of super structure caused by the settlement and lateral spreading of ground liquefaction and landslides (Figure 9.11).

Figure 9.11 Damage to wooden houses and schools

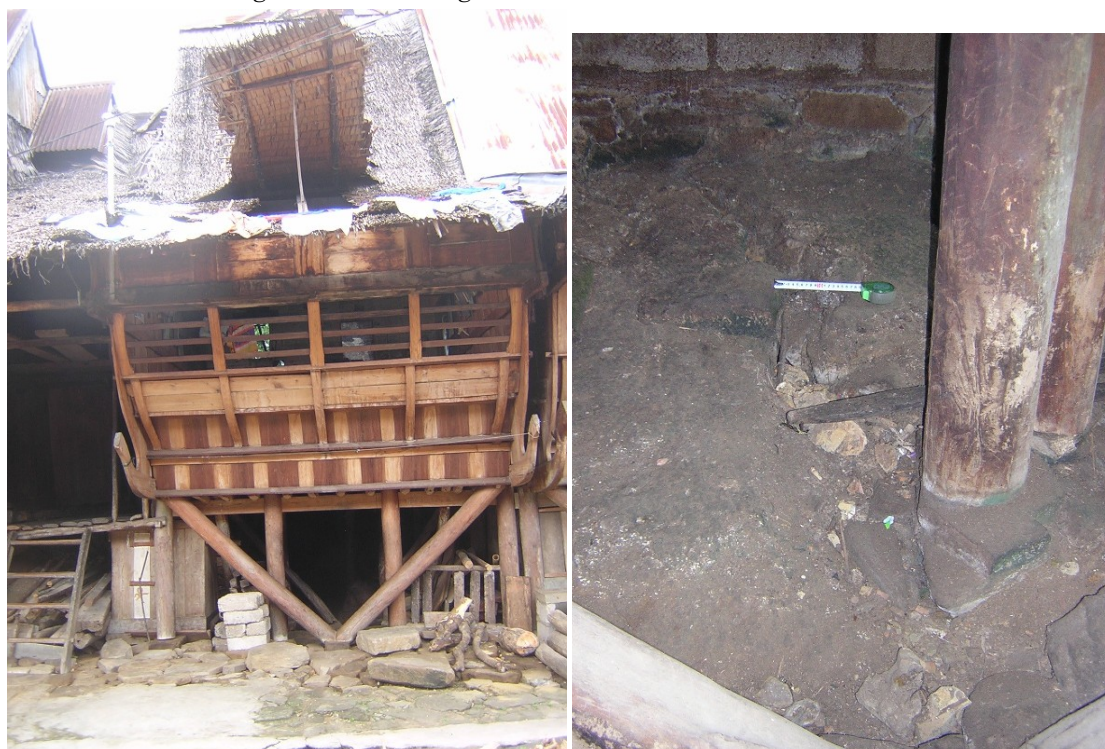
Traditional houses are built with good material and good workmanship, and the damage to this type houses are almost nil except those induced by partial landslide and permanent movement of slopes. The superstructure utilizes good quality cylindrical wooden beams together with truss-type construction method. The villages having traditional houses are all located on hills, where ground motions may be amplified due to topographical effect. When the houses were very close slope crest, some ground cracks with a separation of 100mm and 60mm settlement caused the dilation of super-structure (Figure 9.12). Since these buildings accommodate some relative displacement, the damage was generally non-noticeable in the super-structure.

Figure 9.12 A traditional Nias house and a crack in ground at its basement

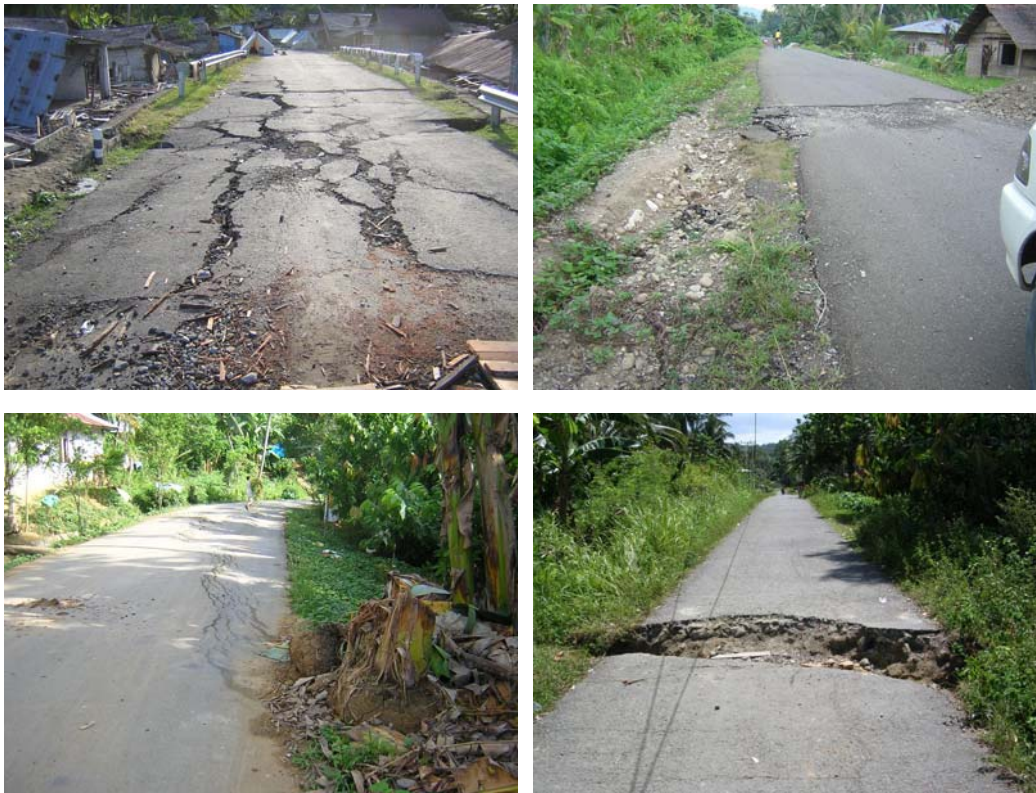
Roadways are generally narrow (less than 5m) and the asphalt surfacing of roadways are generally in poor condition having many potholes. Besides the poor condition of the asphalt surfacing of roadways, the damage was caused by landslides, lateral spreading of liquefied ground, embankment failure (Figure 10.1). The cracks on the roadway pavement were either longitudinal or perpendicular or both to the road alignment. Longitudinal cracking was generally associated with lateral dilation of roadway embankment. Perpendicular cracking to the road alignment was generally observed nearby bridge abutments due to lateral spreading of ground. However, such cracking was also observed in areas, which are non-affected either by landslides or lateral spreading. Although the reason is still unknown, a possible explanation may be related to the fracture propagation during faulting.

Figure 10.1 Damage to roads

- The present roadways are too narrow and they should be widened for smooth flow of traffic
- The foundations of roadways must be improved to increase their bearing and water drainage capacities.
- The asphalt surfacing of roadways must be re-done with appropriate thickness

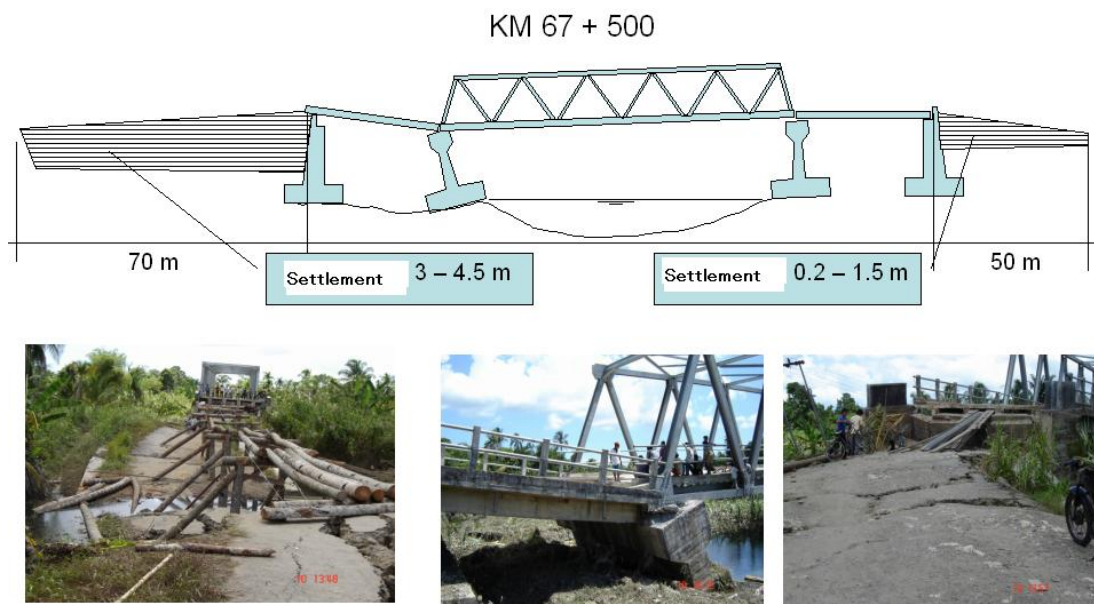
The bridges are designed as simple-supported structures. The bearing supports of many bridges do not have shear-keys or stoppers against both horizontal and vertical movements. The heavily damaged non-accessible large bridges within the surveyed area are Muzoi bridge between Gunung Sitoli and Lahewa route and Sawo bridge between Gunung Sitoli and Telukdalam nearby Tetelesi. These bridges consist of truss super-structures and RC box culverts. The piers of Muzoi bridge were tilted and settled due to bearing capacity and lateral spreading problems associated with liquefaction of ground. The engineers of Department of Public Works pointed out that piers have piles reaching rock formation. It seems that the piles were designed against vertical loads and horizontal loads were not considered. The ground is laterally moved towards the river, which can be clearly inferred from the tilted electric poles next to the bridge and the lateral movement of the ground was more than 4m on both sides.

Figure 10.2 A sketch of Muzoi River Bridge and some views of its present state

The damaged bridges generally need to be re-constructed and it should be next to existing piers with necessary geotechnical investigation of ground and its characteristics. The present truss decks can be used in the new-constructions with some replacement of damaged elements and bolts and bearings together with appropriate stopper against horizontal and vertical relative movements.

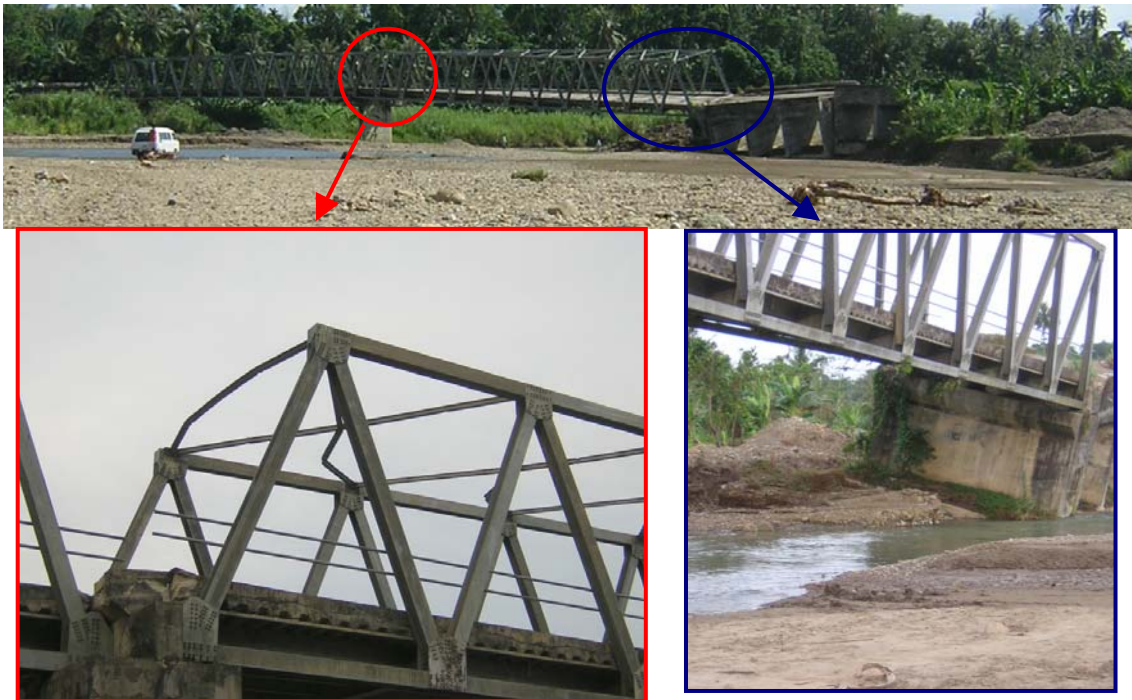
The second pier of Gawo bridge was tilted and slid towards the upstream side of the river and the box-culvert to this pier was also tilted and slid together with the pier (Figure 10.3). The upper deck of the truss section of the bridge is horizontally shifted

about 1.3m. The piers were constructed without using pile foundations. The site investigation indicated that there is a mudstone-like layer and overlaying soil layers consist of sand, gravel and sandy-silt from bottom to top (Figure 10.4(a)). These layers are tilted towards upstream side with an inclination of 5-10 degrees. Furthermore, the river flow is directed towards the pier and box-culvert. Although the construction details of the pier and box culvert are not known, it seems that the toe erosion (scouring) of the pier and box culvert together with liquefaction of inclined sandy layer and horizontal shaking may be the major causes of the damage to Gawo bridge.

Figure 10.3 Gawo Bridge nearby Tetehosi

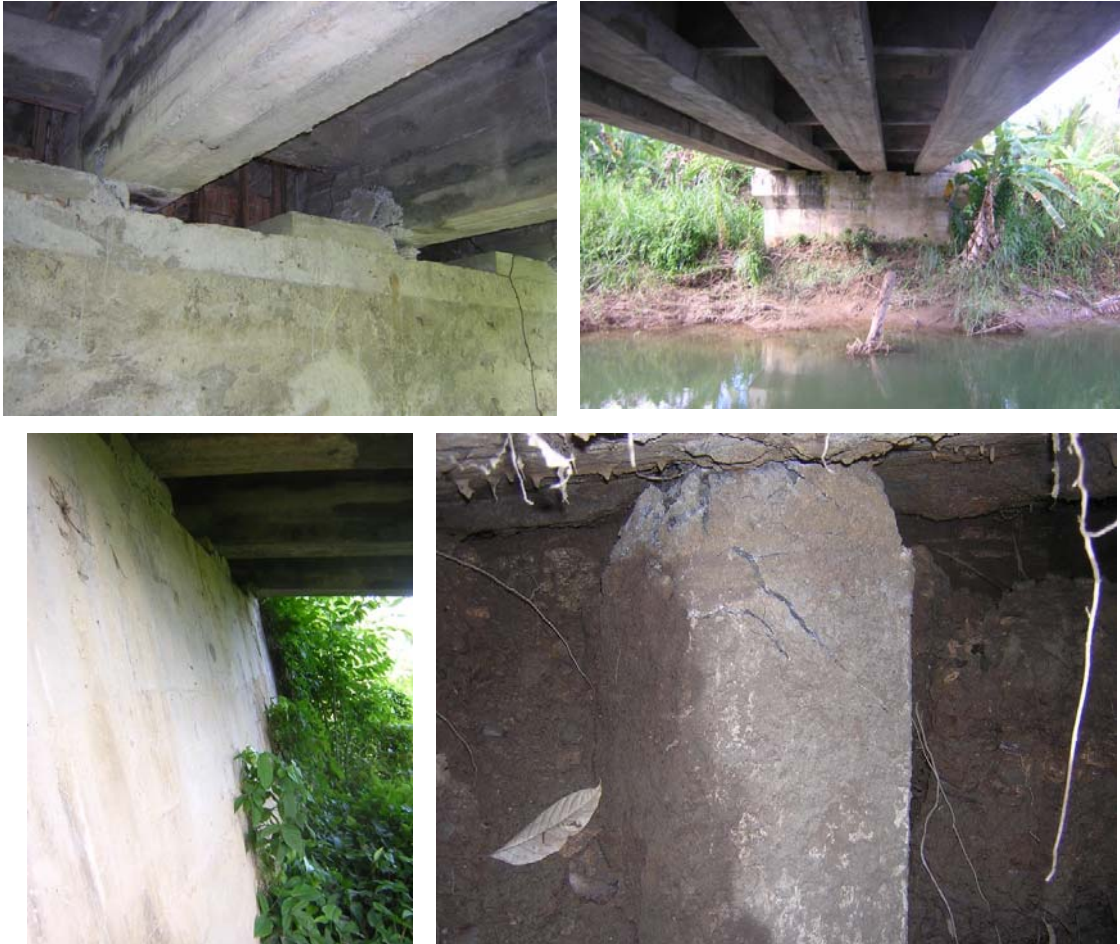
RC bridges in Gunung Sitoli town were damaged by the lateral spreading of liquefied ground. The bridge foundations have some piles and some of these piles were broken at the top (Figure 10.5).

Figure 10.5 Some examples of damage to RC bridges

- Pile design should be re-considered and their length should be sufficiently long to have required end bearing.
- The foundation pile should be designed to resist to lateral flow force of liquefied ground.
- Reconstructed abutments have wing walls to prevent collapse of approach road to bridge.
- The damaged bridge will be repaired by temporary measures. The displaced abutment should be reconstructed on new alignment since it takes long time to rebuilt (Figures 15.2, 15.3 & 15.4)
- The truss bridges will be inspected in detail and decided whether it is possible to reuse it. Damaged parts will be replaced.
- The concrete bridge will be inspected in detail and damaged bridge will be reconstructed. Even if they have no problem, the bridge may be set back and reconstructed due to condition of the foundation ground and geographical conditions.

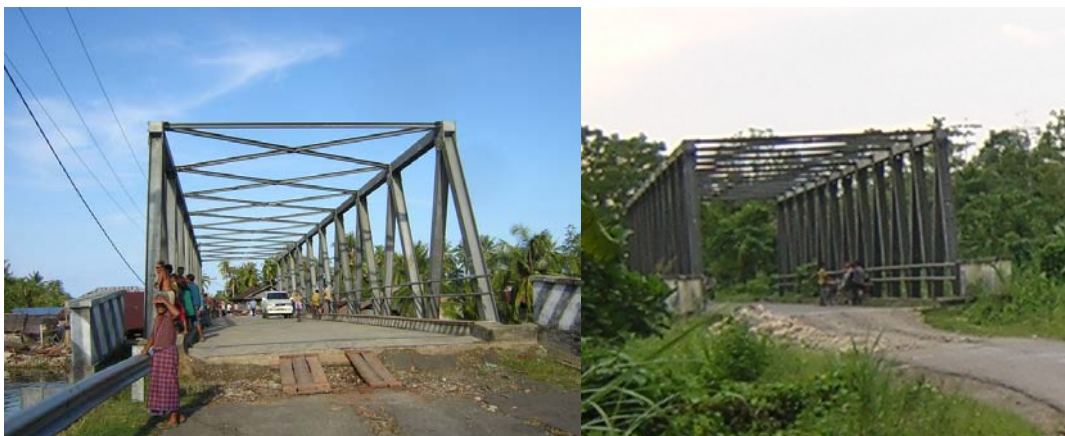
The approach embankments of bridges are generally damaged and settled due to lateral spreading of ground and failure of wing-embankment walls. The settlements were generally greater than 30cm in many locations (Figure 10.7). The backfill materials of approach embankments consist of gravelly soil and it is expected that the potential of settlement or liquefaction is low.

Figure 10.7 Settlement of approach embankments of bridges

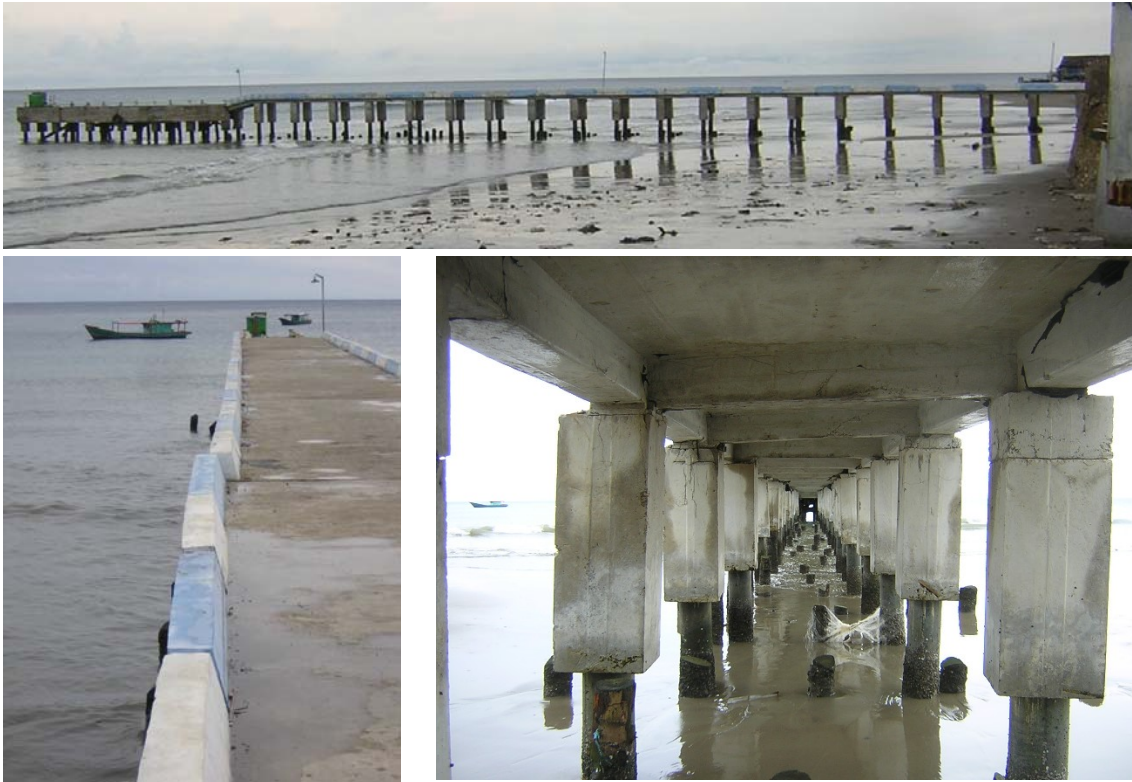
(a) Damage at Gunung Sutoli port

There are some damage to port facilities in Nias Island due to ground shaking rather than tsunami (Figure 11.1). The new wharf of Gunung Sitoli port was damaged by the lateral spreading of liquefied ground. As a result, the pile heads fractured and settled. Furthermore, there was a relative movement of 15cm between the section of the wharf. In Telukdalam new port, a part of wharf sank into the sea and some pile heads were fractured by collision of wharf segments..

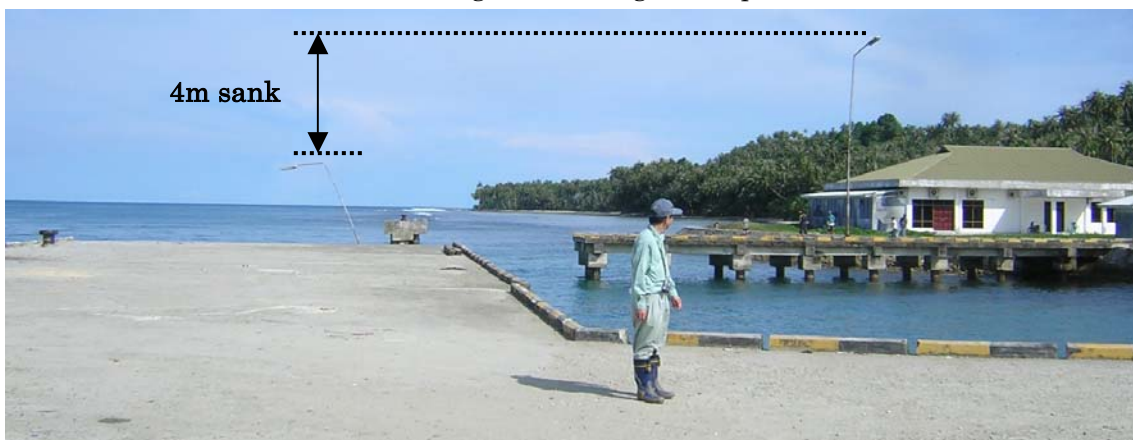
(b) Sank part of the wharf at Telukdalam new port

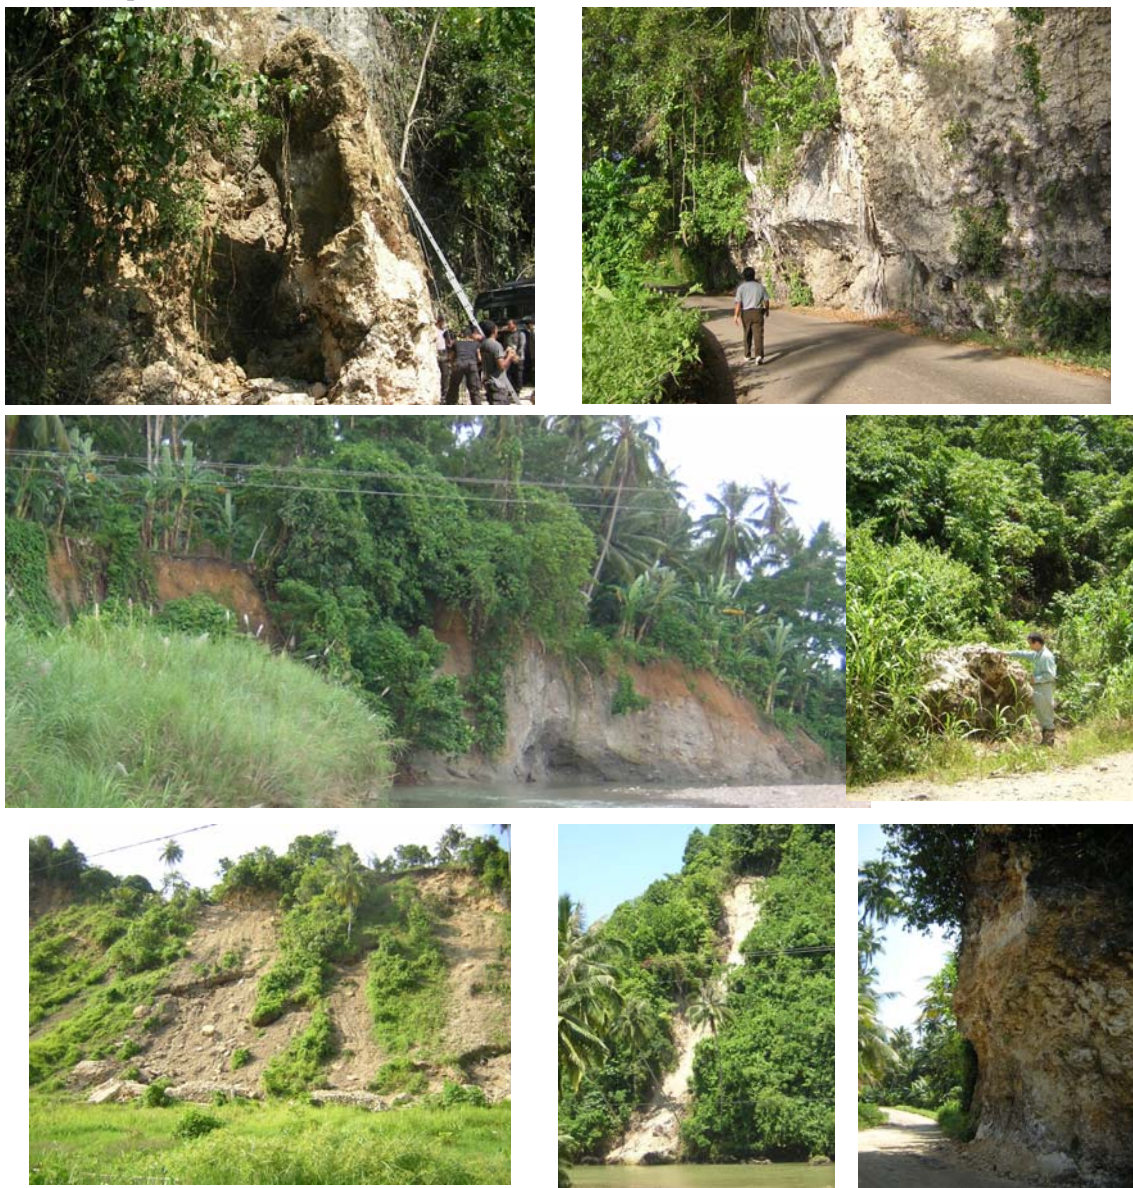
The top rock is porous coral limestone and the joints are widely spaced. Phillite-like rock is beneath the coral limestone. Many rockfall are observed particularly along the roadways pass through porous limestone (Figure 11.1). Slope failures are generally surfacial failure of weathered loose material or individual rock falls. These rockfalls directly hit the roadways. Fortunately, nobody was killed by these rock slopes and rockfalls. In some places the slope has overhangs the roadway. Therefore, it is necessary to widen and cutting slopes to the slope angle less than 60 degrees is desirable with shoulder pockets for individual and limited rock falls.

Figure 12.1 Various slope failures along inspected routes

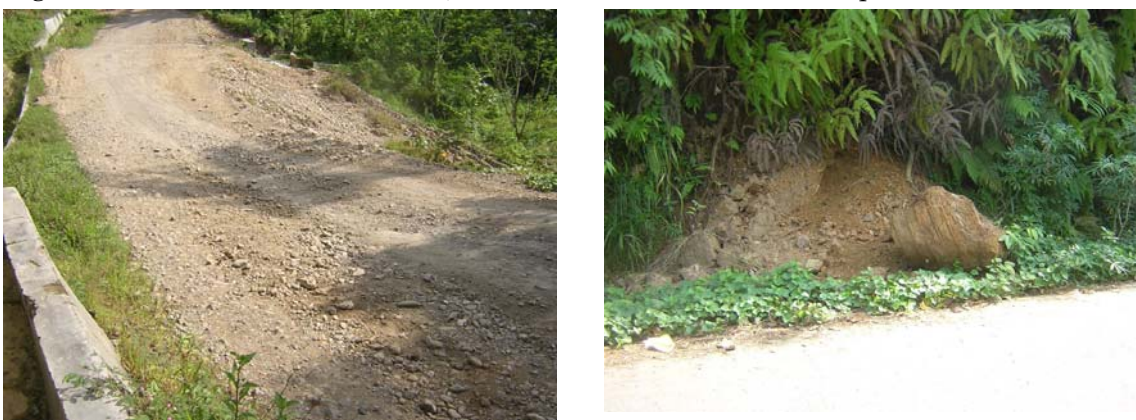
The permanent movements of slopes consisted of weathered rock is also likely during this earthquake. The inspections of villages with traditional houses such as Ohalili nearby Telukdalam and the routes of Lahusa - Telukdalam and Gunung Sitoli – Lawa village indicated that there were permanent movement of slopes. The slope for example between Gunung Sitoli and Lawa village consists of soft sandstone and siltstone. As seen in Figure 12.2, the top part of the slope consists of weathered soft rocks having their bedding plane inclinations largely varied. Figure 12.3 shows some example of slope movements in this type of materials.

Figure 12.3 Some slope movements and rockfall in weathered soft sedimentary rocks

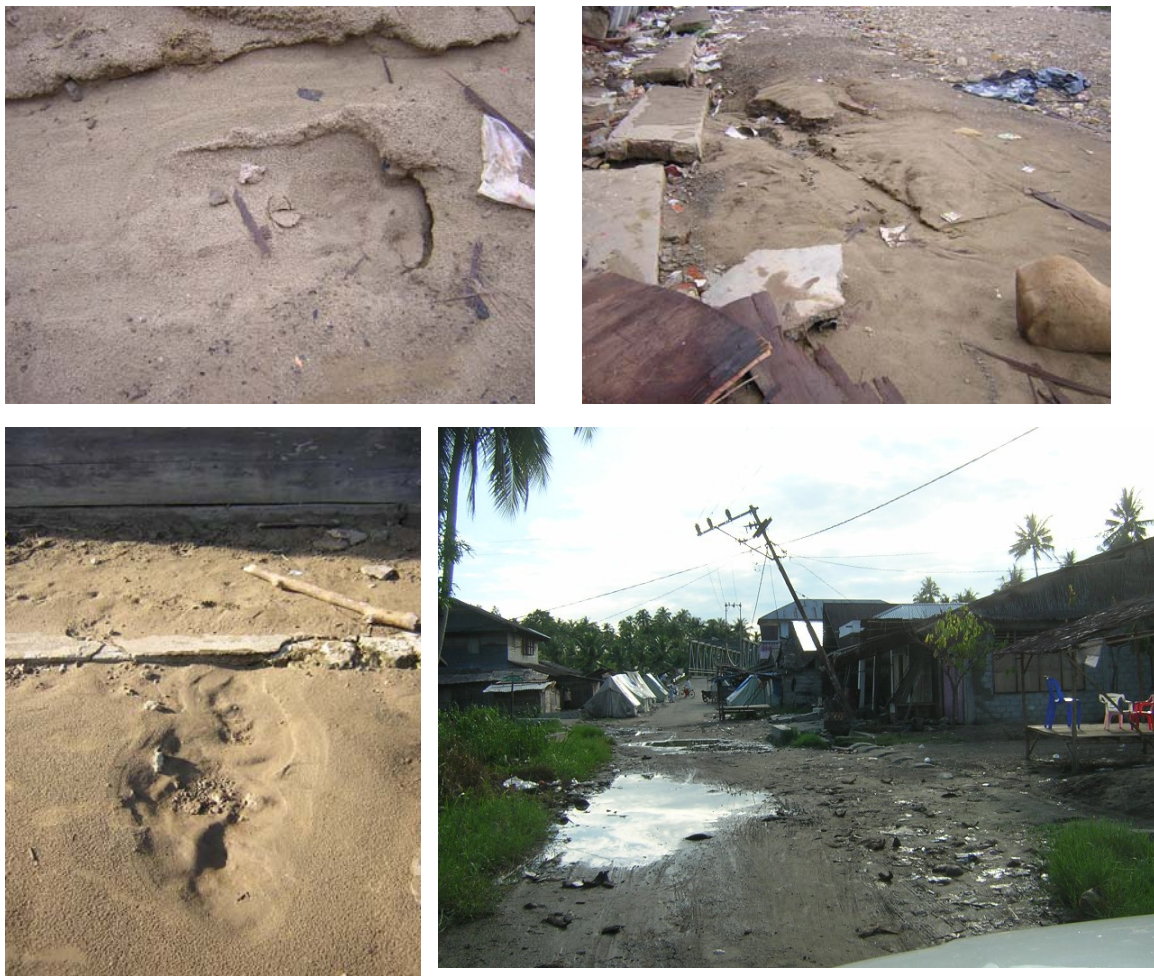
As expected from the magnitude of this earthquake, the liquefaction of sandy ground is very likely. The sandy ground is observed along sea shore and riverbanks. The traces of ground liquefactions could be observed in various locations along the inspected routes. Figure 13.1 shows some examples of ground liquefaction. The all possible forms of ground movements and the effects of ground liquefaction were observed such as sandboils, lateral ground movements, settlement. The damage induced in Gunung Sitoli is widespread along the coastal area and reclaimed ground and in other coastal towns. The lateral spreading of ground nearby bridge abutments were almost entirely associated with liquefaction of sand soil layer as shown in Figure 10.4. However, the geotechnical investigations of ground are lacking in Nias Island and it would be desirable to carry out such investigations for areas particularly affected by ground liquefaction is necessary.

Figure 13.1 Some examples of sandboils in Gunung Sitoli and coastal areas

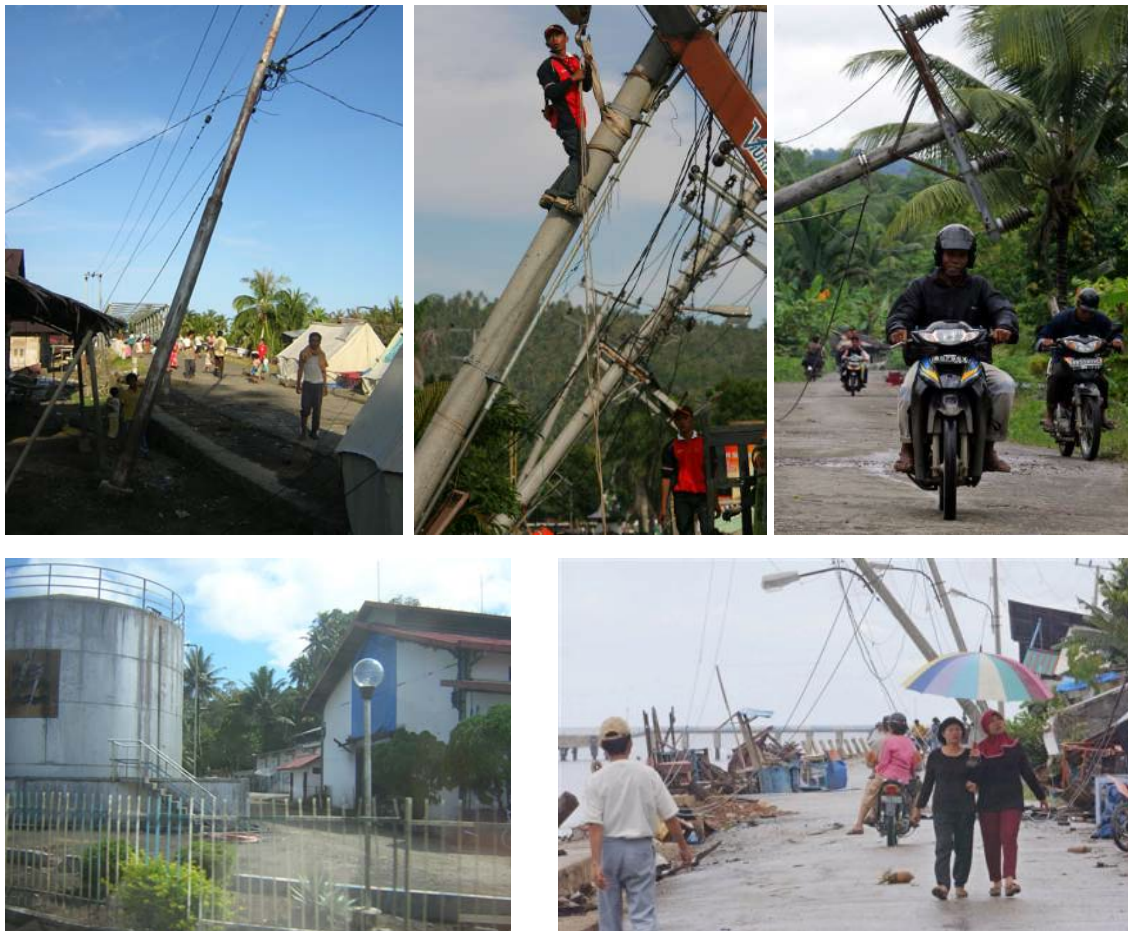
Following the earthquake, lifelines such as electricity, water supply and sewage were severely affected by the earthquake. The electric supply in Nias Island is achieved through oil-powered power generators. The supply of electricity is still insufficient and its voltage is very unstable. In liquefied areas, many electricity poles were broken or tilted by the lateral spreading of ground and slope failures (Figure 14.1).

Figure 14.1 Effects of the earthquake on electricity system

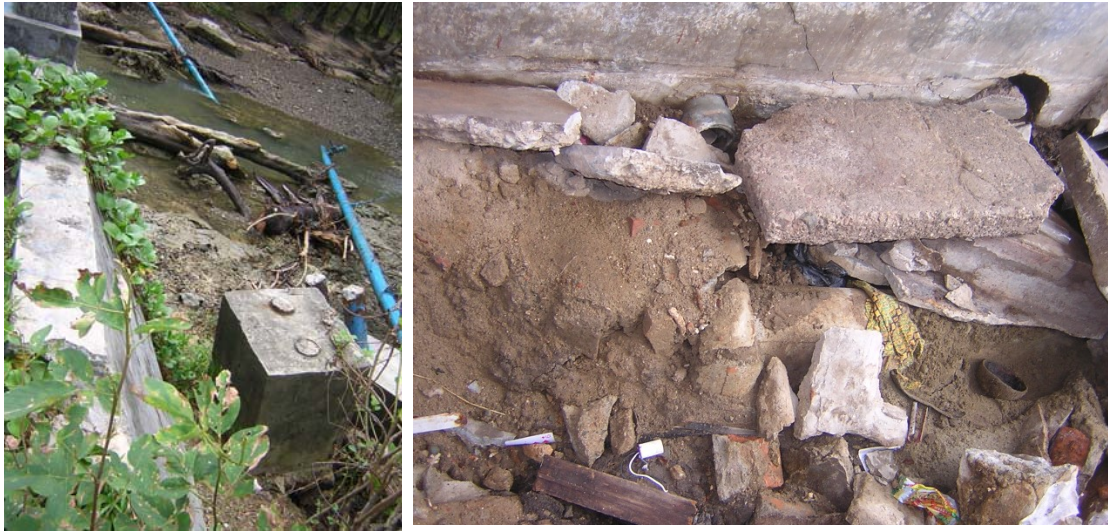
Water supply network is also in bad shape and the water pipes next to bridge abutments were ruptured by the ground movements (Figure 14.2).

Figure 14.2 Views of damage to water pipes and sewage
