Important Features of the Damage Caused by the May 27, 2006, Mid Java Earthquake, Indonesia

Kazuo KONAGAI¹, Yoshiaki NAKANO², Masaomi TESHIGAWARA³
Tomoji SUZUKI⁴, Takaaki IKEDA⁵ and Tetsuya OGUSHI⁶

Key Words : *Java, Indonesia, geotechnical problems, detailings of house,*

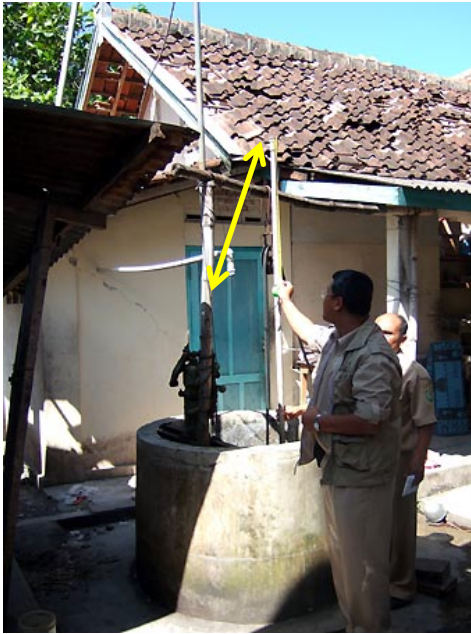
plastic pipes for pumping water out of these wells were found bent, broken and pushed up. They clearly indicate that soils beneath the wells have liquefied, however no clear sand volcanoes were found in their vicinities. Damage to houses surrounding the wells was seemingly less serious than in other areas with no clear evidence of liquefaction. Examples of this contrast are shown in **Fig. 3**. Liquefaction can be the cause of serious destructions to be sure, but it is often observed that liquefied soil isolate the upper soil mass from intense seismic motions. As long as a surface soil mass above the liquefied sand remains coherent, damage to dwellings on the soil mass can be slight. Further studies will be needed.

(a) A plastic pipe was pushed 70cm up.
(Location: -7.9569333, 110.130485)

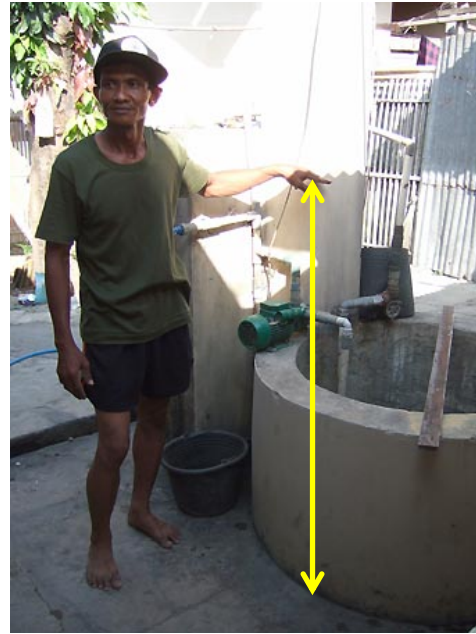
(b) Dark colored water spouted about 1.3 m up above the ground level.
(Location: -7.89510, 110.223825833)

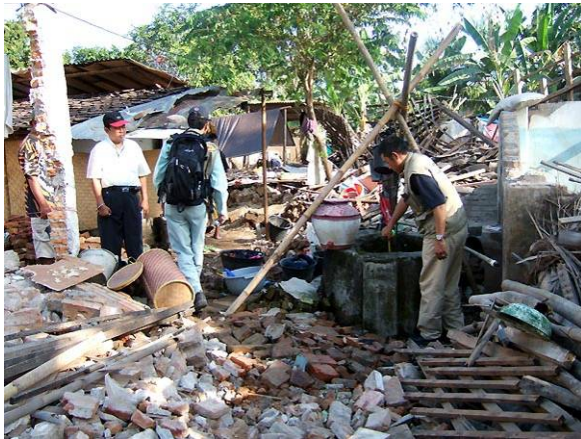
(c) S7deg. 53.458 min., E110deg 23.186min.
No change in water level of -5.0 m.

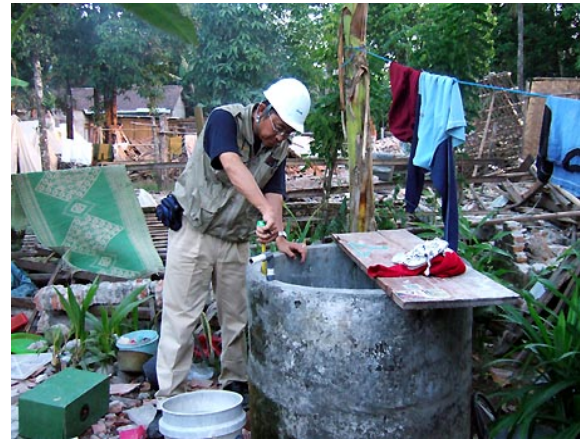
(d) S7deg. 51.044 min., E110deg 20.031min.
Water level decreased by about 0.25m.

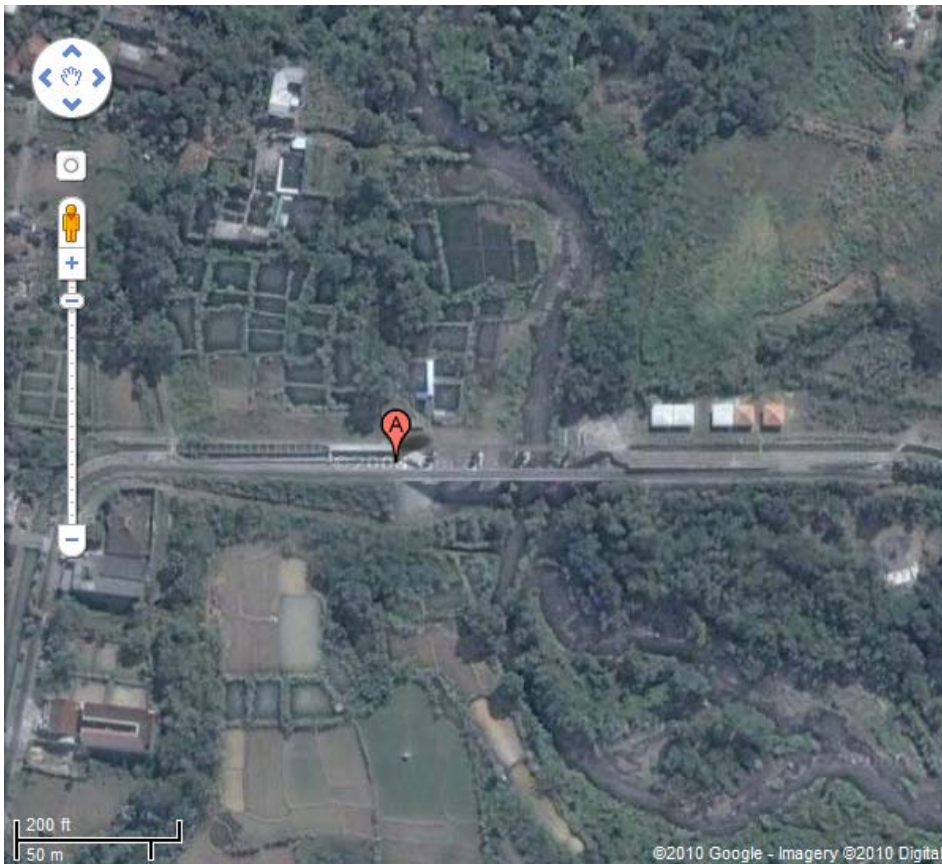
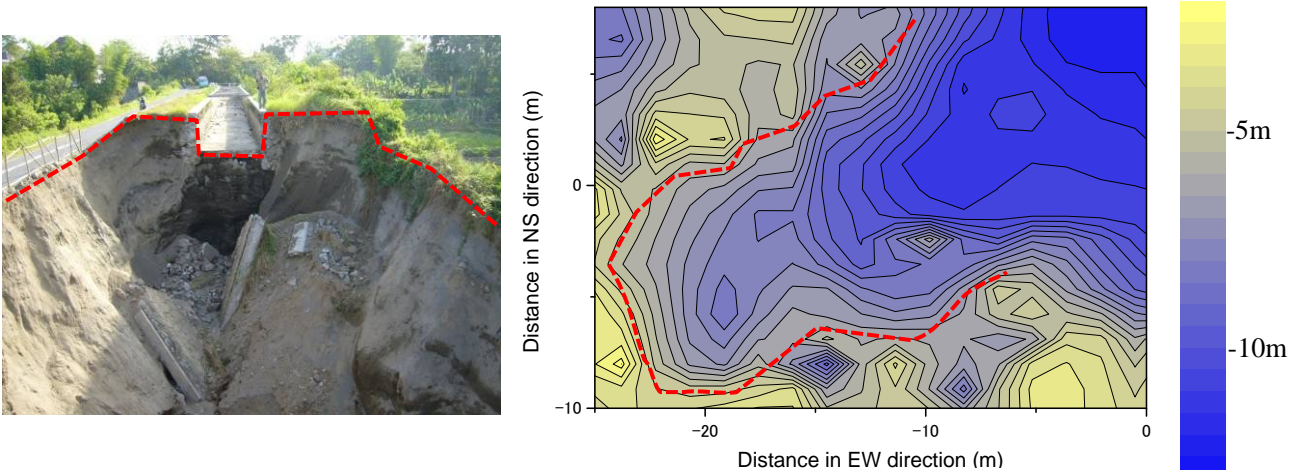
Fig. 4 Damage to Mataram Canal Bridge (Location of the place mark: -7.767826,110.41481): The sandy soil mass of the right embankment behind the masonry abutment of about 10m high slid down towards the river. The scar was laser-scanned from the top end of the rightmost pier.

A bridge of Mataram canal, supplying drinking water and irrigating 19,000 ha of land extending the lower basin of Progo and Opak river, was damaged as shown in **Fig. 3**. Two masonry abutments and four RC piers support a steel box aqueduct of 80m long. RC open channels on both riversides resting on embankments narrow to this aqueduct. The sandy soil mass of the right embankment behind the masonry abutment of about

10m high slid down towards the river. The scar was formed 26 m west behind the abutment immediately beneath a construction joint of the open channel, suggesting that water might have been seeping through the joint into the embankment soil.

Quick restoration of the bridge is a must because of the canal's important functions. Moreover, a road running along the canal resting on the remaining soil mass of the same embankment is under a threat of subsidence. However, a complete reconstruction of the embankment will be just a stop-gap measure, and won't mitigate its geotechnical hazard potential. Even an inch settlement of the embankment will cause cracking of concrete joints, and water will leak again through the joints. A possible and efficient measure may be to replace the embankment with some piers.

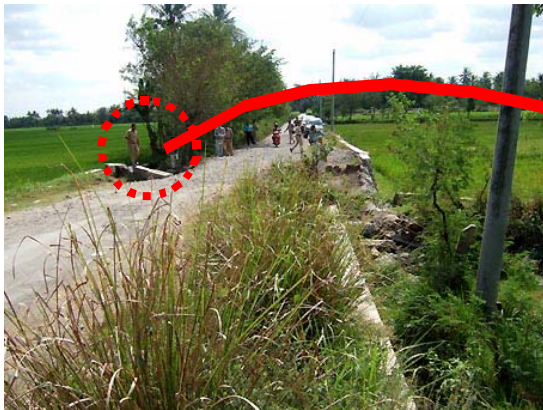
A skewed simply supported RC bridge (4 beams) of 3.5 m wide fell down due to embankment soil subsidence (Location: -7.785033, 110.578). The sunken soil mass seems to have pushed bottom of a stream flowing near by the embankment.

(a) Location of skewed bridge: Edge lines of road are seemingly dislocated right-lateral. However no clear dislocation was found in rice paddies.

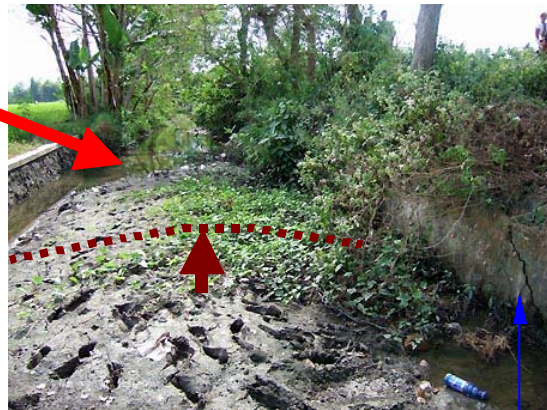
(b) Bottom of stream along the road has been pushed up

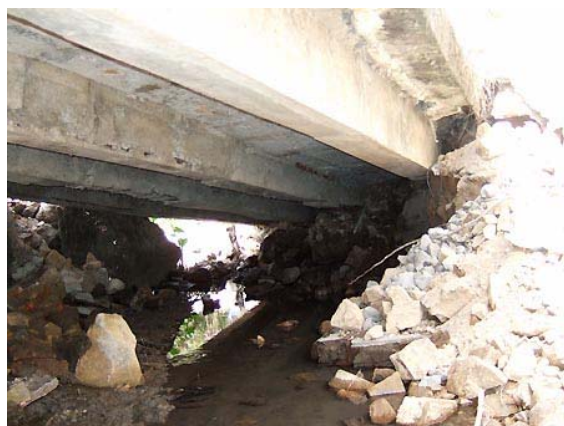
(c) Four simple beams support the deck.

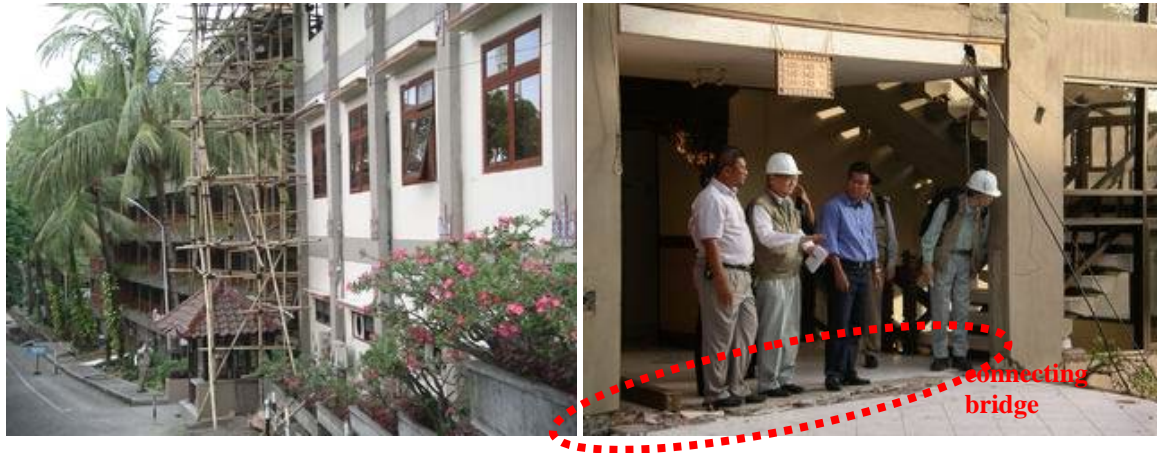
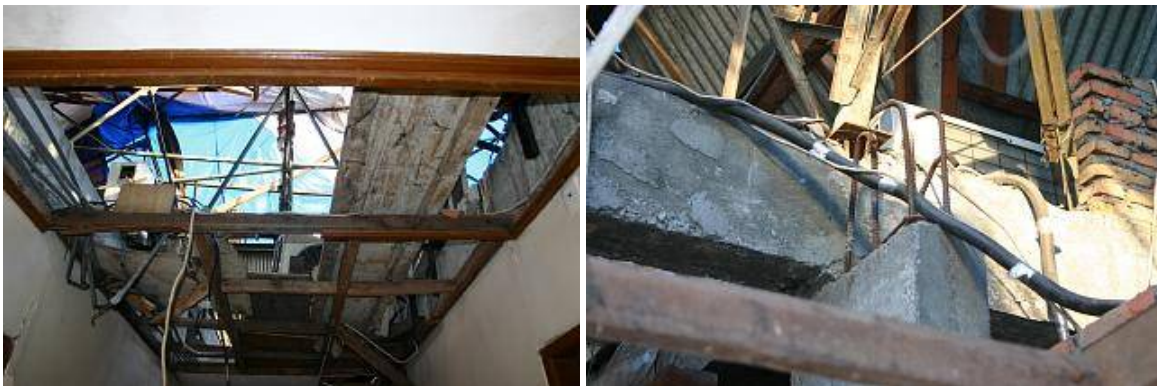
Fig. 6 Jayakarta Hotel

URM walls (UnReinforced Masonry (brick) walls) in RC frames were damaged and a connecting bridge between two adjacent buildings (lobby building and lodging building) was damaged at the expansion joint as well as its roof and handrail wall due to pounding. Roof tiles on a truss system with steel-angle fell down through the ceiling board of guest rooms on the top floor, and falling debris were likely to have been life-threatening to guests present at the time of the earthquake.

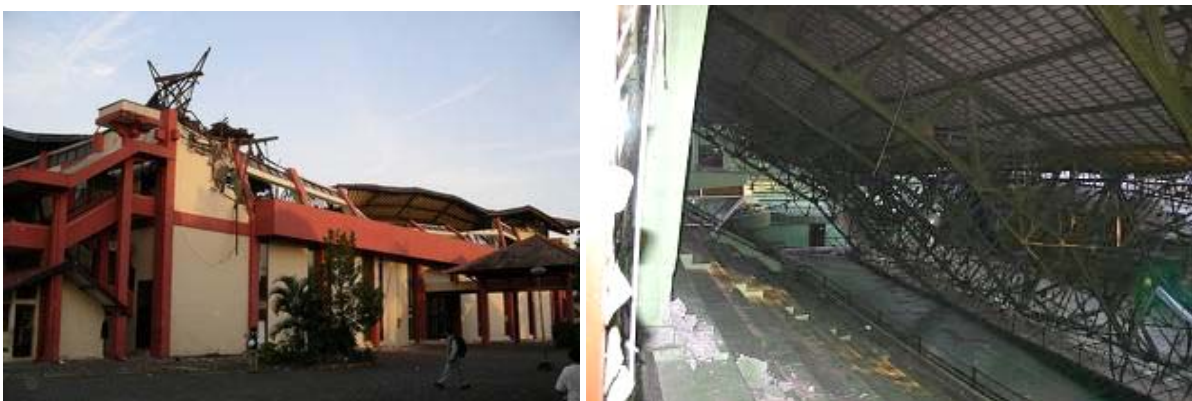
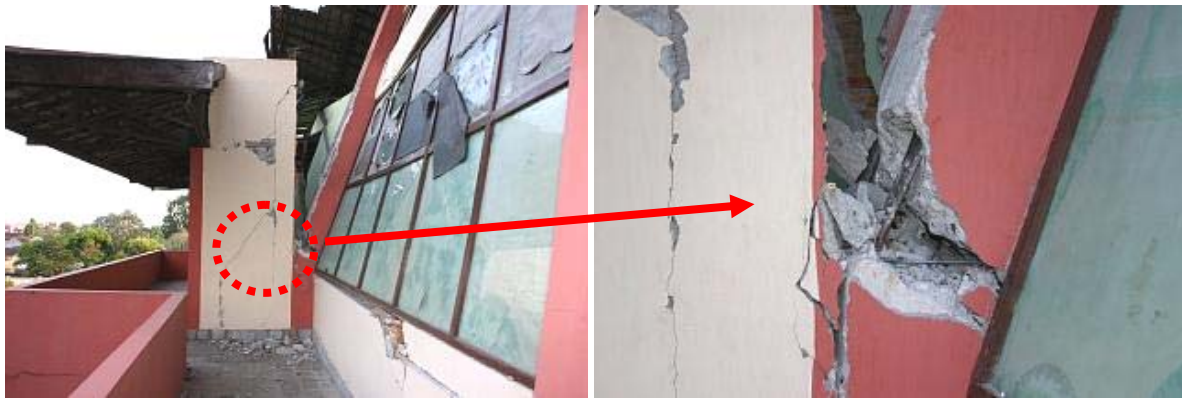
Fig. 7 Amongrogo Sports Center

Extensive damage was found in cantilever RC columns on the top floor as well as in the roof system. The column damage may be attributed to the large inertia force due to shaking and the inward force due to the roof's collapse since the only slight reinforcement was provided in the columns.

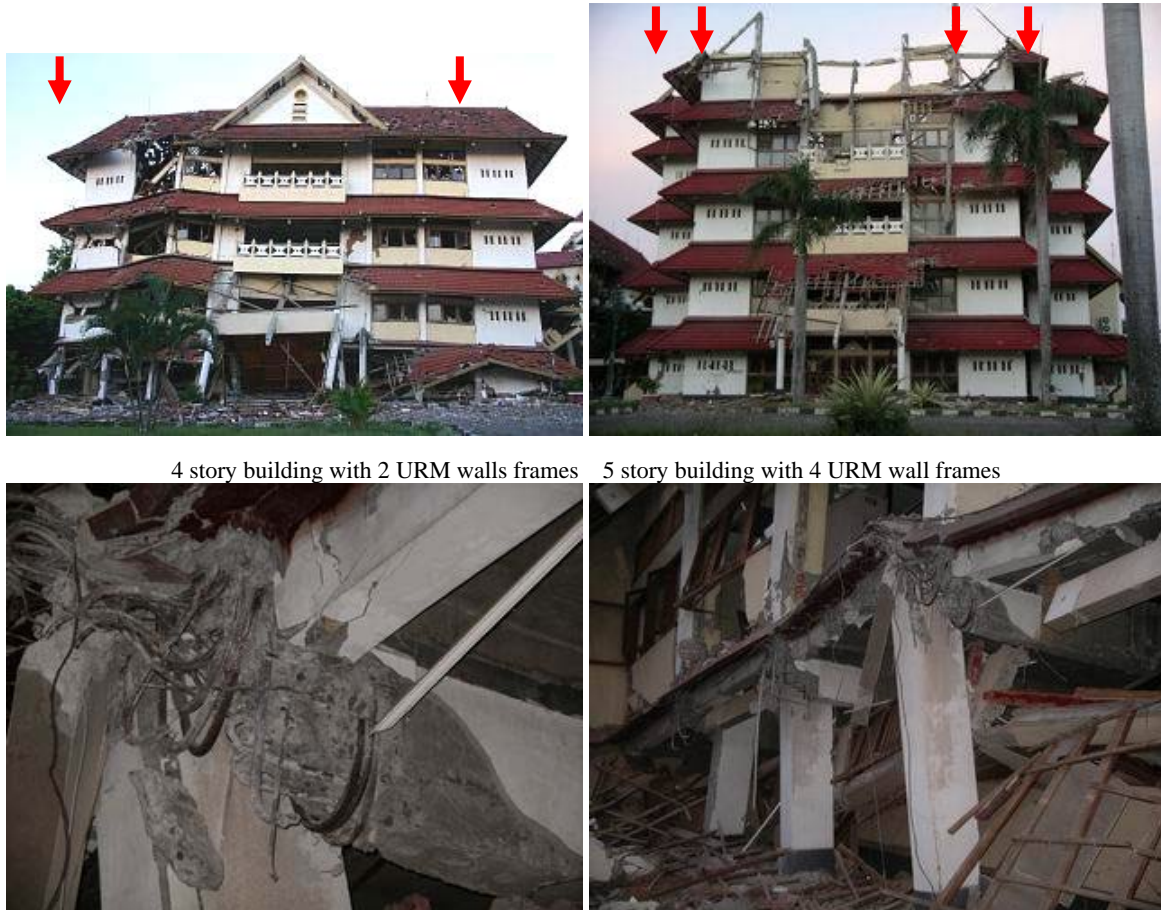
Fig. 8 University of Economic Science (STIK Kerja Sama)

The campus had several multi-story buildings. Serious structural and nonstructural damage was found in most buildings. The first story of one 4 story RC building, which was located just across the open square at the entrance gate, collapsed due to failures at beam-column joints. It had 2 URM wall frames while the neighboring 5 story building had 4 URM wall frames and did not collapse. The damage was also attributed to the insufficient beam-column joint section as compared to the amount of reinforcing bars, which resulted in the poor anchorage at the joints and their subsequent failure.

4 story building with 2 URM walls frames

5 story building with 4 URM wall frames

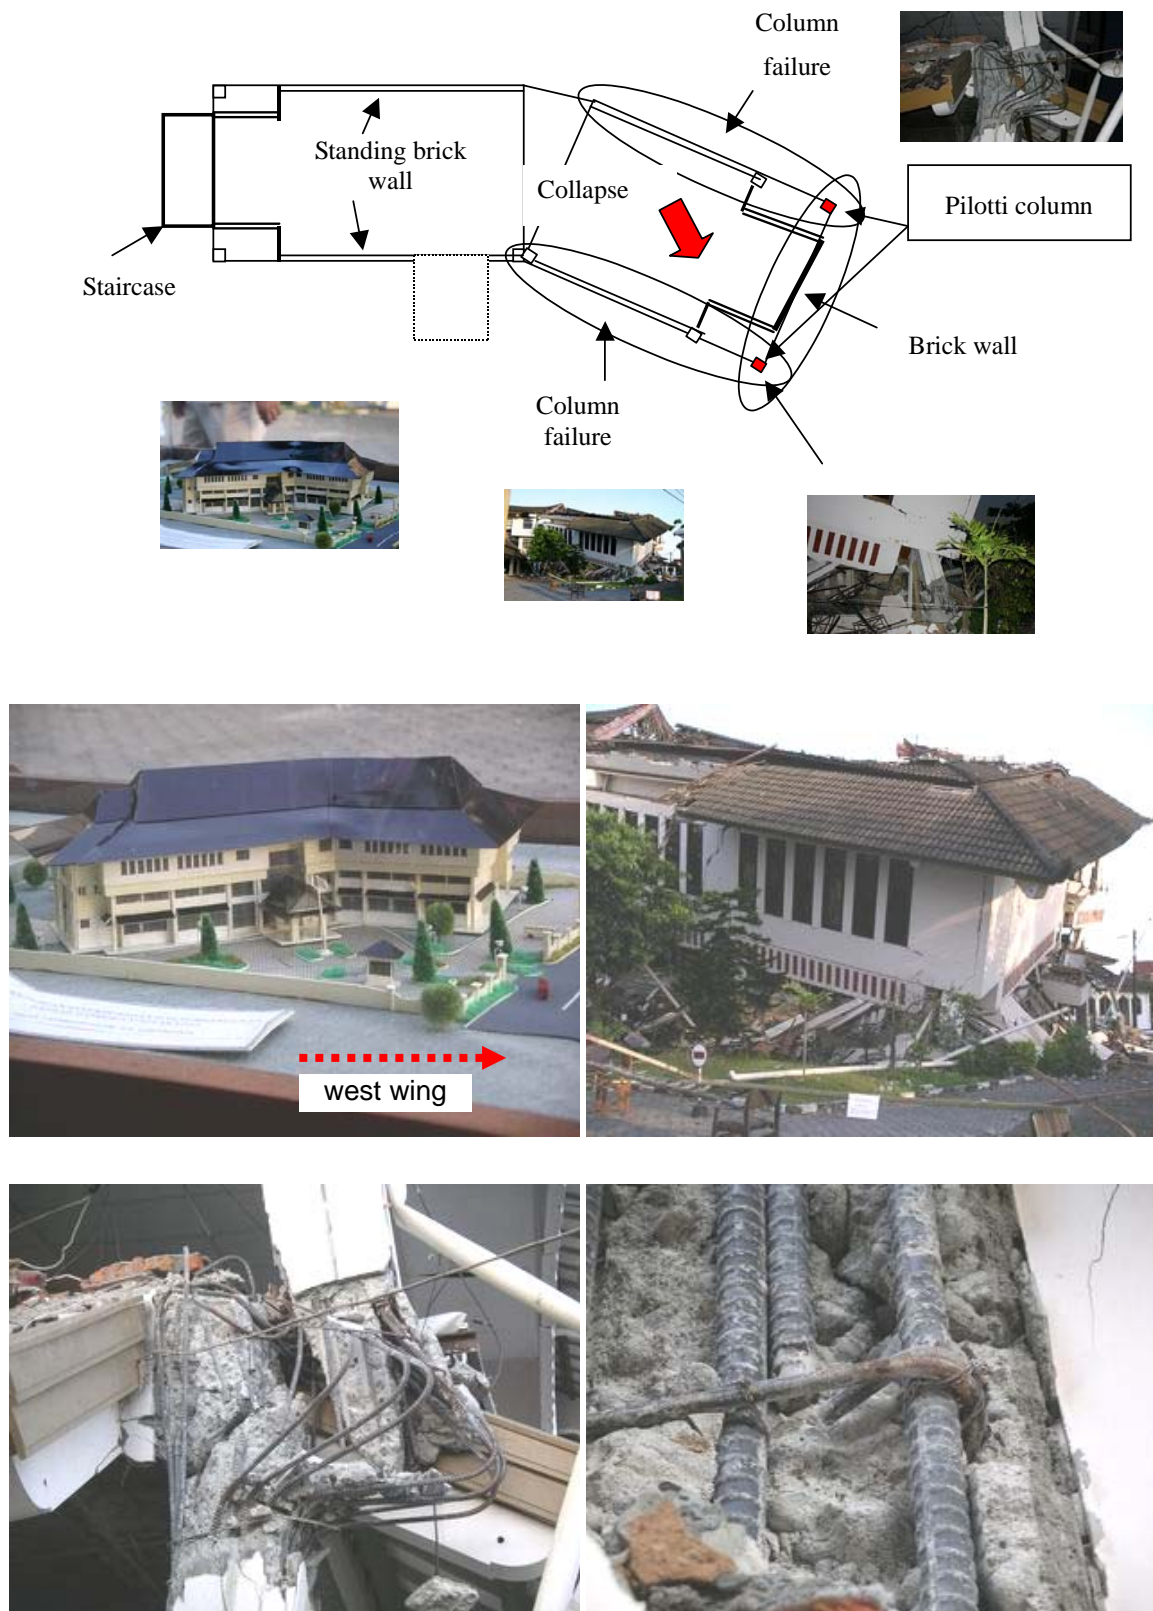
Fig. 9 Finance and Development Audit Agency

The first story of A 3 story RC building collapsed in the west wing due to beam-column failure at the 2nd story while the east wing survived the shaking with damage only to URM walls. Some reinforcing bars of the column were lap-spliced at the joints, resulting in failure. The lateral reinforcement was placed at a space of 25

to 30 cm with 135-degree hooks. The serious damage to the west wing may be attributed to large deformations of flexible columns supporting confined masonry walls above on the west-end exterior frame and torsional response effects

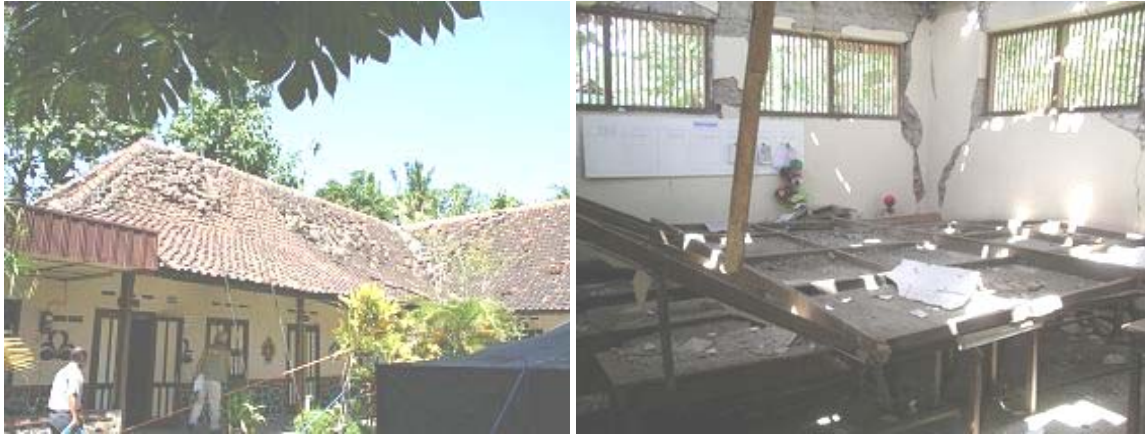
Fig. 10 SD Tempel at Bambanglipuro, Kecamatan Baglipuro

No lintel beams were found and the roof truss was directly placed on URM walls. Major damage was found in URM walls and the timber roof truss, and some ceiling boards fell down in the classrooms.

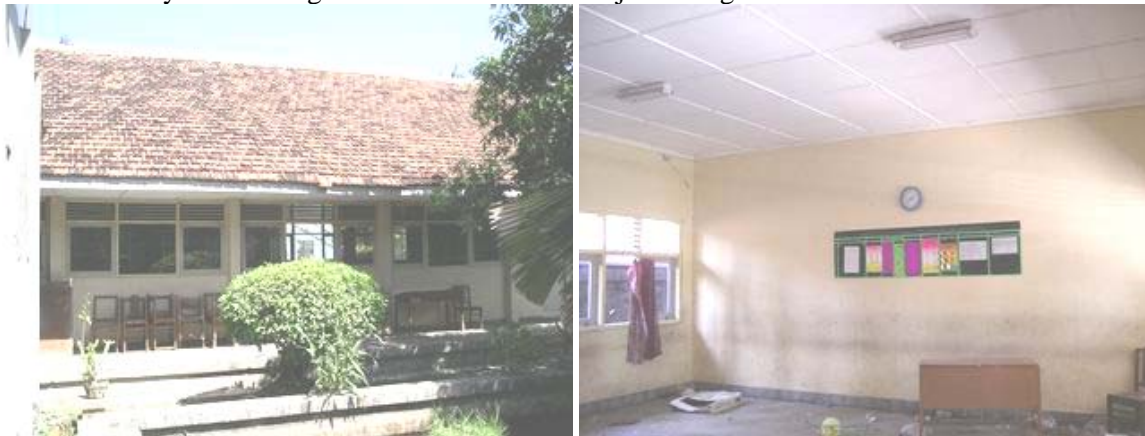
Fig. 11 SMP 2 at Bambanglipuro, Kecamatan Baglipuro

Each class had 3 bays in the longitudinal direction. No major damage was found in the structure.

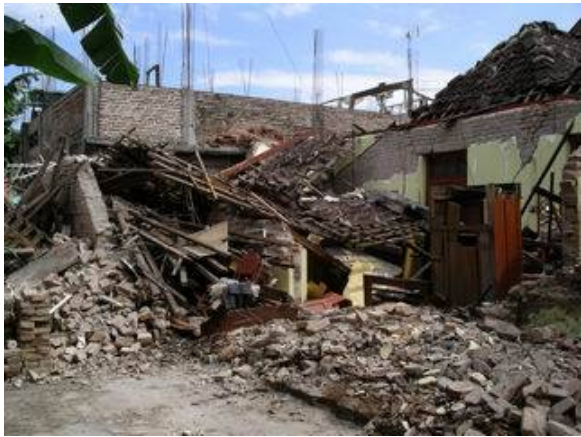
Houses in Imogiri were extensively devastated. They were URM structures with timber truss system and roof tiles on it. URM walls were typically 20 to 25cm thick with 2 or 1.5 brick units of size of 26cm x 12cm x 6cm. Since demolitions to reconstruct damaged houses had started in some damaged houses, it was not easy to identify which debris were due to shaking and which were not. Those with RC frames to confine URM walls often survived the shaking although they had some damage.

Devastated URM house

Devastating damage was found in URM houses in Bantul Regency, Yogyakarta City, and Klaten Regency, killing residents due to heavy debris of brick walls. URM houses with RC beams and columns confining URM walls, however, had relatively less damage, even when they had some damage. Providing RC frames to confine masonry walls is strongly recommended to reduce structural damage to URM houses.

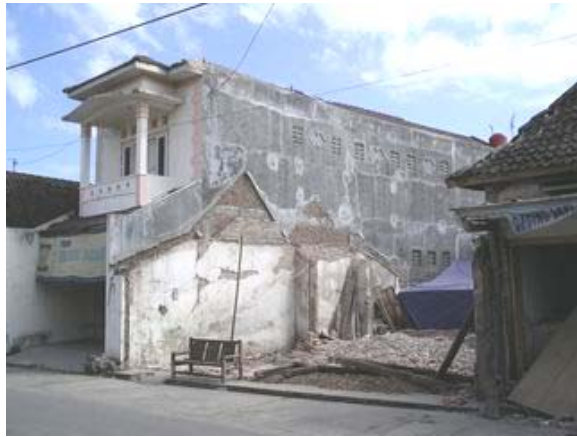
Survived house with URM and RC frame

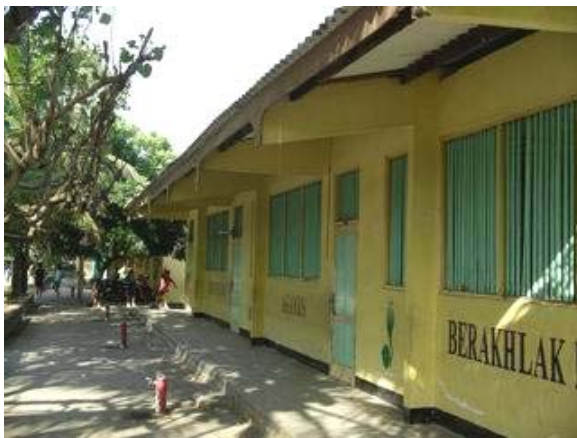
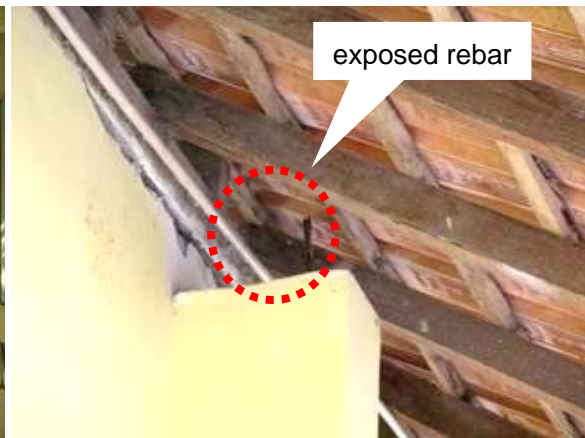
Fig. 13 SD2 Parangtritis

Each class had 2 bays in the longitudinal direction. Each bay was 3.5m long and the column size in the middle was 175mm thick and 350 mm wide. The eaves were supported by Γ -shaped RC columns with a cantilever beam. No major damage was found in the structure. Note that less damage was found in the coastal area around Parangtritis (to Opak river) than in inland areas.

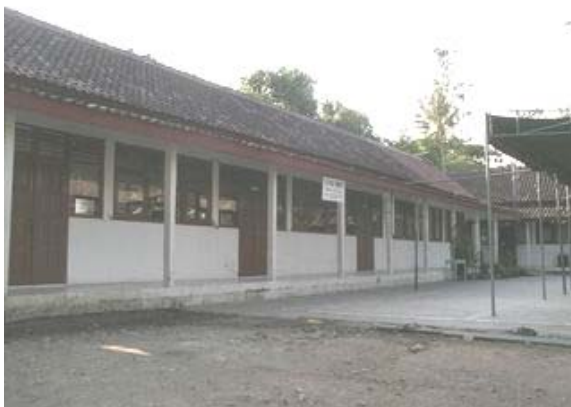
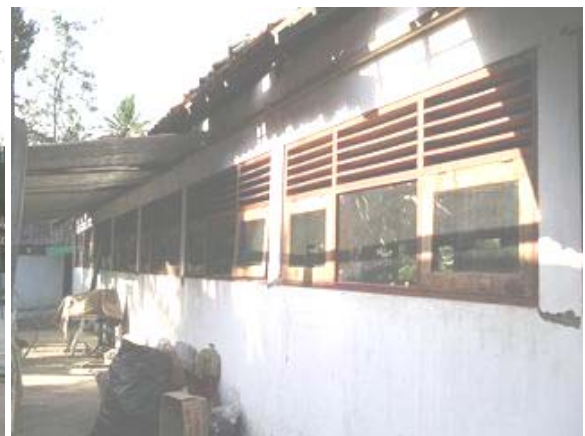
Fig. 14 SLB-PGRI Trimulyo

Each class had 2 bays in the longitudinal direction. Each bay was 3.5m long. Columns had flexural cracks at both ends. The presence of reinforcing bars was not confirmed at the site since the building had minor cracks and rebars were not exposed.

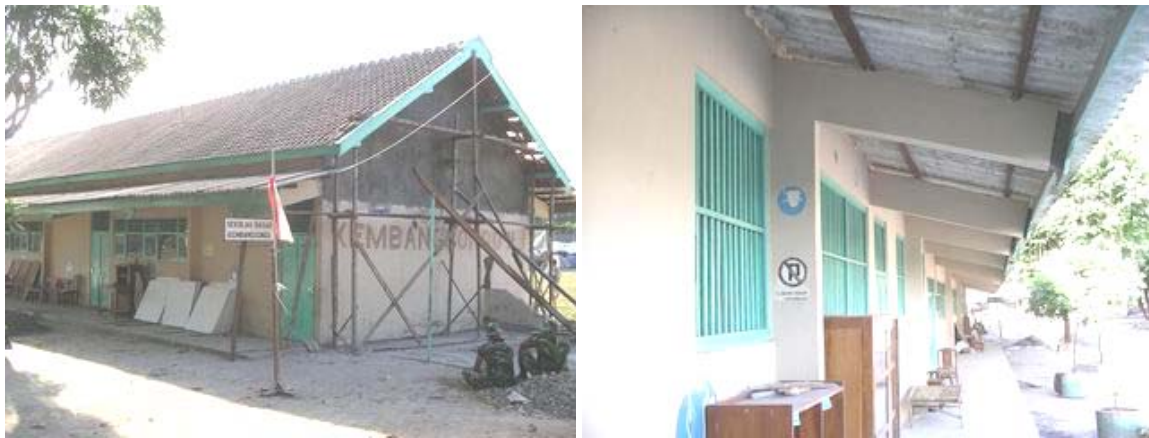
Fig. 15 SD 2 at Kembangsono

The school was located just north of the school at Trimulyo. The eaves were supported by Γ -shaped RC columns with cantilever beams, which were similar to SD2 Parangtritis. The exterior URM wall was damaged and repaired, but no other major structural damage was found in the structure.

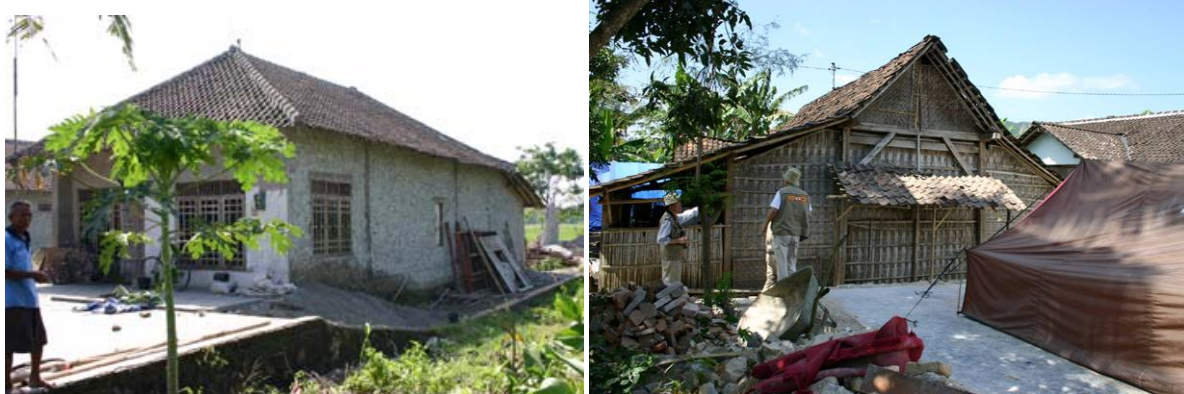
Fig. 16 Traditional houses in Gantiwarno

Traditional stone masonry houses in Gantiwarno Sub-Regency had some damage in masonry walls. They had some RC beams on the wall but no RC columns were provided in the house. Although they were heavy, the stone masonry walls were thick and long enough to resist and survive the shaking. Another traditional houses older than the stone masonry construction had minor damage since they had light bamboo-net walls. The bamboo-net house investigated by the reconnaissance team was older than 70 years.

Stone masonry house

Bamboo-net wall house

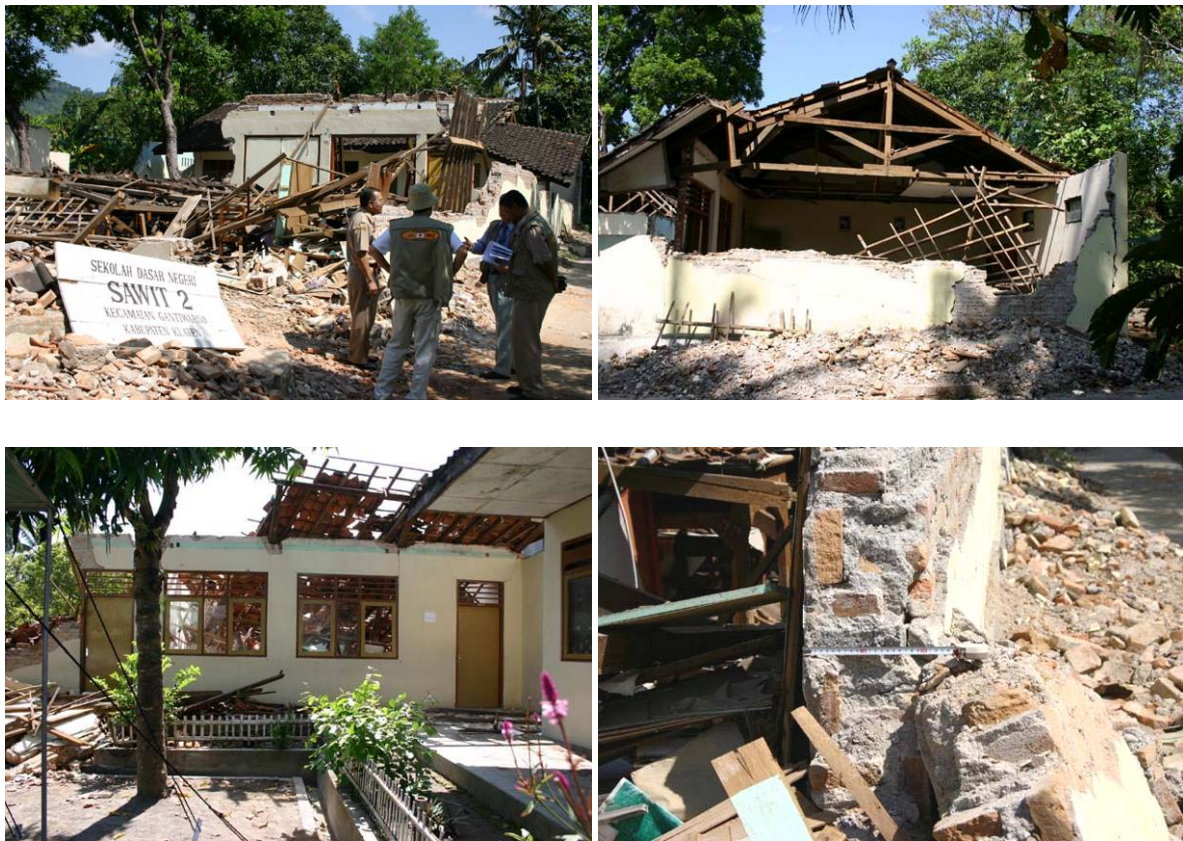
Fig. 17 SD Sawit at Gantiwarno

The school building most probably had RC columns only at the 4 exterior corners but no columns in the middle of the structure. Each class had 2 bays and each bay were 3.5m long. Extensive damage was found in 20cm URM walls and the roof system.

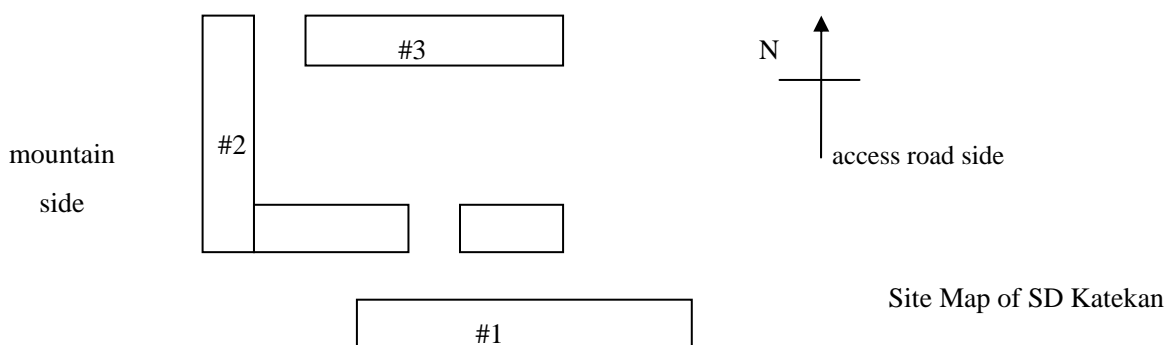
Fig. 18. Katekan elementary school (continued on next page)

The school had 3 buildings, one of them (building #2) were stone masonry structure constructed in the 1970s while the other two buildings (#1 and #3) were URM structure with RC columns. Each classroom of the building #1 had 3 bays, each of which was 3m long. Damage to the roof system and ceiling boards was found in buildings #1 and #3 while cracks in URM stone walls were found in building #2.

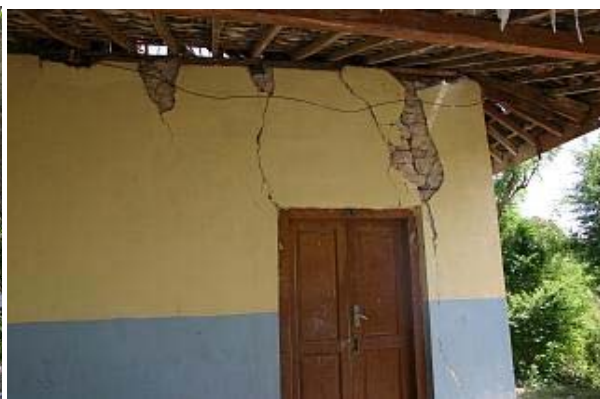
Damage to corner wall

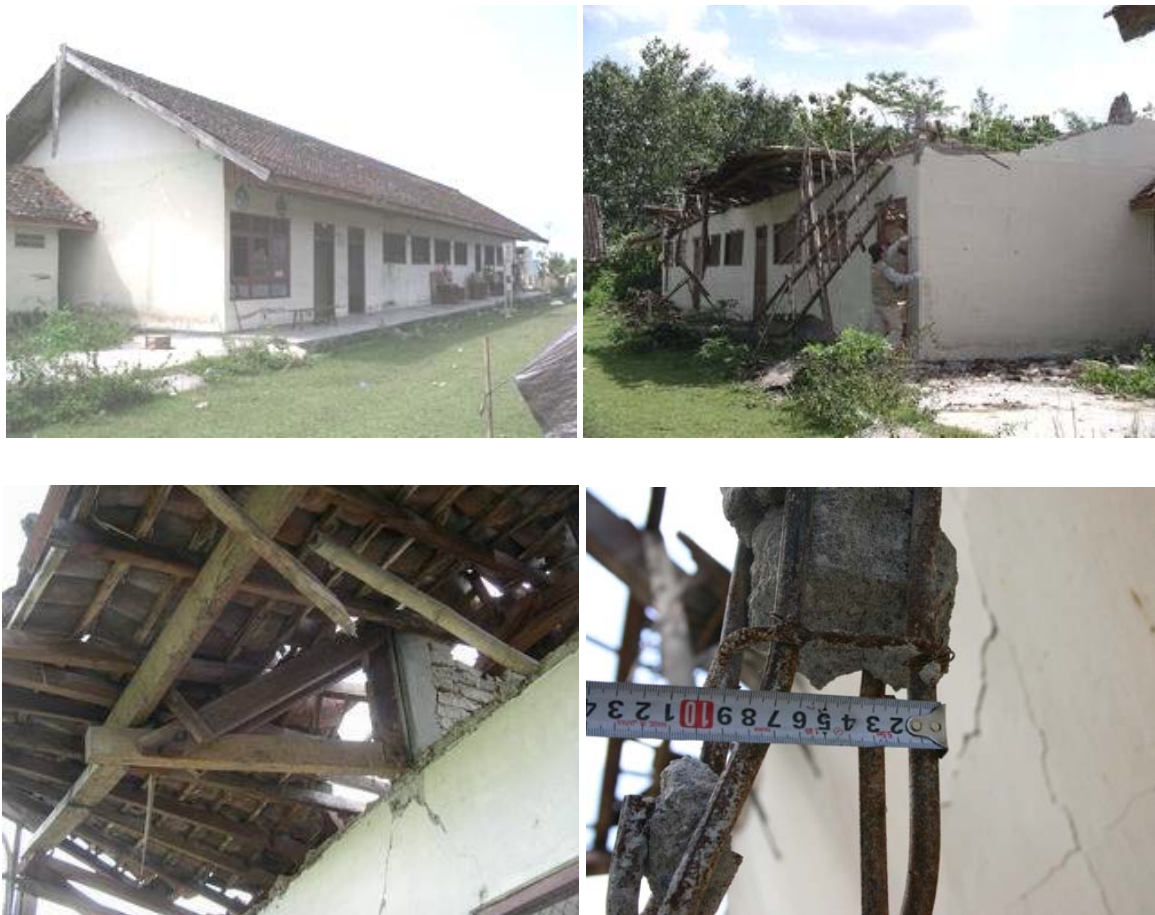
Fig. 19 SD Pesu

The school had two buildings, one was seriously damaged in the roof system and the other survived the shaking. Columns having the 150mm x 150mm section with 4- ϕ 13 rebars and ϕ 6 hoops were provided between classrooms. A mid-span wall was 150mm thick and 500mm wide. The roof was supported by the timber truss fastened to RC columns above.

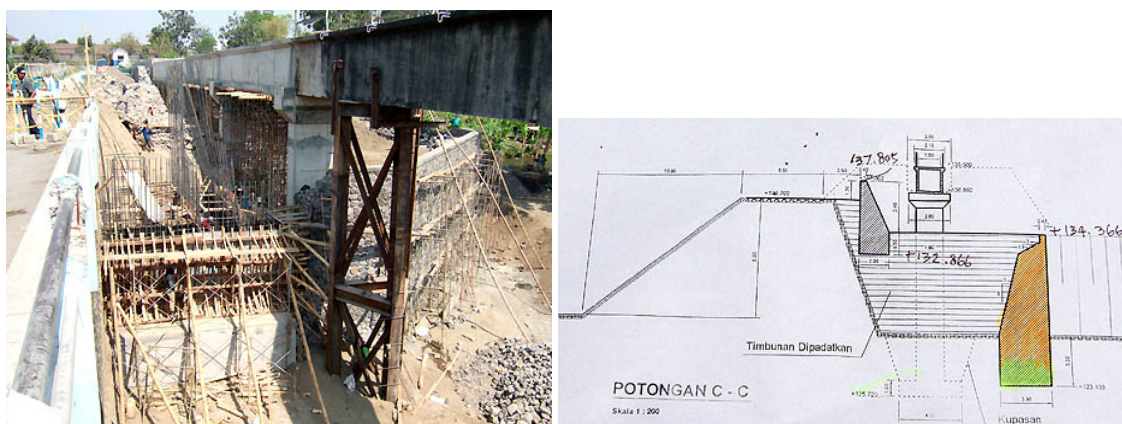
Fig. 20 Reconstruction of Mataram canal bridge (Sept. 18, 2005, Location: -7.767826,110.41481)

"The approach of the canal bridge, an open concrete channel, was supported by three piers, and therefore this part seemed to be rationally reconstructed avoiding possible repetition of embankment erosion due to water leakage. However difficult problem seemed to be lying in that a road runs along the canal on the embankment. To fully utilize the remaining embankment, a loading berm is being put at the toe and on the canal bridge side of the embankment to stabilize the slope. This loading berm was retained by about 9.5m high masonry wall standing upright. Eventually piers of the bridge were half embedded in the loading berm. Moreover to make some clearance between the road embankment and the canal bridge, a massive retaining wall was being constructed in between the canal and the road (**Fig. 20**). If the 9.5m high masonry retaining wall with no reinforcement breaks and/or is displaced, the piers for the canal bridge can move with the loading berm, causing some damage to the concrete open channel of the canal."

"Quick restoration of the bridge is a must because of the canal's important functions. Moreover, a road running along the canal resting on the remaining soil mass of the same embankment is under a threat of subsidence. However, a complete reconstruction of the embankment will be just a stop-gap measure, and won't mitigate its geotechnical hazard potential. Even an inch settlement of the embankment will cause cracking of concrete joints, and water will leak again through the joints. A possible and efficient measure may be to replace the embankment with some piers."
