Damage of Bridges in 2008 Wenchuan, China, Earthquake

This is a reconnaissance report on the damage to bridges during the 2008 Wenchuan, China, earthquake. Site investigation was conducted by the authors on August 10-14, 2008. Presented is a detailed discussion of the damage to twelve bridges as well as possible damage mechanisms. Characteristics of two near-field ground accelerations and Chinese seismic bridge design practices are also presented. An investigation of the damage finds insufficient intensity of seismic design force, inadequate structural detailing for enhancing the ductility capacity and an absence of unseating prevention devices.

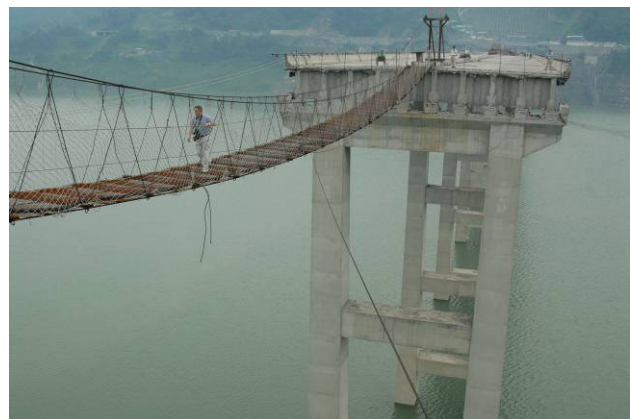
One of the two end-spans of a five-span continuous T-girder bridge collapsed as shown in Photo 2. It was reported that the distance between two adjacent piers which supported the fallen span was extended by about 0.69 m at the top based on measurements taken after the earthquake. Any damage in the piers above the water level was not identified; however, it was reported that piers suffered several small cracks at their base. Because the piers were 100 m tall, only 1% drift can result in 1 m lateral displacement at the deck level. It was likely that foundation flexibility further amplified the lateral displacement of the bridge. The fact that residual

Photo 2 Span of falling girder

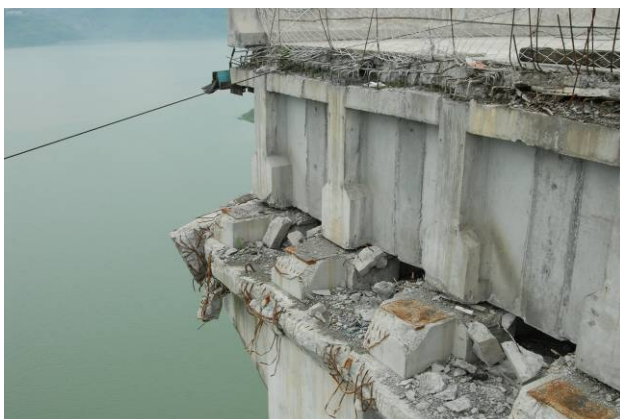
Photo 3 shows the bearings at the side where the span started to fall. The remaining part of the lower bearings and extensive damage to the concrete supports clearly show that the fall of an end span of a five-span continuous T-girder bridge was initiated here. Although reinforced concrete side blocks were installed at both sides of the deck, they could not fully restrict the deck displacement in the transverse direction. Unseating prevention devices were not provided because they were not required in bridges located in regions of seismic intensity 7, according to the code. If unseating prevention devices were installed at this span, collapse could have possibly been prevented.

Photo 3 Bearings at the side where the girder bridge starting to fall

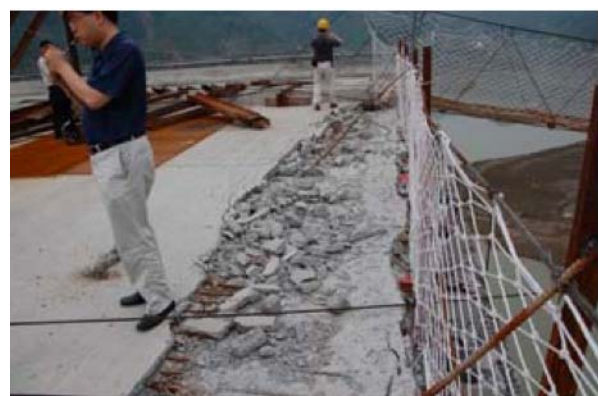
Photo 4 Concrete slab torn off due to fall of the girder bridge from the other side

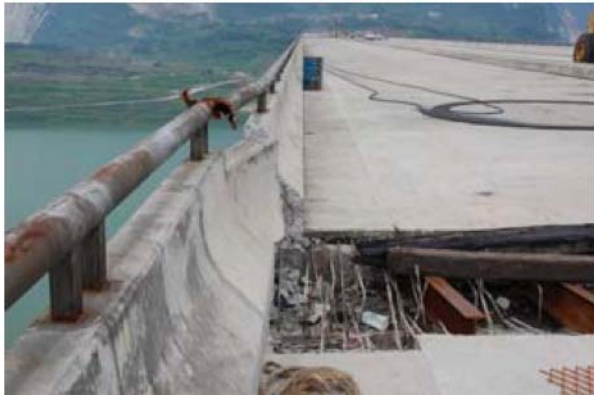
There were many other pieces of evidence that show that deck displacement was extremely large during the earthquake. For example, Photo 5 shows a 300 mm offset between two adjacent T-girder bridges in the transverse direction. Obviously failure of side blocks at both sides of the bridge allowed residual drift to develop in the transverse direction. Photo 6 shows failure of one of the side blocks. Almost all side blocks suffered damage. Photo 7 shows that collisions occurred between adjacent girder bridges; the center curb crashed due to the collision of adjacent girder bridges. Vertical offset was also developed here because almost all elastomeric bearings moved out from their position due to the excessive relative bridge response displacement as shown in Photo 8. Photo 9 shows one of the damaged elastomeric bearings.

Photo 5 Residual drift between two adjacent girder bridges in the transverse direction

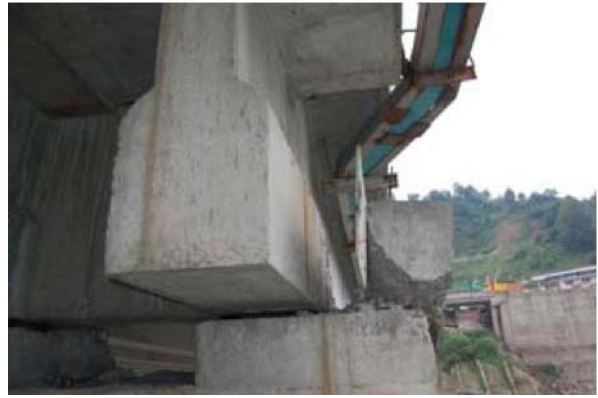
Photo 6 Failure of a side block

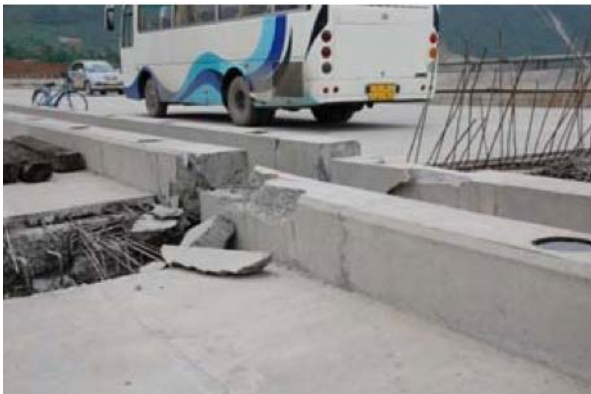
Photo 7 Vertical offset between two adjacent girder bridges and damage of center curb

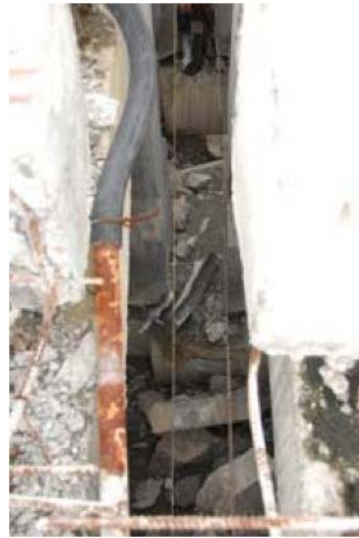
Photo 8 Elastomeric bearings moved out from their position

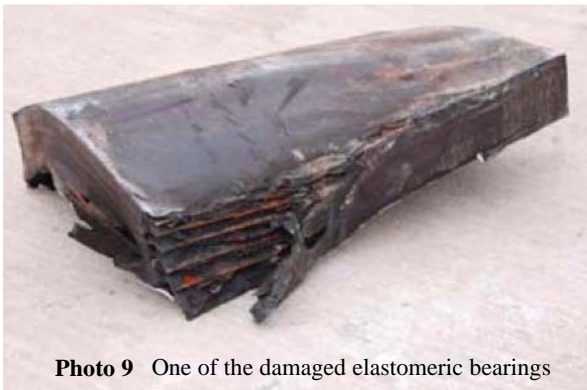
Photo 9 One of the damaged elastomeric bearings

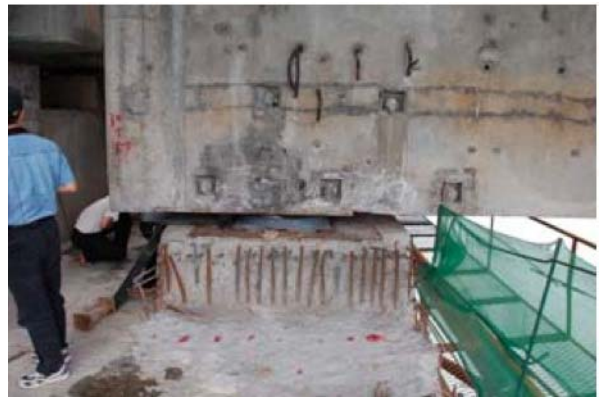
Photo 10 shows the repair of a movable bearing at one of the side spans of the main frame bridge. Steel bearings with rubber pads failed as shown in Photo 11; they were being replaced. Any other damage was not observed except at bearings in the main frame bridge.

Photo 10 Damage of an end bearing of main frame box girder bridge

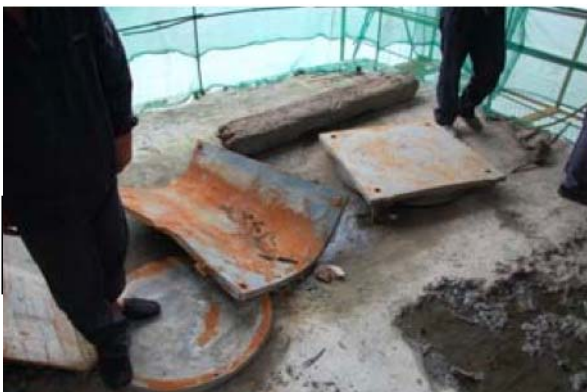
Photo 11 A part of bearings replaced

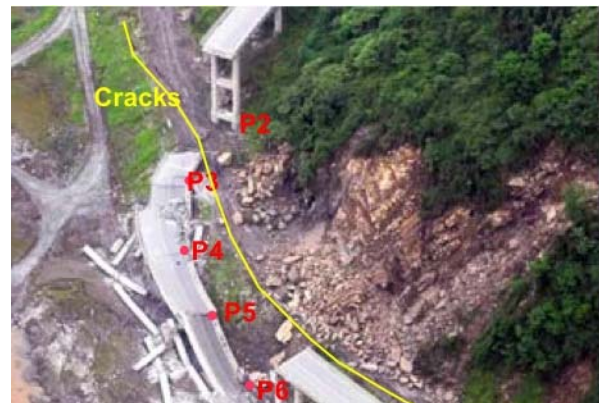
Photo 13 P2-P6 section collapsed (modified from a photo by Xinhua News)

Finally, it was noted that several surface cracks occurred along a line crossing the collapsed section [Lee, 2008], as shown in Photo 13. No further information was available because they were already invisible upon our investigation. Further precise measurement is required to discuss the effect of surface cracks on the damage of this bridge.

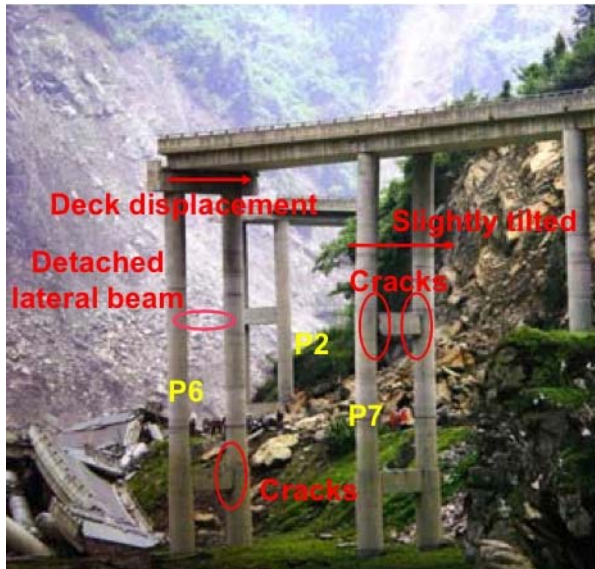
Photo 14 shows the damage of P6 and the adjacent pier P7 immediately following the earthquake. The center lateral beam of P6 fell off and the girder tilted toward the mountain side. Furthermore, large cracks occurred at the column and center/lower lateral beam joints of P7. Thus P7 also tilted and drifted in the mountain side.

Photo 14 Damage of P6 and P7 (modified from a photo by Xinhua News)

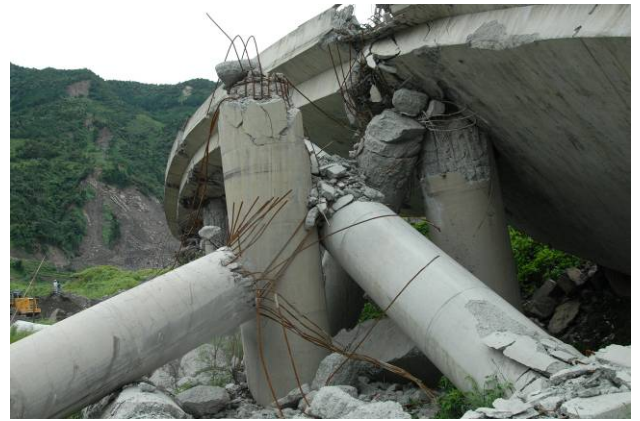
Photo 15 shows the collapse of P5 (refer to Photo 13). P5 had no cap beam and had only a 1 m x 1 m center lateral beam because P7 was an intermediate pier. Subjected to strong ground motion, the lateral beam was detached and the pier was broken into two pieces. Photo 16 shows a lateral beam-column joint where the lateral beam was detached. The surface of the detached lateral beam was very smooth which apparently showed that plastic hinges were not formed at the beam-column joint. Photo 17 shows another beam-column joint after a lateral beam was detached. The lateral beam was connected to a column by eighteen-29 mm diameter beam rebars that were lap-welded with the column rebars. The bars did not rupture at the welded connection but eccentricity could result in deterioration of their capacity under strong tension. Only 10 mm diameter hoops were provided at 300 mm intervals, resulting in poor lateral confinement of the joints. Thus, the evidence shows that insufficient amounts of reinforcement resulted in a brittle failure at the joints.

Photo 15 Collapse of P5

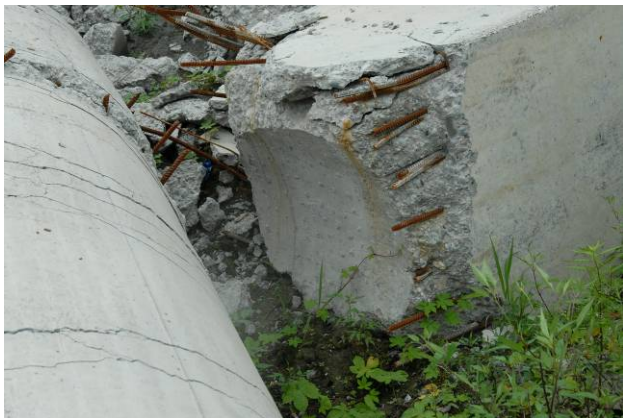
Photo 16 Detached beam-column connection

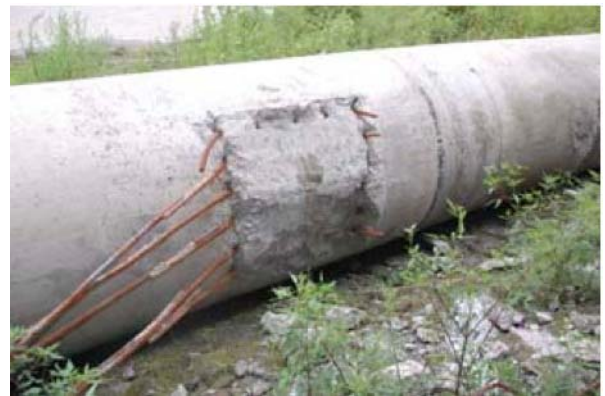
Photo 17 Column where a lateral beam was detached and rebars at joint

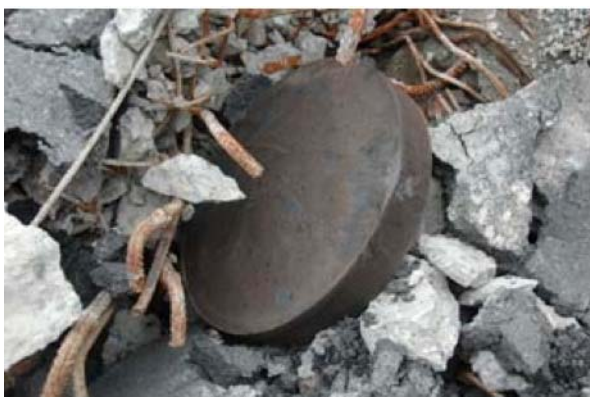
Photos 18 and 19 show a rubber pad and its support on the top of a pier. They were located not at the section collapsed by the earthquake, but at the section removed by explosion; however, they provided useful information for identifying the collapse mechanism. Girders were supported by rubber pads without any special connections, which enabled the girder to laterally displace or freely uplift from the piers.

Photo 18 Rubber pad

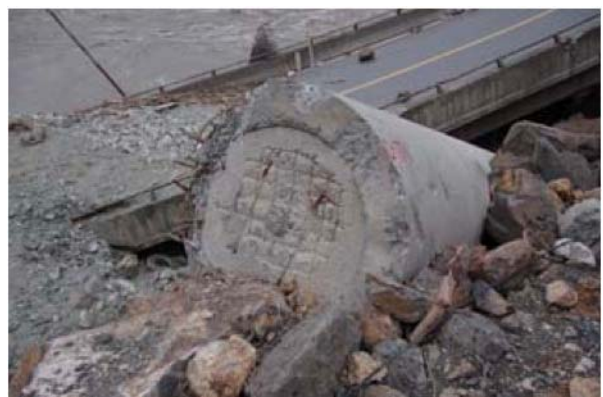
Photo 19 Shoe seat on a pier

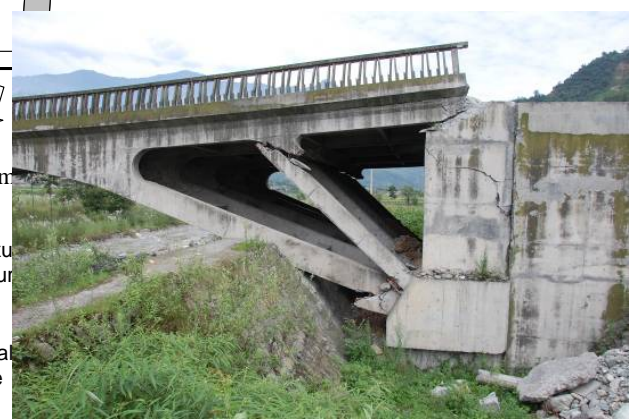
Photo 20 shows the damage of Xiaoyudong Bridge. By numbering abutments, piers, and decks from the left bank, decks 1, 3 and 4 collapsed. Two slant-legs failed at A1 as shown in Photo 21. In the columns, 29 mm diameter main rebars and 10 mm diameter ties were provided; however, the amount of reinforcement was insufficient to form the plastic hinge.

Photo 20 Collapse of Xiaoyudong Bridge (Deck 4, Deck 3 and Deck 2 from the left)

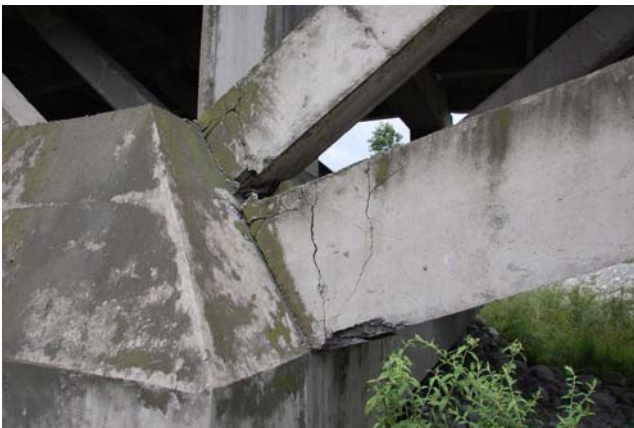
Photo 22 shows the connection of a pile cap, two piles and slant-legs at P2 which supported Deck 2. Flexural and shear failure developed at the slant-legs. These were a typical failure with limited plastic deformation capacity due to insufficient reinforcement. Local buckling of main bars was observed in the slant-legs. If this failure progressed further, the failure shown in Photo 21 would develop.

Photo 22 Connection of pile cap, slant-legs and vertical piers at P2

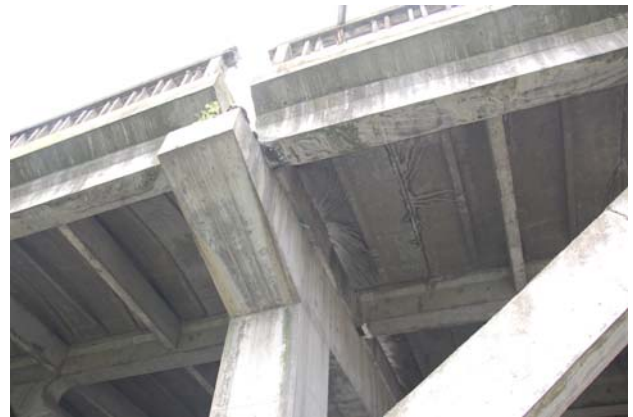
Photo 23 shows Deck 2, which was about to fall off from the cap beam of Pier 1. This obviously shows that response displacement of Deck 2 was quite large. Deck 2 was displaced not only in the longitudinal direction but also in the transverse direction.

Photo 23 Deck 2 about to fall from pier cap at P1

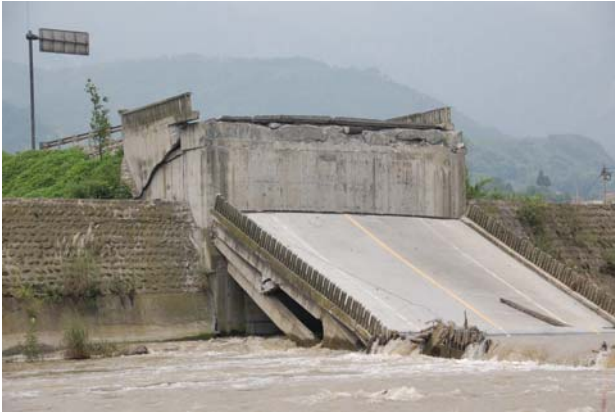
At right abutment A2, pavement permanently displaced about 0.2 m in the backsoil side due to the collision of deck 4 and A2, as shown in Photo 24. Extensive shear cracks were developed in the side walls resulting from the collision. Most likely, deck 4 dislodged from A2 support due to excessive response displacement in the longitudinal direction, and then fell down, which resulted in the columns breaking. Insufficient seat length of about 0.3 m at A2 contributed to the failure.

Photo 24 Shear failure of side walls and setback of pavement at A2

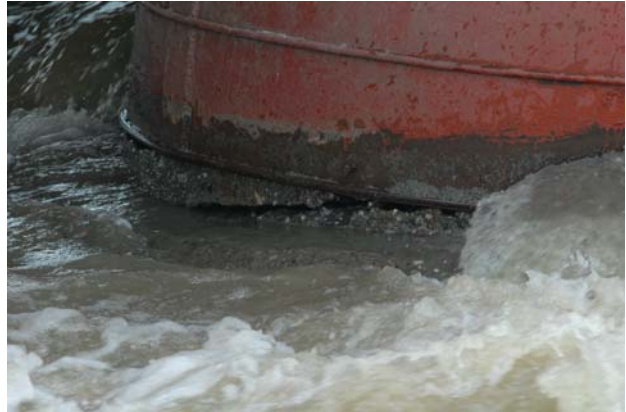
Reinforced concrete pile P2 suffered extensive cracks as shown in Photo 25. This resulted from the extensive drift of P3 in the A2 side as shown in Photo 26. This suggests that Deck 4 collapsed earlier than Deck 3. Once Deck 4 collapsed, the equilibrium of lateral forces between Decks 3 and 4 was lost, and P3 tilted extensively toward A2, which, in turn, resulted in Deck 3 being dislodged from its reliance on P3 and P4. As will be described later, this evaluation is consistent with a farmer's account that Deck 3 collapsed after Deck 4.

Photo 25 Failure of a pile at P3

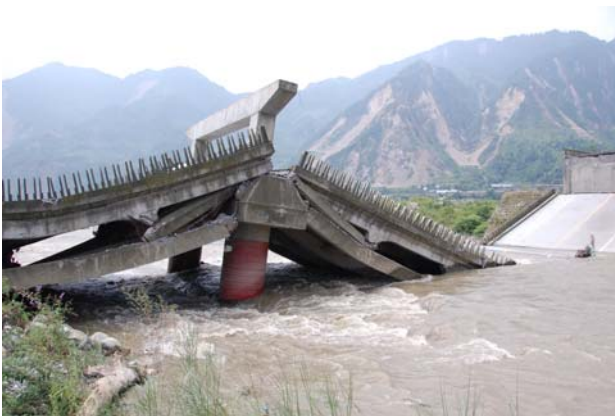
Photo 26 Tilt of P3 and collapse of Decks 3 and 4

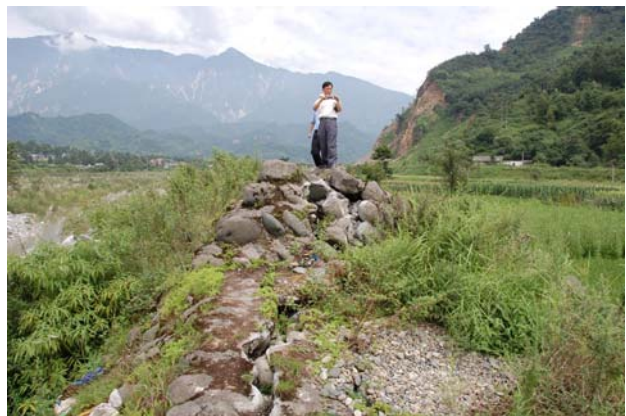
Several surface fault displacements occurred around the bridge as shown in Fig. 6. At the left dyke nearly 70 m upstream of the bridge (refer to Point A in Fig. 6), about 1.5 m vertical offset occurred, with lateral drift being very small, as shown in Photo 27. This fault displacement extended downstream along the left dyke and crossed the approaching road at 10 m and 50 m behind A2 (In fig. 6, points B and C, respectively). The fault displacement caused the failure of backsoil and pavement of A2 at Point B and several large cracks on concrete pavements at Point C as shown in Photos 28 and 29, respectively. A farmer named Shunxue Zhu witnessed the collapse of the bridge. He observed that Decks 1 and 4 collapsed at almost the same time, followed shortly thereafter by the collapse of Deck 3.

Photo 27 1.5 m vertical offset at 70m upstream of Xiaoyudong Bridge

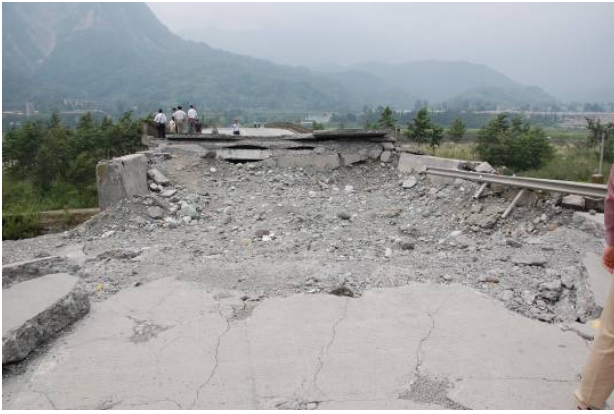
Photo 28 Failure of backsoil and pavement of A1 due to a fault displacement

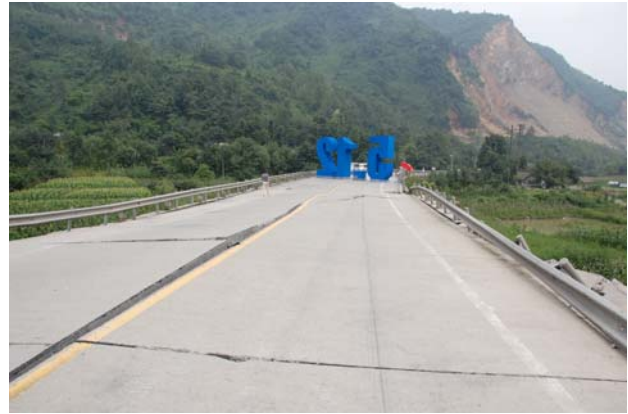
Photo 29 Cracks of concrete pavement due to a fault displacement

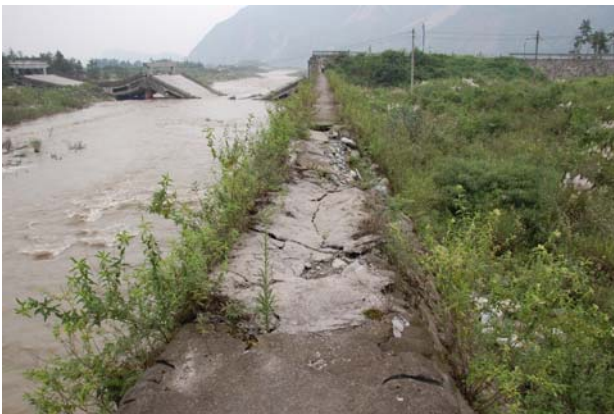
To determine whether the collapse of Decks 3 and 4 was affected by fault displacements, the authors analyzed them at the right dyke near the bridge. The authors found about 0.3 m settlement at the right dyke, about 50 m upstream of the bridge (Point D, Fig. 6). However as shown in Photo 30, the settlement of the dyke at Point D was much less than the offset of the left dyke, and there was no trace of lateral drift near the dyke. No matter how this offset resulted from the general effect of fault displacement, it was hard to understand that the bridge was seriously affected by such a small ground displacement. No further evidence of a fault

Photo 30 Settlement of right dyke at 50 m upstream of Xiaoyudong Bridge

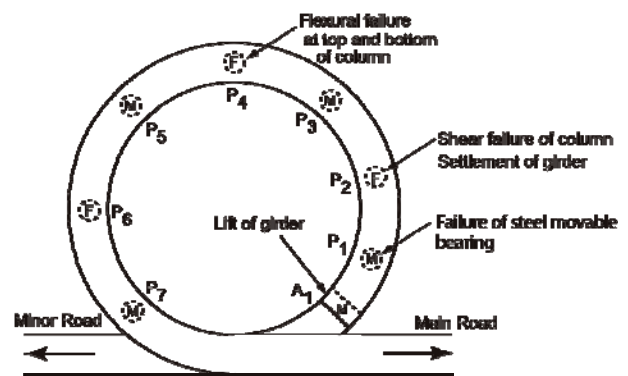
Fig.7 Damage of a lamp bridge, Huilan Bridge

Huilan Bridge is an interchange bridge at the crossing of Demao Road and Huilan Street in Mianyang. This bridge consists of a main bridge and four curved ramp bridges for light vehicles. A ramp bridge suffered damage at its piers as shown in Fig. 7. Other ramp bridges suffered similar damage. They were 170-200 m long ($11\text{m}+(9\sim 11)\times 16\text{m}+15\text{m}$) and 4.5 m wide hollow deck girders with a plane curvature of 25.25m, and they were supported by 0.8 m diameter circular reinforced concrete piers with pre-tensioned PC steel cables inside. Girders were alternatively supported by rubber pad bearings and rigid connections. It was supposed that spans were too short to fully support the girders by rigid connections, and full support by rubber pad bearings would induce a large span displacement in the transverse direction because of the small radius of curvature. Photos 31 and 32 show flexure and shear failure of piers which were rigidly connected to the girders. The failures resulted in settlement in the girders, and a number of extensive transverse cracks occurred at the bottom of deck panels near the support.

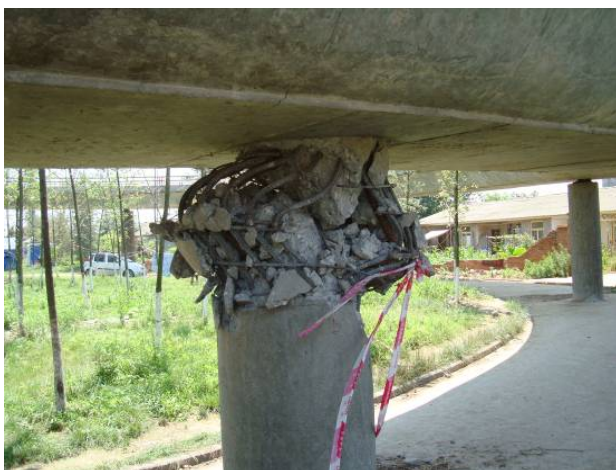
Photo 31 Damaged P2 (left) and undamaged P3 (right)

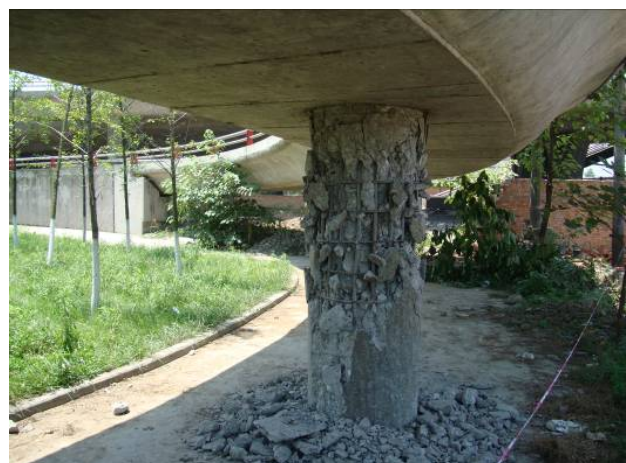
Photo 32 Shear failure

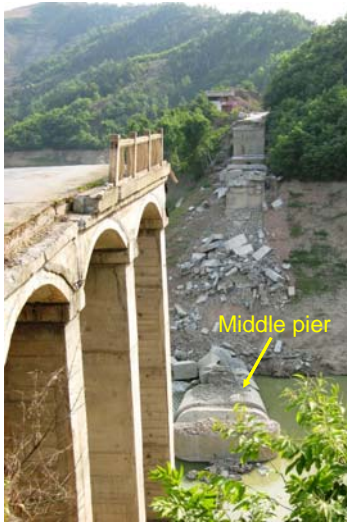
There were many reinforced concrete arch bridges and stone masonry arch bridges in the damaged regions. Most of them survived with limited damage; however, several arch bridges suffered extensive damage. For example, Jingtianba Bridge (China Route 212 and Sicuan Provincial Route 105) connecting Qinchuan of Guangyuan to the large area of Gansu Province, collapsed as shown in Photos 33 and 34. The bridge is about a 270 m long, 7 m wide, and 50 m high, two-span reinforced concrete arch bridge. It was completed in 1997. A part of the mid pier collapse and the right foundation are seen in Photos 33 and 34, respectively. A resident in the area witnessed that the mid piers first toppled in the longitudinal direction, followed by the collapse of the two main arches. However, the account was hardly trusted because the toppling of the mid pier could not occur

Photo 33 Collapse of Jintianba Bridge (Prof. Li Yadong from Xi'nan Jiaotong University)

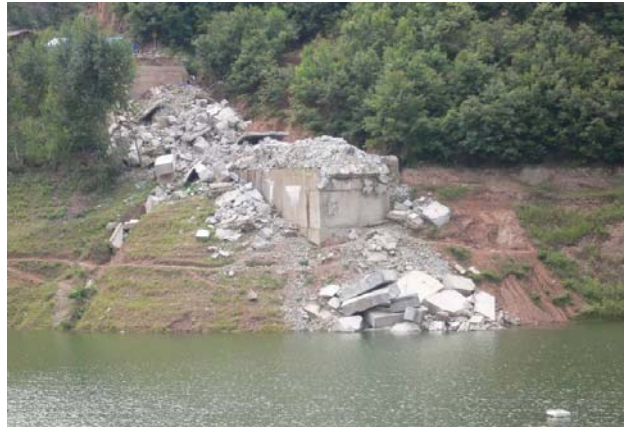
Photo 34 Collapsed arch rib around the base at left foundation

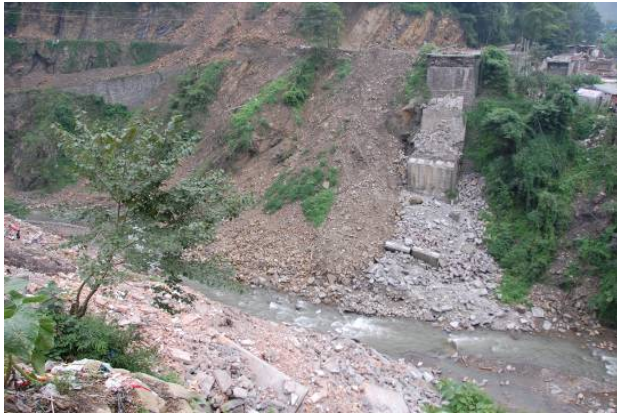
Hongdong Bridge is about an 80 m long, reinforced concrete arch bridge in the district of Mianzhu. It also completely collapsed as shown in Photo 35. Photo 36 shows one of the supports. It was difficult to estimate the failure mechanism because most of the collapsed pieces were removed. It was probably a two-hinge arch bridge based on the reinforcement at the base shown in Photo 36.

Photo 35 Collapsed Hongdong Bridge

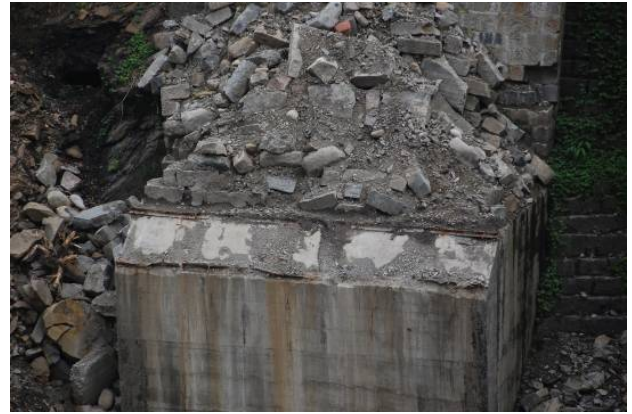
Photo 36 Support of the main arch

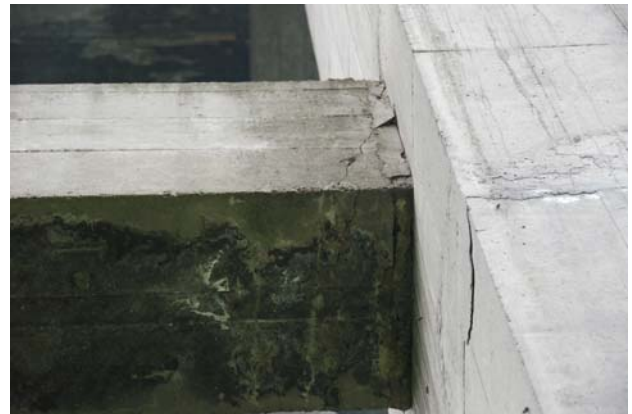
Photo 38 Cracks of a lateral beam close to beam-column joint

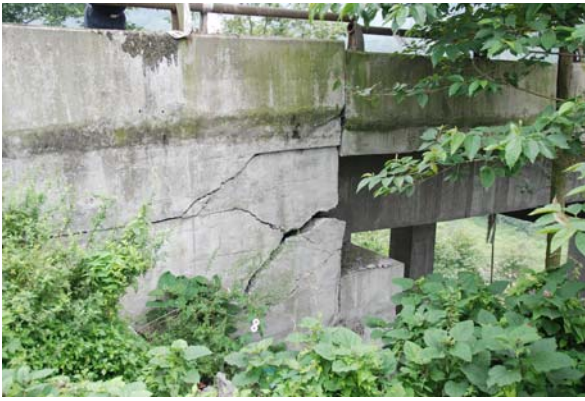
Photo 39 Cracks of side walls at an abutment

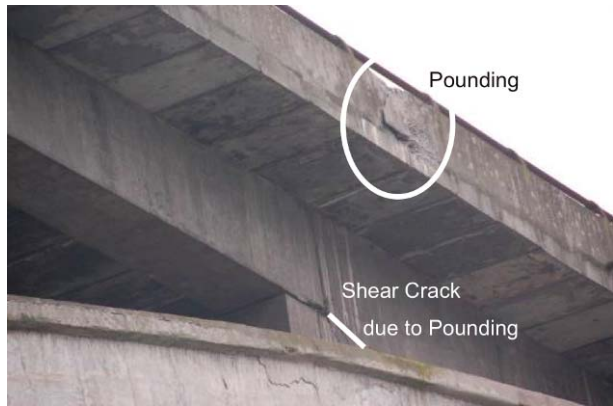
Jinhua Bridge is a 228 m long reinforced concrete arch bridge with the main span of 150m as shown in Photo 37. It was completed in 1997. The main arch consisted of two box section ribs and the rise vs. span ratio was 1/6. Main girders were supported by vertical members with rubber bearings. Photo 38 shows cracks of a lateral beam near a beam-vertical member joint. The cracks showed typical damage for low reinforced concrete structural members with insufficient ductility capacity. Similar damage occurred at many other lateral beams. Extensive cracks occurred on the side walls of the abutments as shown in Photo 39, which were induced by collision between girders and the abutment in the longitudinal direction. Shear cracks occurred at the support of the deck at the arch crown as shown in Photo 40. This was also induced by collision between the girders and the support.

Photo 40 Shear cracks at the support of deck at arch crown

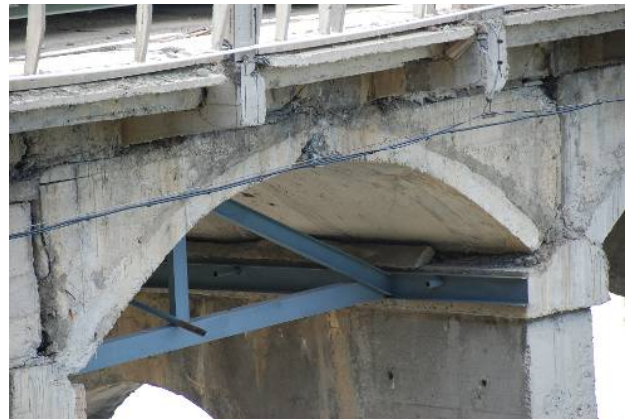
Baishui Bridge is located on national road 212 connecting Qinchuan and Guangyuan City. As shown in Photo 41, it is a three span reinforced concrete arch bridge completed in 1988. It did not suffer serious damage but moderate failure occurred at various locations. For example, Photo 42 shows an emergency repair by steel truss for cracks of arch girders in the transverse direction. Also, a large number of cracks occurred at the abutments. Temporary steel trusses (bailey truss) were set on the damaged decks to ensure traffic safety.

Photo 42 Angle truss for emergency repair of damaged deck

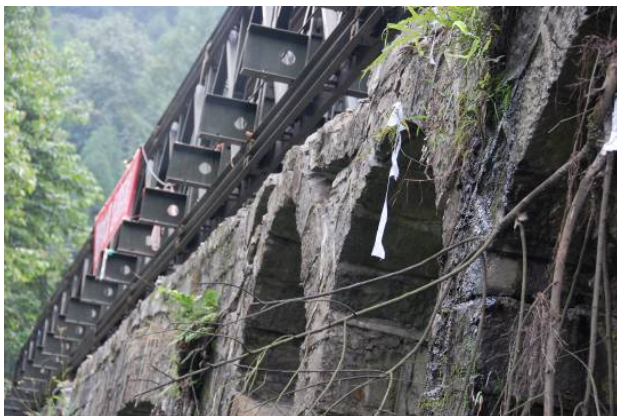
There were also a large number of stone masonry arch bridges. For example, Guantong Bridge is a 30 m long unreinforced sandstone masonry arch bridge between skewbacks as shown in Photo 44. It was built nearly 10 years ago. Because it was built on stable bedrock, damage was not extensive. Only top stones suffered compression failure near the arch crown and the 1/4 point as shown in Photo 45 are due probably to large response displacement of the bridge in the longitudinal direction.

Photo 45 Damage of top stones near arch crown and the 1/4 point

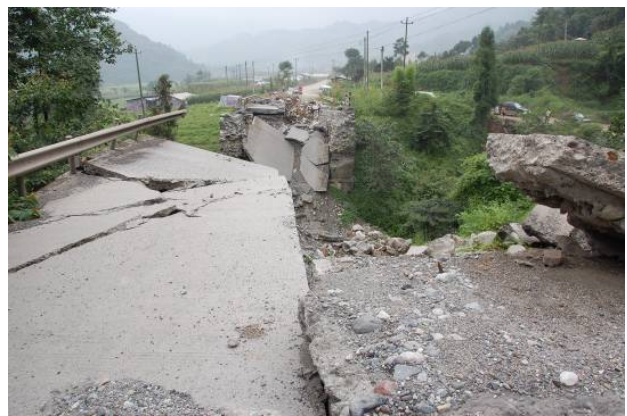
Yingchun Bridge in the district of Mianzhu was a 30 m long unreinforced stone masonry arch bridge along a steep slope. It completely collapsed as shown in Photo 46. It failed because the arch supports lost stability and the retaining walls at the supports toppled outward. Though it was a small bridge, it caused a disruption in the lives of the local population.

Photo 46 Collapse of Yingchun Bridge

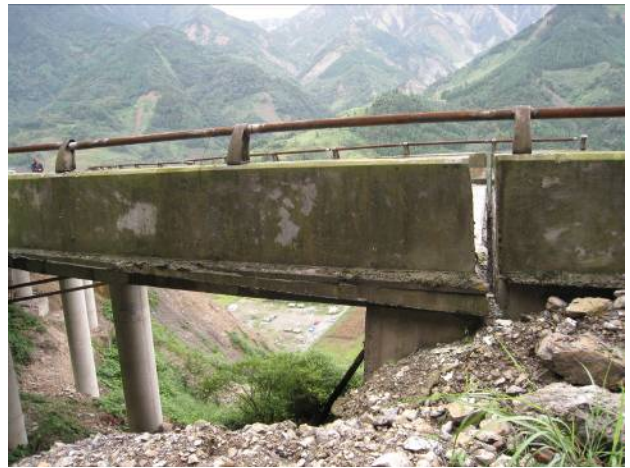
There were many bridges which suffered damage due to slope failure. For example, Longchi Bridge on Duwen Highway between Dujiangyan and Yinxiu is a four-span, simply supported, slab bridge near Longxi Tunnel, as shown in Photo 47. It suffered damage due to slope failure as shown in Photo 48. Lateral drift as well as tilting occurred in the foundations, and this resulted in a large offset of the deck relative to the abutment in the transverse direction.

Photo 48 Offset of the girders in the transverse direction

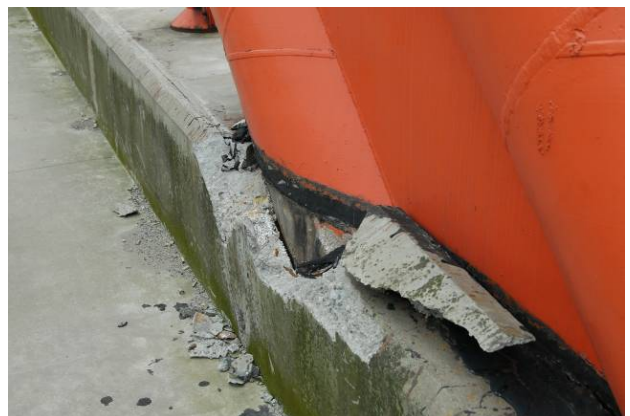
It should be noted that a number of bridges located in the fault regions remained undamaged. For example, Zixia Bridge located 1 km downstream of Zipinpu dam and 10 km away from Miaozipin Bridge and Baihua Bridge suffered almost no damage. As shown in Photo 49, it is a two-span, simply supported pipe arch bridge with about 80 m spans. The arch is composed of two steel pipes. Transverse girders are hung by the arch through vertical members and deck panels are set on the transverse girders. Damage was very minor because of light steel pipe arches, light weight girders and the steady bedrock ground condition at both shores. Photo 50 shows minor damage, such as partial flaking to the cover concrete of curbs around a pipe arch due to its oscillation.

Photo 50 Curb damage at the position of pipe arch
