Damage of 2009 L'Aquila, Central Italy Earthquake

This is a reconnaissance report on the damage to buildings, bridges and other structures caused by the 2009 L'Aquila, Italy earthquake. The authors conducted site investigation during the period of April 18-21, 2009. A detailed discussion on the damage of buildings, bridges and other facilities as well as possible damage mechanisms is presented. Geotechnical damage and ground motions are also presented.

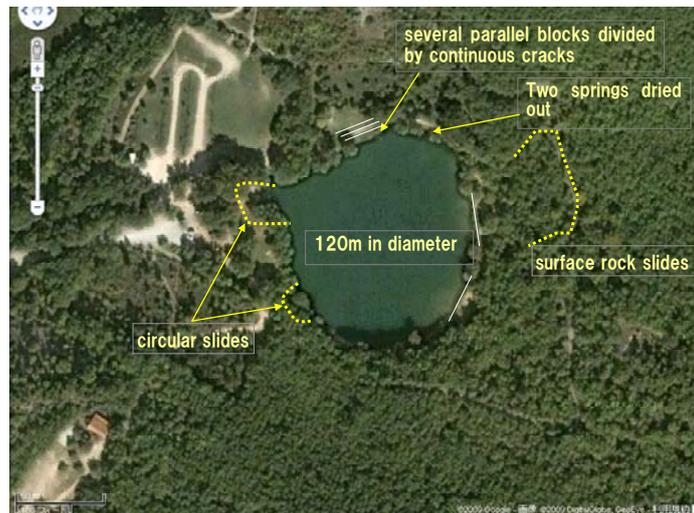
There are a number of sinkholes in the vicinity of L'Aquila featuring the Karst topography of the area. Sinizzo Lake with about 120 m diameter is probably one of the sinkholes. Extensive lateral spreading occurred along the shoreline of Sinizzo Lake as shown in Photo 1. Around the north shore, several parallel blocks were bounded by continuous cracks due to large lateral spreading of the surface ground and they moved toward the lake as shown in Photo 2. The ground at the west shore moved 22 m towards the lake. Two famous beautiful springs at the north-eastern shore dried up after the earthquake, however a new spring was formed close to the original two springs. The fact that the original ground water flow paths were blocked and a new water flow path was formed due to ground deformation during the earthquake implies that the ground water table was high and close to the ground surface. Based on this evidence, it is considered that the lateral spreading was resulted from yielding of the ground due to intensive earthquake shaking as well as degradation of shear strength of the ground due to generation of the pore water pressure.

Photo 1 Lateral spreading around Lake Sinizzo (added on Google map)

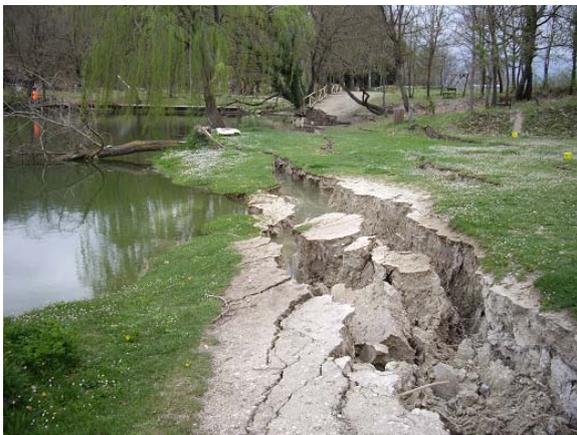
Photo 2 Separated blocks due to lateral spreading

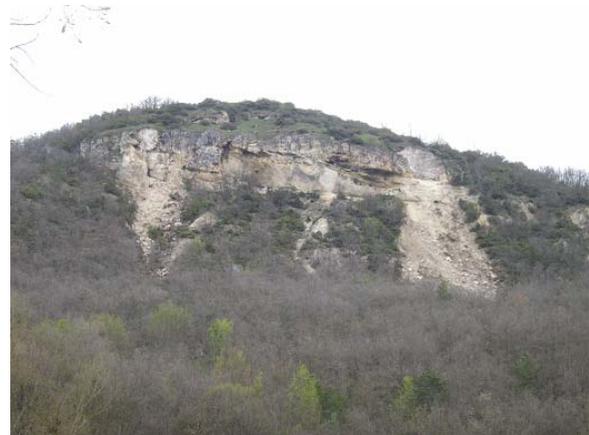
Extensive surface rock sliding occurred on the mountains on east side of the lake as shown in Photo 3.

Photo 3 Surface rock sliding on the mountain (east of the Sinizzo Lake)

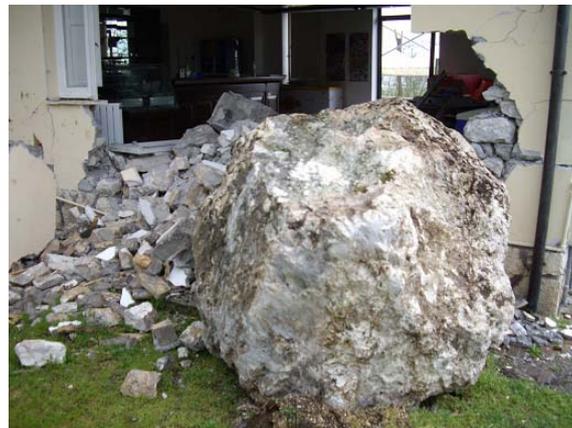
Two large rock falls occurred in Stiffe. The estimated mass and size of one of the rock blocks was 12 t and 1.5m x 1.6m x 1.9m, respectively. This rock block hit and destroyed the wall of a small building in the park near Grotte di Stiffe as shown in Photo 4. Photo 5 shows a broken tree, a shallow dent on the ground and the damaged wall, along the path of the fallen rock block. The velocity and energy at the instance of collision is estimated based on the jumping distance as 15 m/s and 2,700 kJ, respectively. The collision energy was large enough to destroy the wall of a building. The other fallen rock block reached the bottom of the park.

Photo 4 A 12 ton fallen rock with 1.9m long, 1.6m wide and 1.5m tall

It is important to assess the sources of falling rocks so that stability of neighboring rock masses or isolated rocks remaining on a slope can be evaluated. By assessing the collision energy of possible unstable rock masses, the risk to human lives and properties can be evaluated. It may be effective to prepare a check sheet to record information on the height of rock fall sources, size, geological conditions, protection measures and possible fall path.

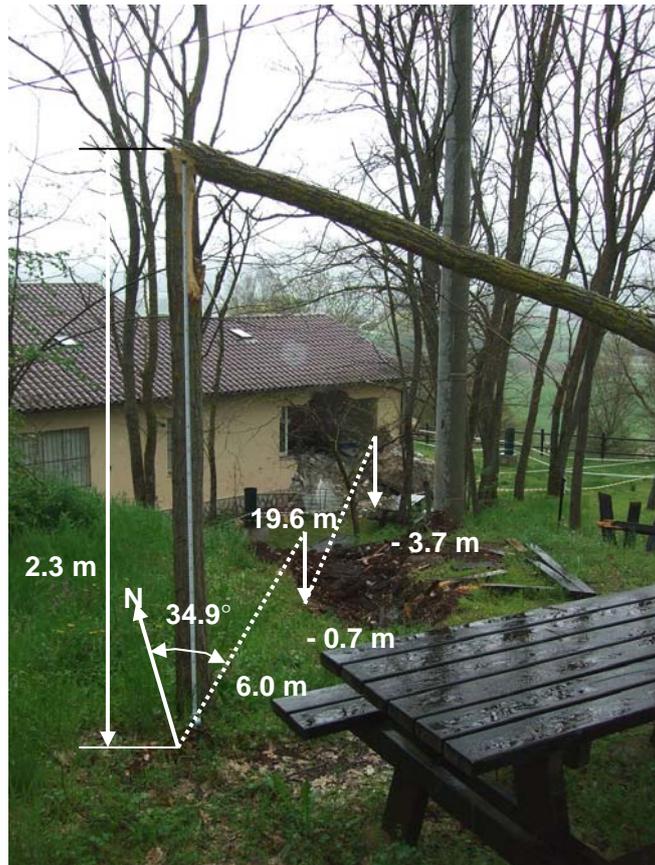
Photo 5 A broken tree, a shallow dent on the ground and a collapsed wall of the building along the path of a fallen rock.

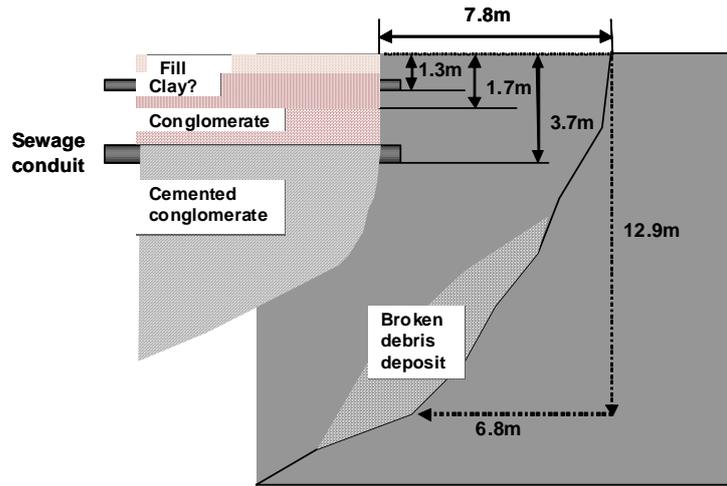
In the old city of L'Aquila, at least two sinkholes nearly 60 m apart developed on roads due to the earthquake and a vehicle was about to fall into one of the sinkholes as shown in Photo 6. This sinkhole was already back-filled with soils for stabilizing the surrounding ground. However the other sinkhole was only partially back-filled as shown in Photo 7 and it was possible to investigate it. The deepest point was 12.9 m from the road surface near the east edge of the sinkhole (refer to Fig. 4). However the cave tended to become deeper towards west. The roof of the cave consists of four horizontal layers. From the bottom to top, they are (1) well cemented calcareous conglomerate, (2) clayey conglomerate, (3) clay, and (4) backfill. It was observed that a sewage conduit was constructed after excavating a 3.7 m deep vertical trench reaching to the level of the calcareous conglomerate. This trench excavation has eventually notched the upper surface of the conglomerate roof of the cave, which could further reduce its effective thickness. The scenario mentioned above may have been responsible for the formation of the sinkhole during the earthquake shaking.

Fig. 4 Section of a sinkhole (Refer to Photo 7)

After experiencing the intense shaking, there are probably a number of unstable thin roofed caves remaining underground in the old city of L'Aquila. Thorough sounding of the condition of foundation rock mass may be important for a safe and rational rehabilitation of the city. Among many techniques available, the surface wave tomography may be effective and it may yield shear wave velocities of ground, which are directly related to its mechanical properties.

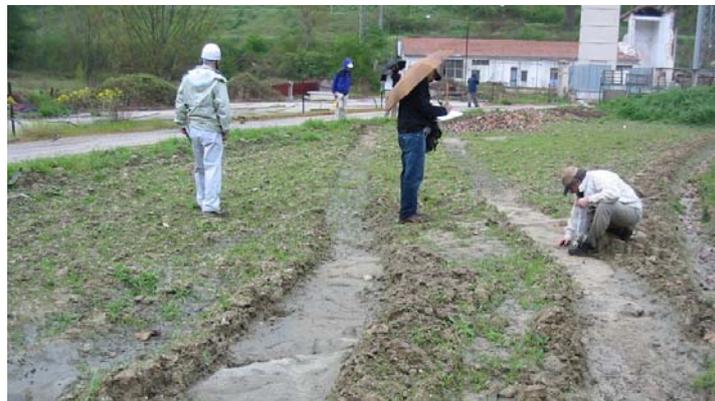
Photo 8 Liquefaction at Martini district of L'Aquila

shown in Photo 8. Sand boiling as thick as 150 mm was observed in various locations. The movement of ground was towards SE direction. Table 3 and Fig. 5 show some physical properties and grain size distribution of sand boils, respectively, based on laboratory tests at Tokai University, Japan and Pamukkale University, Turkey. Boiled sand is almost homogenous and its grain size distribution falls within the “easily-liquefiable bounds” according to Japan Port and Harbour Research Institute classification (1997).

The liquefaction induced lateral spreading. The sum of crack openings from the adjacent field towards the river embankment ranged between 250-350mm. There were several depot-like structures and bridges for railways and roadways in the area where soil liquefaction was observed. However there was no visible damage on the structures probably because the foundations were resting on deep and stiff soils.

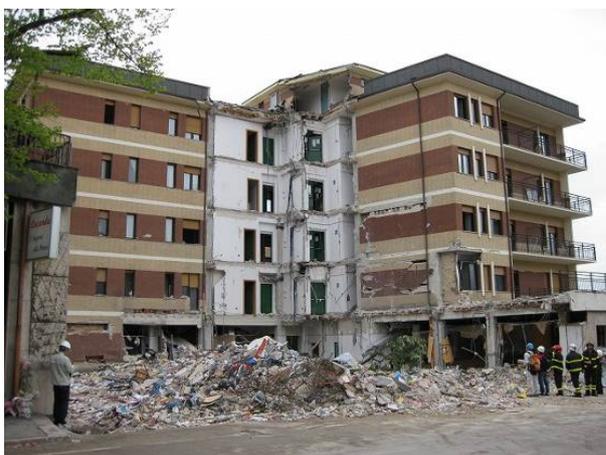
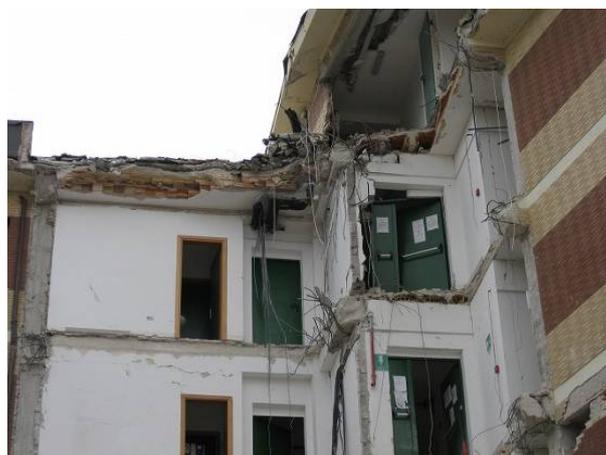
Damage of reinforced concrete buildings were investigated based on Japanese standards and guidelines for evaluation of existing buildings (BRI 2001a, BRI 2001b, BDPA 2005). Photo 9 shows a part of five-story student dormitory which totally collapsed resulting in eight victims. Two extended buildings which did not collapse were connected to the collapsed building by stairs and beam bars as shown in Photo 10. Round 10 mm main bars and 6mm stirrup with 250 mm spacing were set in the beam. Slab bars with 4 mm diameter were set in the ribs under the membrane as shown in Photo 11. Because concrete cover was very thin, bars were all corroded. Compression strength of concrete based on Schmidt Hammer test indicated 14MPa at the foundation in another collapsed building in Photo 12.

Photo 9 Collapsed dormitory and two extended buildings

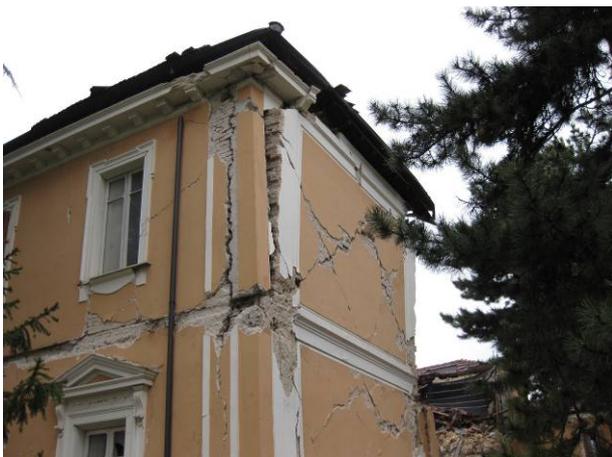
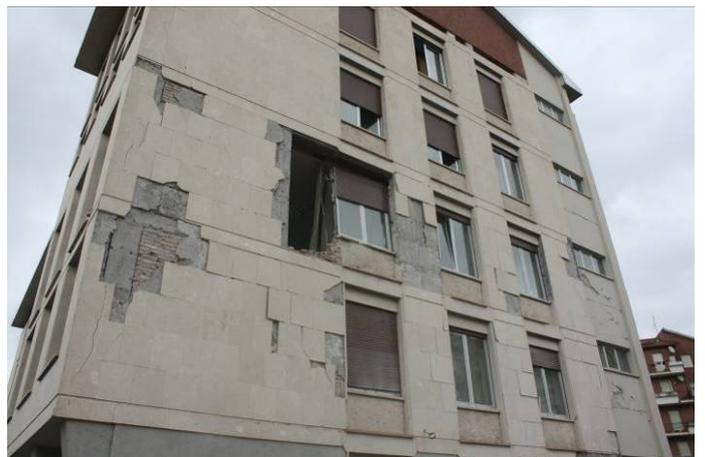
Photo 13 shows damage of a three-story building. The joint failed and masonry wall leaned in the out-of-plane direction. In many buildings, finishing materials and outer wall panels fell away and masonry walls suffered shear cracks as shown in Photo 14. It was found that middle-rise buildings suffered damage at the middle story as shown in Photo 15. Photo 16 is another typical example of such damage of middle story buildings. Size of the column section changed at the second and fourth stories, where damage occurred. However, it is important to note from minor falling of cover concrete and vertical deformation that damage of RC frames was very limited.

Photo 13 Damage of joints and masonry walls

Photo 14 Damage of finish and outer wall panels

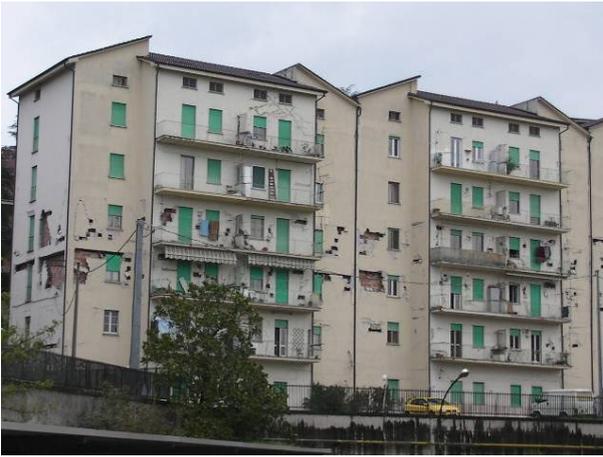
Photo 15 Damage of middle stories

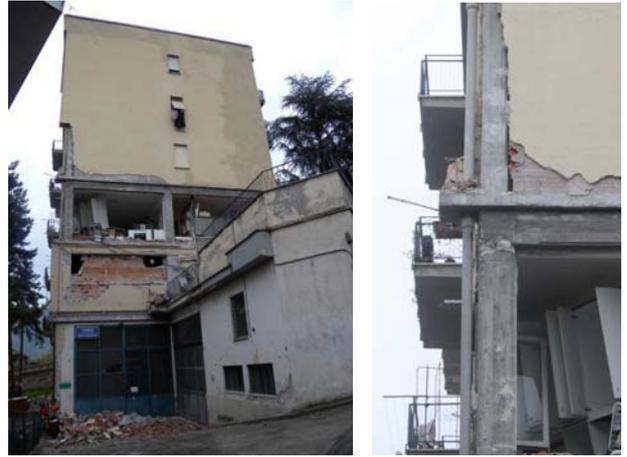
Photo 16 Fall of masonry walls in a six-story building

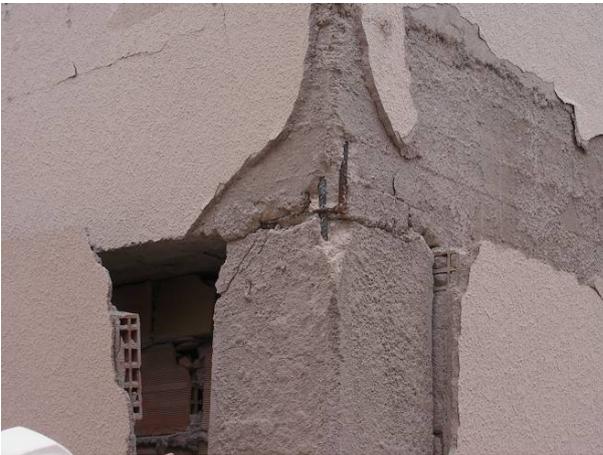
Photo 17 Unveiled reinforcements

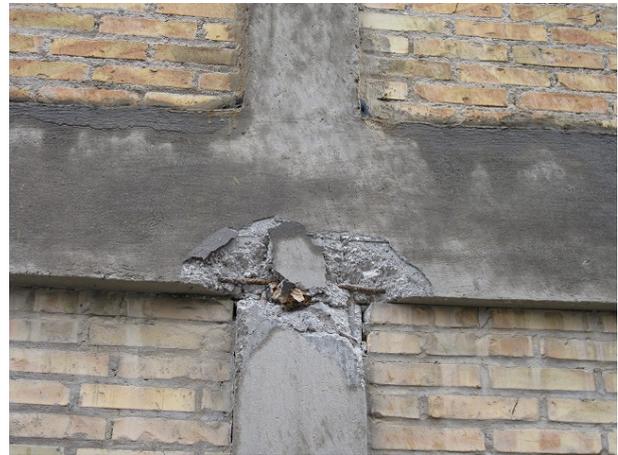
Photo 18 Corrosion of longitudinal bars in a beam

Extensive corrosion of steel bars in reinforced concrete structural members was widely observed not only in buildings but also in bridges. Concrete cover was very thin for preventing corrosion. There were even cases where concrete cover was not virtually provided. Corrosion of bars resulted in direct loss of tension strength as well as loss of bond strength between concrete and bars.

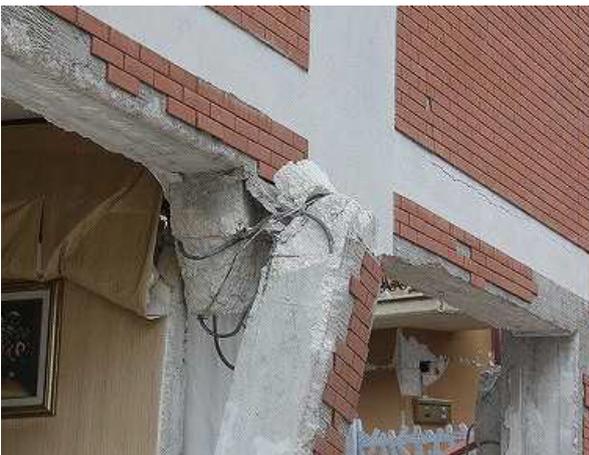
Photo 19 Shear failure of a column at the top

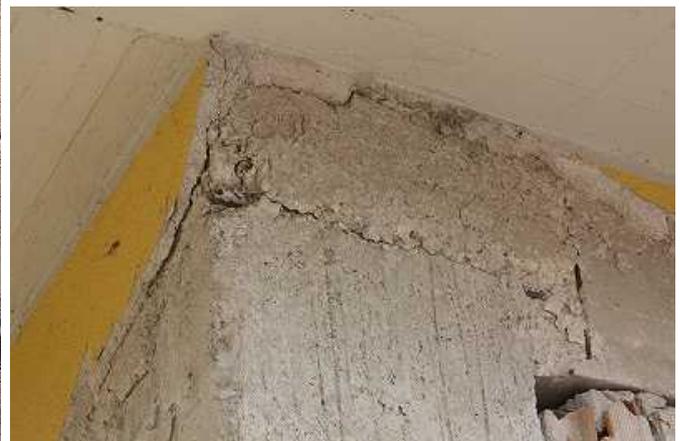
Photo 20 Beam-column joint with construction joint at the top of the column

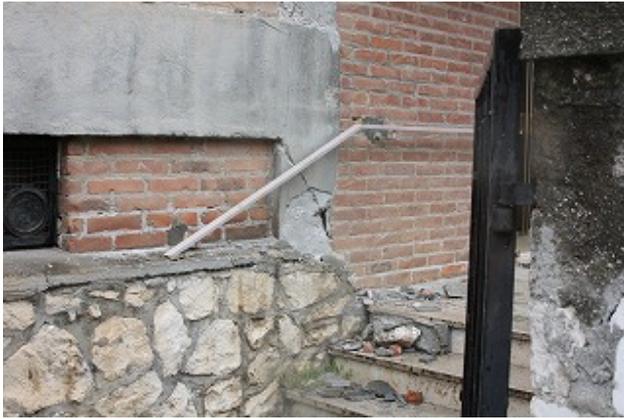
Photo 21 Shear cracks of a short column in the first story

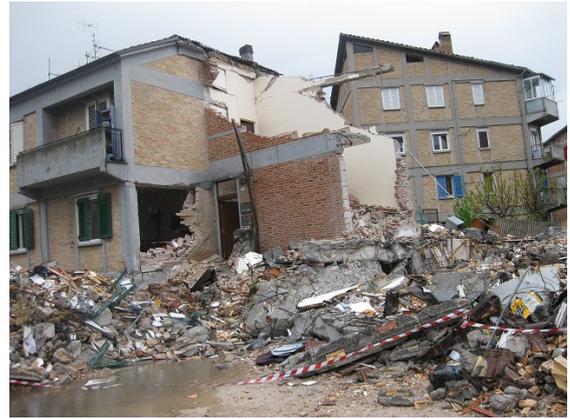
Visible damage from outside of the buildings included cracking and falling of bricks in walls and peeling of finishing-mortar cover in beam-column joint panels as shown in Photo 17. Most steel bars exposed after falling of cover concrete were extensively corroded as shown in Photo 18 due to very thin cover concrete. There were even cases in which there was almost no cover concrete. Photo 19 shows an example of the first story collapse of a building in which construction joint was placed at the top of the column near the beam-column joint as shown in Photo 20. Photo 21 shows shear cracks of a short column in the first story of a two story RC building shown in Photo 22.

Photo 22 Collapse of a two-story RC building

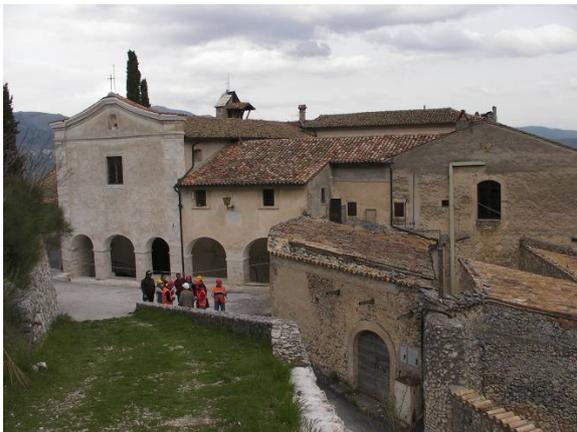
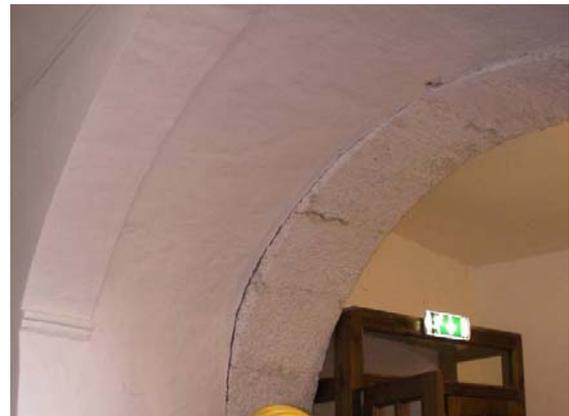
Photo 23 The church and convent of S. Angelo d'Ocre

Photo 24 Cracks and residual drift of an arch

Photos 23 and 24 show damage of Convent and Church of S. Angelo d'Ocre. Shear cracks on wall, residual drift of an arch and cracks on vault were developed. Damage level of the Convent and the Church was evaluated as "slight to moderate damage" based on the damage assessment sheet of cultural heritage for palaces and churches (Decree of the President of the Council of the Ministers 2006). A number of unreinforced masonry buildings were seriously damaged as shown in Photos 25 and 26.

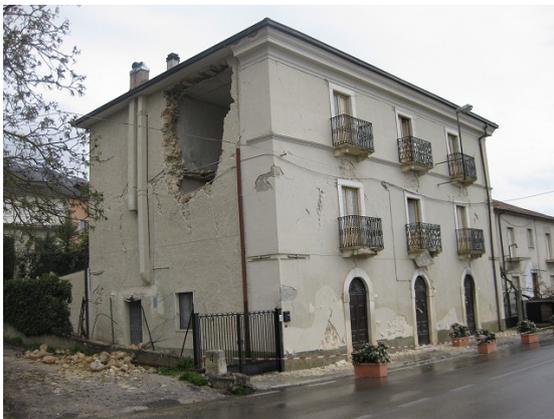
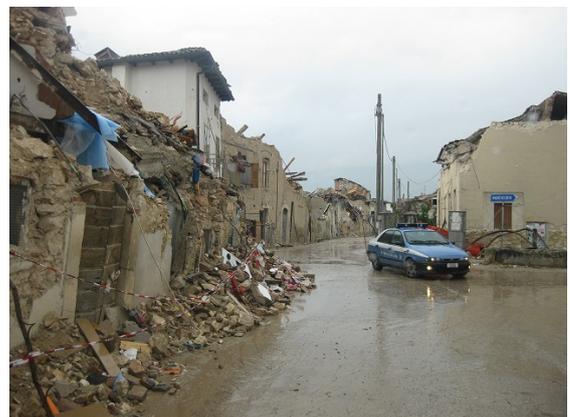
Photo 25 Fall of wall bricks and finishing mortar of an unreinforced masonry building

Photo 26 Collapse of unreinforced masonry buildings in Onna village

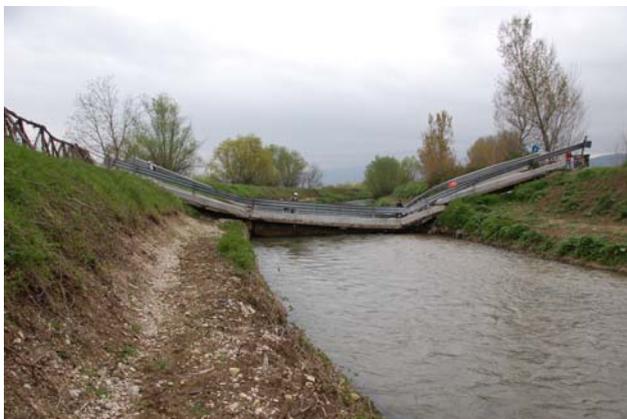
Damage of bridges was investigated referring to Japanese guidelines for repair and restoration of road facilities (JRA 2007). A 35 m long 5 m wide three-span continuous reinforced concrete bridge at the crossing of SR261 on Aterno River for approaching Fossa Town collapsed as shown in Photo 27. Four reinforced concrete pile-bent columns failed slightly above the river surface, and they shifted sideways and penetrated the deck slab as shown in Photos 28 and 29. A column had six 17 mm diameter round main bars as well as 6 mm diameter round hoops at about 300 mm interval. It seems that damage of the column which was induced prior to the earthquake progressed during the earthquake. Steel bars exposed due to very thin covering concrete were extensively corroded prior to the earthquake. The river dykes suffered almost no damage due to the earthquake. Both left and right river dykes were protected by stone masonries at inside facing to river flow. This feature of damage reminds us of a similar damage of the Struve Through Bridge in the 1989 Loma Prieta Earthquake, California, USA (Lew, 1990).

Photo 27 Collapse of a three span continuous bridge near Fossa Station

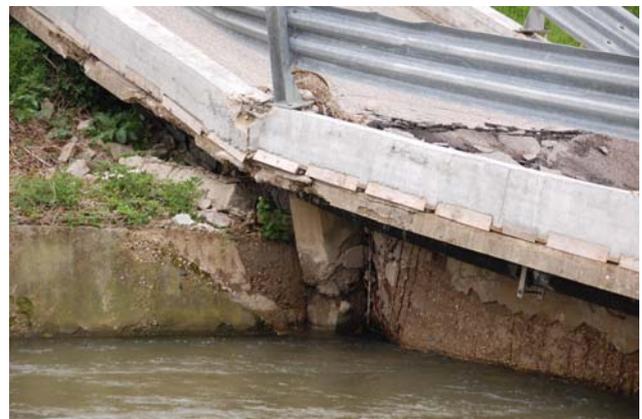
Photo 28 Damage of pile-bent pier

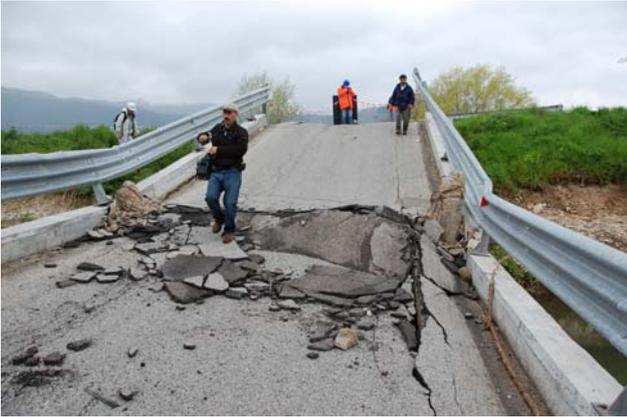
Photo 29 Pile-bent piers which punching Village

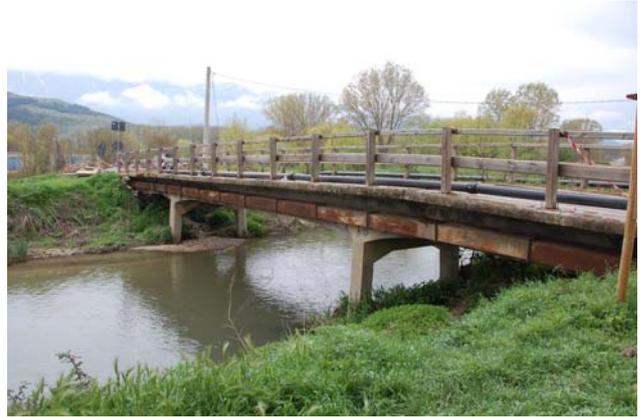
A 20 m long 4 m wide three-span continuous bridge located in the suburbs of Onna Village suffered damage at the top of frame piers as shown in Photo 30. The damage which was developed prior to the earthquake progressed during the earthquake. Embankment right behind the abutment settled and a cast-iron water pipe attached on the bridge suffered damage at the connection between the bridge and the embankment. Several cracks occurred on the river dyke due to soil sliding.

Photo 30 A 20 m long bridge near Onna the deck sheared the deck slab

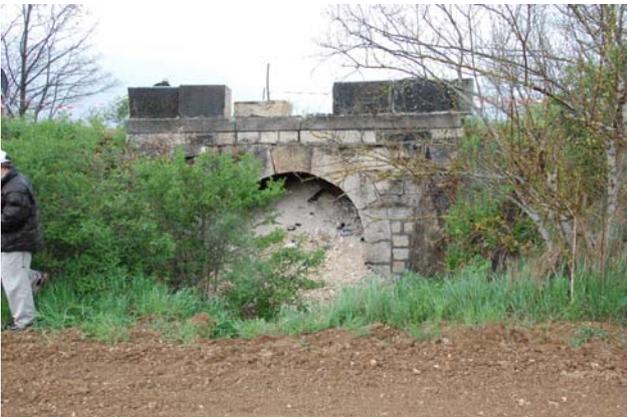
A 2 m long, 2.5 m tall stone masonry arch culvert collapsed and was temporarily repaired by filling crushed lime stone into the culvert as shown in Photo 31. How the arch culvert suffered damage was not known because it was already repaired. However it is likely that a part of stone masonry arch members lost the equilibrium and collapsed during the earthquake. Because the embedment of the arch was shallow without covering masonries on the arch, the arch members had less stability.

Photo 31 Emergency repair of a stone masonry arch culvert (SR261)

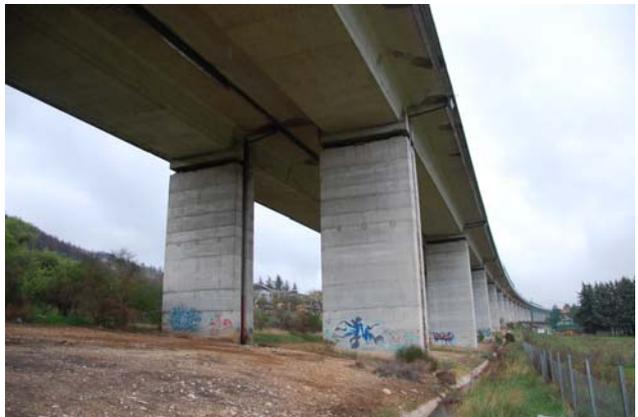
A part of the A24 viaduct in L'Aquila as shown in Photo 32 suffered slight damage. The viaduct is a nearly 37 m long simply supported PC box-girder bridges supported by 11-20 m tall reinforced concrete columns. It is supported by steel fixed and movable roller bearings or elastomeric bearings. Vertical gaps as large as 200 mm were seen at numerous expansions. A number of decks drifted by nearly 200 mm in the longitudinal and transverse directions as shown in Photo 33. It is likely that the gaps at expansions were developed by failure of bearings and the drift of the decks was developed due to residual deformation of elastomeric bearings.

Photo 32 A viaduct of A24 in L'Aquila

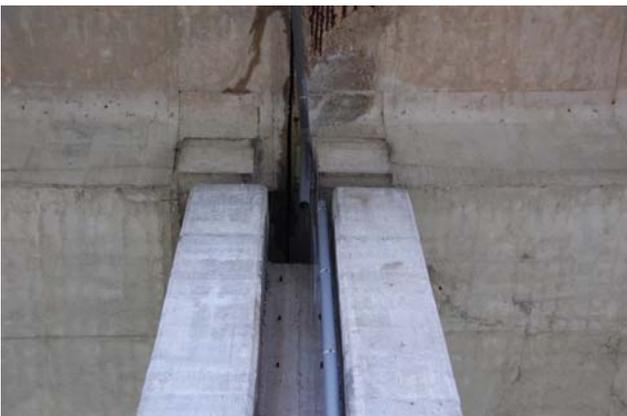
Photo 33 Residual drift of two bridges in the intersection of Route SS17 and Route SR615

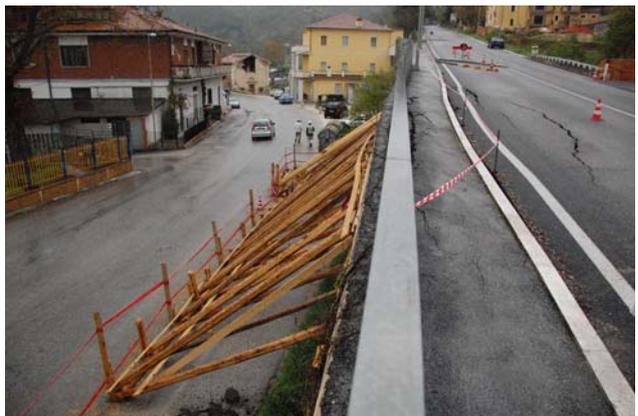
Settlement of road surface occurred at a number of locations in the lowland along Aterno River. One of the two lanes of SS17 at the intersection with SR615 was partly restricted for traffic because the road embankment locally subsided by 350mm and the upper part of the stone masonry retaining wall leaned as shown in Photo 34. The retaining wall was propped by wood bars for resisting the earth pressure.

Photo 34 Subsidence of a road embankment at the

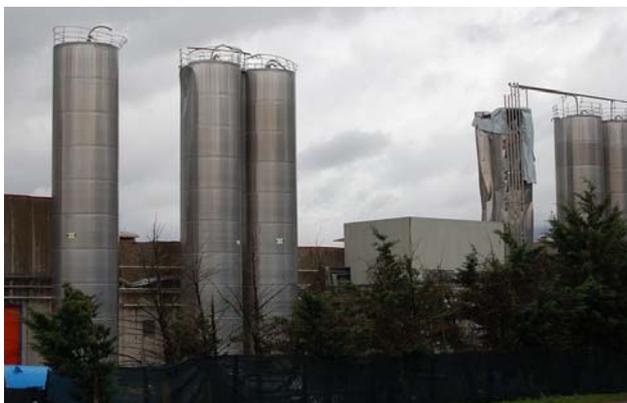
Nearly 20 m tall 4 m diameter silos for storing polypropylene pellets in VIBAC manufacturing plant suffered damage as shown in Photo 35. There were two types of silos built at different times. The first was a group of 8 silos founded on a common pile foundation and supported by a steel frame structure. The other was 12 silos set in two rows on cylindrical skirt resting on 1.2m thick concrete slabs on pile foundations. The cylindrical skirt is fixed to the pile cap with anchor bolts. The silos were made of 6mm structural aluminum.

According to the director of the plant, the silos that were full with the material collapsed during the earthquake, while those with 65% of their full capacities did not collapse. During the earthquake, the silos pounded with the adjacent warehouse partially leaving a dent of impact on its wall. The broken bottom skirts with the silo cones developed the diamond buckling with a circumferential wave number of approximately 6 as shown in Photo 36.

Photo 35 Buckled silos at VIBAC

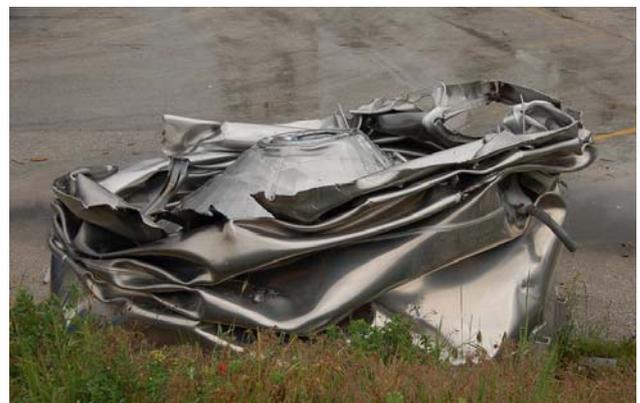
Photo 36 Buckled bottom of a silo
