# THE SURUGA BAY EARTHQUAKE OF AUGUST 11, 2009

Ömer AYDAN

This reconnaissance was carried out  
on the behalf of  
Earthquake Disaster Investigation Committee of  
Japan Society of Civil Engineers

June 2010

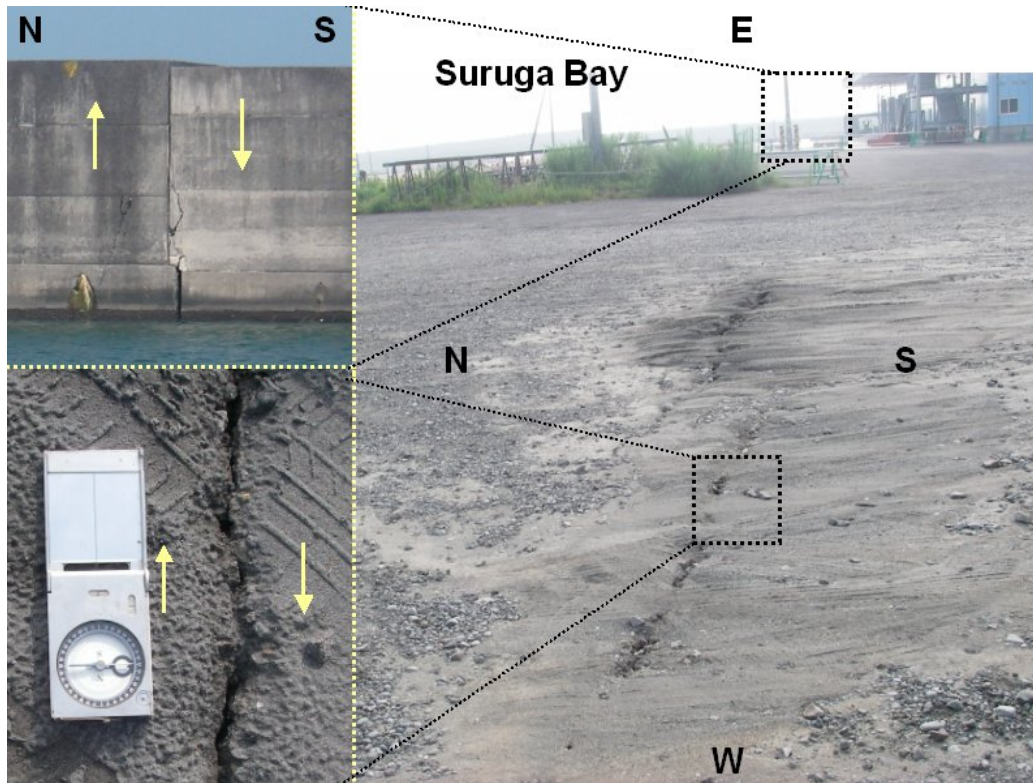
The ultimate slip distribution obtained by Yamanaka (2010) is shown in Figure 13. Yamanaka (2010) estimated the maximum relative displacement to be about 75 cm for a moment magnitude of 6.53. Rupture duration is about 11 s and the ruptured fault length is about 25 km. As the rupture occurred below the sea level, there is no fault breaks reported in many post-earthquake investigations. However, the authors found some surface breaks at the Yaizu port, which is about 18.4 km away from the epicenter as shown in Figure 14. The surface breaks were perpendicular to the shoreline and they have the dextral sense of deformation with sand boiling. The northern side of the

wavebreak in the port moved upward while the southern side downward. Considering the estimated length of the causative fault and sense of the horizontal offset, it is very likely that the ground breaks observed in the Yaizu port may be caused by the causative fault. Furthermore, the first author observed similar type ground ruptures with sand boiling during the 1999 Düzce earthquake (Aydan et al. 2000).

Figure 14: Surface ruptures and deformations observed in Yaizu port

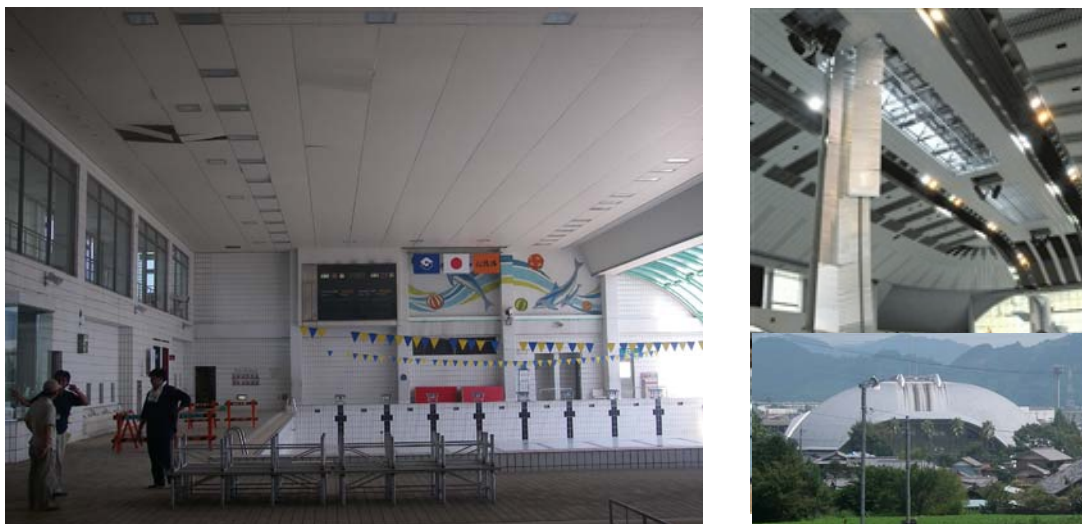
Hall and Sport facilities have different forms of suspended ceilings. Aydan et al. (2007) reported some examples of ceiling falls of pools and restaurants occurred during the Kameyama earthquake, which is a small size earthquake (M5.2) and pointed out the secondary disastrous effects of such falls. The fall of panels of ceiling occurred in indoor pools and gymnasium halls in Shizuoka (Figure 26). Furthermore, the fall of lights also occurred. As the earthquake occurred in around 5 AM in the morning, there were luckily no injuries or casualties. However, this is a very serious issue and it has to be quickly addressed.

Figure 26: Fall of panels from the roof of swimming pools in Shizuoka

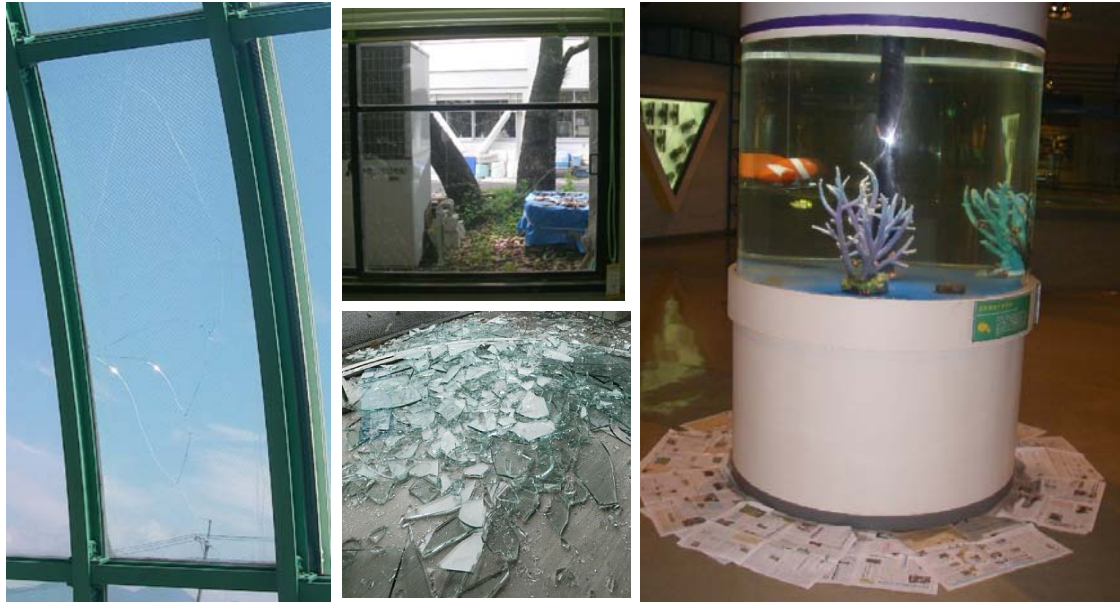
Another form of non-structural damage is the breakage of glasses of show windows, windows of buildings and glass panels. Figure 27 shows several examples of the

breakage of the glass windows. When glasses have covered with transparent films or a contain wire mesh, their behavior becomes more ductile upon fracturing.

Similarly aquariums made of glass or acrylic were either cracked, which resulted in some leakage of water.

Figure 27: Examples of fractured or broken glasses of windows and aquarium

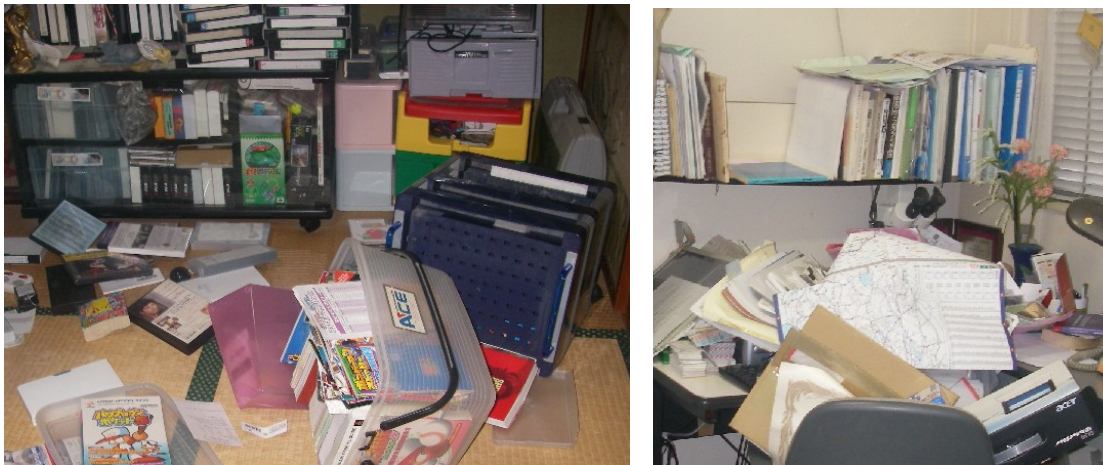
Figure 31 shows several views of toppled non-fixed objects in Kusanagi and Orido of Shimizu Ward of Shizuoka City. The toppling or deformation of non-fixed objects occurred particularly in N-S direction, which clearly indicated a very strong directivity effect of ground motions. These locations are on the hanging wall side of the causative earthquake fault.

Figure 31: Toppling of non-fixed objects

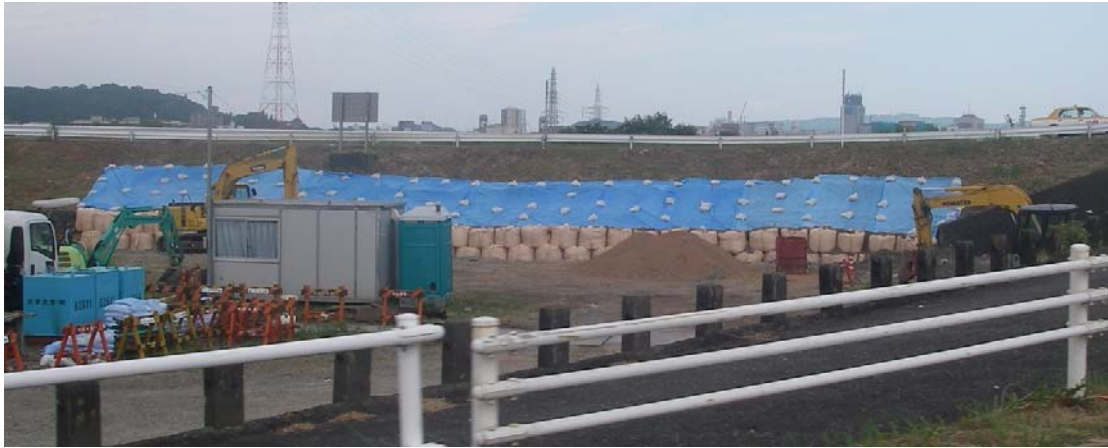
(a) The repair of the right bank of Abe River in Shizuoka City

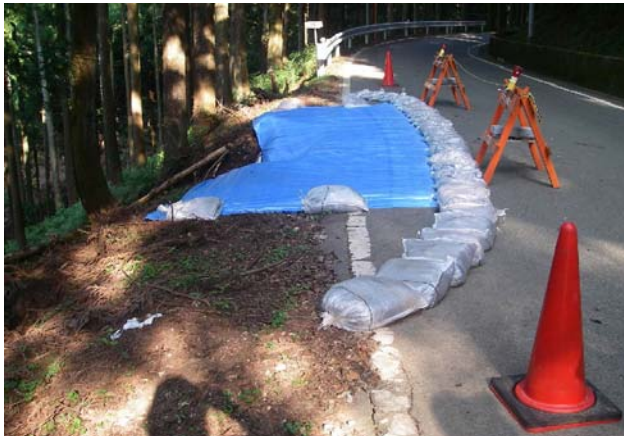
(b) Route 59 (Izu Peninsula)

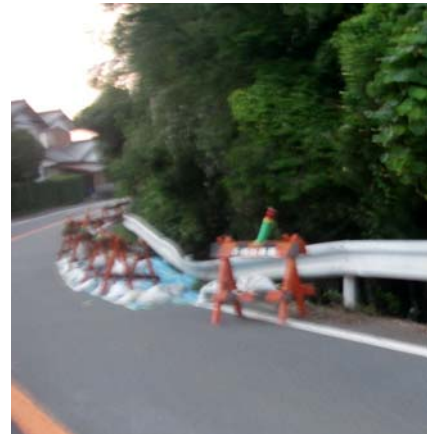
(c) Near Kikugawa

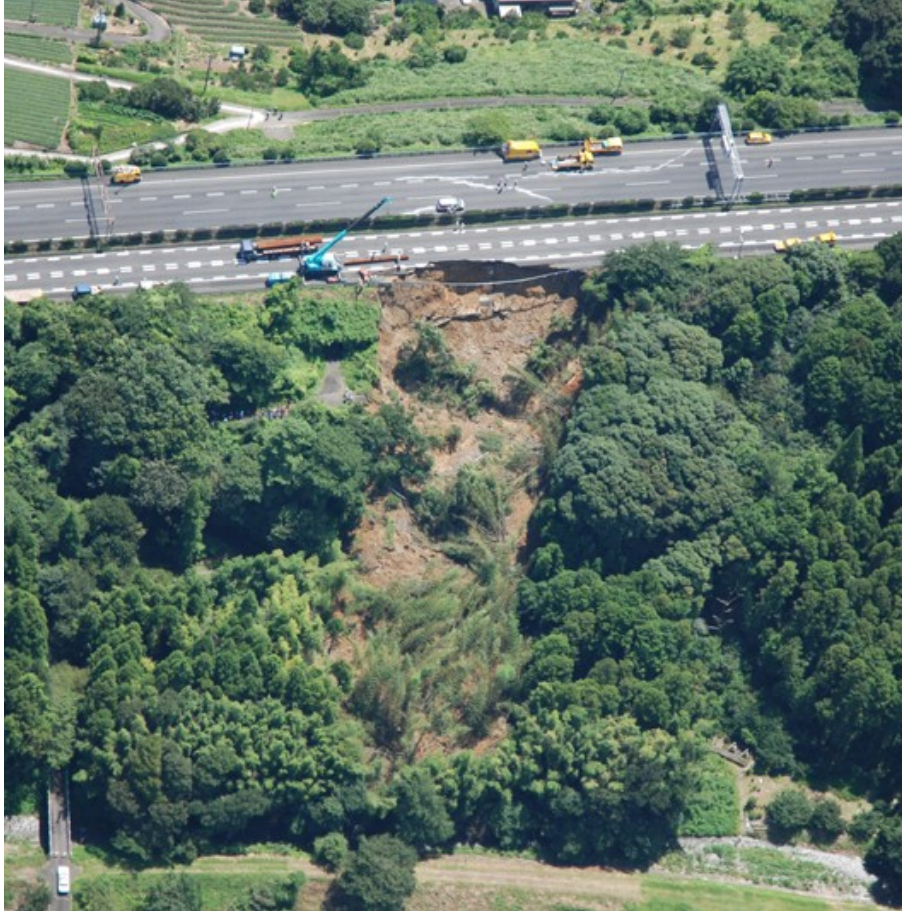
The most spectacular embankment damage occurred on the TOMEI expressway at the point of KP191.6 near Makinohara Service Area (Figure 33). A 40 m long section of the highway slipped towards north. As this expressway connects Tokyo and Osaka and it was the most important religious holiday in Japan, tremendous efforts were done for the quick repairment of the expressway. It was re-open to traffic after 5 days. As No 9 typhoon passed over the area before the earthquake, it was expected that the ground water level raised resulting in the most vulnerable state for the failure of the

embankment during a strong shaking. The embankment was 28 m high and it was built about 50 years ago. The maximum ground accelerations were 488 gals at Kikugawa Interchange (10.2 km away from failure location) and 424 gals at Haibara. Figure 34 shows the pre and post failure configuration of the embankment.

(a) Areal view of the failure (modified Japan Geographical Surveying Institute)

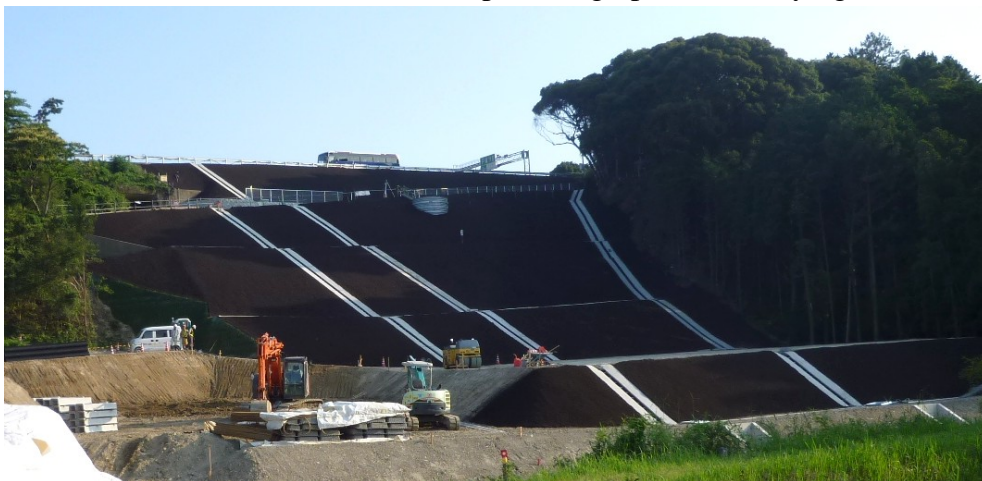
(b) A view of the fully restored embankment (picture on July 1, 2010)

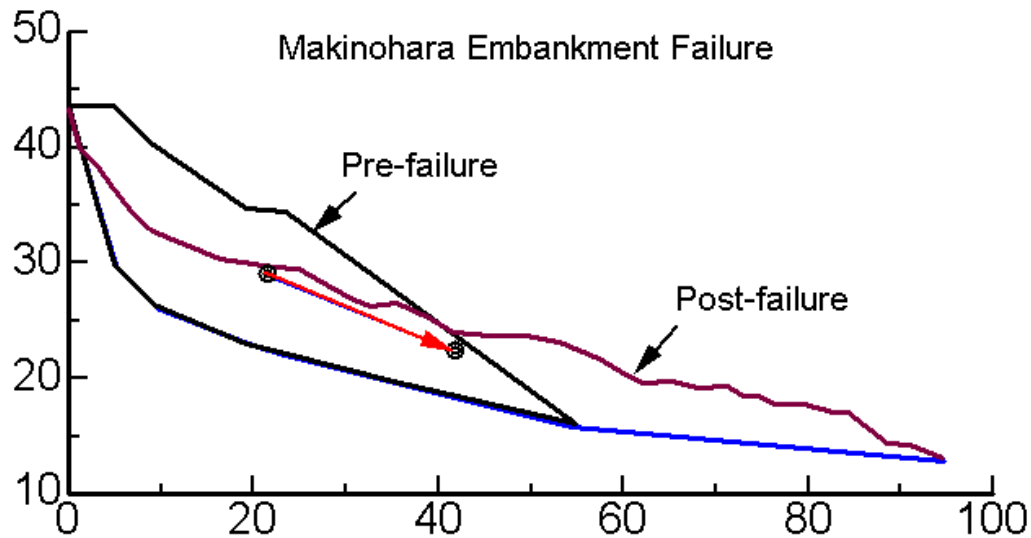
Figure 34: Pre-post configuration of the embankment

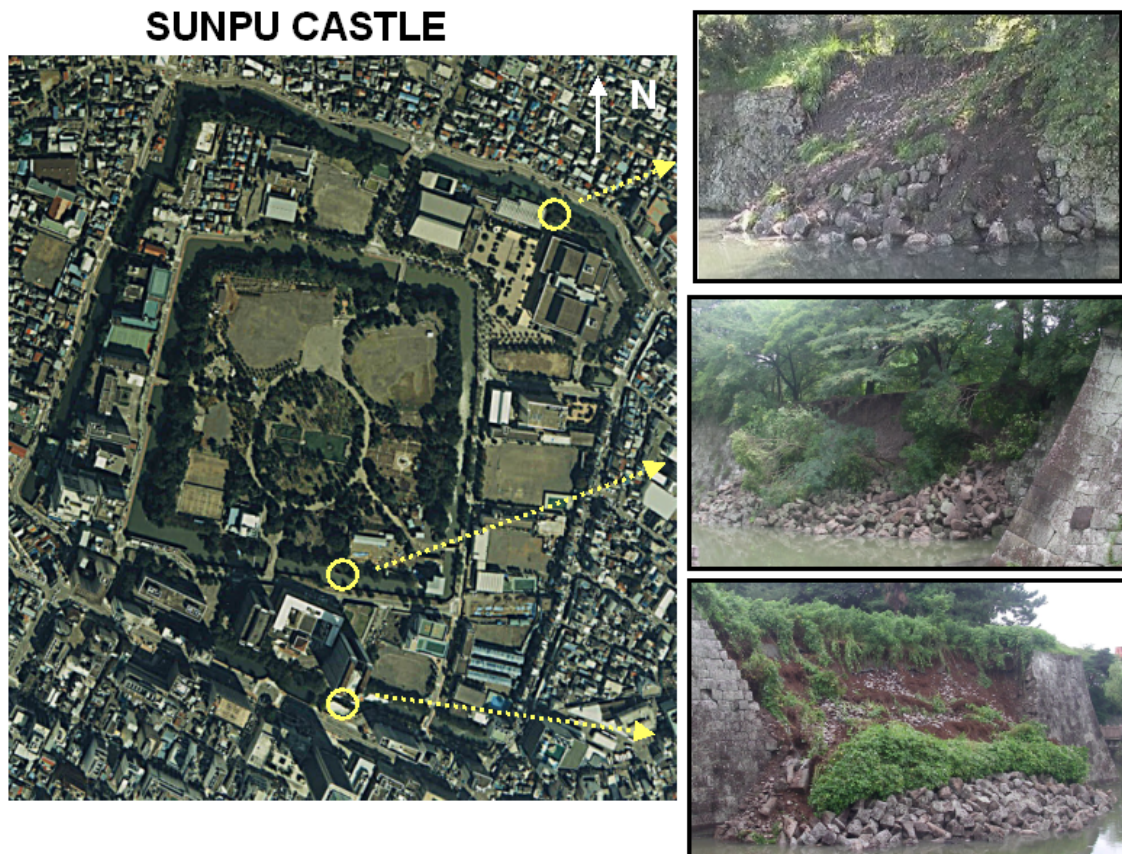
The most publicized retaining wall failure was observed at the remains of the Sunpu Castle (Figure 36). The retaining walls of about 8-9 m high failed at three locations in N-S direction, indicating the directivity effect of the strong ground motions. Two failures occurred at the south and north side of the outer moat (soto-bori) and one failure occurred in the south side of the inner moat (uchi-bori). The size of corner stones is generally large (longest side length is about 200 cm) and placed in an intermittent pattern with an average inclination of  $70^\circ$ . The sizes of blocks at other parts are very variable. Nevertheless the longest side of the stones cut into pyramid shape is generally more than 80 cm and it is placed into the inside of the wall (Figure 37). Old stones are

generally made of andesite and porphrite while the newly restored parts consist of basalt blocks. It is well known that the retaining walls suffered heavy damage in the past. It is reported that all retaining walls were collapsed during the 1854 Ansei earthquake. Some part of the restored retaining wall failed again in the 1935 Shizuoka earthquake. Although the configuration of the retaining walls of Japanese castles is earthquake-resistant, the ground motions are generally expected to be large to fail these retaining walls.

The inspection of the failed retaining walls indicated rounded sandstone and shale gravels used as backfill material except the soil for growing plants on the top of the retaining wall. The first author also noticed some bulging in retaining walls during 2008. As the average inclination of retaining walls was about  $70^\circ$ , it was unlikely for the walls to fail in rotational mode on the basis of previous case histories and analyses (Aydan et al. 2008). The fundamental mode of failure is likely to be the inter-sliding of blocks, which has a pyramid shape under strong shaking in N-S direction. The bulging of the wall probably rotates castle wall blocks and loosen the contact between the load carrying blocks and small filling stones or gravels. Round large river gravels seem to be used as the back-fill material, which probably reduces the apparent friction of the back-fill material. This, in turn, results in the increase of the pressure from the back-fill material on the retaining walls.

Figure 36: An aerial view of Sunpu castle and views of failed retaining walls

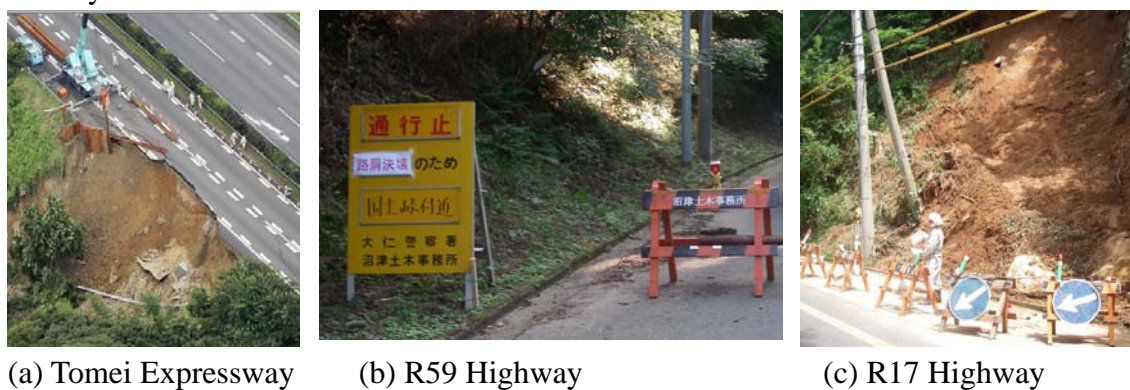
The major damage to roadways was induced near the Makinohara Service area by the embankment failure (Figures 33 and 45(a)). This embankment failure disrupted the traffic on the TOMEI Expressway for about 5 days. The highway R59 was closed to traffic due to embankment and slope failures (Figure 45(b)). There was some reduction of traffic to a single lane on Route 17 (Figure 45(c)) at locations where slope failures or rockfalls occurred. As the Tomei expressway was closed to traffic, the traffic jam on Route 150 was an extremely severe problem. Some sections of the second Tomei Expressway, which is now under construction, was temporarily open to traffic. Furthermore, there were some settlements of embankments next to viaducts and railways at various locations.

Figure 45: Damage to expressways and roadways

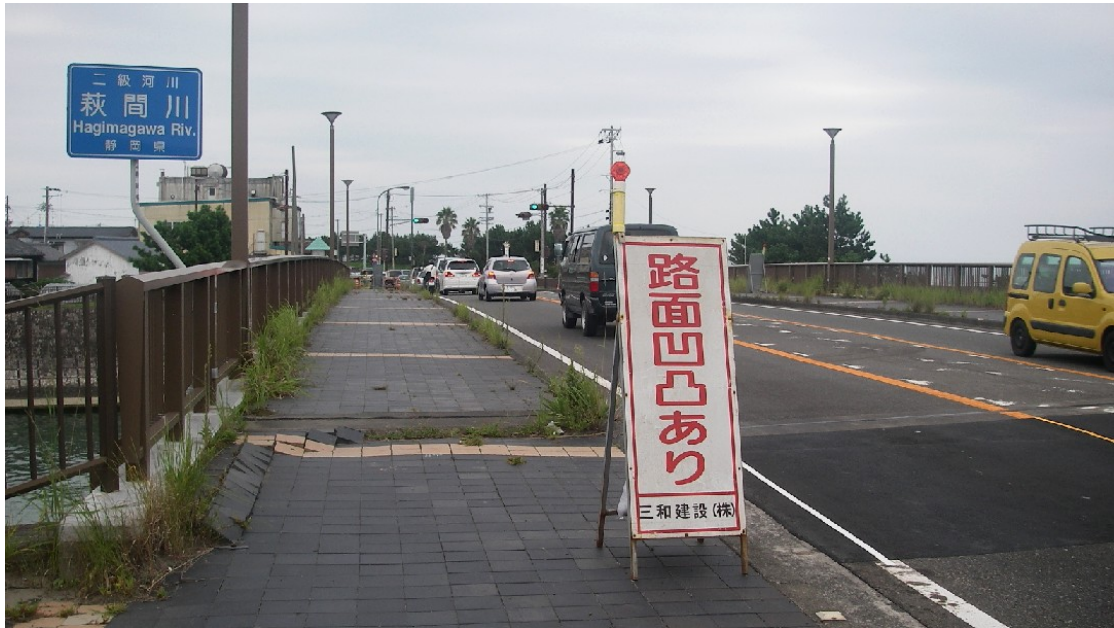
There are four major rivers, namely, Fujikawa, Abe, Oikawa and Tenryu Rivers in Shizuoka Prefecture. There are almost no damage any of bridges crossing these major rivers. However, slight damages were observed at several bridges such as Sagara Bridge over Hagima River and Susuki River Bridge on R150 (Figure 47). The damage at Sagara Bridge was due to settlement of the embankment of at both sides of the bridge.

(a) Sagara bridge on R150 over Hagima River

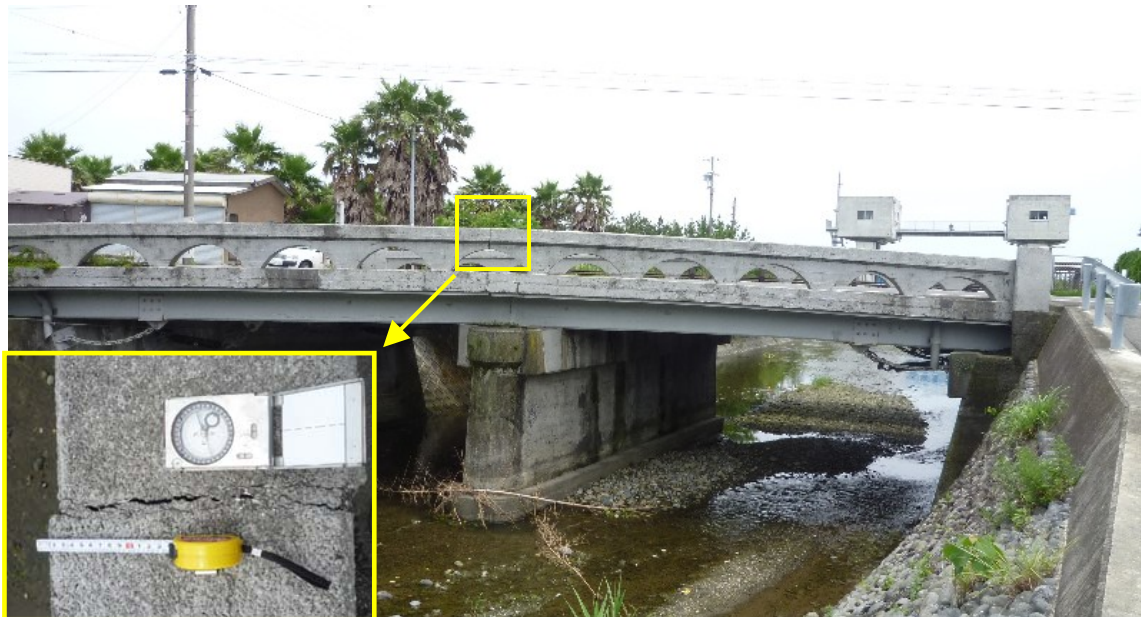
(b) Susuki River bridge on R150

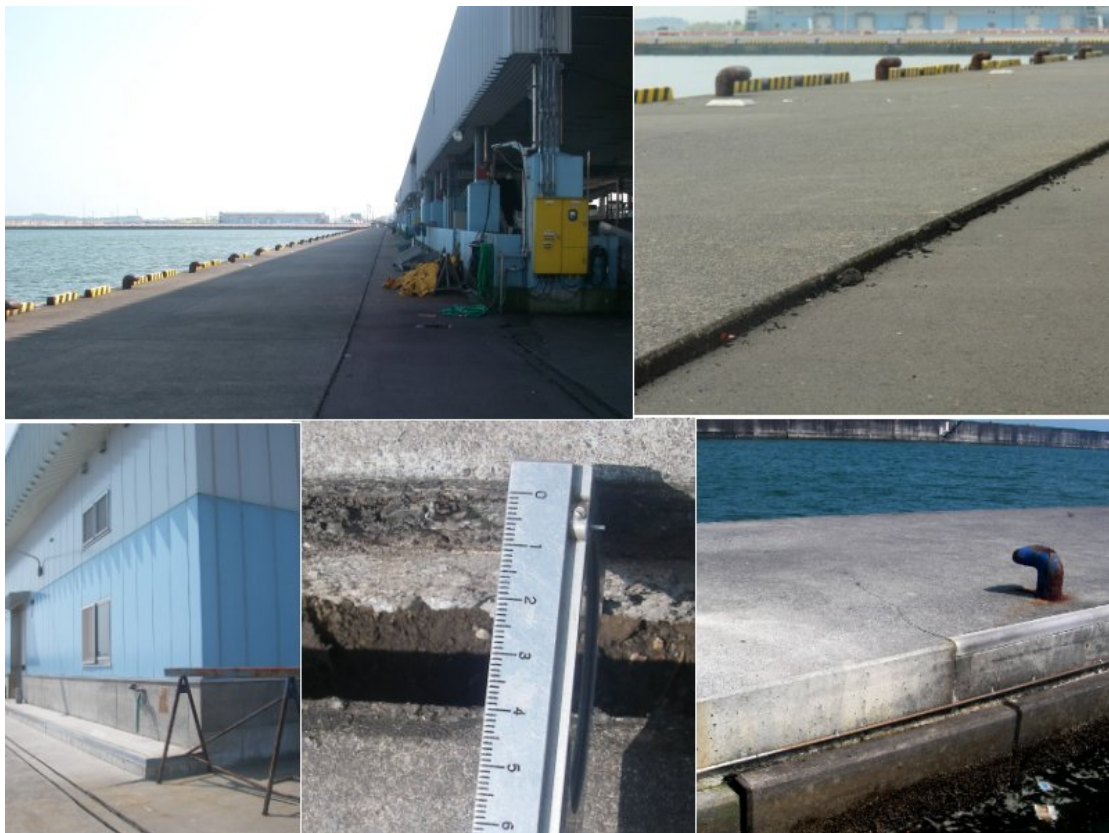
The major ports in the earthquake-affected areas are Shimizu Port, Ohkawa Port, Omaezaki Port, Yaizu Port and Numazu Port. There are also many smaller ports mainly for fishing ships. Settlement and lateral movement of quay-walls were observed almost in all ports around the west shore of Suruga Bay. The ground liquefaction as well as intense shaking by the earthquake heavily damaged the Sagara fishing port. All quay-walls moved towards the sea. Nevertheless, the movement of the quaywalls on the western side of the port moved more than 600mm in north-direction while the eastern quaywall moved more than 400mm towards south. The damage at Yaizu fishing port was in the form of settlement and lateral movement up to 250mm. The segments of the wave-break at Jitogata wharf displaced and separated up to 350 mm. Extensive ground liquefaction was observed in the west wharf of the Omaezaki port. The filling material of the reclaimed area of the wharf liquefied and caused lateral movements and settlement. It was also interesting to note that some tetra-pods were ruptured due to the earthquake, indicating very high ground accelerations.

Figure 48: Damage at Yaizu new fishing port

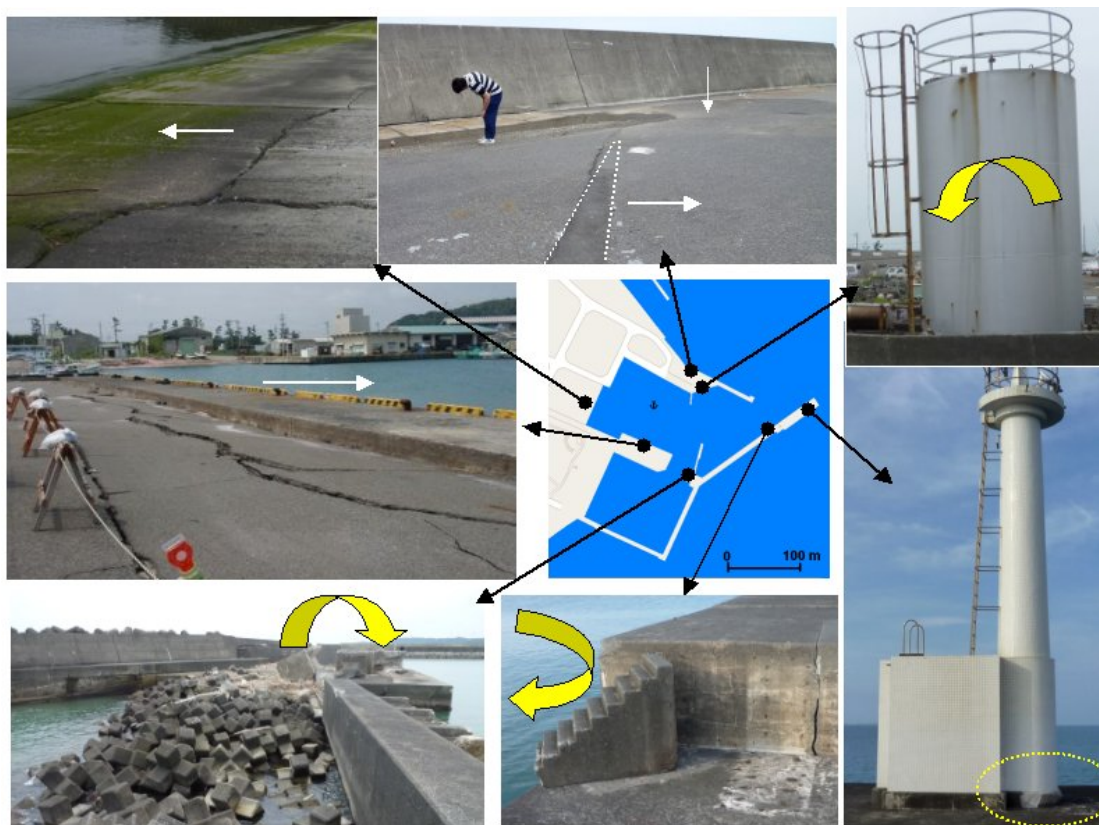
Figure 49: Damage at Sagara fishing port

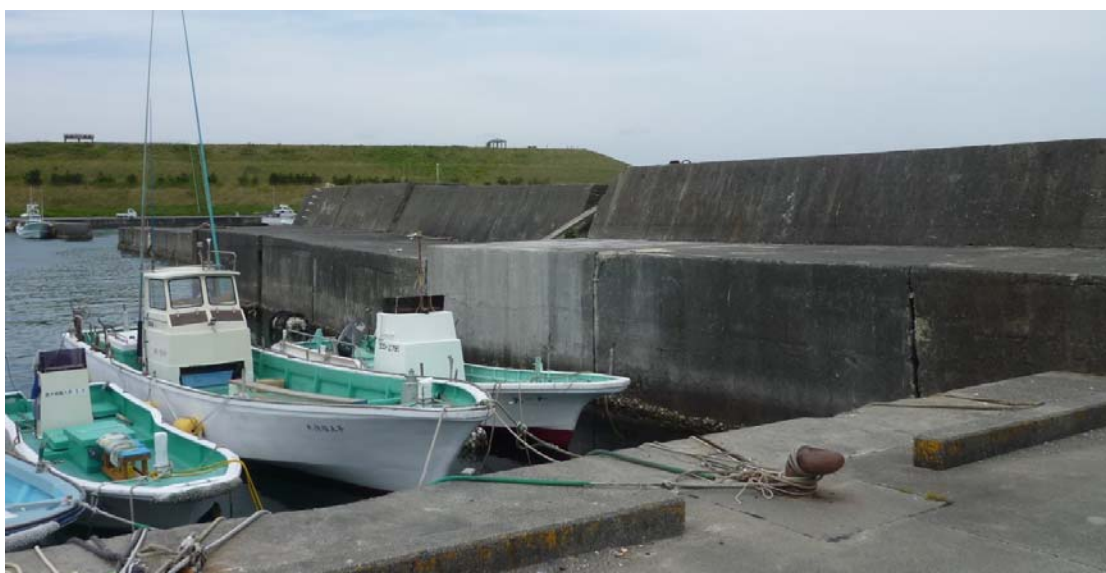
Figure 50: Settlement, separation and lateral movement of concrete blocks of the wave-break of Jitogata fishing port

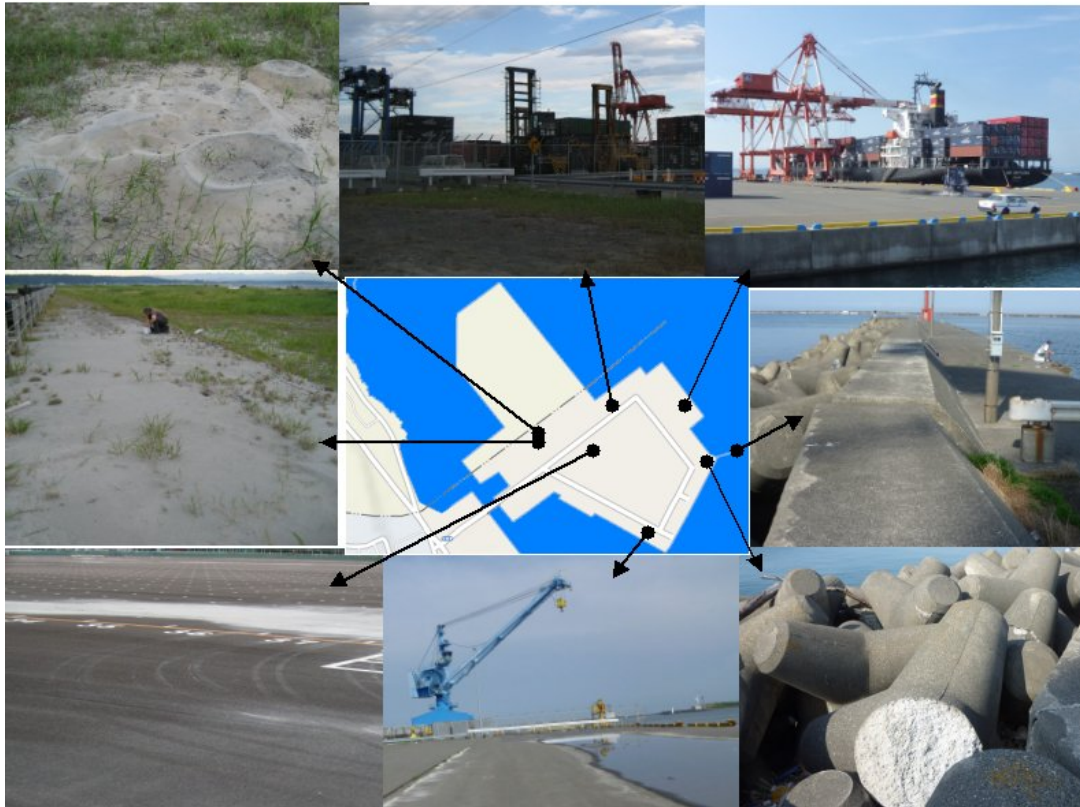
Figure 51: Damage at the west wharf of Omaezaki port on reclaimed land

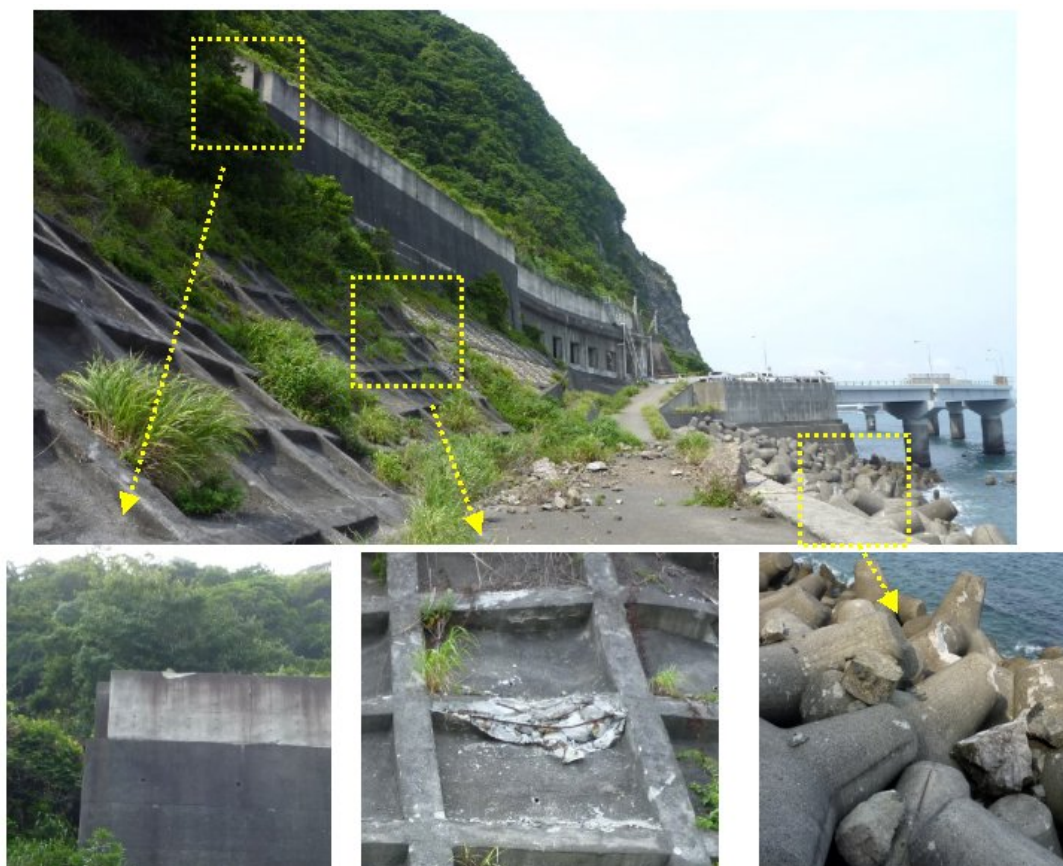
base of rock-shed. These rock blocks were fallen down from the steep slopes and hit the rock-shed and frame-type shotcrete protection of the slope at various locations as seen in Figure 54. Although some parts of the rock-shed spalled due to the impact of rock blocks, the rock-shed was structurally safe and functional.

Figure 54: Slight damage to a rock-shed in Okuzure

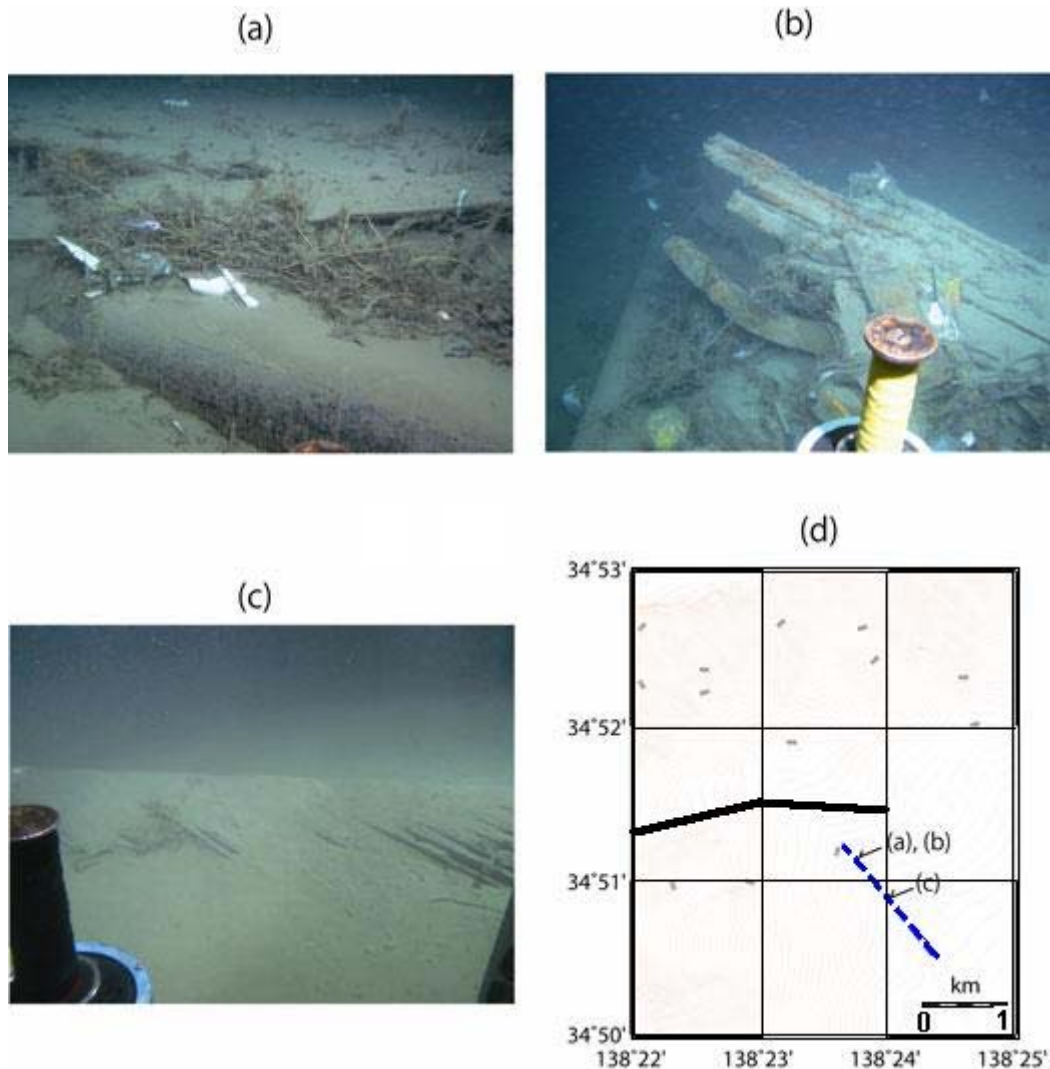
The authorities asked Japan Marine Japan Agency for Marine-Earth Science and Technology (JAMSTEC) to investigate the condition of the 687 m pipeline. The JAMSTEC (2010) carried out the first investigation in December 2009. A remotely operated unmanned exploration (named as HYPER-DOLPHINE) was used for the visual inspection of the pipeline and its surrounding. The inspections by the HYPER-DOLPHINE indicated that the 687m pipeline was displaced by more than 2 km from its original position and the pipeline was torn apart. In the vicinity of the ruptured pipeline, shipwrecks and muddy sediments were found (Figure 57).

The JAMSTEC undertook a Bathymetric surveying in the vicinity of the ruptured pipeline using a multi-beam echo-sounder in order to understand the cause of the pipeline rupture from February 27<sup>th</sup> to March 1<sup>st</sup>, 2010. The multi-beam bathymetric survey data was compared with those from 2004 and 2006 surveys. The results showed that the seafloor was subsided after the earthquake, about 5 km off the coast of Yaizu City (138°23' E, 34°52' N) at a water depth of 600 meters. The subsequent high-resolution underwater mapping revealed a horseshoe-shaped scarp. This is

interpreted as a geologic evidence for a submarine landslide, which is 450 meters wide and 10 to 15 meters deep. Therefore, it was concluded that the submarine landslide caused the rupture of the pipeline.

Figure 57: Views of the pipeline and its original position and location of the ruptured part (dotted line) (from JAMSTEC, 2010)

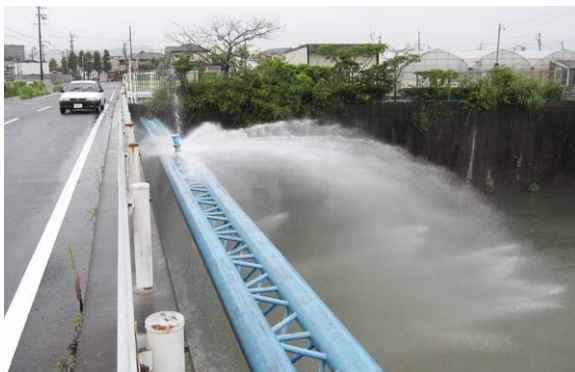
(a) Suruga ward of Shizuoka City

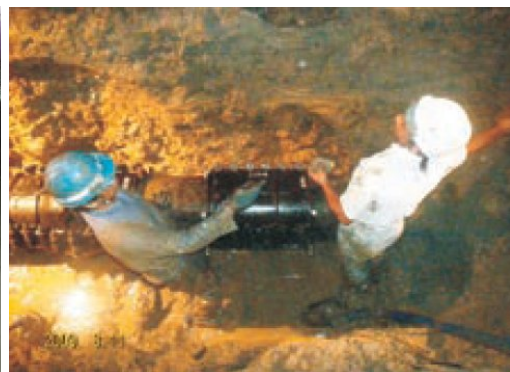
(b) Makinohara City
