A RECONNAISSANCE REPORT
ON
THE PARIAMAN-PADANG EARTHQUAKE OF SEPTEMBER 30, 2009*

2009 Pariaman-Padang Earthquake Reconnaissance Team

Japan Society of Civil Engineers,

October 2009

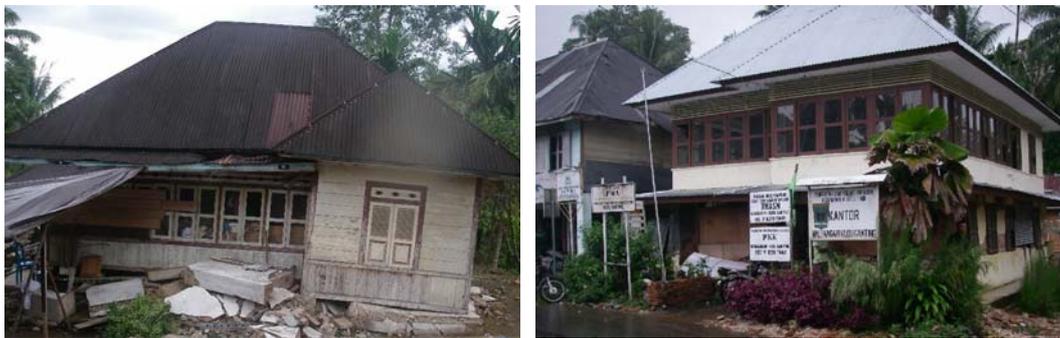
If there was no foundation failure due to landslides or shaking, timber framed structures performed well even in liquefied areas and areas close to the epicenter of the earthquake. Those with timbers as infill walls performed much better than those having brick infill walls (Figure 5.1).

(a) Damaged due to foundation failure

(b) Non-damaged

Figure 5.1 Views of damaged and undamaged residential houses in Koto Timur

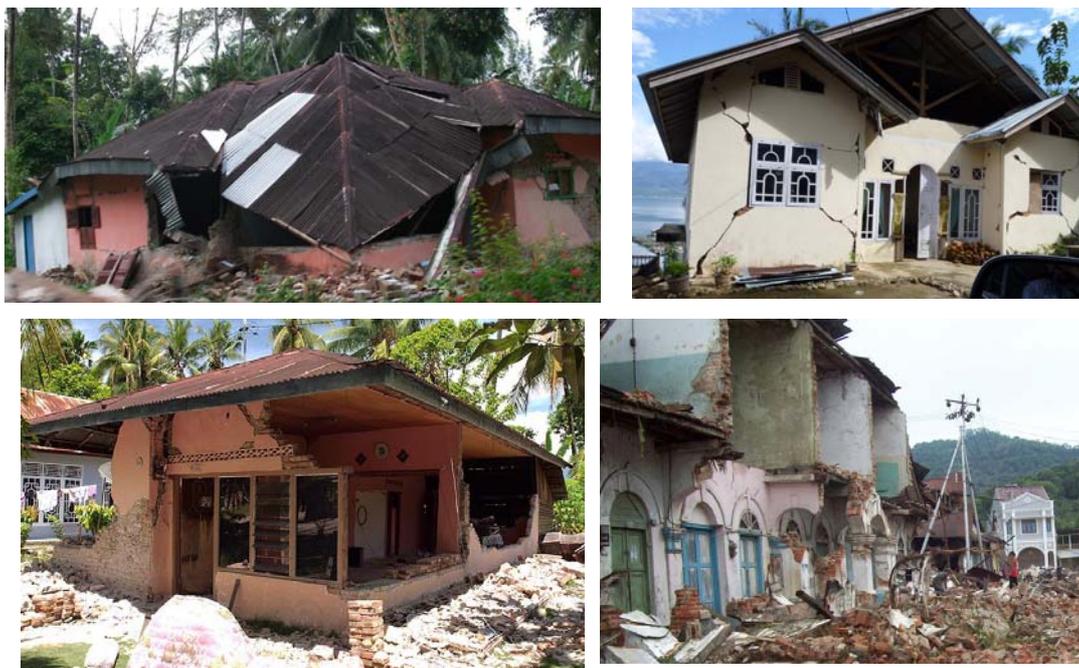
The low rise masonry buildings with or without thin column performed very badly during the earthquake. Most of these buildings collapsed or heavily damaged due to mainly out-of plane failure of masonry walls as seen in Figure 5.2.

Figure 5.2: Collapsed or heavily damage masonry buildings

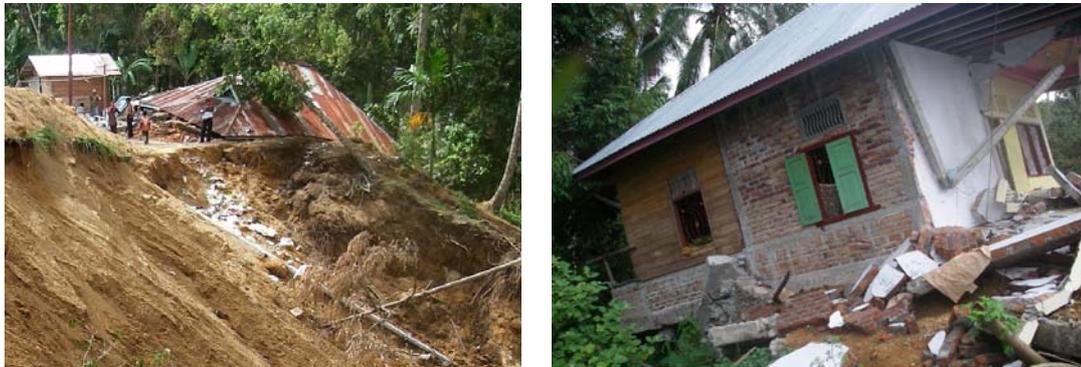
Buildings of any type in the areas of landslides collapsed or were heavily damaged by the earthquake. Particularly timber buildings were much weaker to the foundation failure due to landslides as compared with those with reinforced concrete frame buildings (Figure 5.3).

Figure 5.3: Collapsed or heavily damaged buildings due to foundation failure by landslides

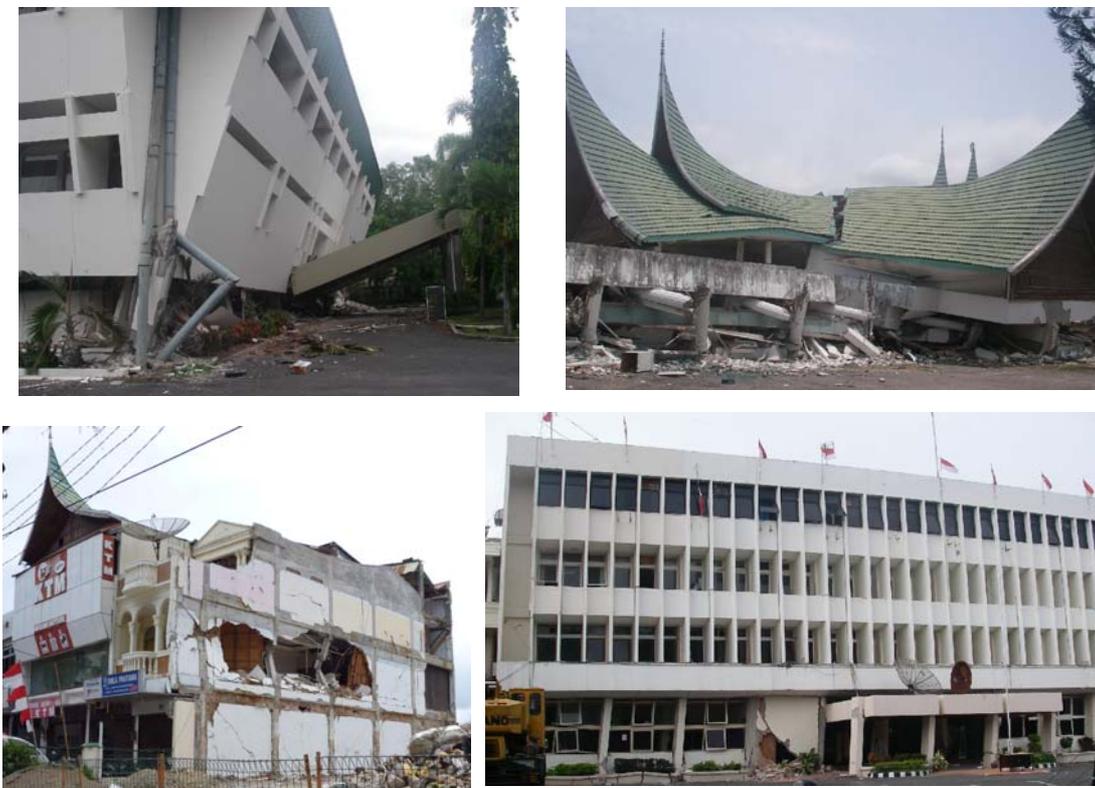
This earthquake heavily damaged reinforced concrete (RC) structures. The causes of damage are well known and they are simply the existence of weak floor, poor detailing of column-beam connections, collision of adjacent structures, poor integration of in-fill walls with the RC frame and top-heavy roofs. Many RC buildings are governmental buildings or hospitals. The concrete buildings with two or more stories either collapsed or were heavily-damaged.

Figure 5.4: Collapsed or heavily damaged RC buildings

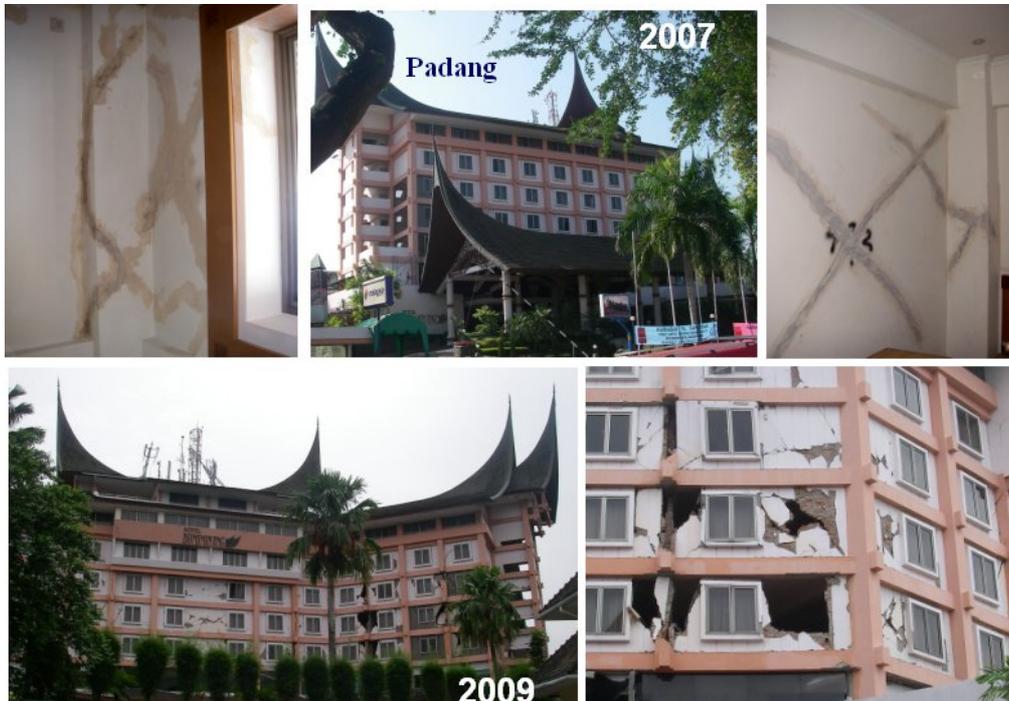
earthquake and repaired by just plastering cracks were extensively damage by this earthquake. The examples of such buildings were the five star hotel Bumiminang and Ramayana Department store (Figure 5.5). Another important observation was the location of fire at the Ramayana Department Store. The fire was also caused at the same place in the 2009 earthquake as that in the 2007 earthquake.

(a) Damage state of hotel Bumiminang

Figure 5.5: Damage state of RC buildings repaired by just plastering cracks in 2007

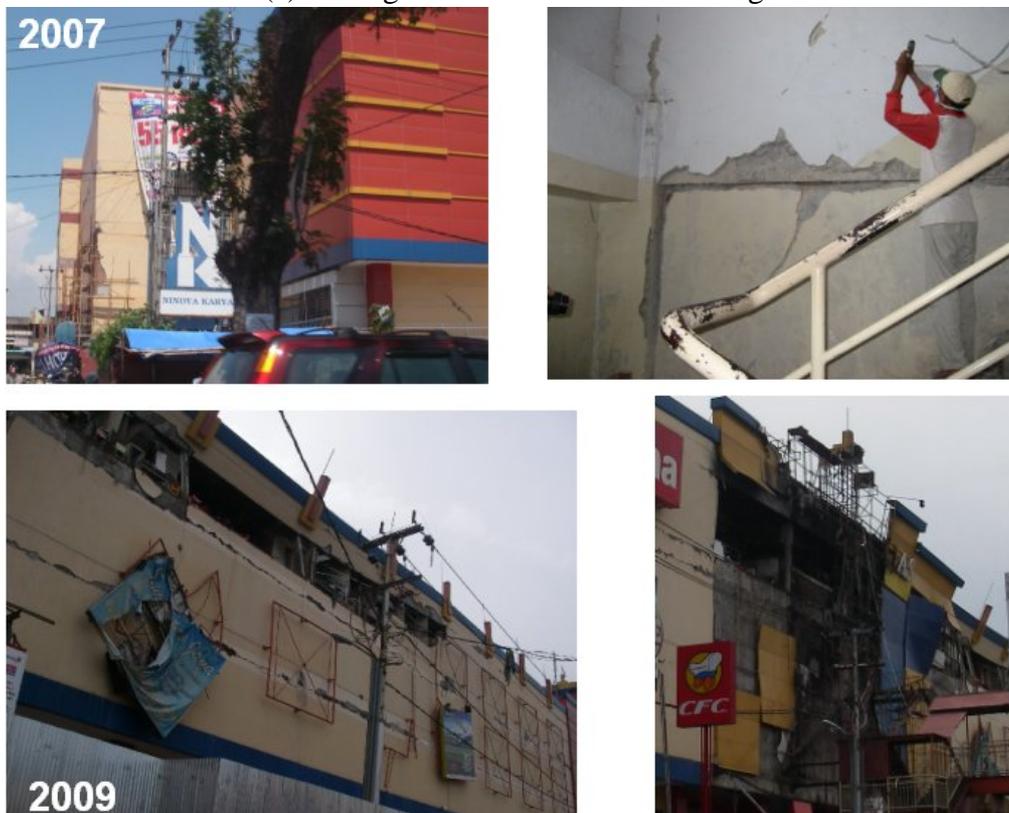
(b) Damage state of Ramayana Department Store

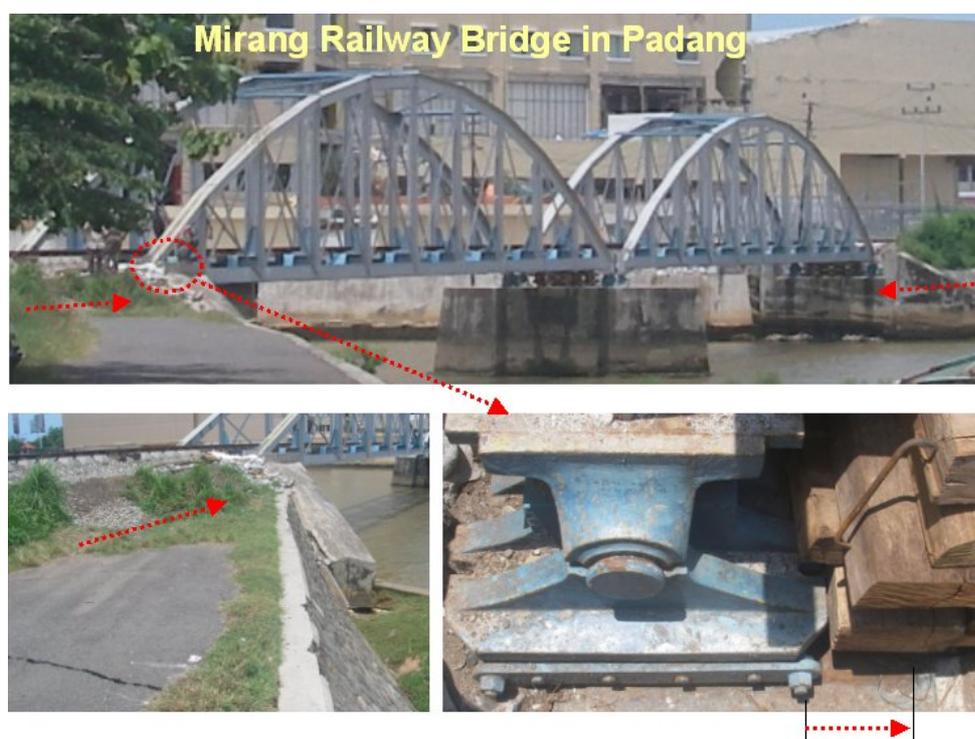
Figure 5.6: Damage to Mirang railway bridge in Padang

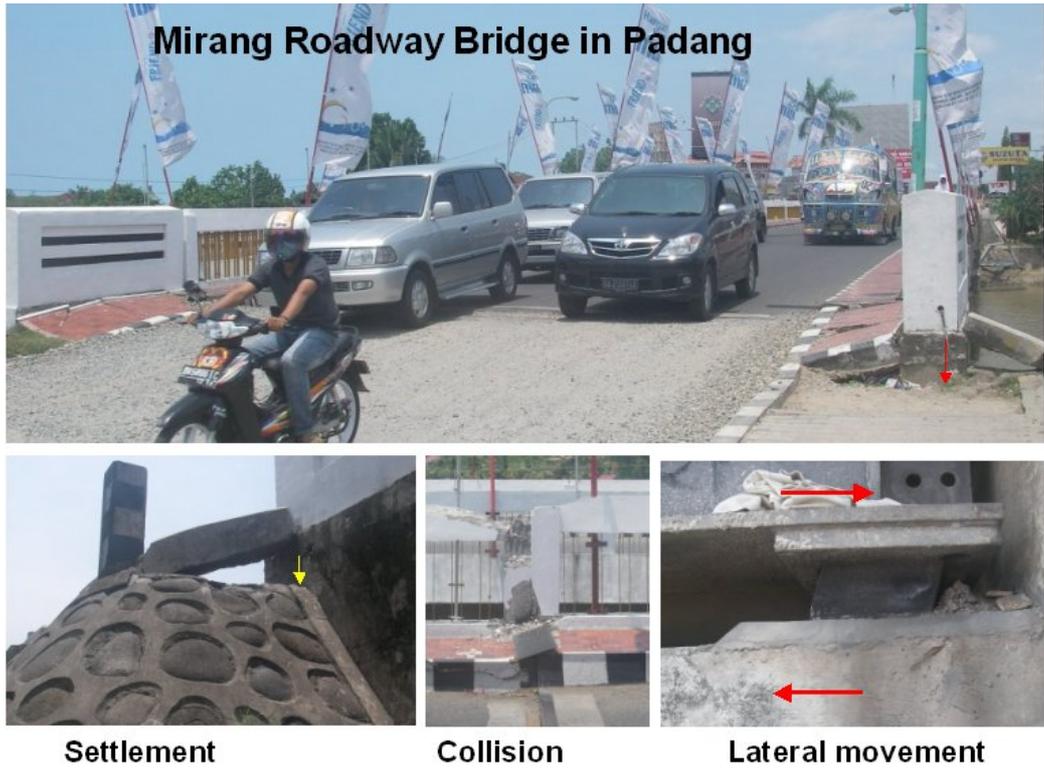
Figure 5.7: Damage to Mirang roadway bridge in Padang

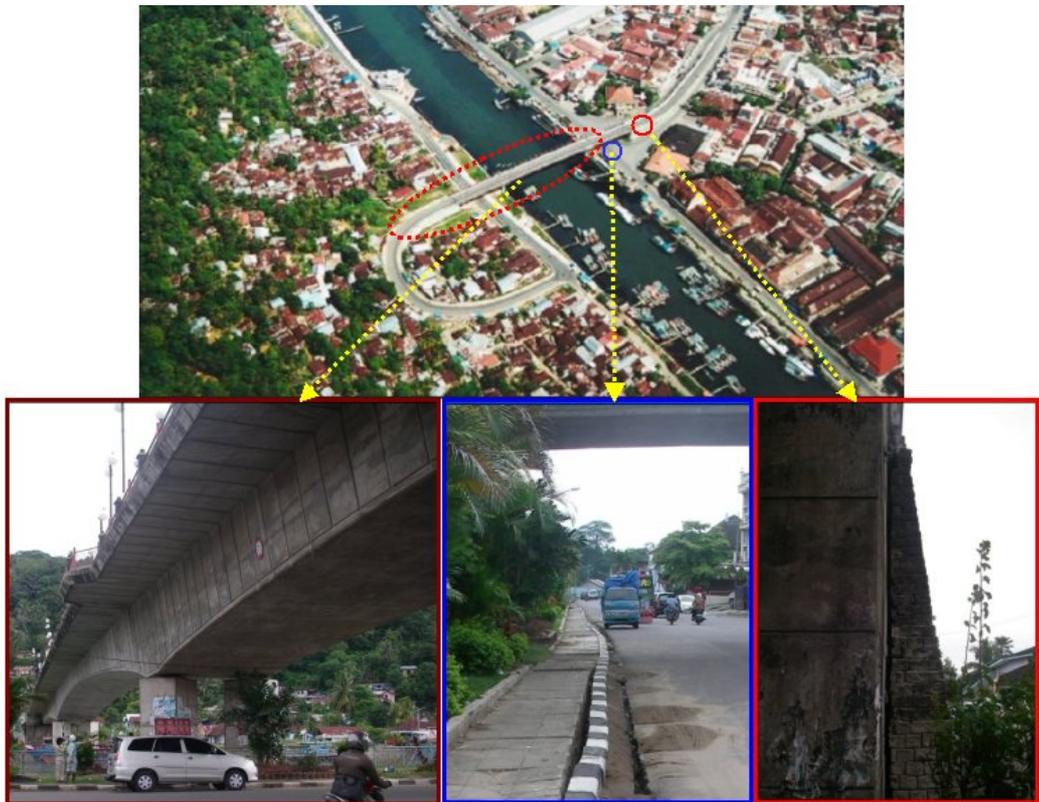
Figure 5.8: Sitinurbaya Bridge on Batang Arau in Padang downtown (damage due to abutment settlement and movements)

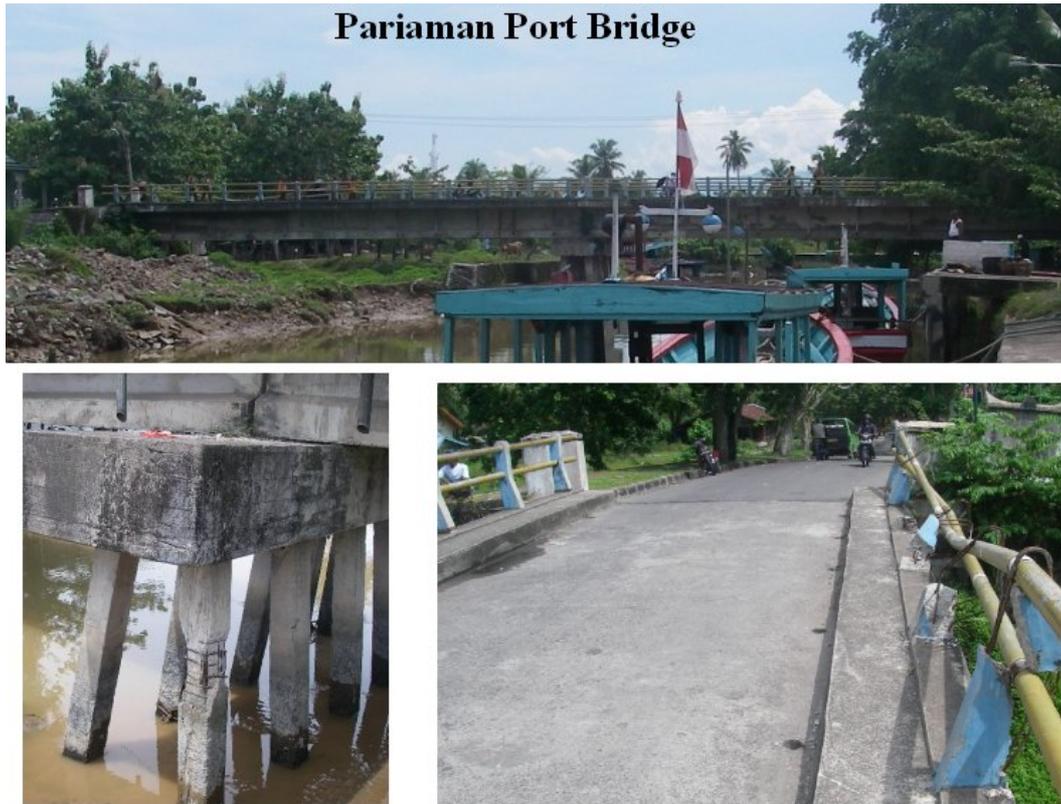
Figure 5.9: Slight damage to piers and railings

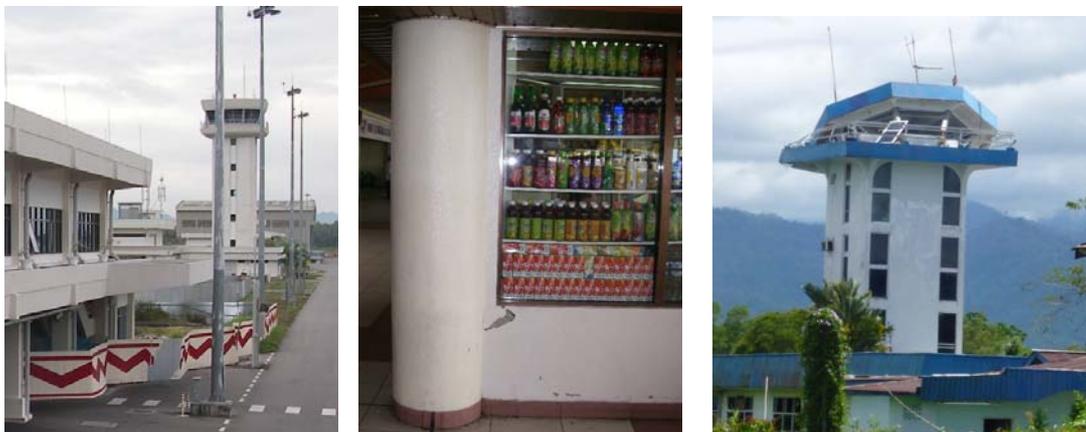
(a) Minangkabau airport

Figure 5.10: Views of damage at Minangkabau and Tabing airports

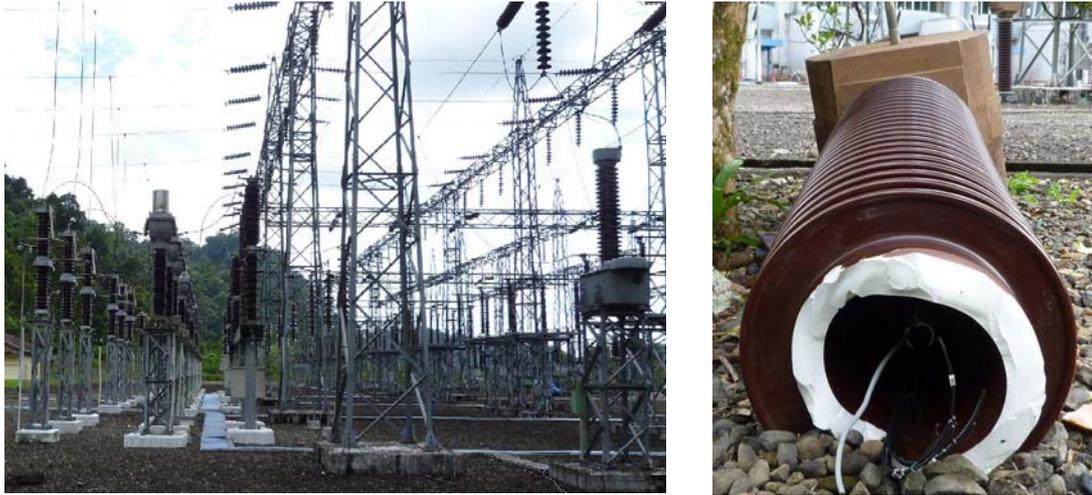
Figure 5.12: A view of Maninjau sub-station and broken ceramic isolator.

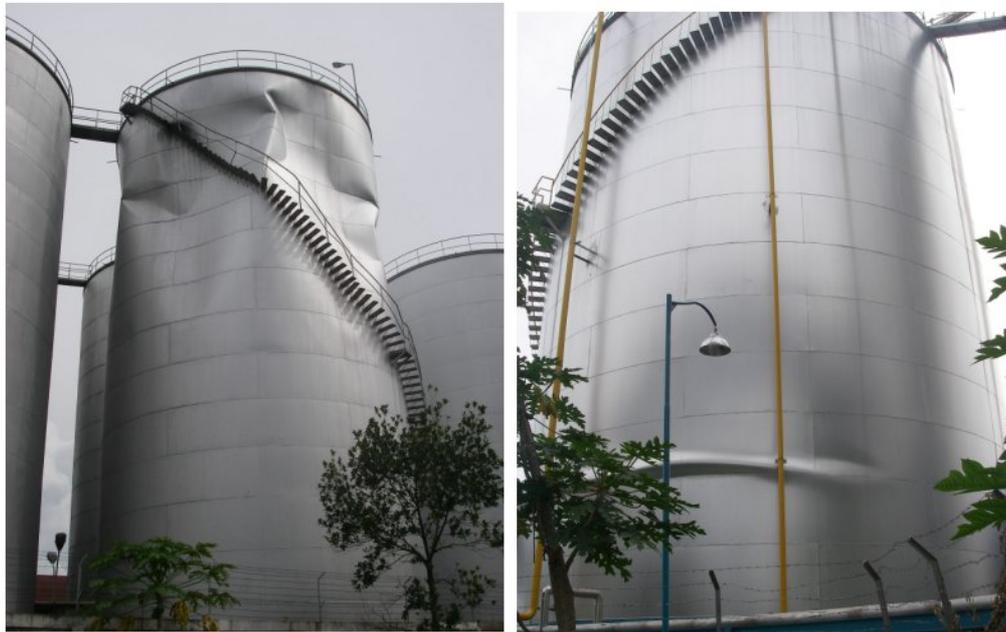
There are many cylindrical storage tanks at the Teluk Bayur port. Although most of the storage tanks performed well and non-damaged during the earthquake, there were some buckling failures at some of these cylindrical tanks. Furthermore, settlement of soil around some of tanks was observed.

Figure 5.15: Views of buckled tanks at Teluk Bayur port

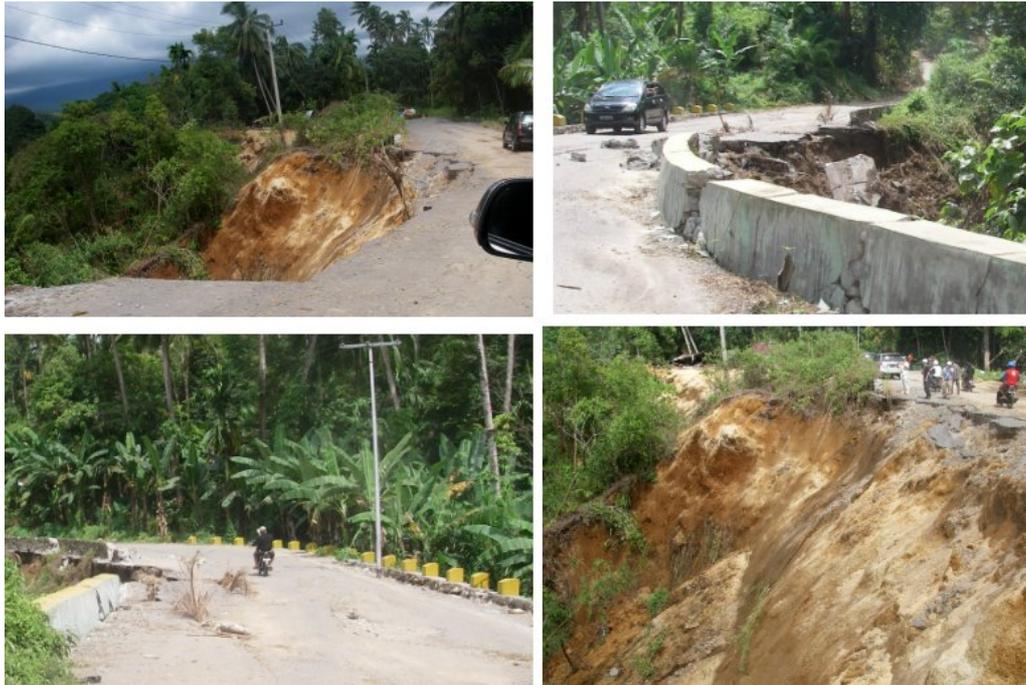
There was extensive damage to roadways due to slope failures in the mountainous areas such as Padang Alai and Tandikat. This damage was of great scale when roadways run along the thin ridge of the mountains. The ground was made of loosely packed volcanic ash. The slope failures were initiated due to intense ground shaking combined with high water content and lack of cohesive force and layers dipping towards the slope (Figure 6.1).

Figure 6.1: Roadway damage due to slope failures in Padang Alai

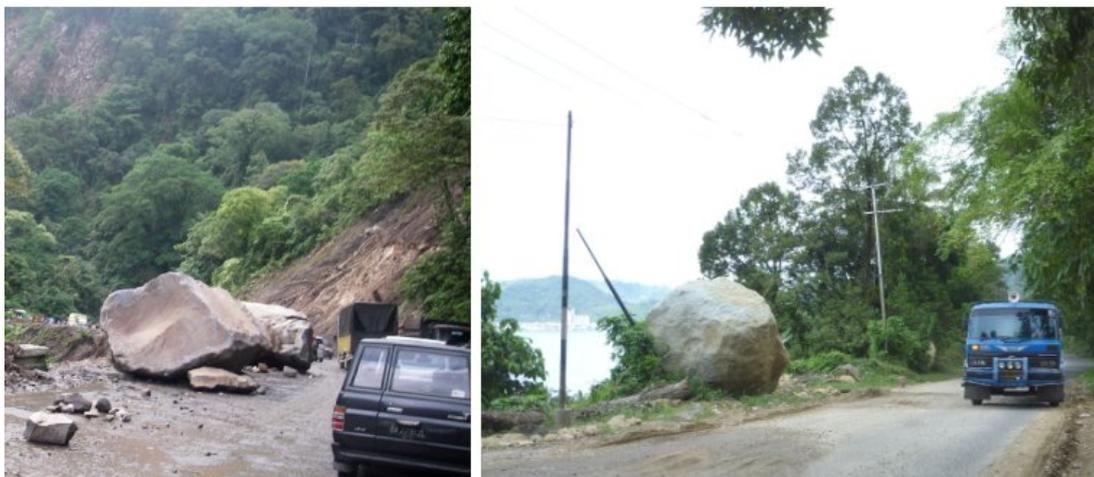
There was also some damage to roadways due to rock falls. These failures were observed along Padang-Bukittinggi Highway and Padang-Bungus. The fallen rock blocks were more than 5m in diameter (Figure 6.2).

Figure 6.2: Roadway damage due to rock falls

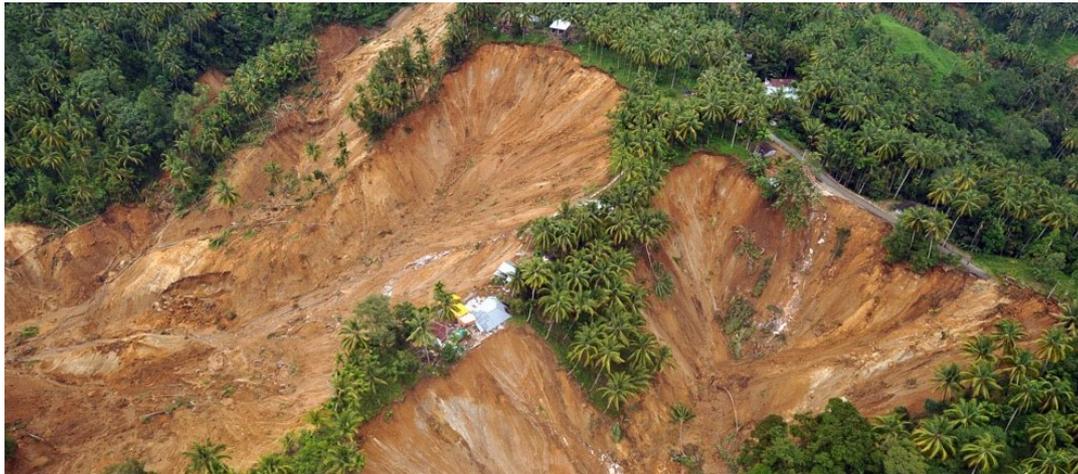
Extensive slope failures were observed in Padang Alai and Tandikat (6.3). The area is covered very loosely compacted and layered volcanic ash. The grain size of layers varies from the clay size to gravel size. Large fragments are made of pumice and their unit weight is very light. The sandy and gravel sized layers are porous and rich in water content. The site investigation indicated that layers have inclination more than 10 degrees towards to slope side. The failure of slopes took place along the interface of clayey and sandy layers due to intense ground shaking, which is expected to be more than 0.3g and the failed body become fluidized during the motion. More than 200 people were killed in a slope failure at Tandikat.

Figure 6.3: Slope failures in Padang Alai

Loosely sedimented porous volcanic ashes with clayey layers are very prone to slide during earthquakes. The people living in those areas should be re-located. If such measure is difficult to implement, some safety zone must be introduced between the settlements and crest of the slope.

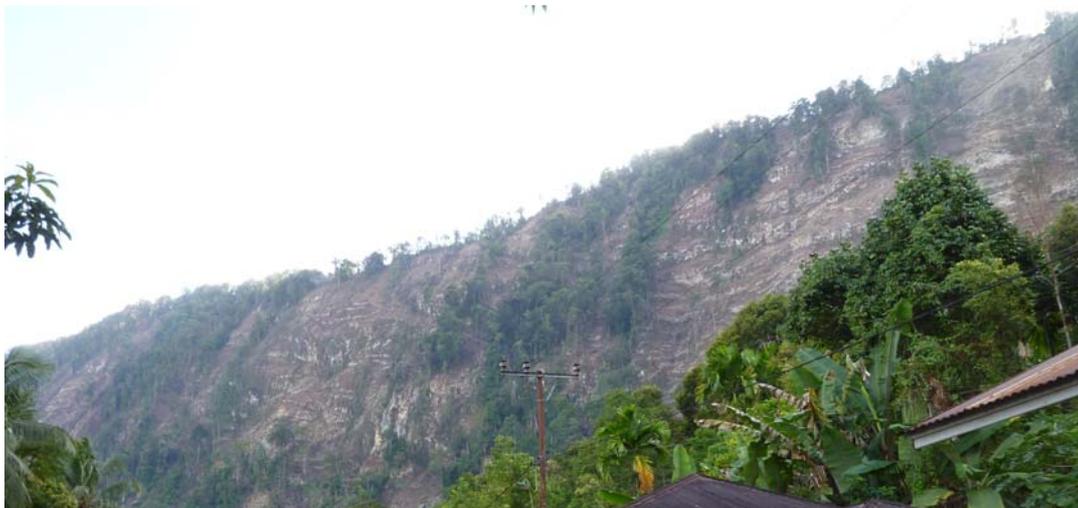
Figure 6.4: Rockfalls and slope failure in the inner rim of Maninjau Crater

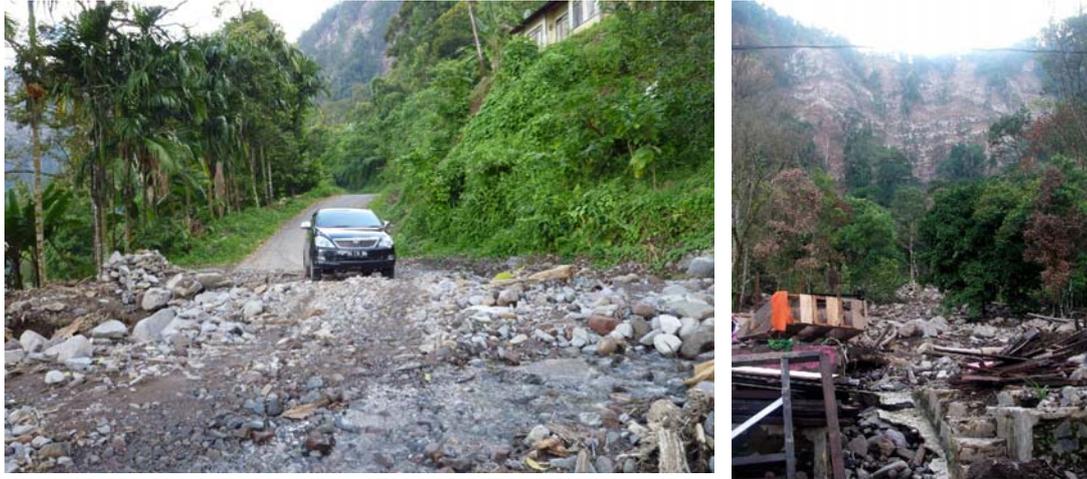
Furthermore, the hard rocks are andesite or basalt and they are jointed due to cooling joints. There were numerous rockfalls in mountainous regions consisting of hard rocks. The spectacular rock falls and slope failures particularly southern inner rim of Maninjau Crater (Figure 6.4). The debris created some landslide dams and the breach of the landslide dam caused huge debris flow 15 hours after the earthquake and causing some structural damage (Figure 6.5).

Figure 6.5: Debris flow induced damage due to the breach of landslide dams

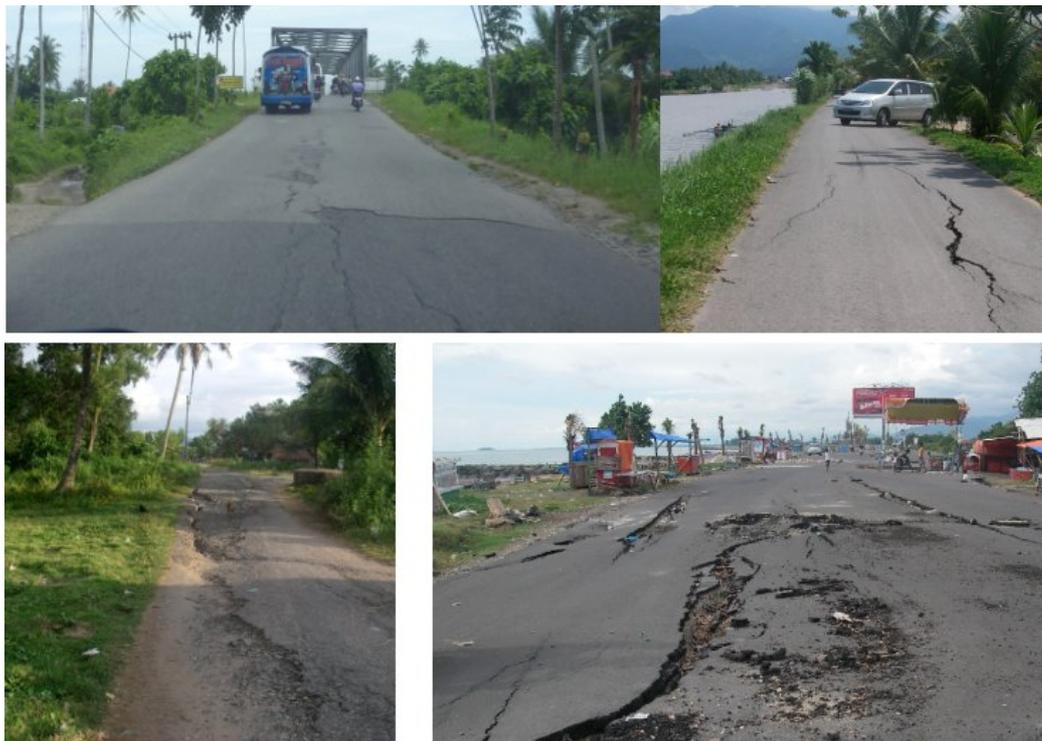
Embankment failures of roadways and rivers were also widespread in the area where the ground motions were high (Figure 6.6). The embankment failures at abutment of the roadway bridges were widespread. One of the major causes of the embankment failures was ground liquefaction induced lateral spreading.

Figure 6.6: Views of some embankment failures in the epicentral area

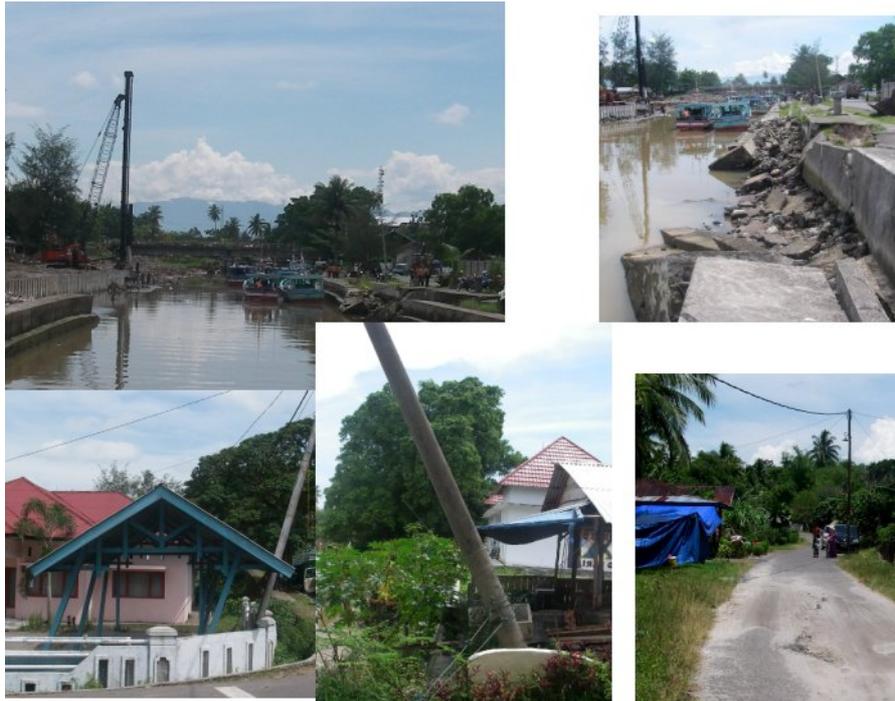
Figure 6.7 Ground liquefaction and its effects in Pariaman

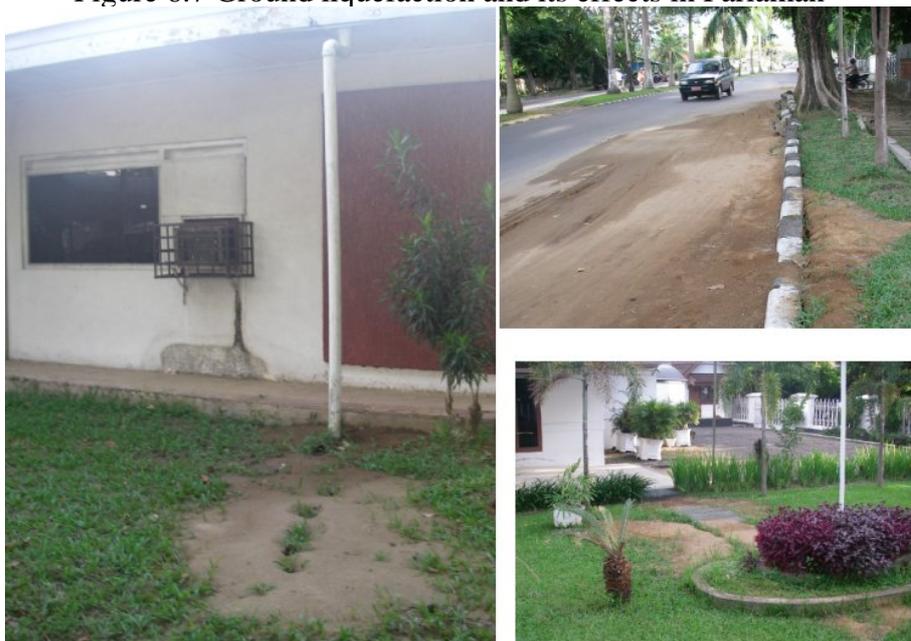
Figure 6.8 Ground liquefaction in Padang

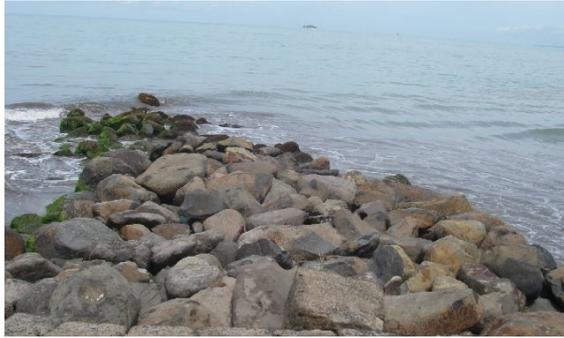
(a) Susidence of wave break at Pariaman

Figure 6.9: Effect of ground liquefaction on various structures

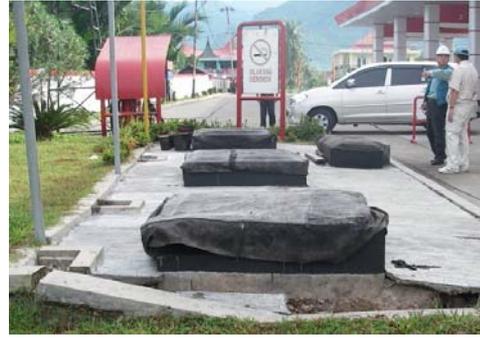
(b) Uplift of petrol tank

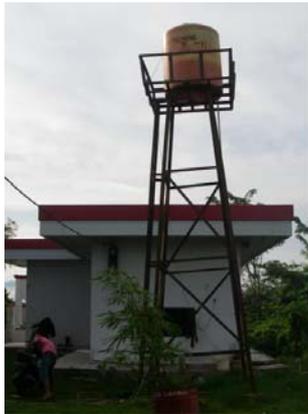
(c) Tilted structures

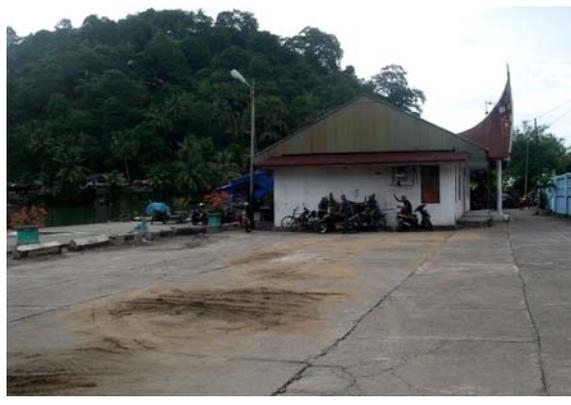
(d) lateral spreading at Padang Port
