**A RECONNAISSANCE REPORT**

**THE DARFIELD (NEW ZEALAND) EARTHQUAKE OF SEPTEMBER 4, 2010**

**On the behalf of JSCE**

**Earthquake Disaster Investigation Committee**

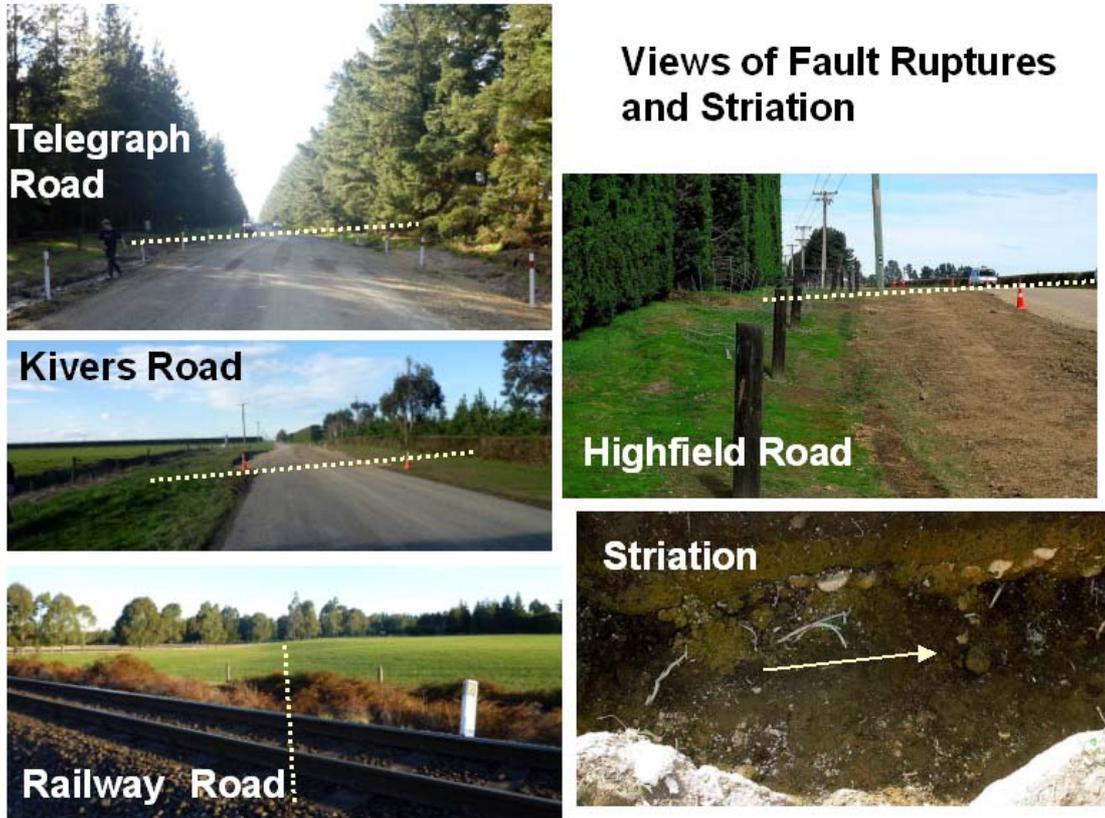
Figure 12: Views of faulting and striation

The maximum slip of the earthquake fault, named as Glendale fault recently by GNS, was 4 m with an average slip of 2 m. The observed surface rupture was 24 km while the aftershock activity was distributed over a length of 60-70 km.

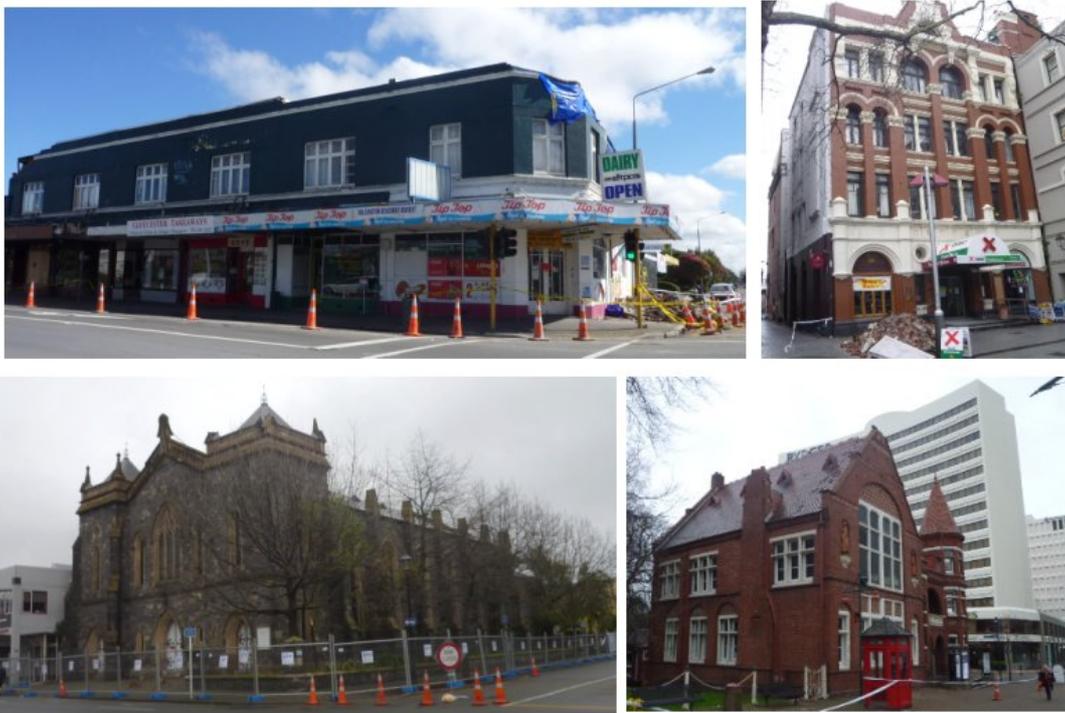
Many of the worst-affected buildings in both Christchurch and the surrounding districts were older unreinforced masonry buildings (Figures 18 and 19). The low story timber framed residential houses except those on liquefied ground and new reinforced concrete or steel framed buildings were almost intact (Figure 20). These buildings are characterized as typically 2 or 3 stories. However, 2 story buildings are most common. The causes of damage to unreinforced masonry buildings may be classified as:

- a) Out-of-plane failure of walls
- b) Parapet failures
- c) Anchorage failures
- d) Chimney failures

Figure 18: Damage to unreinforced masonry buildings in Christchurch

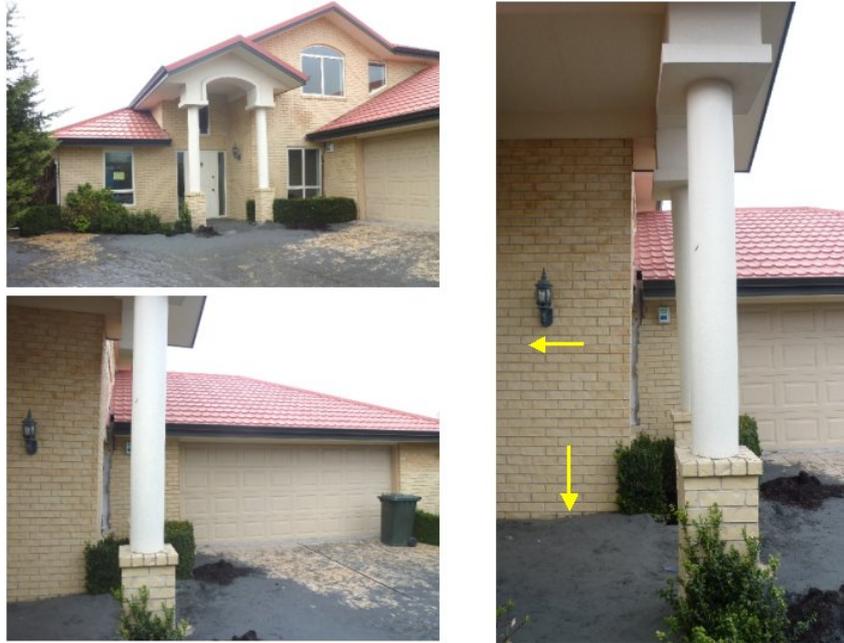
(a) Ground liquefaction induced separation, lateral movement and settlement induced damage to a building

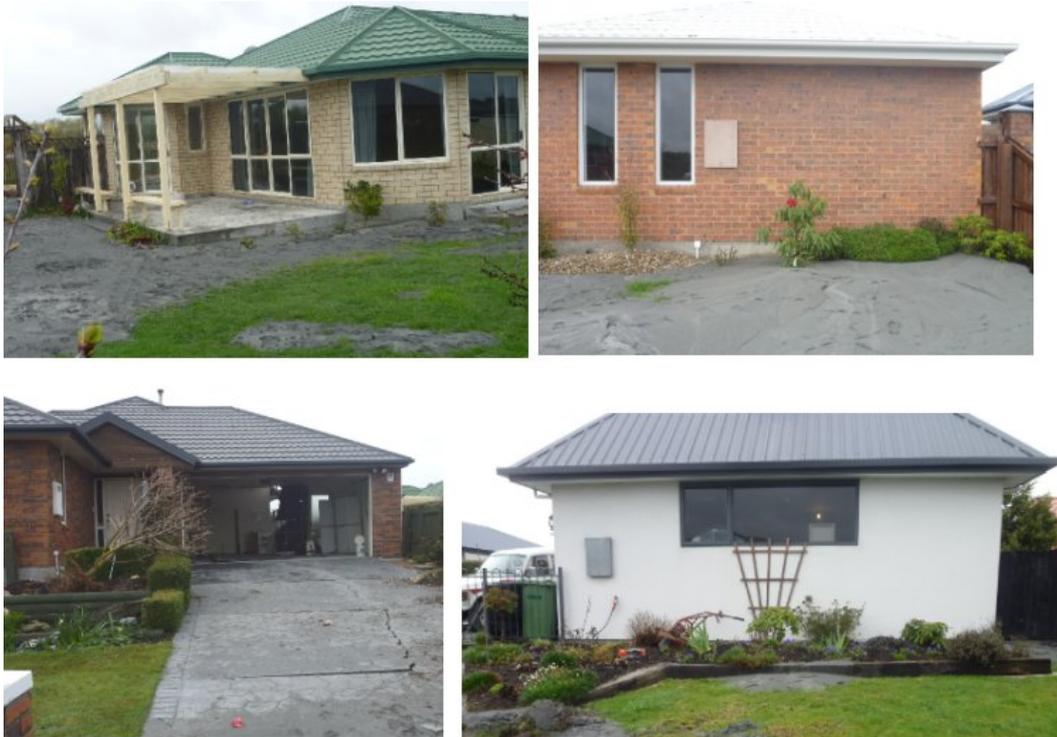
(b) Ground liquefaction induced separation, lateral movement and settlement induced damage to several buildings

Figure 19: Ground liquefaction induced damage to residential buildings in Kaiapoi

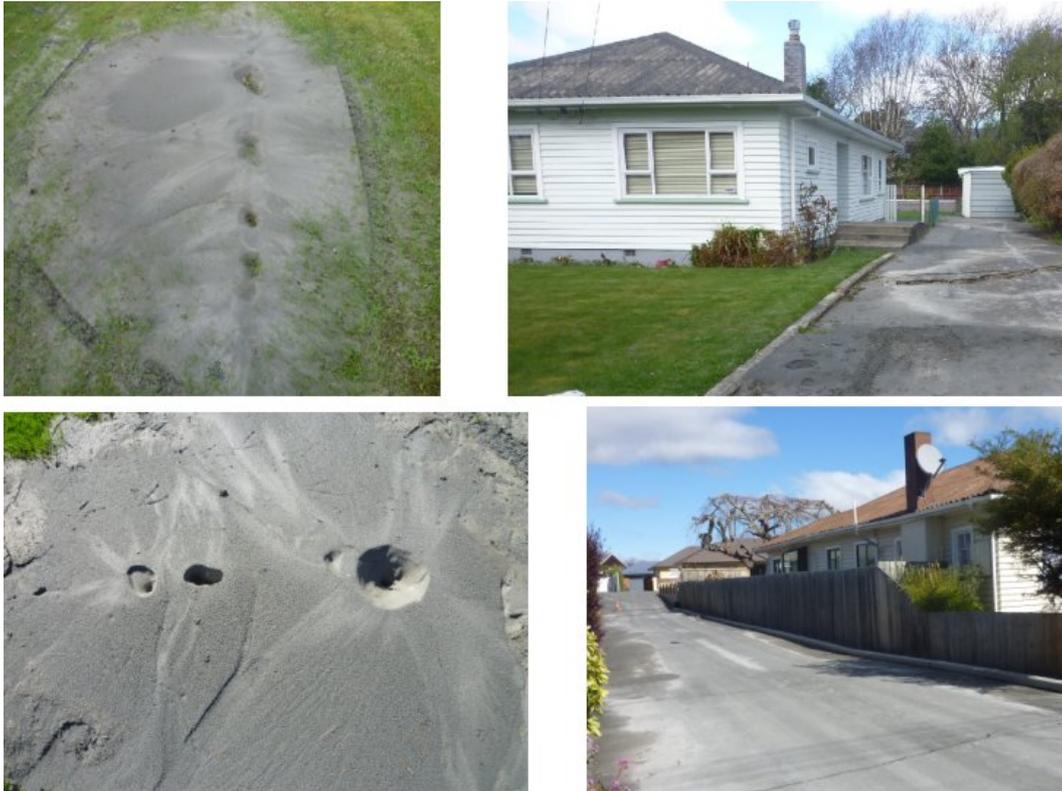
Figure 23: Ground liquefaction along Avonside Drive

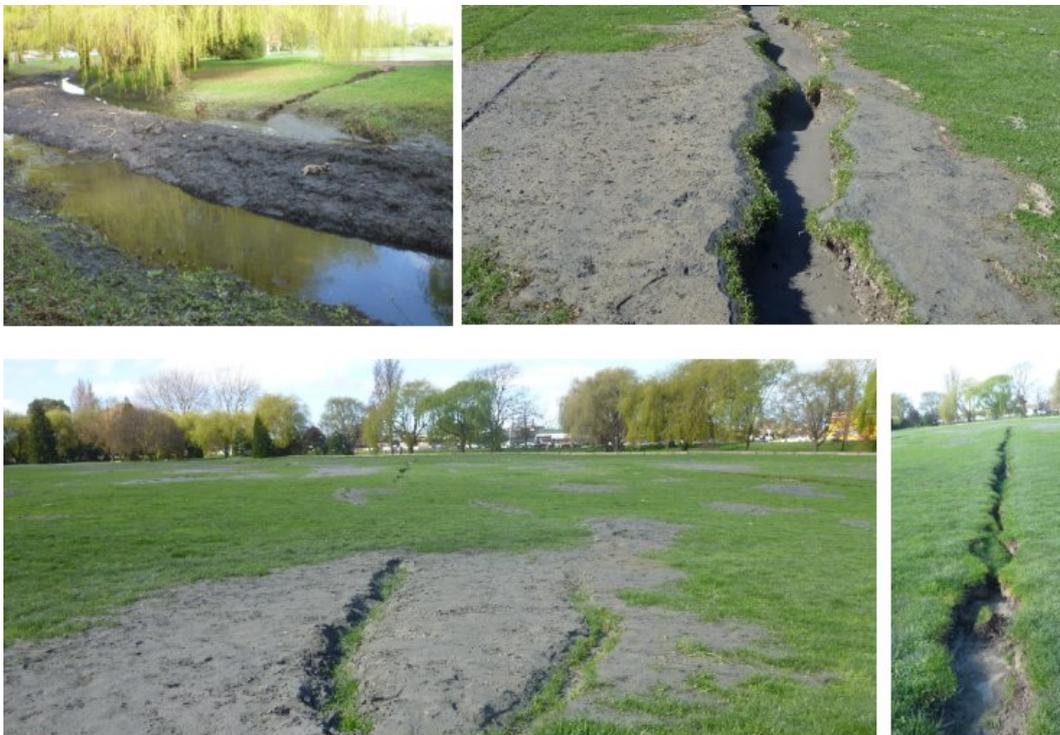
Figure 24: Ground liquefaction at Porrit Park

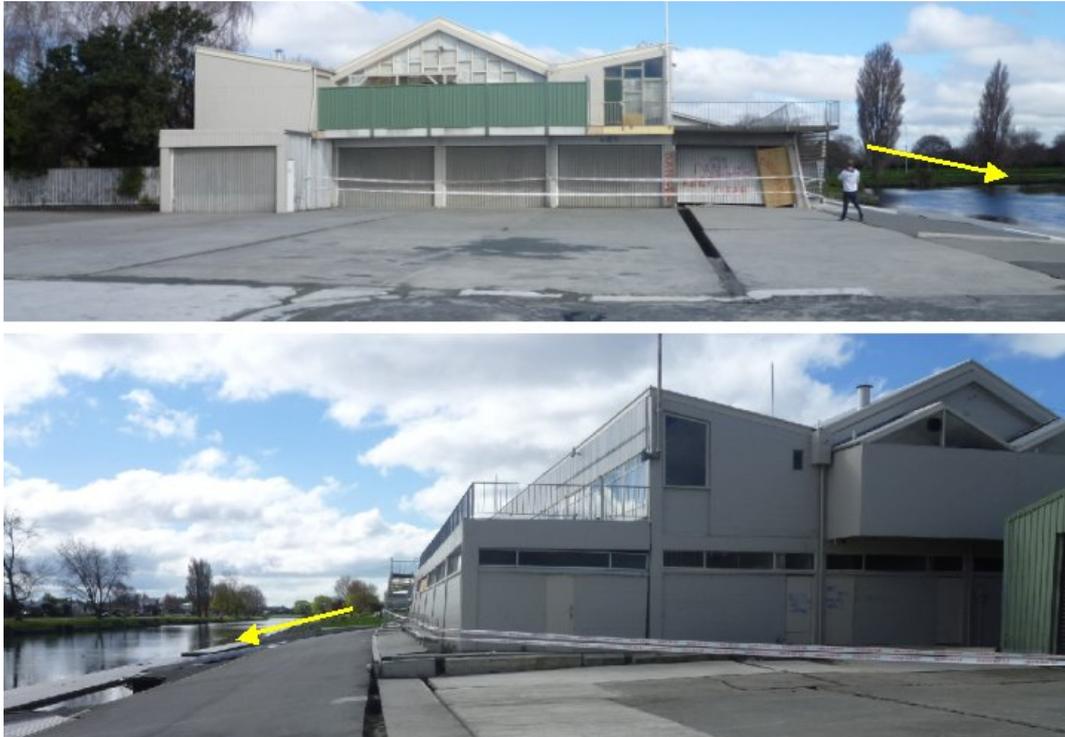
Figure 25: Lateral spreading induced damage at Canterbury Rowing Club building

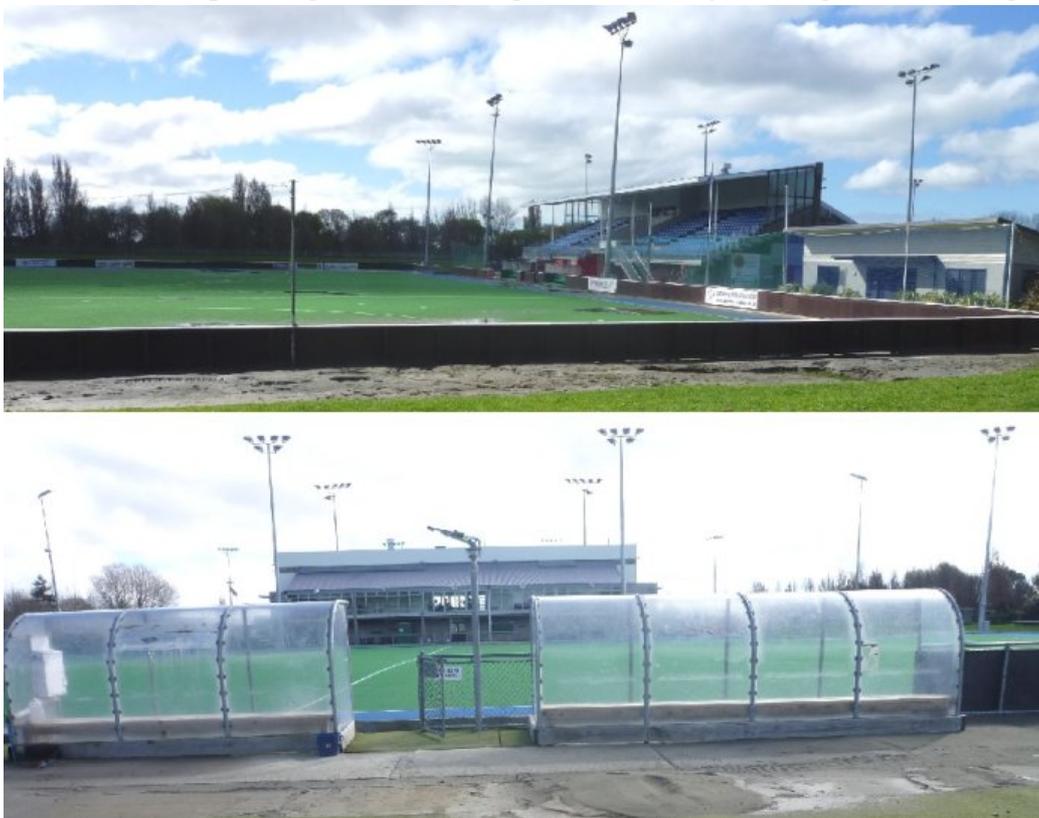
Figure 26: Ground liquefaction in the vicinity of sport facilities in Porrit Park

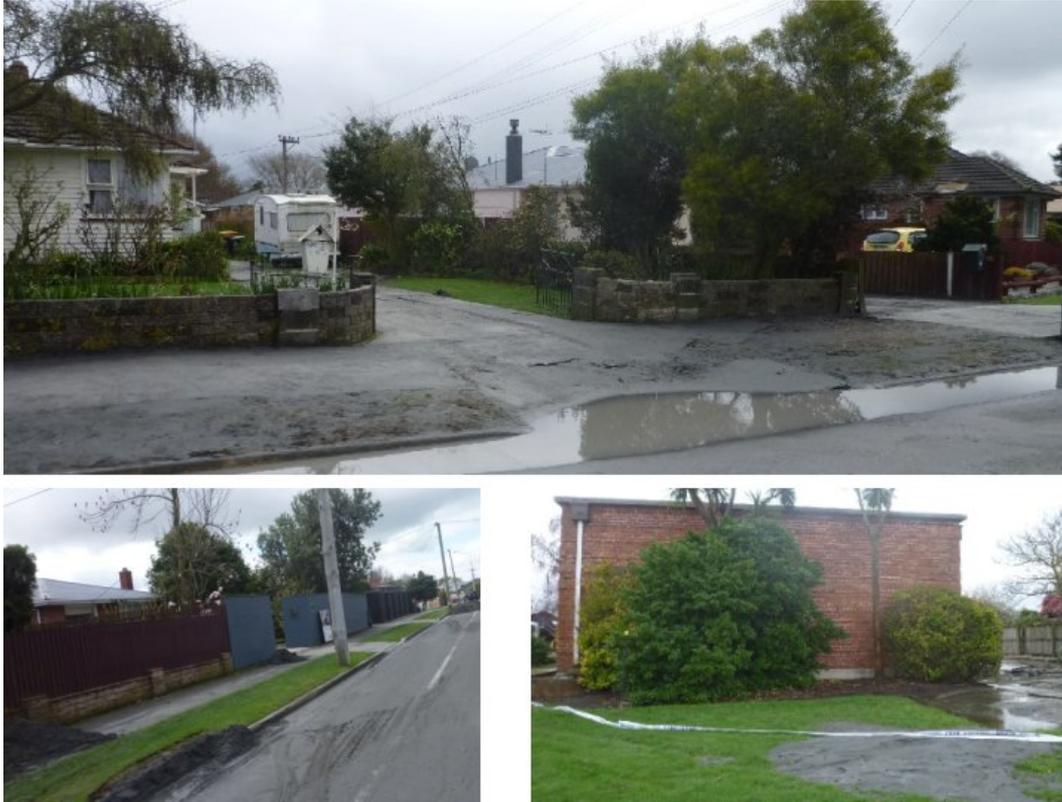
Figure 27: Ground liquefaction in New Brighton

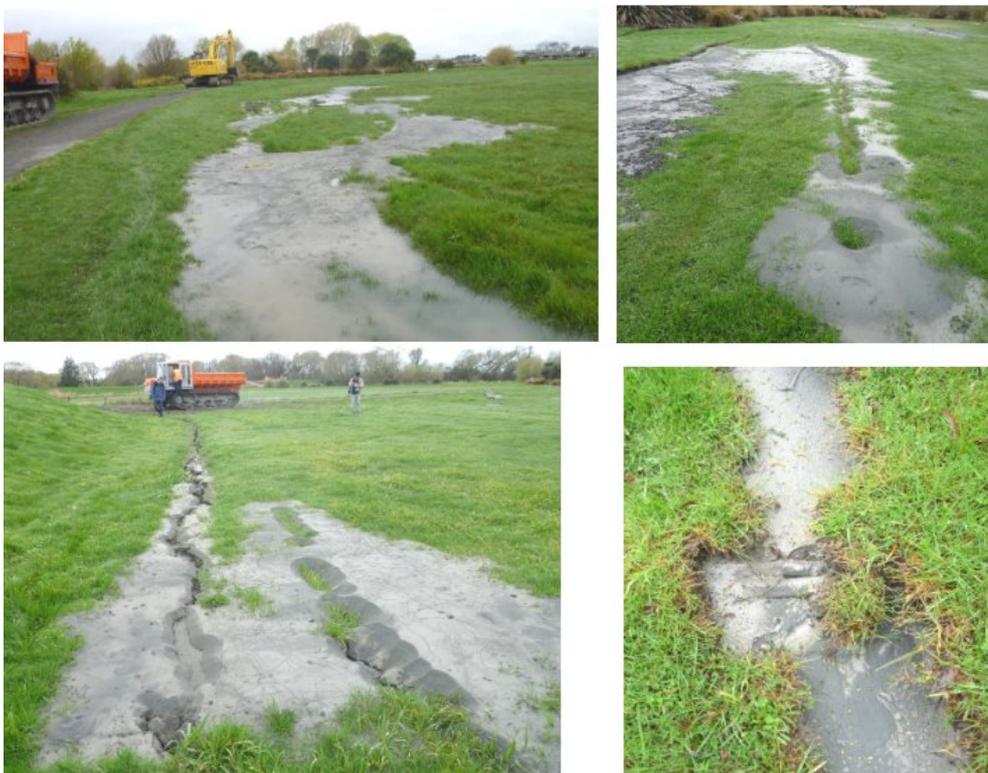
Figure 28: Ground liquefaction in Kaiapoi

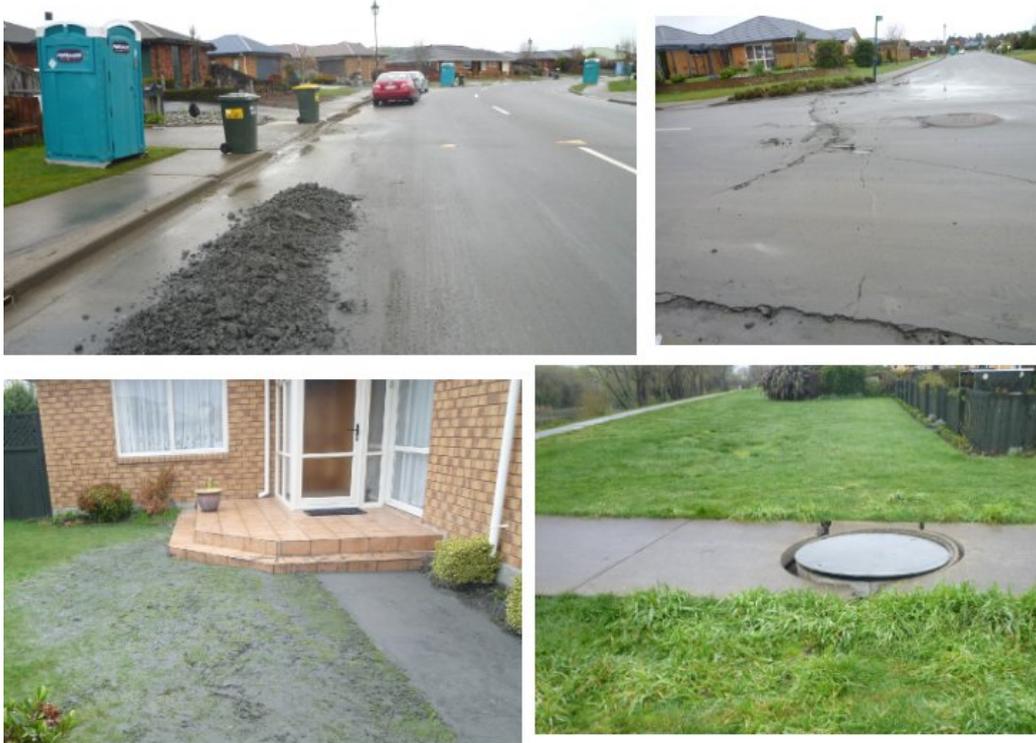
Figure 29: Effect of ground liquefaction in Hilton Street of Kaiapoi town

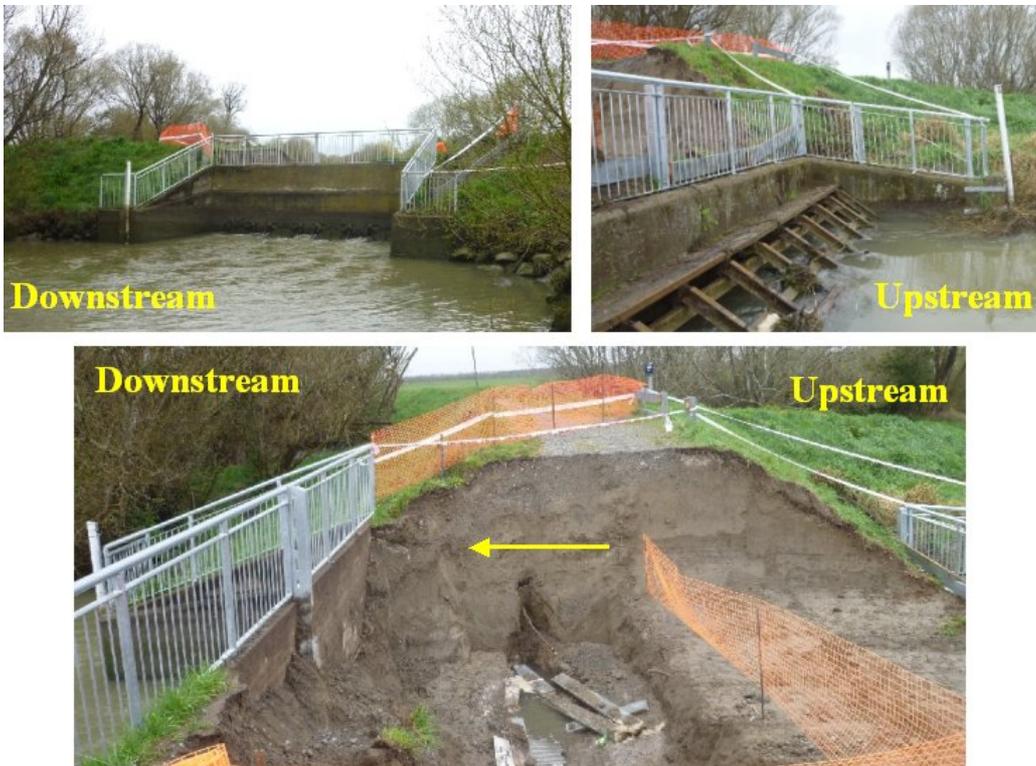
Figure 30: Liquefaction induced damage on tidal gate

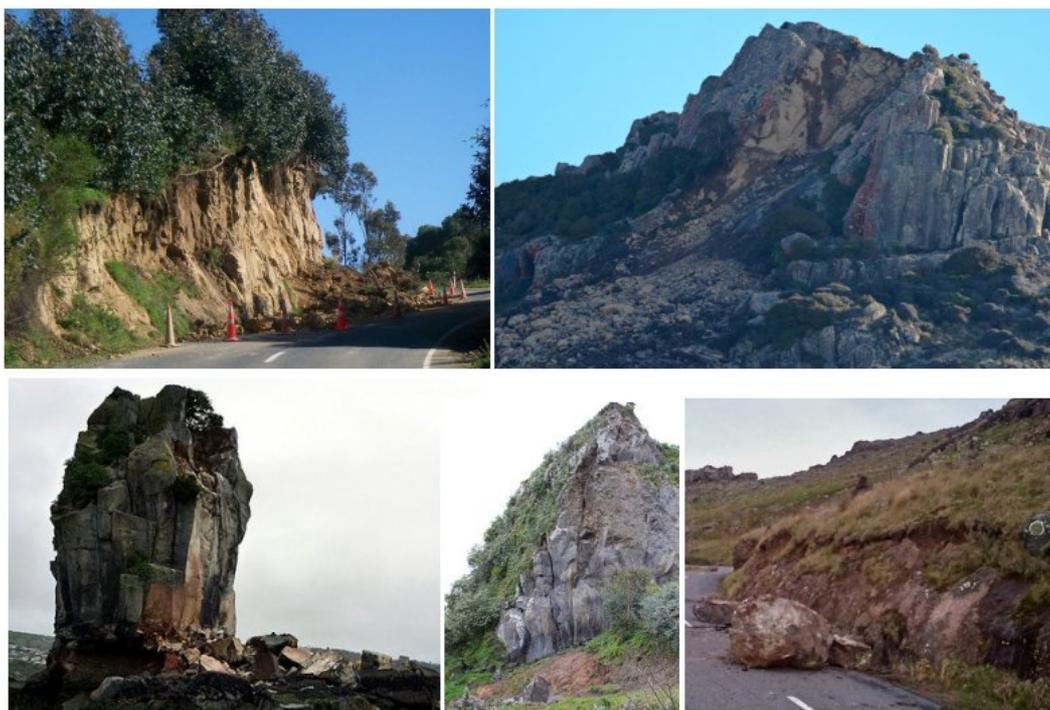
In addition to extensive ground liquefaction, retaining-wall failures, slope failures were also observed as seen in Figures 33 and 34. A slope failures was reported in the Rakaia Gorge, blocking State Highway 77. Some rockfalls reported at Castlerock, Lyttelton and Summit Road. Figure 35 compares the observations with empirical magnitude and epicentral limit distance relations for coherent and disrupted slopes. Once again, we note good correlations between observations and empirical relations.

Figure 33: Slope failures and rockfalls (compiled from various web sources)

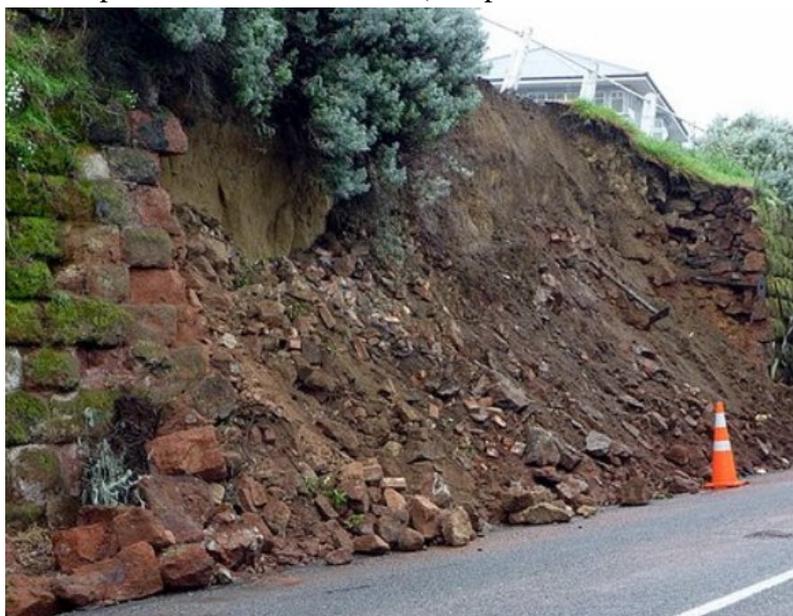
Figure 34: Masonry retaining wall failure in Lyttelton (compiled from web sources)

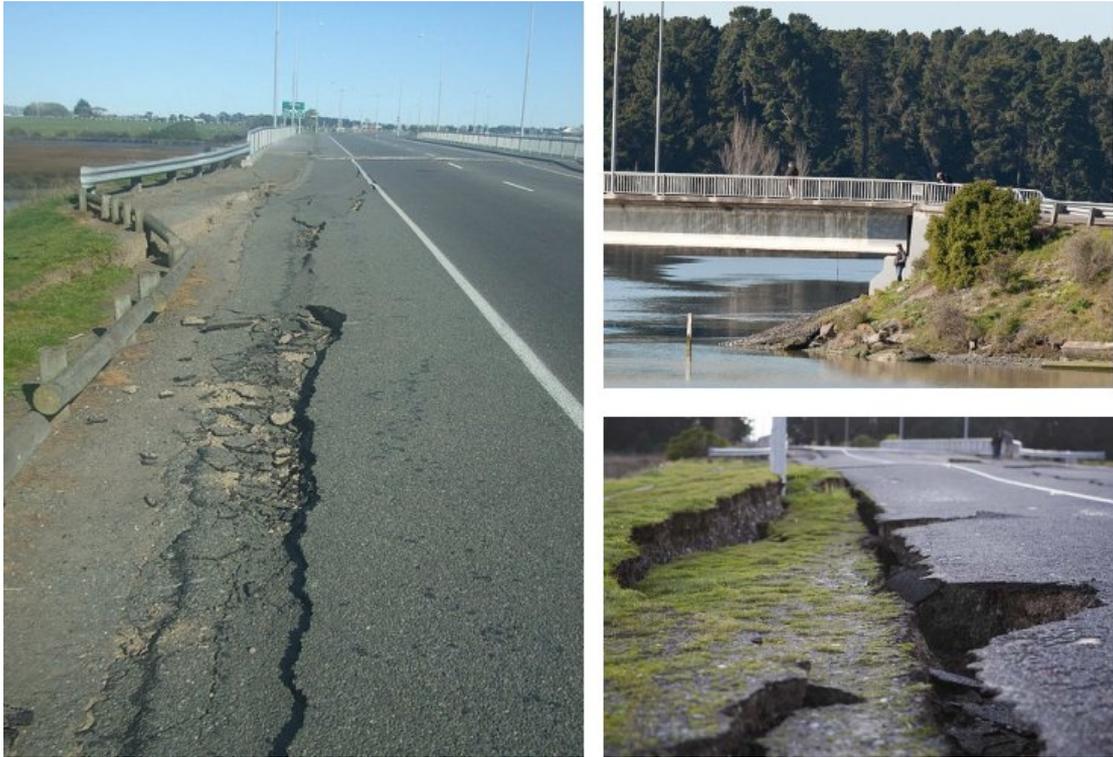
Bridges in the Canterbury area have suffered little damage and major bridges were found to be in structurally sound condition. The damage to bridges was mostly limited to the Christchurch and Kaiapoi area and it was due to distortion and sliding of the neoprene bearings, small cracks in the foundation (abutments and piles) and settlement of approach embankments due to soil movements (Figure 36). The bridge on Bridge Street connecting South Brighton to Christchurch suffered some damage due to the settlement and tilting its abutments as well as the extensive cracking and settlement of approach abutments. This bridge was closed to traffic.

(a) views of damage to the bridge (compiled from various web-sites)

Figure 36: Views of the bridge on Bridge Street in New Brighton

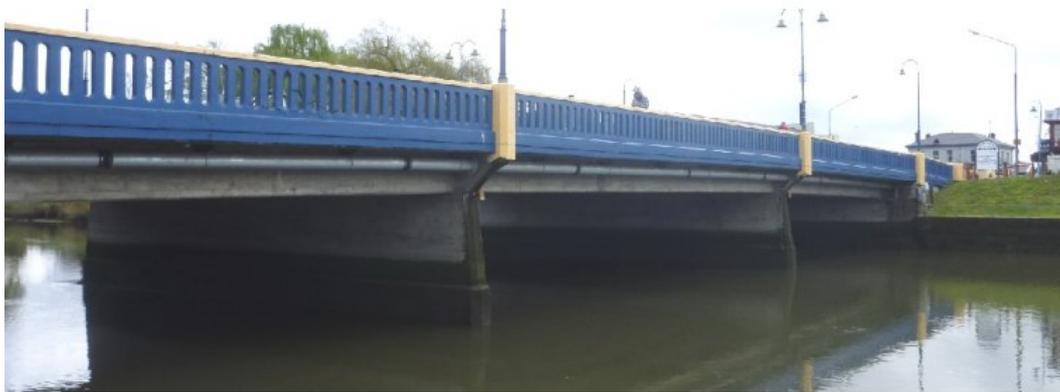
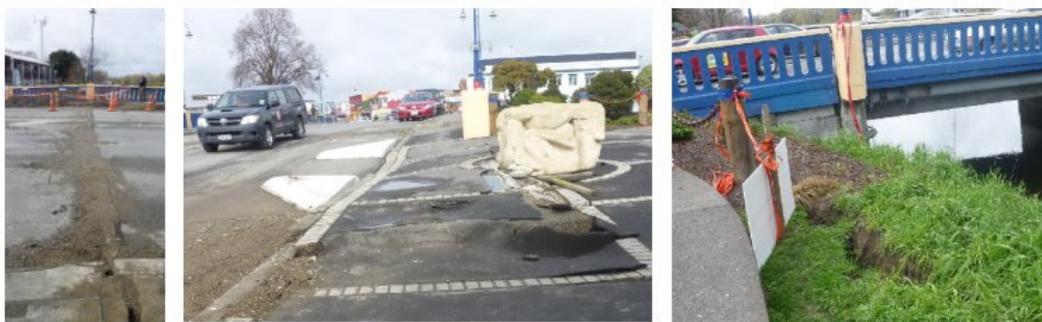
The authors had a chance to inspect two roadway bridges in heavily liquefied area in Kaiapoi (Figure 37). The bridges were all structurally sound except some settlement and movements of approach embankments at both sides and soil in the vicinity of piers.

(a) Bridge on William Street in Kaiapoi (ground liquefied at both sides)

Figure 37: Almost non-damaged bridges in Kaiapoi except settlement at abutments

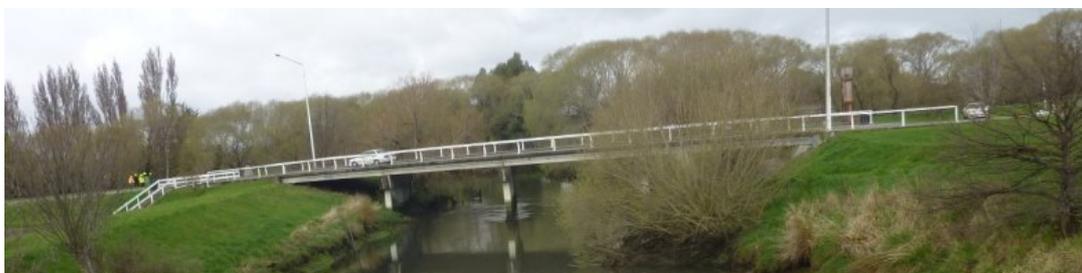
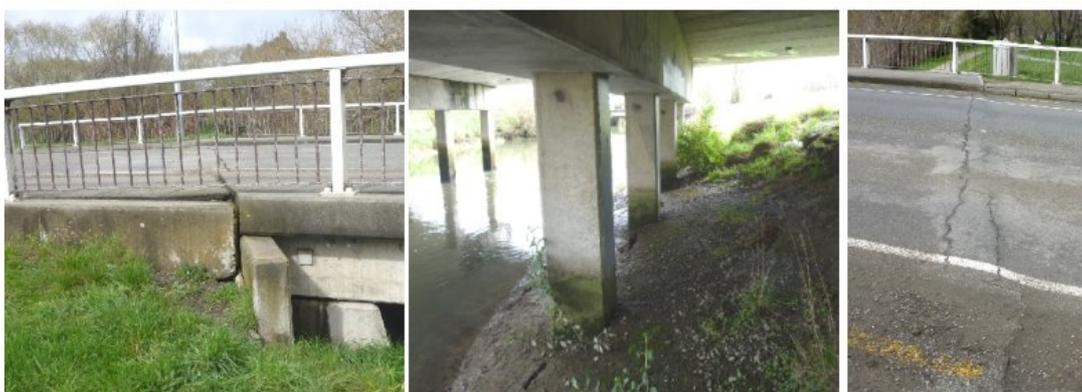
(b) Bridge on Smith Street leading to Christchurch Northern Motorway (1)

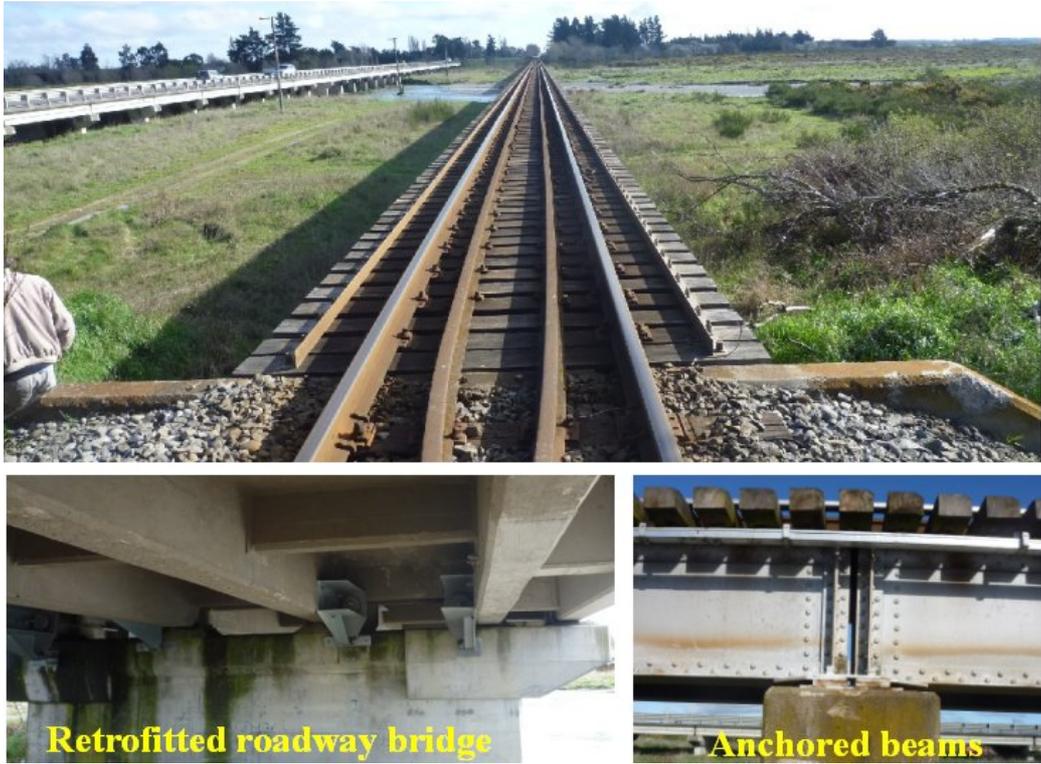
The Selwyn roadway and railway bridges (about 250 m long) near the west end of the earthquake surface rupture built as a simple beam structures performed very well during the earthquake (Figure 38). While the bearings of the girders of railway bridges were all anchored to the piers in the construction stages, the roadway bridge girders were recently retrofitted by at both ends of the girder. The inspection on the site showed no damage to these two bridges.

Figure 38: Non-damaged Selwyn road and railway bridges (6 km from the fault)

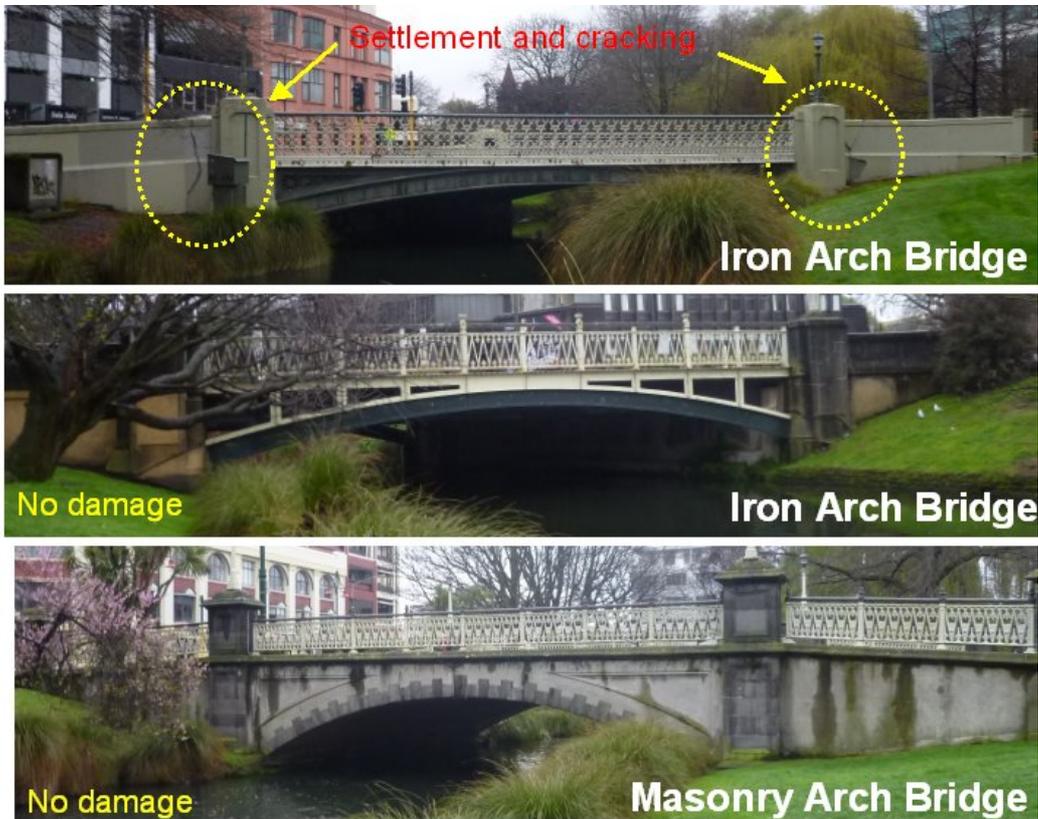
The bridges on Avon River in the downtown of Christchurch were almost non-damaged. The authors inspected two old iron arch bridges and one stone-arch bridge (Figure 39). There were some settlement and cracking at one of the iron arch bridge while two other bridges suffered no damage.

Figure 39: Views of damaged and non-damaged bridges in the downtown

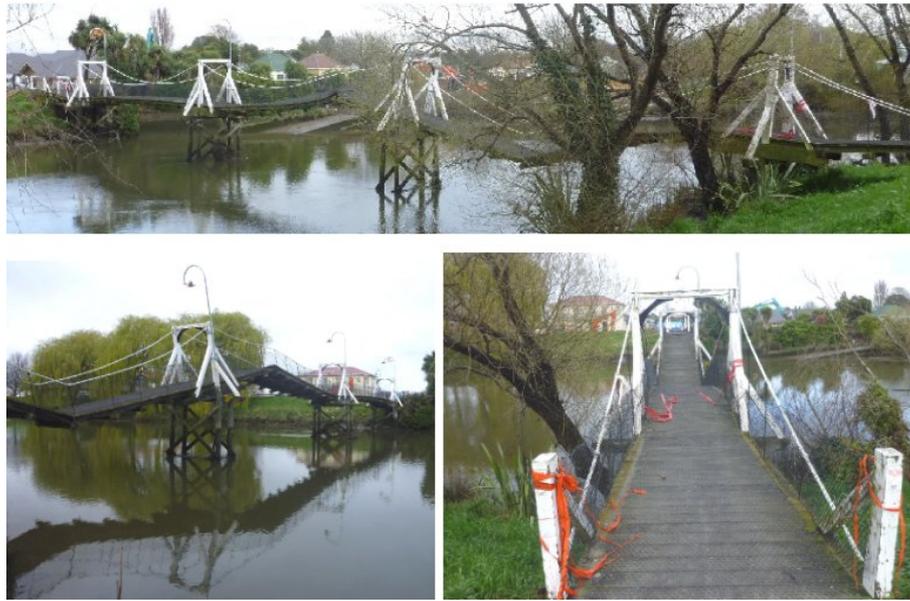
Five pedestrian bridges in Kaiapoi and Dallington were either collapsed or suffered heavy damage due to ground liquefaction and associated lateral spreading (Figure 40). The piers of these pedestrian bridges were generally made of timber and they were embedded into shallow liquefiable soil. The both abutments of these pedestrian bridges moved toward the center of the rivers or creeks causing very high axial forces leading to the buckling of these bridges. It was also interesting to note that one of pedestrian bridges having steel piers probably extending to the firm ground below did not suffer any damage in spite of ground liquefaction near its abutments.

Figure 40: Views of buckled pedestrian bridge in Kaiapoi

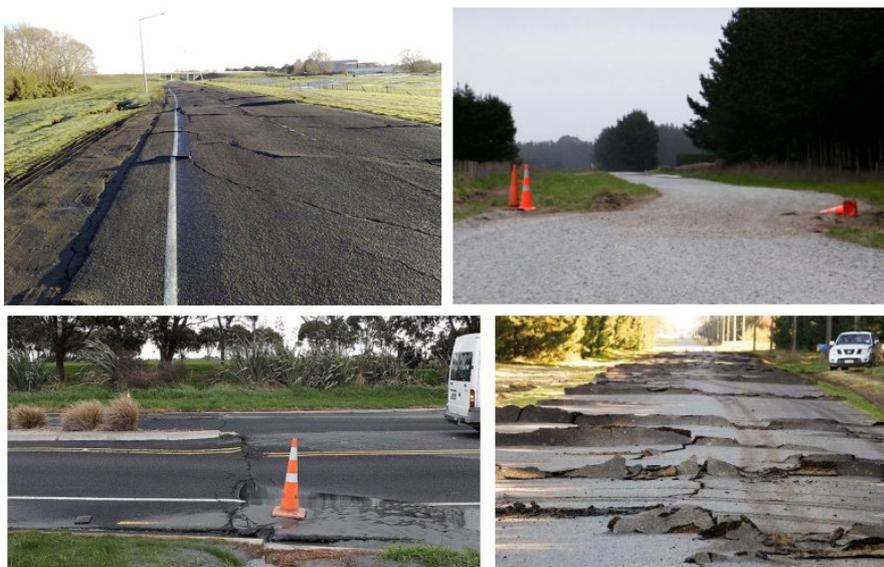
The settlement and lateral spreading of ground in liquefied areas or faulting, where surface ground ruptures were observed, mainly caused roadway damage (Figure 41). As they are built directly onto the ground surface, their temporary repair was quite quick. In areas where manholes were uplifted, the roadways were temporarily re-asphalted in order to eliminate the elevation difference between manholes and roadway surface. Open cracks were re-filled and buckled pavements were cleared away.

Figure 41: Views of damage to the roadways (compiled from various web-sites)

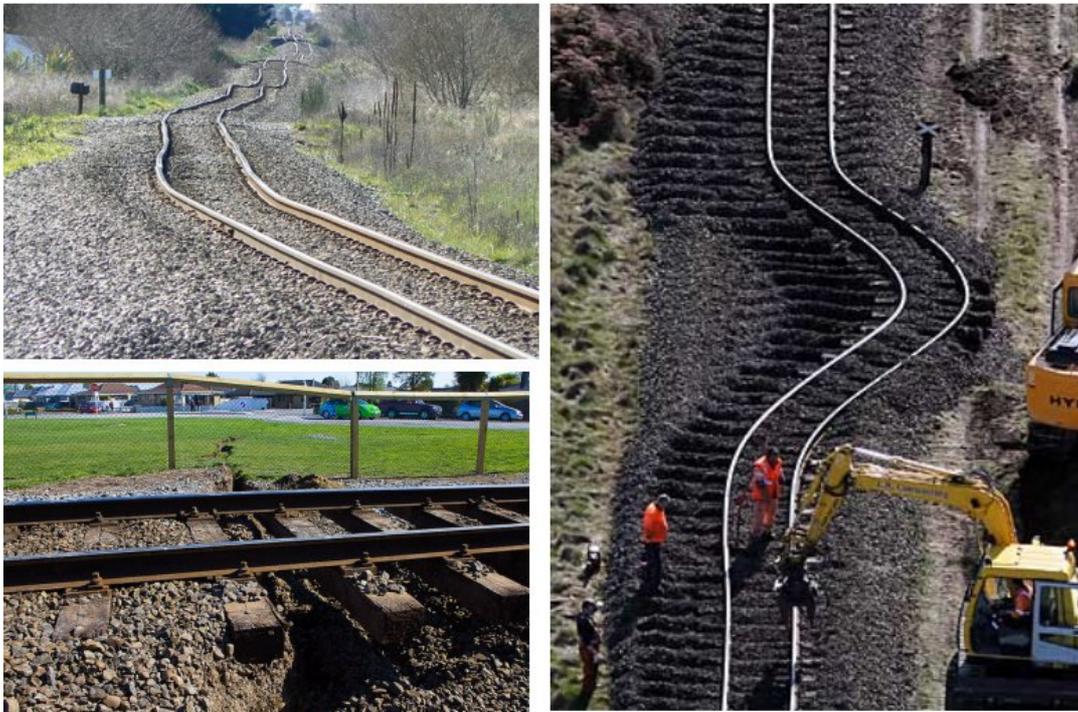
The settlement and lateral spreading of ground in liquefied areas or faulting, where surface ground ruptures, were observed mainly caused railway damage (Figure 42). A 5 km section of rail track was damaged near Kaiapoi and there was lesser track damage at Rolleston and near Belfast. As a precaution, state rail operator KiwiRail shut down the entire South Island rail network after the earthquake, halting some 15 trains. KiwiRail Network established that the main damage to rail infrastructure was to 4 km of track and bridge abutments in the Kaiapoi area, and between Rolleston and Darfield. The damage near Kaiapoi was due to embankment failure caused by the lateral spreading of ground. The earthquake faulting damaged train tracks near Railway Road by Rolleston. Two locomotives running light (i.e. without any carriages or wagons) came to a stop just 30 metres short of a major buckle in the line. The railway station at Kaiapoi was tilted and laterally moved due to ground liquefaction.

Figure 42: Views of damage to the railways (compiled from various web-sites)

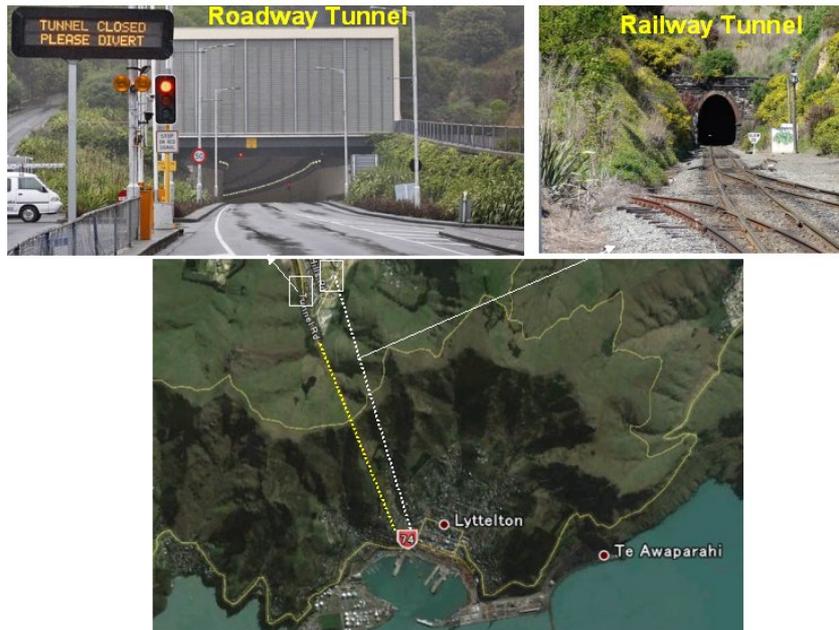
The Lyttelton rail and road tunnel links Christchurch and its seaport, Lyttelton (Figure 44). The single track railway tunnel was bored through the Port Hills to Lyttelton, opening in 1867. The double lane road tunnel was opened on 27 February 1964 and it is currently the longest road tunnel (1945 m) in New Zealand. The tunnel is part of State Highway 74. The Lyttelton railway tunnel was inspected by the KiwiRail engineers and it was found that there was no damage to the tunnel. The Lyttelton road tunnel was

inspected by the New Zealand Transport Agency, and some cracks in the lining and sulphur smells were found. However, the tunnel was structurally sound in spite of earthquake induced cracks. Recently Aydan et al. (2010) proposed some empirical relations to estimate the degree of damage level in tunnels. This empirical relations applied to assess the damage level in the Lyttelton tunnels. The observations were found to be consistent with empirical estimations as seen in Figure 45.

Figure 44: Views of the tunnels (arranged from various web-sources)

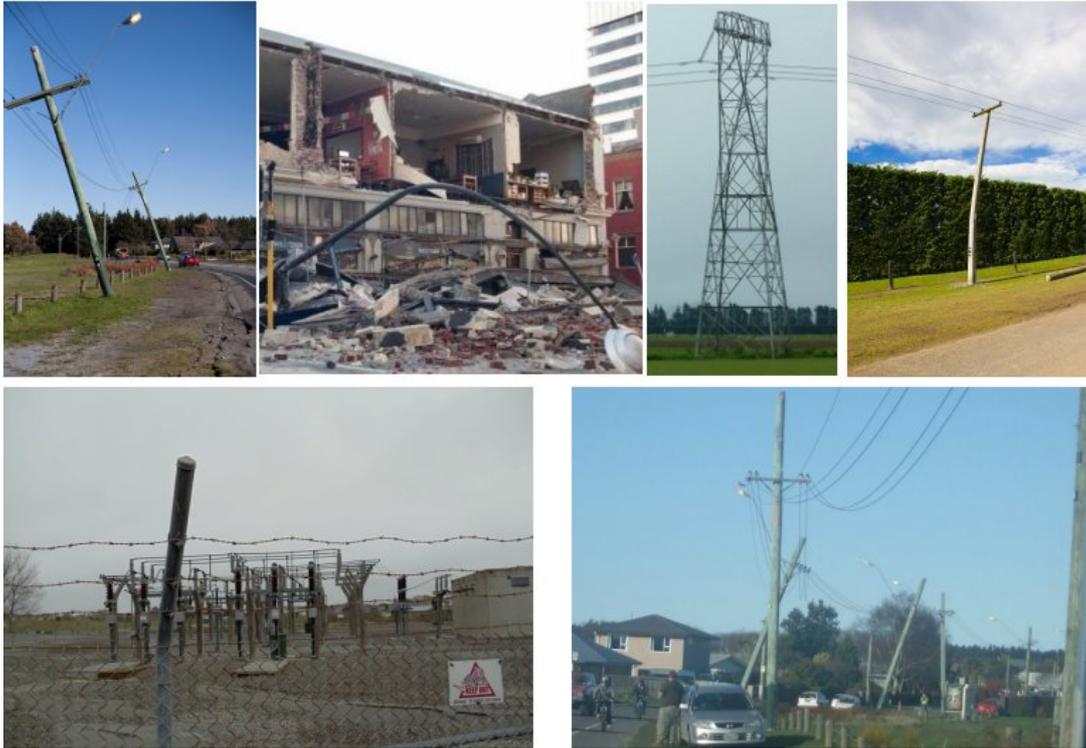
Electricity supply is off in much of the area surrounding Christchurch in Sept. 4. The national distribution system was intact but damage to distribution transformers, some of

which have been dislocated, delayed restoration. The power restored to 90% of the greater Christchurch area by 6:00pm the day of the earthquake. However, damaged areas of the CBD and Kaiapoi remained shutdown. In many towns outside Christchurch, the electrical grid was disrupted and the power was fully restored after two days.

Figure 47: Views of damage to electricity facilities (partly from some web-sources)

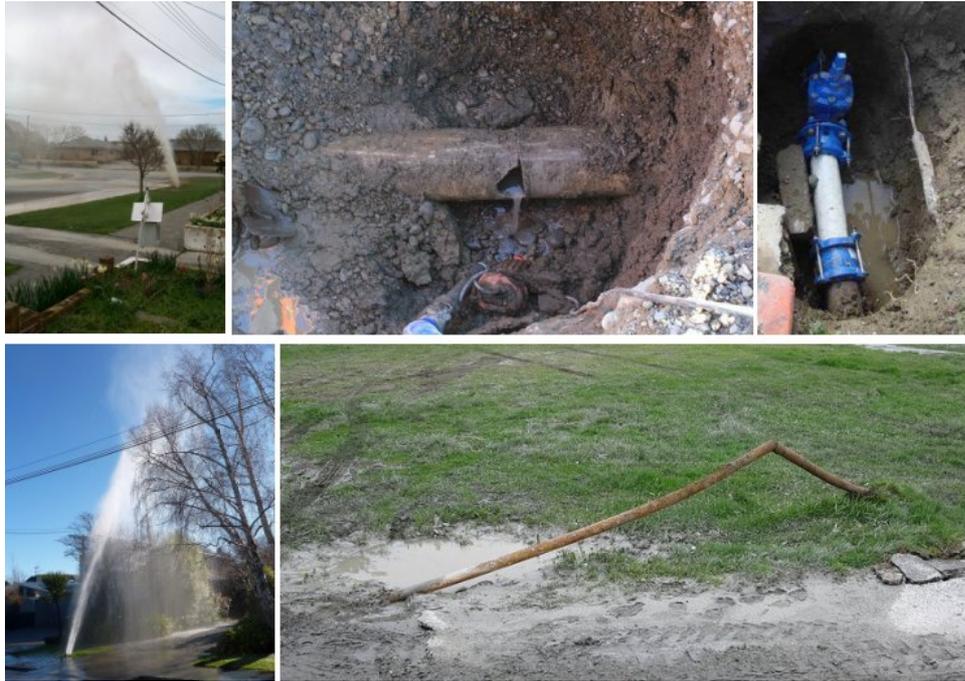
In Rolleston the local council warned residents that their water supply has been contaminated. The contamination is due to cracks and leaks in the waste water pipes. A “boil water” notice is in place in parts of all affected areas. Water tankers are delivering water in the Waimakariri District and Christchurch City. Ruptured water mains and broken pipes caused surface flooding in several streets. Tanks of fresh water placed around the city

Figure 48: Views of damage to water pipe (partly from some web-sources)

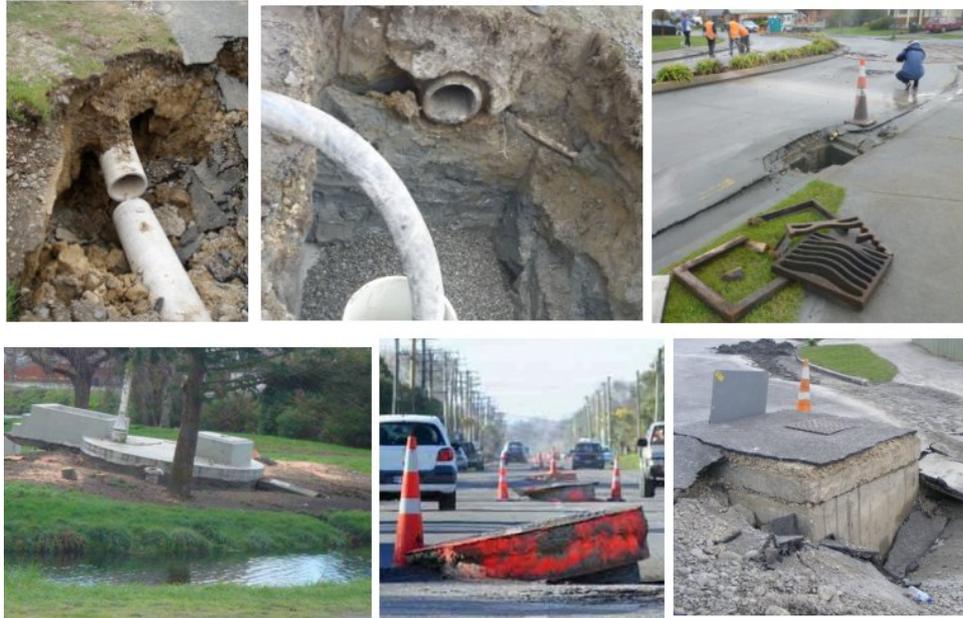
Sewerage and water supply infrastructure particularly affected in the low-lying eastern areas of Christchurch City and Waimakariri District as well as rural areas in Selwyn District. Sewerage pipes as well as water pipes have been leaking. All schools in the Christchurch, Waimakariri and Selwyn districts are closed until at least Wednesday. For Christchurch City, wastewater trunk mains were intact but there was significant localized damage, and the wastewater treatment plant was still running on bypass. Sewerage infrastructure had taken disrupted due to the damage at one pumping station and two wastewater treatment-pumping stations "beyond repair, some sewerage pipes had burst, raising fears of contaminated water. Portable toilets had been provided.

Figure 49: Views of damage to sewage system (partly from some web-sources)

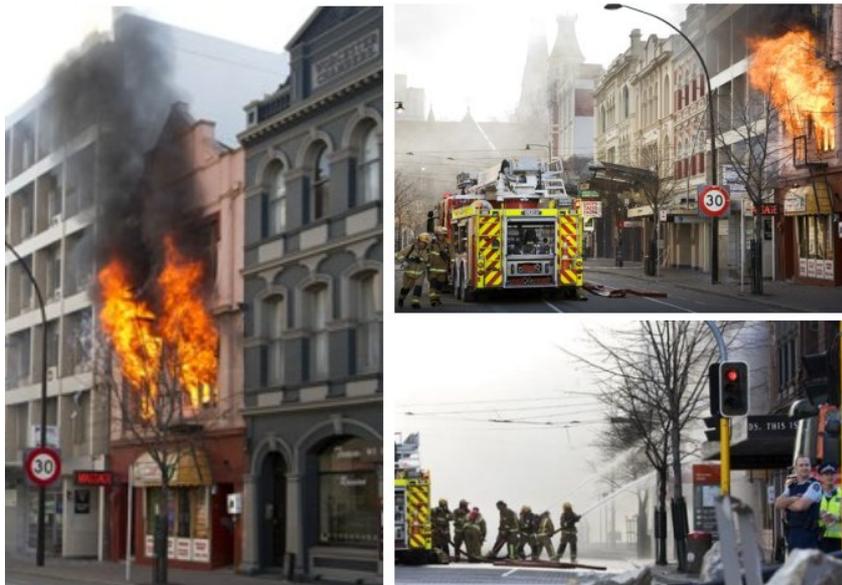
One building on Worcester Street in downtown area caught fire after its electricity was turned back on, igniting leaking LPG in the building. The fire was quickly extinguished by the Fire Service before it could spread.

Figure 50: The fire of a building at Worcester Street (from various web sources)
