**A RECONNAISSANCE REPORT**

**THE DARFIELD (NEW ZEALAND) EARTHQUAKE OF SEPTEMBER 4, 2010**

**On the behalf of JSCE**

**Earthquake Disaster Investigation Committee**

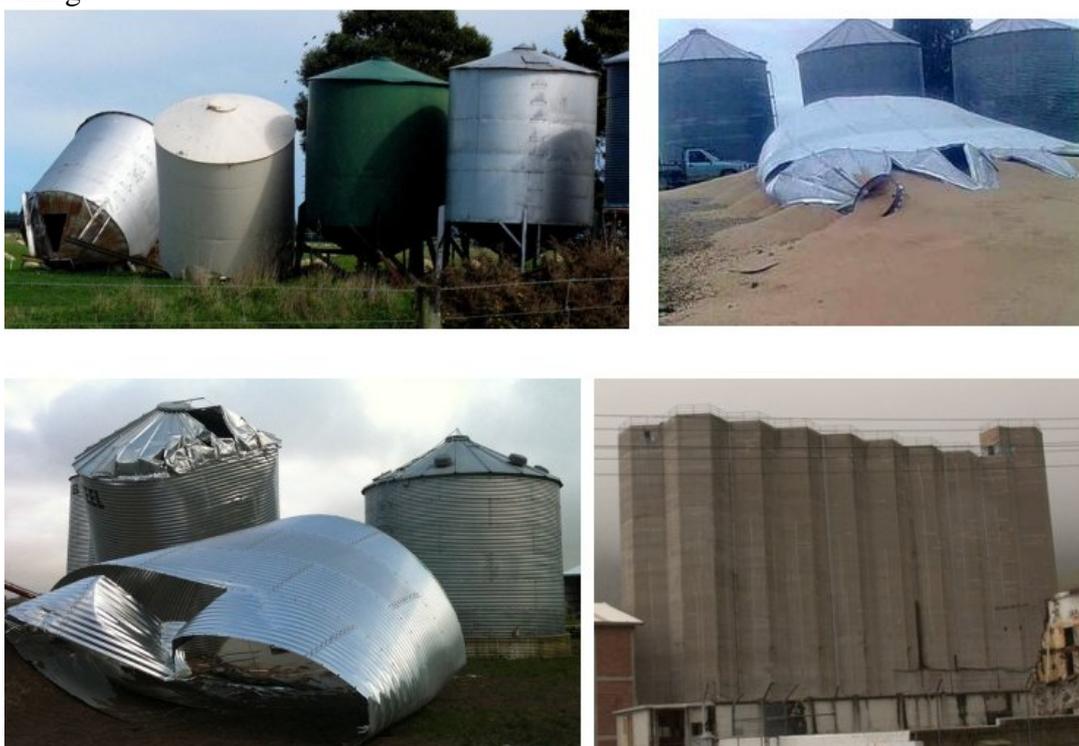
Food producer Goodman Fielder says only its Christchurch flour mill received limited damage in the quake. Almost 70 silos have failed due to the earthquake. It was also reported that some damage occurred to some liquid storage tanks due to the ground shaking.

Figure 51: Views of damaged and non-damaged silos
