Berlin

3.5 CONCLUSIONS AND RECOMMENDATIONS

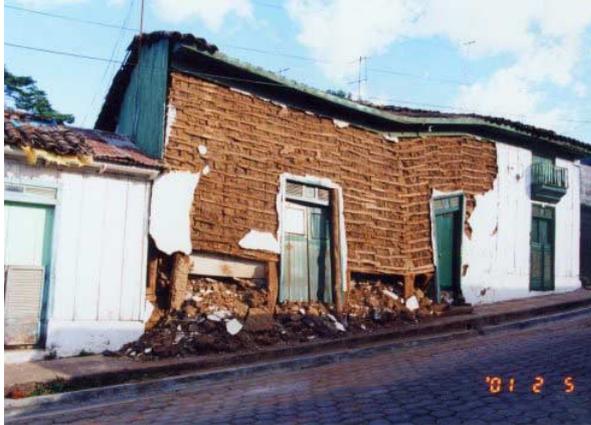
Berlin is located in Usulután. The National Emergency Committee (COEN) reported 3,155 destroyed dwellings and 3,216 damaged dwellings there. The damage observed was similar to the damage observed in San Agustín (**Figures 3.28 to 3.31**).

Figure 3.28. Damaged bahareque house with very poor foundation.

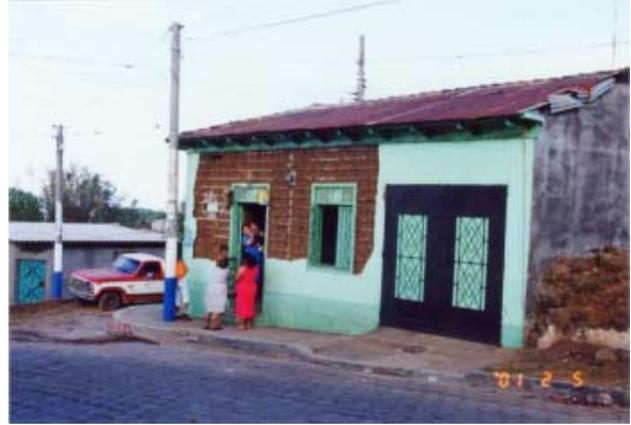
Figure 3.29. Bahareque house that suffered mud cover spalling.

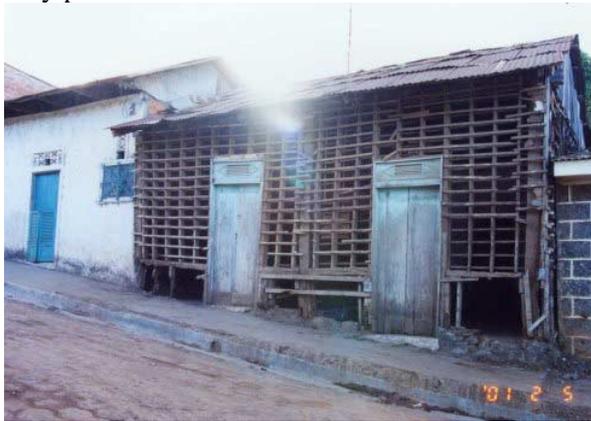
Figure 3.30. Bahareque house that lost all its mud walls.

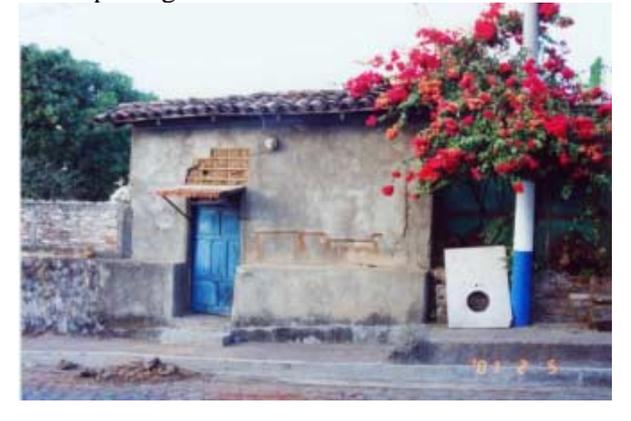
Figure 3.31. Bahareque house exhibiting mud cover spalling and vertical cracking at the connection between two perpendicular walls.

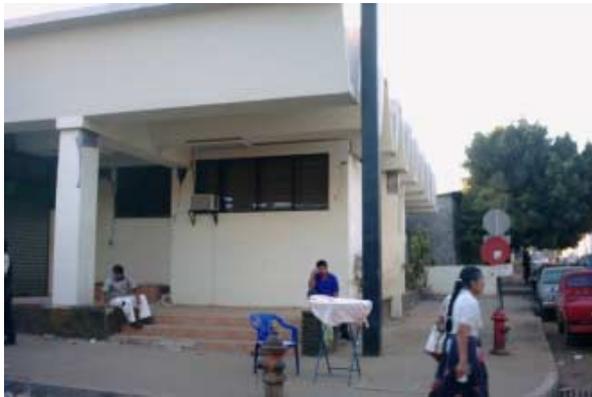
Figure 3.34. RC TELECOM building (Courtesy Mr. LaFolie).

The National Emergency Committee (COEN) reported 1,116 and 950 destroyed and damaged dwellings, respectively. **Figures 3.34 to 3.36** show the damage to the RC TELECOM building.

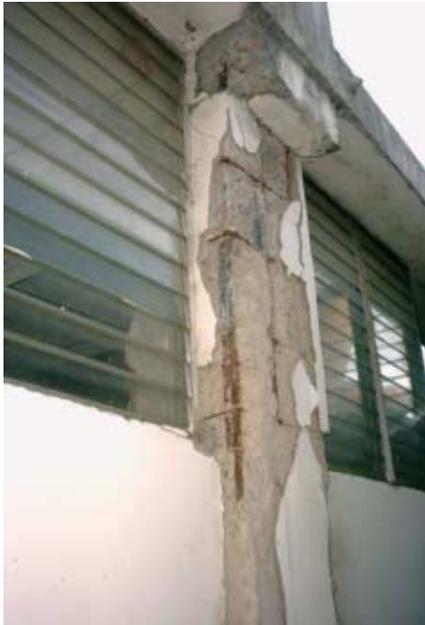
Figure 3.35. Typical damage in the TELECOM building. Thin concrete cover spalled (Courtesy Mr. LaFolie).

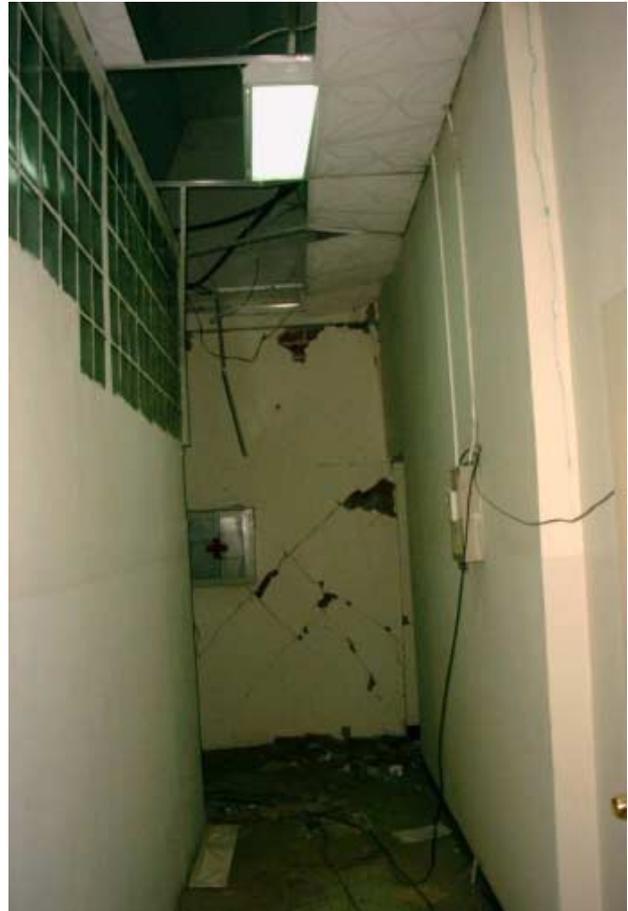
Figure 3.36. Typical damage in the TELECOM building (Courtesy Mr. LaFolie).

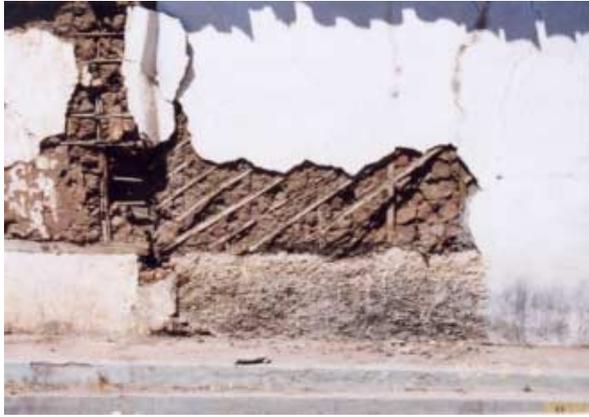
Figure 3.37. Spalling of the mud cover in a bahareque dwelling. The wall presents horizontal, vertical, and diagonal canes.

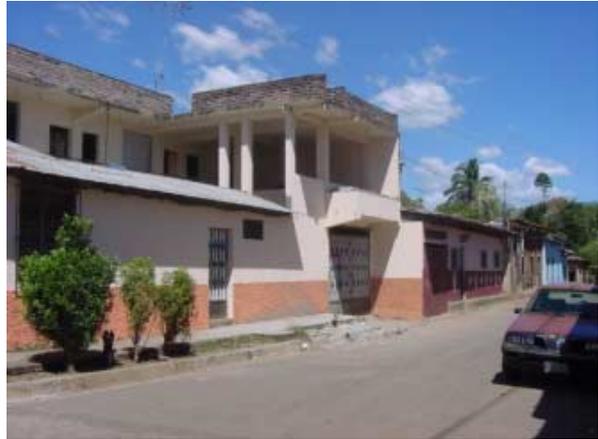
Figure 3.38. Reinforced masonry structure performed well.

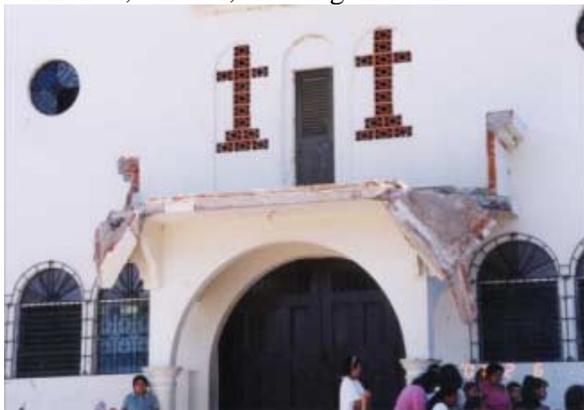
Figure 3.39. Failure of a unreinforced masonry parapet. The slab also shows insufficient reinforcement.

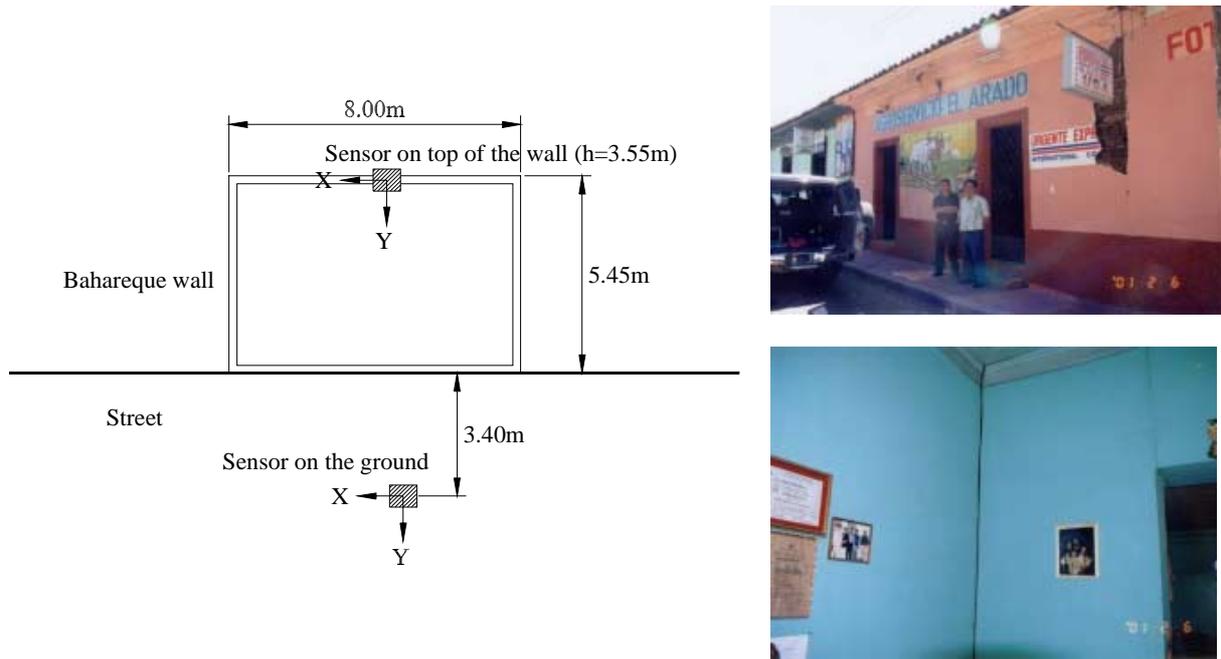
Figure 3.40. Surveyed bahareque house

Microtremor measurements were carried out simultaneously on top of a bahareque house wall and at the ground level. The location of the house ($89^{\circ}33.52\text{W}$, $13^{\circ}41.41\text{N}$) and some views of it are shown in **Figure 3.40**. The house consisted of four walls (thickness=24cm; height=3.55m) and the roof composed of a wooden truss and ceramic tiles. The distance between the horizontal and vertical spreaders of the wall was 17 and 35cm, respectively. **Figure 3.40** also shows the location and orientation of the sensors used to measure microtremors (X: longitudinal direction; Y: transverse direction). In general, the house performed well during the earthquake. Only mud cover spalling and cover cracking was observed.

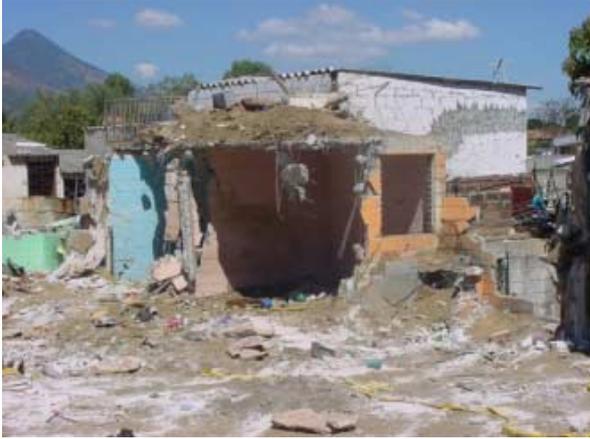
Figures 3.43 and **3.44** show the dwellings located by the side of the landslide. All the houses on the landslide way were totally leveled. The walls of some of the houses on the sides of the landslide were also affected. Other houses just a few meters away from the landslide did not suffer any damage (**Figure 3.45**).

Figure 3.43. Concrete block dwelling affected by the landslide at Las Colinas. There is still soil on top of the roof.

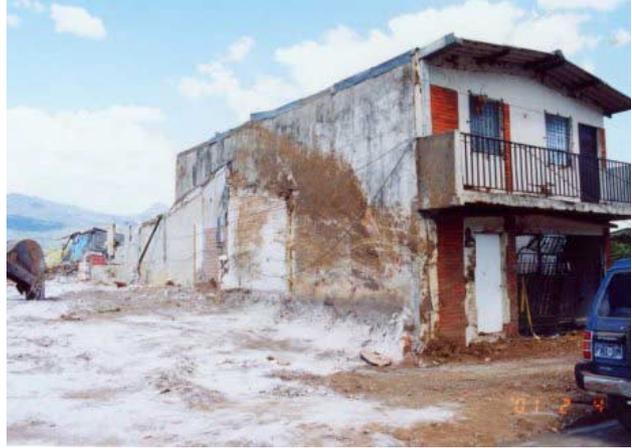
Figure 3.44. Dwelling on the border of the landslide. Neither the earthquake ground shake nor the landslide affected this dwelling.

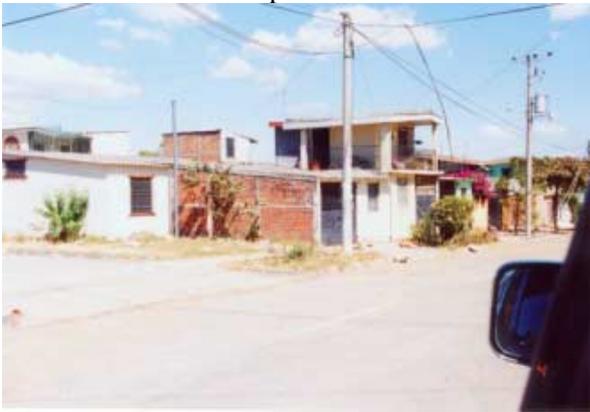
Figure 3.45. Reinforced masonry dwellings few meters away from the landslide did not suffer any damage.

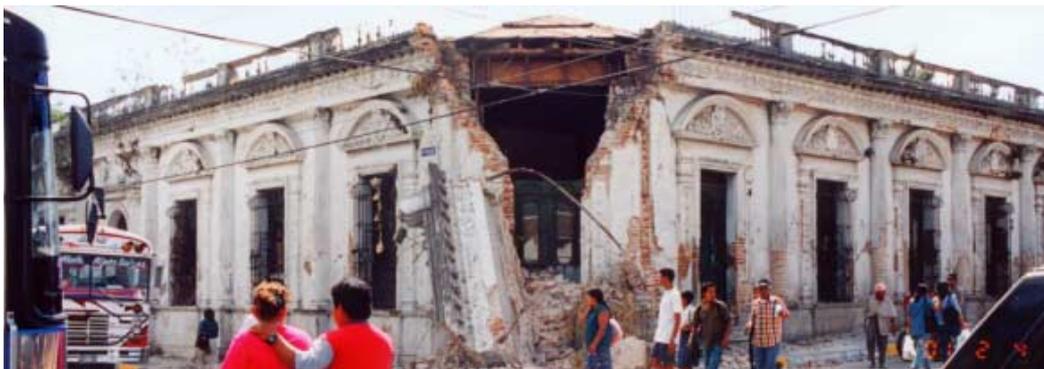
Figure 3.46. Unreinforced masonry structure suffered structural damage at the historical center of Nueva San Salvador.

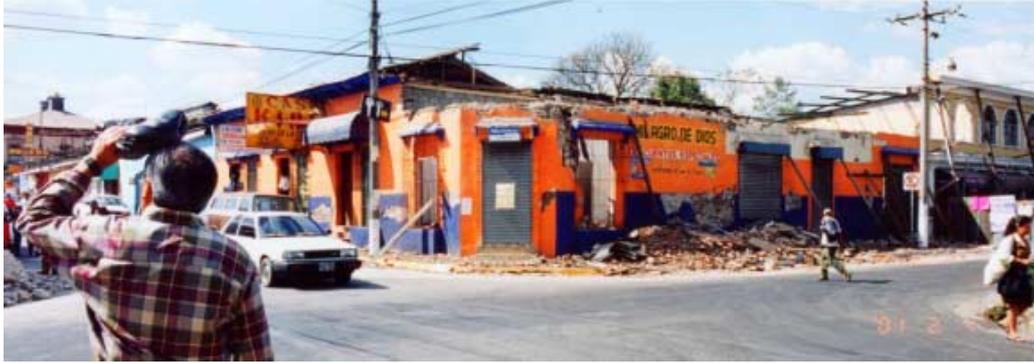
Figure 3.47. Adobe construction suffered damage at Nueva San Salvador.

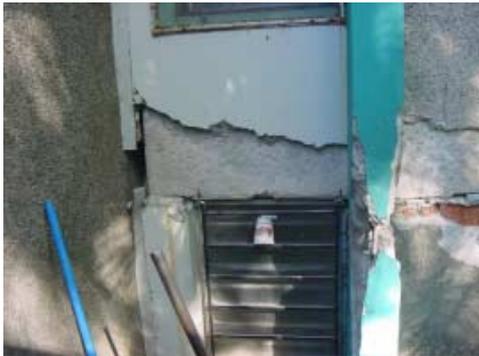
Figure 3.48. Finishing spalling. The seismic joint between two adjacent buildings was 5cm. No evidence of pounding was observed.

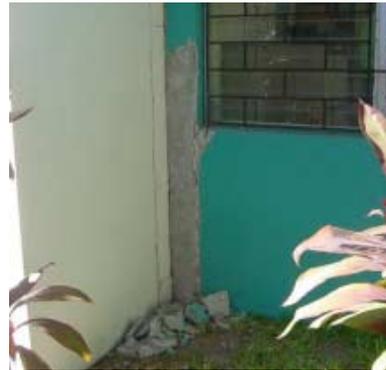
Figure 3.49. A thin layer of styrofoam was placed between the window splay and the column of the main structure.
