4.3 WATER SUPPLY SYSTEM

4.4 TRANSPORTATION

4.6 CRITICAL FACILITIES

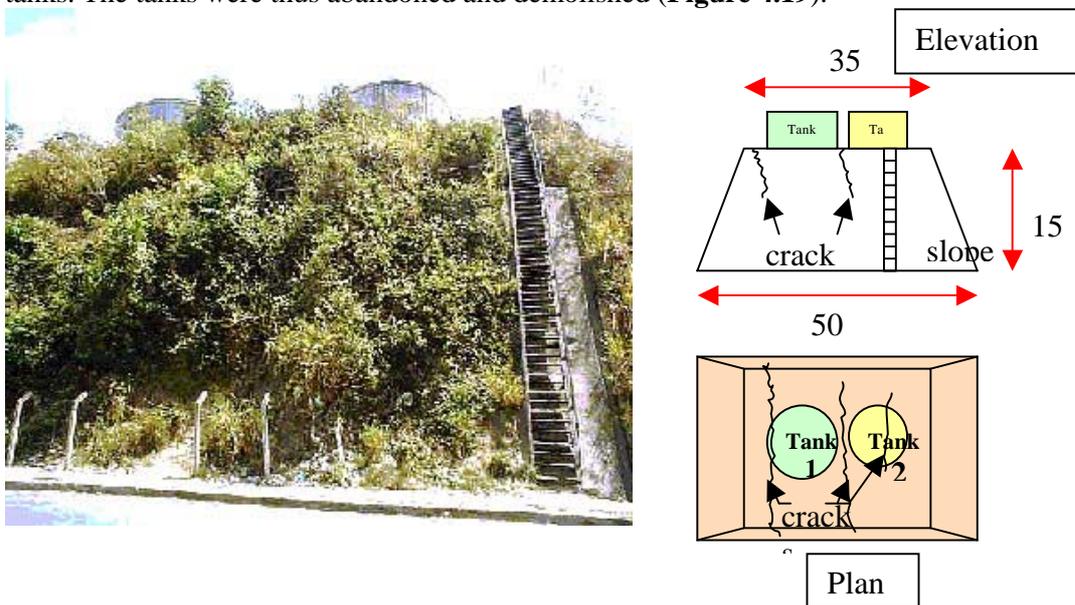
Water tanks are often constructed on hilltops and thin mountain ridges so that they can supply waters to widely spread areas. A typical wall of a water tank in El Salvador is a cylindrical shell of reinforced masonry or reinforced concrete. Two tanks of “Las Colinas del Norte” are located on a thin hilltop of Apopa Town (Figure 4.18). There appeared extensive 1m-deep cracks on the top terrace as illustrated in Figure 4.18. Paved walkways around the tanks were fissured. The cracks were certainly a serious threat for about 200 houses around the hill of a possible landslide that can carry off foot soils of the tanks. The tanks were thus abandoned and demolished (Figure 4.19).

Figure 4.18. Tanks on a thin hilltop, “Las Colinas del Norte”, Apopa

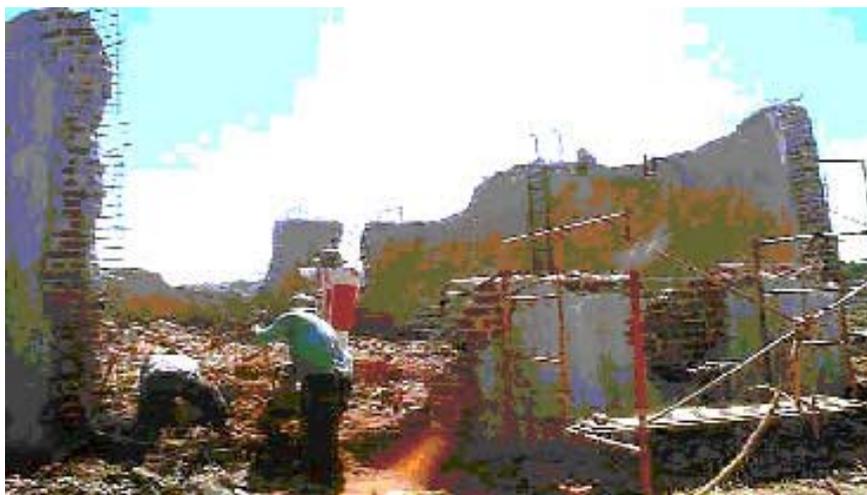
Figure 4.19. Reinforced Masonry wal of “Las Colinas del Norte” tank

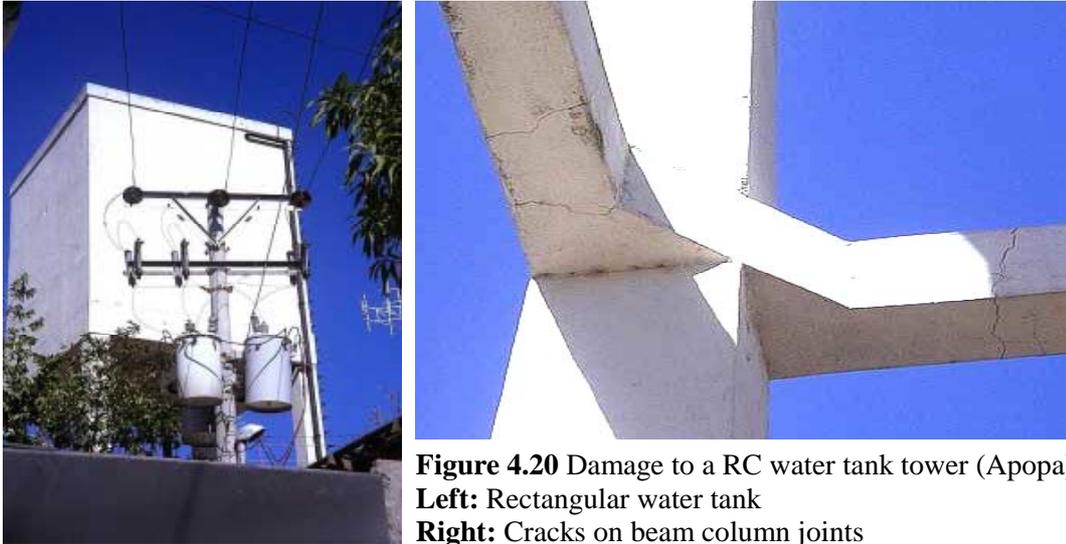
RC towers for some elevated water tanks were cracked. Beam-column joints of these towers carrying heavy tanks are the most susceptible to intense shakes (See **Figures 4.20 left and right**). Intense ground motions, however, were not the sole cause of the damage to the towers. At San Luis Talpa, Comalapa, RC columns were arranged in octagon and joined together slightly above their bottom ends with an octagonal RC frame. Cracks were mostly found on the mid-span of each side of the horizontal RC frame. The cause of this cracking may be attributed to unequal settlement of the column foundations (**Figure 4.21**), which settlement could induce some unexpected torque within the beams.

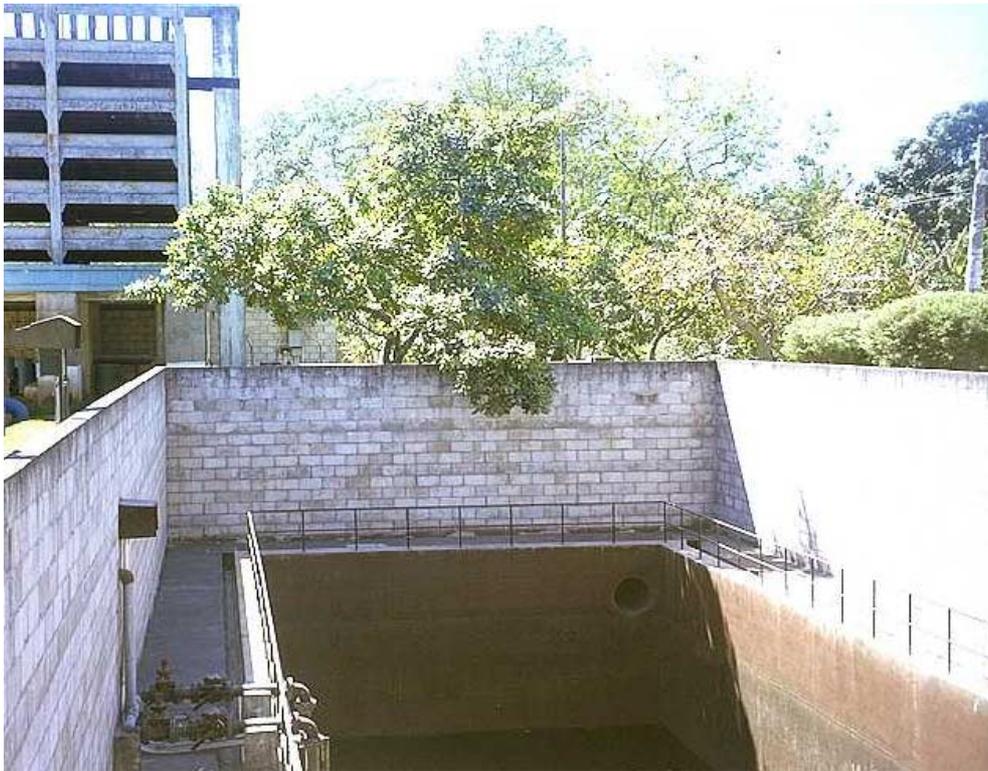
A 50m long sedimentation basin at Guluchapa Treatment Plant, Ilopango, takes 300 m³ water from Cuaya River and neighboring wells (**Figure 4.22**). The continuous concrete bottom slab of this basin was cracked, and the possibility of introducing watertight joints was discussed in its restoring work. Cracks were also found on construction joints on the walls surrounding a filtering facility (**Figure 4.23**).

Figure 4.22. A 300 m³ sedimentation basin at Guluchapa Treatment Plant, Ilopango. The bottom slab was cracked

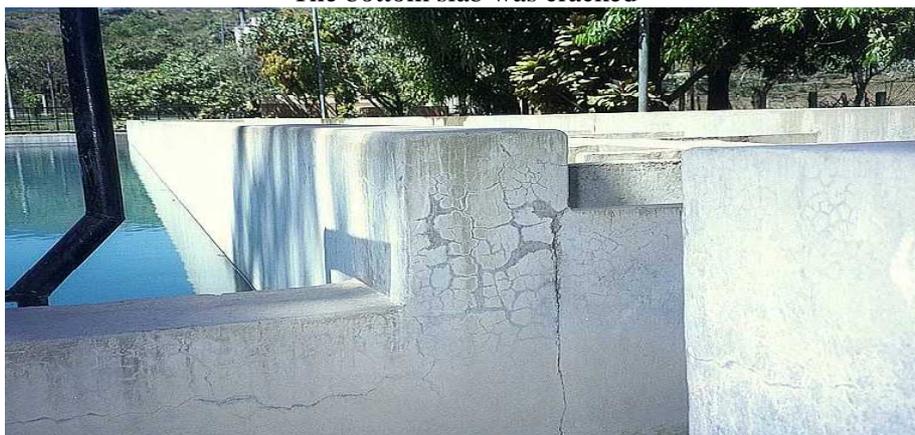
Figure 4.23. Cracks on construction joints on RC walls surrounding filtering facility

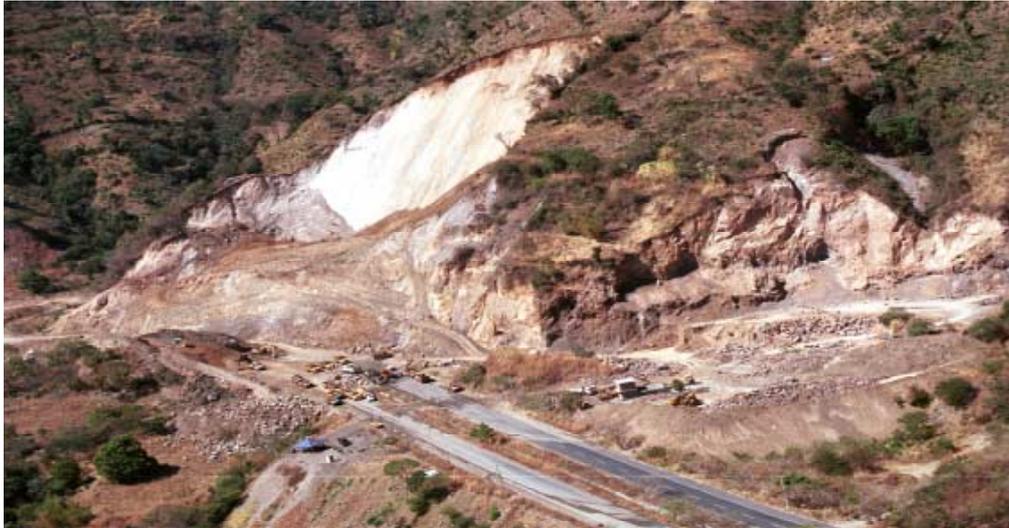
The most significant traffic disruption was due to the blocking of the Pan-American mountain highway by a large landslide (see Section 3.5) at the curve “Leona” to the East of San Vicente. The coastal highway “El Litoral” became an alternative traffic route for several weeks while the Pan-American highway was being cleared from the 100,000 m³ slide (Figure 4.25). Two of the four lanes of the highway were re-opened for restricted traffic following the earthquake.

Figure 4.25. Landslide at “Leona” blocking the Pan-American Highway.

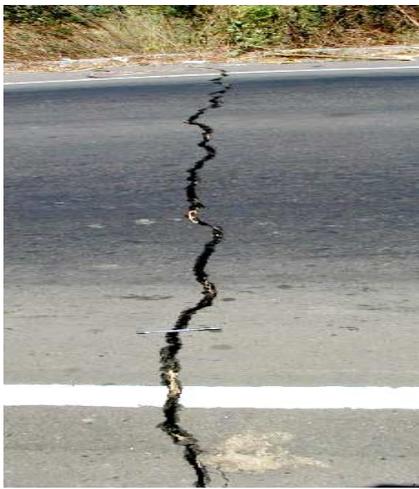
Other damage to the main routes includes cracks crossing the “El Litoral” and the route to the International Airport (see Figures 4.26 and 4.27).

Figure 4.26. Horizontal Crack at Km 78 of El Litoral highway.

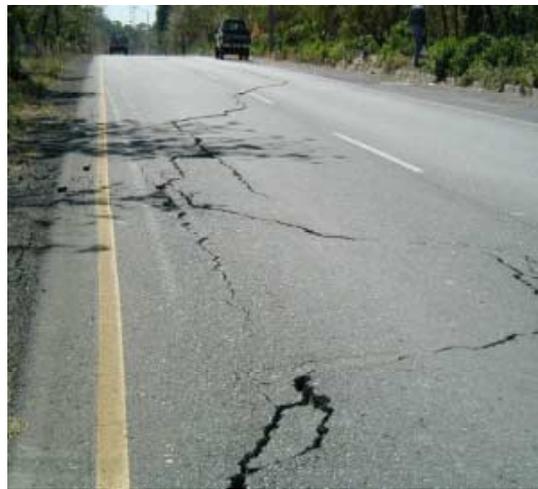
Figure 4.27. Cracks at Km 19 ½ of Comalapa Road.

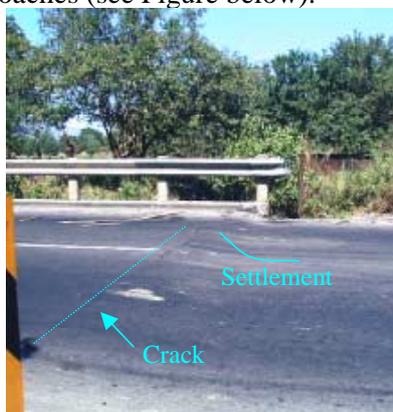
In general, bridges sustained no or very little damage. The most affected bridges were found in the central western part of El Salvador (Sonsonate, Comasagua Zacatecoluca, Comalapa, and Usulután departments) where minor damage such as settlements and cracks were commonly observed at the bridge approaches (see Figure below).

Figure 4.28. Settlement of a bridge approach

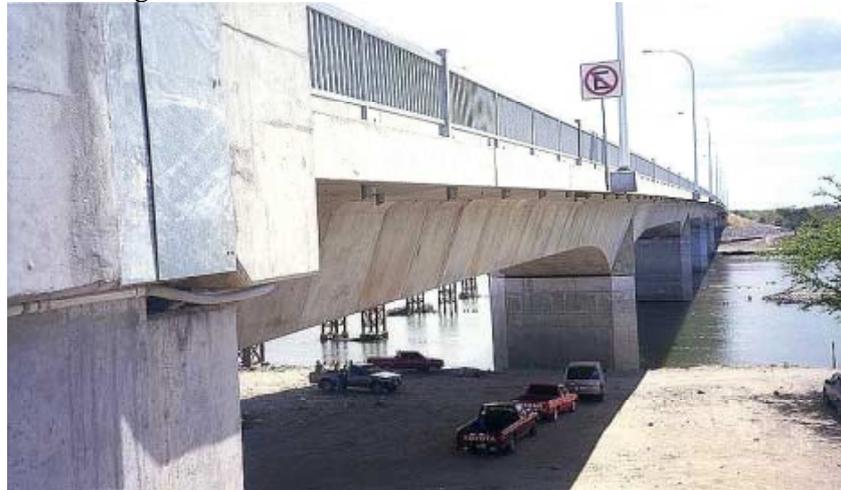
The recently constructed San Marcos Lempa bridge, spanning the River Lempa sustained only superficial concrete cracks and buckling of expansion joint covers and typically observed settlement and cracks at the west bridge abutment.

Figure 4.29. San Marcos Lempa Bridge.

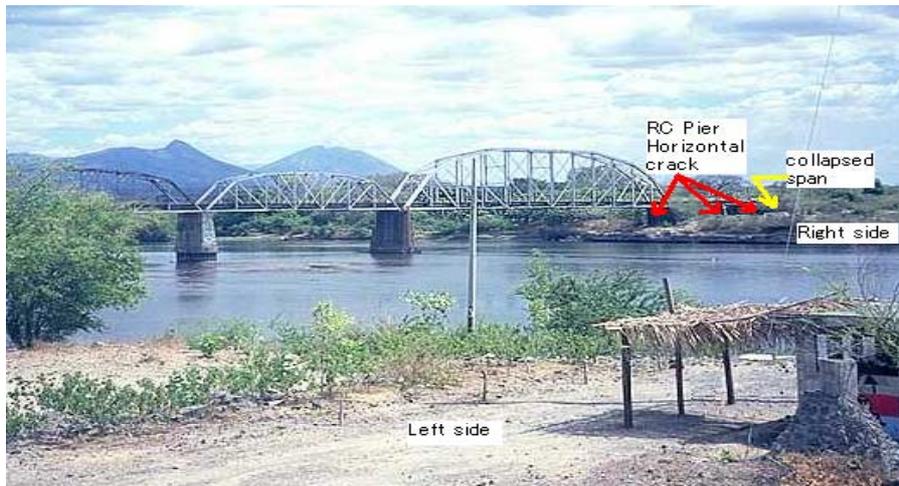
Liquefaction was observed along the riversides, but it did not cause any damage to the San Marcos Lempa Bridge. Next to the San Marco Lempa Bridge stands a 65-year-old railway bridge, “El Puente de Oro” (The golden bridge, **Figure 4.30**). Liquefaction induced lateral spreading with up to 18 cm wide cracks topped one of its simple supported spans and cracked its concrete piers as shown in **Figure 4.31** below.

Figure 4.30. “El Puente de Oro” Railway bridge.

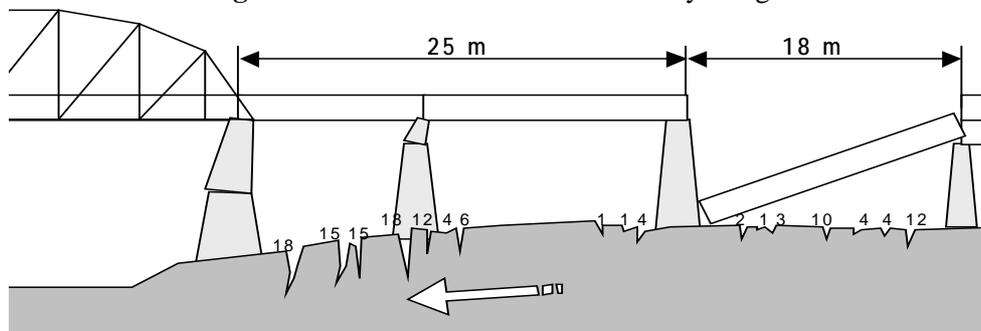
Figure 4.31. Sketch of toppled span and cracked piers caused by lateral spreading.

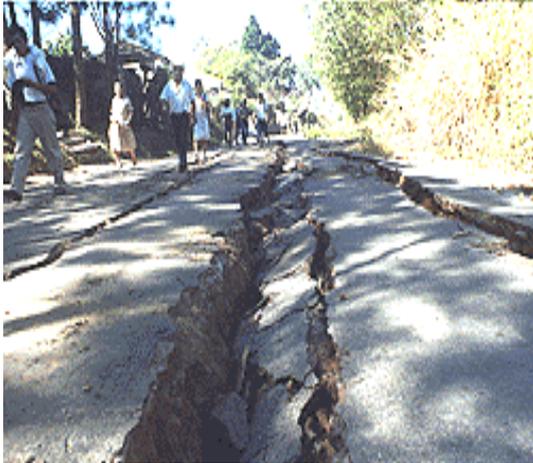
Typical widespread damage consists of slope failure and rock fall debris blocking the roads and embankment deformations causing cracks especially in unpaved roads. Debris from collapsed dwellings block roads at many locations. **Figures 4.22** and **4.33** show some typical damage. Most block roads were cleared from debris and re-opened for traffic within 24 hours of the Earthquake.

Figure 4.32. Longitudinal cracks in road to Comasagua, La Libertad

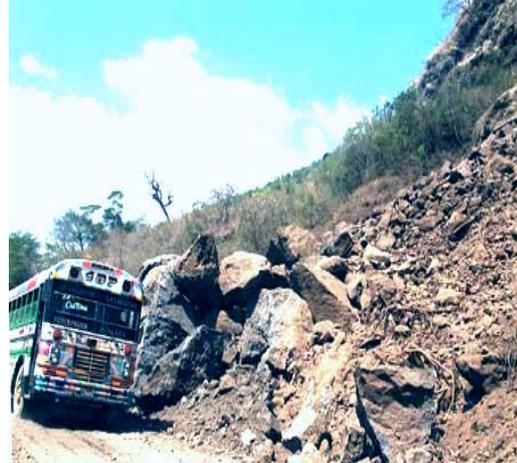
Figure 4.33. Rock fall blocking the road to Teotepeque, Jicalapa, La Libertad

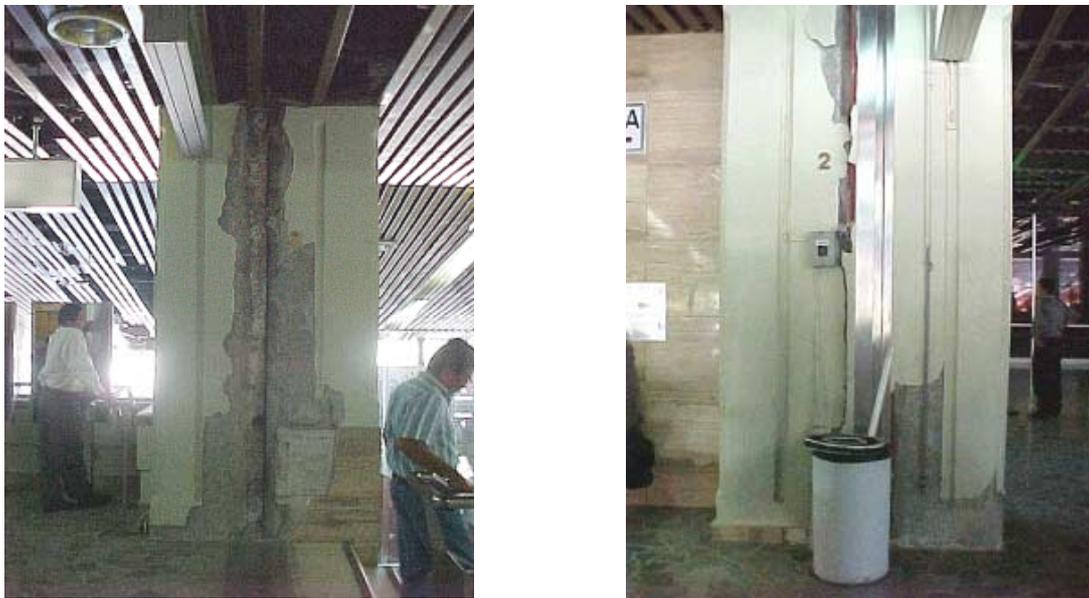
The damage to the RC passenger terminal building became more obvious as we went up the floors. The first floor suffered some minor to moderate damage mostly to secondary members such as ceiling panels, window panes, lamps and so on. Some ceiling panels came off with cables and other devices put behind them. Some finished surfaces of beams and columns were cracked and spalled (**Figure 4.34**). Infill masonry walls along the southern side of the building were completely cracked. Walls in restrooms and stairways were cracked in such a way that finished concrete cover and tiles came off. In VIP rooms, window frames were slightly bent.

Figure 4.34. Spalling of concrete columns

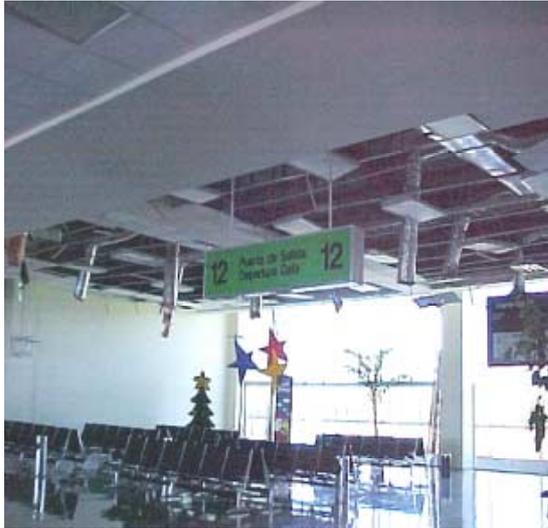
On the second and third floors, there were clear marks of pounding remaining on some expansion joints between building blocks. Several walls were moderately cracked. Ceiling panels came off (**Figure 4.35**), and about 80% of the air conditioners and signs fell down. A reinforced masonry wall near boarding gates was cracked along mortar block joints (**Figure 4.36**). On the third floor, about 75% of the windows were left unusable because their window frames were deformed.

Figure 4.35. Damage to ceiling panels (passengers waiting room)

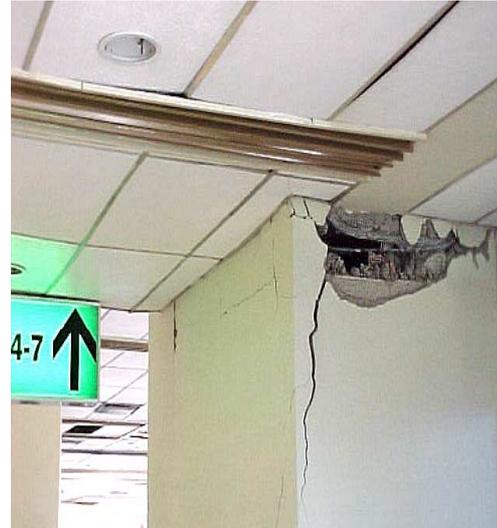
Figure 4.36. Reinforced masonry wall near boarding gates cracked along mortar block joints

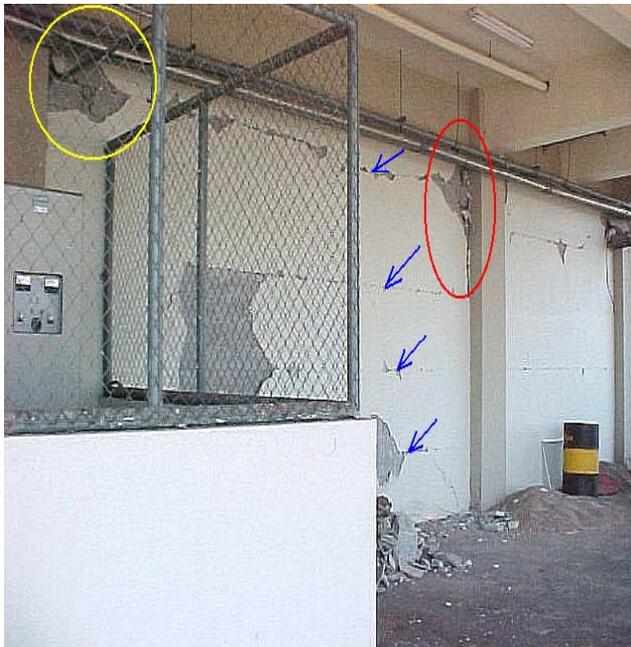
Cracks were found in other RC buildings in AIES-I and AIES-II, newly extended zones of the airport. Lateral and diagonal cracks appeared on some infill walls (**Figure 4.37**). A short RC column carrying thick beams sustained heavy damage (**Figure 4.38**). Transverse and longitudinal cracks appeared on runways and their approaches (**Figure 4.39**). These cracks, however, turned out to be less serious for aircrafts to pass.

Figure 4.37. Lateral and diagonal cracks appeared on some infill walls

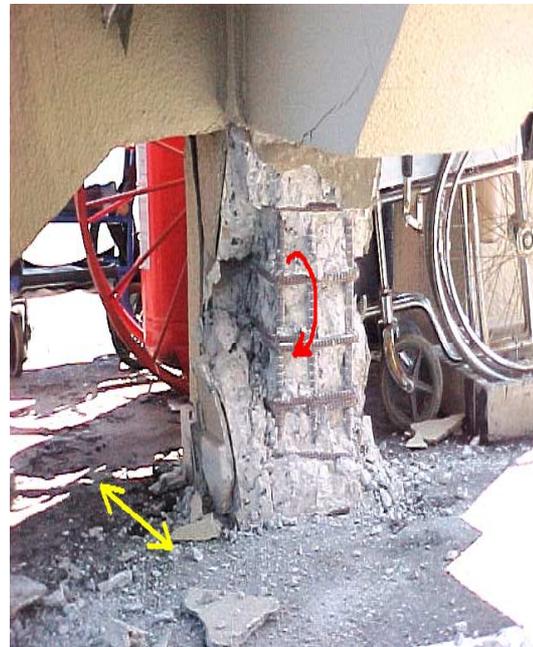
Figure 4.38. Crumbled short RC column

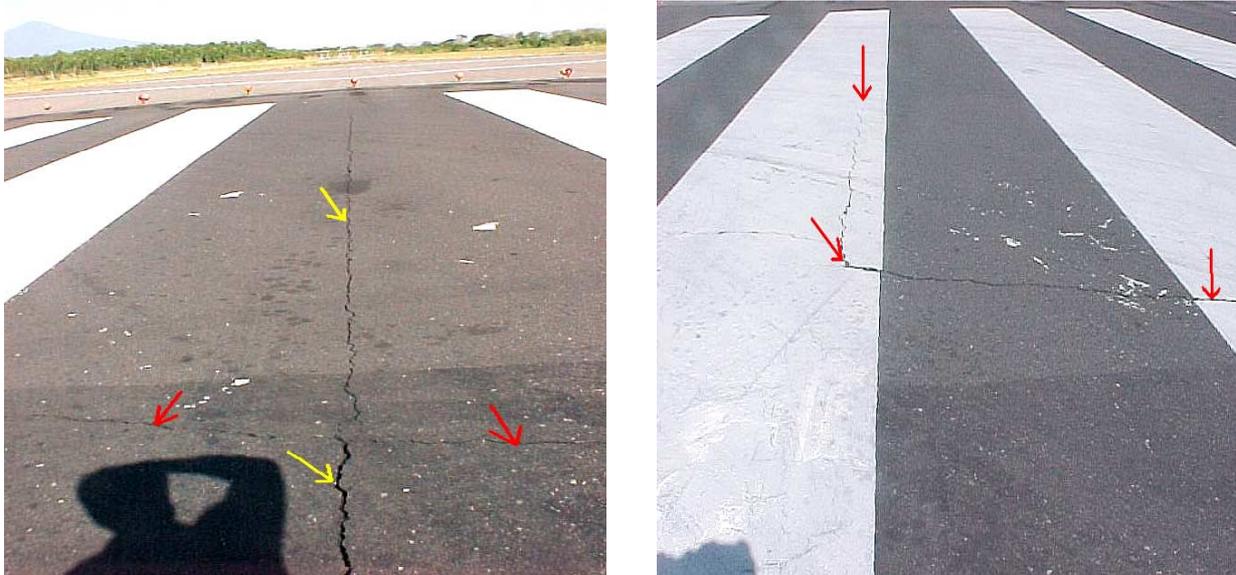
Figure 4.39. Transverse and longitudinal cracks appeared on runways and their approaches
