## 2.5 LAS COLINAS LANDSLIDE

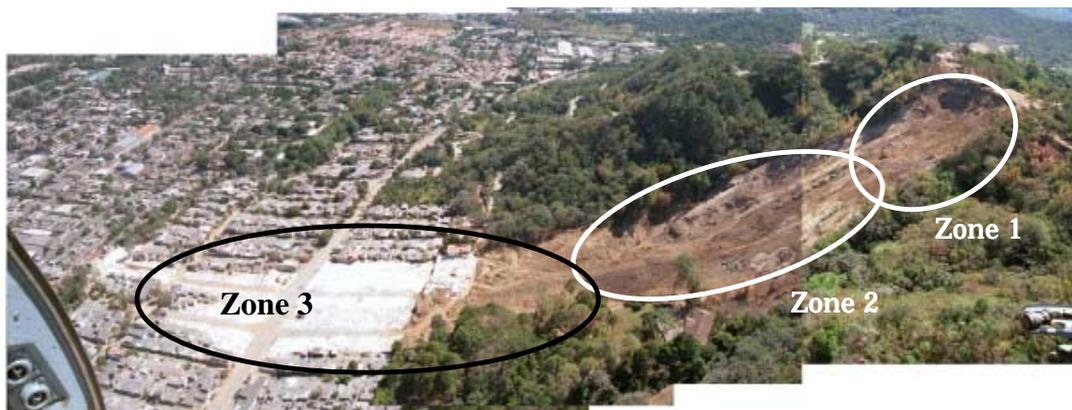
**Figure 2.11** Bird's eyes view of the Las Colinas landslide

The failure surface can be roughly divided into three zones in **Figures 2.11** and **2.13**. The uppermost zone (**Zone 1**) is a hollow of about 100m in diameter, which was caved in some 10-20 m from the original ground surface. North beyond the hollow, there appears a steepest slope (**Zone 2**) which becomes gradually gentle as it comes close to the toe (**Zone3**). The inclination of the slope is about 26 degrees above the elevation of 960 m in **Zone 2**, and is about 9 degrees below the level in **Zone 3**.

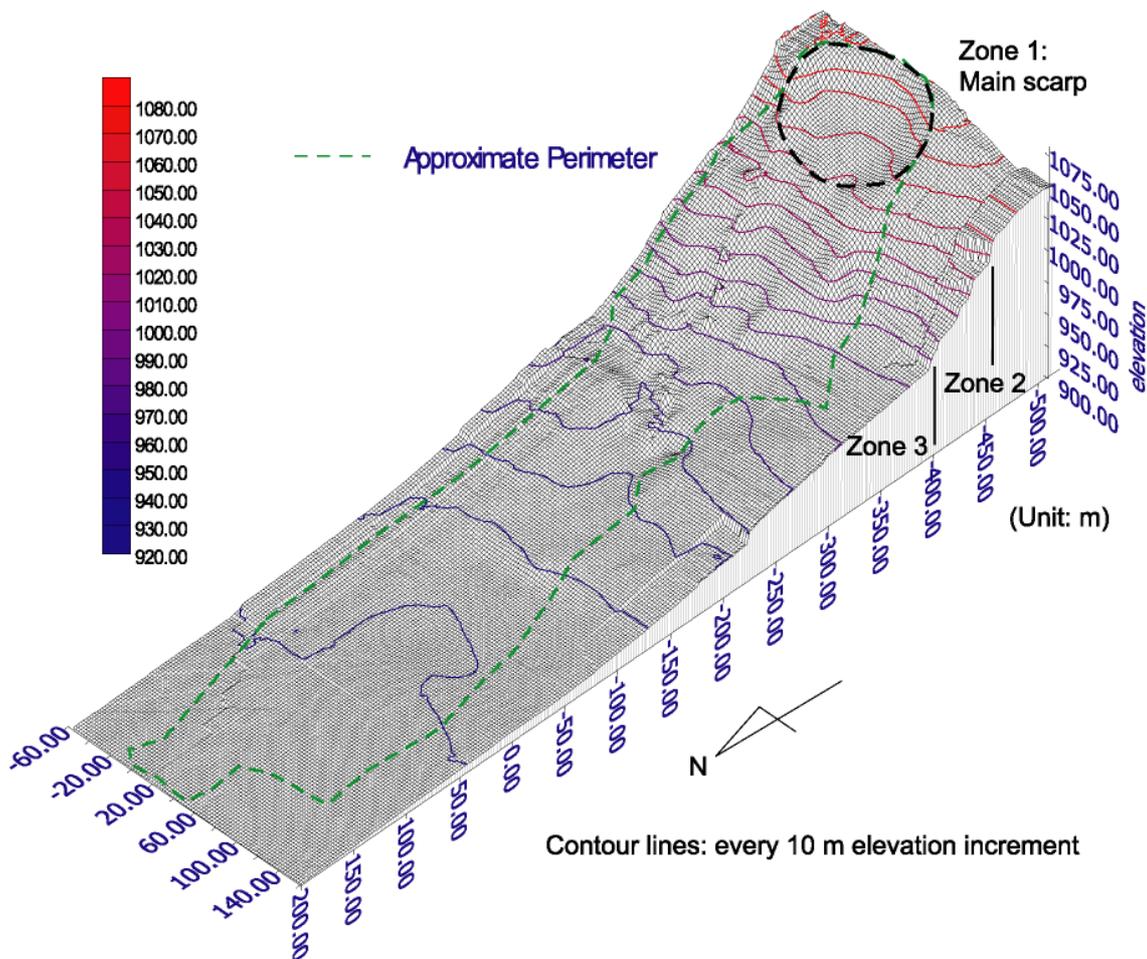
The surveyed slope was plotted with the map software SURFER (see **Figure 2.13**). The distances from the top end of the scar to the toe of the slope and to the farthest reach of the soil mass are 480m and 700m respectively. The elevation of the head-scarp and the toe of the slide are 1080m and 920m, respectively, namely, there is an average gradient of 160 m over 700 m distance in the damaged area. The average inclination from the top of source area to the toe of the deposit is about 13 degrees.

**Figure 2.13** Surveyed Slope plotted with surfer with green dashed perimeter.

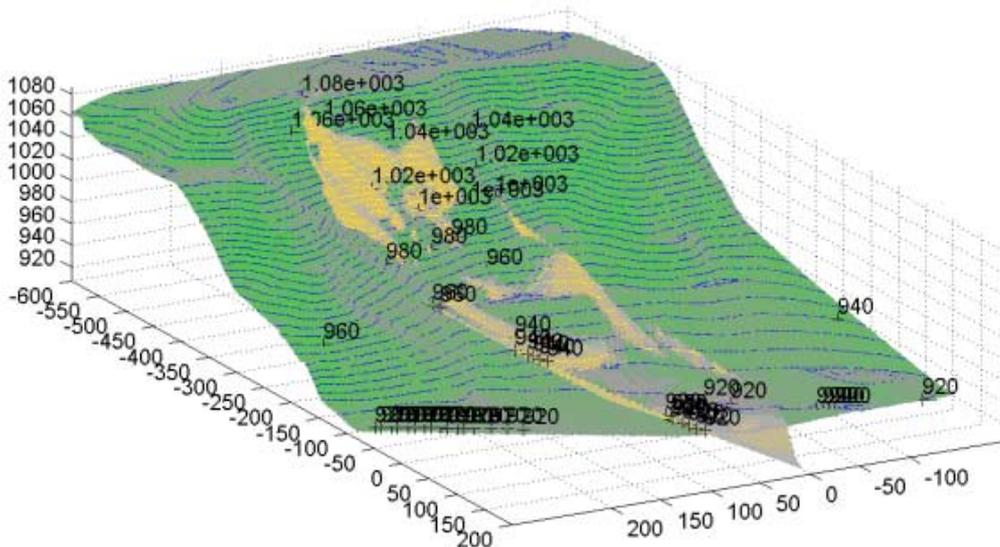
The slope data was interpolated to an x-y grid with 2.5 meters spacing and the surveyed slope height i.e. the z-coordinates were subtracted from the original slope z-coordinates. Since the surveyed slope was slightly higher than the original slope in some areas (see yellow areas in **Figure 2.16**), these areas were excluded from the volume calculation by only considering positive values of the slope height differences between the original and the surveyed slope data. The slope height differences were added together and finally multiplied by 6.25 ( $2.5 \times 2.5$ ) to obtain the volume. The total slide volume is estimated to be about 200,000 cubic meters.

**Figure 2.16** Survey and Original Plot over lap. Volume was estimated from regions where original slope lies above the surveyed slope.

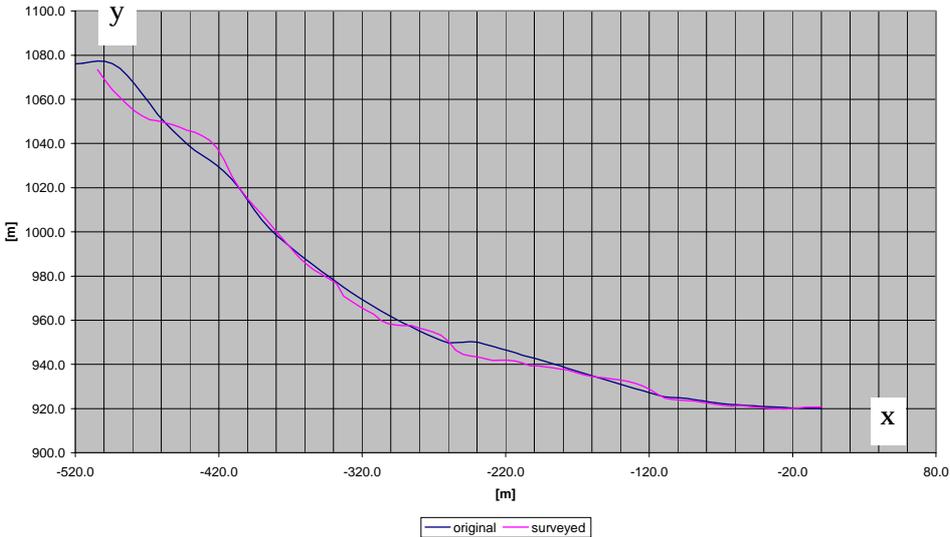
A section plots of the surveyed and original slopes are shown in **Figure 2.18**. The baseline of the cross section was drawn from point {0,0} to {-520, 100}. In the plot, the heights (z-coordinates) are plotted against the x-coordinates. The steep slope configuration in zone 2 after the earthquake roughly remained unchanged as mentioned before.

**Figure 2.18** Section of original and surveyed slope(s). The three black lines correspond to the surveyed slope and the shifted positions.

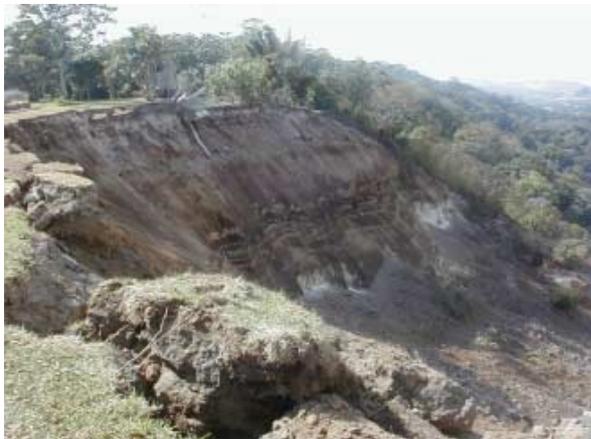
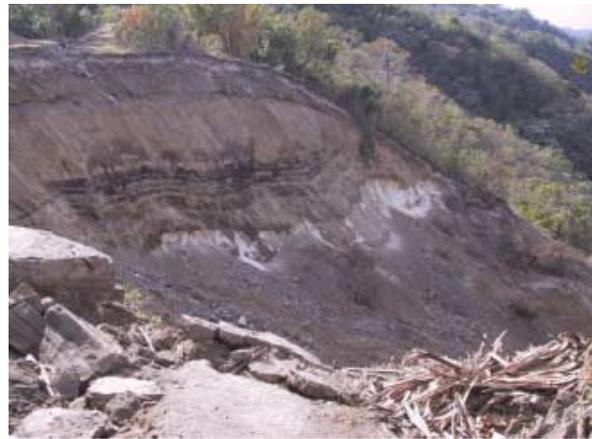
Two photos (**Figure 2.19**) of the same soil layers appearing on the west half of the uppermost scarp were taken on January 14 and February 4, respectively. Dark and blight colored stripes appearing on the scarp shows a stratified soil profile with the top lapilli tuff layer of about 2.0 m thickness overlying a pair of two differently colored (ocher and white) pumice layers of about 11.9m thickness. Some bedding planes separate the lapilli tuff into some sub-layers of varying thickness (10cm to 25cm). Dark brown color of soil indicates that the soil is moistened, and this pair of photos shows that the dark colored stripes were steadily thinning, in other words, exposed soils were drying. This fact may evidence that the intact soils along the slip surface were wet before the event. Beneath the dark and wet soils, there appear white and/or ocher colored pumice soils. They were also moistened and weakly cemented. The pumice is easily broken into small pieces or into powder just by rubbing together with fingers. Broken fragments of this pumice have sub-angular or angular shapes. Some pieces were medium-sized (1 mm × 4 mm × 7 mm for example) and some were fairly large reaching 12 mm × 25 mm × 35 mm (**Figure 2.20**). As shown in **Figure 2.21**, cracks and joints were observed even on an intact part of pumice.

**Figure 2.19** West slope of main scarp

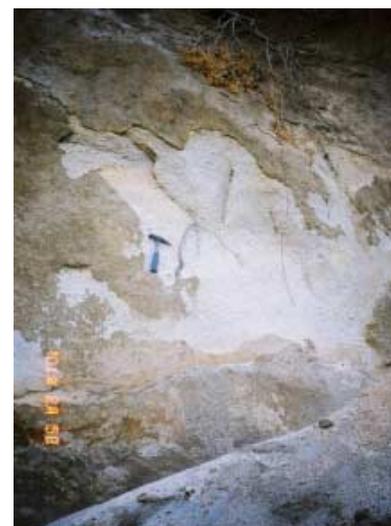
**Figure 2.21** Cracks and joints on the exposed intact pumice

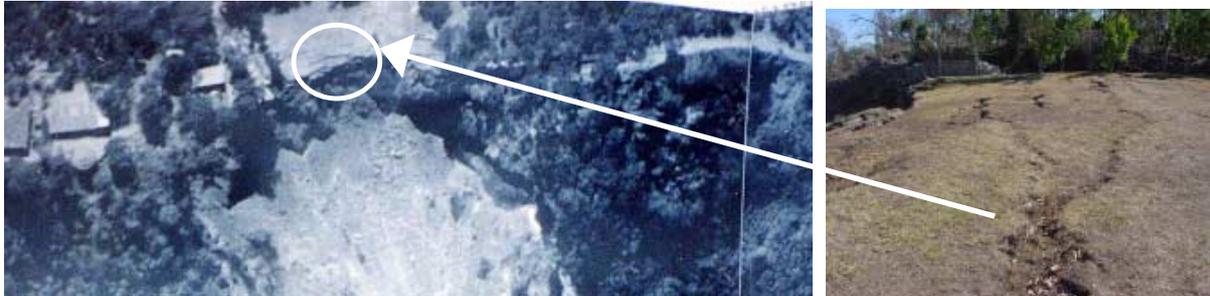
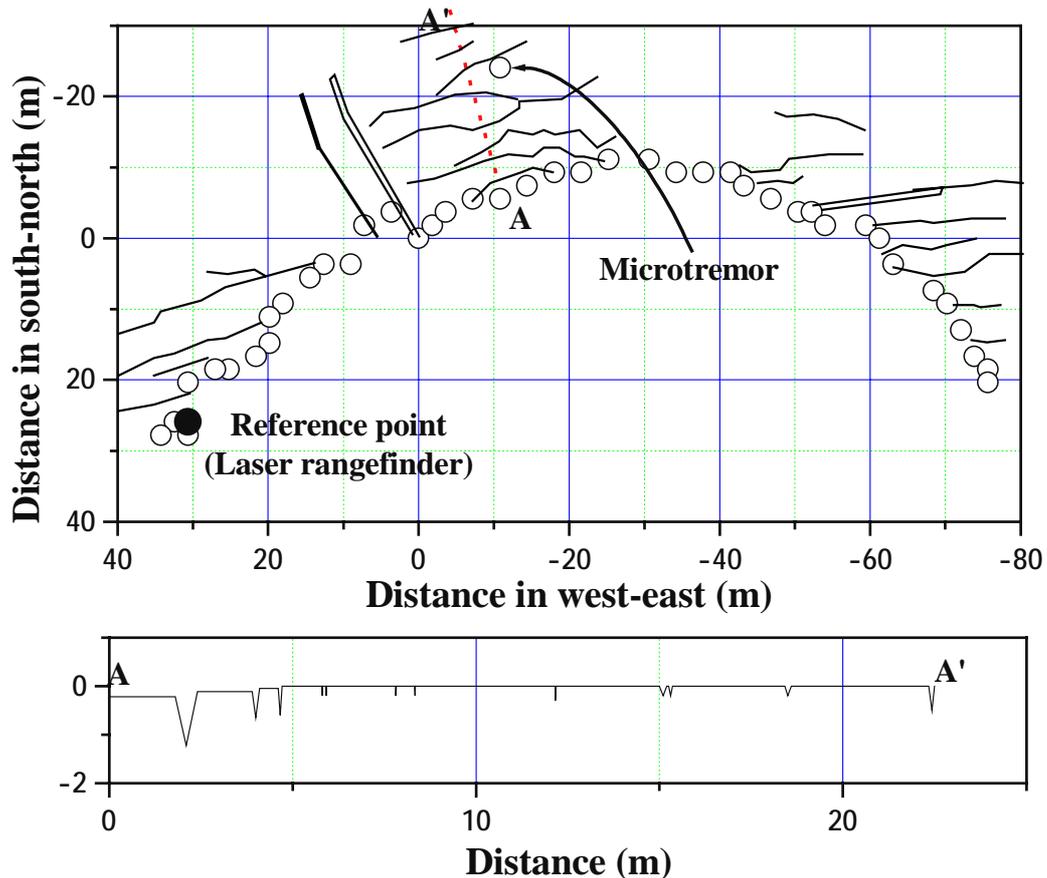
Total 43 points were marked along the perimeter of the scar using a GPS receiver (**Figure 2.22**). Behind the scar, there were extensive cracks running in almost west-east (See photos in **Figure 2.22**). Crack openings (12 visible cracks; **Table 2.2** and **Figure 2.22**) were measured along Line A-A'. Total 1.25 m's opening was reached over the 22 m's distance of Line A-A'. Namely, about 5% average strain was induced within the soil behind the scar. Extensive cracks were found along the ridge crest even in areas that did not slide (see **Figure 2.12**); the cracks can certainly cause further slides.

Cracks appearing on the top terrace behind the scar (**Zone 1**): Cracks map is shown below.

**Figure 2.22.** Perimeter of scar, Las Colinas Landslide

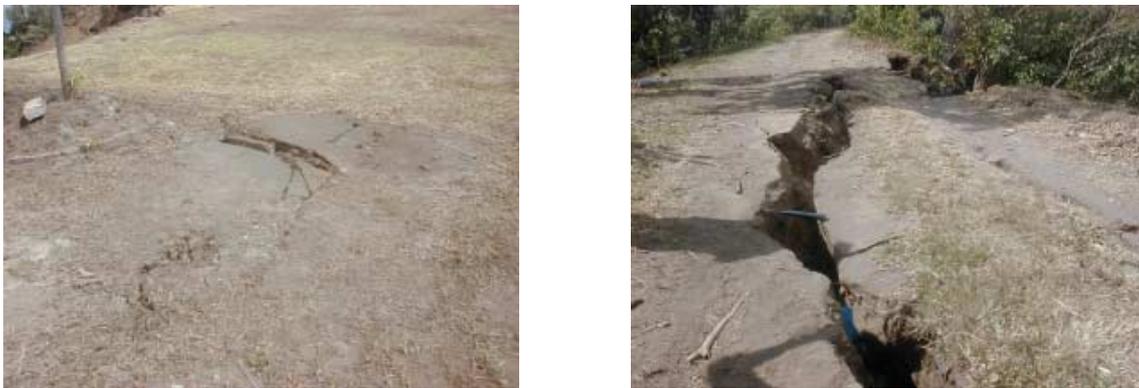
**Figure 2.23.** Crack at the top terrace (photographed on Jan. 14 by Mr. Jose Antonio Rivas)

A pair of photos (**Figure 2.23** by Jose Antonio Riva, Geotérmica Salvadoreña) was taken on January 14, a day after the earthquake. Both pictures show that edges of cracks were lightly dusted with fine sand. This fact may evidence that the landslide caused some soils to liquefy though the underground water level did not seem to be substantially high from the field observation. There was no written material available showing the possible underground water level.

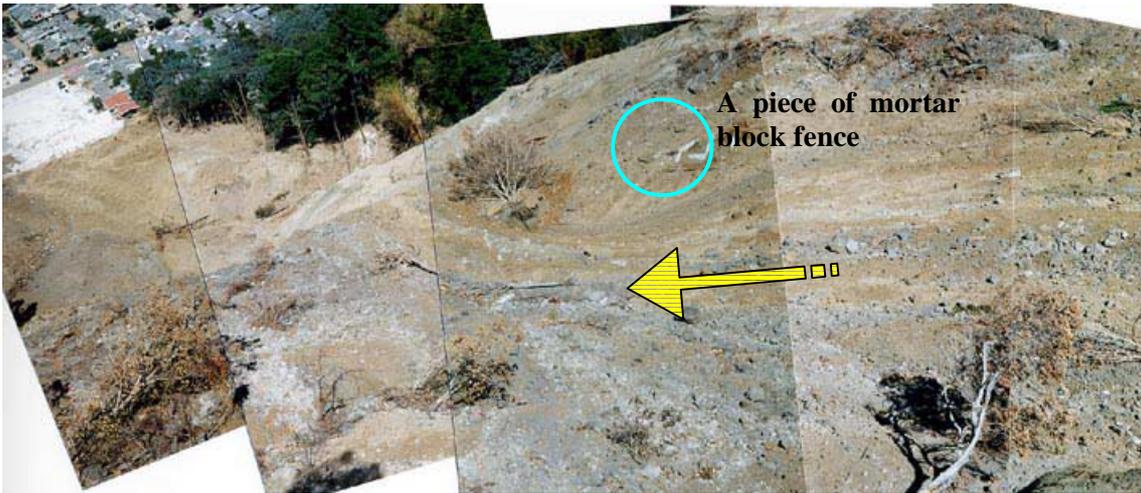
There are some downward streaks remaining on the bottom of the upper hollow (arrow in **Figure 2.24**), and broken pieces of a mortar-block fence were caught on the soil mass remaining on the outer edge of the hollow (arrow in **Figure 2.25**). These may evidence that most soil mass, which originally fitted into the hollow, seems to have been pushed forward, and flown down the lower steep slope. Along the streaks, a number of broken pieces of lapilli tuff and some uprooted trees were found. The largest piece of the lapilli tuff remaining there was 88 cm×64 cm×14 cm.

**Figure 2.24.** Lower part of the hollow: A piece of mortar block fence (within the circle) is caught on the small amount of the soil mass stopped at the lower edge of the hollow.

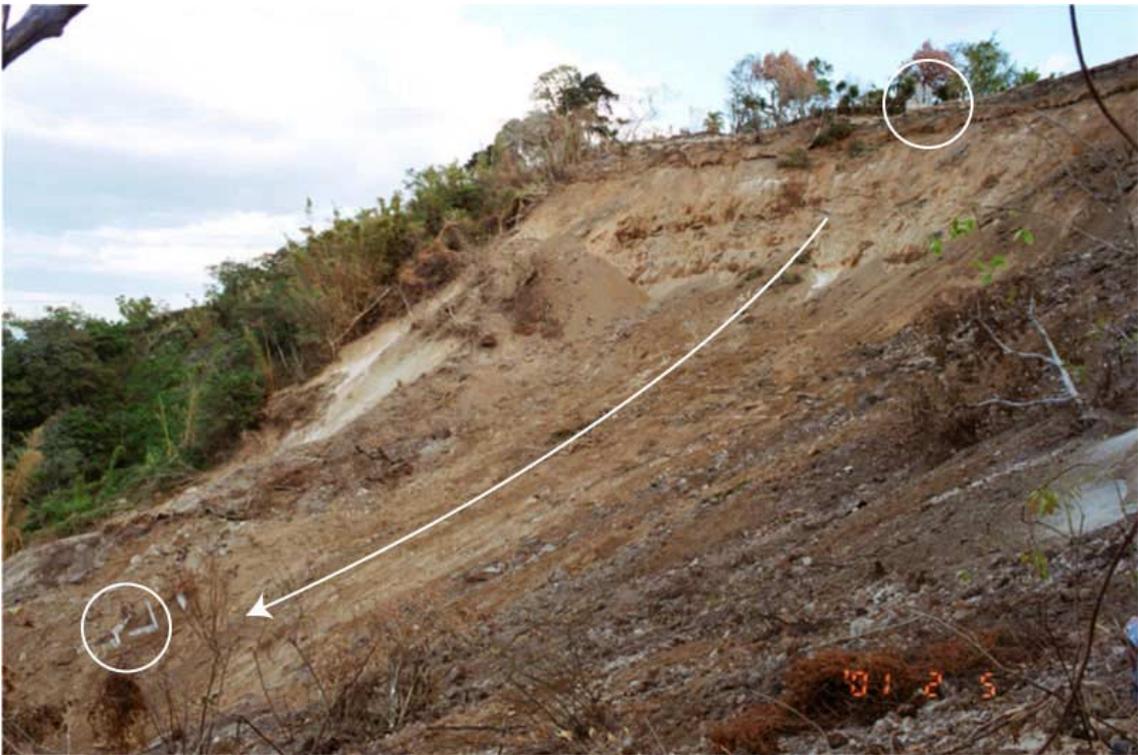
**Figure 2.25.** Fallen block fence

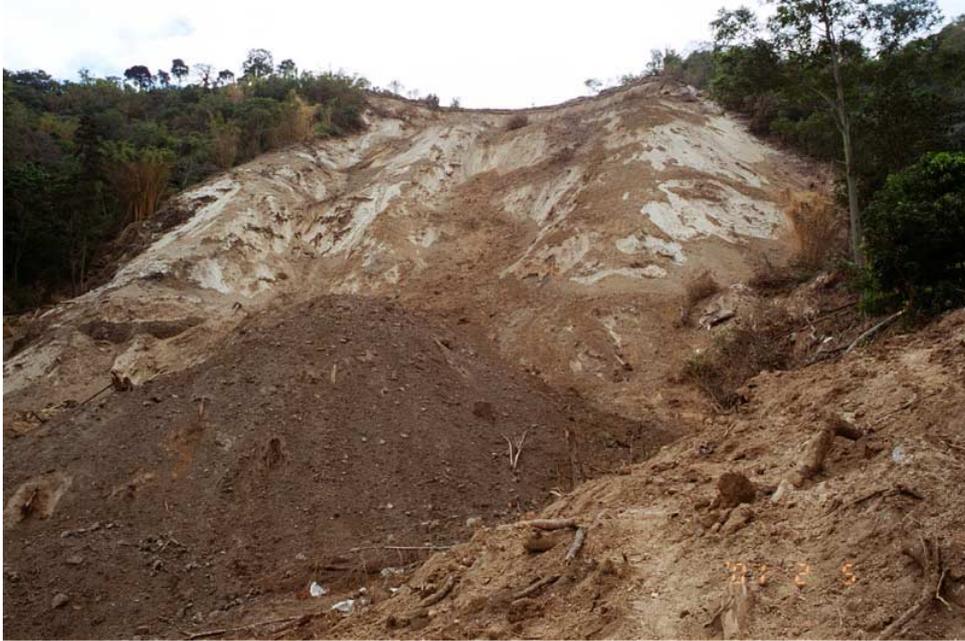
**Figure 2.26** shows the lapilli tuff exposed on the lower steep slope (**Zone 2**). This surface exhibits an arrangement of volcanic products in strata of varying thickness (7 to 30 cm) and about general 10 degrees dip toward the toe of the slope.

**Figure 2.26.** Steep slope (**Zone 2**)

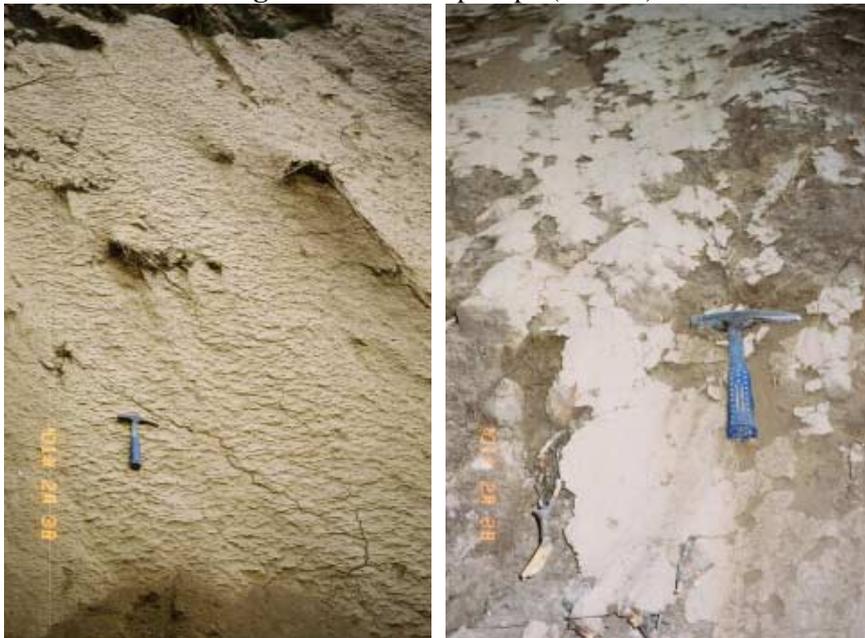
As shown in **Figure 2.27**, the steepest slope in **Zone 2** was covered thin with a film of mud including porous fragments of pumice; the film was noticeably stiff after totally dried up. The film covered trees, bamboo and other plants pushed down on the slope. This fact suggests that the original slope in **Zone 2** was not scraped off, and is consistent with the result from the 3D survey of the slope configuration. This fact also suggests that the bottom surface of the slid soil mass was wet, and may have liquefied (Sassa, 2000), possibly related to some weak tephra layers spreading over less permeable paleosols.

**Figure 2.27.** Thin mud film

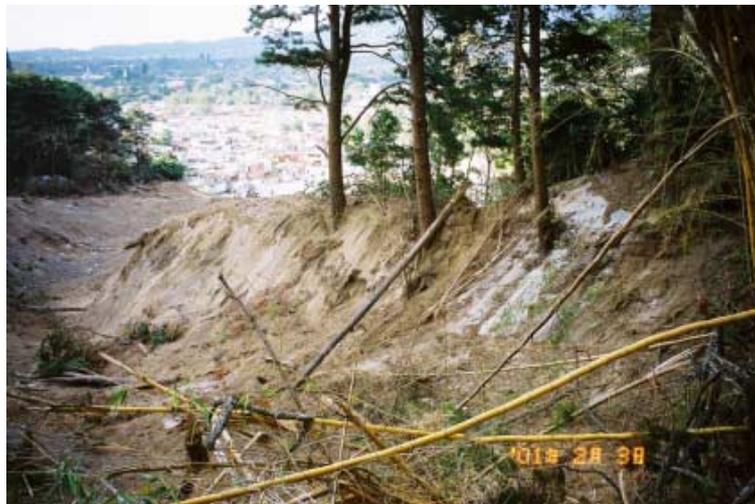
The slid soil mass seems to have surged across a small ravine coming down from east mountainside, and splashed up a small bank. Some splashes were remaining 6-8 m high on some tree trunks on this bank (Figure 2.28). The huge amount of slid soil mass flooded many houses and thus caused more than 500 deaths. A complete view of Zone 3 was taken from the toe of the exposed slip surface (Figure 2.29a). The slid soil mass and destroyed houses had been removed, and the cleared area was totally white with disinfectant.

Figure 2.28. Toe of the slope

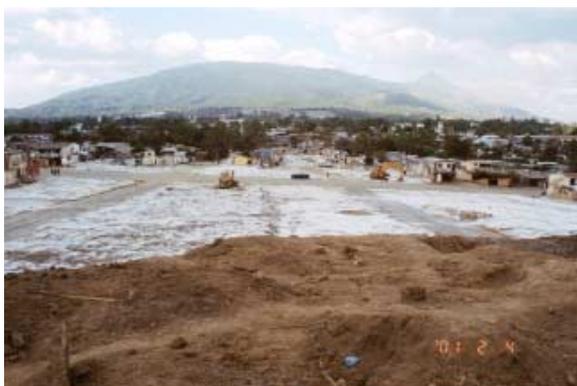
(a) Complete view of Zone 3  
(Feb. 4, 2001)

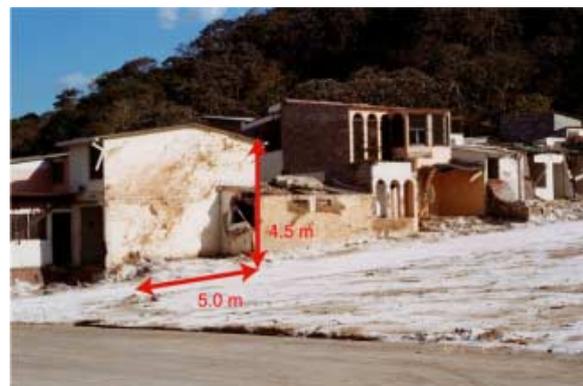
There were many splashes of mud remaining on house walls, trees and etc. In general, the splashes seem to be higher at around the toe of the slope than those in the middle or close to the distal end of the soil deposition zone. The highest splash of about 8 m was found on a trunk near the toe. Figure 2.29b shows the walls of a dwelling on the eastside perimeter of the slid soil mass, the wall spotting in parabola with mud splashes. The parabola with its peak of about 4.5m high drops downward, and reaches the ground after about a 5m horizontal run. This fact suggests that the time  $t$  needed for the splashes to reach the ground from their peak height  $\Delta h (= 4.5 \text{ m})$  was about 1s ( $\Delta h = g \cdot t^2 / 2$ ), and during this time, the splashes ran about the 5m horizontal distance (5 m/s). The main stream of the soil mass flow might have faster than this speed after running through dwellings standing close together.

(b) House wall spotting with splashes
