Japan Society of Civil Engineers
Yotsuya 1, Shinjuku-ku, Tokyo 160-0004
<http://www.jsce.or.jp/>

Provisional Report on the January 13, 2001 Earthquake Occurred Off The Coast of El Salvador (updated 15, February, 2001)

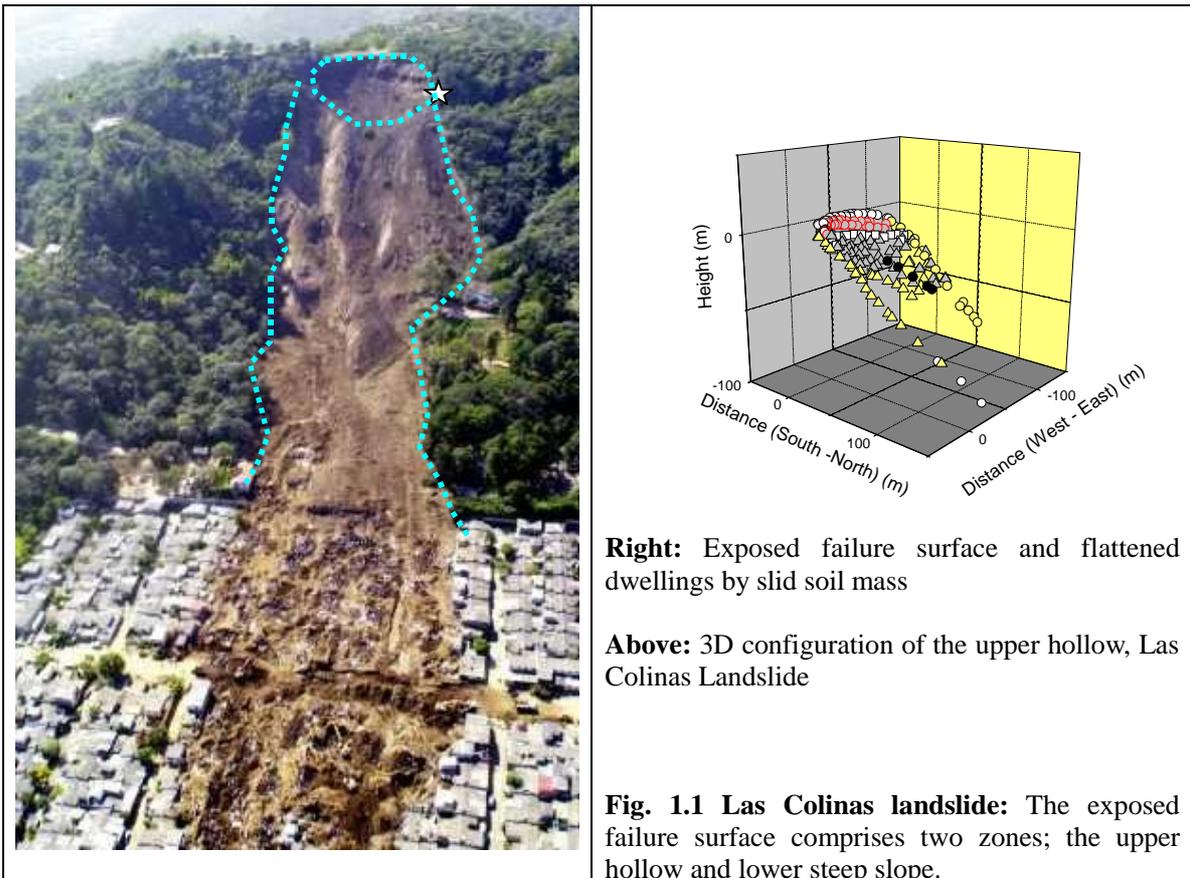
Using a laser rangefinder with a digital compass built in, the 3D configuration of the upper hollow (zone 1, **Fig. 1.1(a)** and **(b)**) was first surveyed from two reference points, one on the left edge of scar (closed circle in **Fig. 1.2**: N13 396.87', W89 17.168') and the other on the right (not plotted in **Fig. 1.2**). The distances from the top end of the scar to the toe of the slope and to the farthest reach of the soil mass are 480m and 750m respectively. A possible soil mass that was fitted in the upper hollow is roughly estimated to be about 75,000 m³, and is presumably the greater part of the soil, which flushed more than 600 lives to death.

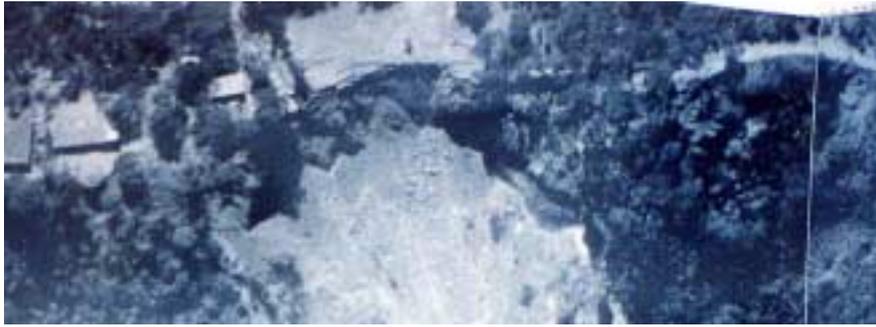
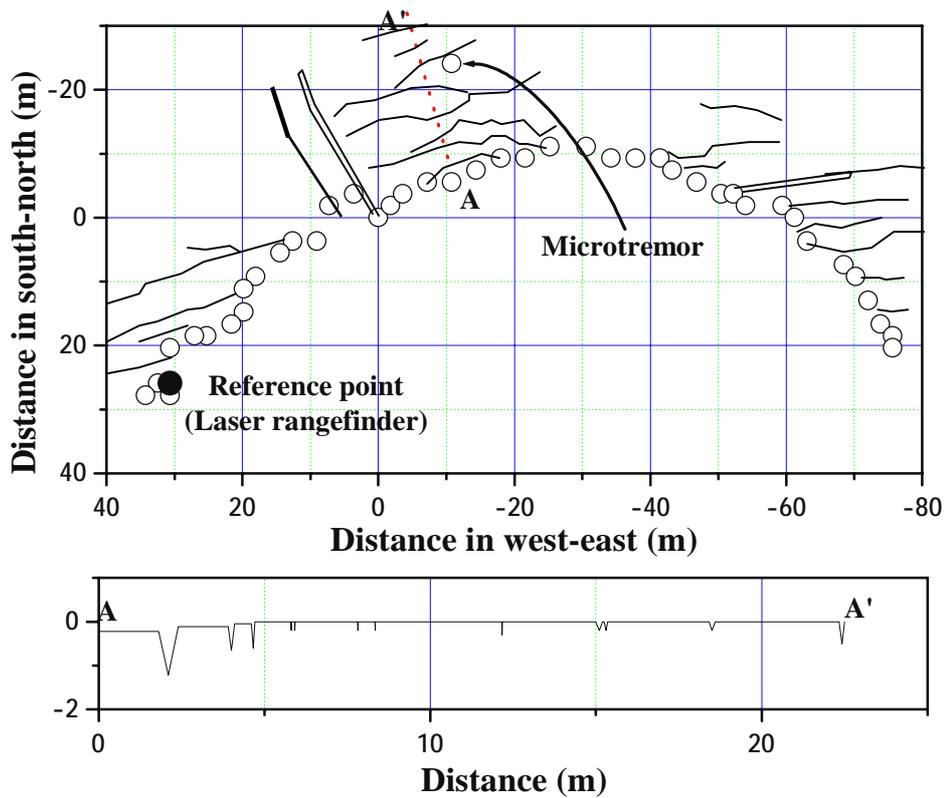
Fig. 1.2. Perimeter of scar, Las Colinas Landslide

Total 43 points were marked along the perimeter of the scar using a GPS receiver (**Fig. 1.2**). Behind the scar, there were extensive cracks running in almost west-east. Crack openings (12 visible cracks; **Table 1.1** and **Fig. 1.2** (below)) were measured along Line A-A'. Total 1.25 m's opening was reached over the 22 m's distance of Line A-A'. Namely, about 5% average strain was induced within the soil behind the scar. Extensive cracks were found along the ridge crest even in areas that did not slide (**Fig. 1.3**); the cracks are certainly the threat of further slides.

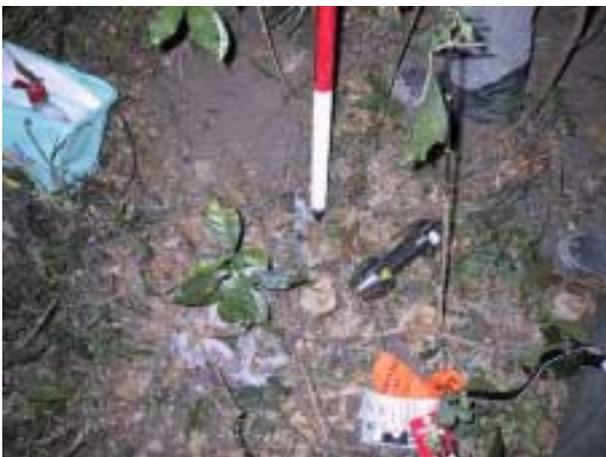
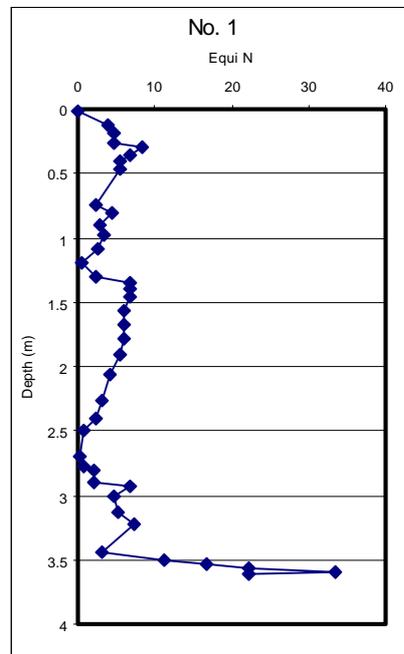
Fig. 1.4 Sounding using cone-penetrometer

Sounding of soil stiffness was done by using a single cone-penetrometer at the western crest of the hollow (**Fig. 1.4** and *Star mark* in **Fig. 1.1(a)**). Thin soft wet layers were found at about 1.2m and 2.5m deep. These two weak layers seem to be pumices and/or fragmental volcanic products, white-yellow-colored light porous volcanic rocks sandwiched in the uppermost part (EL. +1030 - +1076) of the ridge. This part of the ridge is a thick sediment of tephra, with some wet layers of pumice or tuff underlain thin gray less-permeable films. The tephra sediment is overlaid with a stiff tuff forming the top terrace of the slope.

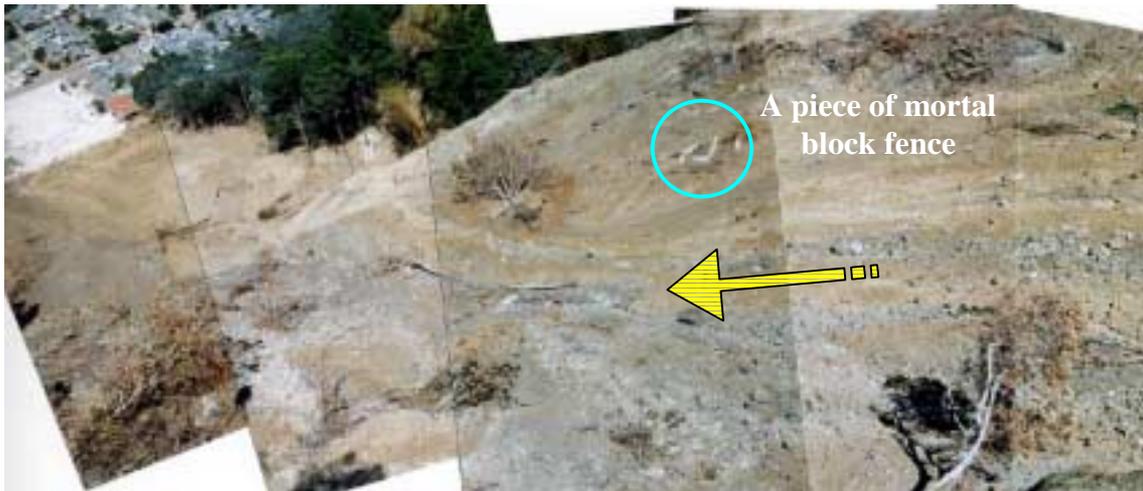
Fig. 1.5 Lower part of the hollow: A piece of mortar block fence (within the circle) is caught on the small amount of the soil mass stopped at the lower edge of the hollow.

Broken pieces of a mortar-block fence were caught on the soil mass remaining on the outer edge of the hollow, and there are some downward streaks remaining on the bottom of the hollow (arrow in **Fig. 1.5**). These may be evidencing that most soil mass, which originally fitted into the hollow, seems to have been pushed forward, and flown down the lower steep slope.

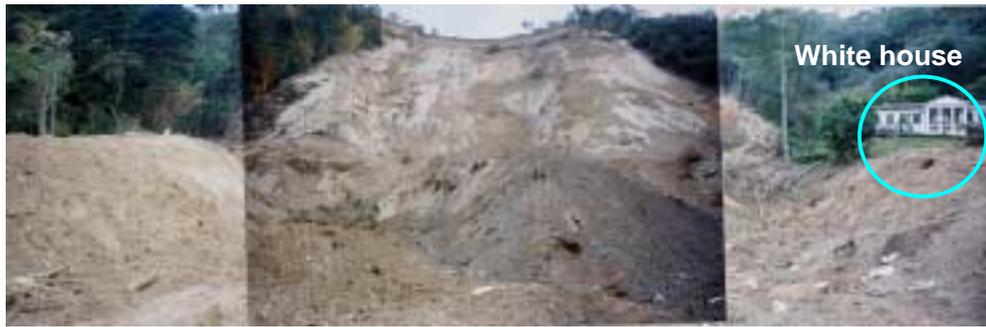
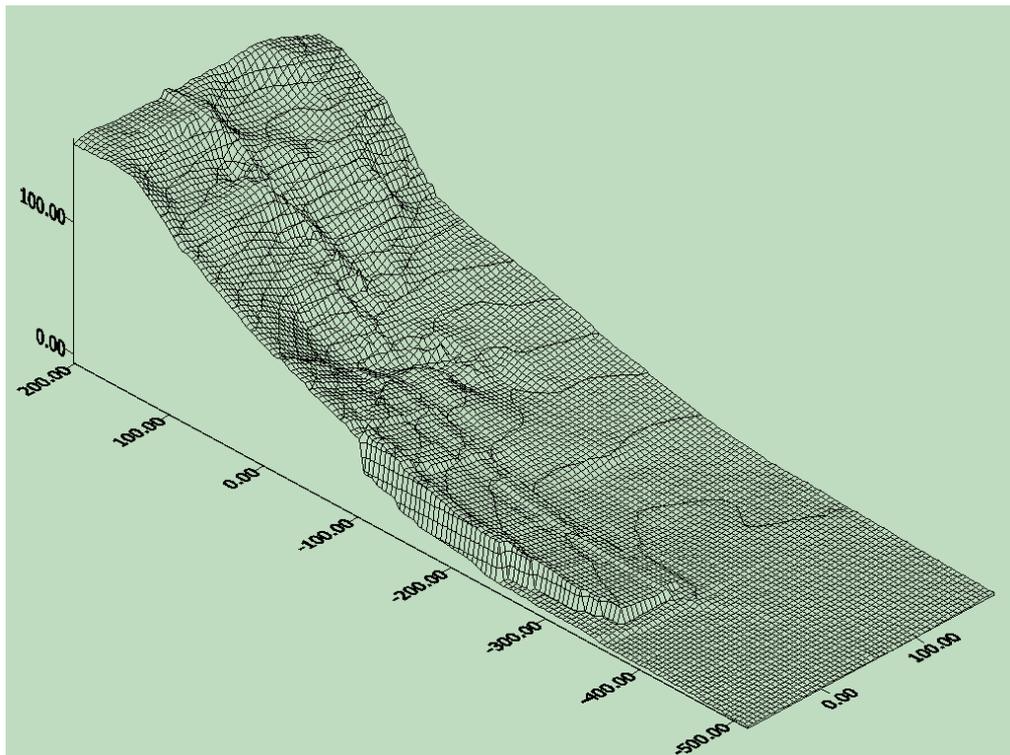
The 3D configuration of the entire slope was surveyed from three reference points (**Fig. 1.6**). Two ravines coming down from both sides of the slope curve forward and meet at the middle of the slope width. The steepest slope was covered thin with a film of mud including porous fragments of pumice; the film is noticeably stiff after totally dried up. The film covered trees, bamboos and other plants mowed down on the slope (**Fig. 1.7**). This fact suggests that the bottom surface of the slid soil mass was wet, and may have been liquefied (Sassa, 2000), possibly related to some weak tephra layers spreading over less permeable paleosols (http://landslides.usgs.gov/html_files/central.a.shtml).

Fig. 1.6. 3D Configuration of the slope
(Contour lines: every 10 m elevation increment)

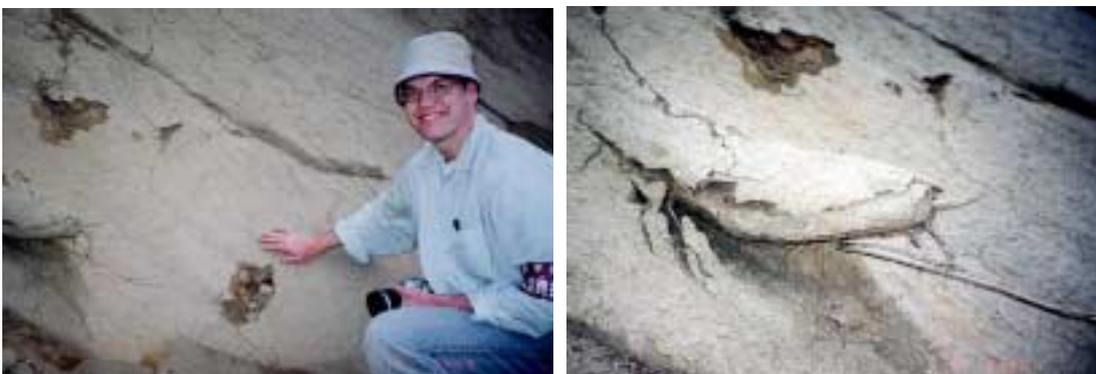
Fig. 1.8 Thin mud film

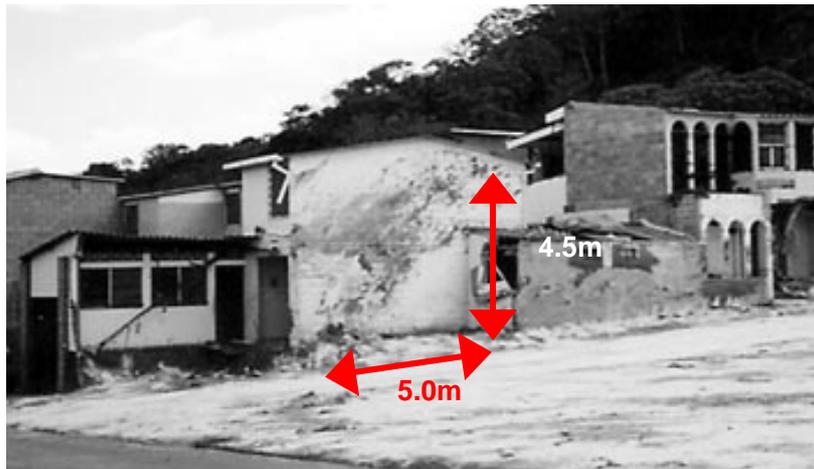
Fig. 1.9. House wall spotting with splashes

There were many splashes of mud remaining on house walls, trees and etc. In general, the splashes seem to be higher at around the toe of the slope than those in the middle or close to the distal end of the soil deposition zone. The highest splash of about 10 m was found on a trunk near the toe. There was water stopped on a pavement. Fig. 1.9 shows the wall of a dwelling on the eastside perimeter of the slid soil mass, the wall spotting in parabola with mud splashes. The parabola with its peak of about 4.5m high drops downward, and reaches the ground after about a 5m horizontal run. This fact suggests that the time t needed for the splashes to reach the ground from their peak height Δh ($= 4.5$ m) was about 1s ($\Delta h = g \cdot t^2 / 2$), and during this time, the splashes ran about the 5m horizontal distance (5 m/s). The main stream of the soil mass flow might have faster than this speed even after running through dwellings standing close together.

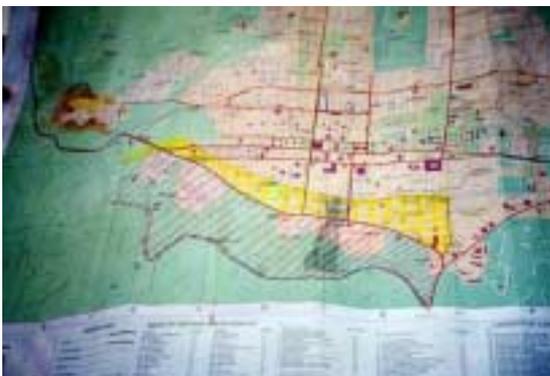
Extensive cracks running along the ridge crest are the serious threat of further slides. The city of Santa Tecla is controlling the potential hazard zones, the red zone with the highest risk and the yellow zone of slightly less danger (**Fig. 1.10**). A week after the earthquake, the number of residents evacuated from the zones exposed to the menace of possible landslides reached 14,000, and as of Feb. 3, about 4,000 refugees were still being forced to live in tents (**Fig. 1.11**).

Fig. 1.10. Zones of potential risk

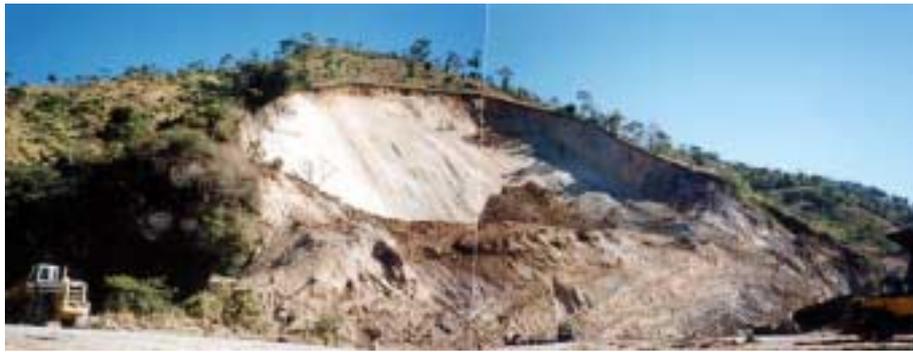
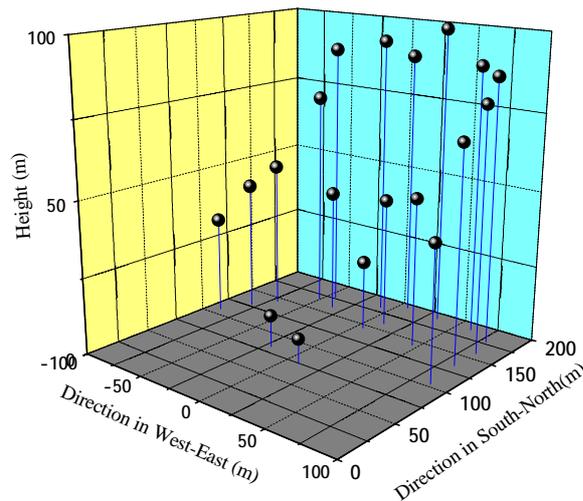
Fig. 1.2 Configuration of San Viente Landslide

At the 53rd km of the Panamerican Highway, in San Vicente, a slid soil mass has blocked the road (**Fig. 1.12, above**). Three dimensional shape of the slip surface (hollow) was measured (**Fig. 1.12 below**), and the possible volume of the slid soil mass was roughly estimated to be about 300,000 m³. A steeply dipping joint surface seem to have served as a slide plane. Some cracks were found further above the upper end of the scar.

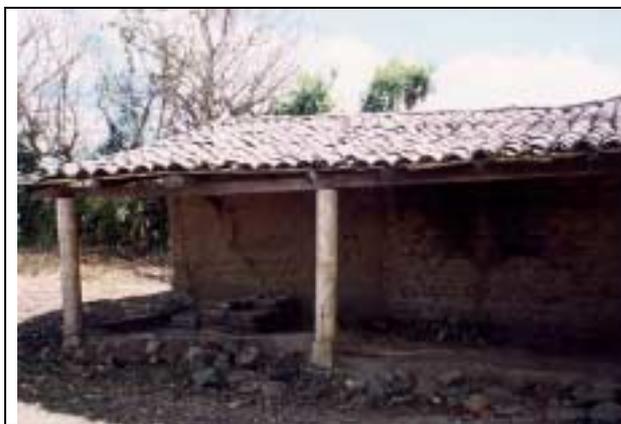
Fig. 1.3. Bahareque house near San Vicente landslide: This bahareque house, standing on the terrace high above the headscarp of the slide, performed quite well, though it suffered some diagonal shear cracking.

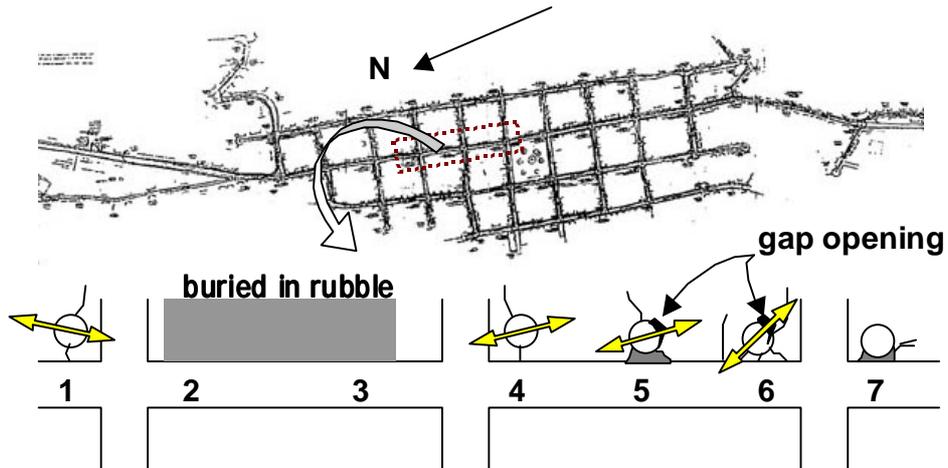
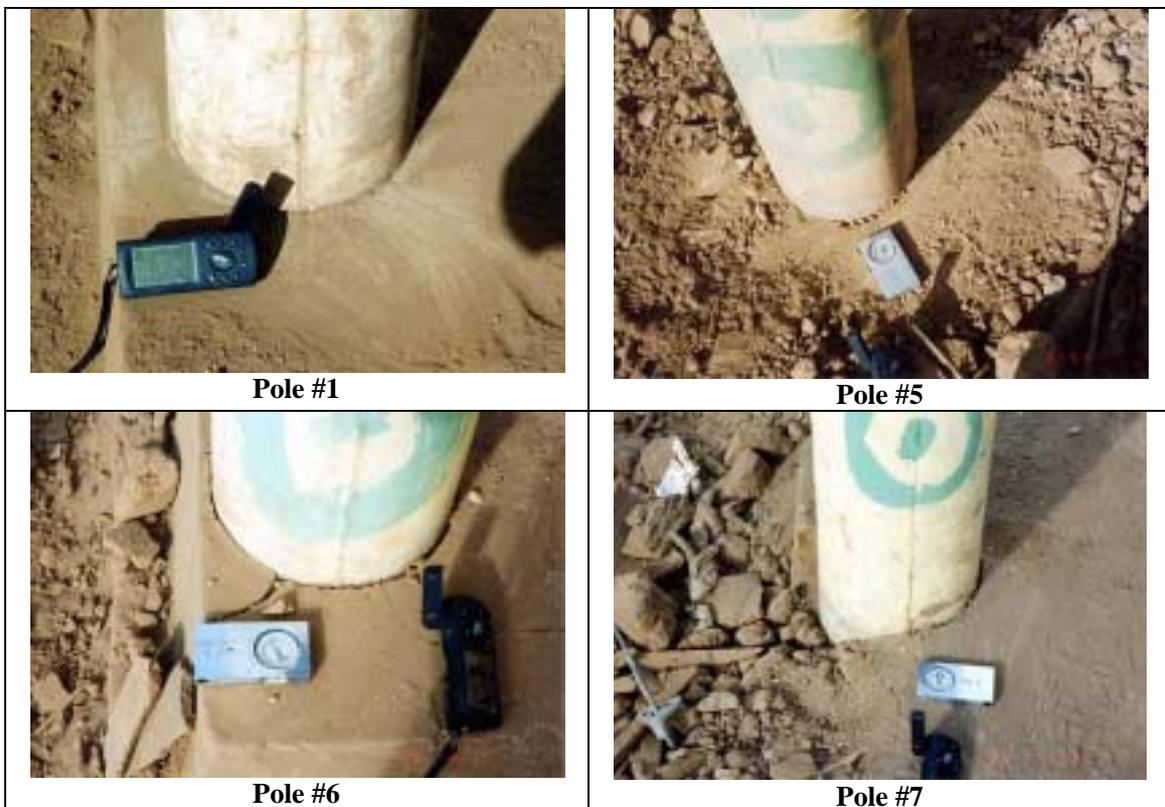
Utility poles (5m tall) are embedded upright in concrete-paved sidewalk. Cracks developing outwardly on the pavement from these poles were mapped. Some poles (No. 6 and 7) are very close to the step-shaped edge of the sidewalk. The thin cover concrete thus might have affected the crack pattern. Though the number of the examined utility poles is not sufficient for thorough statistical manipulations, some poles seem to have been forcibly shaken in about N-S direction.

Fig. 2.1. Cracks appearing around utility poles

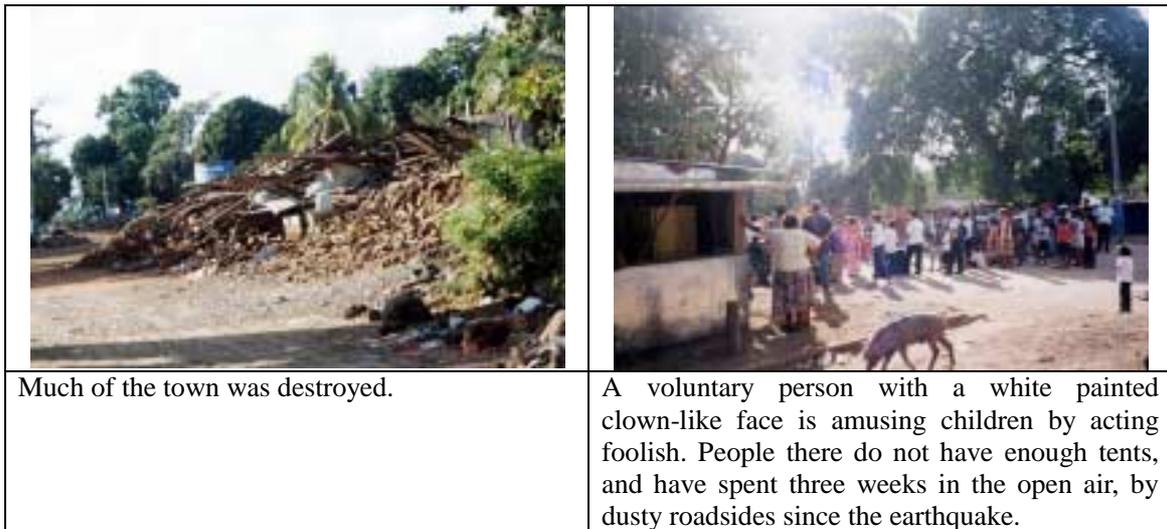
About 90% adobe and un-reinforced masonry houses were flattened in this town (Fig. 2.2, next page).

Fig. 2.2. San Agustin (Feb. 4, 2001)

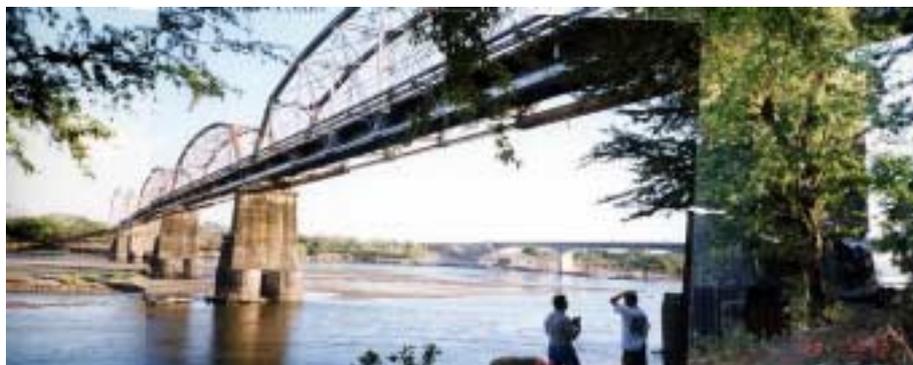
Fig. 3.1. Old railway bridge crossing Rio Lempa

Immediately above the San Marcos Bridge of Carretera Litoral Highway, there is an old railway bridge (1936-) crossing the Rio Lempa (**Fig. 3.1**). The upper deck of the bridge, after the railway was discontinued, was totally asphalt-paved, and served as a route for vehicles. Liquefaction-inflicted lateral spread of soil and associated cracks were found only on the right side of the river (**Fig. 3.2**); the right riverside might have been an old river trace. Fine sands (0.3-0.5 mm) cover thin the ground surface.

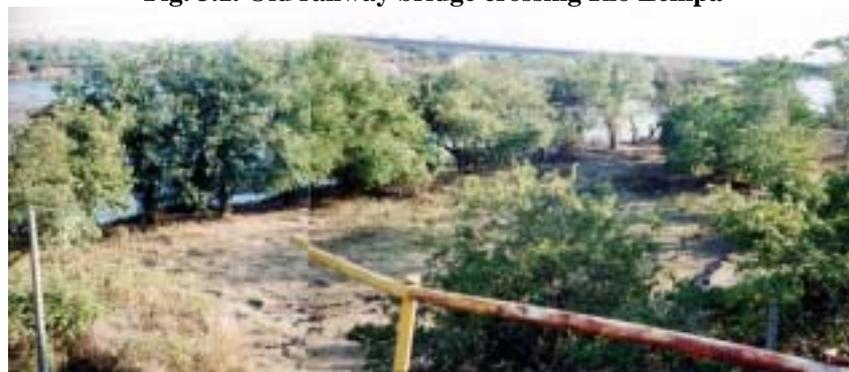
Fig. 3.1. Lateral spread of soil and associated cracks

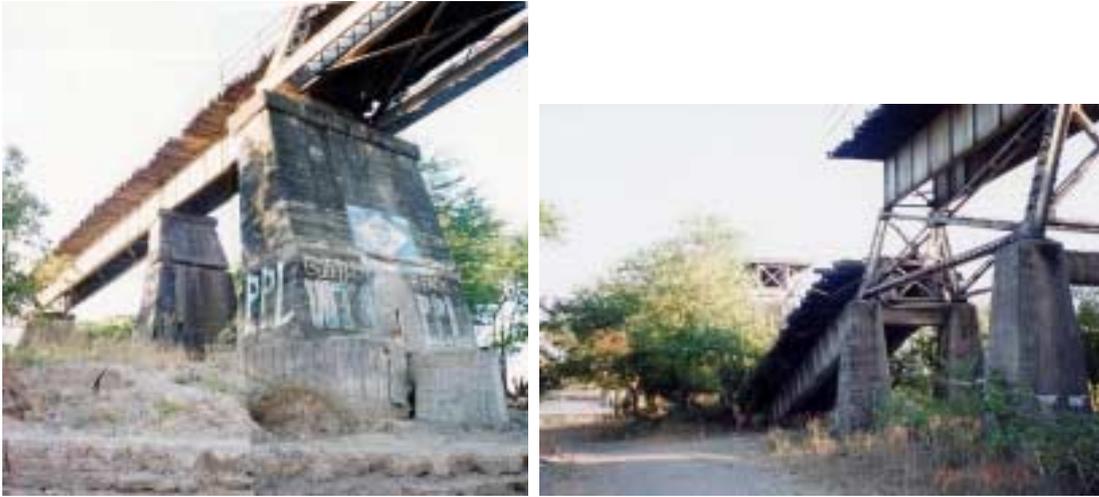
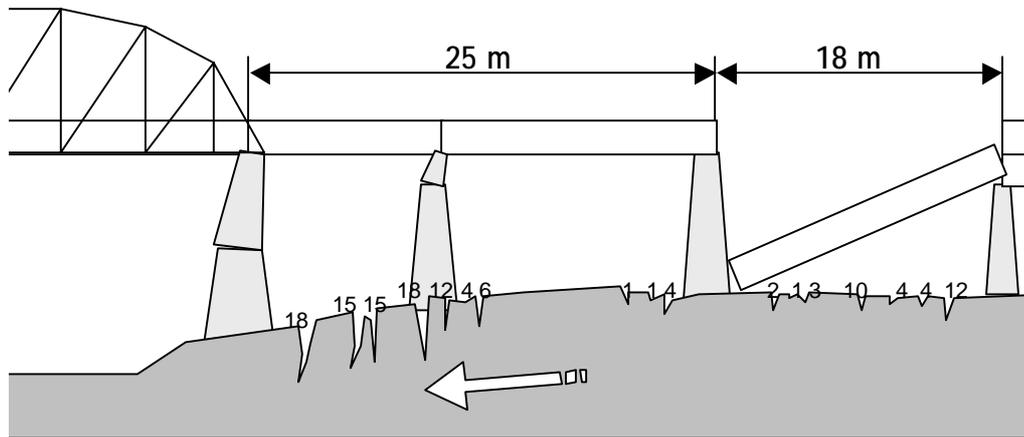
Fig. 3.2. Crack openings (cm)

Visible crack openings were measured (**Fig. 3.2**). Total 1.27 m's opening was reached over the 45 m's distance. Piers (caisson foundations?) supporting truss guiders seem to be stable and stiff. The truss girders propped up the right approach girders, while the lateral flow of soil have carried the lower parts of piers towards the river. → Construction joints opened wide.
