6 DAMS

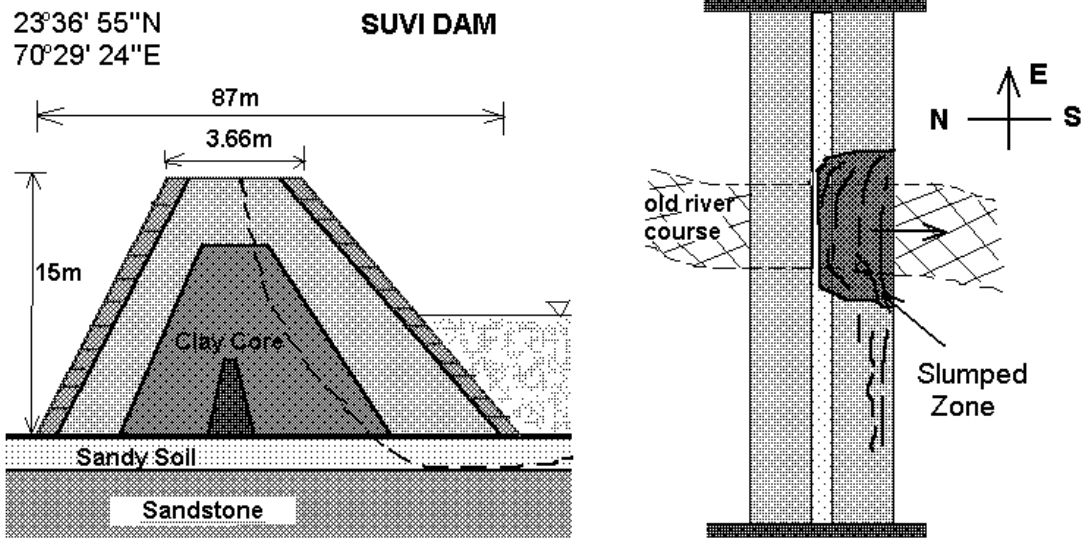
SUVI DAM: Suvi dam is built nearby Lilpar which is north of the presumed fault. The east-west length of the dam is about 2.7km. The crest of the dam is 3.66m wide and the bottom is 87m wide (Figure 6.2). The crest height is 15m. It is completed in 1666 for irrigation and water supply purposes. The position of the dam is $23^{\circ} 36' 55''\text{N}; 70^{\circ} 26' 64''\text{E}$. While the upstream side of the dam had multiple longitudinal cracks indicating to movement towards to the reservoir (Figure 6.3 and 6.4), no visible cracks were observed on the downstream side. The longitudinal direction of the dam was EW. The direction of the sliding took place towards the epicenter. Huge sliding occurred along a section, which was the old river course. It seems that the soil below may be liquefied. The foundation is sandstone and the surface deposit thickness should be about 1-2m. Some lateral spreading of ground was observed. Granular sands could be found along the cracks (Figure 6.4). This may be due to soil liquefaction as quartzitic sand with a repose angle of 32 degree are observed along the cracks. A large longitudinal crack appeared at the boulder toe of the dam. Boring and SPT were carried out to restore the damaged part before a rainy season (Figure 6.5).

Figure 6.2 Damage to Suvi earth dam

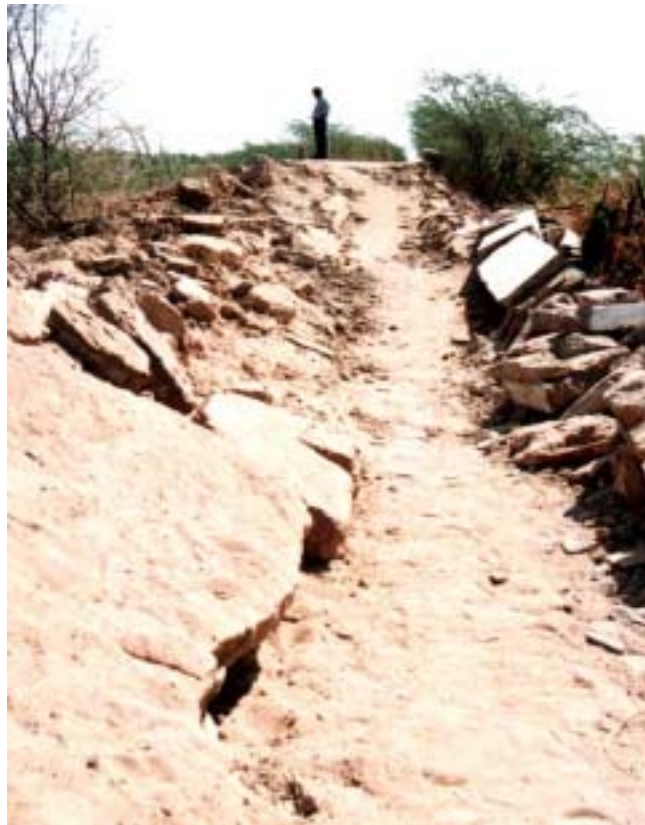
Figure 6.3 Settlement and slumping of Suvi dam towards upstream side

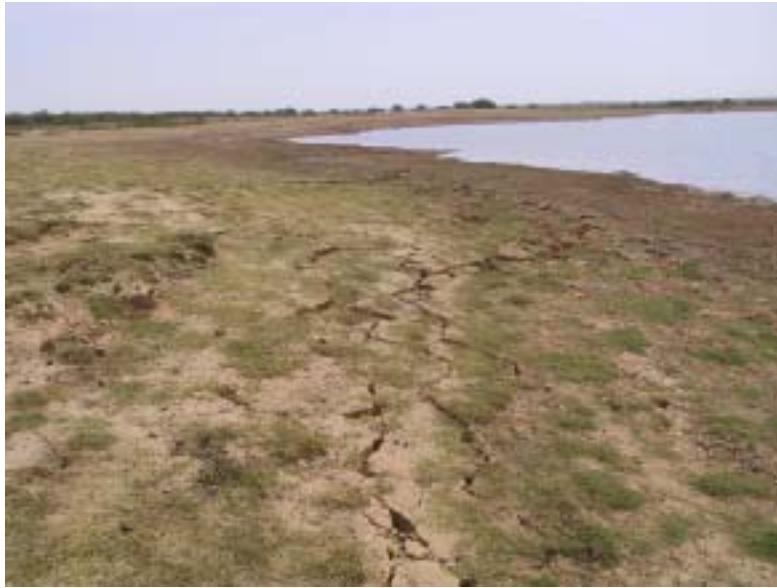
Figure 6.4 Lateral spreading of the ground due to the liquefaction

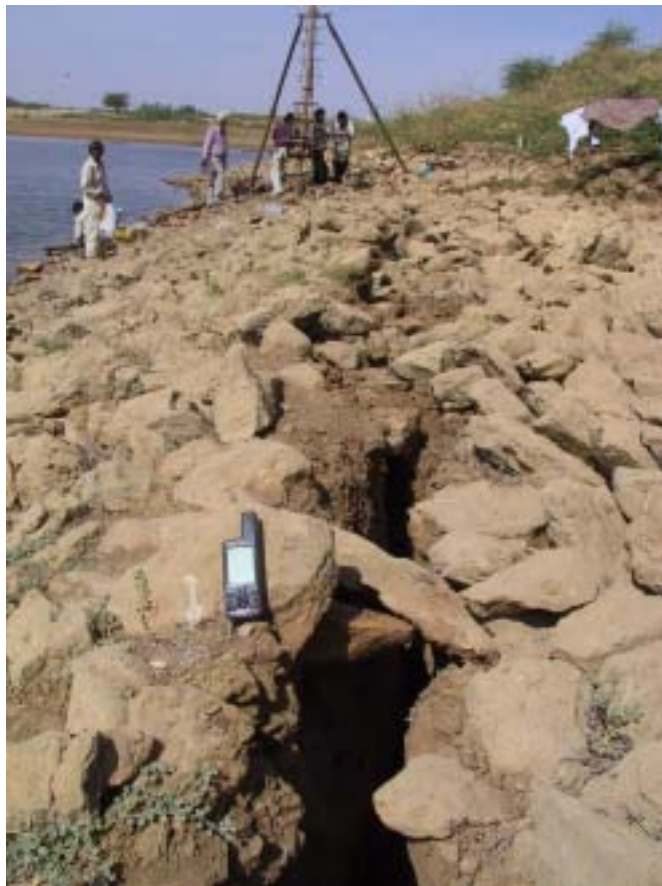
Figure 6.5 Large crack at the boulder toe.

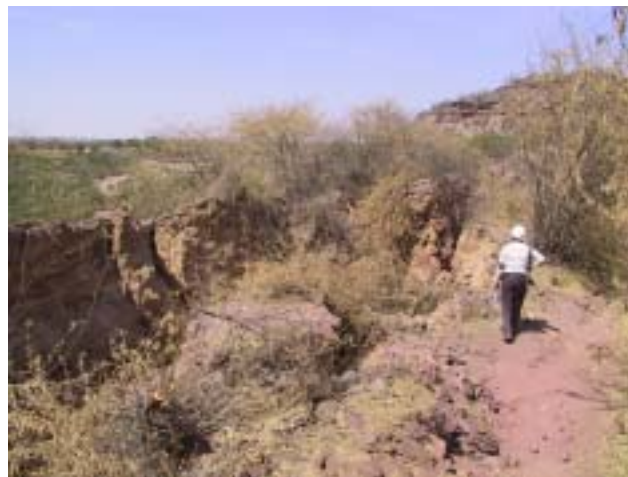
CHANG DAM: The Chang Dam with a height of 20m was built for irrigation purpose and it is an earth dam. The dam is mostly aligned in the EW direction with a curvature at its west end. The curved part of the dam failed (Figure 6.6). The downstream side of the dam moved northward while its upstream side moved southward. The failed part coincided with the old river stream. Although the base rock is mudstone with almost horizontal layering, the old river course may be consisted of sandy material. In the upstream side the sand boiling can be clearly observed even more than 50 days passed from the earthquake. A sketch of the dam failure is shown in Figure 6.7. It seems that the failure of the dam is due to liquefaction at its base as shown in Figure 6.8 and it resembles to the failure of San Fernandes dam. Furthermore, some lateral spreading could be observed at many locations around the reservoir. Water intake of this was masonry and it was totally collapsed (Figure 6.9).

Figure 6.6 Settlement and slumping of Chang dam

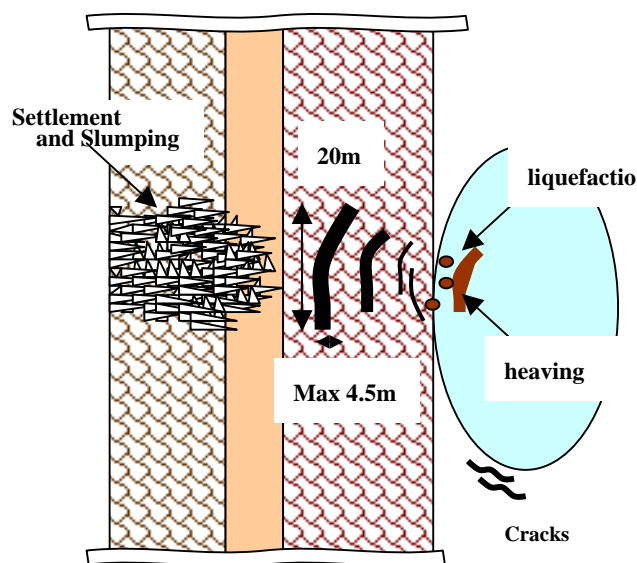
Figure 6.7 A sketch of failure of Chang earth dam

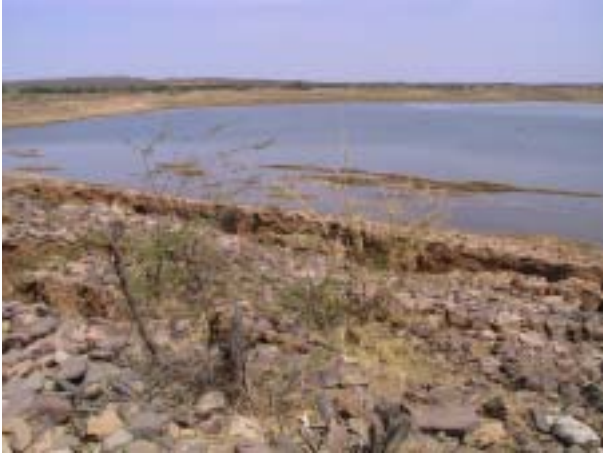
Figure 6.8 Upstream slope failure due to liquefaction

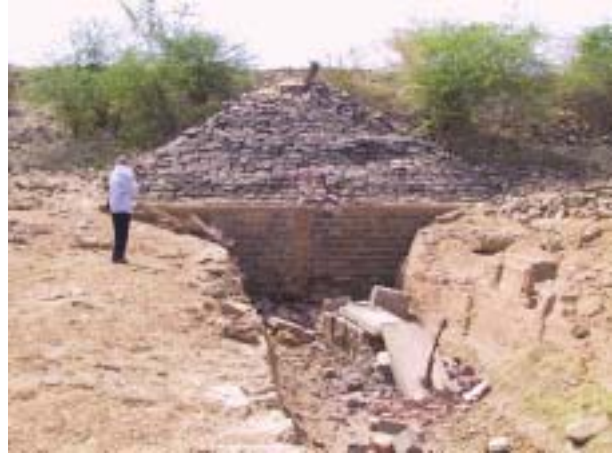
Figure 6.9 Failure of water intake tower

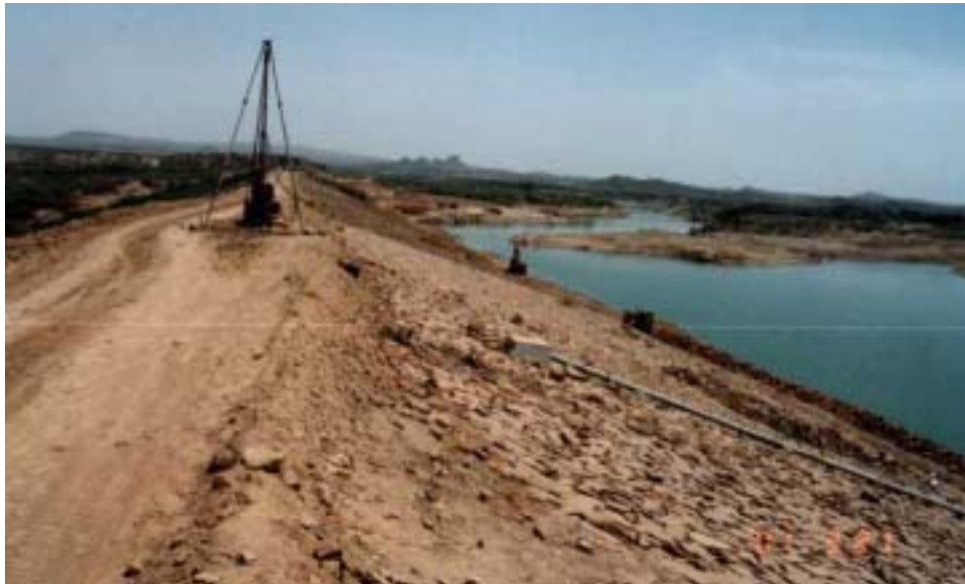
Figure 6.10 Rudramata dam

RUDRAMATA DAM: The dam was also earth-fill with a height of 20m. The downstream side of the dam was not damaged while the upstream side of the dam has cracks running along the longitudinal axis of the dam near the toe of the dam. The cracked section was removed and new soil placement was under construction. The water-intake tower is masonry and it was slightly damaged (Figures 6.10 & 6.11). In the dam reservoir some bulging of sandstone layers were visible. However, the cause of bulging was not well understood.
