Provisional Report on the June 23, 2001 Atico Earthquake, Peru (Updated 04, September, 2001)

PREFACE

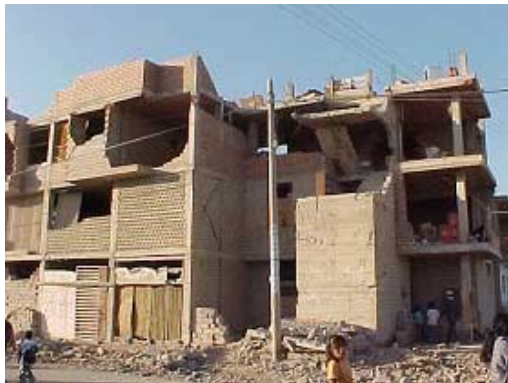
Figure 4

The northeast area, which has been being developed since 1980's along the northwestern hillside, was the most seriously damaged. Most dwellings there were RC framed with infill walls of mortar blocks and/or bricks (**Figure 4**).

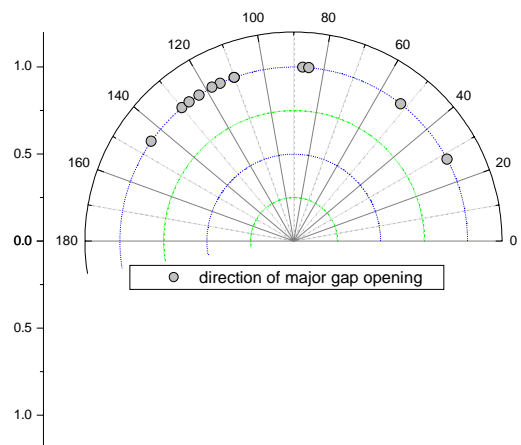
Utility poles (5m tall) are embedded upright in concrete-paved sidewalk. Cracks developing outwardly on the pavement from these poles were mapped. Some poles are very close to the step-shaped edge of the sidewalk. The thin cover concrete thus might have affected the crack pattern. Though the number of the examined utility poles is not sufficient for thorough statistical manipulations, some poles seem to have been forcibly shaken in about Northwest –Southeast direction, transverse direction of the valley (**Figure 5**).

Figure 5 Directions of major gap openings at bottom ends of utility poles (Tacna)

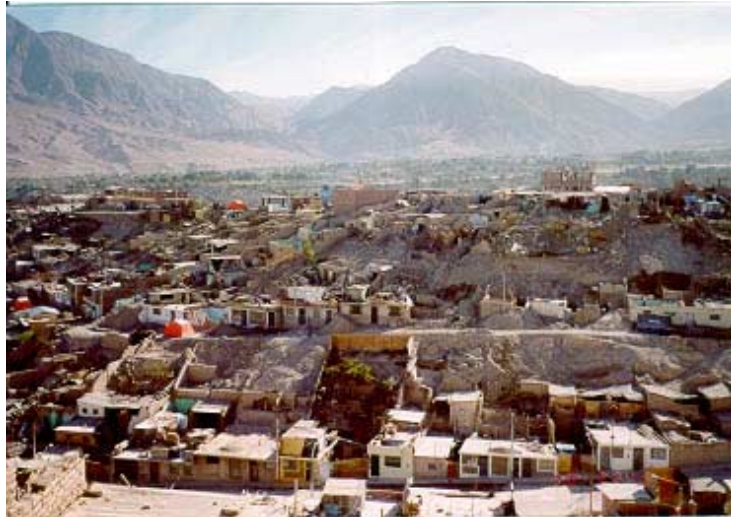
Moquega was the hardest hit city by this earthquake. A number of adobe buildings collapsed in the downtown area and many others sustained heavy damage. A thin mountain ridge, the northeast extension of a sand rock terrace rising behind the central area of Moquegua city, dips gently towards northeast. This ridge is densely covered with adobe dwellings, and the damage to dwellings was the severest there (**Figure 6**).

Figure 6 View of the terrace next to San Francisco hill

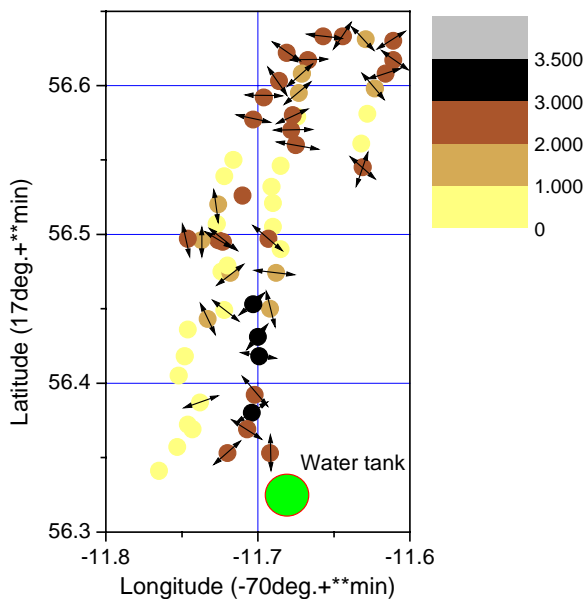
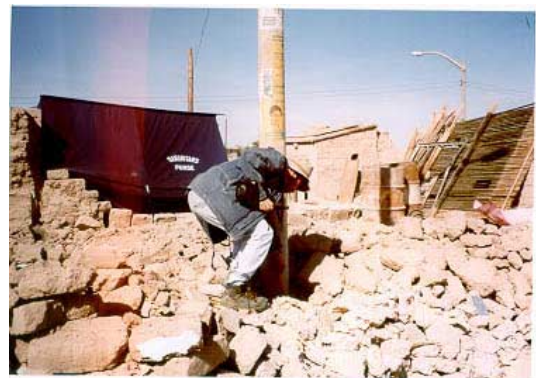
Figure 7 shows the observed distribution of crack intensities. Arrows indicate the inferred directions of strong ground motions. In this figure, the first, second and third lines from left to right lined up with the inspected utility poles are streets along a narrow valley, along the ridge and on the other hillside, respectively. It is noted that no utility pole along the valley was cracked while those around the highest peak of the ridge near a water tank (green solid circle) were severely cracked. This contrast suggests that some topographical effect must have been responsible for amplifying ground motions. The arrows along the ridge show that the effect was more pronounced in the transverse direction of the ridge.

Figure 7. Distribution of cracked utility poles in San Francisco area, Moquega

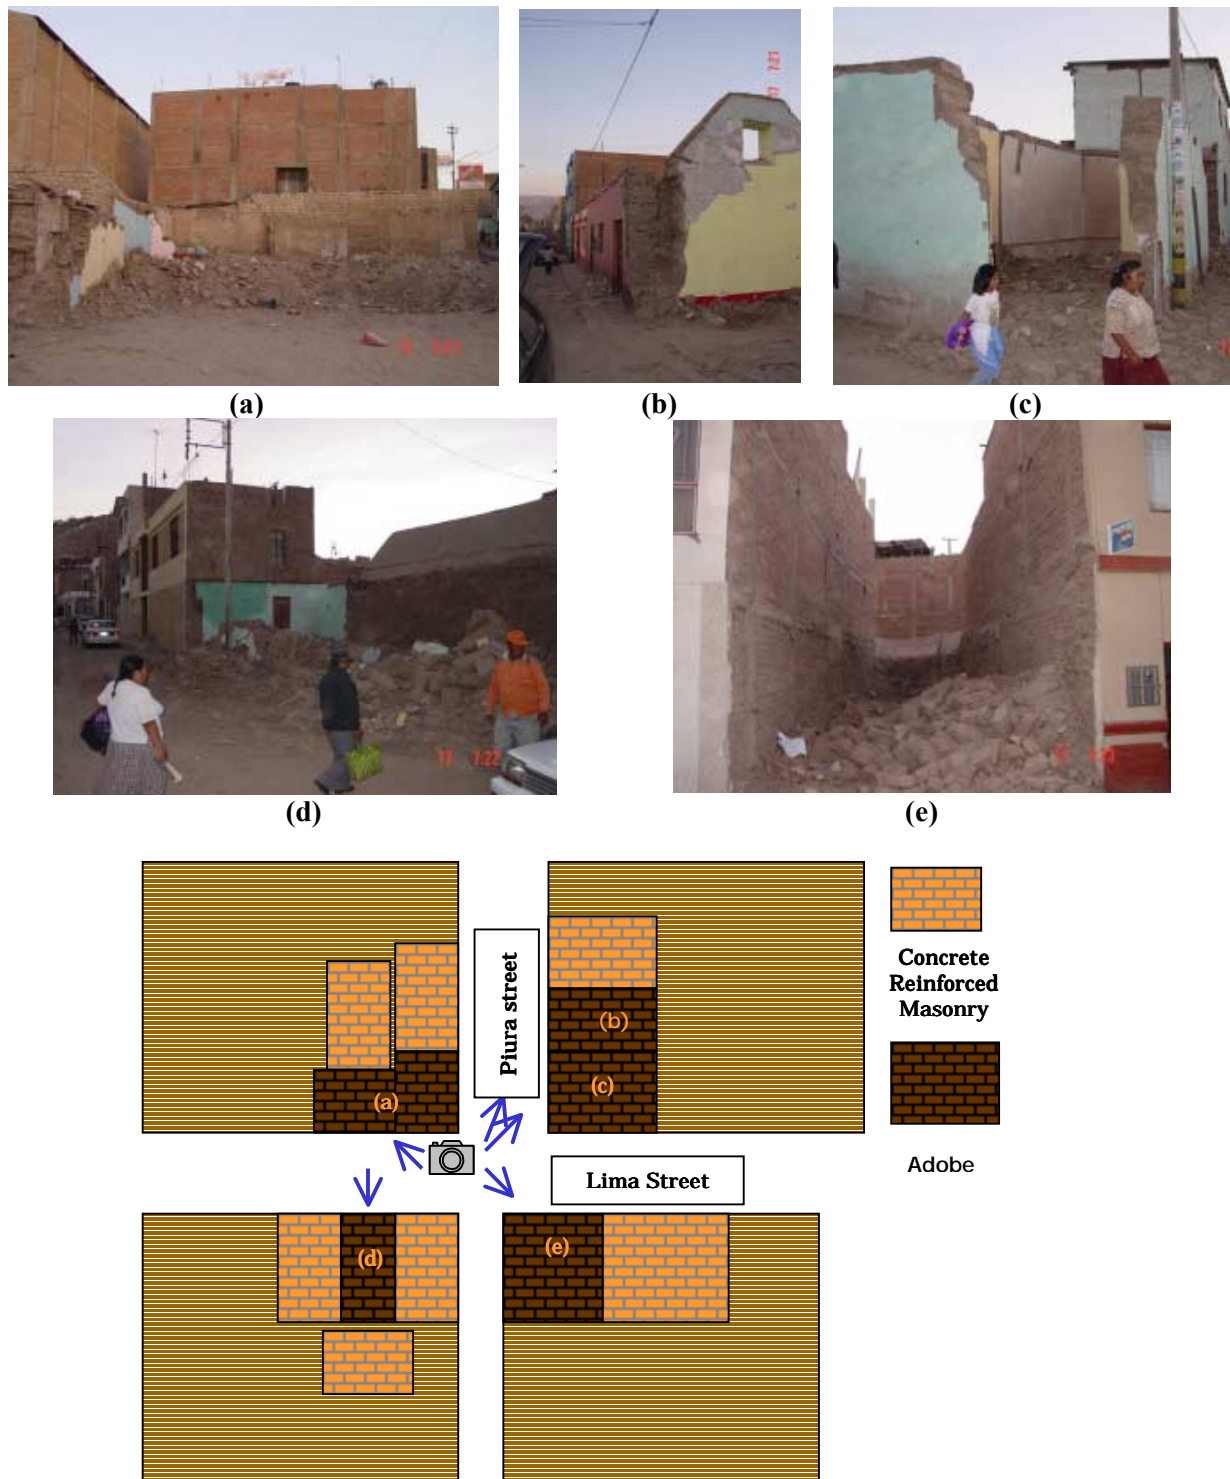
Structures of adobe performed in general badly as observed in many other earthquakes. Below follows a sketch and some figures showing collapsed adobe structures whereas neighboring reinforced masonry structures suffered on only minor damage (**Figure 10**). **Points (b)** and **(c)** show that a corner of an adobe structure is a weak point.

Figure 10. Sketch showing location of **Points (a)-(e)**.

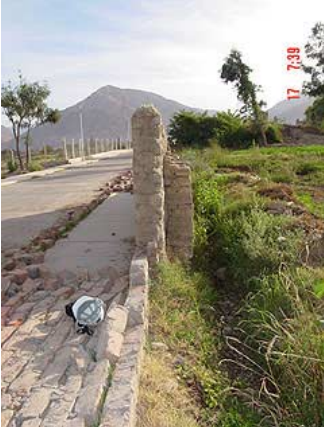
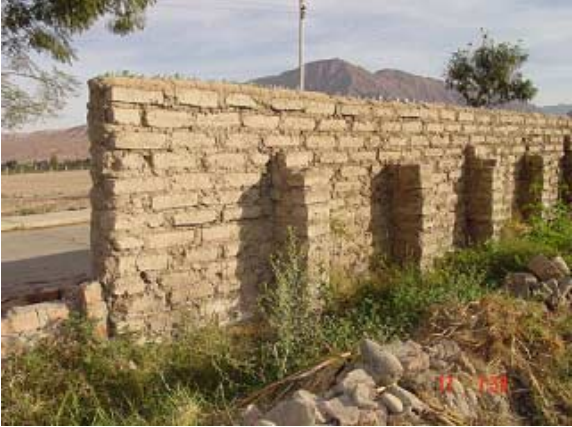
In **Figure 11** and **12** an adobe wall with side support still stands after the shake while the brick wall next to it fell over. This type of side support could be a simple but effective strengthening technique for adobe houses (**Figure 13**).

Figure 11: Standing adobe wall and fallen masonry wall.

Figure 12: Close up of side support

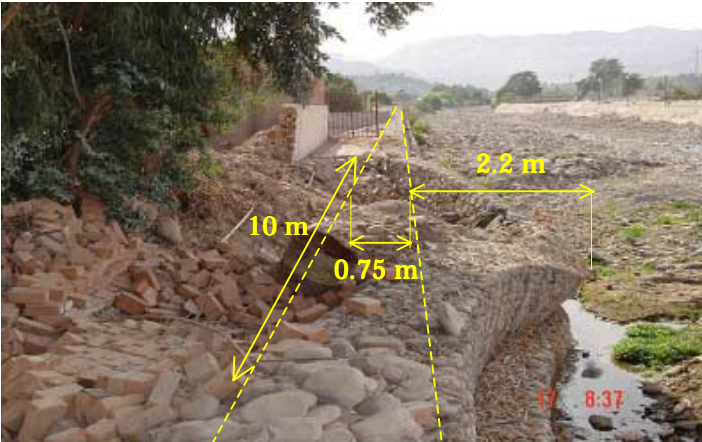
Figure 14 shows a gabion wall that even after undergoing around 44 % (2.2/5) shear strain in the vertical plane still has not ruptured. This is good example of the ductility of Mechanically Stabilized Earth structures. (Photo taken at the masonry factory in Moquegua, below the hotel El Mirador).

Figure 14. Deformed Gabion wall

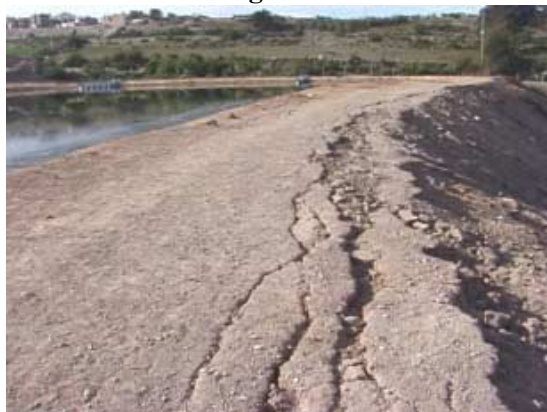
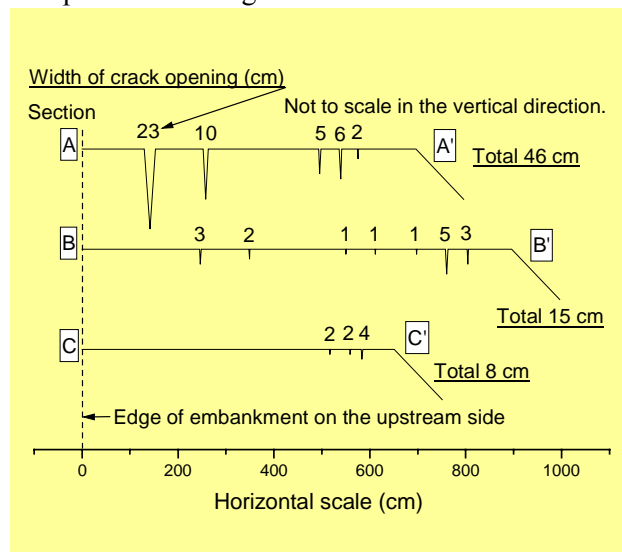
By the earthquake, the embankment on the downstream side of the lower pond suffered cracking in its crest (**Figure 16, left**). The total opening width of the cracks amounted up to 46 cm at maximum (**Figure 16, right**), and the residual settlement at the embankment shoulder was about 10 to 20 cm. In addition, the embankment between the upper and lower ponds became partly wet (**Figure 17**), suggesting a sign of piping. This location corresponds to a boundary between the original embankment constructed 40 years ago and the newer embankment re-constructed 6 years ago.

Figure 16. Longitudinal cracks

After the earthquake, in order to avoid instability of these embankments, the water level in both ponds were lowered by about 1 m. In order to cope with the current influent flow rate of 120 liters per second, which exceeds the design flow rate of 38 liters per second, the oxidation period had to be reduced down to 5 hours from the design value of 10 hours. These operations resulted into poor quality of treated water, which was used for irrigation purposes. Because the pipes to distribute the treated water were also damaged by the earthquake, it leaked into the adjacent Osmore River, affecting the quality of the river water.

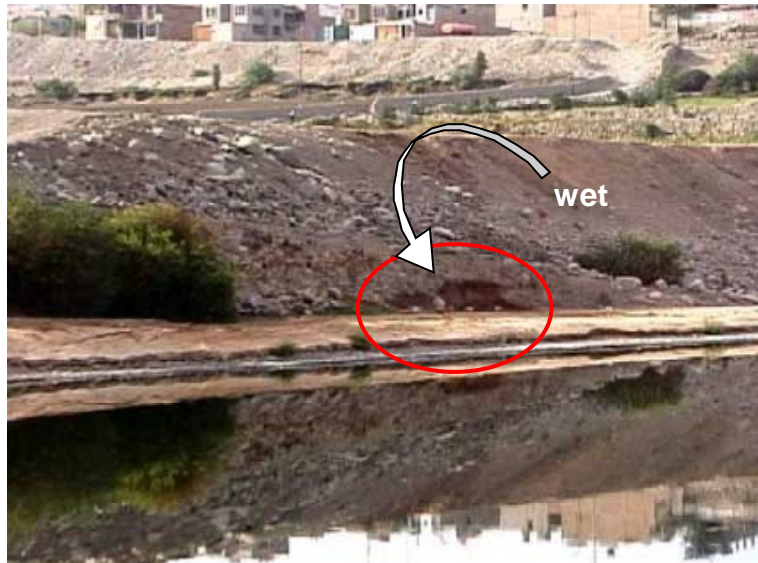
Figure 17. Embankment between the upper and lower ponds

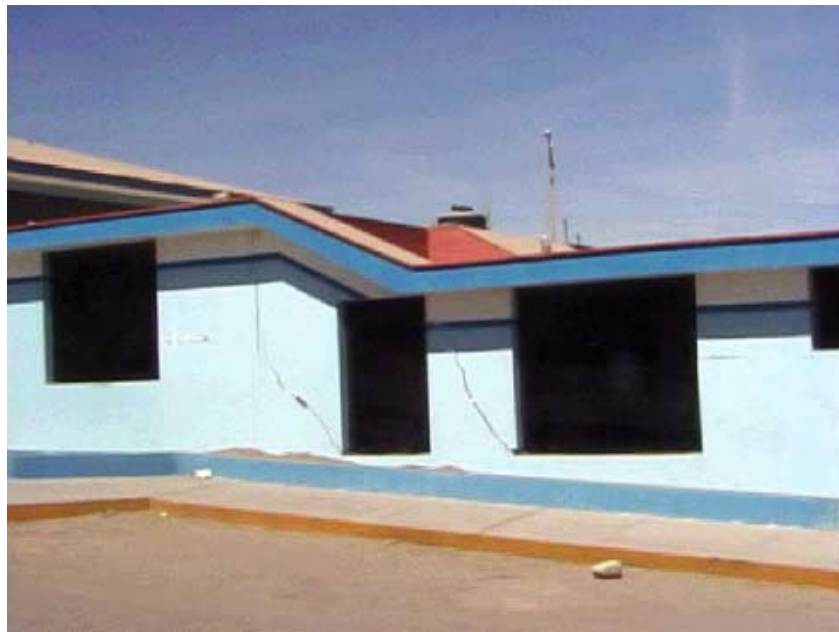
At San Antonio in Moquegua, one school constructed on expansive soil layers suffered extensive cracks in the walls and floors (**Figure 18**). They had been formed before the earthquake, which were not worsened by the earthquake. Similar damage to adjacent houses was also observed. It is reported that the expansive soil layers were activated by water leaking from sewage pipes installed in the affected area.

Figure 18. School constructed on expansive soil layers

In Moquegua, a plan of developing a new residential area for those who lost their houses in the severely damaged area (San Francisco, **Figures 6 and 7**) is under way. In order to avoid any damage in the newly developed area due to the expansive soils, it is required to establish procedures for detecting the existence of expansive soil layers and for evaluating their effects on buildings and underground pipes.

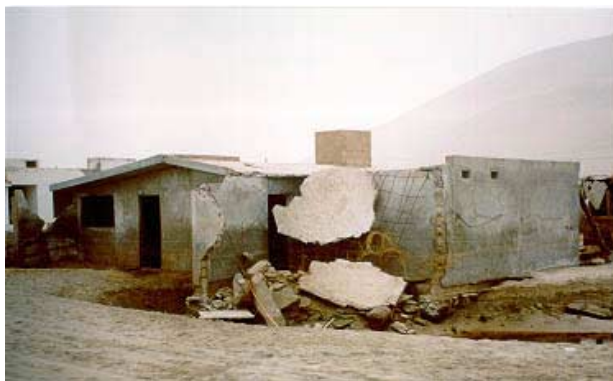
The orange colored zone in **Figure 19** is considered to have been inundated with water. The surges destroyed a great number of dwellings, hotels and restaurants there (**Figures 20** and **21**). The inundated zone was covered thin with wet fine silty soils suggesting that the water surged over the zone was stopped there for a while as is shown in **Figure 22(c)**. From a number of RC columns pushed down (**Figure 22(a)**), possible directions of tsunami surges were estimated (**Figure 22 (b)**).

Figure 20. Destroyed dwellings by tsunami

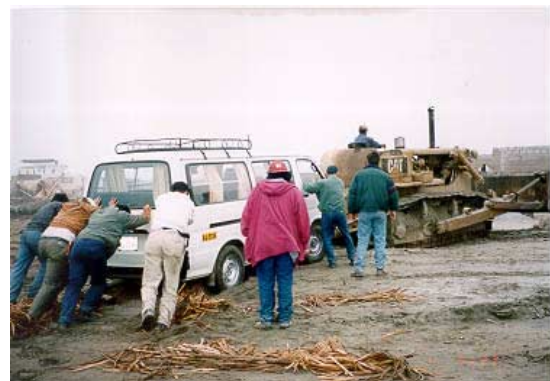
Figure 21. A car caught in soft silty soils

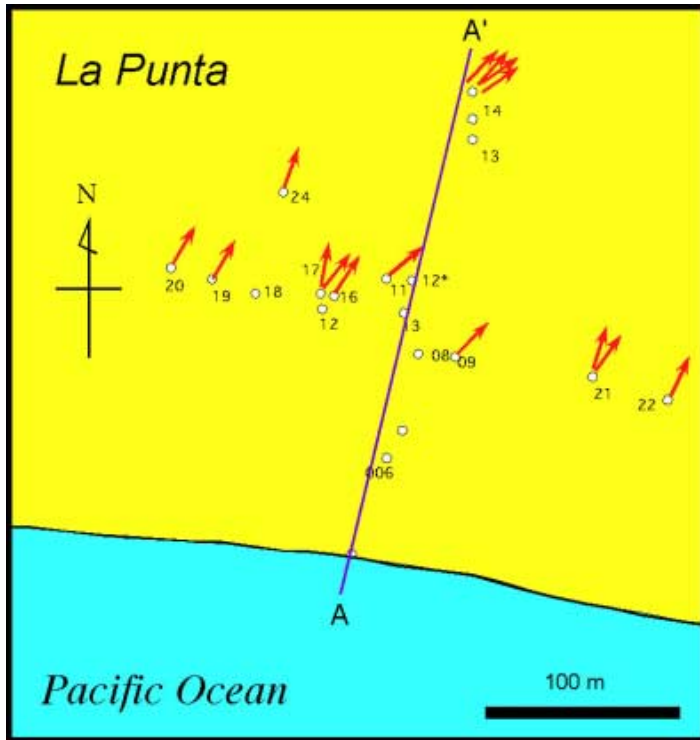
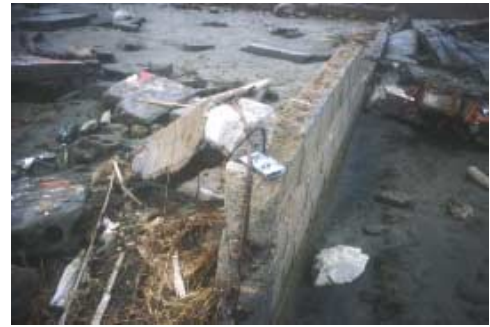
↑ (a) reinforcing bars bent by tsunami

Figure 22. Possible directions of tsunami surge and estimated tsunami height

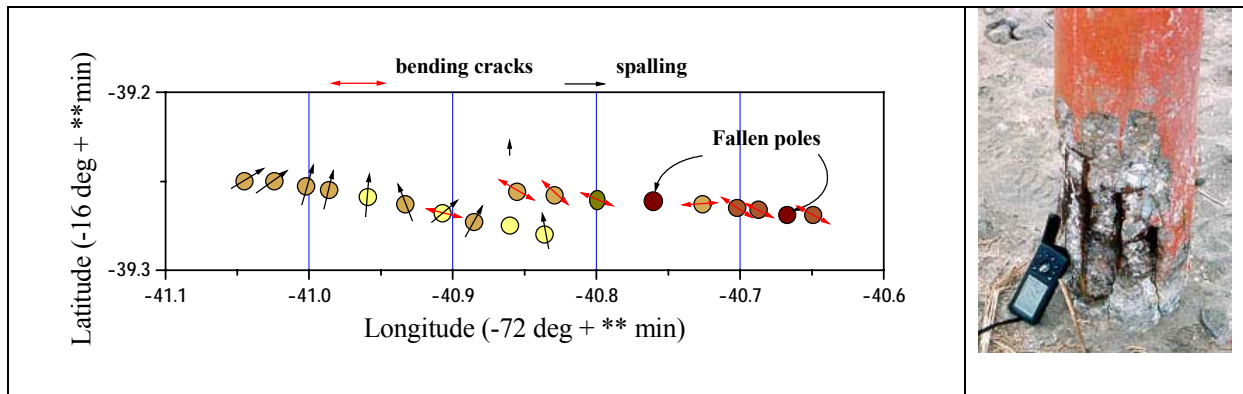
Direction of the surge was also estimated from spalled utility poles (**Figure 23**). Two lines of utility poles along the coast were examined. Most poles on the front were still standing almost upright while those about 100m inland were more or less tilted because their foot soils were scoured by the surge. Probably for this reason, spalled poles were mostly found on the front. Lateral hair cracks were found on some poles, which seemingly suggest that the poles have experienced lateral shake before the area was inundated. The red arrows show inferred directions of strong ground motion, which seem to have been intense in about EW direction.

Figure 23. Spalled and cracked utility poles

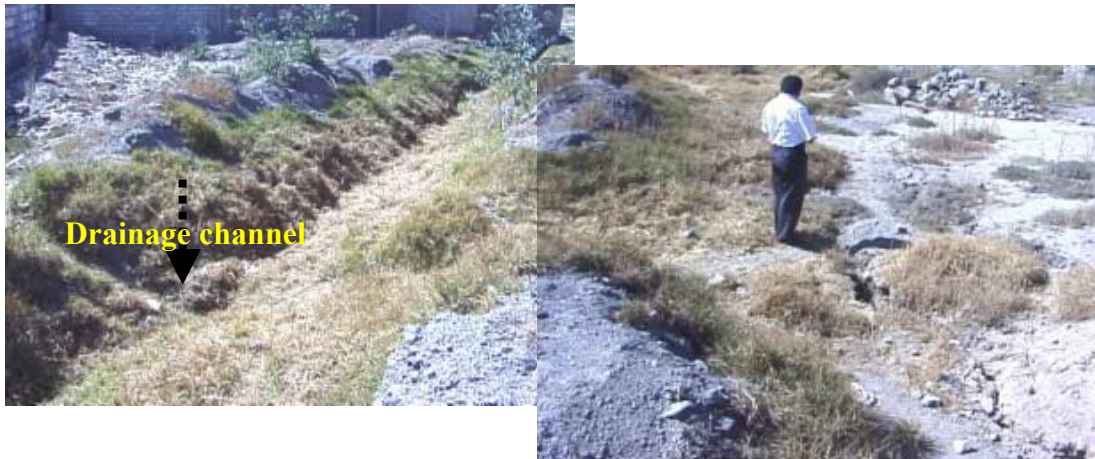
Liquefaction occurred in a lowland of Arequipa (at Lara, Socabaya district; latitude of $S16^{\circ}27.271'$, longitude of $W71^{\circ}32.148'$, and elevation of 2288 m). It induced lateral spreading of ground as typically shown in **Figures 24a** and **24b**. The plan of the affected area is shown in **Figure 25**. The lateral spreading caused collapse of brick walls (**Figure 26a**) and closing of drainage channels that had an original opening width of about 50 cm (**Figure 26b**). Several cracks were also formed in almost level ground at a horizontal distance of about 25 m from the closed drainage channel (**Figure 26c**). It should be noted that there was no damage to concrete pipes with a diameter of about 50 cm used for the drainage channel to under-pass an unpaved road (**Figure 25**).

(a) Lateral spreading toward drainage channel

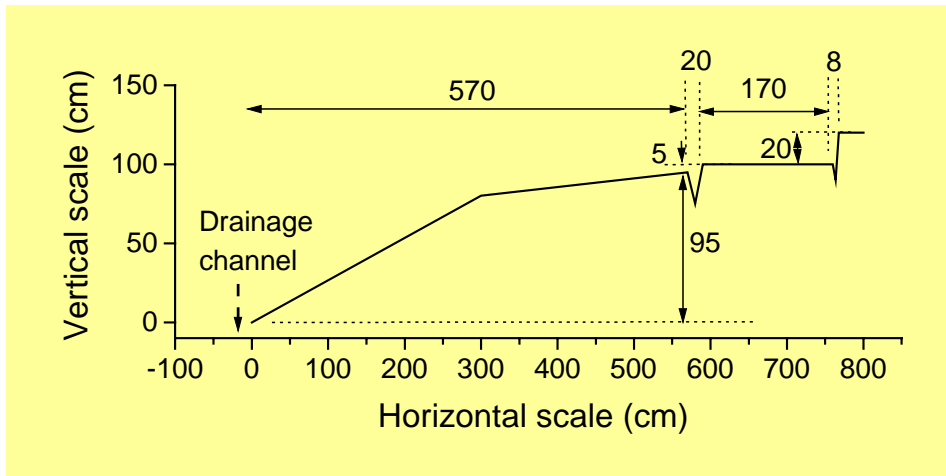
(b) Cross-section of lateral spreading

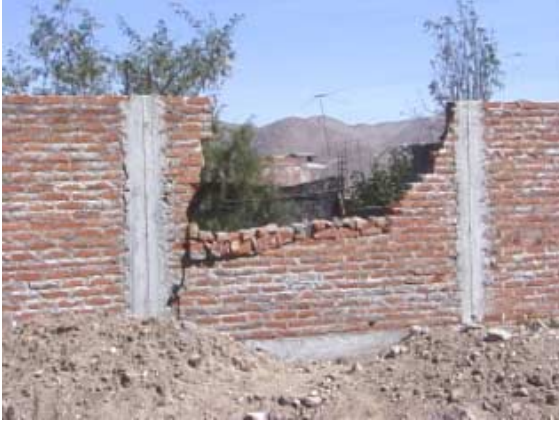
(a) Collapsed brick wall due to lateral spreading

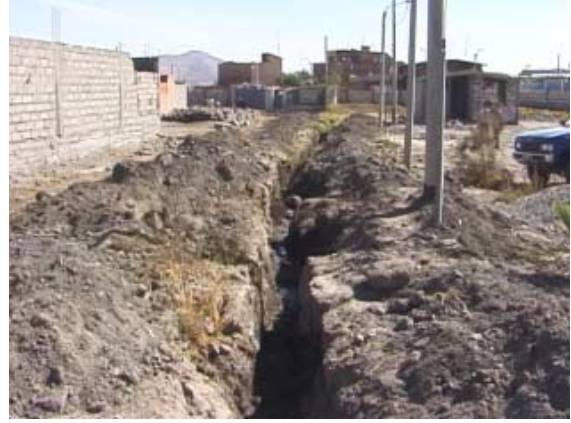
(b) Re-excavated drainage channel that was clogged with spread soil

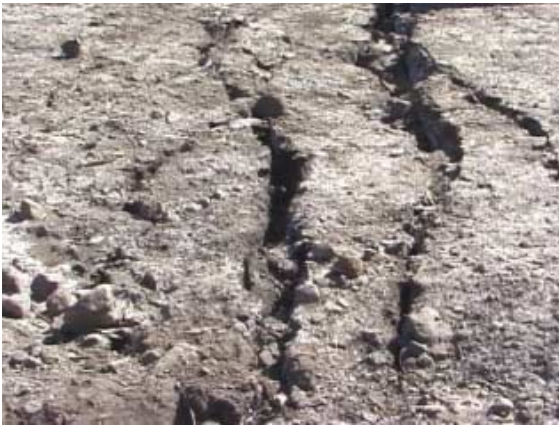
(c) Cracking in ground surface located at a horizontal distance of about 25 m from drainage channel

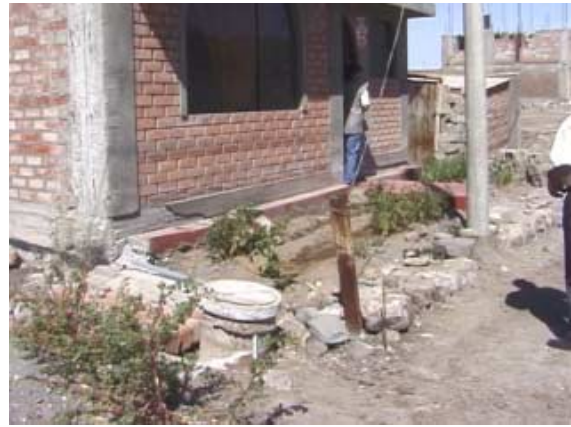
In the affected area, one house suffered uplift of sewage catch basin by about 20 cm (**Figure 26e**) and heaving of house floor due to sand boils (**Figure 26f**). The boiled sand was black under wet state and white under dry state, possibly containing some volcanic or organic components, which also contained coarser particles having a maximum diameter of about 5 mm. It is reported that the heaving took place during the earthquake shaking. It was accompanied by additional ejection of water that lasted for about 1 day, which may have been affected by the re-excavation work of the closed drainage channel.

(d) Uplift of sewage catch basin located near drainage channel

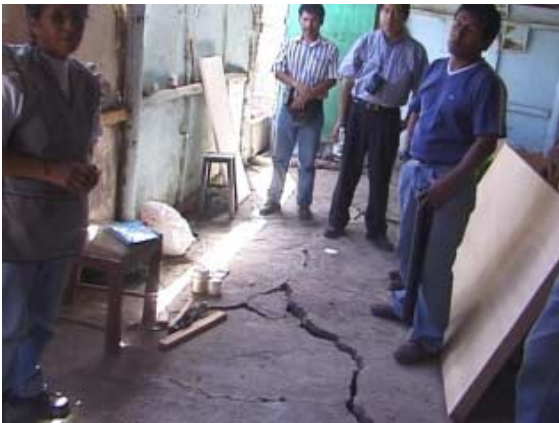
(e) Heave of house floor due to sand boil

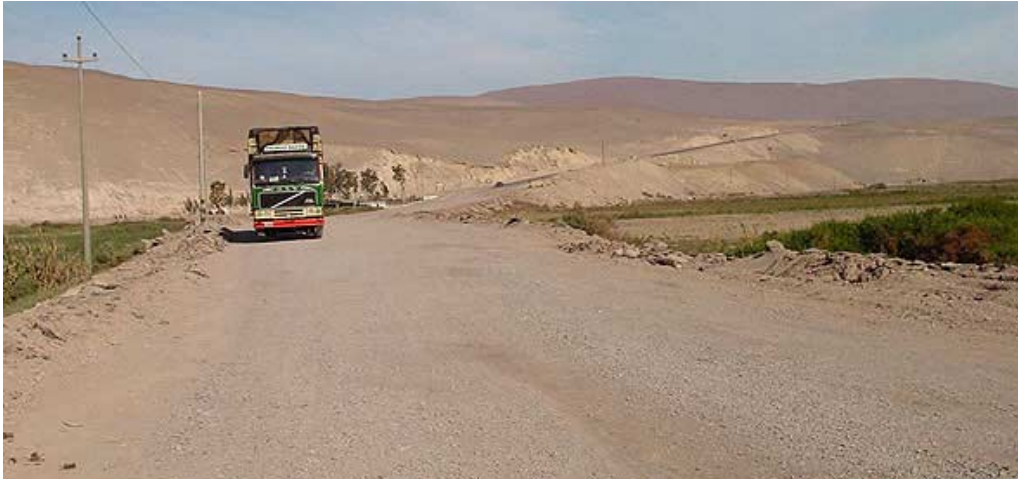
At the 1213 km of the Pan American Highway the ground shaking damaged the pavement so much that it had to be removed to allow the traffic to pass (**Figure 27**) and heavy traffic was redirected to another route. The white rail side guard along the road buckled severely due to the large soil deformations as seen on the right side of **Figure 28**. The large ground deformations may have been a combination of a basin effect and soft soil layers since the damaged part of the road is situated in an alluvial valley. Similar road damage was observed at other alluvial valleys along the part of the Pan American highway between Tacna and Moquegua.

Figure 27. Pan American Highway Pavement removed after damaged due the earthquake (looking in southbound direction).

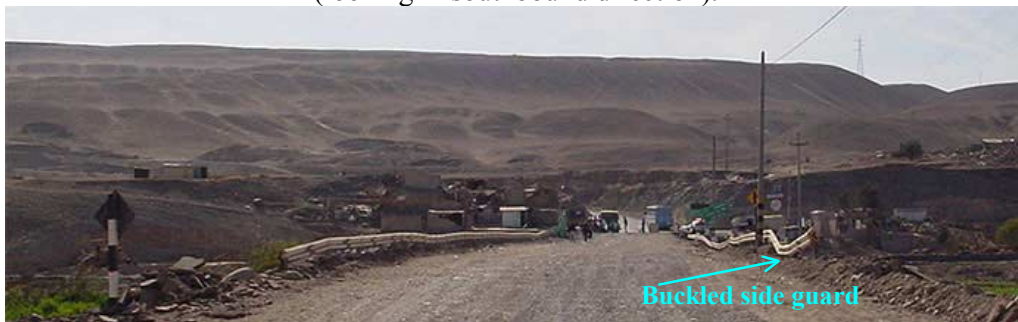
Figure 28. Buckled side guard (looking in northbound direction).

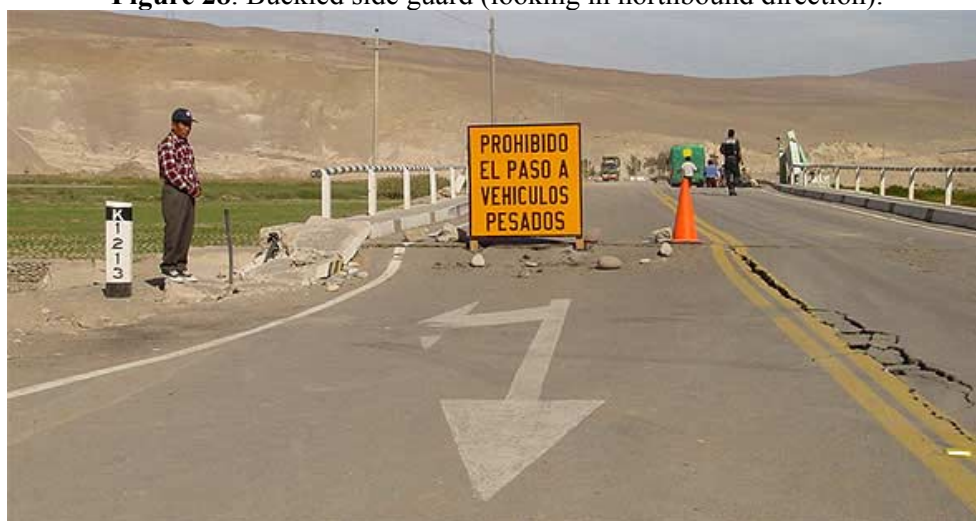
Figure 29. Settlement of bridge approach and cracking of road. Only one lane is open for traffic (looking in southbound direction).
