Provisional Report on the June 23, 2001 Atico Earthquake, Peru (Updated 04, September, 2001)

SOURCE CHARACTERISTICS AND STRONG GROUND MOTION

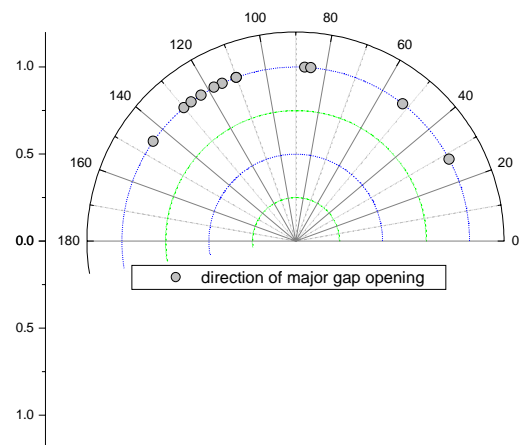
Utility poles (5m tall) are embedded upright in concrete-paved sidewalk. Cracks developing outwardly on the pavement from these poles were mapped. Some poles are very close to the step-shaped edge of the sidewalk. The thin cover concrete thus might have affected the crack pattern. Though the number of the examined utility poles is not sufficient for thorough statistical manipulations, some poles seem to have been forcibly shaken in about Northwest –Southeast direction, transverse direction of the valley (**Figure 5**).

Figure 5 Directions of major gap openings at bottom ends of utility poles (Tacna)

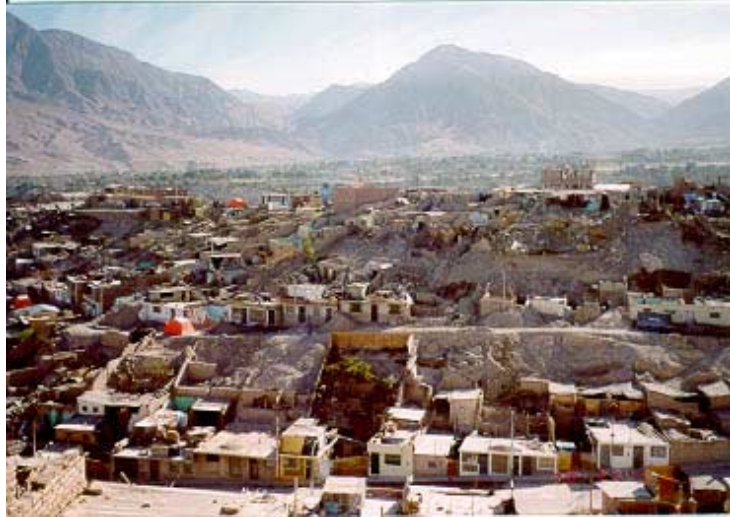
Moquega was the hardest hit city by this earthquake. A number of adobe buildings collapsed in the downtown area and many others sustained heavy damage. A thin mountain ridge, the northeast extension of a sand rock terrace rising behind the central area of Moquegua city, dips gently towards northeast. This ridge is densely covered with adobe dwellings, and the damage to dwellings was the severest there (**Figure 6**).

Figure 6 View of the terrace next to San Francisco hill

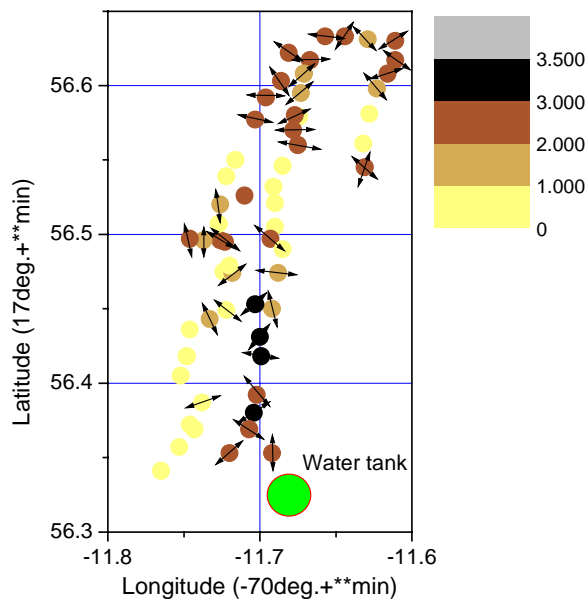
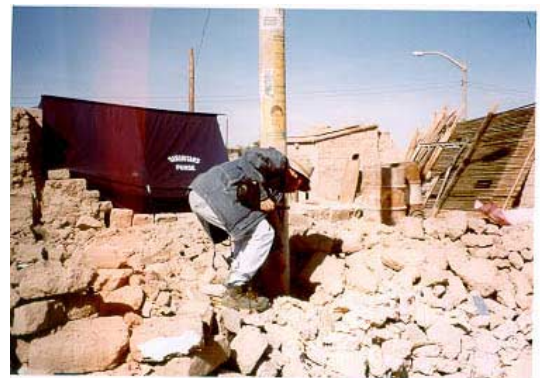
Figure 7 shows the observed distribution of crack intensities. Arrows indicate the inferred directions of strong ground motions. In this figure, the first, second and third lines from left to right lined up with the inspected utility poles are streets along a narrow valley, along the ridge and on the other hillside, respectively. It is noted that no utility pole along the valley was cracked while those around the highest peak of the ridge near a water tank (green solid circle) were severely cracked. This contrast suggests that some topographical effect must have been responsible for amplifying ground motions. The arrows along the ridge show that the effect was more pronounced in the transverse direction of the ridge.

Figure 7. Distribution of cracked utility poles in San Francisco area, Moquega

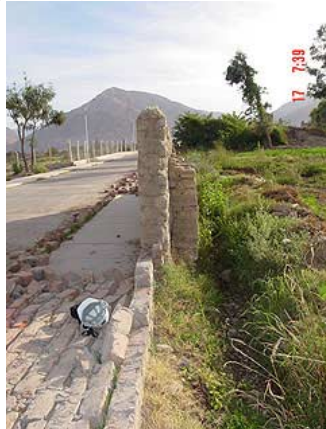
In **Figure 11** and **12** an adobe wall with side support still stands after the shake while the brick wall next to it fell over. This type of side support could be a simple but effective strengthening technique for adobe houses (**Figure 13**).

Figure 11: Standing adobe wall and fallen masonry wall.

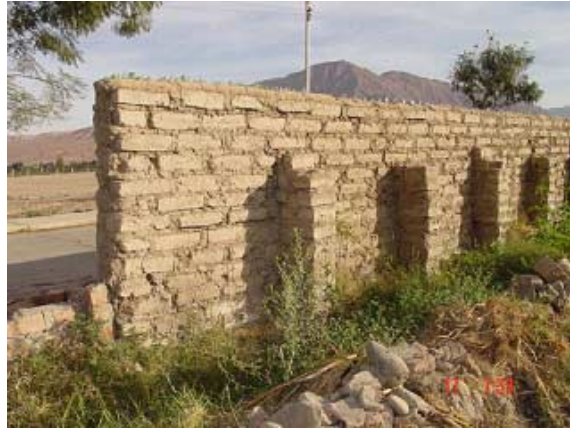
Figure 12: Close up of side support

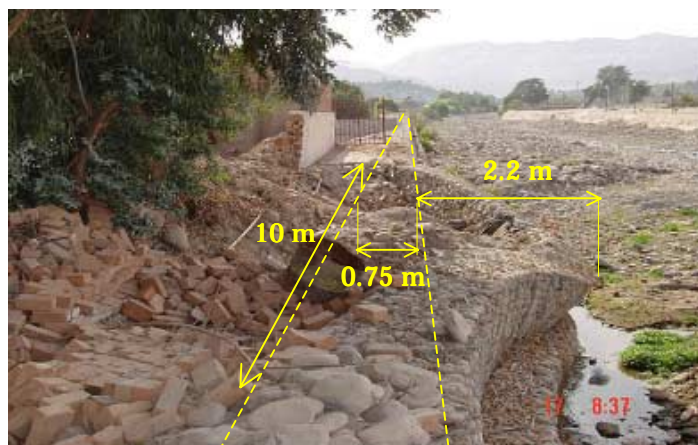
Figure 14 shows a gabion wall that even after undergoing around 44 % (2.2/5) shear strain in the vertical plane still has not ruptured. This is good example of the ductility of Mechanically Stabilized Earth structures. (Photo taken at the masonry factory in Moquegua, below the hotel El Mirador).

Figure 14. Deformed Gabion wall

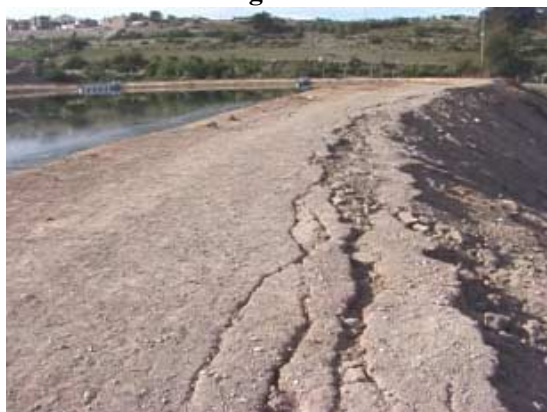
By the earthquake, the embankment on the downstream side of the lower pond suffered cracking in its crest (**Figure 16, left**). The total opening width of the cracks amounted up to 46 cm at maximum (**Figure 16, right**), and the residual settlement at the embankment shoulder was about 10 to 20 cm. In addition, the embankment between the upper and lower ponds became partly wet (**Figure 17**), suggesting a sign of piping. This location corresponds to a boundary between the original embankment constructed 40 years ago and the newer embankment re-constructed 6 years ago.

Figure 16. Longitudinal cracks

After the earthquake, in order to avoid instability of these embankments, the water level in both ponds were lowered by about 1 m. In order to cope with the current influent flow rate of 120 liters per second, which exceeds the design flow rate of 38 liters per second, the oxidation period had to be reduced down to 5 hours from the design value of 10 hours. These operations resulted into poor quality of treated water, which was used for irrigation purposes. Because the pipes to distribute the treated water were also damaged by the earthquake, it leaked into the adjacent Osmore River, affecting the quality of the river water.

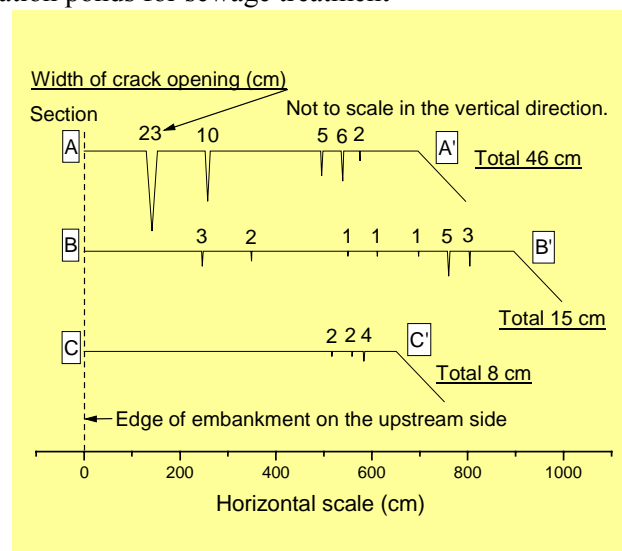
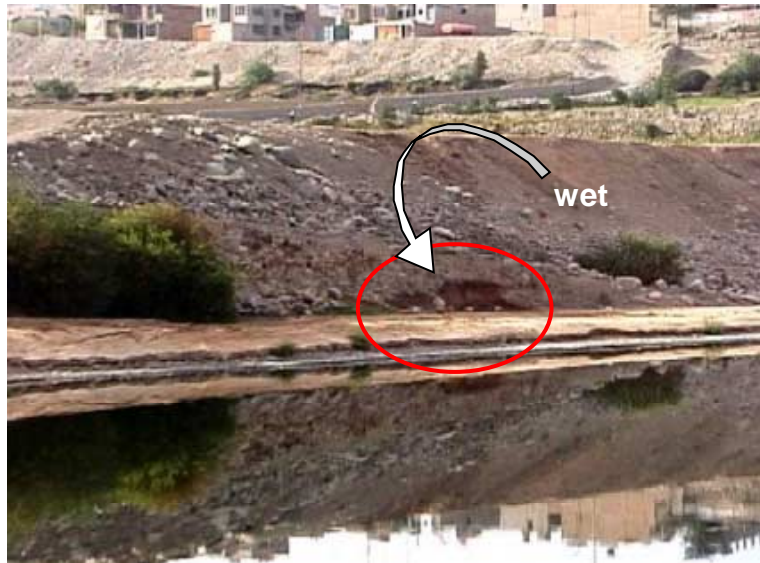
Figure 17. Embankment between the upper and lower ponds

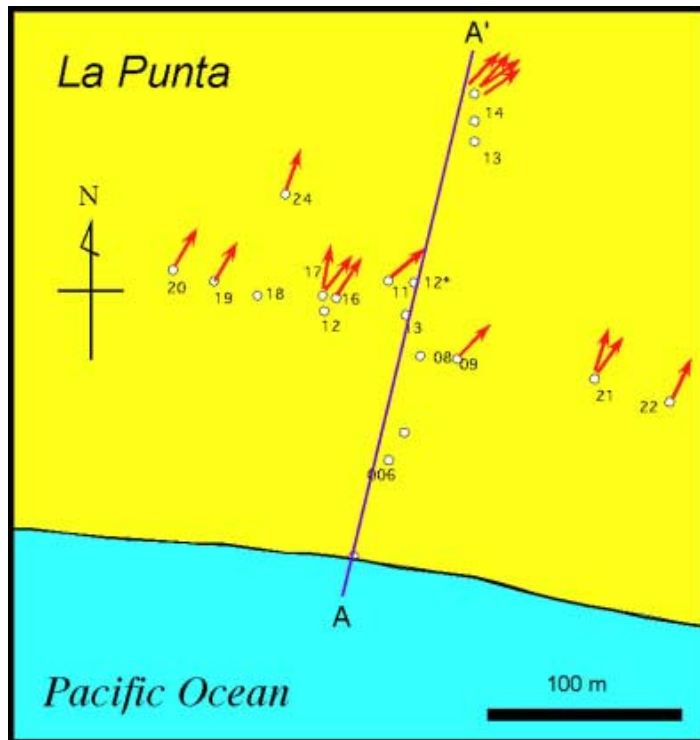
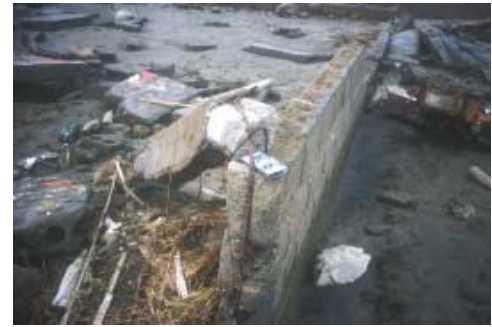
↑ (a) reinforcing bars bent by tsunami

← (b) Possible directions of tsunami surge

Figure 22. Possible directions of tsunami surge and estimated tsunami height

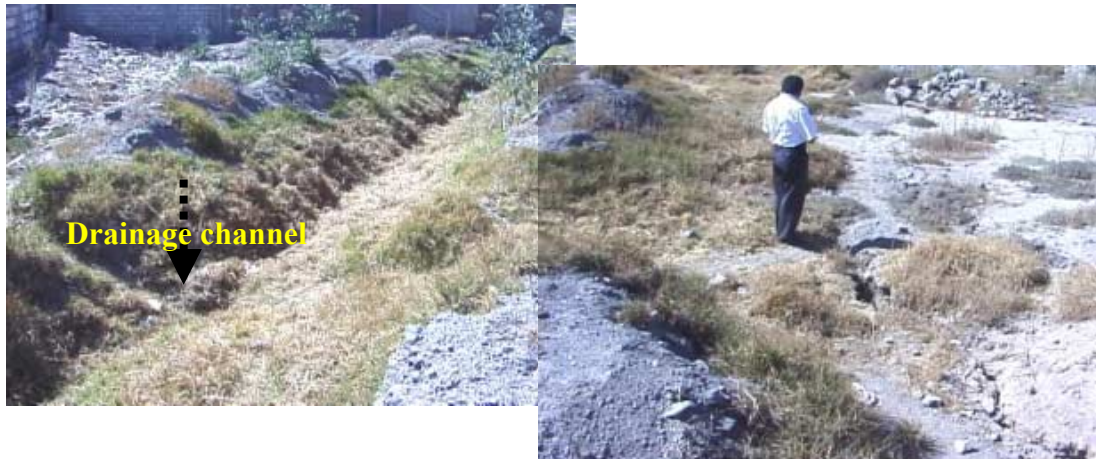
Liquefaction occurred in a lowland of Arequipa (at Lara, Socabaya district; latitude of S16°27.271', longitude of W71°32.148', and elevation of 2288 m). It induced lateral spreading of ground as typically shown in **Figures 24a** and **24b**. The plan of the affected area is shown in **Figure 25**. The lateral spreading caused collapse of brick walls (**Figure 26a**) and closing of drainage channels that had an original opening width of about 50 cm (**Figure 26b**). Several cracks were also formed in almost level ground at a horizontal distance of about 25 m from the closed drainage channel (**Figure 26c**). It should be noted that there was no damage to concrete pipes with a diameter of about 50 cm used for the drainage channel to under-pass an unpaved road (**Figure 25**).

(a) Lateral spreading toward drainage channel

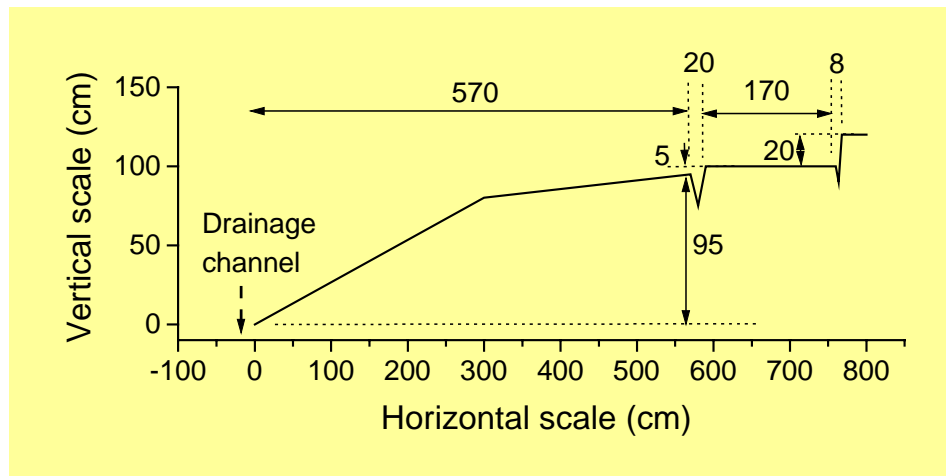
(b) Cross-section of lateral spreading

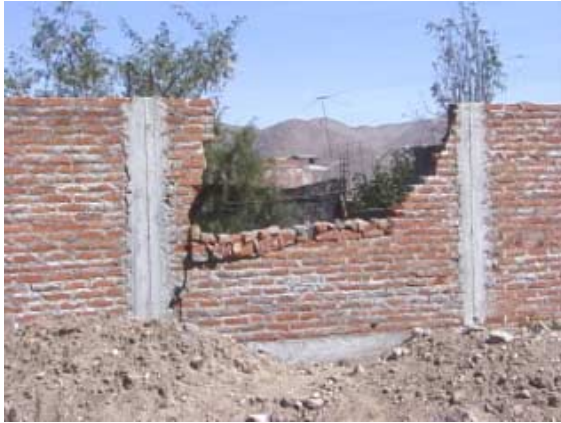
(a) Collapsed brick wall due to lateral spreading

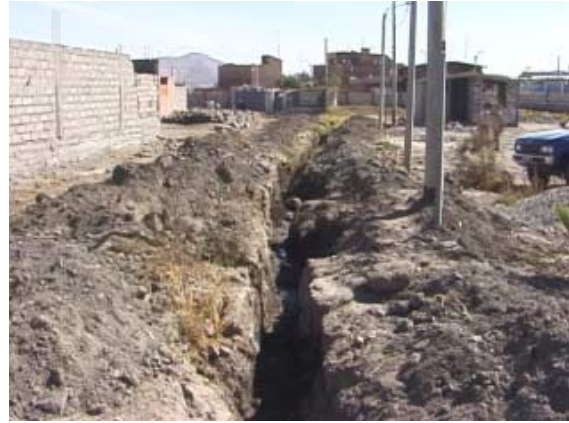
(b) Re-excavated drainage channel that was clogged with spread soil

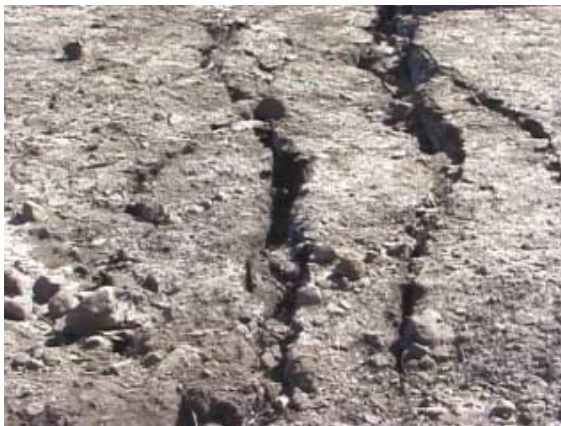
(c) Cracking in ground surface located at a horizontal distance of about 25 m from drainage channel

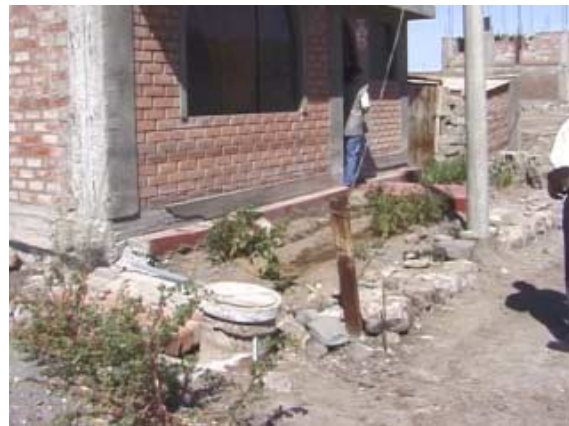
In the affected area, one house suffered uplift of sewage catch basin by about 20 cm (**Figure 26e**) and heaving of house floor due to sand boils (**Figure 26f**). The boiled sand was black under wet state and white under dry state, possibly containing some volcanic or organic components, which also contained coarser particles having a maximum diameter of about 5 mm. It is reported that the heaving took place during the earthquake shaking. It was accompanied by additional ejection of water that lasted for about 1 day, which may have been affected by the re-excavation work of the closed drainage channel.

(d) Uplift of sewage catch basin located near drainage channel

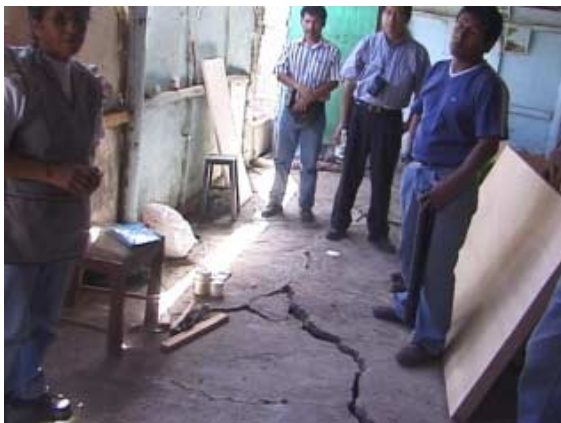
(e) Heave of house floor due to sand boil

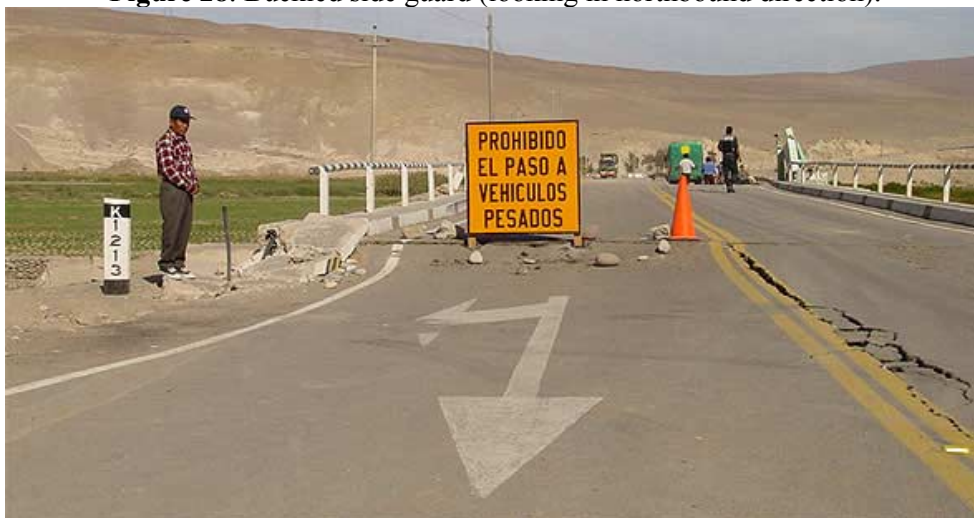
Figure 29. Settlement of bridge approach and cracking of road. Only one lane is open for traffic (looking in southbound direction).
