5. DAMAGE TO BUILDINGS AND DWELLINGS

5.2 STRUCTURAL DAMAGE SURVEY

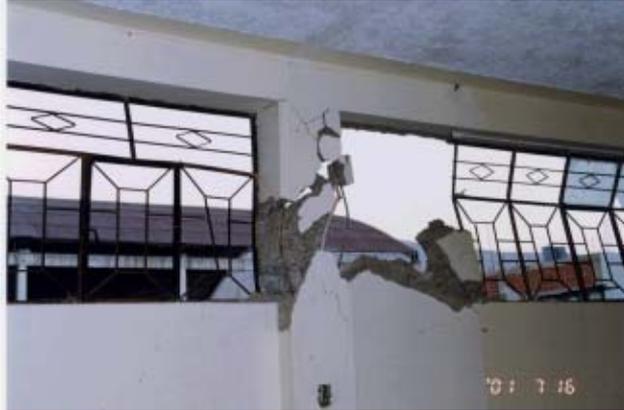
(1) Damage to short columns: This type of damage was extensive at schools and public buildings. Insufficient gaps between columns and non-structural elements caused large shear forces to be induced on the short columns (**Photos 5.2 and 5.3**). The damage was the worse for the insufficient transverse reinforcement and for the rusty rebars causing spalling of cover concrete.

Photo 5.2 (above) Municipality office, Tacna

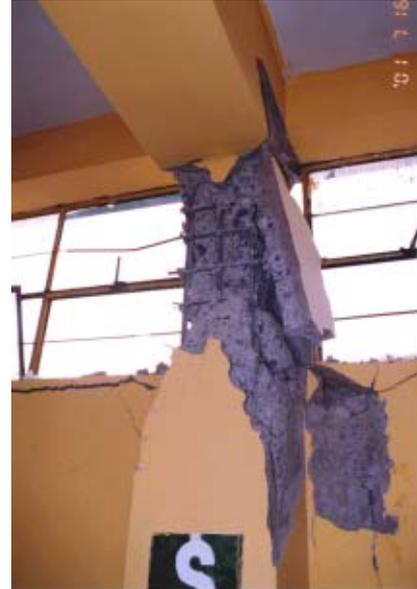
Photo 5.3 (right) Andres Avelino Caceres School, Tacna. The green sign “S” on the column says that the place is “safe” during a seismic event.

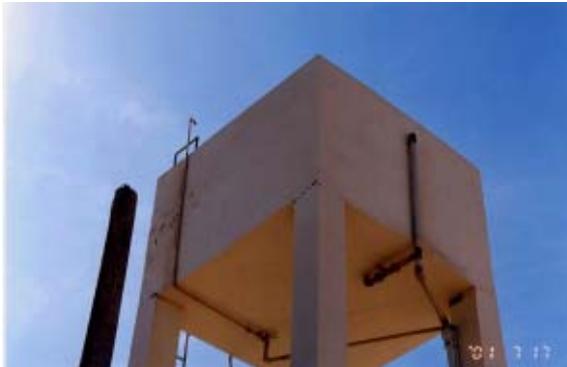
(2) Damage to columns for elevated water tanks: In the photos below, damage was found localized at both the columns-tank connections and the short columns.

Photo 5.4 Elevated water tank, San Antonio School, Tacna

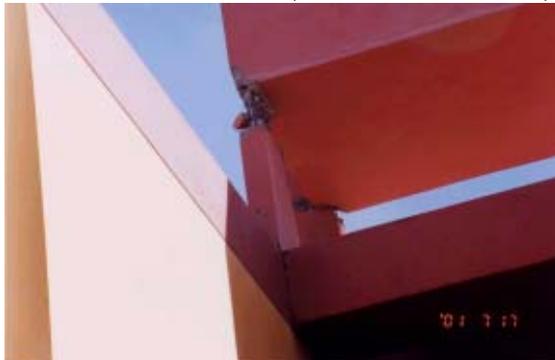
Photo 5.5 Elevated water tank at a residential building, Tacna

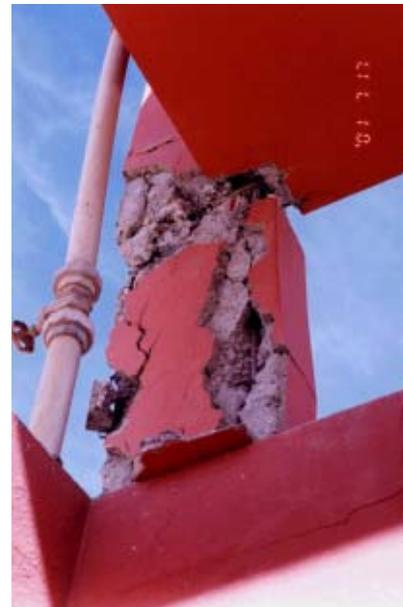
Photo 5.6 Elevated water tank at a residential building, Tacna.

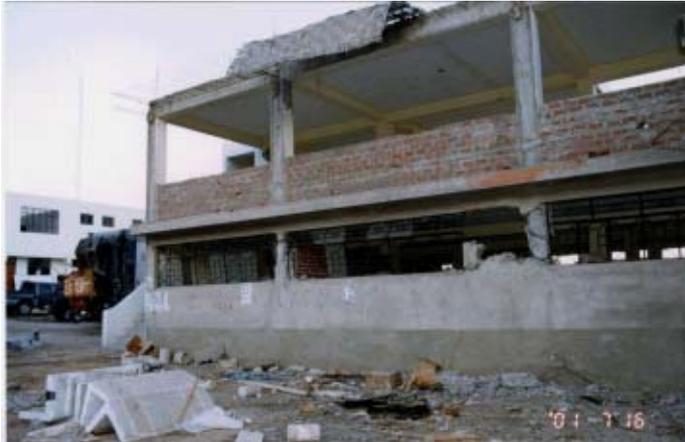
(3) Deficiencies in structural layout: The current code encourages the use of stiff frames in both longitudinal and transversal directions of a building. It is, however, a customary of long standing to provide them only in one direction, and it does not seem to be done away with ease (See **Photos 5.7** and **5.8**).

Photo 5.7. In the first floor, deep beams are provided in one direction only whereas in the second floor they are provided in both directions.

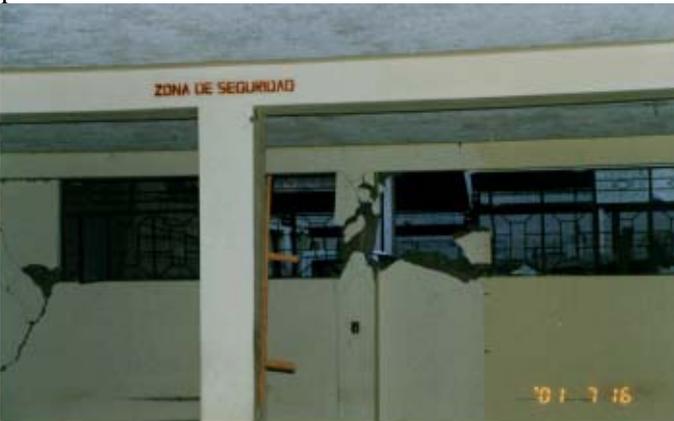
Photo 5.8. Detail of the first floor of building in **Photo 5.7**.

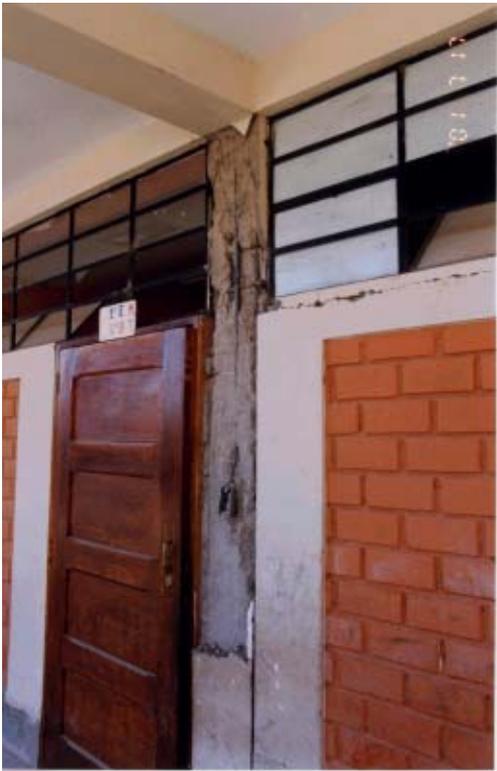
(4) Deficiencies in placement of utility pipes, insufficient concrete cover in structural elements, and finishing falling (Photo. 5.9)

Photo 5.9. Detail of concrete cover spalling due to insufficient cover and utility pipe in the column border.

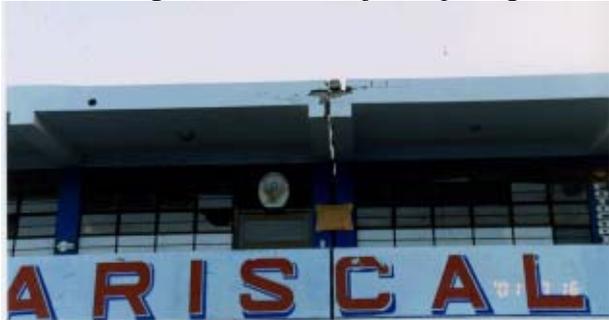
(5) Pounding: An insufficient joint opening between two buildings caused pounding (**Photo 5.10**).

Photo 5.10. Pounding between two buildings at Andres Avelino Caceres School, Tacna.

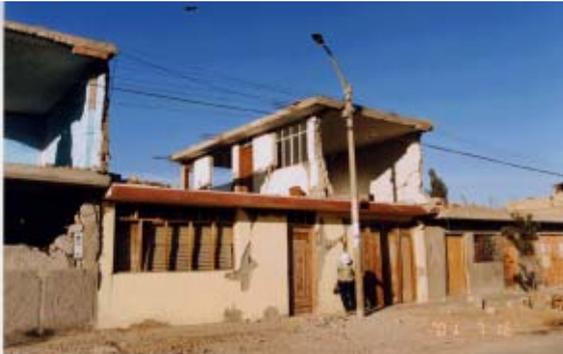
Photo 5.11. Out-of-plane failure in an unreinforced masonry dwelling

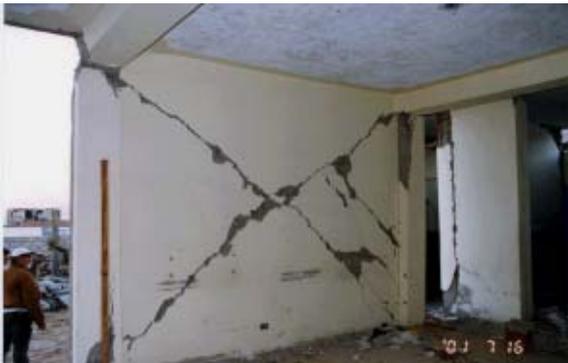
Photo 5.11. In-plane failure of a masonry infill.

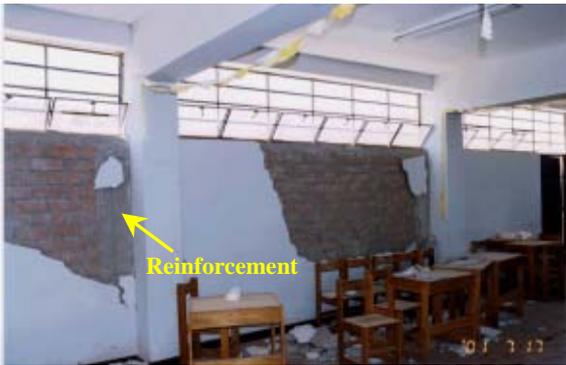
Photo 5.13 shows that flexible joints between masonry infill walls and RC frames successfully minimized the damage. Only fragments of thick mortar finishing came off.

Photo 5.13. Masonry infill parapet at San Antonio School, Moquegua.

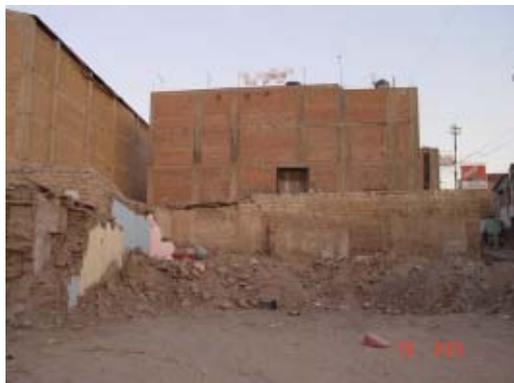
Photo 5.15

In general, adobe structures performed badly as observed in many other earthquakes. **Figure 5.1** and **Photos 5.14 to 5.18** present collapsed adobe structures neighboring reinforced masonry structures, which suffered only minor damage.

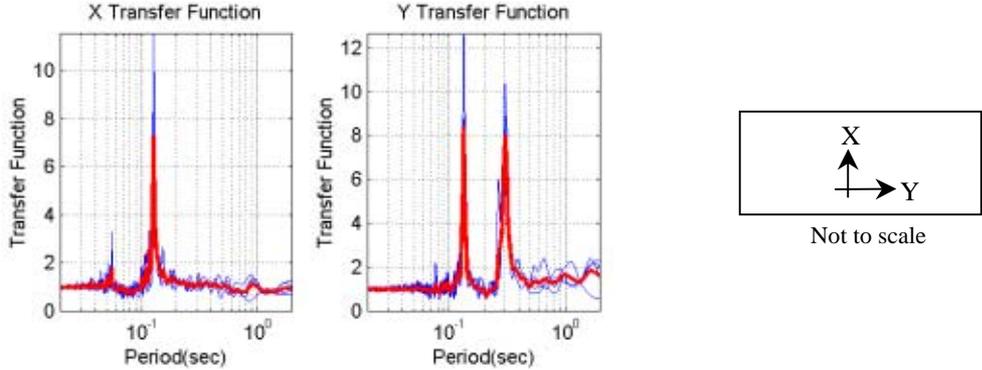
The transfer functions of Buildings A and B show one peak in the X direction and two peaks in the Y direction, each peak corresponding to one vibration mode. The shift of the predominant periods towards larger values observed in Building B with respect to Building A reflects the damage undergone by the former structure. For instance, the larger period observed in Building A (Y direction) is 0.3sec, which is smaller than the 0.45sec observed for Building B.

Figure 5.2. Building A transfer function and X and Y axis direction

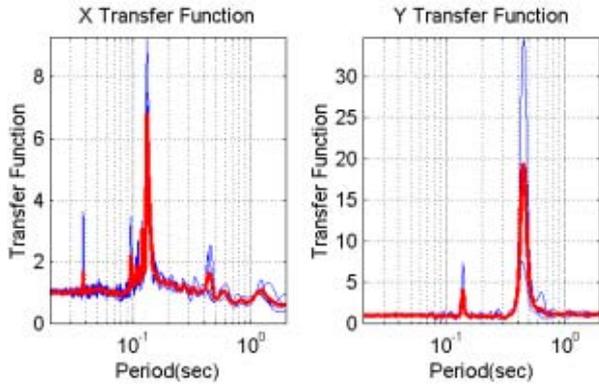
Figure 5.3. Building B transfer function

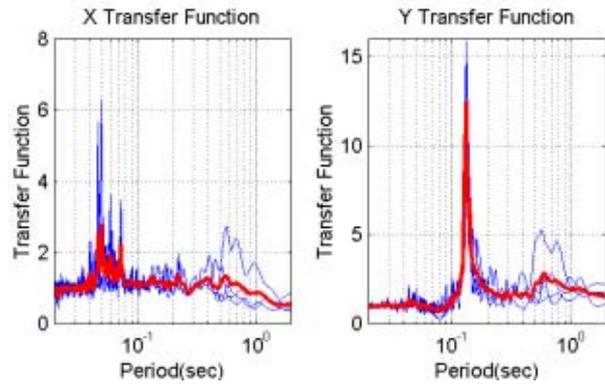
Figure 5.4. Building C transfer function

Building C predominant periods are 0.05 and 0.12sec in the X and Y directions, respectively. These values are smaller than the correspondent values for Buildings A and B due to the difference in the number of stories. Building C is stiffer in the X direction, in which masonry walls are provided to resist shear, than in the Y direction, in which the structures is mainly a RC frame.

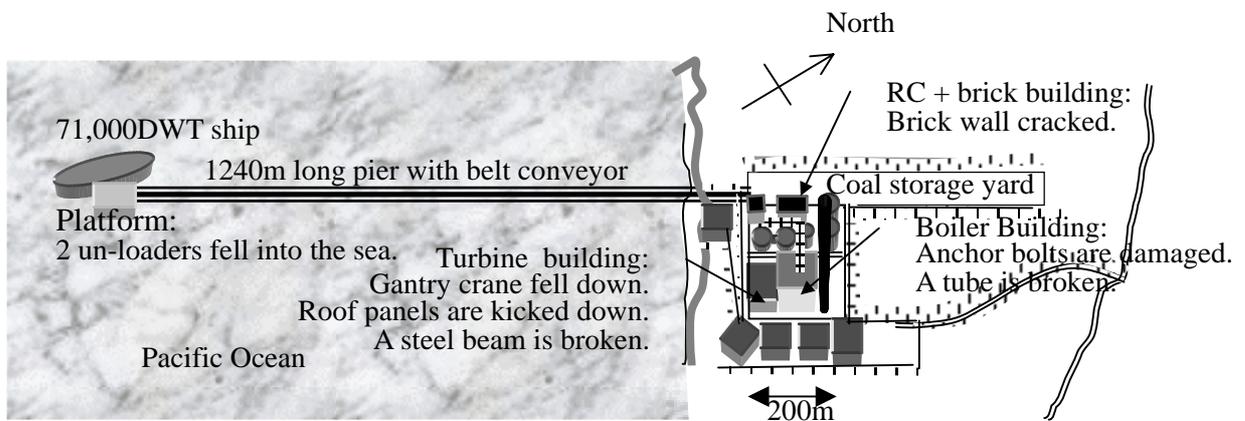
Figure 5.2.1 Earthquake Damage of Ilo 125MW Thermal Power Plant, Plan

As shown in **Figure 5.2.1**, two un-loaders (bucket-type) at the platform fell down into the sea. Also the plant administration office building, a RC frame with brick infill, was slightly damaged.

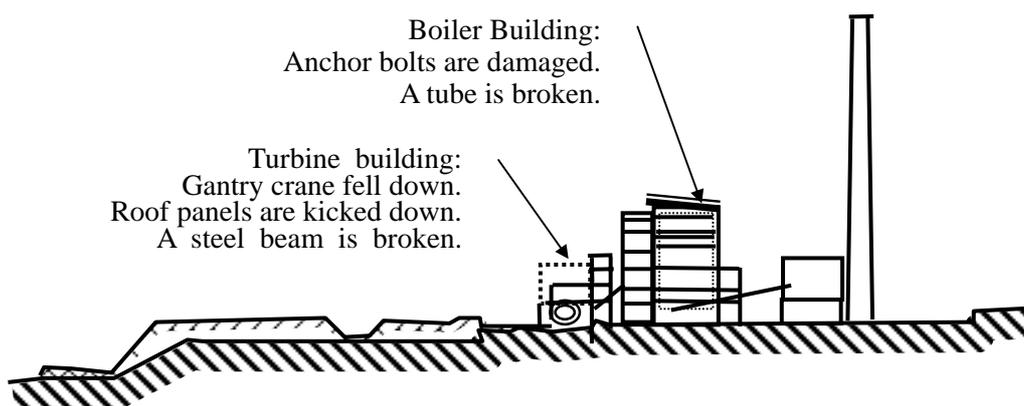
Figure 5.2.2 Earthquake Damage of Ilo 125MW Thermal Power Plant, Elevation

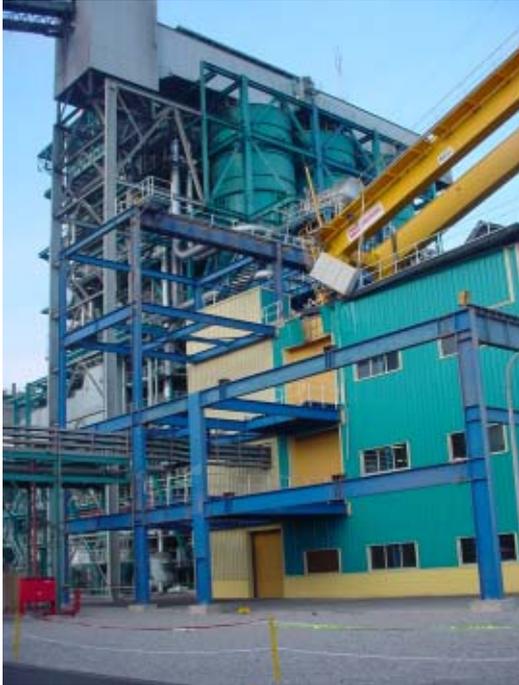
Photo 5.2.3 shows the boiler plant built in a multi-story steel braced frame. Since the detail dimensions of the frame were not available to the author, the elevation of a similar boiler plant (Radiant Boiler Type C , 125MW Shin-Ebetsu Power Station, Hokkaido Electric Power Ltd.) is shown in **Figure 5.2.3** for the readers information. **Photos 5.2.4** through **5.2.7** show the damage to column anchorages in the boiler plant frame. Some of the column anchorages connected to the steel brace members were damaged.

Photo 5.2.3 A view of boiler plant

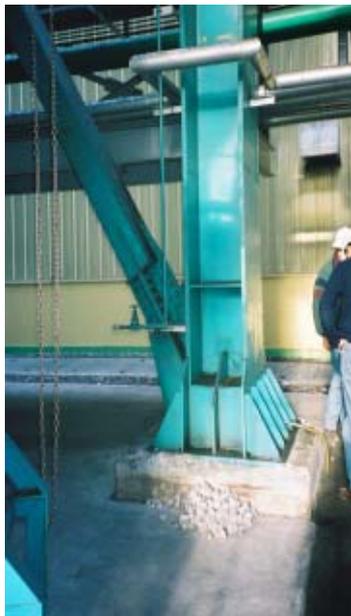
Photo 5.2.4 Damaged column anchorage

Photo 5.2.4 shows the end of an exterior column connected to the vertical brace of a H-shaped cross-section with cover plates. This column end was anchored to its base concrete with 8 bolts, and all the bolts yielded at their threaded portions, and pulled as much as 2 cm up as shown in **Photo 5.2.5**. The next interior column end had 12 anchor bolts and they did not suffer any serious damage as shown in **Photo 5.2.6**. One column end had only 4 bolts, and they were all completely broken as shown in **Photo 5.2.7**. In all these cases, vertical braces were not damaged at all. This implies that these anchor bolts might be proportioned in reference to a certain working stress under a specified design load, and apparently, capacity criteria to assure brace yielding was not adopted. Yielding of exterior anchor bolts caused redistribution of design traction forces, and resulted in breaking of anchor bolts in other column bases. Structural damage to this extent can be ranked as slight to moderate, but unluckily, a tube was reportedly damaged and steam was rising during the earthquake. A long inspection time is usually necessary for a damaged pipe system to be fully restored, causing some serious delay in resuming normal service.

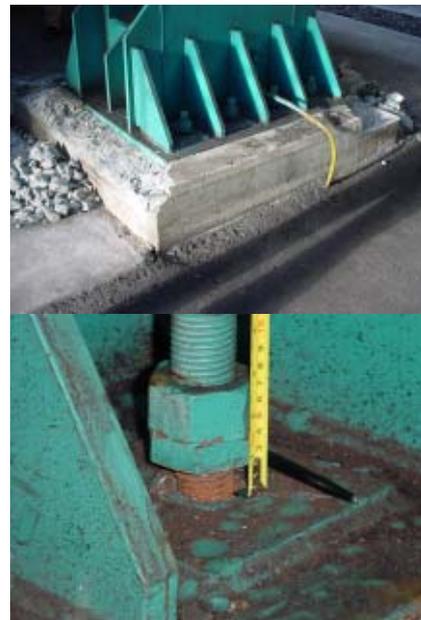
Photo 5.2.5 Yielding of anchor bolts in 8-bolt layout column base

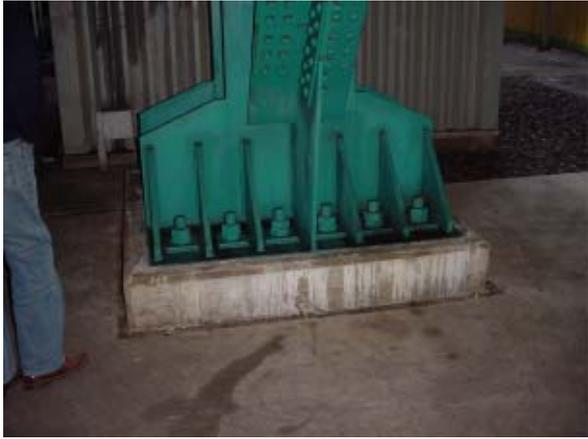
Photo 5.2.6 Almost no damage is seen at interior column anchorage, 12-bolt layout

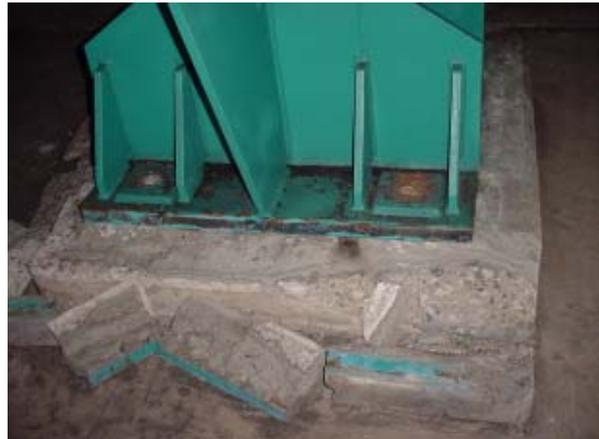
Photo 5.2.7 Completely broken anchor bolts in 4-bolt layout column anchorage

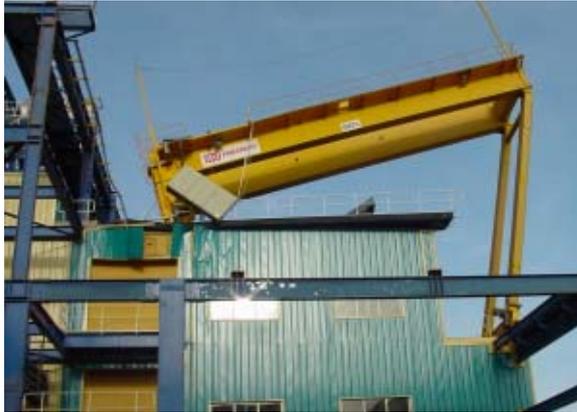
In the turbine building next to the boiler plant, a gantry crane fell down on the roof of the turbine room as shown in **Photos 5.2.8** through **5.2.12**. This crane was used for maintaining the turbine room, and for this reason, the roof panels were removable. The crane pushed down the roof panel into the turbine room. The guide rail for gantry crane was connected to its girder by clips and fastening bolts. As shown in **Photo 5.2.11**, these fasteners were all broken and missing, and this caused the crane to fall. The impact load on the roof panel must have been large enough for the steel sub-beam of the roof panel to be severely damaged. The shear connections at its both ends were also sheared off as shown in **Photo 5.2.12**. The roof panel hit a pipe in the turbine room and damaged it slightly. However, this earthquake did not do any serious damage to the main structure (steel braced frame) of turbine building.

Photo 5.2.8 Gantry crane fell down

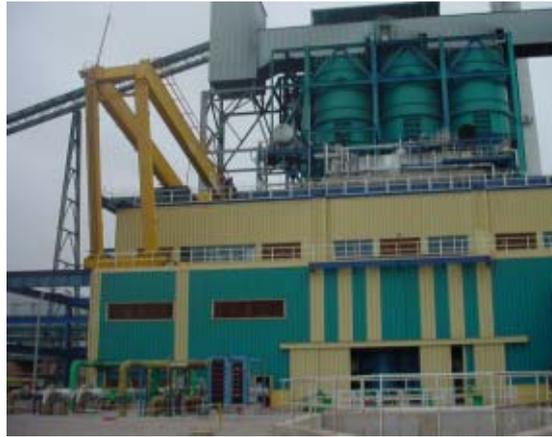
Photo 5.2.9 Crane were used for maintenance of turbine room

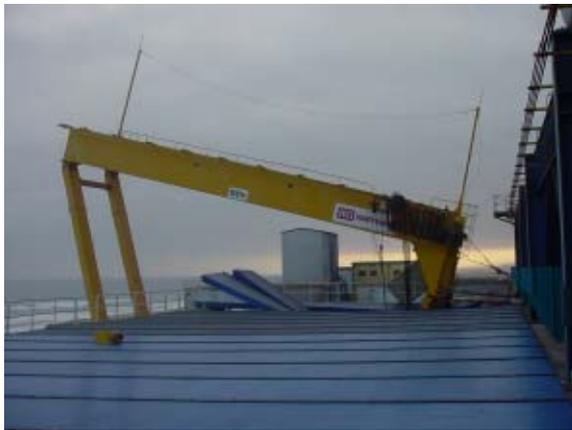
Photo 5.2.10 Crane kicked down the removable roof panels

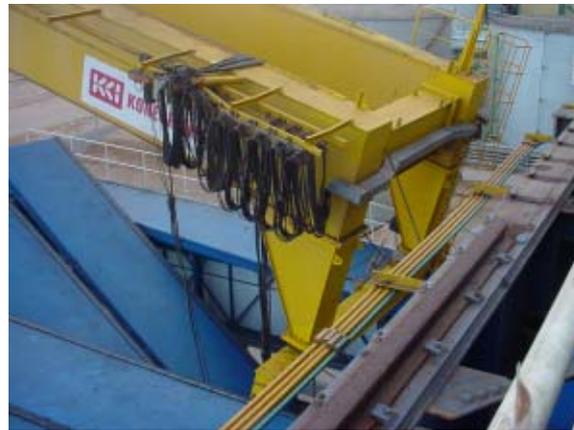
Photo 5.2.11 Fasteners that fixed crane rail were completely broken

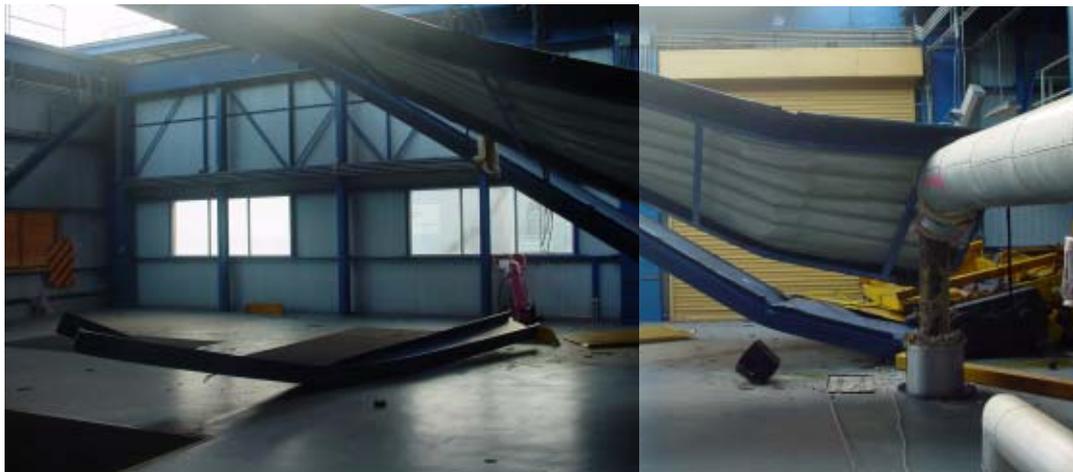
Photo 5.2.12 Steel sub-beam supporting roof panels was completely broken
