4. LIFELINES

4.1 SEWAGE TREATMENT FACILITY

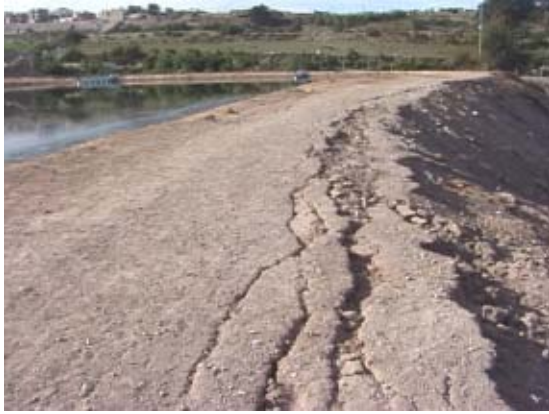
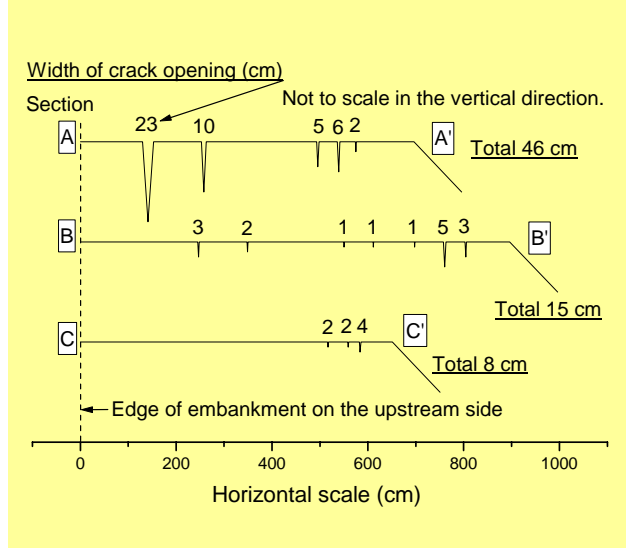
Figure 4.2. Longitudinal cracks

By the earthquake, the embankment on the downstream side of the lower pond suffered cracking in its crest (**Figure 4.2, left**). The total opening width of the cracks amounted up to 46 cm at maximum (**Figure 4.2, right**), and the residual settlement at the embankment shoulder was about 10 to 20 cm. In addition, the embankment between the upper and lower ponds became partly wet (**Figure 4.3**), suggesting a sign of piping. This location corresponds to a boundary between the original embankment constructed 40 years ago and the newer embankment re-constructed 6 years ago.

After the earthquake, in order to avoid instability of these embankments, the water level in both ponds were lowered by about 1 m. In order to cope with the current influent flow rate of 120 liters per second, which exceeds the design flow rate of 38 liters per second, the oxidation period had to be reduced down to 5 hours from the design value of 10 hours. These operations resulted into poor quality of treated water, which was used for irrigation purposes. Because the pipes to distribute the treated water were also damaged by the earthquake, it leaked into the adjacent Osmore River, affecting the quality of the river water.
