## 1. TECTONIC SETTING, GEOLOGICAL STRUCTURE AND SURFACE FAULT

### 1.3 ACTIVATED FAULT

## 1.4 FAULT AND DAMAGE TO ABDARREH

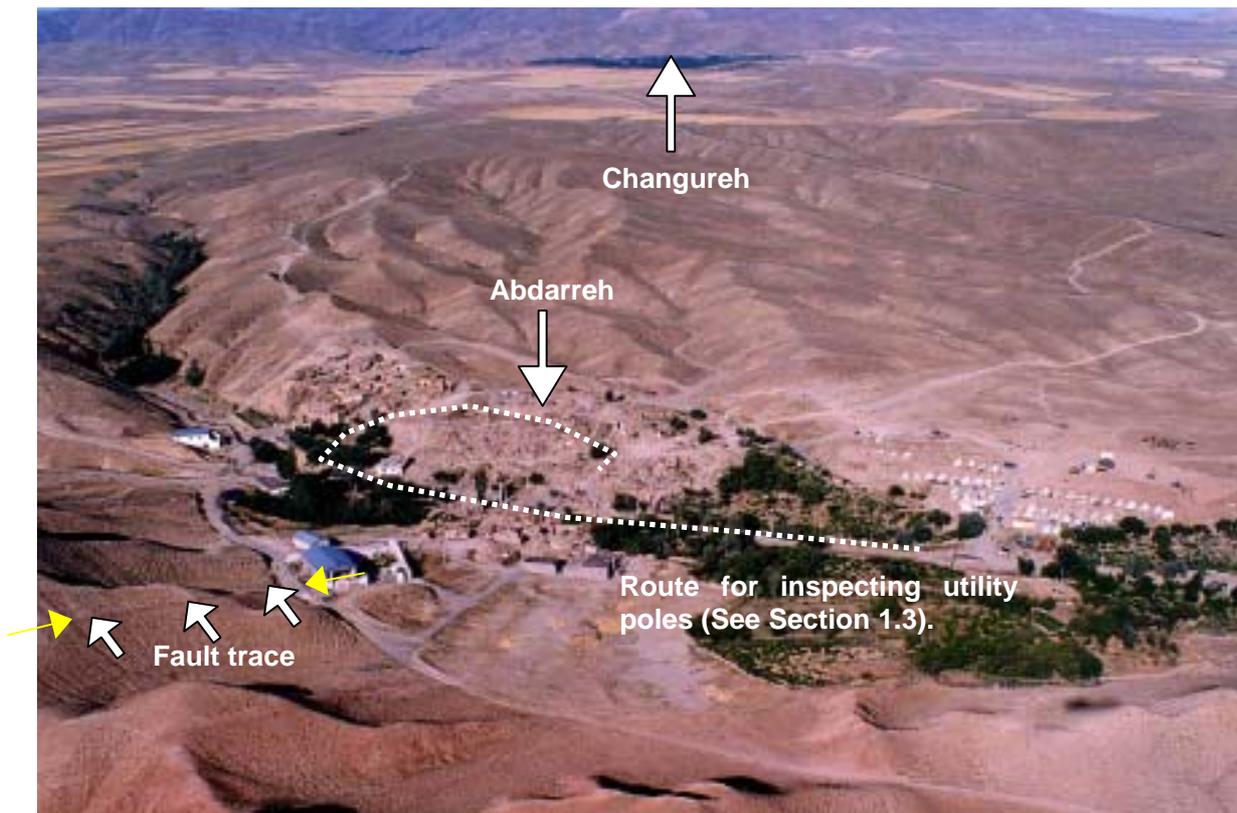
**Fig. 1.3** Surface fault trace and affected areas

A surface fault related to this earthquake appeared across the epicenter area of the main shock. According to Sassan, Eshighi, Mehdi Zare and Mohammad R. Mahdaviifar, IIEES, surface fissures are continually lined up 3 km straight across the barren terraces between Changureh and Abdareh (**Fig. 1.3**).

The authors traced an about 700m part of the surface fault extending east from Abdareh. The rupture runs straight across the mountain ridges, and is related to the compressional mechanism. The southern hanging wall side has been pushed about 5-10 cm up. This trace of the fissures trends N70°W, and is approximately orthogonal to the axis of the focal solution for this earthquake given by NEIC and Harvard university (2002).

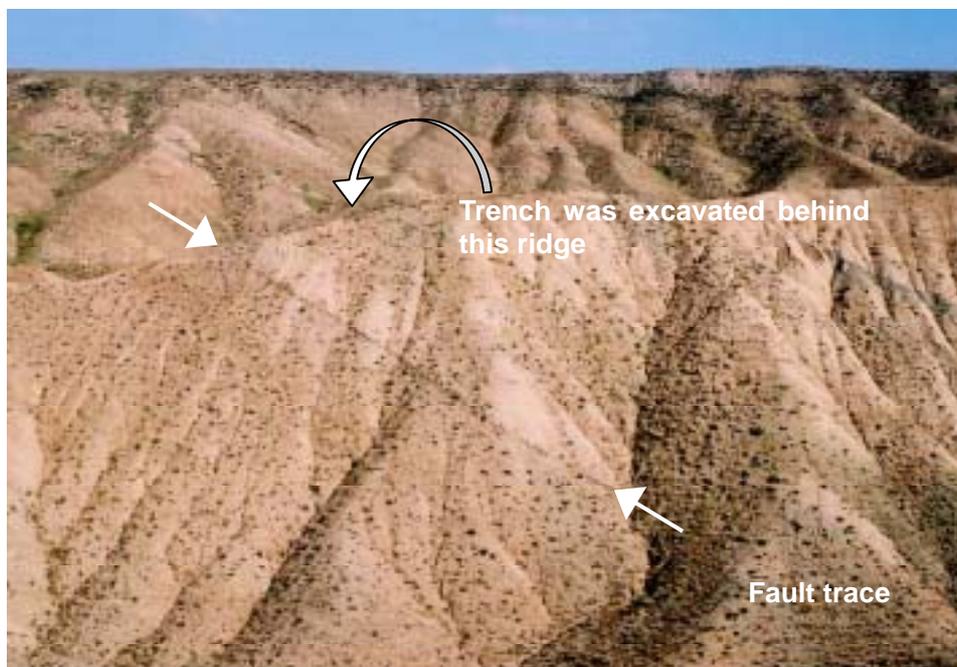
**Fig. 1.4** Surface fault trace and location of trench

A trench was excavated at a narrow valley approximately 500 m east of Abdareh (**Fig. 1.4**). The site was chosen in expectation of finding charcoals that would allow dating possible previous events. Since the location was inaccessible by any machines, the trench was dug by hand, and was 3 m wide, 5 m long and about 1.2 m deep with east and west side walls cutting straight in the middle of the valley and along the mountainside (**Figs.1.5, 1.6**).

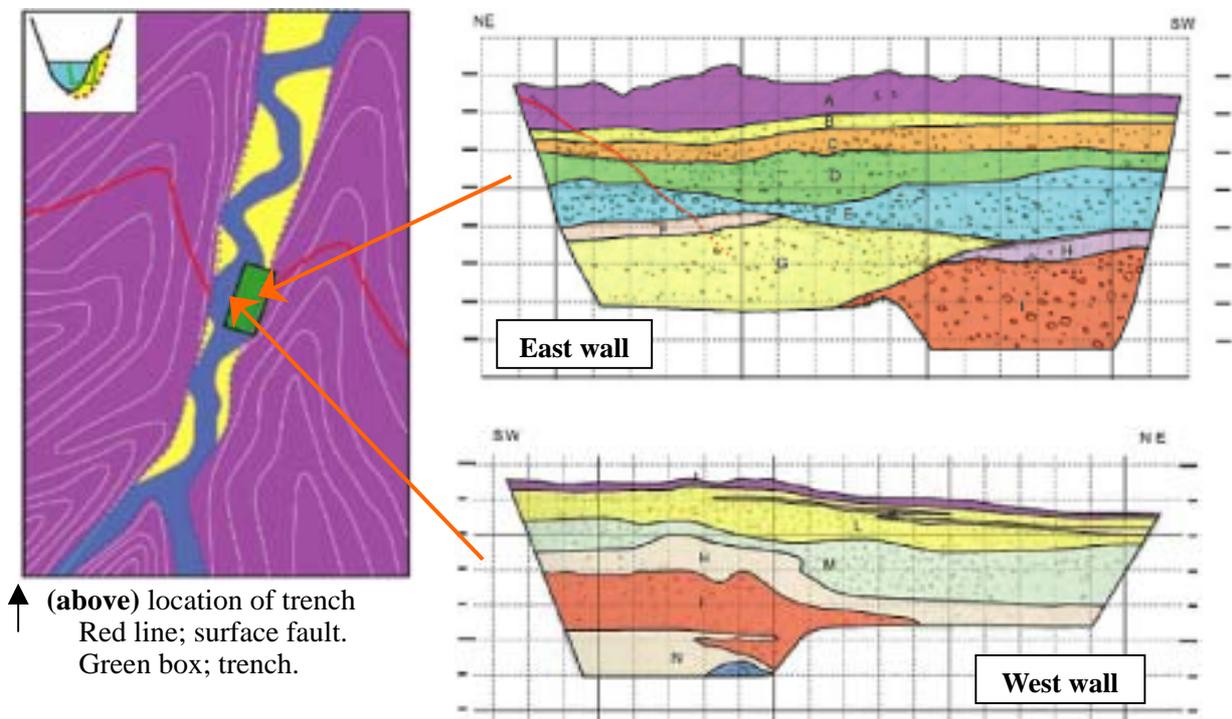
**Fig. 1.6** Illustration of trench.

**Fig. 1.6** shows a sketch of the east and west walls of the trench. Layer A is the weathered soil covering thin both the mountainside and the valley. Layer B is composed of granule and less matrix. Layer C contains semi-angular pebbles. Layer D is a matrix rich bed. Maximum grain size of 2 cm is reached in this layer. Layer E is a clearly imbricated gravel bed. The average and maximum gravel sizes are about 1 cm and 5 cm, respectively. Layer F is a paleo-soil covering a gravel bed of layer G. Layer H is also a paleo-soil bed, but is overlain by gravels of layer G. Layer I is a gravel bed covered by layer H. Maximum gravel size of layer I is about 5 cm. Layer F, G, H are overlain by layer E with unconformity. The fault found clearly from surface to layer E. It is recognized as open rupture and there is no displacement along the fault. In the layers below layer F, the fault is hardly recognized.

On the west-side wall, layer H and I are considered to be extensions of those on the east wall. The uppermost bed of the valley sediment, layer J, is a sandy soil with much matrix. Layer K is a thin bed of silt or very fine sand. Layers L and M are sand and gravel beds. The matrix is rather rich in layer L than layer M. Layers N and O are paleo-soil and gravel beds overlain by layer I. Though the surface fissures lined up across the valley have clearly proven the presence of the fault at the slope foot, no clear fault dislocation was observed on the west-side wall probably because the strain caused by the faulting has spread over the uncemented soil. Nothing indicating previous fault dislocations was found in the trench.

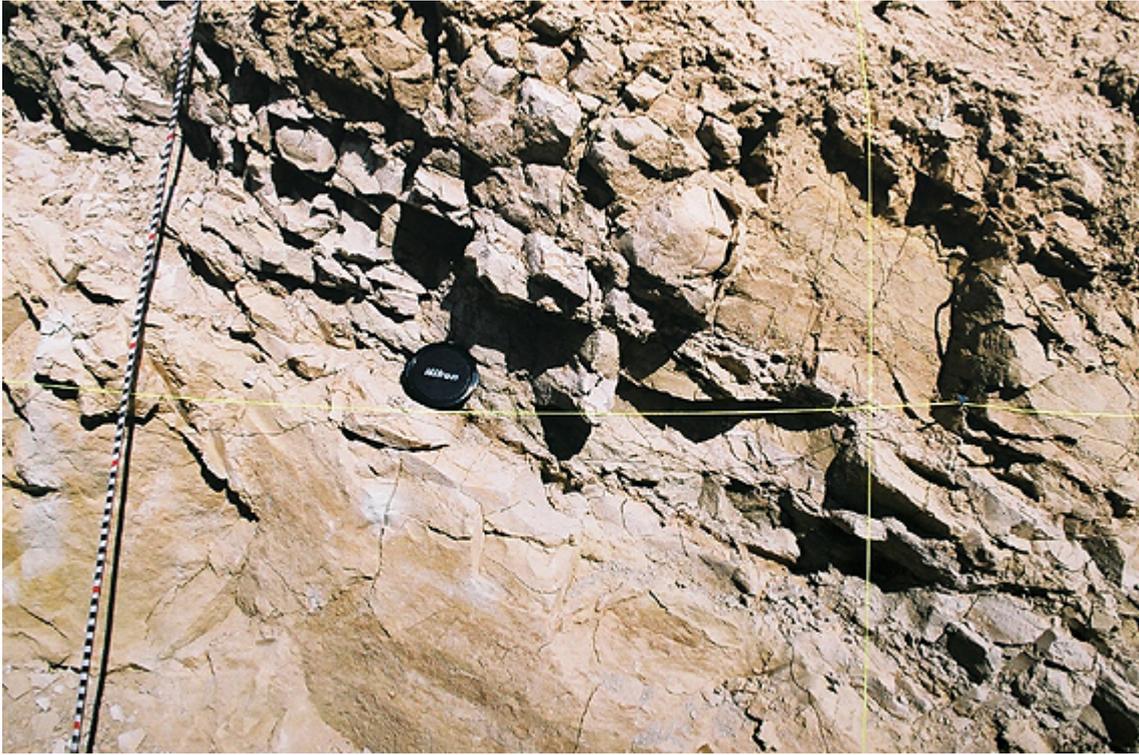
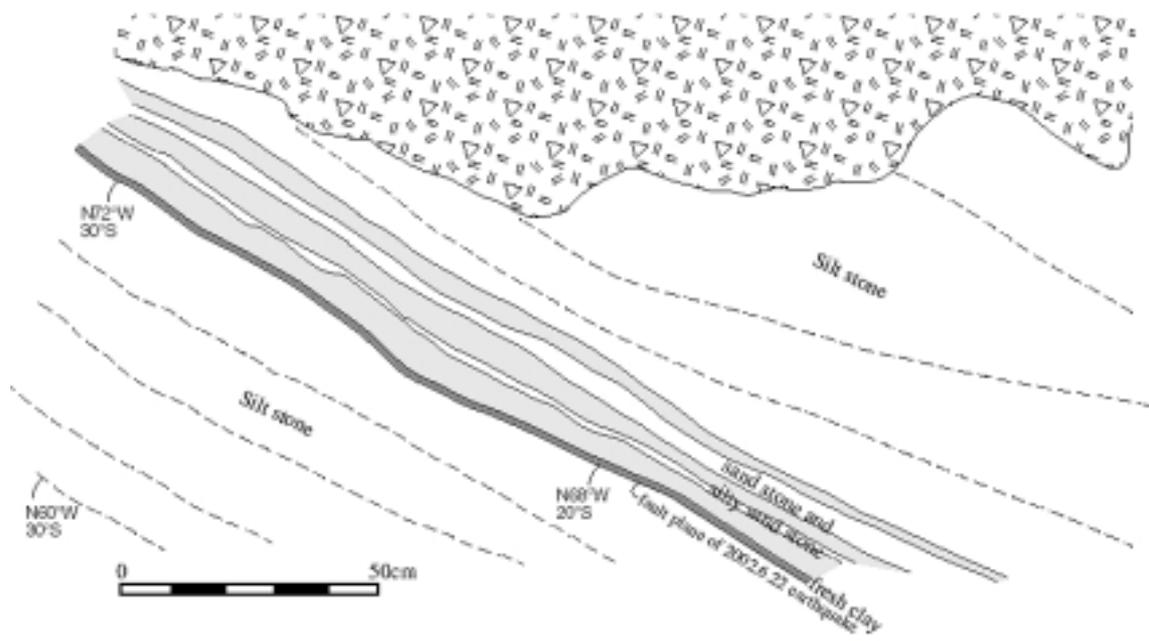
Fig. 1.7 Exposed surface of silt rock

On the east edge of Abdareh, surface soil was scraped off to observe the fault trace on a silt rock (**Fig. 1.7**). The silt rock dips to south. Tufficious fine sand and silt film is caught thin in the silt rock and faulting occurred on its bedding plane. Most southern part of the tufficious sand has developed into clay of 2-3 cm thick probably because of the continual fault dislocations. Siltstone among the thin tufficious sand film has been weakened.

A “bedding plane fault” can be considered as a by-product of folding, and causes a moderate earthquake of M6 class.

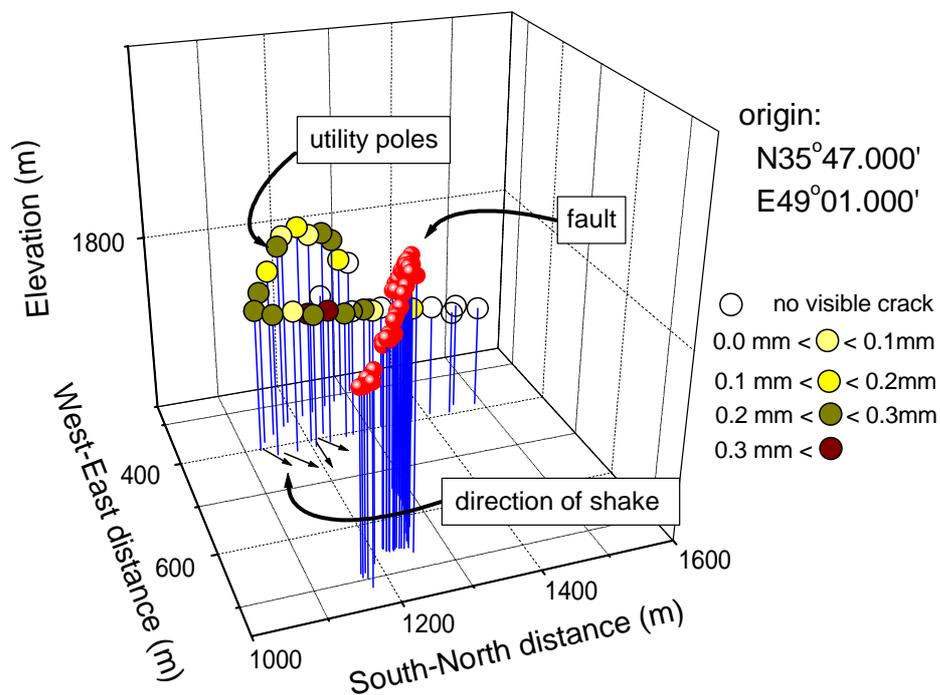
**Fig. 1.8** Locations of cracked utility poles

Distribution of cracked utility poles is considered to be a good index for estimating possible spatial distribution of intense ground motions. Observed crack intensities on total 28 utility poles were roughly classified into the following 5 groups:

**Figure 1.8** shows the observed distribution of crack intensities. In this figure, the route taken for the inspection is lined up with the utility poles (colored circles). The route goes straight from right to left along a valley, and turns sharply up towards the ridge when it reaches the southern edge of the village. Then it comes slightly back along the ridge. Several arrows near the bend of the route indicate the inferred directions of strong ground motions. The other line of dark sphere marks is the fault trace. It goes across another mountain ridge that rises east of the village, and meets the route. It is noted that the fault trace seemingly divides the utility poles into two groups; cracked poles on the hanging wall side and less damaged on the foot wall side. This clear contrast suggests that the shake on the hanging wall side must have been more intense than that on the foot wall, and thus must have been responsible for serious destruction of the village. The arrows show that the motion was intense in the normal direction to the fault trace.
