4. BUILDINGS, DWELLINGS AND BRIDGE

4.1 CHARACTERISTIC OF THE BUILDING INVENTORY

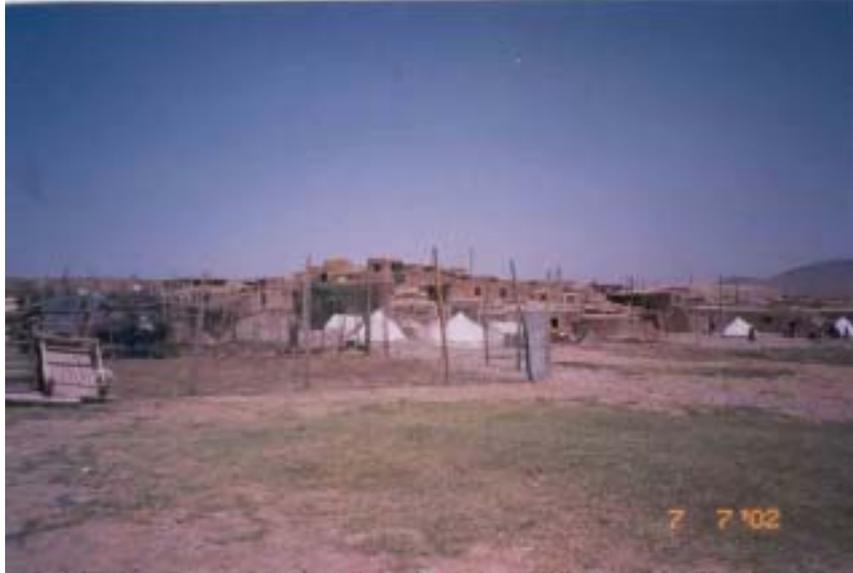
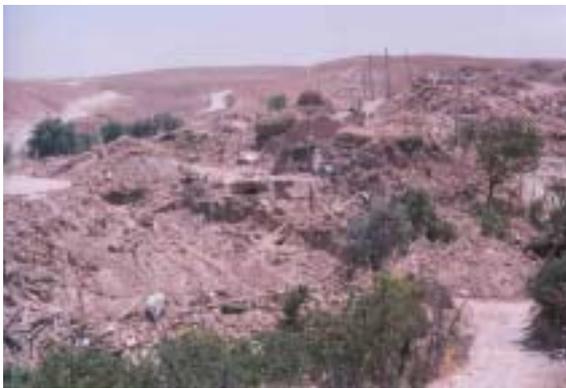
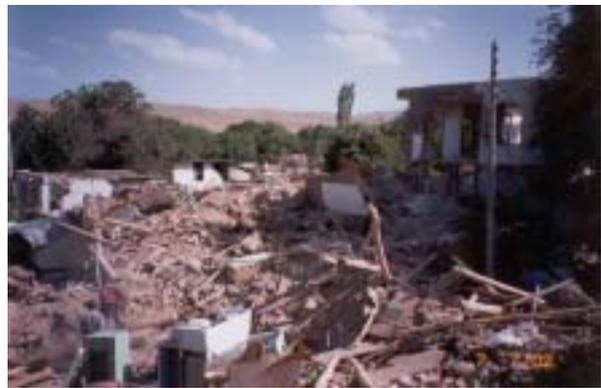
The old adobe buildings were used not only as residential units but also as warehouses or sheepfolds. The construction of low quality adobe buildings consisted of mud-brick bearing walls, which supported a flat slab or arch floor slab. Stone was also used as an alternative material of a bearing wall in villages near mountain. Flat slabs were constructed with wooden beams thatched with mud-straw materials, while arch slabs were built by mud-brick bonded with mud-grout. The seismic performance of non-engineered dwellings is a function of wall thickness, internal subdivisions, roof mass, nature of the continuity with adjacent dwellings, distance to the fault, site effects, etc. **Figure 4.1** shows the failure of adobe buildings with arch floor slabs and/or wooden floor slabs.

(a) Adobe dwellings with arch roof and/or timber roof (Abdareh)

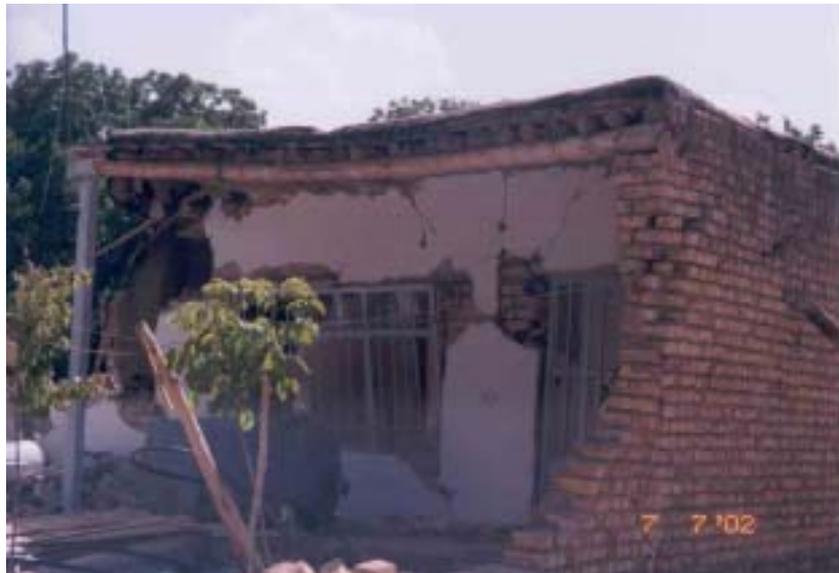
(b) A timber roof thatching with asphalt (Changureh)

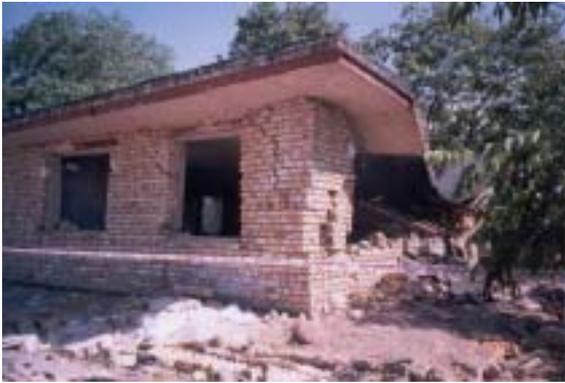
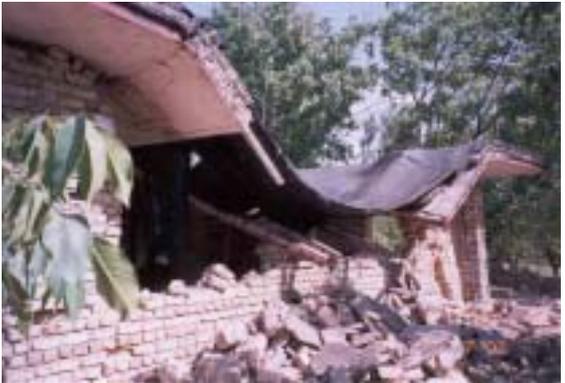
Unreinforced masonry (URM) structures suffered severe damage during the earthquake. Unfortunately, as masonry is the most universally available and economical construction material, individual owners used it widely around the regions. The URM is most commonly used in Iran together with steel-masonry (Jack-arch) floors poured on top of URM bearing walls. The high in-plane rigidity of the Jack-arch floor system led to a good distribution of seismically induced forces to bearing walls. However, reliance of floor on brittle URM bearing walls to resist lateral forces ensures that once the strength threshold is exceeded, severe damage and/or dramatic collapse are likely to occur. In-plane, out-of-plane, and combined in-plane and out-of-plane failures have been observed, as normally expected from URM structure buildings. **Figure 4.2** shows a collapsed URM structure building with steel-masonry Jack-arch slab.

Figure 4.2 Collapse of a URM structure (Abiz)

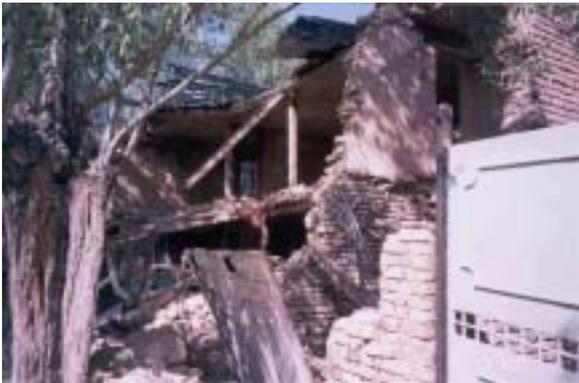
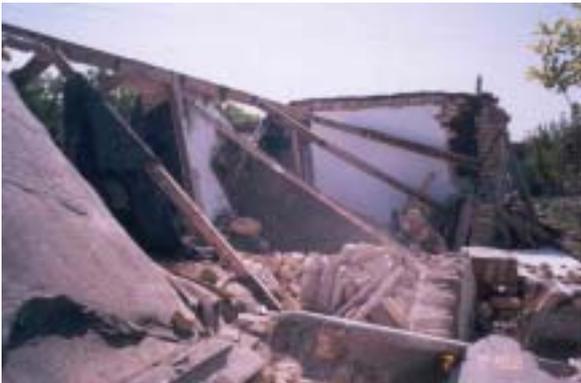
Revised Iranian Seismic Code (1988) has a chapter for URM structure buildings. The design of new constructed governmental buildings like schools conformed to the Iranian Seismic Code detailing in their construction. In-plane failure of bearing walls was frequently observed in these types of URM structures. **Figure 4.3** shows an example in which the horizontal and vertical R/C ties are constructed following the Iranian Seismic Code.

Figure 4.3 Newly constructed URM structure (Esfad)

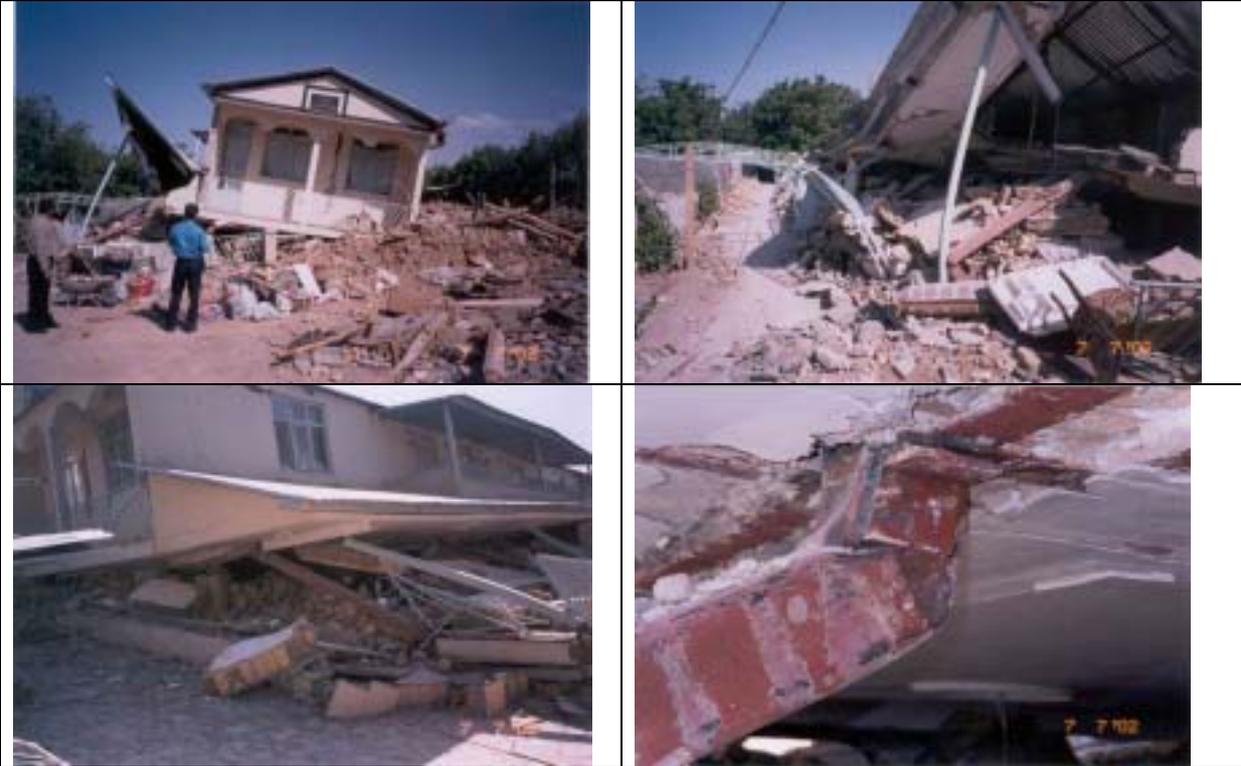
Because of high economic reason, structural steel was rarely used as a lateral resistance system in a structure. On the other hand, the use of steel was limited to the steel-masonry Jack-arch floors. **Figure 4.4** shows a two-story semi-steel structure with steel columns and beams. The building consisted of one interior and two exterior wings. URM bearing walls supported the roof slabs of exterior wings while steel columns were used to support the roof slab of the interior wing. The URM bearing walls collapsed and supported roofs fell down but the four relatively slender columns supported the interior wing without collapse.

Fig. 4.4 A typical collapsed URM structure (Esfeden)

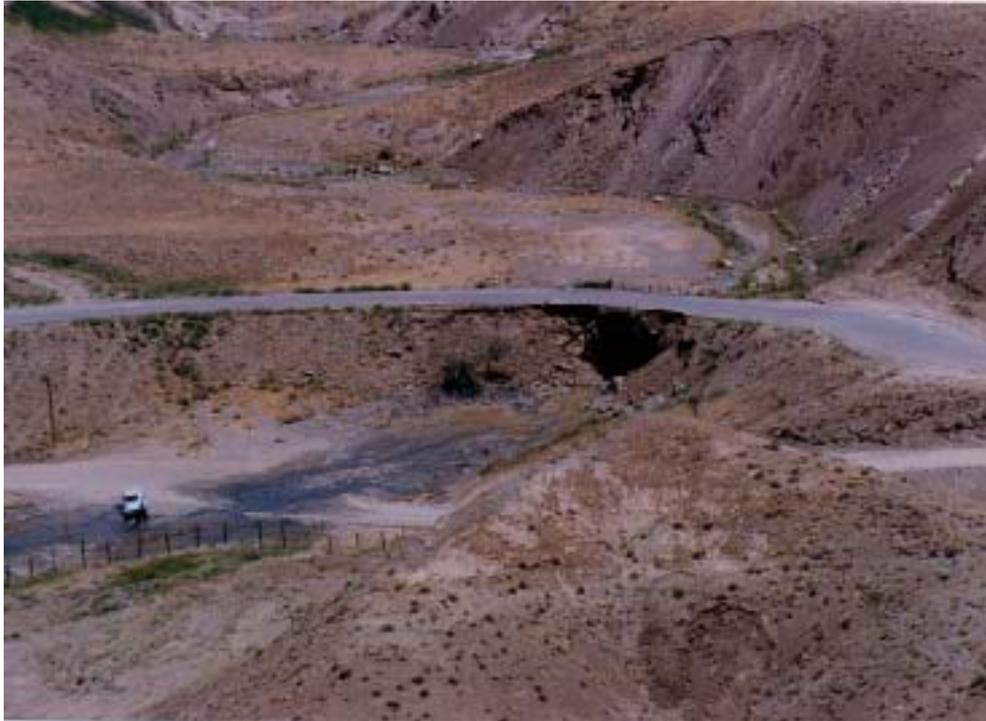
Most of bridges consisted of stone piers supporting an arch masonry slab or reinforced concrete slab. Only one bridge in the investigated area suffered damage from the earthquake. This was a single-span reinforced concrete overpass located between Abdareh and Changureh. The stone pier at one side collapsed and the settlement of slab caused a horizontal crack at the stone pier of the other side. **Fig. 4.5** shows the damaged bridge, which was closed to traffic.

Figure 4.5 Damaged bridge between Abdareh and Changureh
