**JSCE- AIJ Joint Investigation/ Technical Support Team  
for Restoration and Reconstruction  
of the Affected Areas by the Pakistan Earthquake on  
Oct. 8, 2005**

Nov. 2005

# A QUICK REPORT ON 2005 KASHMIR EARTHQUAKE

Investigation and Support Team  
For Disaster Mitigation of  
Oct. 8, 2005 Kashmir Earthquake

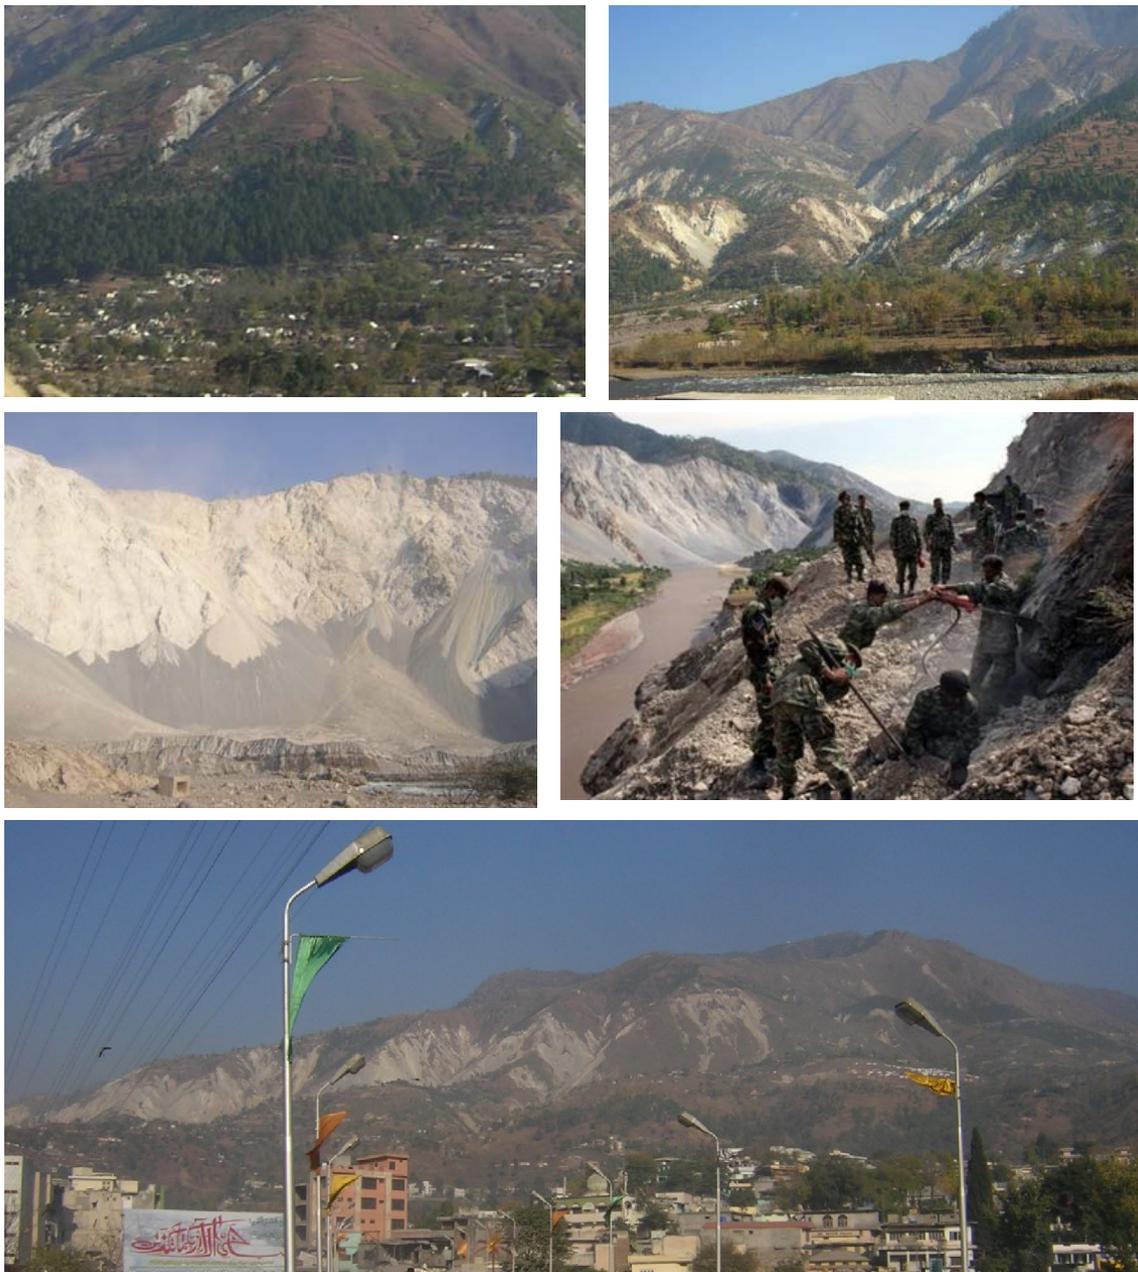
Except a surface rupture observation nearby Bagh by Pakistan Geological Survey (2005), no distinct surface rupture was observed during the investigations in Balakot and Muzaffarabad and Jhelum Valley by the JSCE team. However, there were numerous slope failures particularly on the NE side of the valleys. There were very large scale surficial slope failures in the whitish about 100m thick dolomitic layer,

which is a highly deformed and fractured rock unit (Figure 7.4). Figure 7.5 shows a laboratory test on ground deformation in loose non-cohesive ground during thrust faulting. As noted from the figure, in spite of upward motion of the base-rock, some surficial slope failure (similar to small scale seemingly normal faulting) occur within the non-cohesive deposits. Furthermore, the thickness of deposits increases above the tip of the moving hanging wall as a rigid-body. Therefore the slope failures observed particularly on the hanging-wall side of the fault can be interpreted as the surface expressions of the earthquake faulting.

Figure 7.4 Slope failures observed in the regions of Balakot and Muzaffarabad

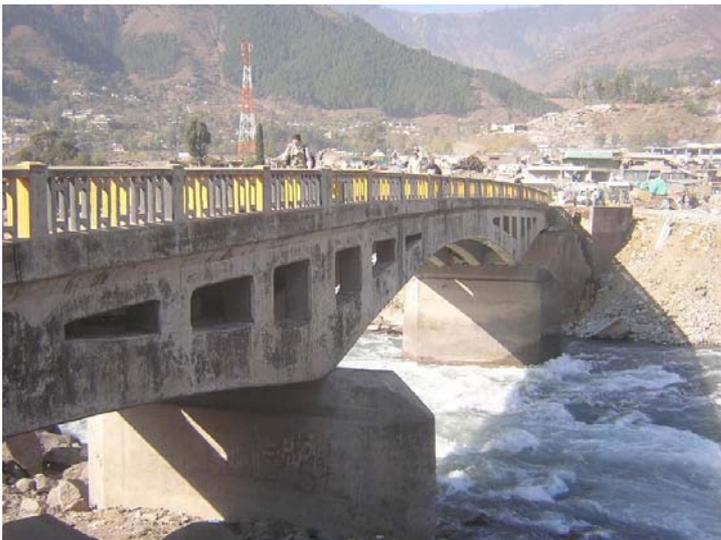
(a) RC Balakot Bridge

There are three bridge types in the epicentral area. Old bridges are either stone arch masonry bridges or truss bridges. New bridges are mainly cast-in place concrete bridges. Heavily damaged bridges observed in valleys running parallel to the strike of the causative fault. Furthermore, the longitudinal axis of the damaged bridges were parallel or sub-parallel to the slip direction of the fault. The largest damaged bridge is located in Balakot town, where the NW tip of the causative fault terminated (Figure 9.1(a)). The axis of the bridge is N38E. The girder of the bridge was displaced about 1m in the SE direction. While the SW side of the bridge sits over the pier beneath, the NE side of the bridge is offset from the pier by about 35-50cm. In other words, it seems that the distance between the piers decreased. The ground on the NE side of the bridge is likely to experience the permanent displacement of ground resulting from the slope failure as well as from faulting. There is no doubt that the inferred ground motion is quite at Balakot and this may also cause the permanent displacement of the bridge deck as the girders was not fixed against horizontal ground motions. Nevertheless, the pedestrian suspension bridge to the south of this bridge experienced compression in its longitudinal axis as seen in Figure 9.1(b), besides its anchors blocks toppled down and the abutment was translated in the SW direction by about 10-20cm. In the same valley, there was another non-damaged RC bridge, whose longitudinal axis is parallel to the valley axis and it is about 2km far away upstream from the damaged Balakot bridge.

Figure 9.1 Damaged bridges at Balakot

There are several severely damaged bridges in the epicentral area. The most severely damaged largest bridges were in Balakot town. Balakot Bridge is a 3 span girder bridge. The girder of the bridge is displaced laterally for about 1m downstream side and the NE side of the bearings are offset from the pier. Furthermore, the concrete of the girder is damaged at several locations. Damage to the cross beam of the superstructure is found to be relatively severe while the damage to main girders is negligible. The damage to foundation could not be observed visually during the inspection. Figure 11.1 illustrates the possible options for the restoration and rehabilitation of the bridge. The first option is to jack up the superstructure and to translate to its original position as illustrated in Figure 11.1(a).

The second option is to widen the piers and to support the abutment with a RC liner. Furthermore, new shoes (bearings) must be installed at appropriate positions. Furthermore, damaged cross girders and damaged main girders must be repaired. The residual strength of the bridge must be computed in order to check its capacity before the restoration works start. In addition, it is highly recommended to execute regular inspections to prevent the failure of the bridges and consequent accidents. Nevertheless, a new bridge might be necessary if we consider that operation period of bridge and the extent of the damage by the earthquake.

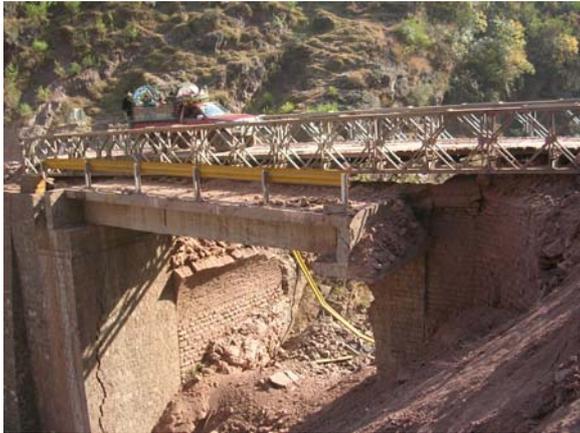
(a) RC bridge with masonry abutments

Several bridges in Jhelum valley between Muzaffarabad and Chakoti route were damaged. Damage to bridges was mainly caused by the collapse or permanent movements of masonry abutments as seen in Figure 9.2.

Next we describe our recommendations for the three damaged bridges along the roadway in Jhelum Valley between Muzaffarabad and Chakoti. The first damaged bridge is located 5 km south east of Muzaffarabad city. This bridge is a single girder bridge, which is under construction. Its north-west side of the girder was fell down to ground. The abutment was of stone masonry and it failed during the shaking of the earthquake. It is recommended to construct a new bridge along the present bridge as a permanent measure. However, if the existing girder is to be restored, then it is recommended to construct reinforced concrete abutments instead of stone masonry abutments.

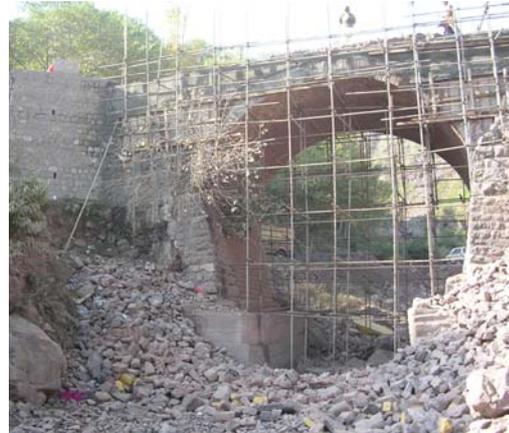
(b) Damaged masonry arch bridge

The top side part of arch masonry superstructure collapsed partially as a result of earthquake shaking. The collapsed section may be repaired by casting a new concrete liner. The east masonry abutment of the bridge damaged by the earthquake and it is recommended to cast a peripheral concrete and install ground anchors as illustrated in Figure 11.4.

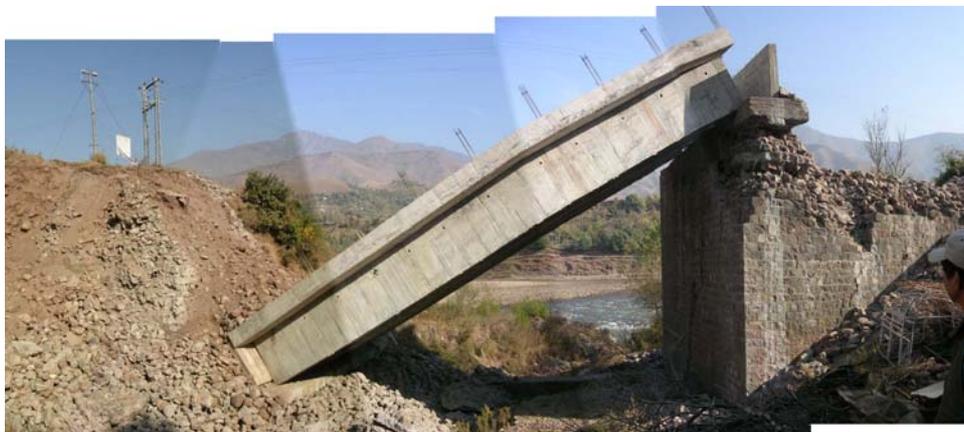
(c) Damaged RC bridge with masonry abutments

The west abutment of third bridge along the Jhelum Valley was partially damaged by the earthquake. As a temporary measure, an emergency bridge was installed. As for permanent measure, the box culvert is suitable for this bridge in view of its span (Figure 11.5).

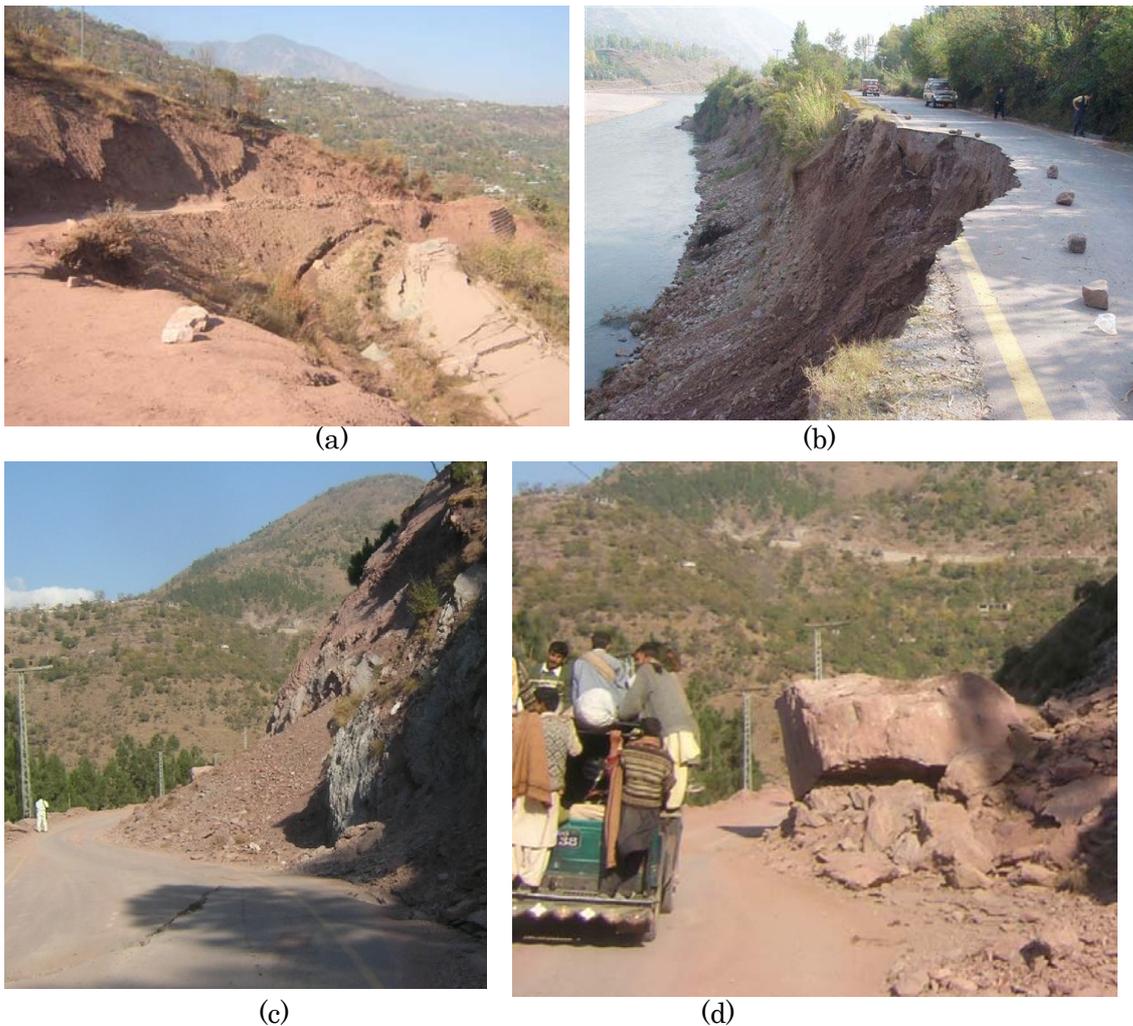
Figure 9.4 Damage to roadways

Damage to roadways was mainly caused by slope and embankment failures and rock falls (Figure 9.4). The damage to the pavements of roadways by ground shaking could not be observed. The largest roadway damages were observed along highways between Murree and Muzaffarabad and it was about 48km from the USGS epicenter (Figure 9.4(a)). The damage was caused by the embankment failure in a circular sliding failure mode. About 100m long section of the roadway sank more than 15m. The ground consisted of debris of weathered shale and the layers are inclined parallel to the sliding direction (Eastward) of the embankment. The embankments of roadways between Muzaffarabad and Murree, and Muzaffarabad and Chakoti were failed at numerous locations (Figure 9.4(b)). Slope failures and rockfalls obstructed highways. Rockfalls were wide-spread all over the epicentral area.

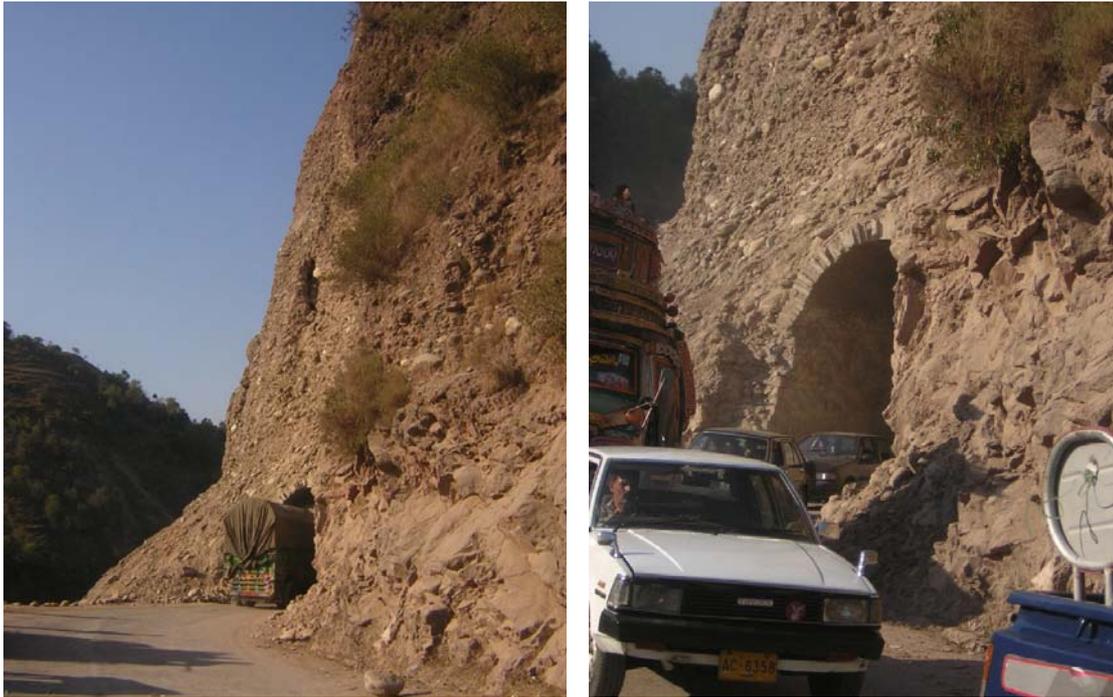
Figure 9.5 Lightly damaged roadway tunnel

The only tunnel in the epicentral area is located about 4km south of Muzaffarabad. The tunnel is lined with stone masonry lining and it is excavated in shale with an overlaying non-cemented conglomeratic deposit. The south portal of the tunnel was lightly damaged by the slope failure of overlaying conglomeratic deposit as seen in Figure 9.5.

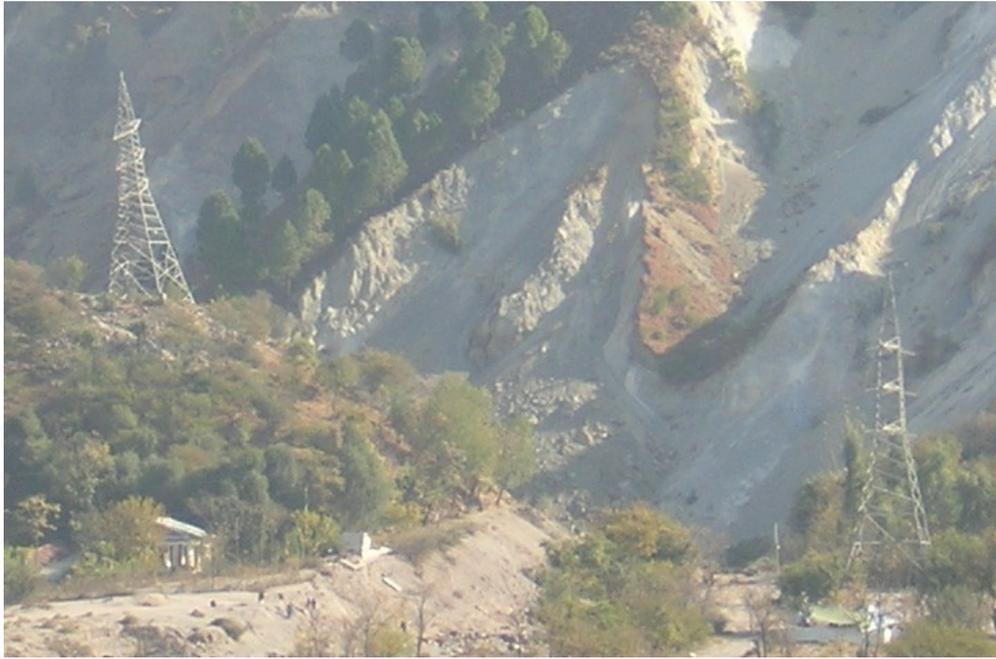
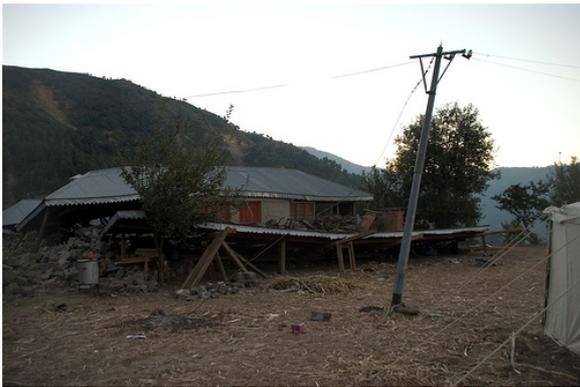
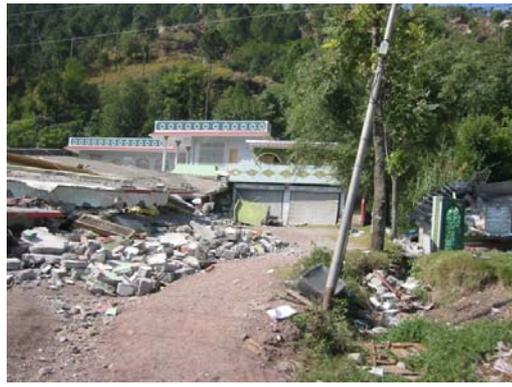
Figure 9.6 Damage to pylons and poles

Damage to pylons and poles were either caused by slope failures or faulting. The most severe damaged observed on NE side of the valley nearby Balakot. Figure 9.6 shows the damaged pylons. The damage to pylons were caused by the uplift of ground and the pylons were all tilted. At this particular location, at least 6 pylons were tilted.

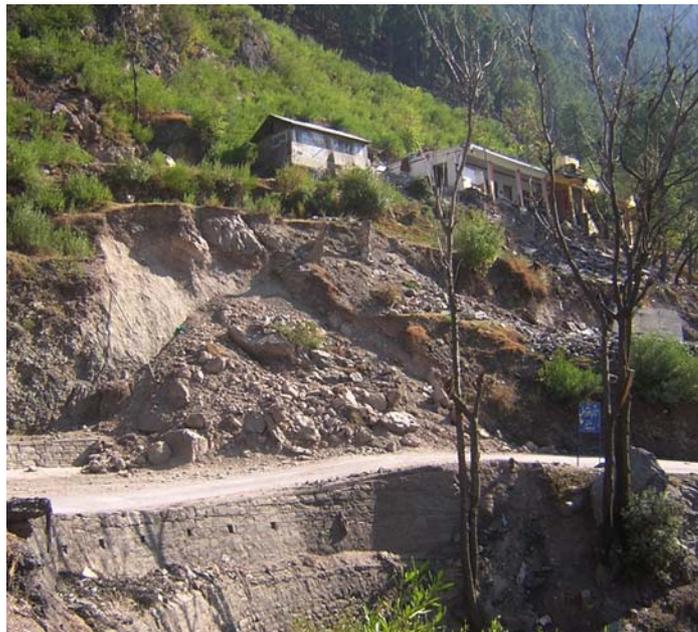
Soil slopes failures occurred in either plane sliding mode or circular sliding. Planar sliding modes are generally observed on soil slopes over the bed-rock (Figure 10.2(a)). Deep-seated circular type soil slope failures observed when the soil thickness was large. Figure 10.2(b) shows one example nearby Balakot. There were several scarps indicating several circular type slip surfaces within the slope. However, the close inspection of this slope indicated some failures and movements had already took place long before the earthquake.

(a) Planar sliding of soil slope nearby Balakot

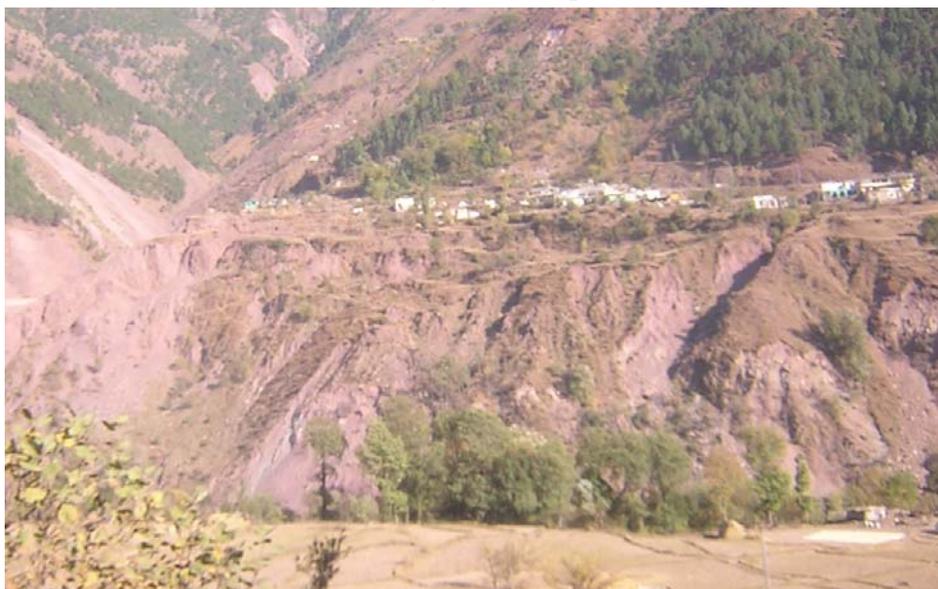
(b) Deep-seated circular sliding

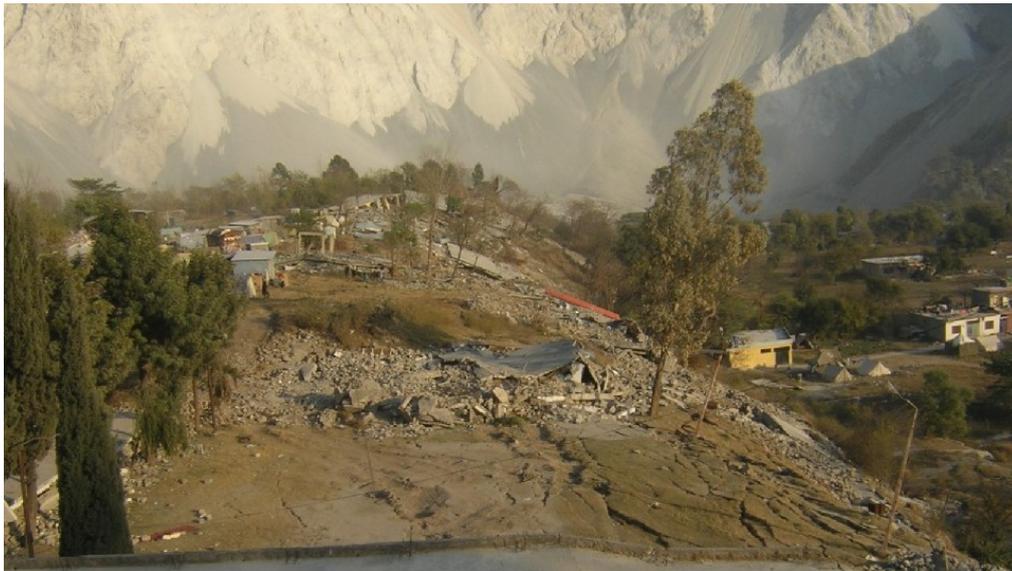
(a) Muzaffarabad

Some peculiar soil slope failures were observed in both Balakot and Muzaffarabad (Figure 10.3). These slope failures occurred in conglomeratic soil deposits with rounded large cobbles. Since the slope angles were quite steep (70-80°), these slopes failed on planes involving partly vertical tensile cracks and curved shear plane. The residual slope angles (repose angle) ranges between 40-45°, which may be considered to be equivalent its friction angles. Some needle penetration tests were carried out at both Balakot and Muzaffarabad. The cohesion of soil matrix of the conglomeratic soil deposit is inferred from the needle penetration index tests to be ranging between 60-100 kPa.

Figure 10.3 Soil slope failures at Muzaffarabad and Balakot

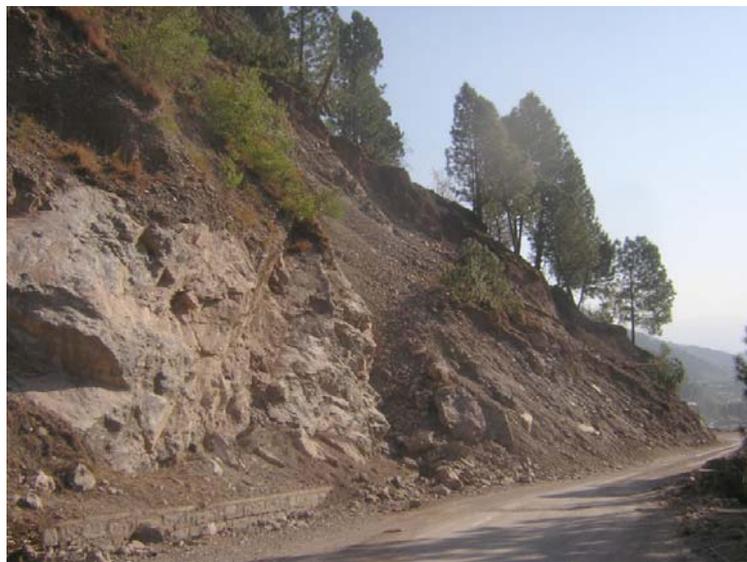
(a) Nearby Balakot

Rock units in the epicentral area are schists (phyllite-like), sandstone, shale, limestone and dolomite. Particularly red shale of Balakot formation is prone to weathering and the thickness of the weathered rock seems to be about 2-5m. Dolomitic rock unit is intensively sheared and this unit is thought to be constituting the fault fracture zone. Figure 10.4 shows a surficial slope failure in weathered red shale nearby Balakot. The surficial slope failures in dolomitic rock unit was spectacular and continued for several kilometers as they are clearly noticed in satellite images (Figure 10.5 and Figure 10.6)

Figure 10.4 Surficial slope failures in weathered or fractured rock

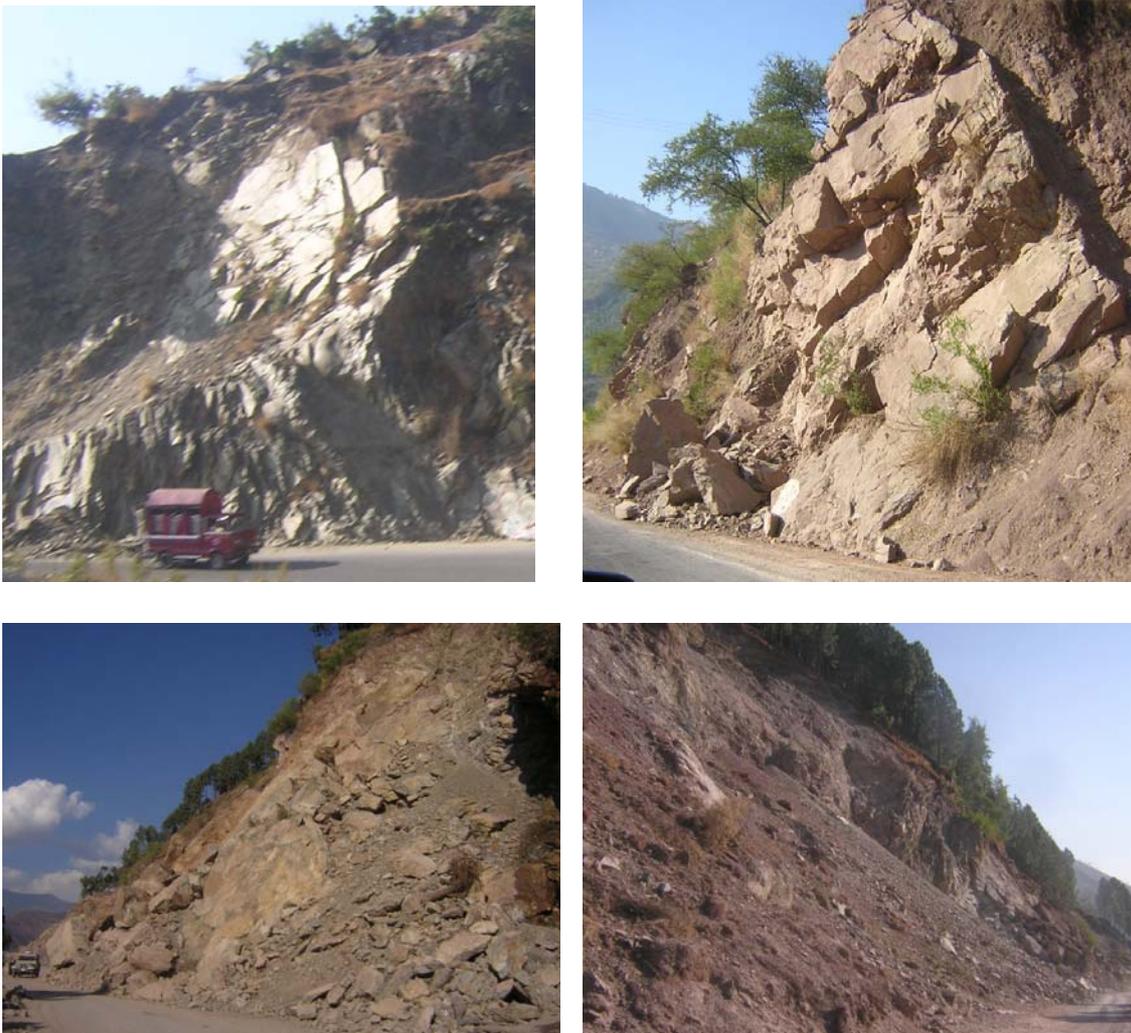
Figure 10.7 Some examples for planar sliding failure of rock slopes

Rock units are schists (phyllite-like), sandstone, shale, limestone and granite. Except granite, all rock units have at least one throughgoing discontinuity set, namely, bedding plane or schistosity plane. Since rock units had been folded, they also include joint sets and fracture planes as a result of tectonics movements. Granite also has at least three discontinuity sets. In regard with rock slope failures classified in Figure 10.1, the rock slope failures are mainly planar sliding, flexural or block toppling failure. Planar sliding failures were observed mainly in schists, sandstone and shale while flexural toppling failure was observed in intercalated sandstone and shale (Figures 10.7 & 10.8). The inclination of layers ranges between 30-65°, which implies the sliding failure can be easily caused by a small intensity of disturbing forces resulting from such as earthquakes, heavy rainfall or the both.

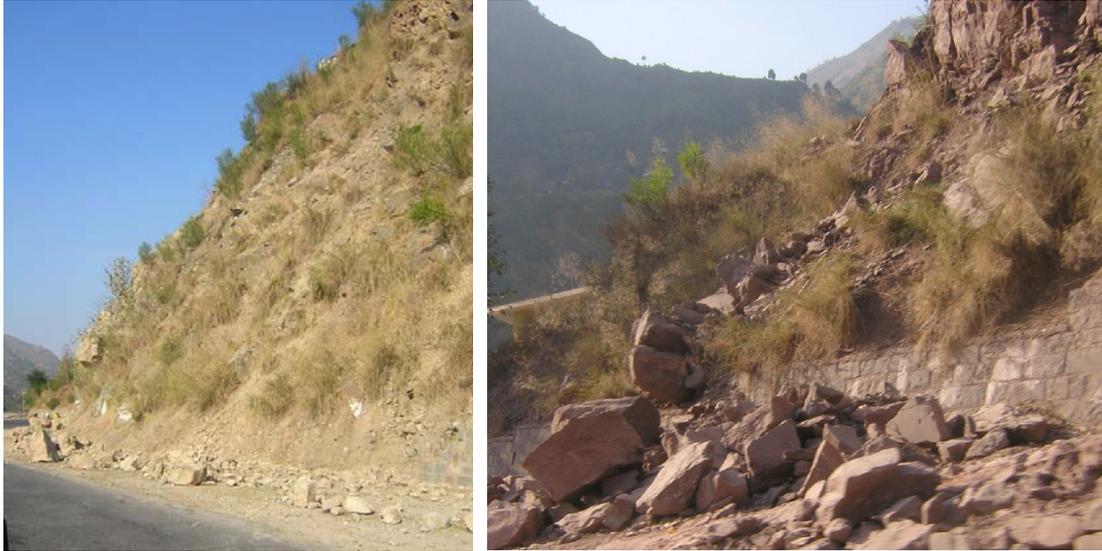
Rockfalls in the epicentral area generally resulted from the toppling of rock blocks due to excitation of the earthquake. Numerous rockfalls were observed for a great length of roadways. Rockfalls were common in sandstone slopes. Some flexural slope failures were also observed in intercalated sandstone and shale formation with undercutting.

(a) Rockfalls

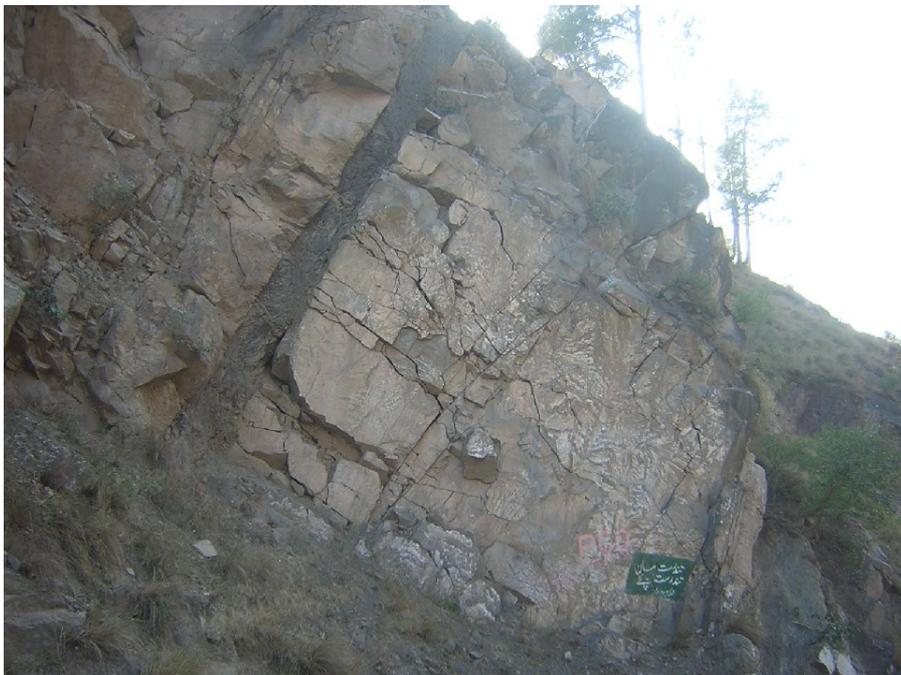
(b) Flexural toppling failure

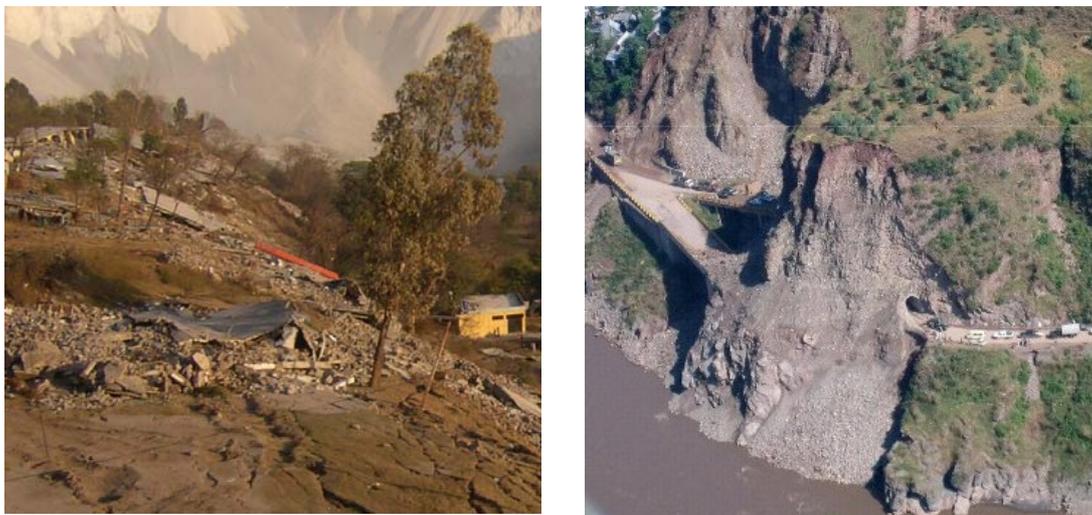
There are many empirical methods, which are outcomes of rich past experiences on slope stabilities. Tables 11.1 and 11.2 prepared by major governmental and local authorities. Particularly, Japan Highway Authority (JH) and Japan Railways (JR) provide basic guidelines how to design (slope angle) and how to assess the stability of slopes depending upon the ground conditions (rock or soil) and slope height without any particular emphasis on neither rainfalls or earthquakes. For example, the JH empirical criteria suggest the recommended slope angles for ground containing gravels (or cobbles) should be less than 40-51°. For the similar ground conditions, JR recommends that slope angle must be less than 45°. When we apply these empirical criteria to failed slopes of ground containing large cobbles in both Balakot and Muzaffarabad, it is understood that the initial slope angle of the failed slopes were greater than 60° (Figure 11.15).

Figure 11.15 Some examples of slope failures in ground containing cobbles
