Provisional Report of the May 27, 2006, Mid Java Earthquake, Indonesia

June 15, 2006

**Advanced Body of the
“JSCE/AIJ mission for reconstruction
recommendations for areas devastated by the
May. 27, 2006, Java earthquake, Indonesia”**

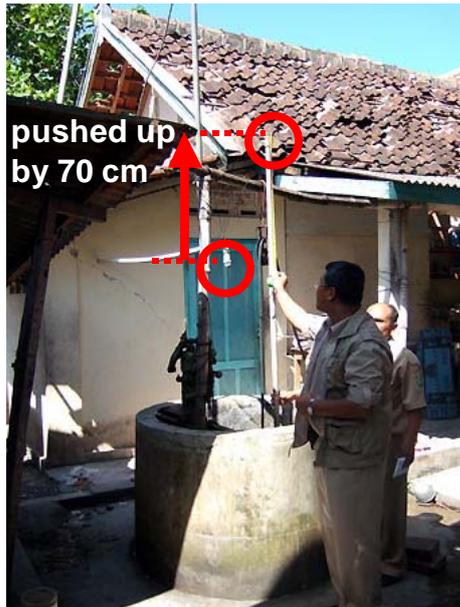
(a) S7deg. 57.416 min,
E110deg. 18.291 min
plastic pipe was pushed 0.7m up.

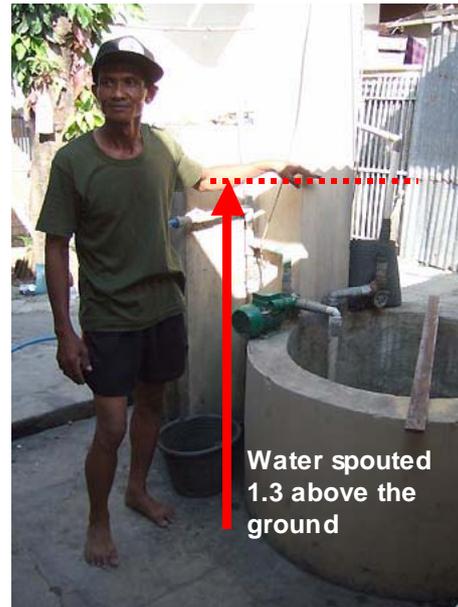
(b) S7deg. 53.706 min,
E110deg. 22.995 min
dark colored water spouted about
1.3 m up above the ground level.

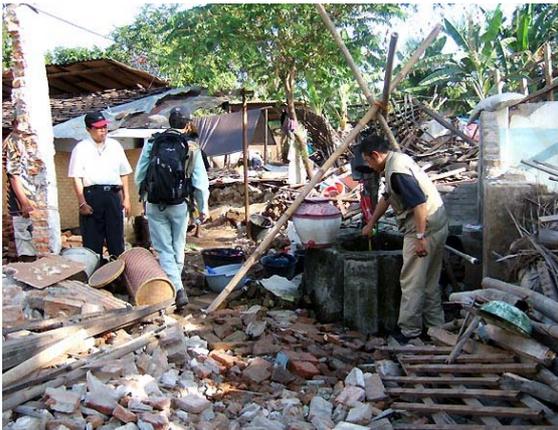
(c) S7deg. 53.458 min,
E110deg. 23.186 min
no change in water level of -5.0 m.

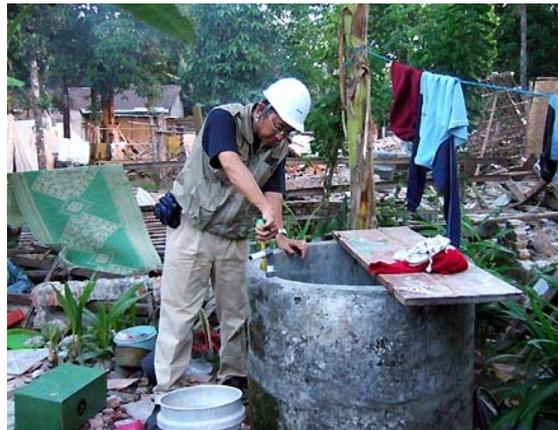
(d) S7deg. 51.044 min,
E110deg. 20.031 min
water level decreased by about 0.25 m.

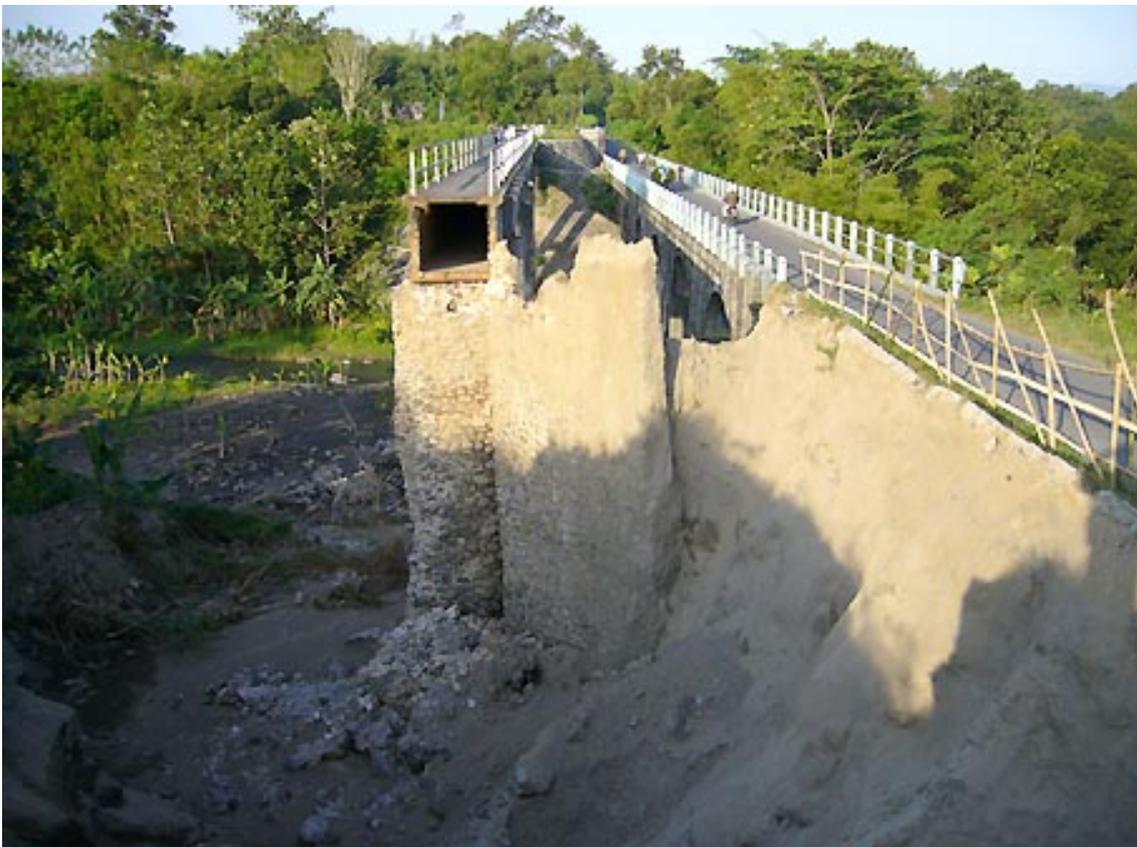
A bridge of Mataram canal, supplying drinking water and irrigating 19,000 ha of land extending the lower basin of Progo and Opak river, was damaged as shown in Fig. 3. Two masonry abutments and four RC piers support a steel box aqueduct of 80m long. RC open channels on both riversides resting on embankments narrow to this aqueduct. The sandy soil mass of the right embankment behind the masonry abutment of about 10m high slid down towards the river. The scar was formed 26 m west behind the abutment immediately beneath a construction joint of the open channel, suggesting that water might have been seeping through the joint into the embankment soil.

Fig. 3. Mataram canal bridge: Soil mass of right embankment behind masonry abutment has gone.

Quick restoration of the bridge is a must because of the canal's important functions. Moreover, a road running along the canal resting on the remaining soil mass of the same embankment is under a threat of subsidence. However, a complete reproduction of the embankment will be just a stop-gap measure, and won't mitigate its geotechnical hazard potential. Even an inch settlement of the embankment will cause cracking of concrete joints, and water will leak again through the joints. A possible and efficient measure may be to replace the embankment with some piers.

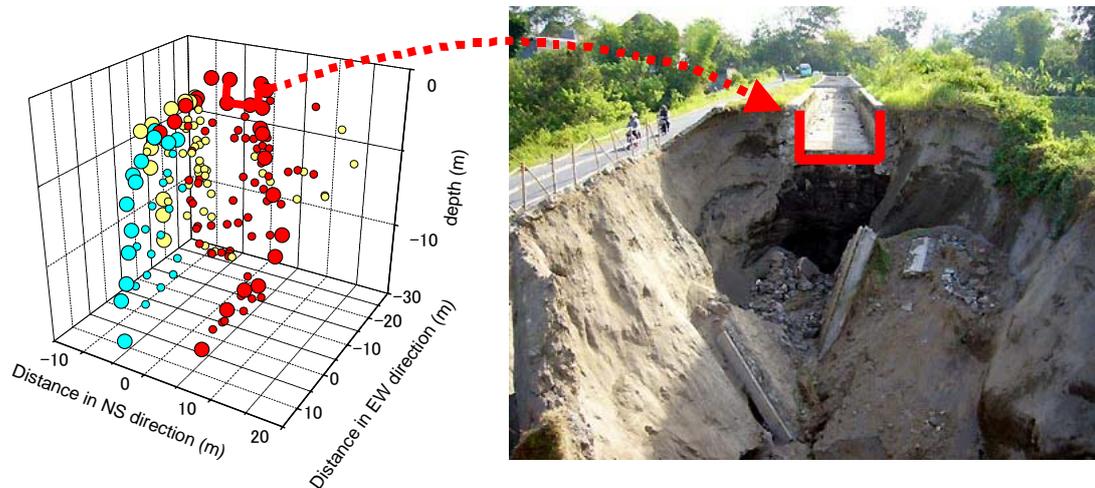
Fig. 4 Measured cave: The cave of the embankment was laser-scanned for its 3D image. Total soil volume about 2,000 m³ has gone. Scar did appear immediately beneath the construction joint.

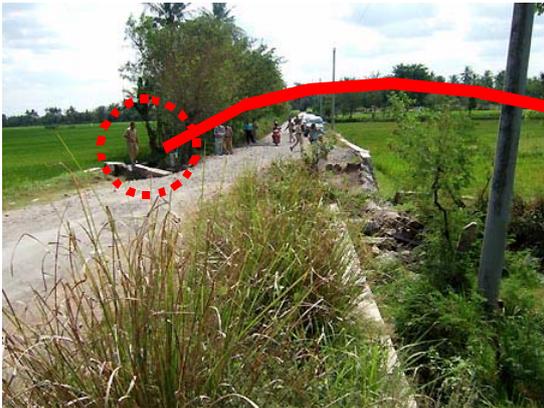
A skewed simply supported RC bridge (4 beams) of 3.5 m wide fell down due to embankment soil subsidence. The sunken soil mass seems to have pushed bottom of a stream flowing near by the embankment.

(a) Location of skewed bridge: Edge lines of road are seemingly dislocated right-lateral. However no clear dislocation was found in rice paddies.

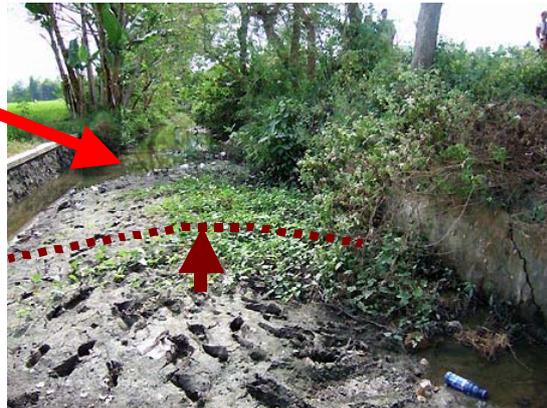
(b) Bottom of stream along the road has been pushed up

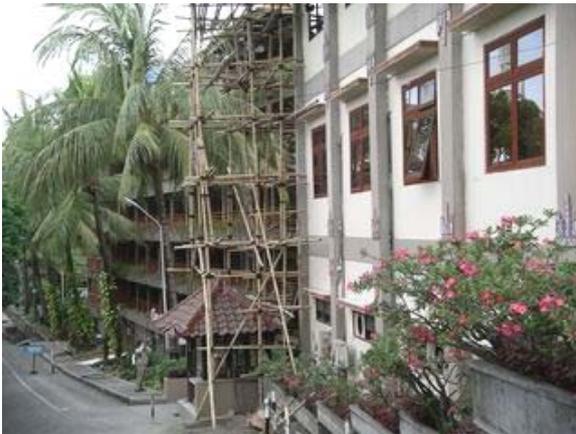
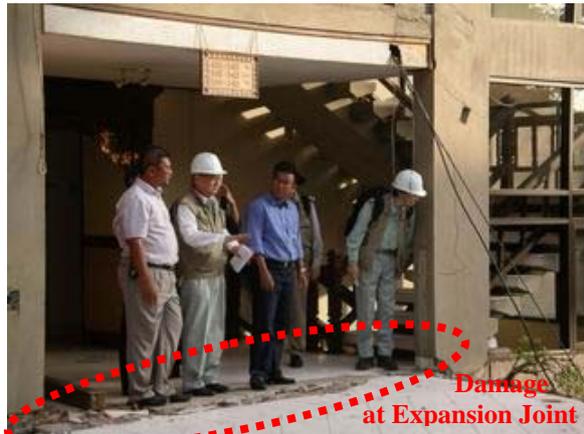
URM walls (brick walls) in RC frames had damage and a connecting bridge between two adjacent buildings (reception building and lodging building) was damaged at the expansion joint as well as its roof and handrail wall due to pounding. Roofing tiles on a steel truss system fell down through the ceiling board of guest rooms on the top floor, and falling debris were likely to have been life-threatening to guests staying at the time of the earthquake.

Closely neighboring structures with narrow gaps at expansion joints in between sustained pounding damage. Expansion joints should be therefore designed and constructed properly considering deformations expected during shaking.

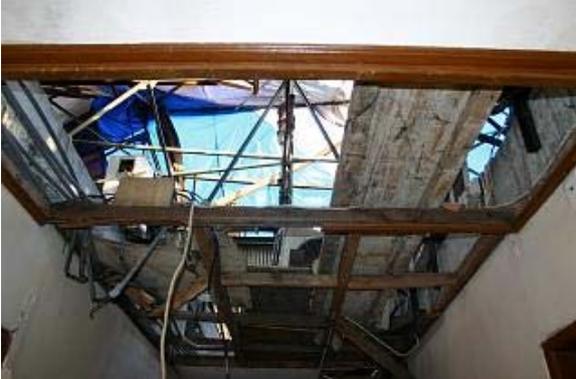
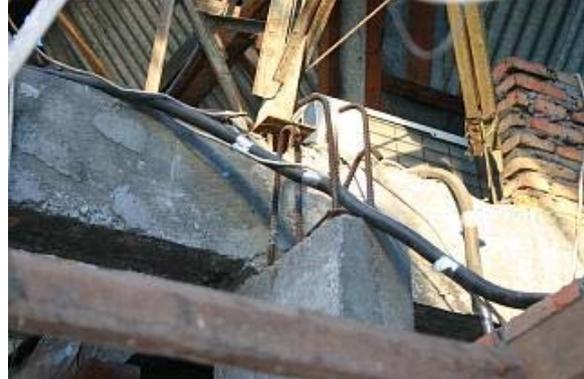
Damage to roof system above top story (some column rebars were not anchored to beams)

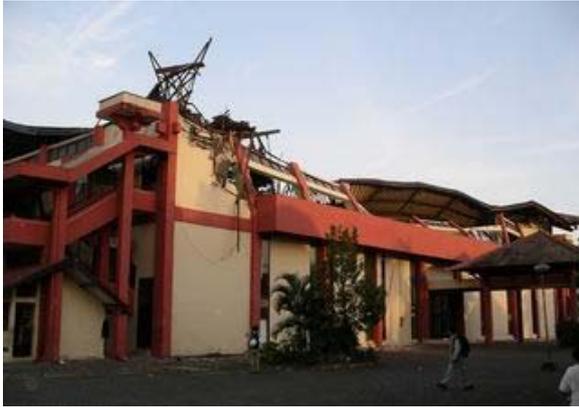
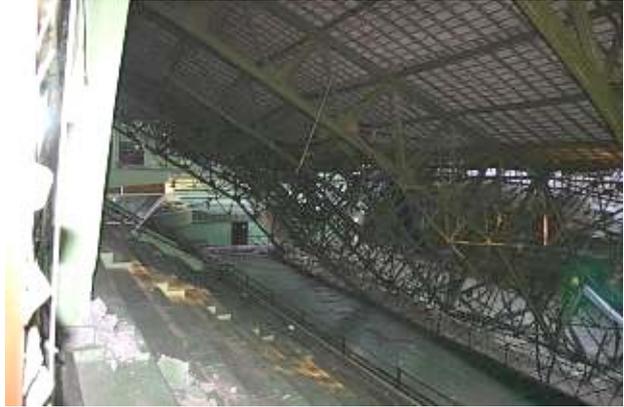
Extensive damage was found in cantilever RC columns on the top floor as well as in the roof system. The column damage may be attributed to the inertia force due to shaking, the inward force acting on the columns due to collapse of the roof, and the small amount of reinforcement provided in the columns.

Amongrogo Sport Center / Collapsed roof system associated with column failure underneath

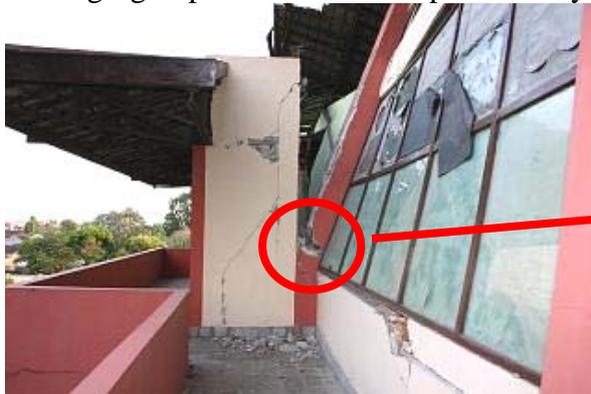
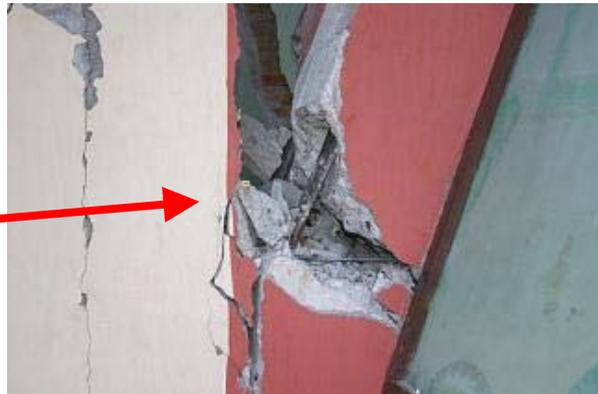
Heavy damage to RC columns and exposed rebars

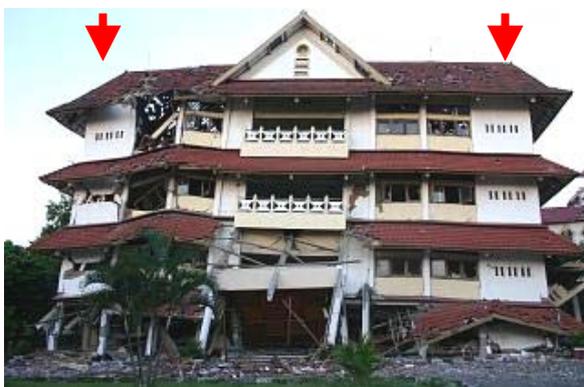
The university campus had several multi-story buildings. Serious structural and nonstructural damage was found in most buildings. One 4 story RC building, which was located just across the open square at the entrance gate, lost its first story due to beam-column joint failure. It had 2 URM wall frames while the neighboring 5 story building had 4 URM wall frames and did not collapse.

4 story building with 2 URM walls frames

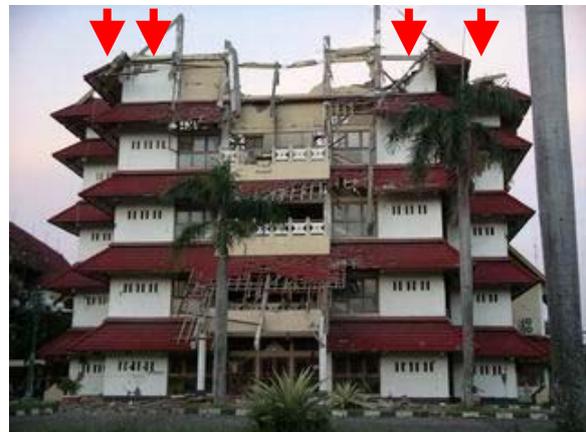
5 story building with 4 URM wall frames

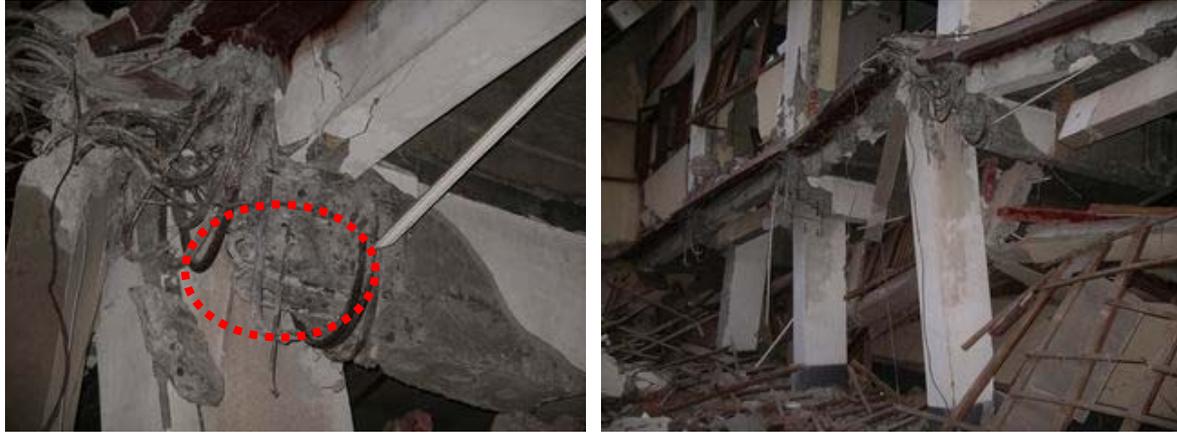
The damage was also attributed to the inadequate detailing of rebar ends placed at the bottom of beams and the insufficient section volume of beam-column joint as compared to the amount of reinforcing bars, which resulted in the pull-out failure of beam rebars at the joints.

University of Economic Science (STIE) / Beam bottom rebars inadequately anchored to joints

Concrete spalling at beam-column joints was observed in some RC buildings, exposing buckled longitudinal reinforcement. Some beam bottom reinforcing bars were improperly detailed and pulled out of the beam-column joints. They had 180-degree hooks in the ends but were straightly terminated in the joints without bent anchorage into the joint core concrete. Rigid beam-column joints properly confined with lateral reinforcement and beam reinforcement bent into the joint core to develop its full anchorage are most essential for RC structures to perform successfully during earthquakes.

Congestion of rebars was found in some buildings. Beams and columns therefore should be large enough to provide enough concrete volume at the beam-column joints for sufficient embedment length and anchorage of reinforcing bars.

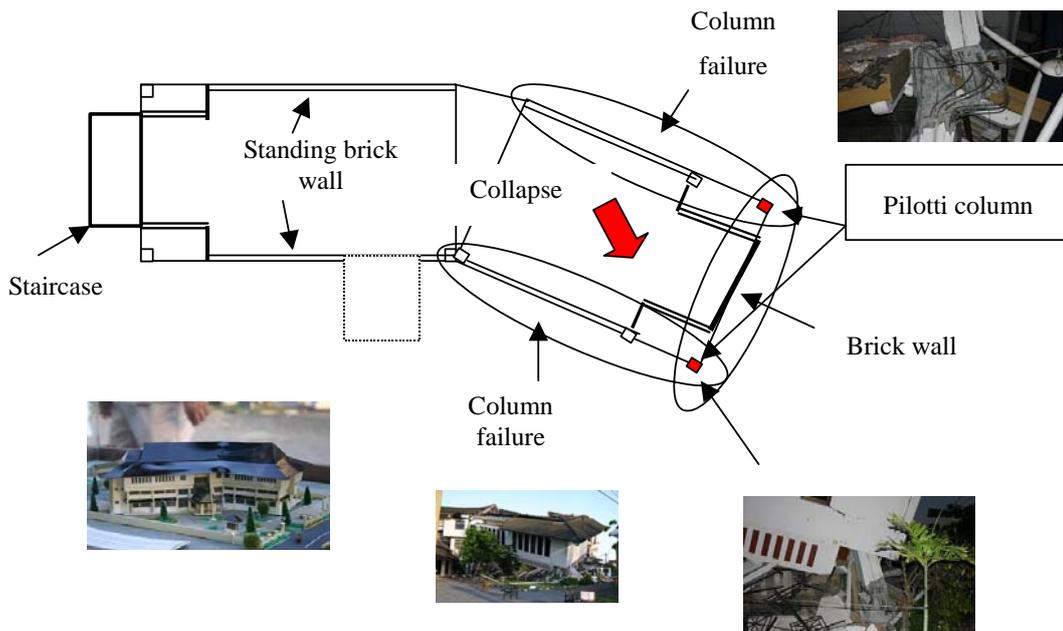
The 3 story RC office building lost its first story in the west wing due to beam-column joint failure in the 2nd floor while the east wing survived the shaking with damage to URM walls. Some rebars in columns were lap-spliced at joints, resulting in joint failure. The lateral reinforcement was placed at a space of 25cm to 30cm with 135-degree hooks. The serious damage to the west wing may be attributed to large deformations of soft columns supporting confined URM walls above on the west-end exterior frame and torsional response effects.

Building sketch and typical damage (BPKP)

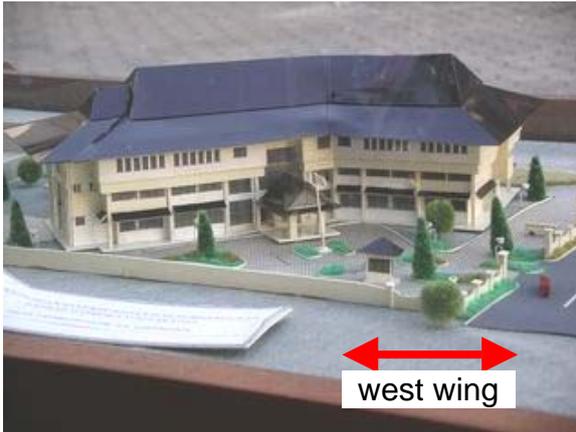
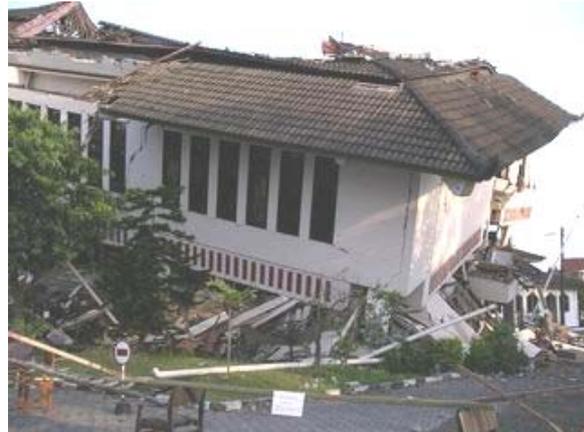
General view of Finance and Development Audit Agency (BPKP) and collapsed west wing

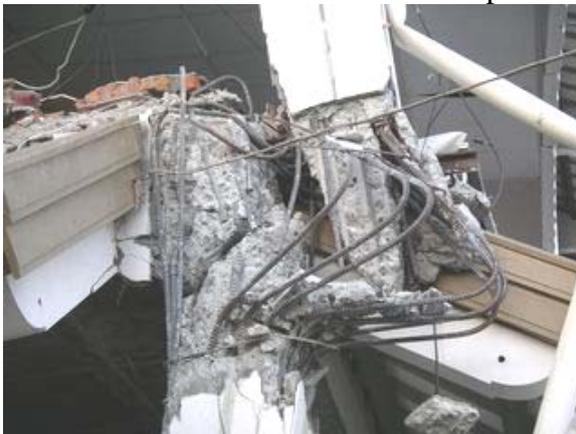
Beam-column joint failure

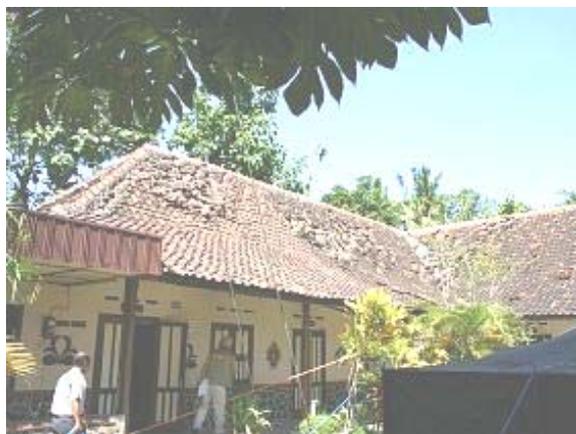
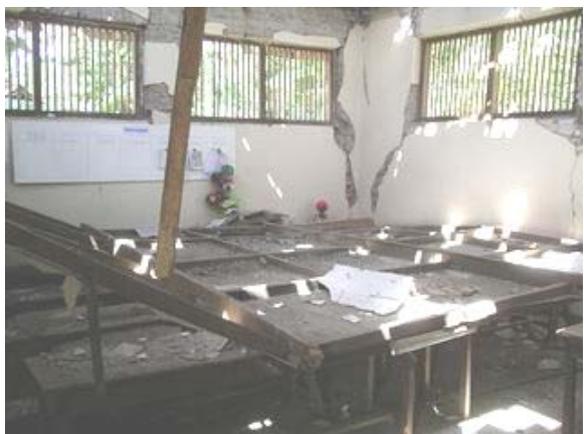
No lintel beams were found and the timber roof truss was directly placed on URM walls. Major damage was found in URM walls and the roof truss, and some ceiling boards fell down in the classrooms.

SD Tempel at Bambanglipuro / Heavy damage to URM wall and fallen ceiling boards

Even when a building had minor structural damage, some schools were significantly damaged in their roof system. Since the earthquake occurred early in the morning (5:53 local time), the loss of human lives was minimized. Falling debris such as bricks, ceiling boards, roofing tiles etc. are significantly life-threatening especially to school children. The structure underneath the roof should be rigid and strong enough to properly support the roof system during an earthquake. As pointed out in (1) above, providing RC frames is strongly recommended to provide sufficient in-plane and out-of-plane stiffness and strength to buildings.

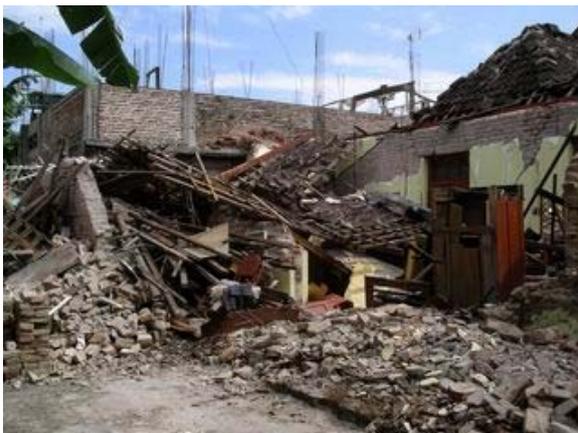
Houses in Imogiri were extensively devastated. They were URM structures with timber truss system and roofing tiles on it. URM walls were typically 20cm to 25cm thick with 2 or 1.5 brick units, having a geometry of 26cm x 12cm x 6cm. Since demolitions to reconstruct damaged houses had started in Imogiri, it was not easy to identify which debris were due to shaking and which were not. Those with RC frames to confine URM walls often survived the shaking although they had some damage.

Devastated URM house

Devastating damage was found in URM houses in Bantul Regency, Yogyakarta City, and Klaten Regency, killing residents due to heavy debris of brick walls. URM houses with RC beams and columns confining URM walls, however, were relatively less damaged, even when they were not intact. Providing RC frames to confine masonry walls, therefore, is strongly recommended to reduce structural damage to URM houses.

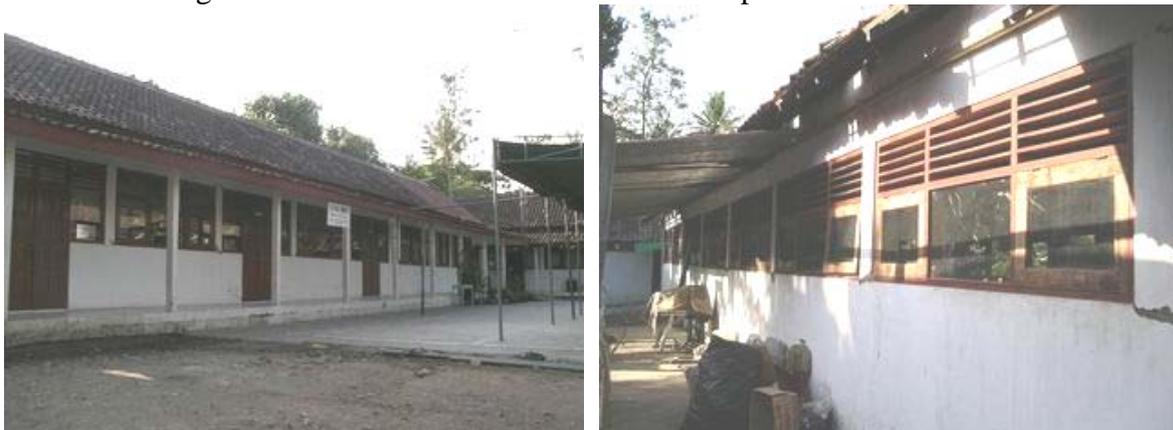
Each class had 2 bays in the longitudinal direction. Each bay was 3.5m long. Columns had flexural cracks at both ends. The presence of reinforcing bars was not confirmed at the site since the building had minor cracks and rebars were not exposed.

SLB-PGRI Trimulyo / Cracks found in column ends

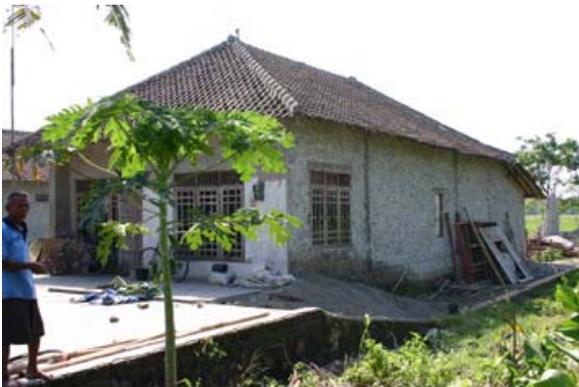
Traditional stone masonry houses in Gantiwarno Sub-Regency had some damage in masonry walls. They had some RC beams on the wall but no RC columns were provided in the houses. Although they were heavy, the stone masonry walls were thick and long enough to resist and survive the shaking. Another traditional house older than the stone masonry construction had minor damage since they had light bamboo-net walls. The bamboo-net house investigated by the reconnaissance team was older than 70 years.

Stone masonry house with cracks in walls

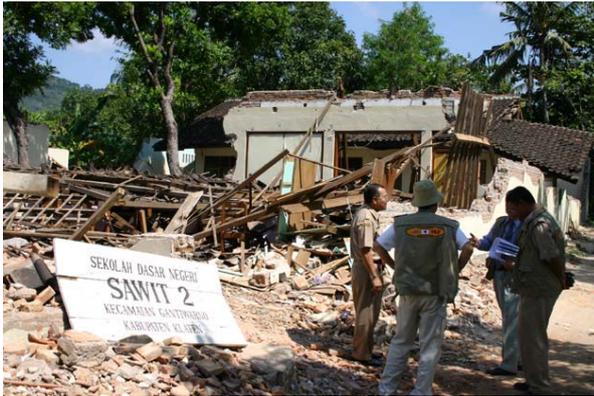
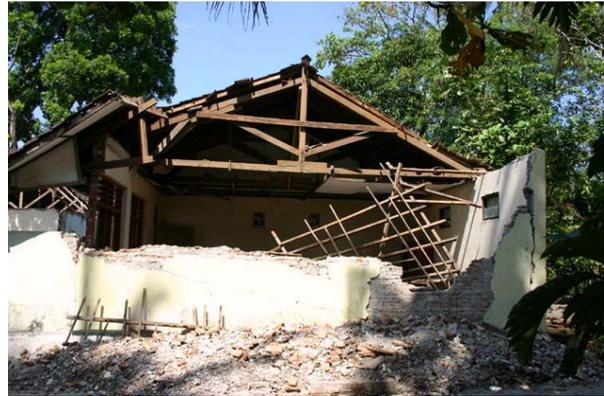
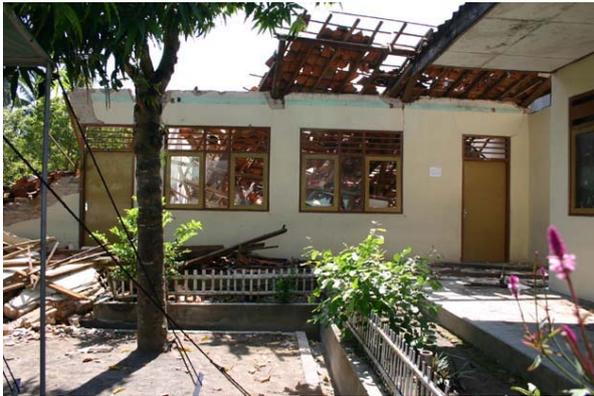
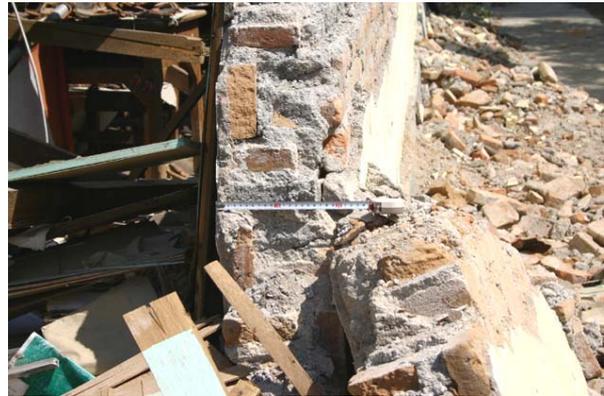
The school building most probably had RC columns only at the 4 exterior corners but no columns in the middle of the structure. Each class had 2 bays and each bay was 3.5m long. Extensive damage was found in 20cm thick URM walls and the roof system.

SD Sawit at Gantiwarno / Collapsed building

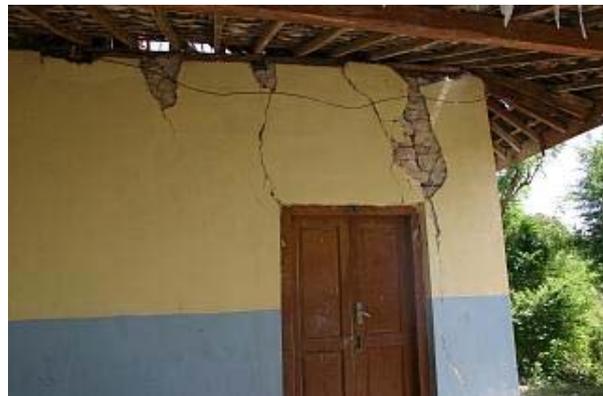
Damage to corner wall

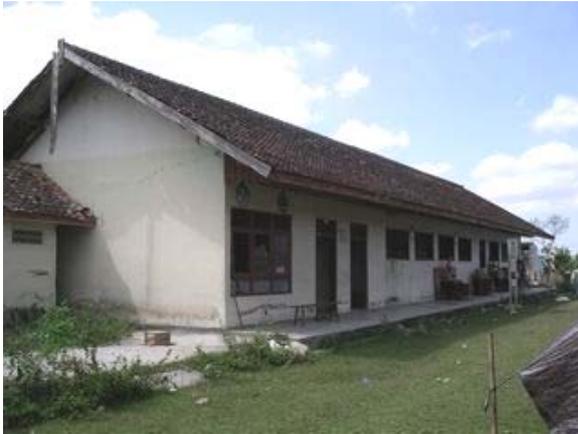
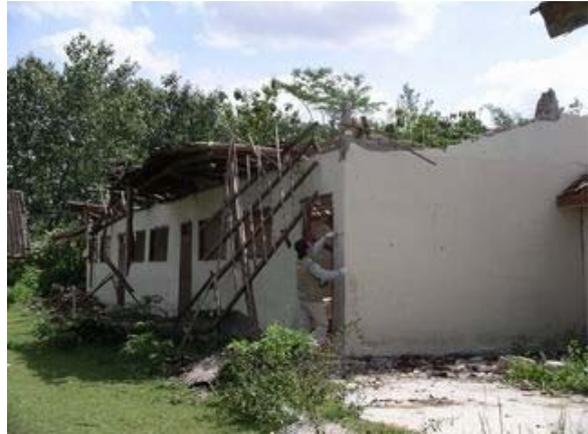
The school had two buildings, one was seriously damaged in the roof system and the other survived the shaking. Columns having a geometry of 150mm x 150mm with 4- ϕ 13 main rebars and ϕ 6 hoops were provided between classrooms. Mid-span walls were 150mm thick and 500mm wide. The eaves were supported by the timber truss fastened to RC columns

One building extensively damaged in the roof system

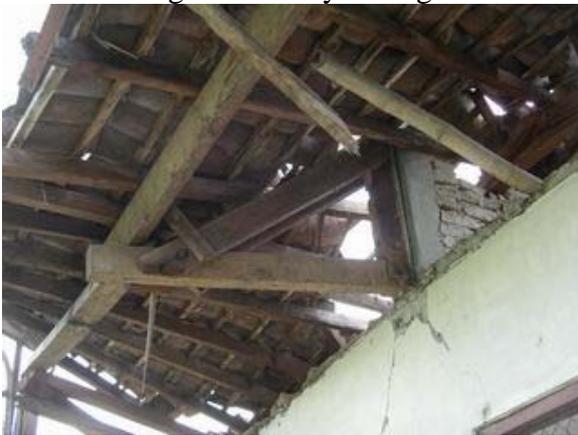
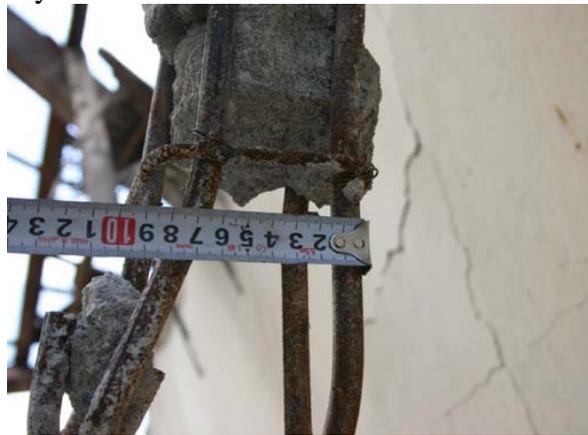
SD Pesu / Exposed rebars in a column supporting roof system above
