JSCE (Japan Society of Civil Engineers)
- NPO: EWB (Engineers Without Borders, Japan)
Joint Team
for
INSTRUCTIONS FOR GEOTECHNICAL INVESTIGATION
AND THE PRACTICAL UTILIZATION OF ITS RESULTS
FOR RECOVERY AND RECONSTRUCTION OF NIAS
ISLAND AND FOR DISASTER PREVENTION OF NORTH
SUMATRA AND WEST SUMATRA PROVINCE

Feb. 17 -25, 2007

SUPPORT ACTIVITIES FOR THE RECOVERY AND RECONSTRUCTION BY TRANSFERING THE TECHNIQUE ON GEOTECHNICAL INVESTIGATION IN NIAS ISLAND DAMAGED BY THE M8.7 OFF-SHORE SUMATRA EARTHQUAKE, MARCH 28, 2005

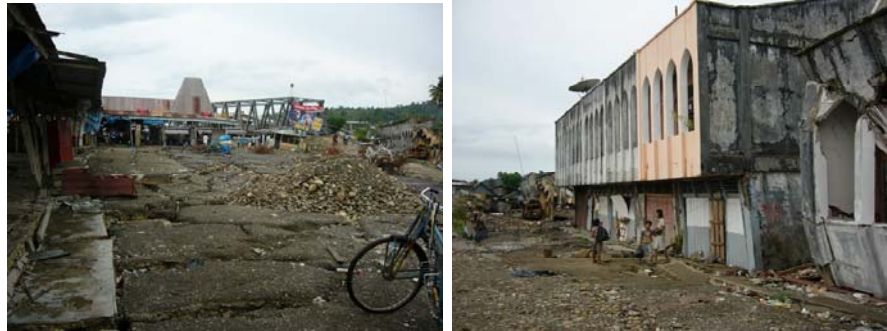
Figure 6. Effect of liquefaction and lateral spreading on RC building and truss bridge

As expected from the magnitude of this earthquake, the liquefaction of sandy ground is very likely. The sandy ground is observed along seashore and riverbanks in Nias Island. Permanent ground movements such as settlement and lateral spreading, and associated structural damage due to liquefaction were widely observed in various locations along the coastal area and reclaimed ground. The lateral spreading of ground nearby bridge abutments were almost entirely associated with liquefaction of sandy soil layer. The damage induced in Gunung Sitoli due to ground liquefaction is widespread along the coastal area, reclaimed ground and riverbanks. All the possible forms of ground movements and the effects of ground liquefaction were observed such as sand boils, lateral ground movements and settlement. As a result, many buildings in such areas were heavily damaged with partial settlement, inclination and uplift of ground floor. The buildings without raft foundations and

continuous tie-beams could not resist to ground failures due to liquefaction unless they are built on piles extending into the non-liquefiable layer. Figure 7 shows the damages of buildings due to liquefaction. In Figure 8 grain size distribution curves for soil samples in Gunung Sitoli can be seen. It can be seen that these soils have almost the same grain size and they are very liquefiable. Swedish weight sounding tests were conducted at 2 points in Gunung Sitoli. Soil profile, converted SPT N-value from Swedish weight sounding test and Liquefaction Potential based on the result of geotechnical investigation are shown in Figure 9.

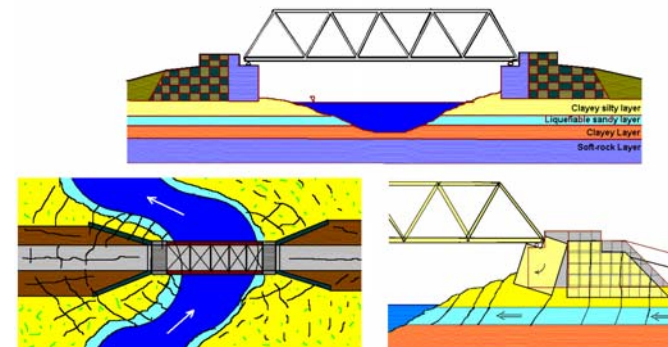
Damage of Bridges Associated with Ground Liquefaction

The lateral spreading of ground was larger on the convex side of the river bank as the ground can freely move towards the river.
Thickness of liquefiable layer is probably 1-2m thick

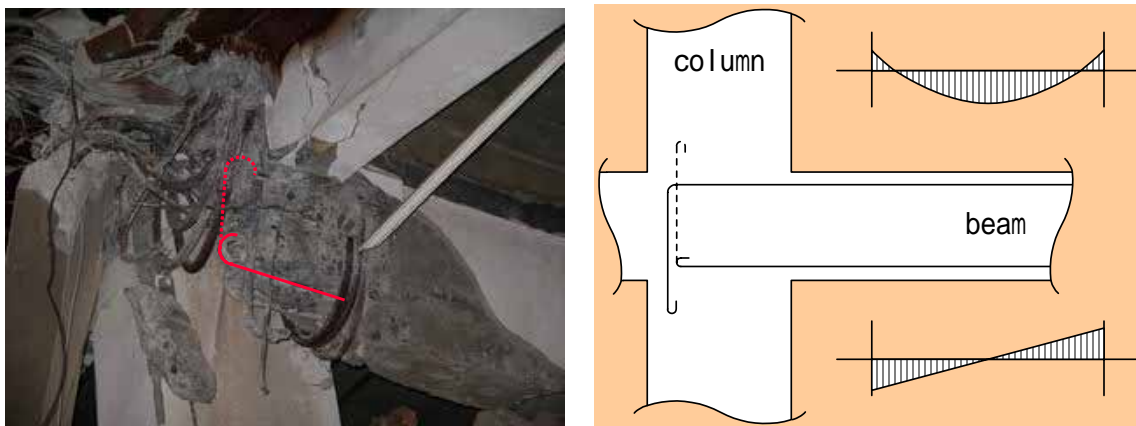
Photo 1 Pull-out failure of beam rebars at joint during 2006 Central Java Earthquake

Note: Some beam bottom reinforcing bars were improperly detailed and pulled out of the beam-column joints. They had 180-degree hooks in the ends but were straightly terminated in the joints without bent anchorage into the joint core concrete. Rigid beam-column joints properly confined with lateral reinforcement and beam reinforcement bent into the joint core to develop its full anchorage are most essential for RC structures to perform successfully during earthquakes.

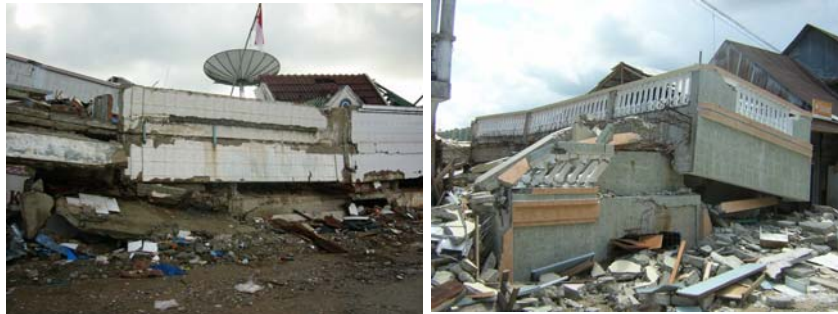
Figure 7: Pan cake failure of buildings

The collapses and heavy damage of RC buildings in Telukdalam town, which is about 150km from the epicenter, may be associated with soft ground condition in addition to the problems mentioned above. It seems that the ground shaking may be amplified in soft ground as it is the common case for shaking in coastal areas due to earthquakes in inter-plate subduction zones.

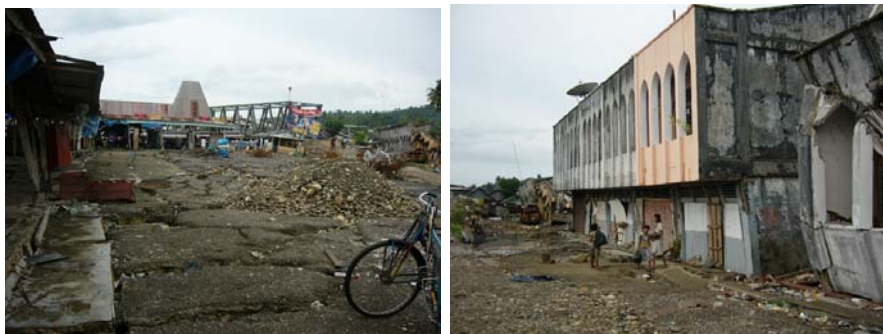
Figure 8: Effect of liquefaction and lateral spreading on RC building and truss bridge

As expected from the magnitude of this earthquake, the liquefaction of sandy ground is very likely. The sandy ground is observed along seashore and riverbanks. Damage of ground like settlement, lateral flow and associated structural damage due to liquefaction were widely observed in various locations along the coastal area and reclaimed ground. The damage induced in Gunung Sitoli due to liquefaction is widespread along the coastal area, reclaimed ground and riverbanks. The all possible forms of ground movements and the effects of ground liquefaction were observed such as sand boils, lateral ground movements, settlement. The lateral spreading of ground nearby bridge abutments were almost entirely associated with liquefaction of sand soil layer. Figure 9 shows grain size distribution curves for soil samples in Gunung Sitoli. It can be seen that these soils have almost the same grain size and they are very liquefiable. Swedish weight sounding tests were conducted at 2 points in Gunung Sitoli. Soil profile, converted SPT N-value from Swedish weight sounding test and Liquefaction Potential based on the result of geotechnical investigation are shown in Figure 10. Method of liquefaction assessment is according to the Recommendation for Design of Building Foundations, Architectural Institute of Japan. In this study, maximum acceleration of strong ground motion is taken as 350cm/s^2 for ultimate limit, which is as large as observed in liquefied area during Hyogoken-Nambu earthquake. There is a 3m thick loose sandy layer at the subsurface of reclaimed ground (shop house), which is inferred to be easily liquefiable from the result of Swedish weight sounding. As mentioned above, many buildings in such areas were heavily damaged with partial settlement, inclination and uplift of ground floor. As a result, almost all building were demolished and removed. At the site of Governor's house, there exist sandy layer, but having relatively large N-value and partially liquefiable during strong ground motion obtained from the assessment based on the test result. The elevation of the site is slightly higher than that of the reclaimed area and only small damages such as cracking in floor concrete were observed after the earthquake. The results obtained from geotechnical investigation are in good accordance with the observed damages caused by the earthquake. However, the geotechnical investigations of ground are scarce in Nias Island and it would be desirable to carry out such investigations in areas particularly affected by ground liquefaction in relation to recovery and reconstruction of Nias Island.
